**U.S. ENVIRONMENTAL PROTECTION AGENCY, REGION V
POLLUTION/SITUATION REPORT #115**

**KALAMAZOO RIVER/ENBRIDGE SPILL – REMOVAL
SITE # Z5JS
MARSHALL, MICHIGAN
LATITUDE: 42.2395273; LONGITUDE: -84.9662018**

Date: 9/16/2011

Reporting Period: 0700 hours 8/29/2011 through 0700 hours 9/12/2011

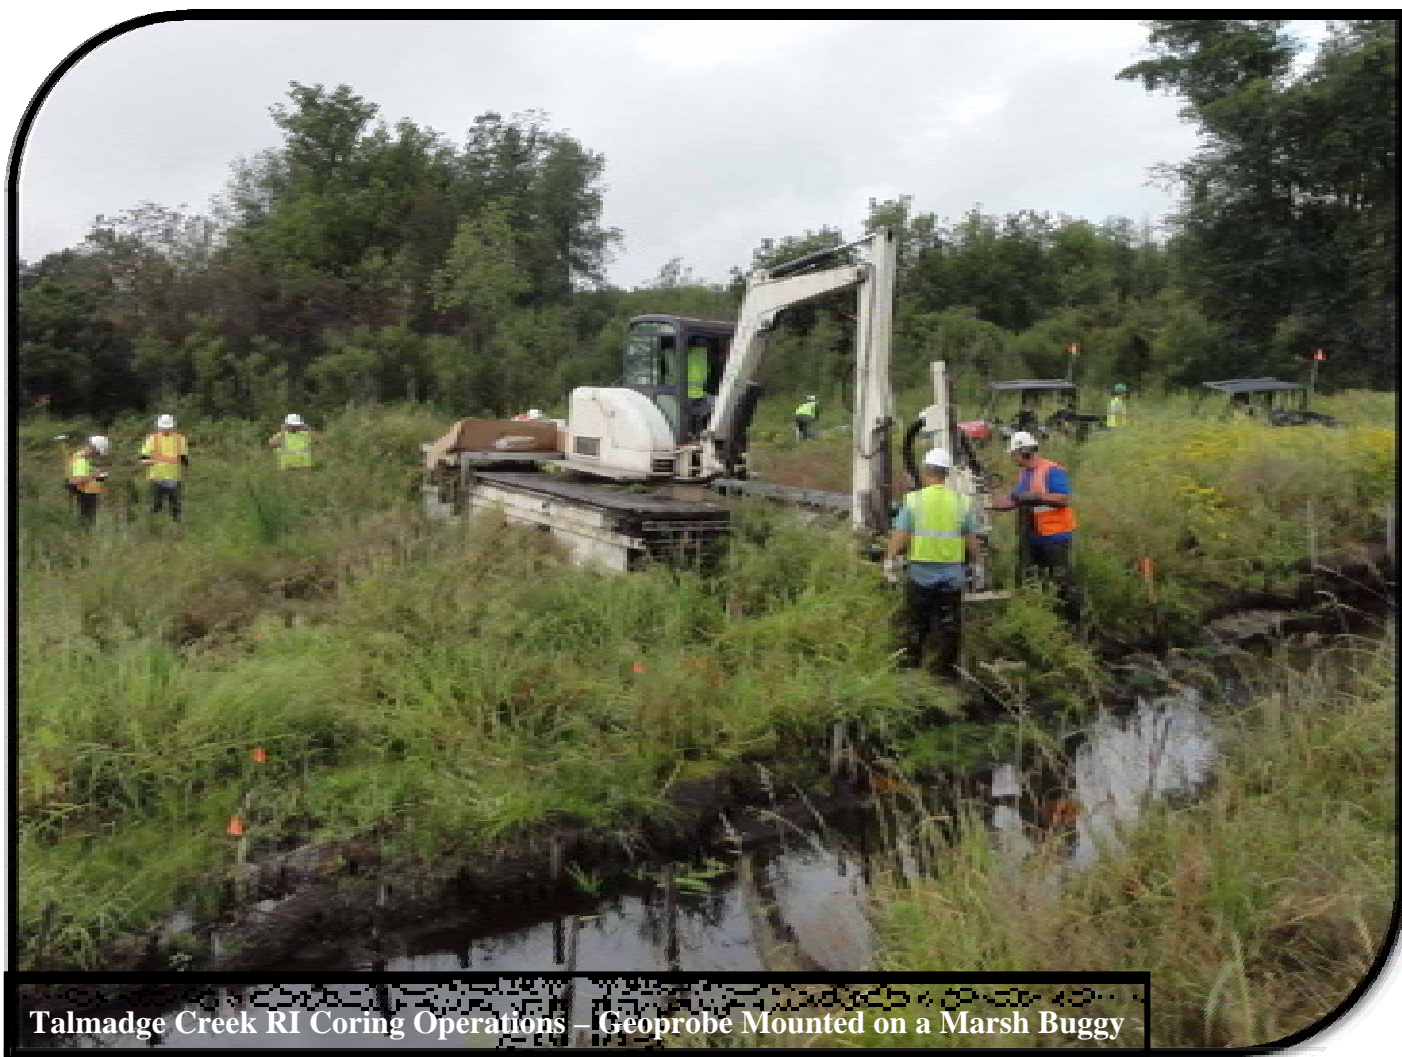
Talmadge Creek RI Coring Operations – Geoprobe Mounted on a Marsh Buggy

- Under direction of MDEQ, Enbridge continued defining the nature and extent of remaining crude oil impacts to the sediment and floodplain area of the Talmadge Creek. Teams conducted visual observations, conducted poling, collected soil cores from the banks of the Talmadge Creek, delineated floodplain areas, and collected ground water samples from temporary wells.

- Remedial Investigation (RI) work continued along Talmadge Creek. Enbridge focused on increasing resources for the RI. Crews conducted coring activities utilizing increasingly mechanized techniques.
