U.S. ENVIRONMENTAL PROTECTION AGENCY, REGION V  
POLLUTION/SITUATION REPORT #128

**KALAMAZOO RIVER/ENBRIDGE SPILL – REMOVAL**  
**SITE # Z5JS**  
**MARSHALL, MICHIGAN**  
**LATITUDE: 42.2395273; LONGITUDE: -84.9662018**

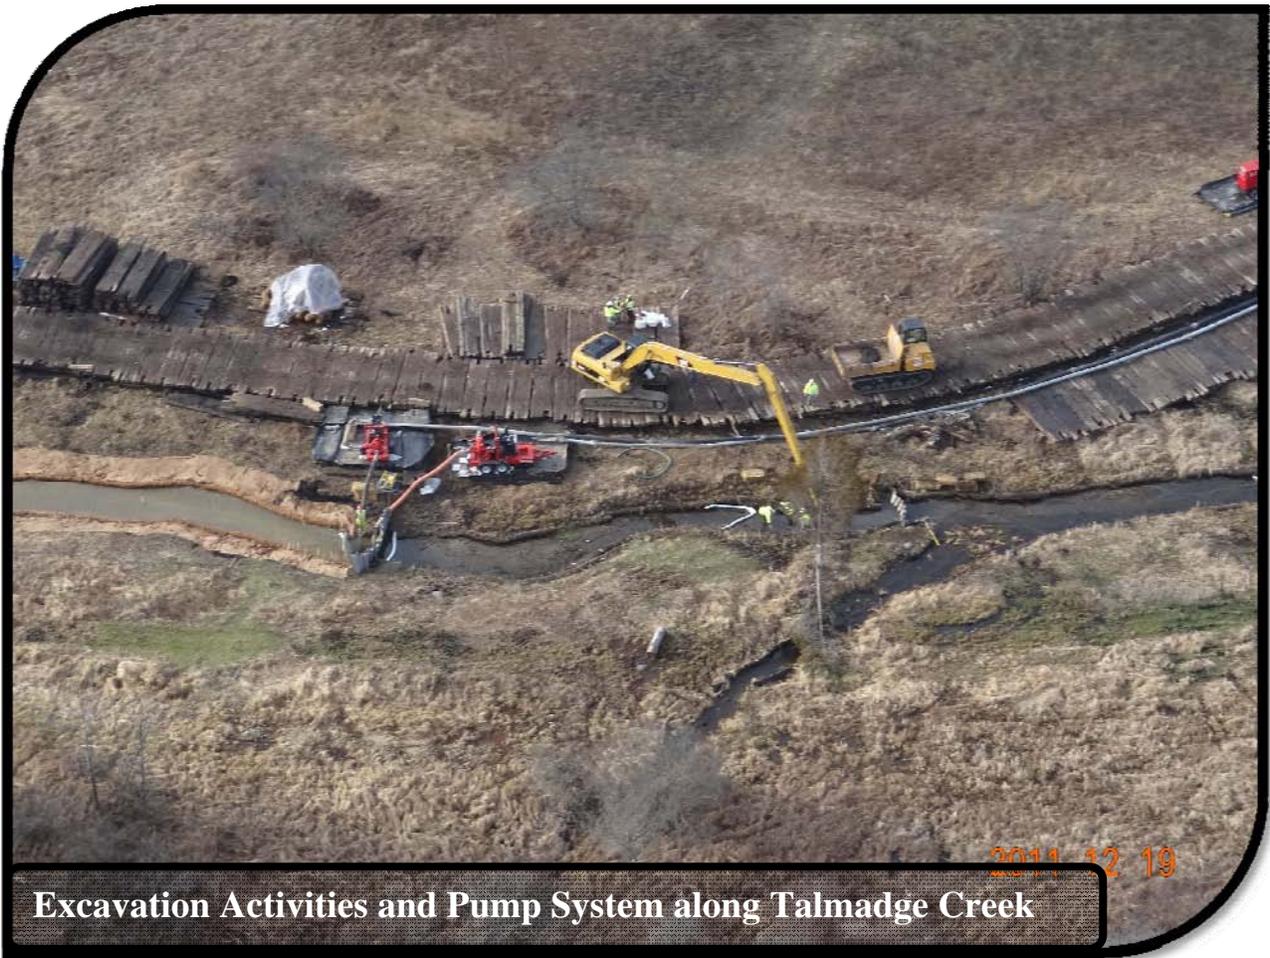
Excavation Activities and Pump System along Talmadge Creek

- Teams continued to operate and maintain the pump-around and GAC dewatering systems, and maintain soil erosion controls. Prior to the holiday intermission, sheet piling and dewatering systems were removed from Talmadge Creek; thereby returning the creek to natural flow conditions.
- Excavation, restoration, and post – excavation verification sampling continued from MP 0.5 through MP 1.0.
- Teams maintained soil erosion and sediment controls within Talmadge Creek.
