U.S. ENVIRONMENTAL PROTECTION AGENCY, REGION V
POLLUTION/SITUATION REPORT #135

**KALAMAZOO RIVER/ENBRIDGE SPILL – REMOVAL
SITE # Z5JS
MARSHALL, MICHIGAN
LATITUDE: 42.2395273; LONGITUDE: -84.9662018**

From: Ralph Dollhopf, U.S. EPA, Federal On-Scene Coordinator
Date: 3/5/2012
Reporting/Operational Period: 0700 hours 2/16/2012 through 0700 hours 02/23/2012

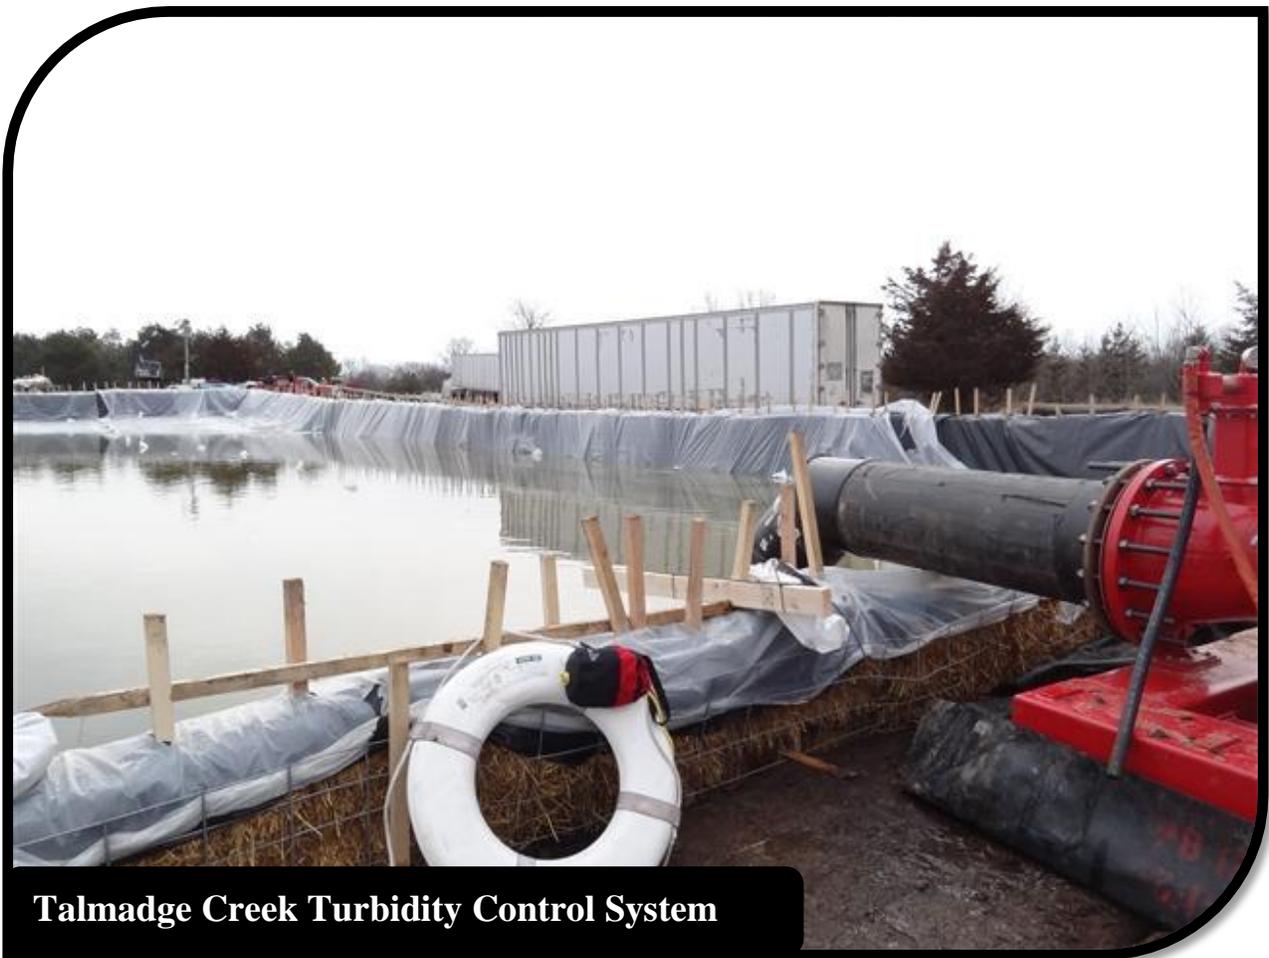
Talmadge Creek Turbidity Control System

- Operation and maintenance of the pump-around and GAC dewatering systems is on-going.
- Maintenance of soil erosion and sedimentation controls continues.
- Construction was completed and operation of a large scale turbidity control system began in order to mitigate sediment and oil contaminated sediment from entering the Kalamazoo River during remediation activities.
- Demobilization from MP 0.75 through MP 1.55 began.
- Excavation between MP 1.55 and MP 2.08 was initiated. Excavation activities were suspended until additional sediment control measures could be established.
