U.S. ENVIRONMENTAL PROTECTION AGENCY, REGION V
POLLUTION/SITUATION REPORT #138

**KALAMAZOO RIVER/ENBRIDGE SPILL – REMOVAL
SITE # Z5JS
MARSHALL, MICHIGAN
LATITUDE: 42.2395273; LONGITUDE: -84.9662018**

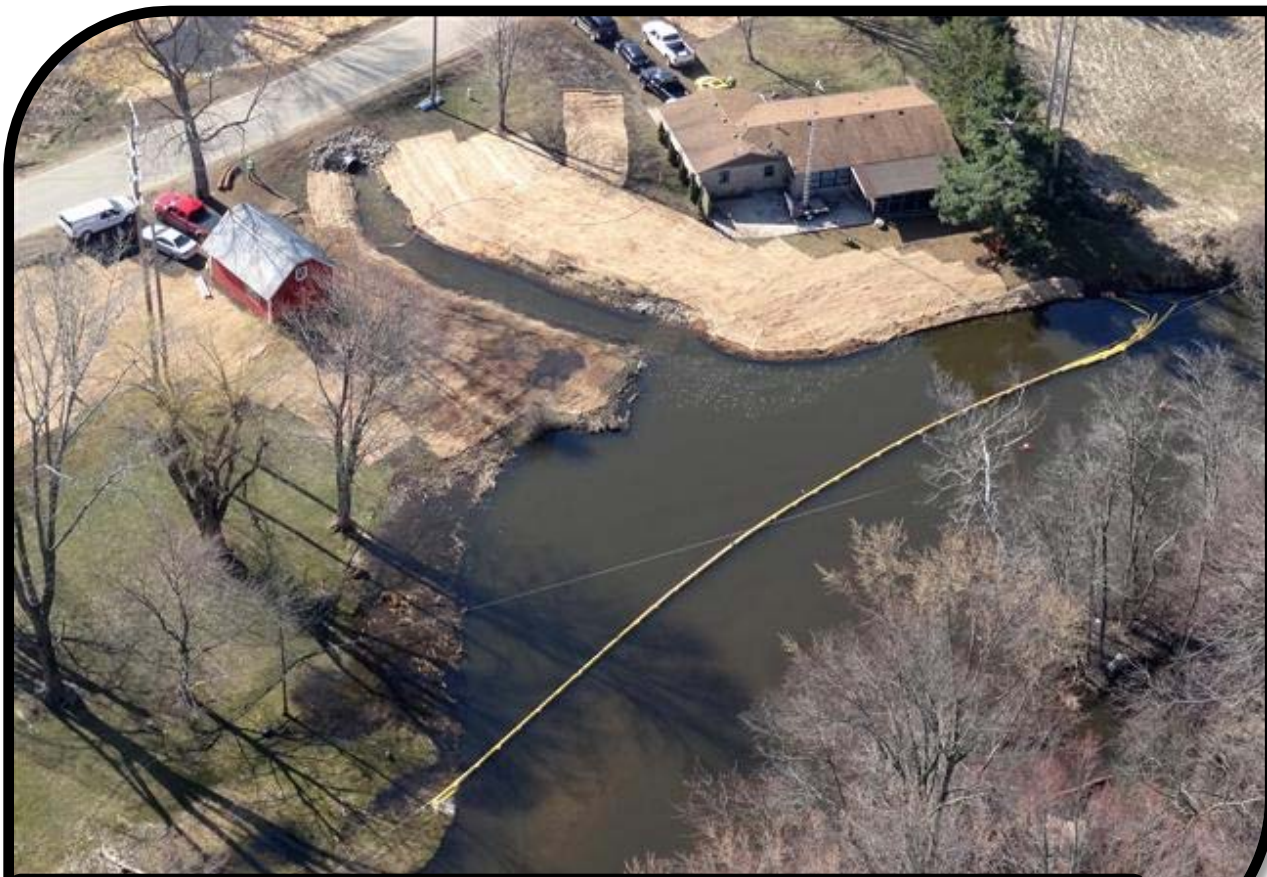
Confluence Excavation and Restoration Activities Completed

- Removal of soil erosion and sedimentation controls was completed.
- Excavation, restoration and demobilization between MP 1.75 and MP 2.25 was completed.
- Crews continued to demobilize sheet piling, equipment and road mats from the recently completed confluence excavation. Crews conducted some oil-impacted soil scraping activities in some areas as road mats were being removed between A-Drive and the confluence.
