U.S. ENVIRONMENTAL PROTECTION AGENCY, REGION V
POLLUTION/SITUATION REPORT #139

**KALAMAZOO RIVER/ENBRIDGE SPILL – REMOVAL
SITE # Z5JS
MARSHALL, MICHIGAN
LATITUDE: 42.2395273; LONGITUDE: -84.9662018**

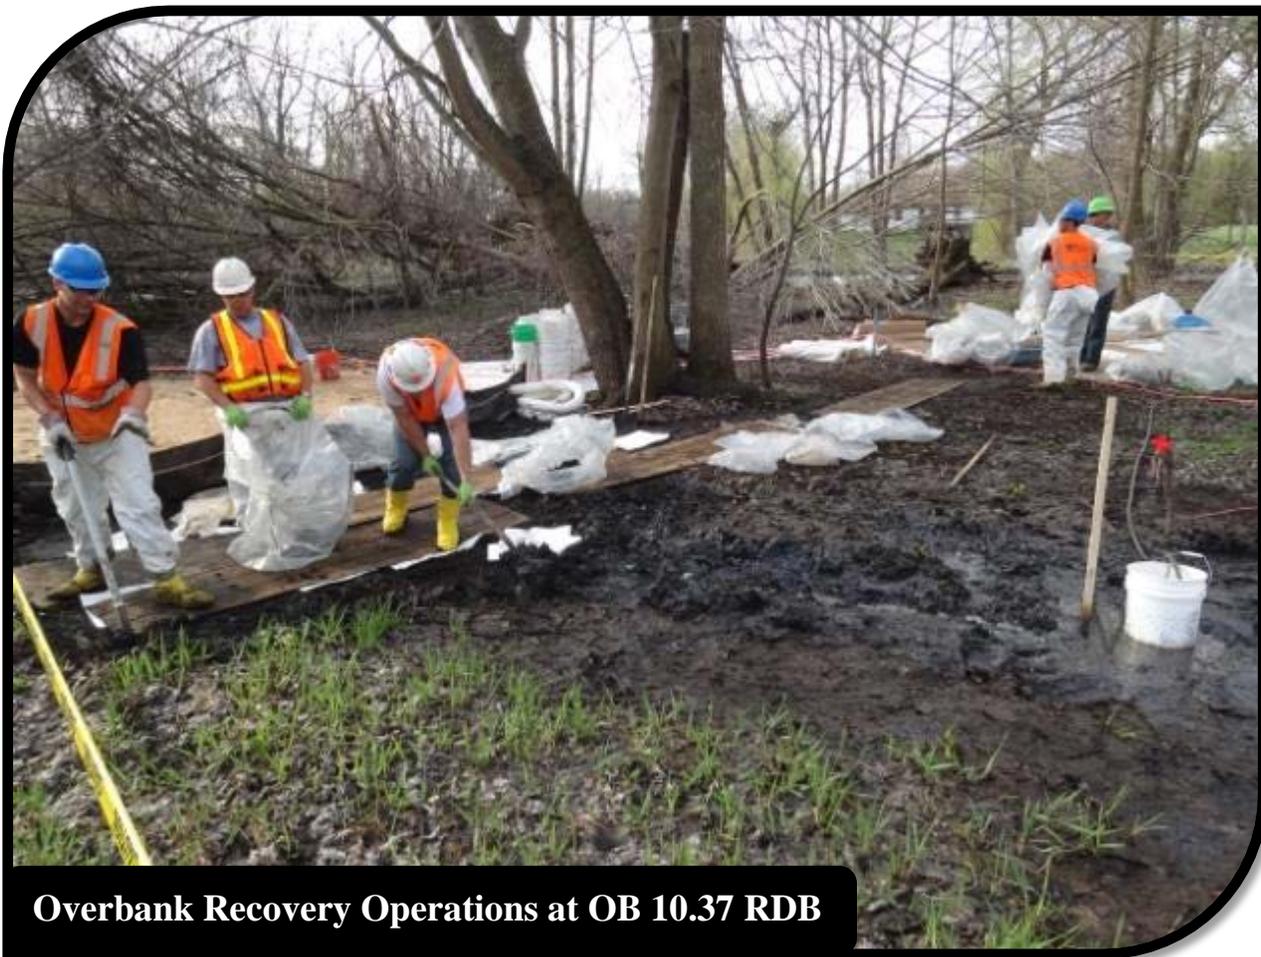
Overbank Recovery Operations at OB 10.37 RDB

- High water levels continued to impede excavation activities at OB 8.97 Island and OB 10.37 RDB. Approximately 60% of the soil removal work was completed at OB 8.97 Island and 88% at OB 10.37 RDB at the conclusion of the operational period.
- Activities at OB 9.10 LDB were completed.
