U.S. ENVIRONMENTAL PROTECTION AGENCY, REGION V
POLLUTION/SITUATION REPORT #144

**KALAMAZOO RIVER/ENBRIDGE SPILL – REMOVAL
SITE # Z5JS
MARSHALL, MICHIGAN
LATITUDE: 42.2395273; LONGITUDE: -84.9662018**

From: Ralph Dollhopf, U.S. EPA, Federal On-Scene Coordinator
Date: 05/09/2012
Reporting/Operational Period: 0700 hours 04/26/2012 through 0700 hours 05/03/2012

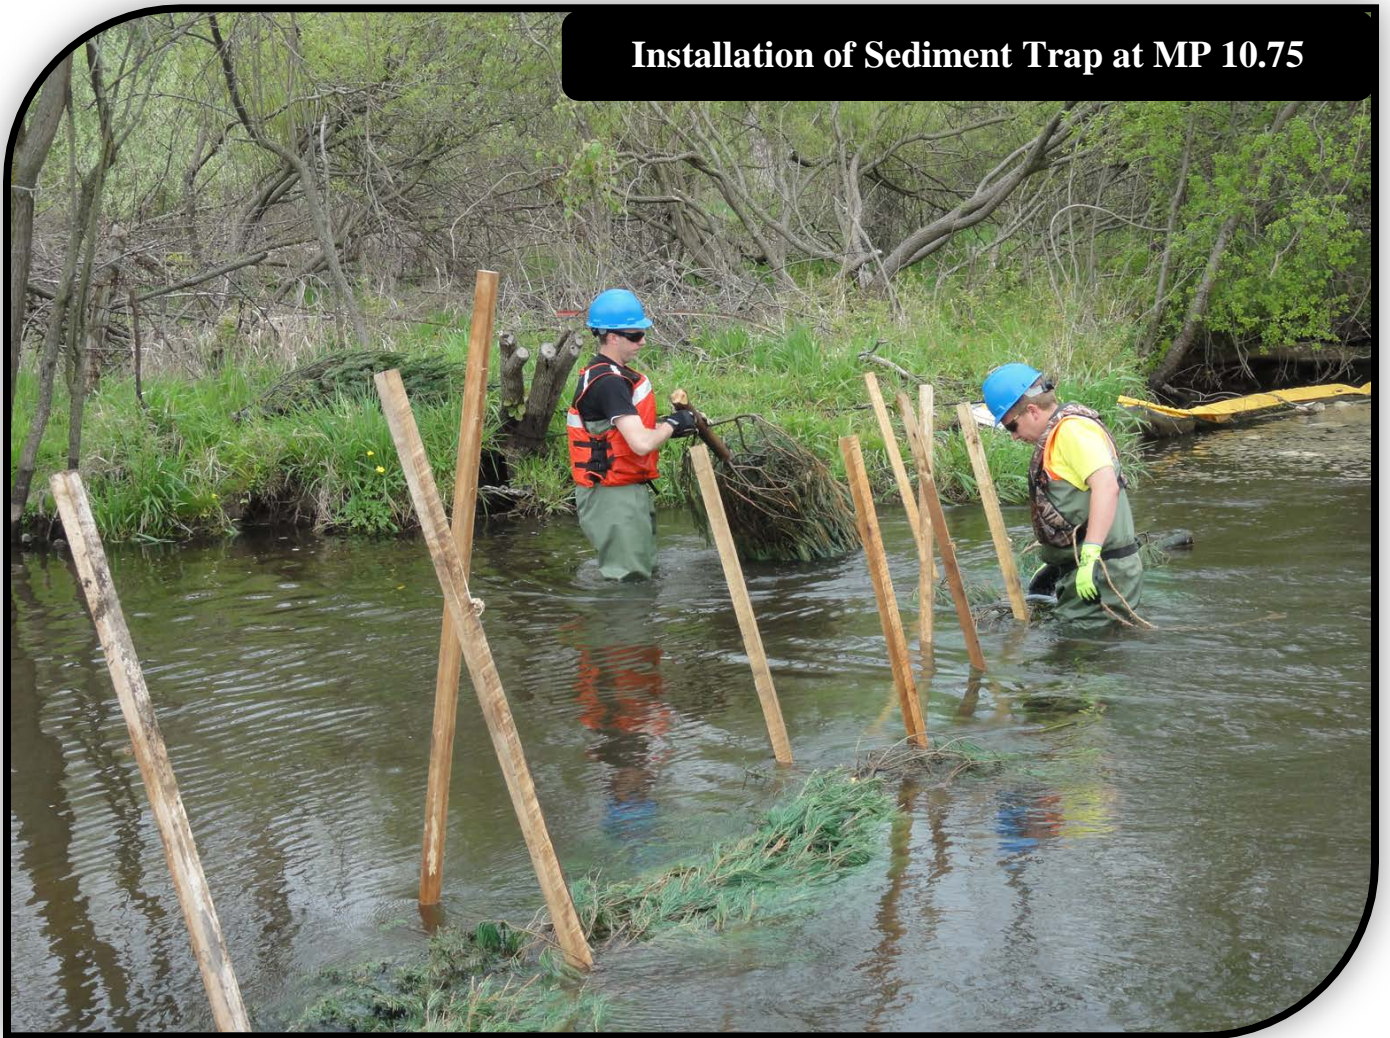
Installation of Sediment Trap at MP 10.75

- Crews completed the installation of the sediment traps at MP 19.25, MP 14.75, and MP 10.75 during this operational period. Installation of the sediment trap at MP 36.01 is pending a signed access agreement with the land owner.
- Crews continued to maintain 1,950 feet of surface hard boom at 11 protective containment sites, and 3,475 feet of surface hard boom at 3 control points. Teams removed debris accumulated within the boomed areas and recorded observations and estimates of surface area of accumulated petroleum sheen at the control points.
