**U.S. ENVIRONMENTAL PROTECTION AGENCY, REGION V  
POLLUTION/SITUATION REPORT #180**

**KALAMAZOO RIVER/ENBRIDGE SPILL – REMOVAL  
SITE # Z5JS  
MARSHALL, MICHIGAN  
LATITUDE: 42.2395273; LONGITUDE: -84.9662018**

**Date:** 06/05/2013

**Reporting/Operational Period:** 0700 hours 05/06/2013 through 0700 hours 05/20/2013

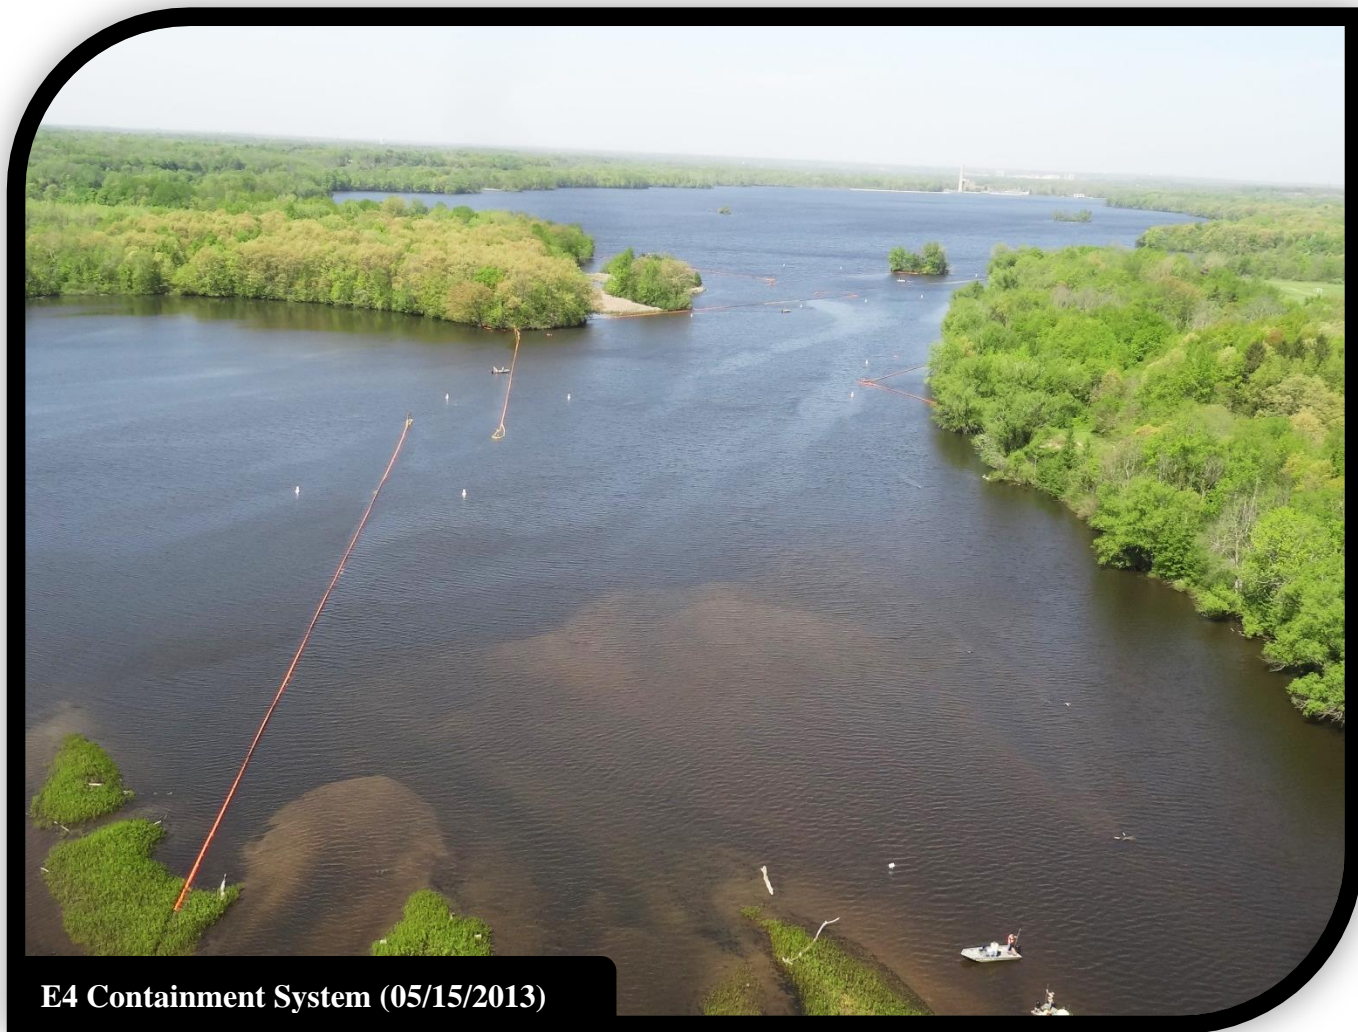
**E4 Containment System (05/15/2013)**

- Enbridge completed installation of the E4.0 Containment System (3,525 feet of surface hard boom and 2,750 feet of subsurface half-curtain) on May 14, 2013. Baseline bathymetry and maintenance of the E4.0 Containment System was conducted following installation.
