U.S. ENVIRONMENTAL PROTECTION AGENCY, REGION V
POLLUTION/SITUATION REPORT #184

**KALAMAZOO RIVER/ENBRIDGE SPILL – REMOVAL
SITE # Z5JS
MARSHALL, MICHIGAN
LATITUDE: 42.2395273; LONGITUDE: -84.9662018**

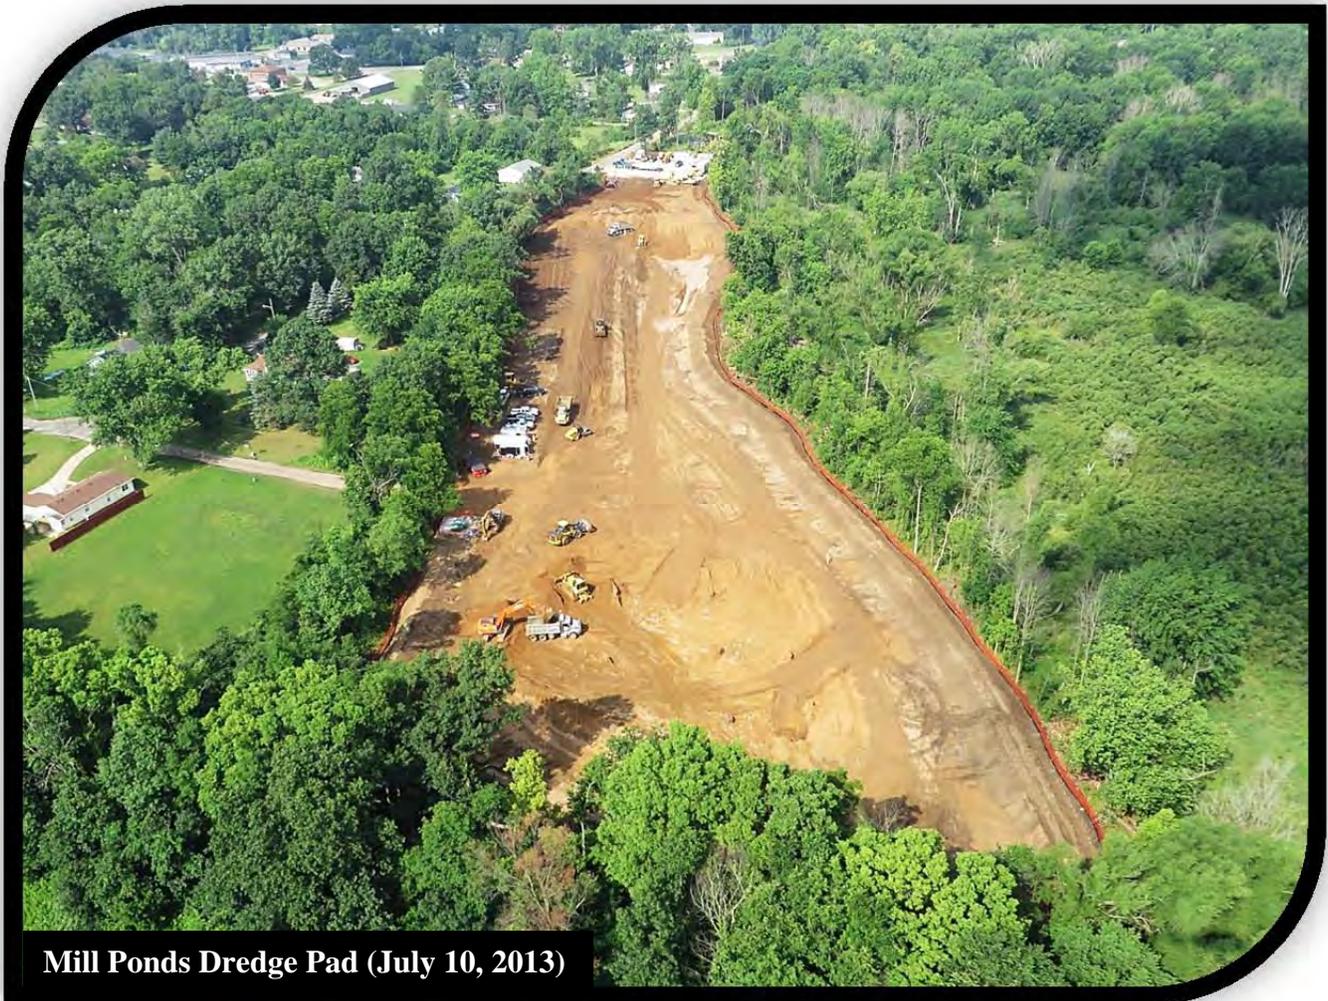
Mill Ponds Dredge Pad (July 10, 2013)

- Dredge pad construction continued at Ceresco Dredge Pad, MP10.4 sediment trap, and the Mill Ponds Dredge Pad. Dredge pad construction activities included development of bag filter pad, pugmill pad, water treatment pad, and sediment staging areas.
