U.S. ENVIRONMENTAL PROTECTION AGENCY, REGION V
POLLUTION/SITUATION REPORT #188

KALAMAZOO RIVER/ENBRIDGE SPILL – REMOVAL
SITE # Z5JS
MARSHALL, MICHIGAN
LATITUDE: 42.2395273; LONGITUDE: -84.9662018

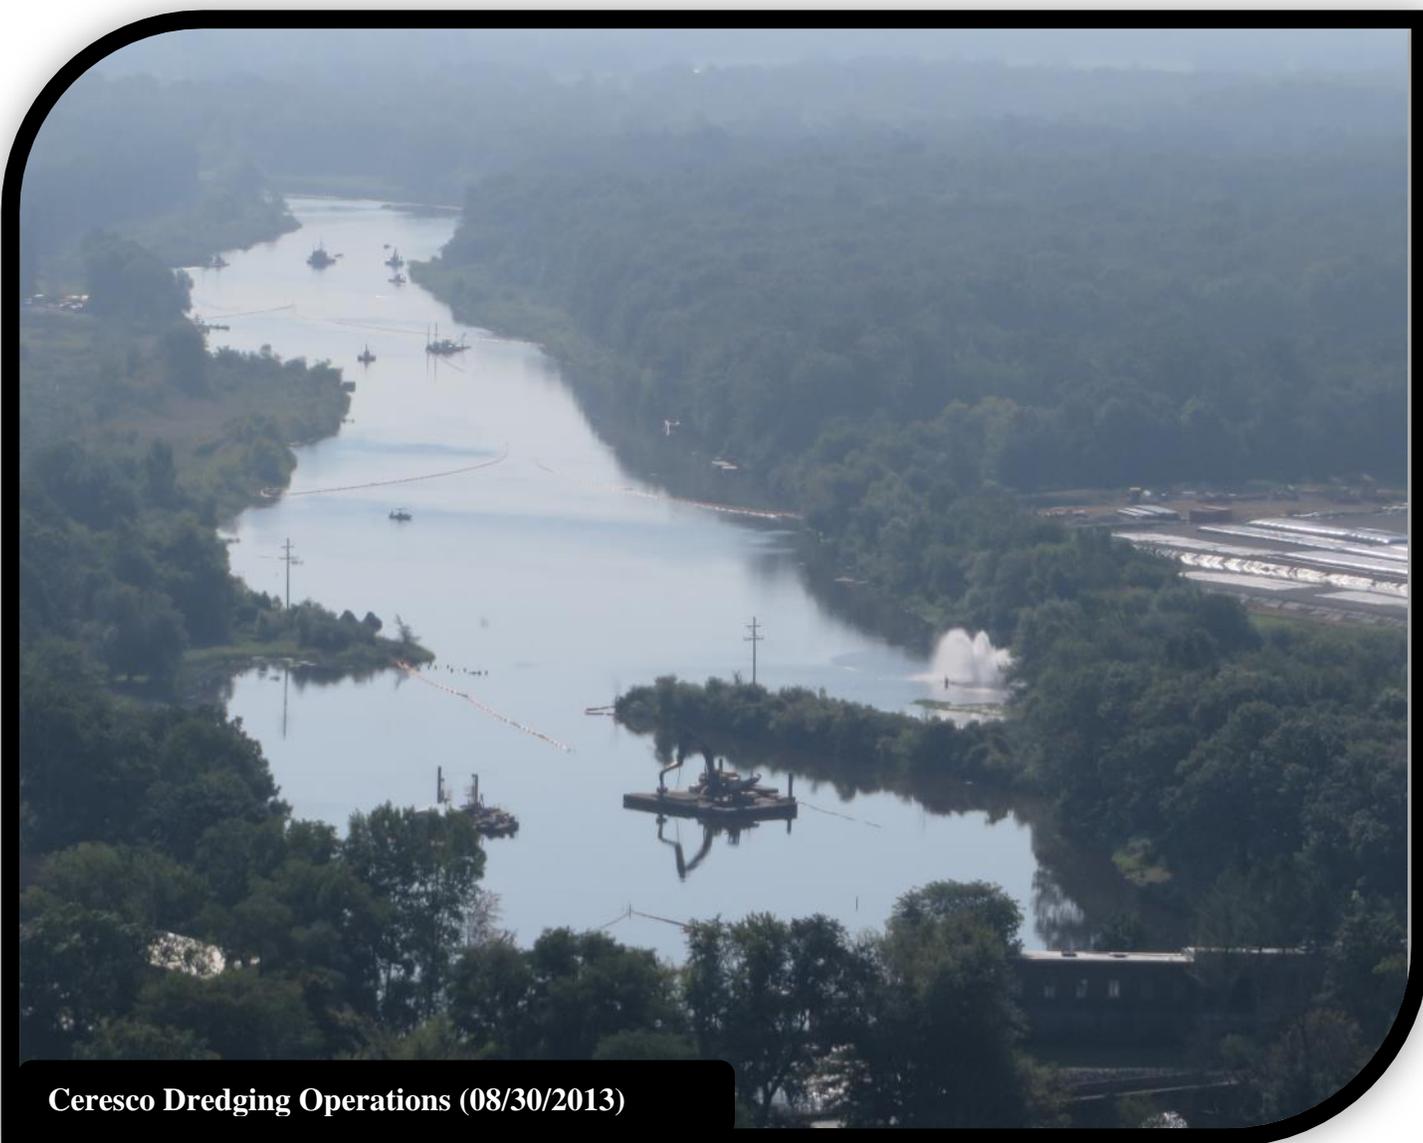
Ceresco Dredging Operations (08/30/2013)

- Dredging continued at the Ceresco Dam impoundment. During the reporting period, a total of 29,172,161 gallons of water was treated at the Ceresco Dredge water treatment facility. Throughout the period, 5,775 feet of dredging containment was maintained, installed, and relocated as appropriate. At the close of the reporting period, a total of 21,288 yd³ of dredged sediment was onsite in Geotube bags. Once adequately dewatered, sediment will be solidified and transported off-site for disposal. As of the close of the reporting period, no sediment from the Ceresco dredge pad has been shipped off site for disposal.
