**U.S. ENVIRONMENTAL PROTECTION AGENCY, REGION V
POLLUTION/SITUATION REPORT #193**

**KALAMAZOO RIVER/ENBRIDGE SPILL – REMOVAL
SITE # Z5JS
MARSHALL, MICHIGAN
LATITUDE: 42.2395273; LONGITUDE: -84.9662018**

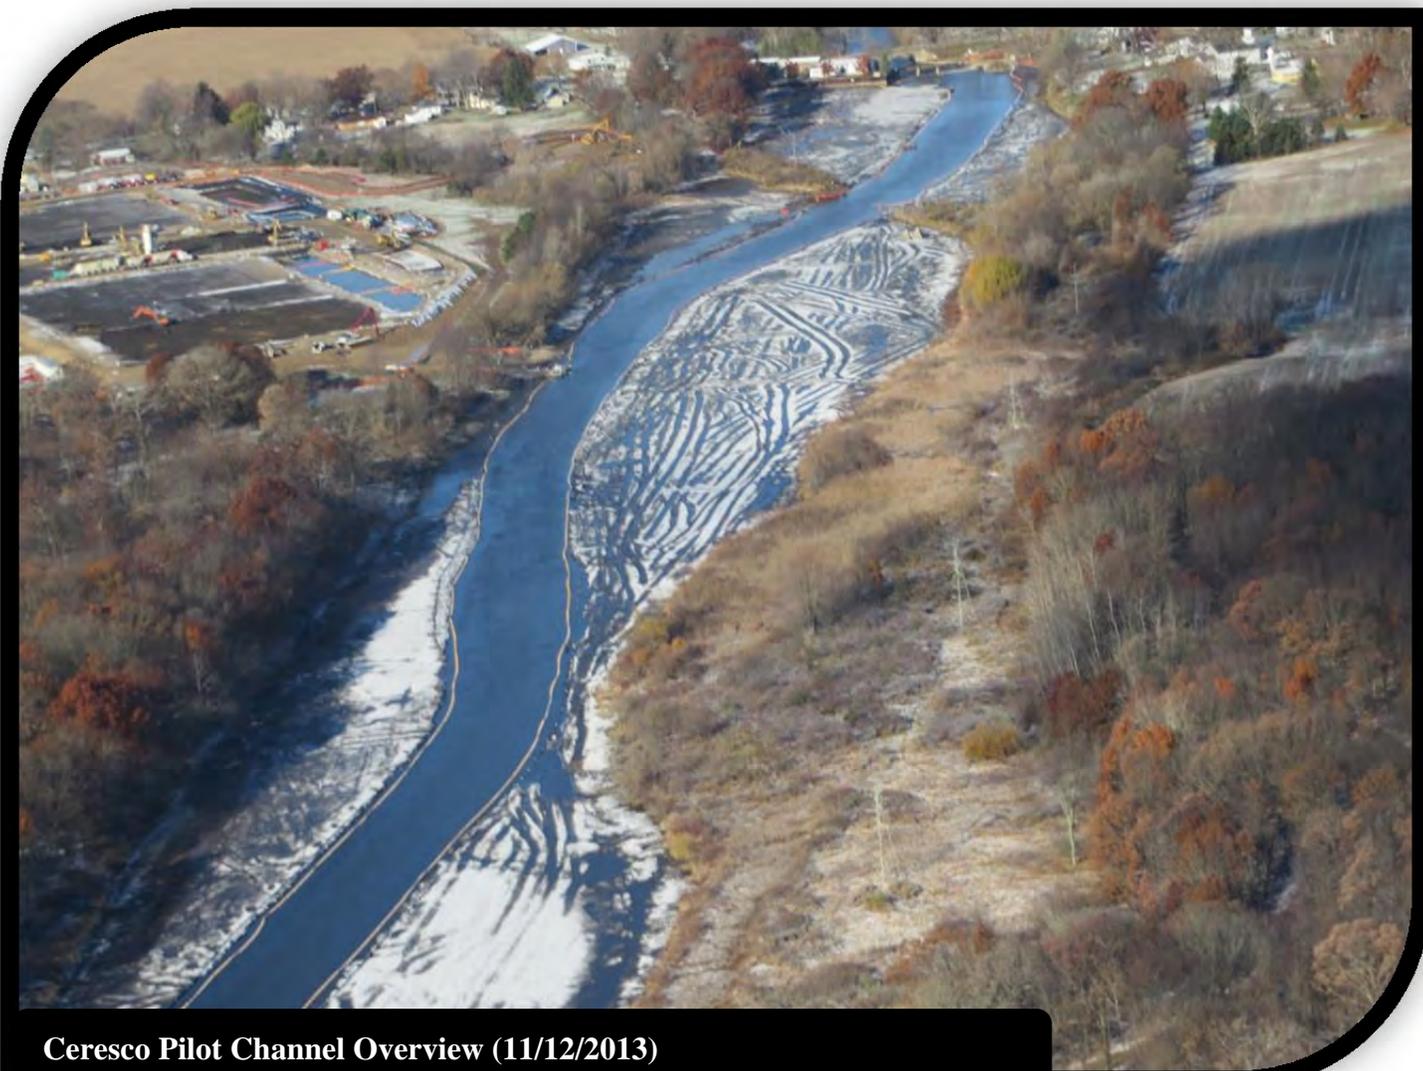
Ceresco Pilot Channel Overview (11/12/2013)

- Dam notching and drawdown at the Ceresco Dam impoundment was completed to the MDEQ permitted elevation on November 6, 2013. Additional containment was placed around the newly exposed overbanks for stabilization. On November 15, 2013, MDEQ issued a dam notching permit revision to allow for additional notching of the dam by an additional 1.7 feet. The additional notching and drawdown began November 17, 2013.

- Scraping of the newly exposed overbank soils in the "bowl" area immediately upstream of the dam commenced on November 13, 2013 and continued throughout the period.
