Region 5 Land Revitalization Technical Assistance Project

GREEN BUILDING AND HISTORIC PRESERVATION CASE STUDIES FOR MOLINE MULTI-MODAL STATION PROJECT (4 OF 5)

CHRISTMAN BUILDING LANSING, MICHIGAN

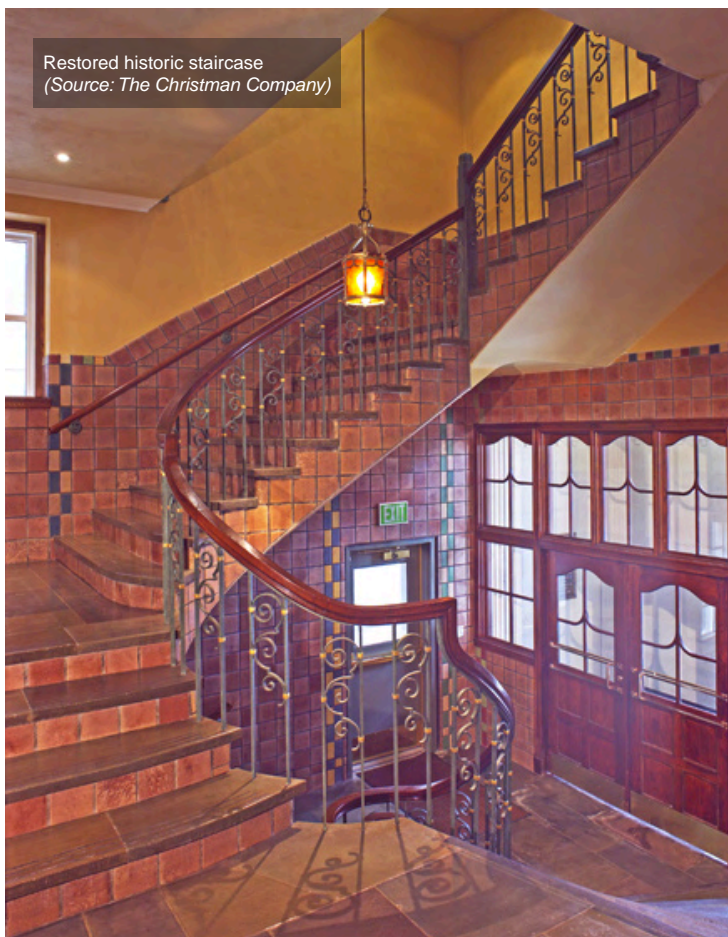
Restored historic staircase
(Source: The Christman Company)

All of the preservation work on the building was approved by the State Historic Preservation Office and the National Park Service to ensure that standards protecting the building, individually listed on the National Register of historic places, were upheld. Restoration of historically significant building features included the main entrance doors and plaques, the mica shade light fixtures and Pewabic wall tiles in the main hall, and the light fixtures and verdigris bronze handrail finish in the stairwell and lower level. Other restored and reused building components included door hardware, wood trim, wood windows, and floors in the entry and historic staircase made of Bluestone or black and white linoleum.

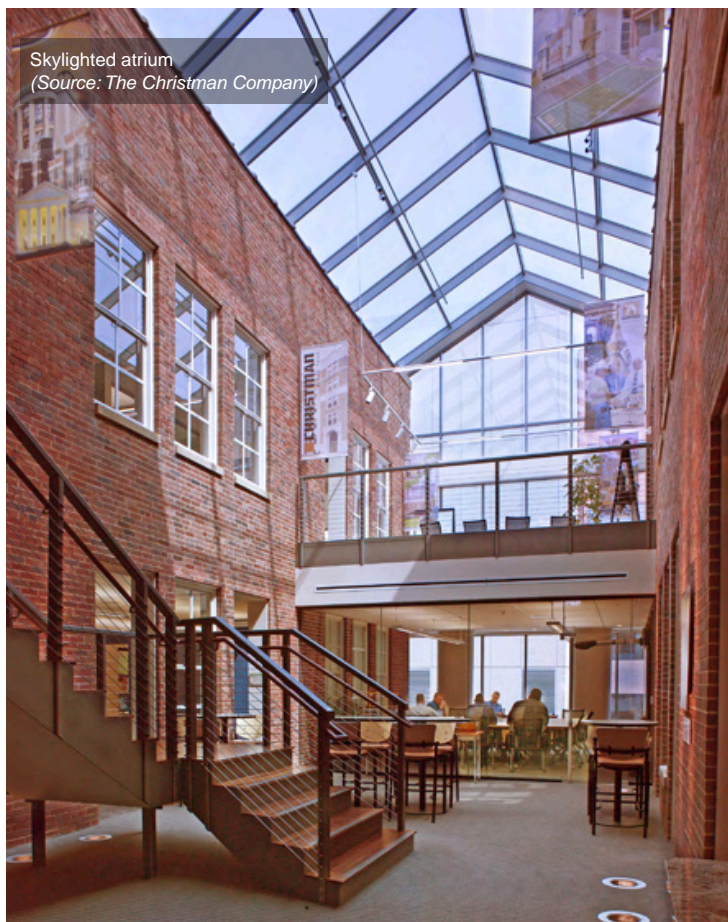
Skylighted atrium
(Source: The Christman Company)

A skylighted atrium was created in the heart of the building and is accessible to floors 4 and 5 and the newly created floor 6, providing a social gathering area for occupants. The new 6th floor space is not visible from the street and offers outstanding views of the state capitol and cityscape.
