Review Article

Durability of HDPE geomembranes

R. Kerry Rowe*, Henri P. Sangam

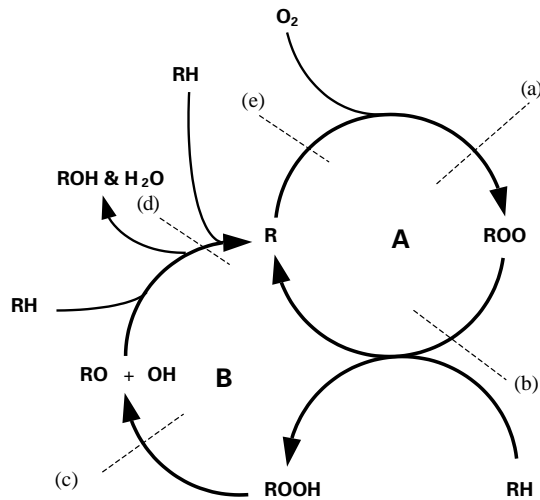
RH: Polyethylene polymer chain
 R : Reactive free radical
 ROO : Hydroperoxy radical
 ROOH: Hydroperoxid

(a) (b) (e) : Primary antioxidants
 (c) (d) : Secondary antioxidants

Fig. 1. Oxidation cycles in polyethylene (modified from Grassie and Scott, 1985).

Oxidation can have a particularly severe impact on polyethylene materials (Hawkins, 1984). It is generally agreed that the fundamental process underlying the oxidation of a polymeric material like HDPE is a free radical chain mechanism (Kelen, 1983; Grassie and Scott, 1985). As can be seen from Fig. 1 the oxidation mechanism involves two interacting cyclical processes (Grassie and Scott, 1985). The first cycle (A) is the alkyl/alkylperoxy chain reaction and the second (B) involves the homolysis of hydroperoxides, which feeds the chain reaction with the new radicals. If any of the interactions between the two cycles are broken, the oxidation can be retarded and can even be stopped if all the links are impeded. Antioxidants and stabilizers are often used to retard the oxidation, and can be classified into two distinct groups referred to as primary and secondary antioxidants (Chirinos-Padrón and Allen, 1992; Fay and King, 1994). Primary antioxidants function by trapping the free radical formed in the presence of oxygen while the secondary antioxidants reduce the active hydroperoxides to inactive alcohol (Yachigo, 1992). The effectiveness of the antioxidants depends on various factors including the total

amount, the types and the combination used and the service temperature of the geomembrane (Chirinos-Padrón and Allen, 1992; Fay and King, 1994). If oxidation occurs, the resulting chain scission leads to a decrease in molecular weight making the material brittle, and more prone to environmental stress cracking (Tisinger and Giroud, 1993).

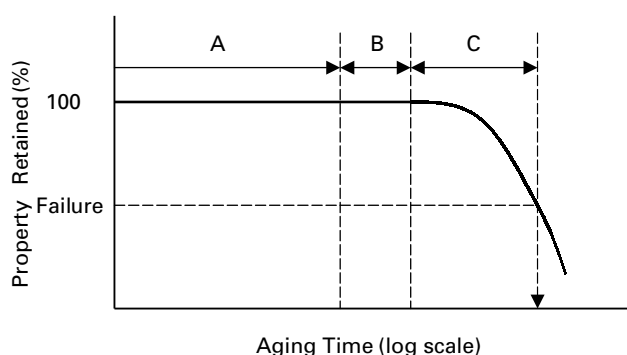
A = Period during which depletion of antioxidants occurs

B = Induction time to onset of polymer degradation

C = Time to reach the failure level of degradation of a particular property

The oxidative degradation of HDPE geomembranes appears to proceed in three relatively distinct stages (Hsuan and Koerner, 1995, 1998) as shown in Fig. 2. The first stage (A) corresponds to the depletion of antioxidants and is due to either their consumption as a result of their chemical reactions with the oxygen, free radicals and alkyl peroxides and/or their physical loss by diffusion, extraction or volatilization (Luston, 1986). The time required for the depletion of antioxidant will, in part, depend on the type and the amount of antioxidants in the new geomembrane. The amount of antioxidant in the material is often measured in terms of the oxidative induction time (OIT). Two types of tests may be used: the standard-OIT (ASTM D3895-95) and high-pressure OIT (ASTM D5885-97) tests. A good discussion of these two methods has been provided by Hsuan and Koerner (1998).

Entering into the induction period (Stage B; Fig. 2), the antioxidants are completely depleted and hydroperoxides' concentration starts to acuminate. Once the concentration of hydroperoxides reaches a critical level, decomposition of hydroperoxides and accelerated chain reactions begin, signifying the end of the induction period (Rapoport and Zaikov, 1986). At this second stage, evaluating changes in molecular composition provides a logical method for measuring the course of polymer degradation. Among the available methods, the molecular composition is usually studied by Fourier transform infrared (FTIR) spectroscopy that has long been recognized as a powerful tool for polymer characterization. This technique gives quantitative and qualitative information about the physico-chemical composition of polymers, copolymers, polymer blends, composites and additives

During Stage C (Fig. 2), hydroperoxides start to decompose yielding abundant free alkyl radicals and leading to an accelerated oxidation (Kelen, 1983; Hsuan and Koerner, 1995). In the early stage of this acceleration, cross-linking occurs in these alkyl radicals due to oxygen deficiency (Hamid et al., 1992). Consequently, the molecular weight increases while mechanical properties appear relatively unchanged. As the oxidation advances further, the reaction of oxygen within the material with alkyl radicals change to chain scission causing a reduction in molecular weight as the chains shorten. Such changes in the molecular size (weight) can be detected by the melt flow index test (ASTM D1238-00) since the melt flow index is inversely related to the molecular weight. They can also be assessed in terms of environmental stress cracking test known as “Single Point Notched Constant Tensile Load Test” (SPNCTL) and described in ASTM D5397-99-Appendix.

A direct consequence of the degradation that occurs during Stage C is the decrease of both stress and strain at break while tensile modulus and yield stress increase. The test usually used to assess the changes in tensile properties is ASTM D638-99. As the degradation progresses further, the geomembrane will become increasingly brittle and the tensile properties change to the point that cracking occurs in stressed areas. Once sufficient cracks have developed to significantly increase flow through the geomembrane, the geomembrane may be considered to have reached the end of the so-called “service life”.
