Using Compost to Improve Stormwater Management and Erosion Control on Roadsides

Texas DOT Compost Story

September 13, 2007

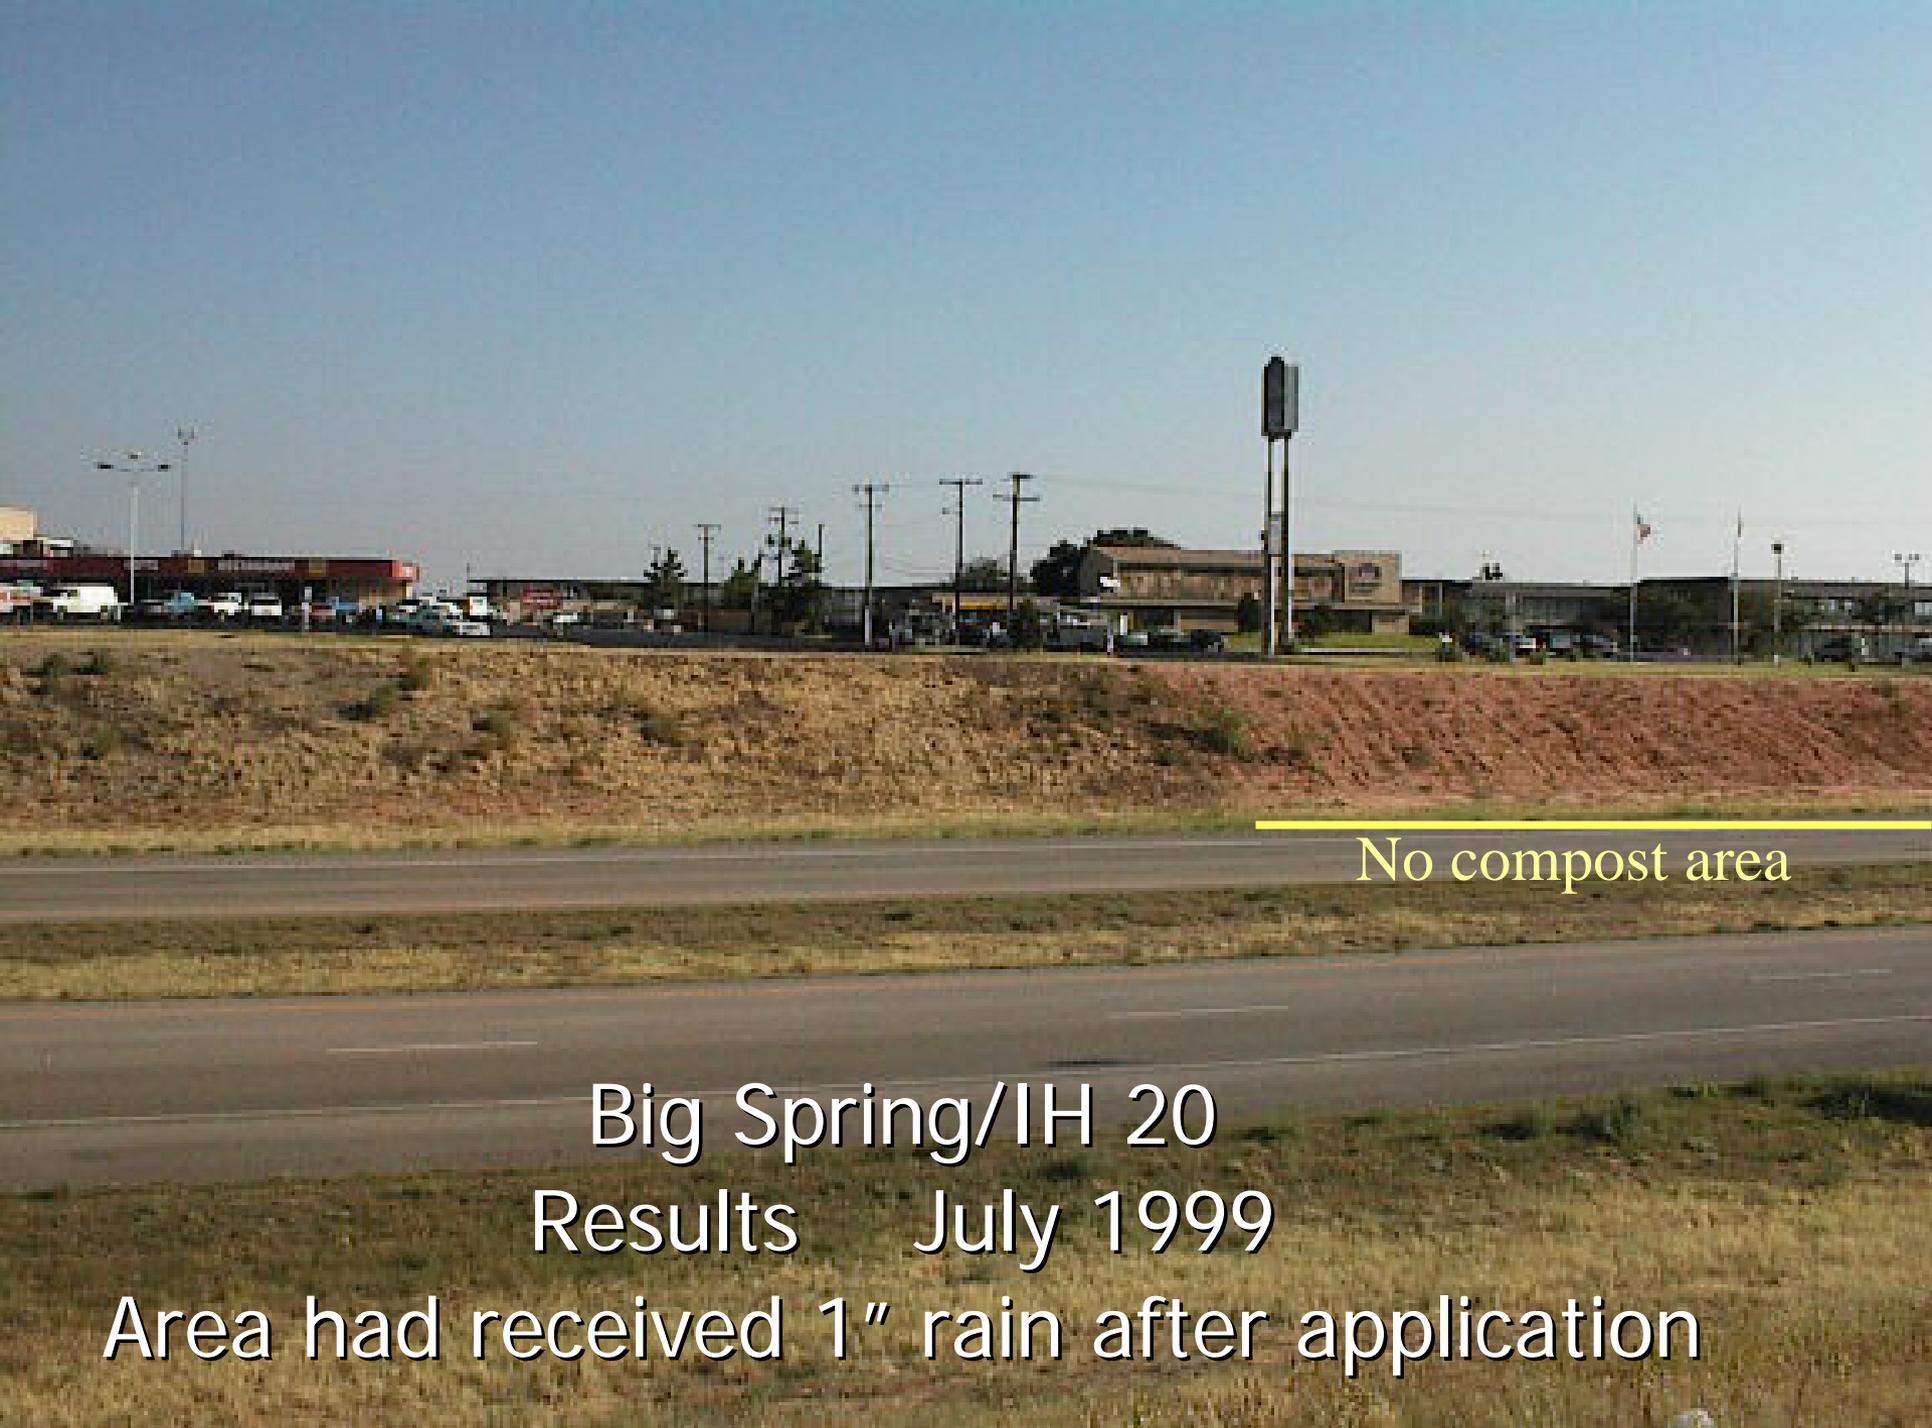
No compost area

Big Spring/IH 20

Results July 1999

Area had received 1" rain after application

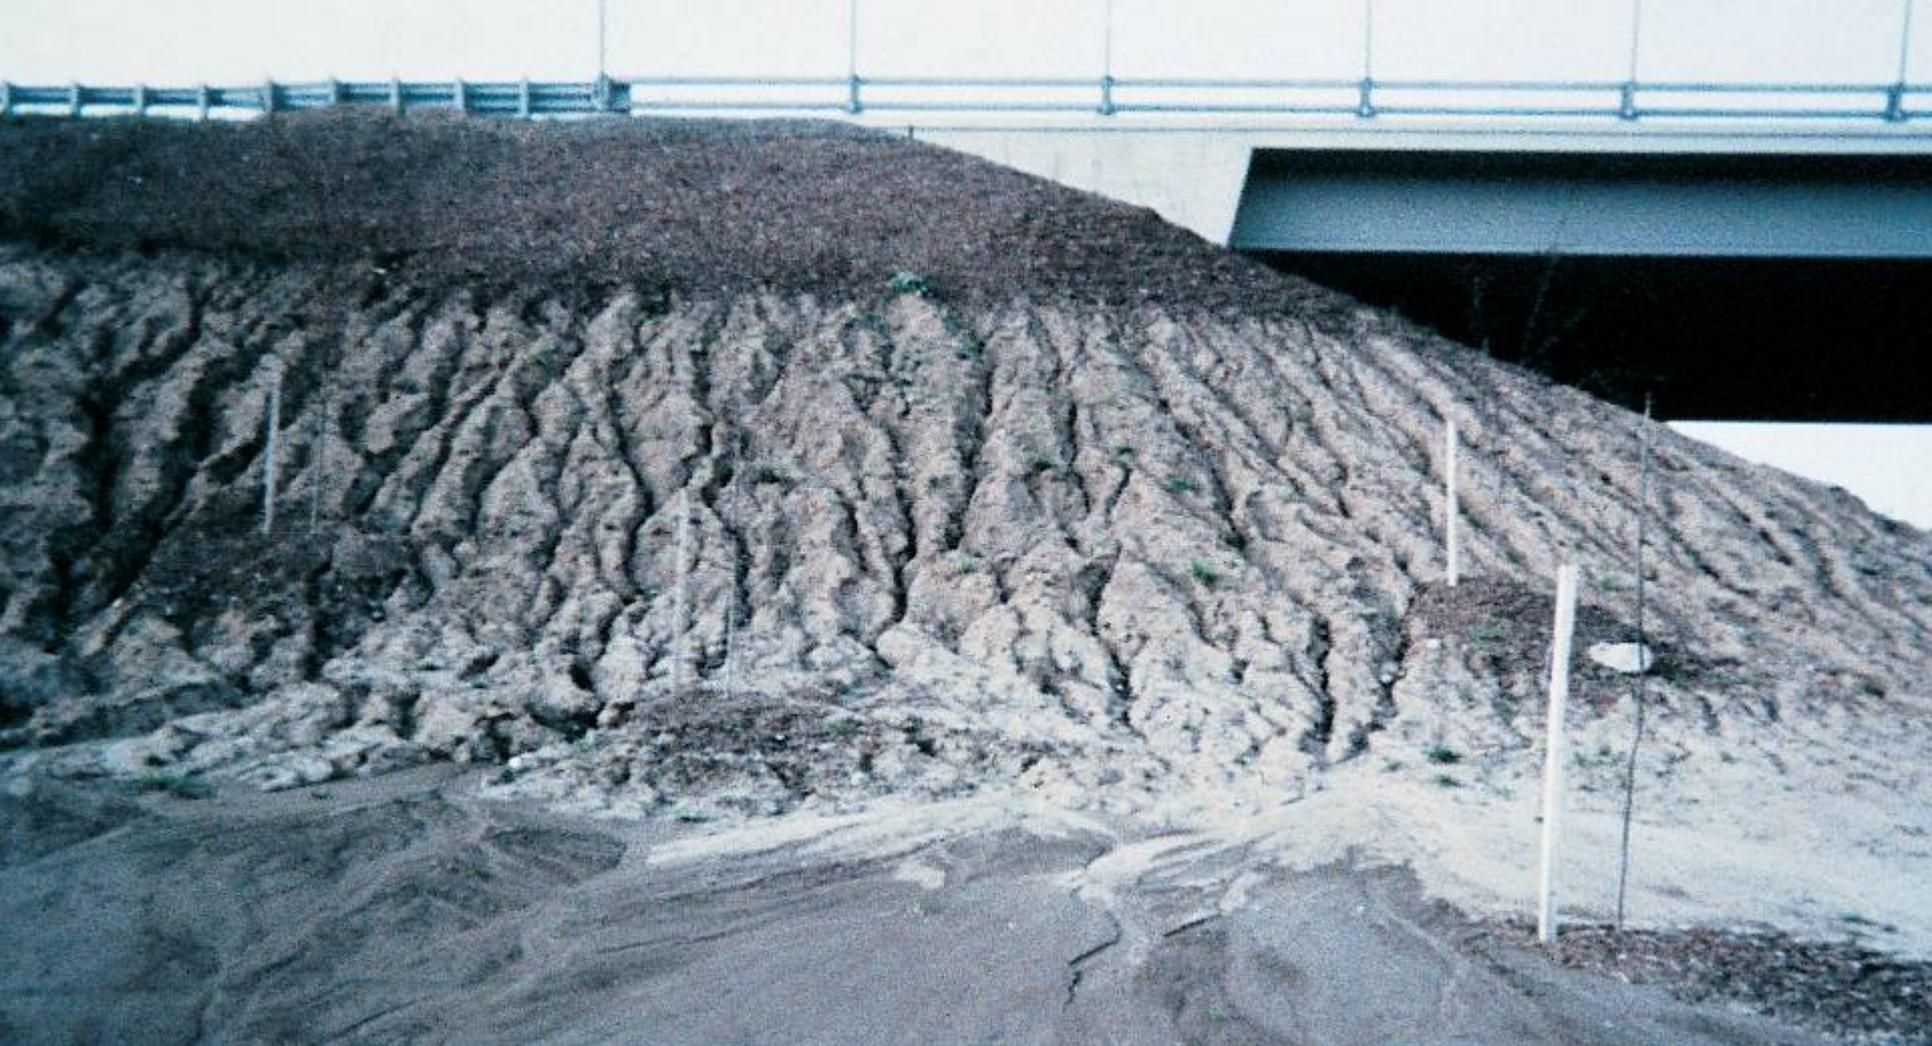
New construction, top 8 feet and new trees mulched;
After a 13 inch rain

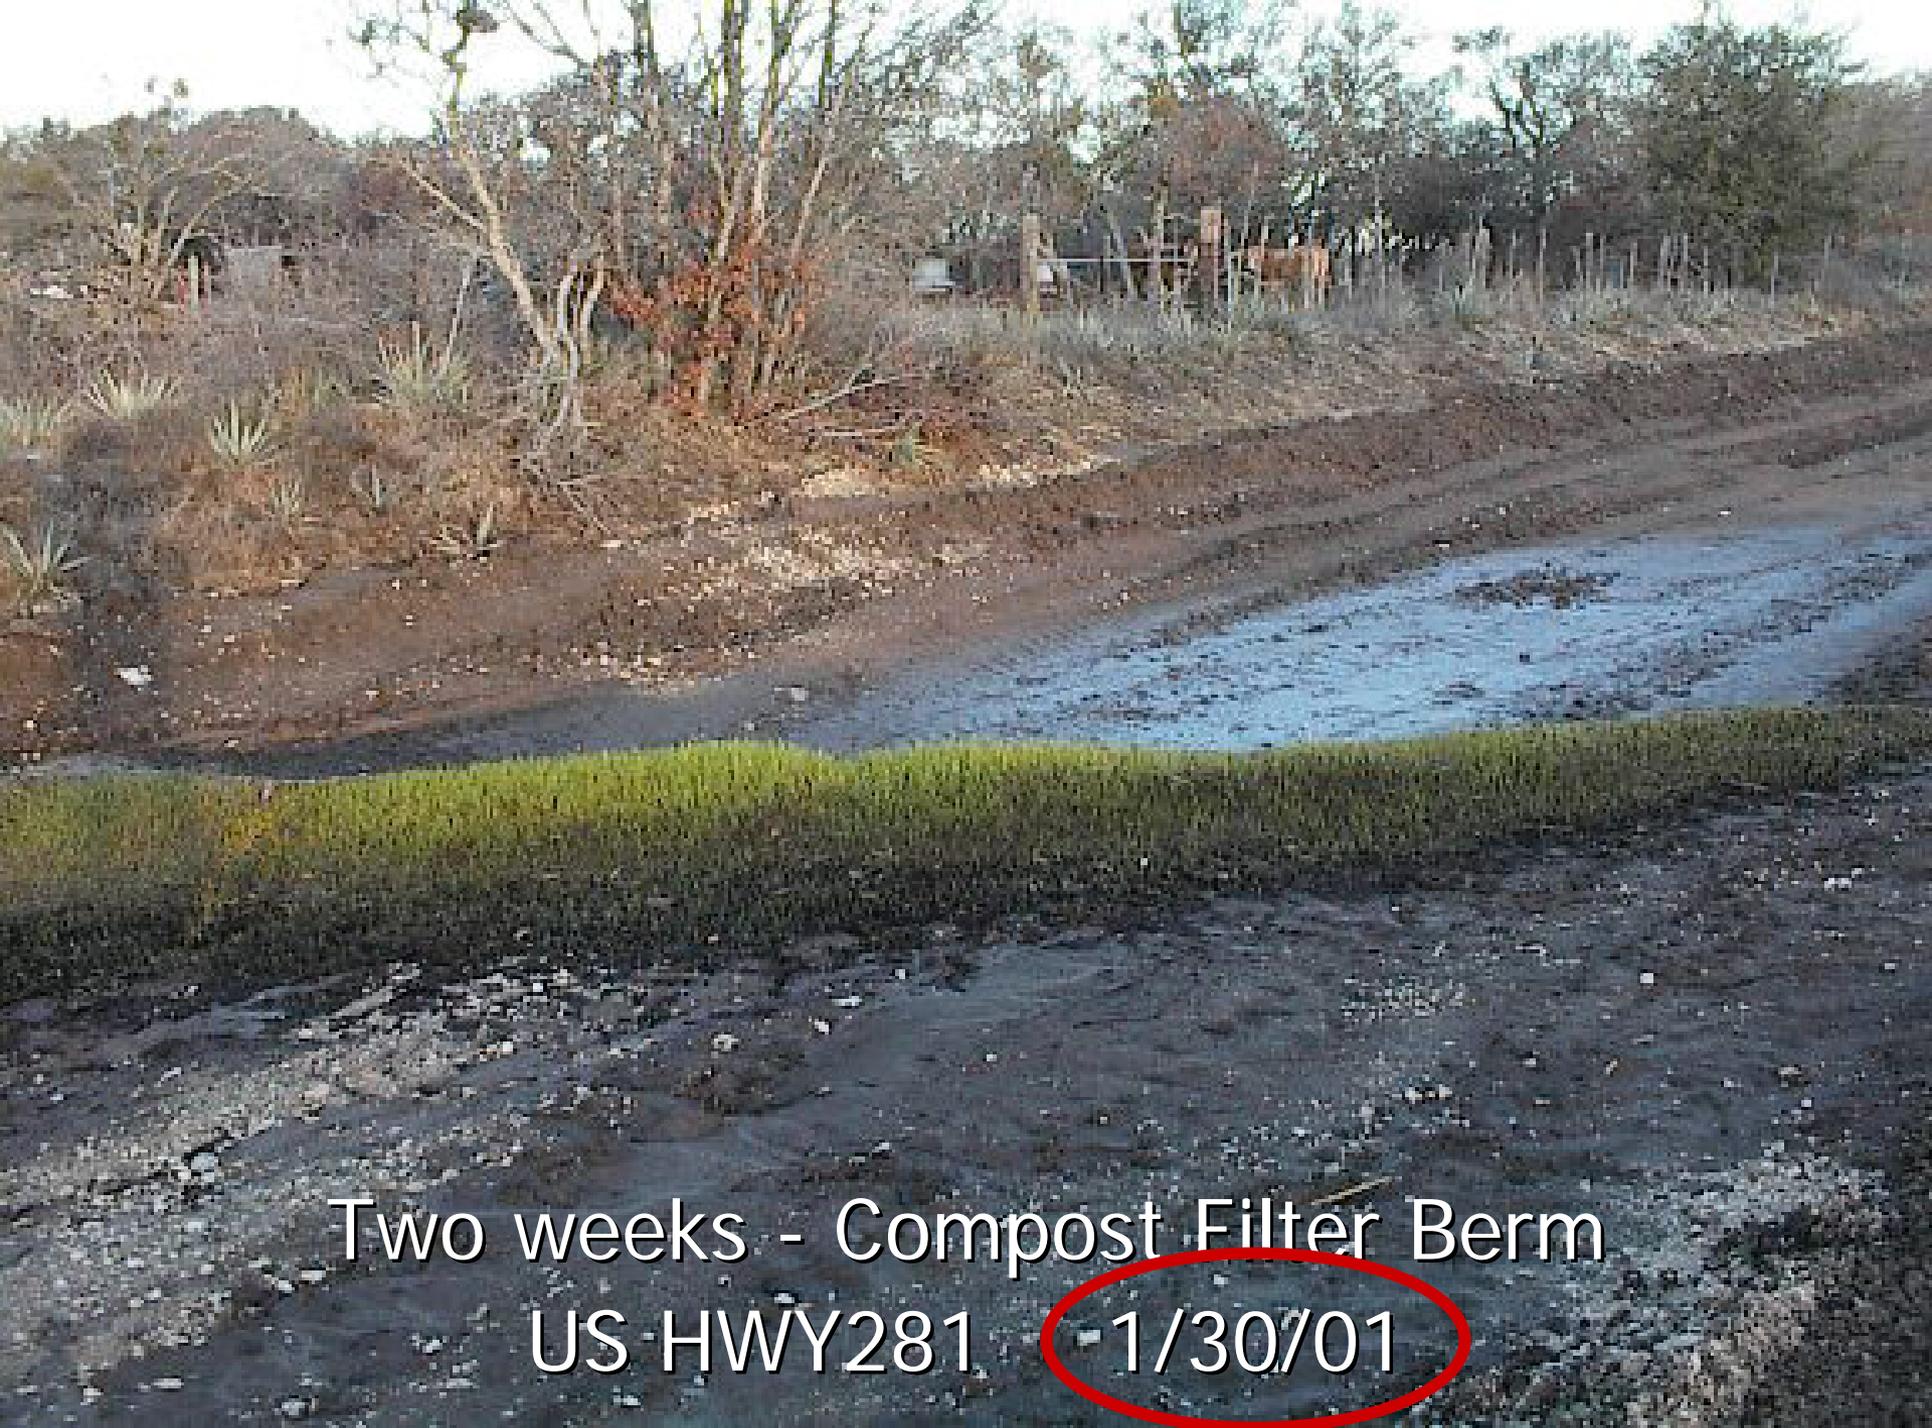
Two weeks - Compost Filter Berm
US HWY281 - 1/30/01

Filter berm working after a 3 "rain event

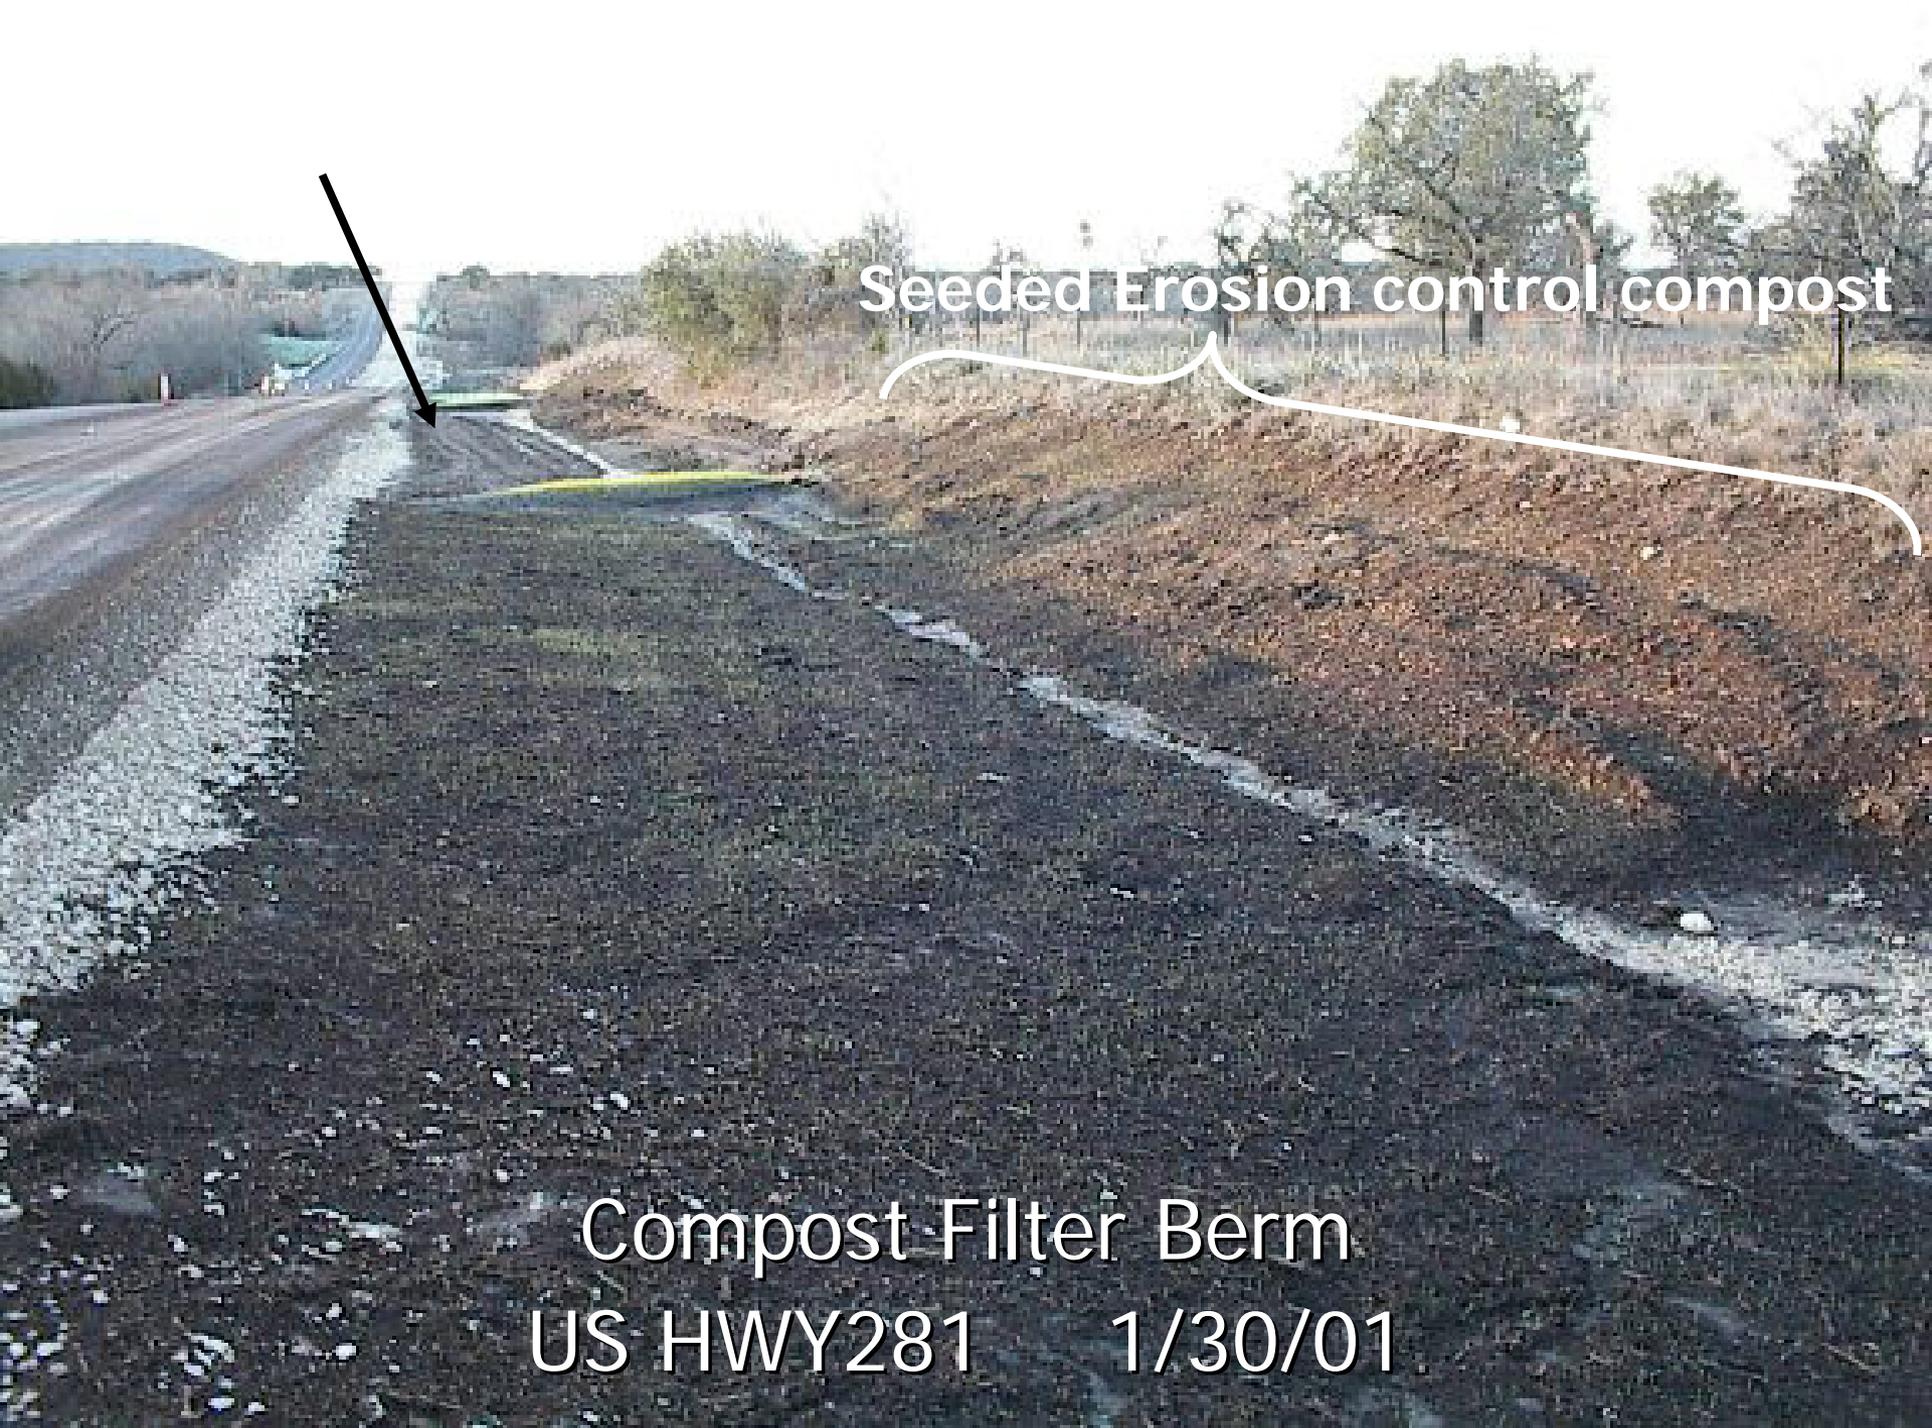
Seeded Erosion control compost

Grass established with Erosion Control Compost

Drill seeded, no compost

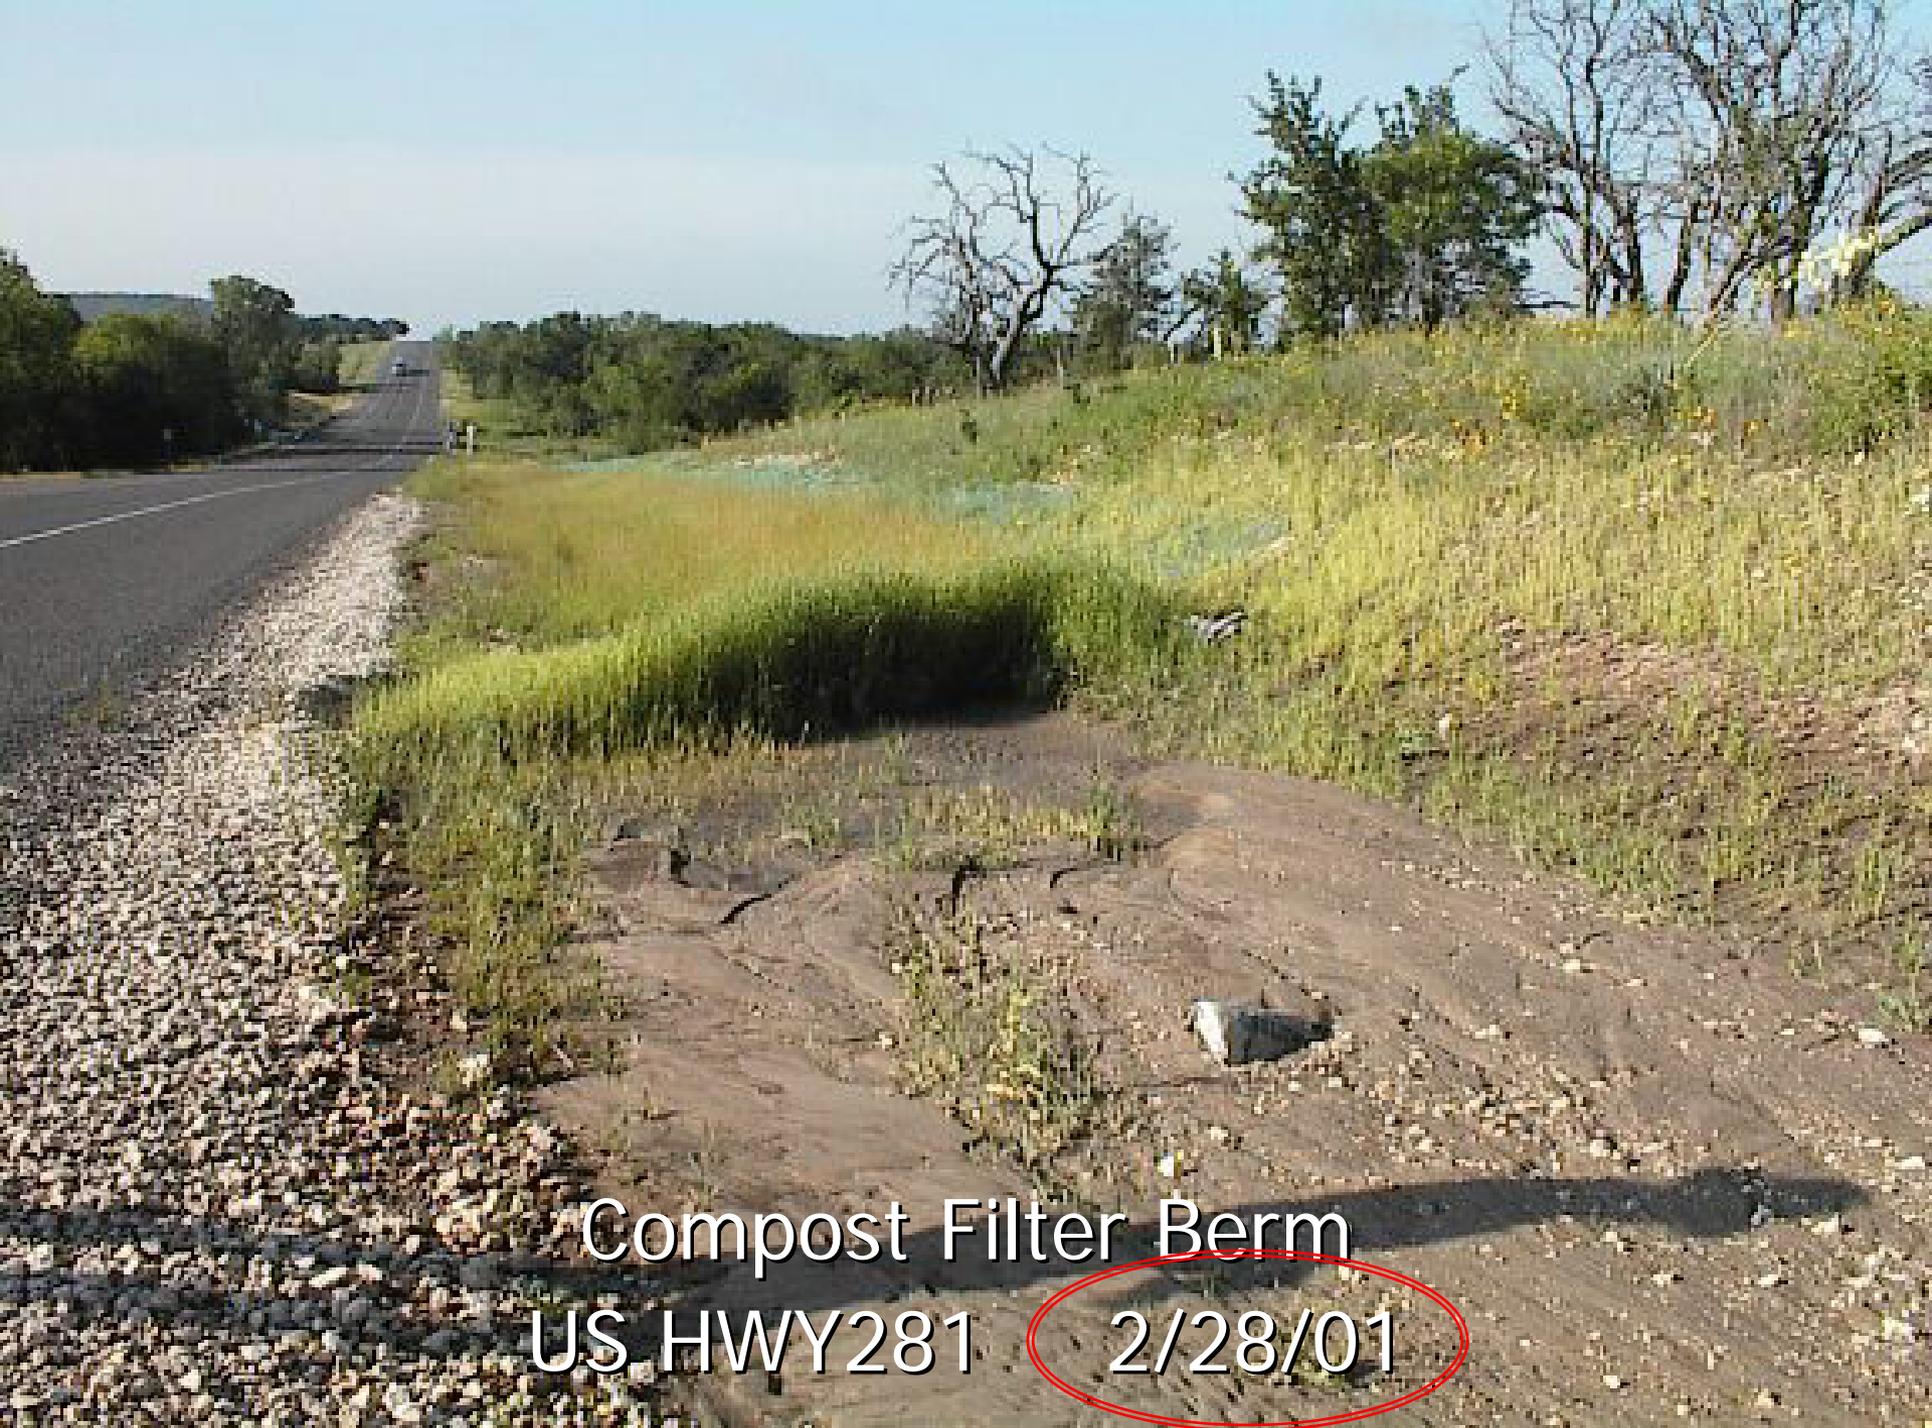
Compost Filter Berm
US HWY281 2/28/01

Filter berm working during a rain event

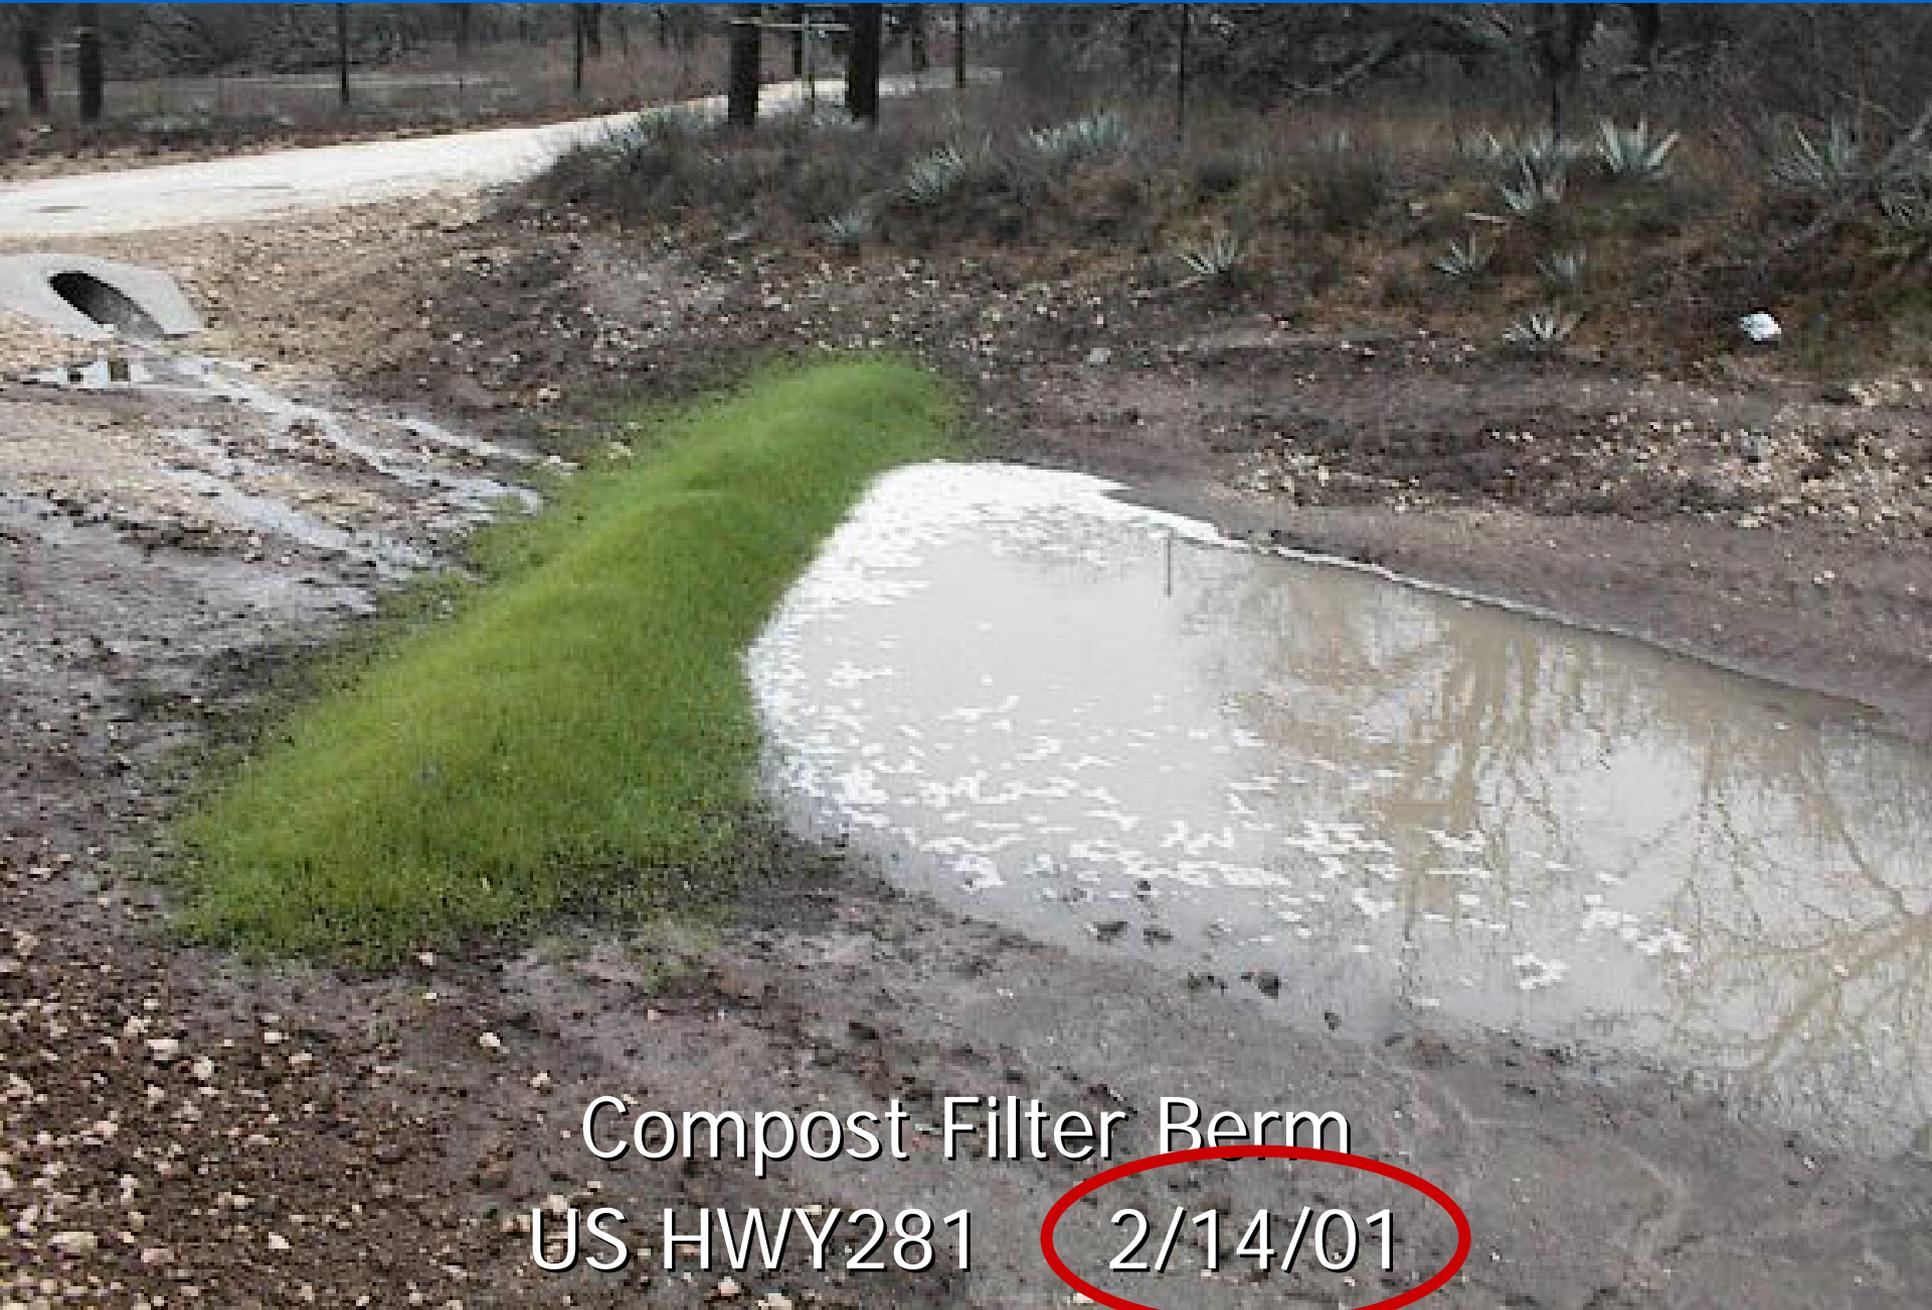
Compost Filter Berm
US HWY281 2/14/01

Berm continues to work after being driven over

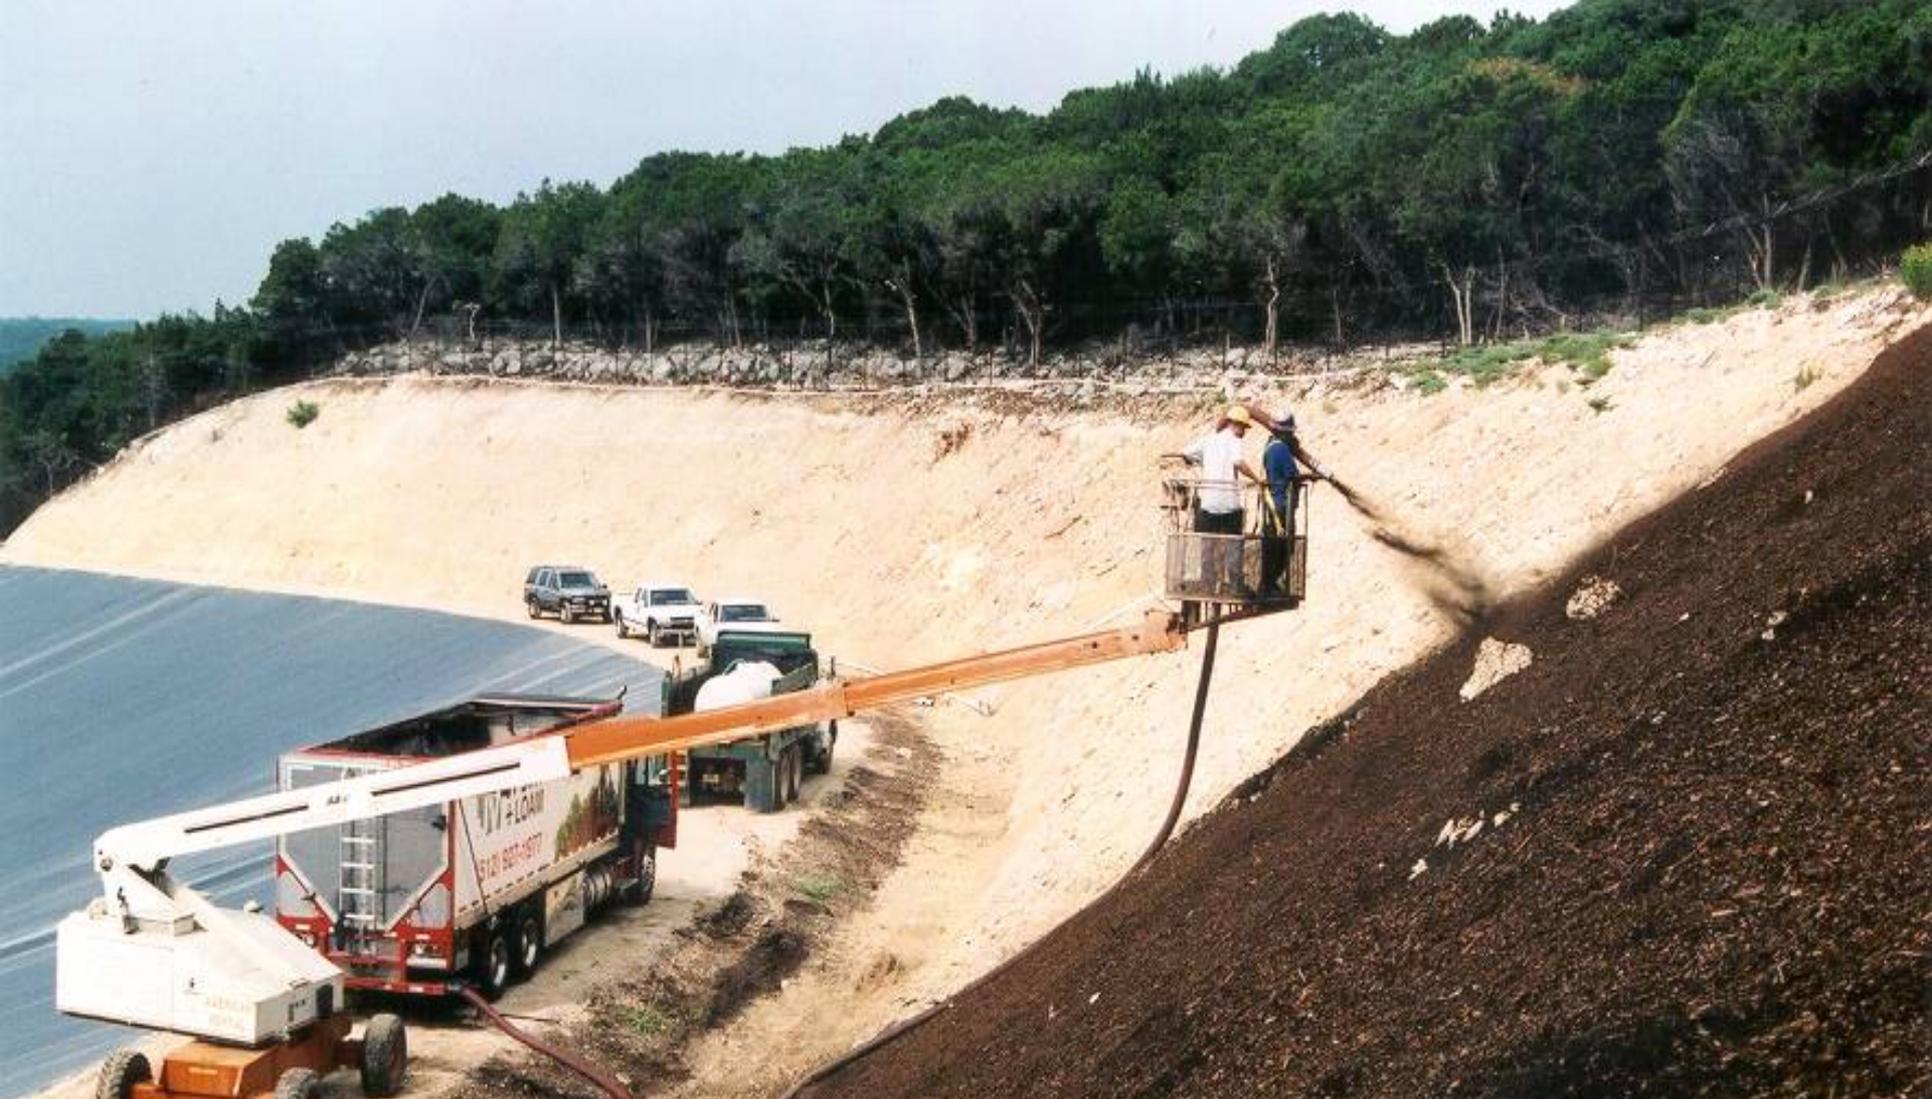
Application to 1:1 ROCK SLOPE
2" compost mulch w/native seed mix
Barton Creek Development – Austin, TX
AUGUST 17, 2002

- Significant rain event, tropical storm
 - two rain events in three days, 5" and 7"
- No loss of application materials
- Slope stabilized and covered

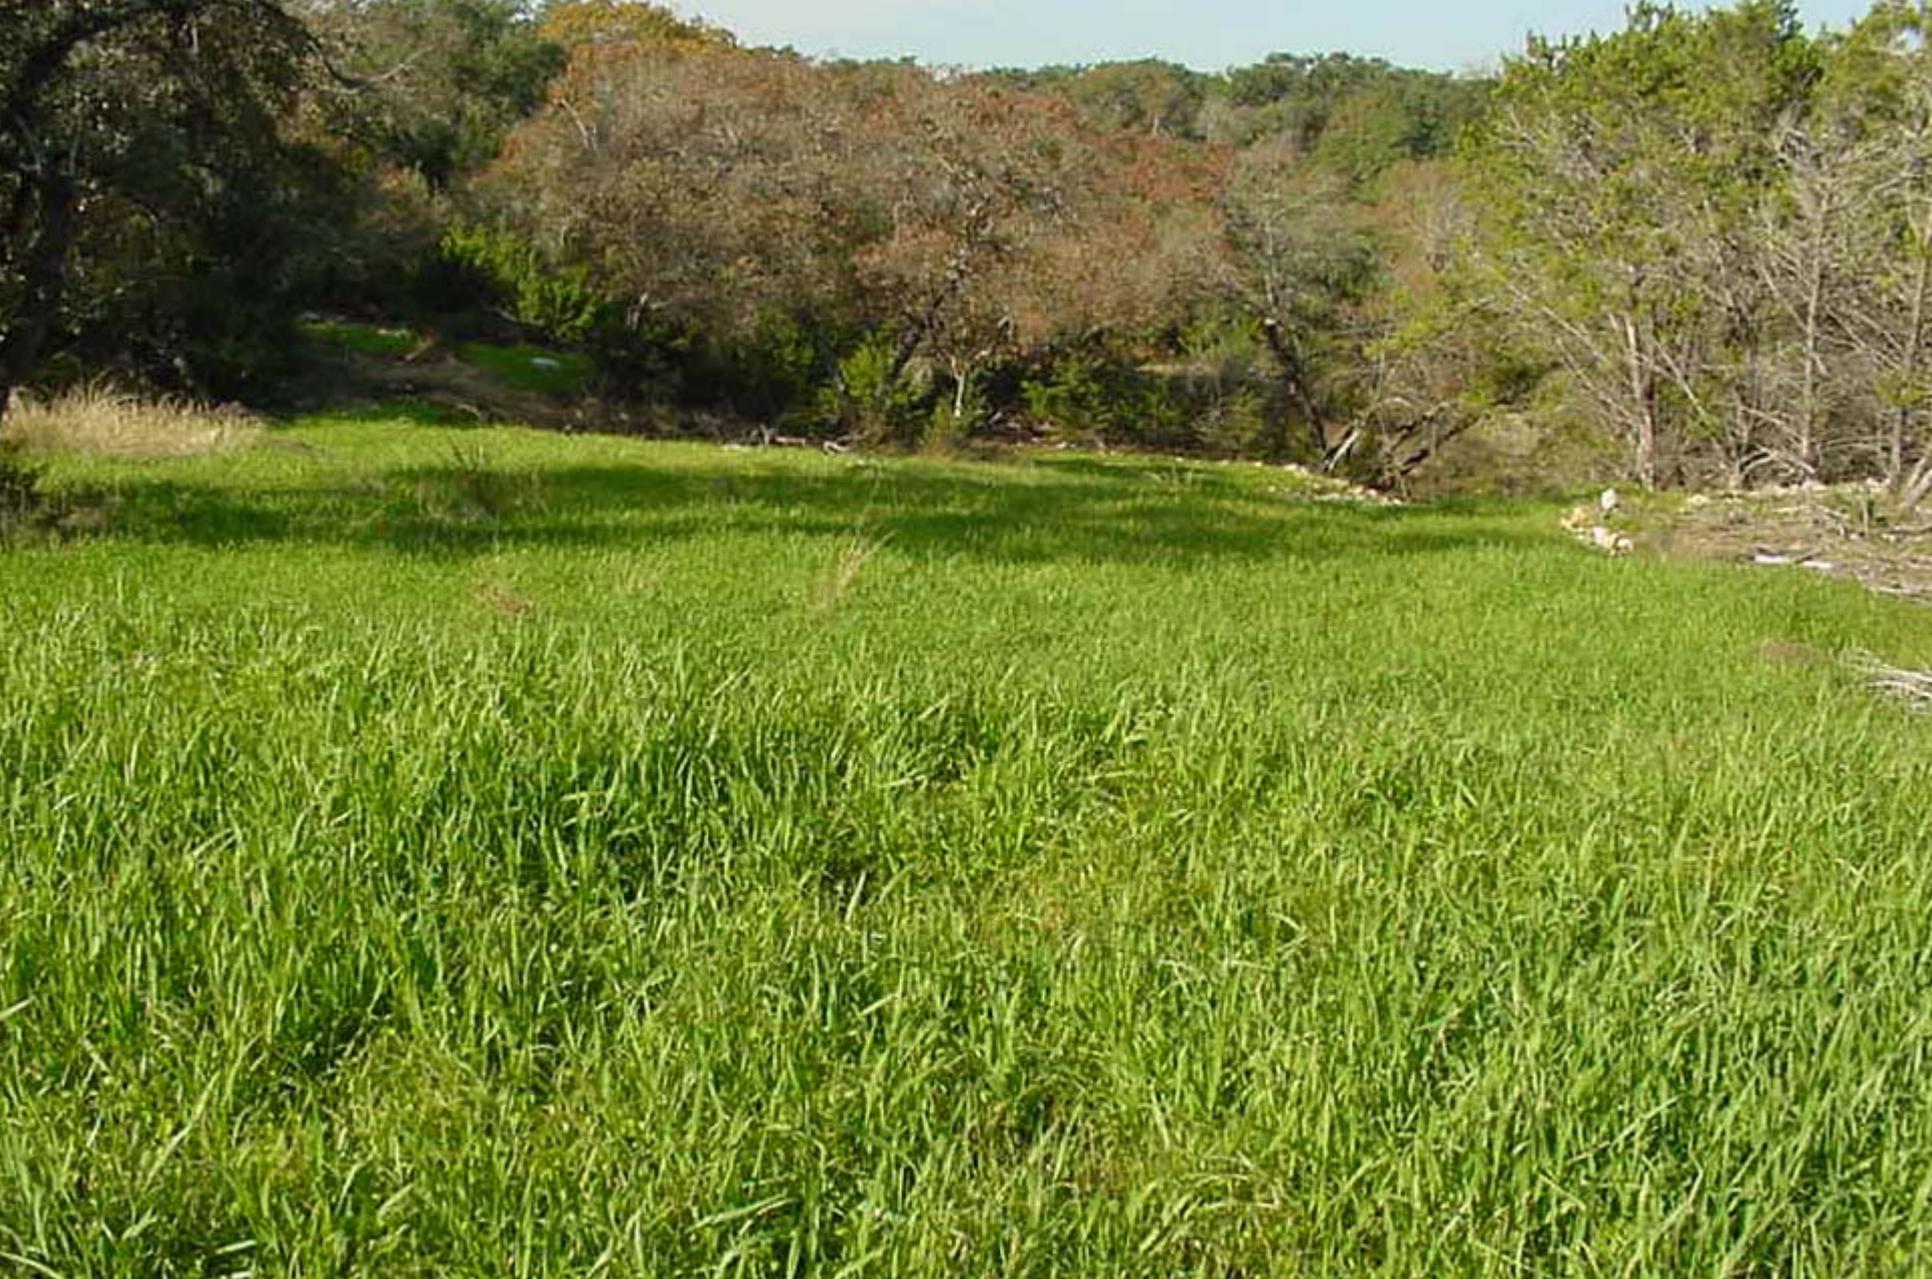
Grass Coverage in 6 Weeks and Over 24”
Rainfall

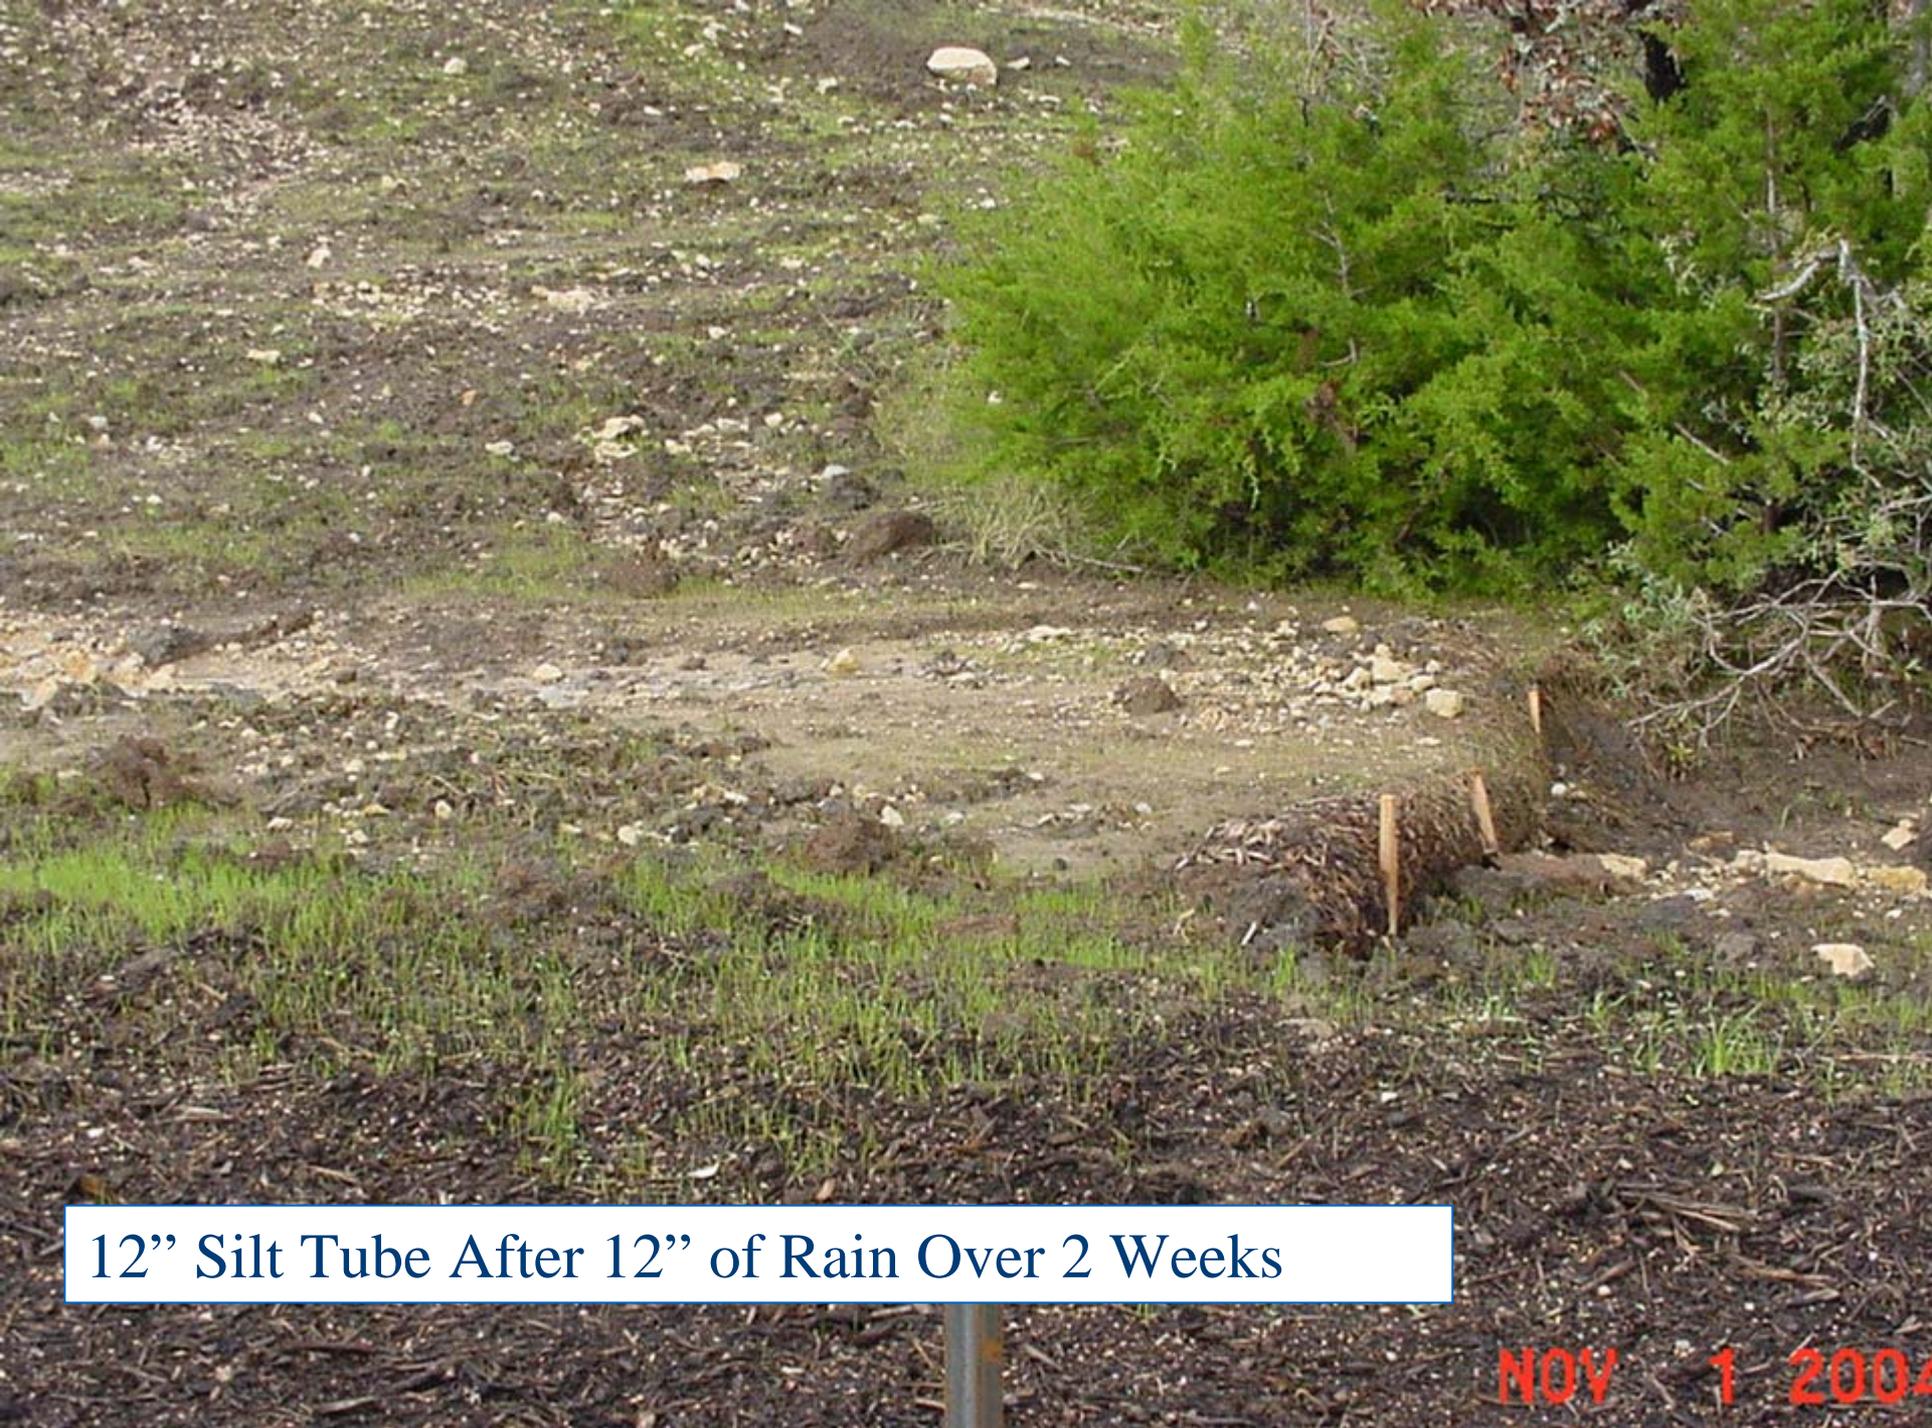
12" Silt Tube After 12" of Rain Over 2 Weeks
