Using Compost to Improve Stormwater Management and Erosion Control on Roadsides

Texas DOT Compost Story

September 13, 2007

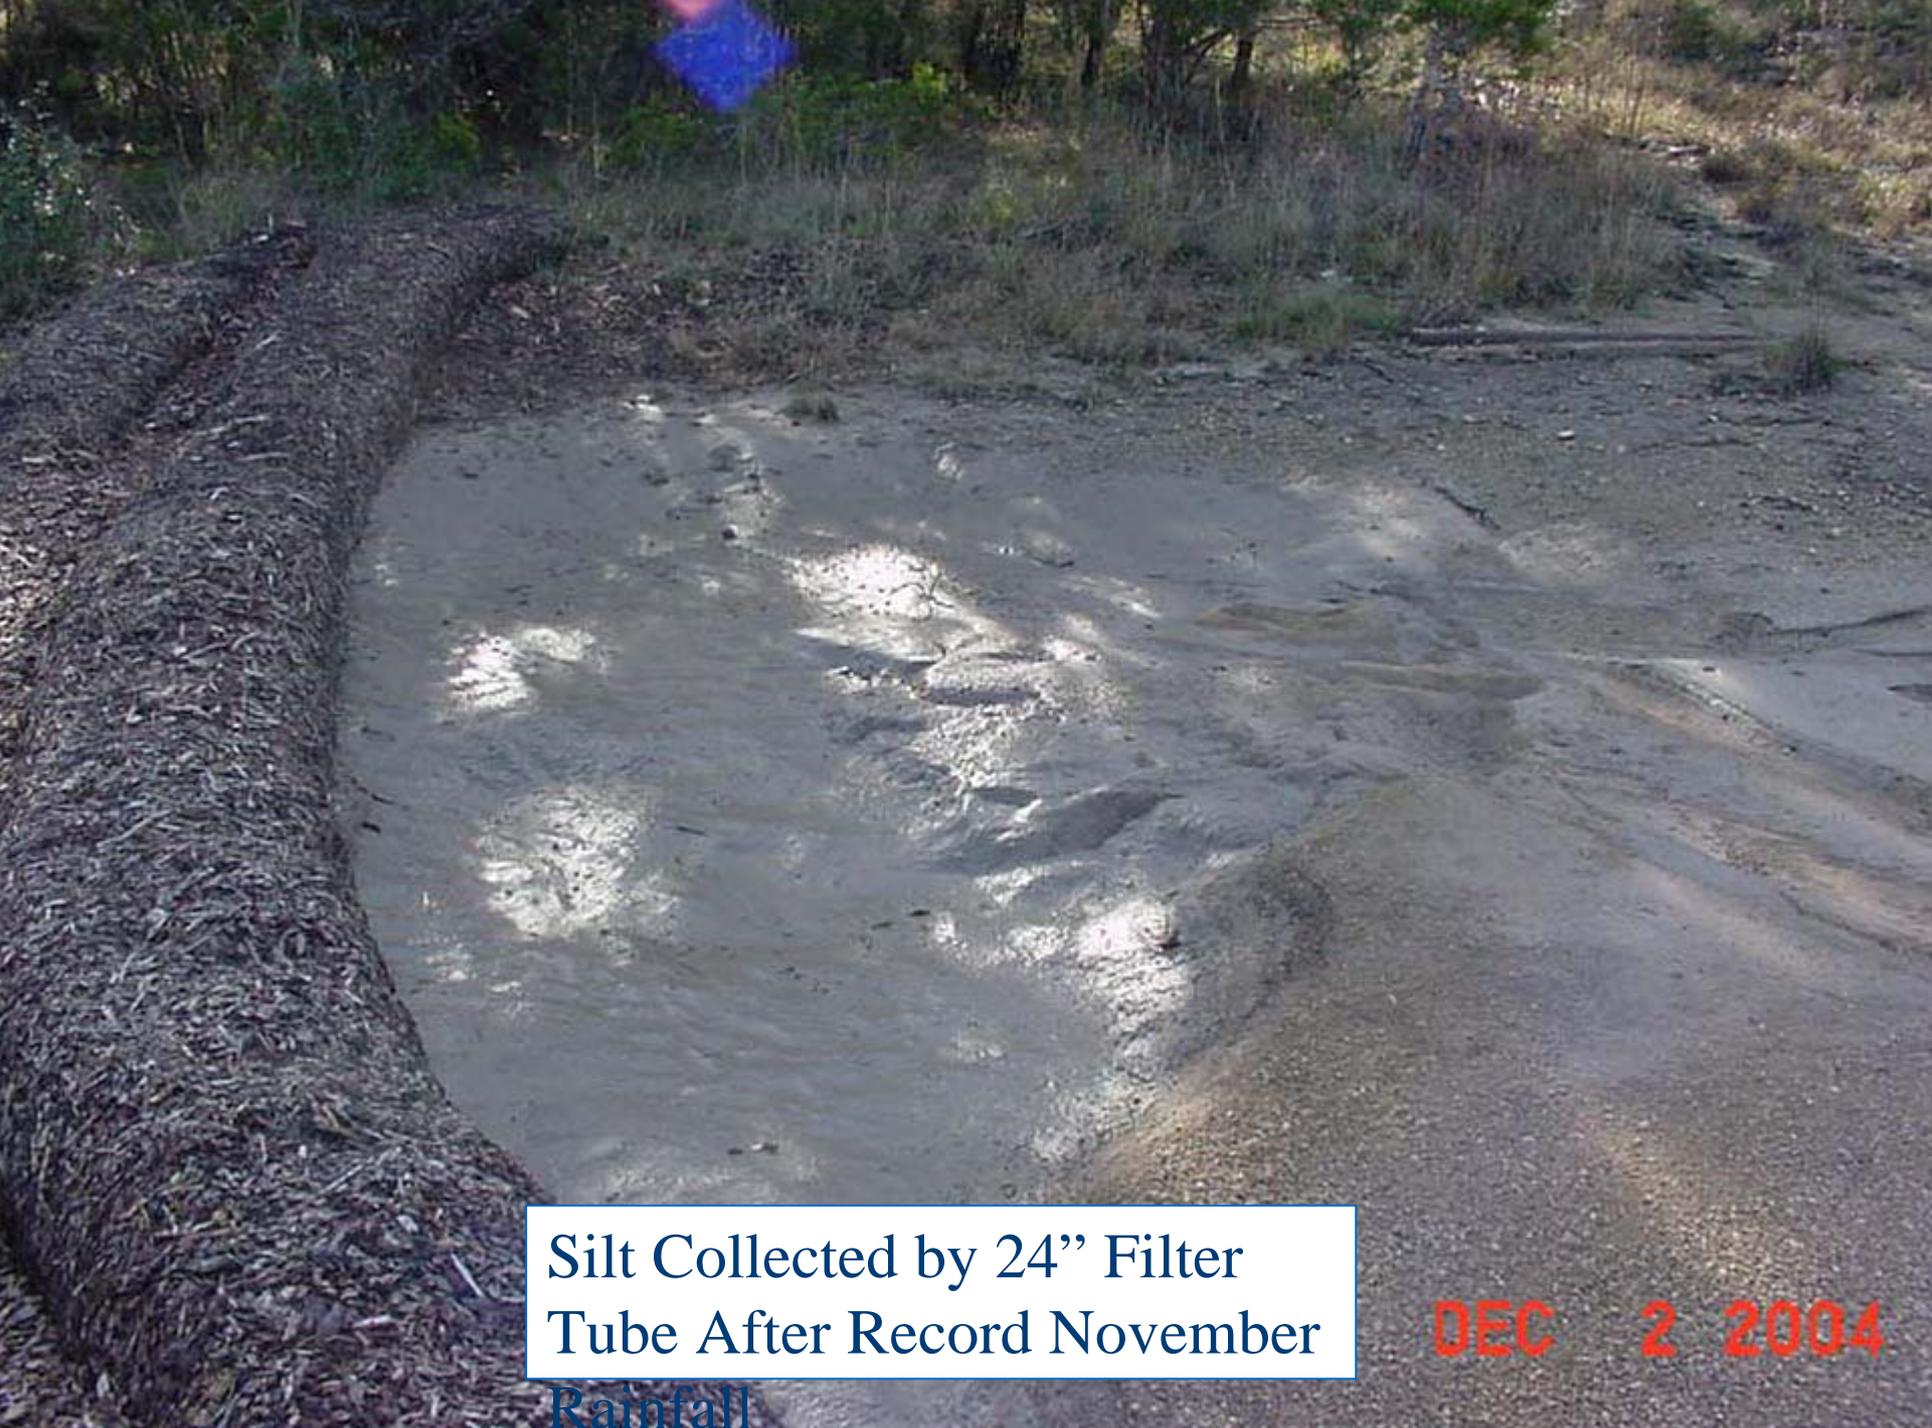
Silt Collected by 24" Filter
Tube After Record November
Rainfall

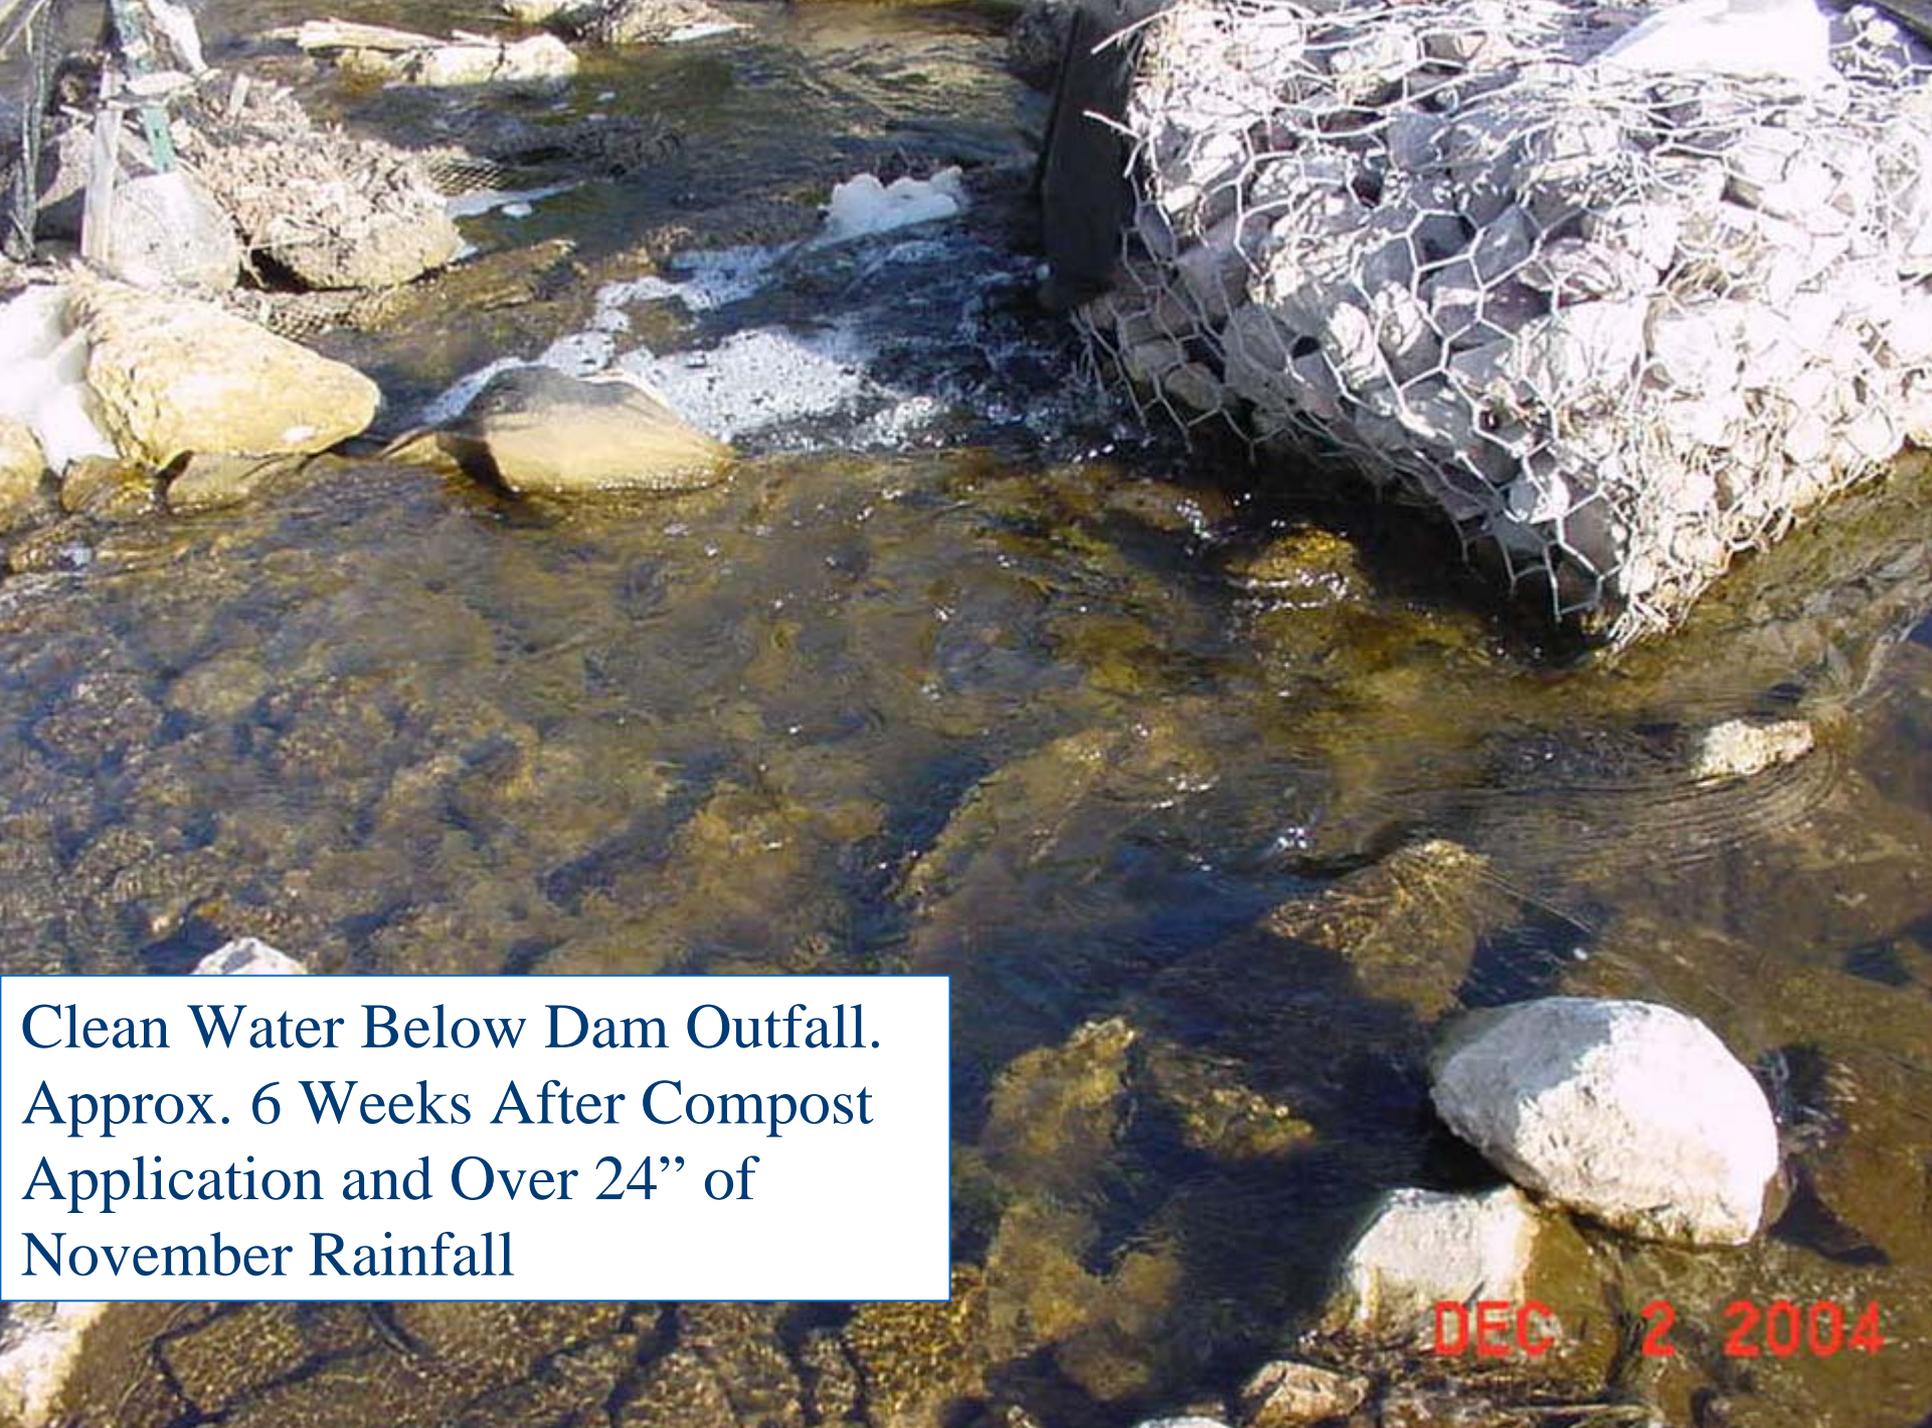
Clean Water Below Dam Outfall.
Approx. 6 Weeks After Compost
Application and Over 24" of
November Rainfall

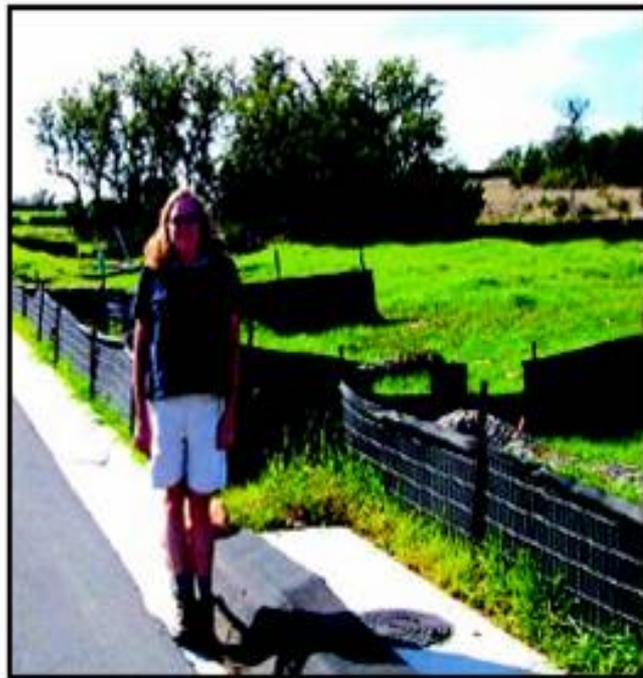
The developers of West Cypress Hills on Texas 71 West drafted Sally Brannon to spruce up landscaping in the area. Among other things, she oversaw the installation of thousands of mulch logs, left, to slow the flow of water runoff.
