Dust Sampling at the Montrose Superfund Site

DATE: May 15, 2013

MONTROSE – ON-SITE DUST CONTROL INSPECTION CHECK LIST

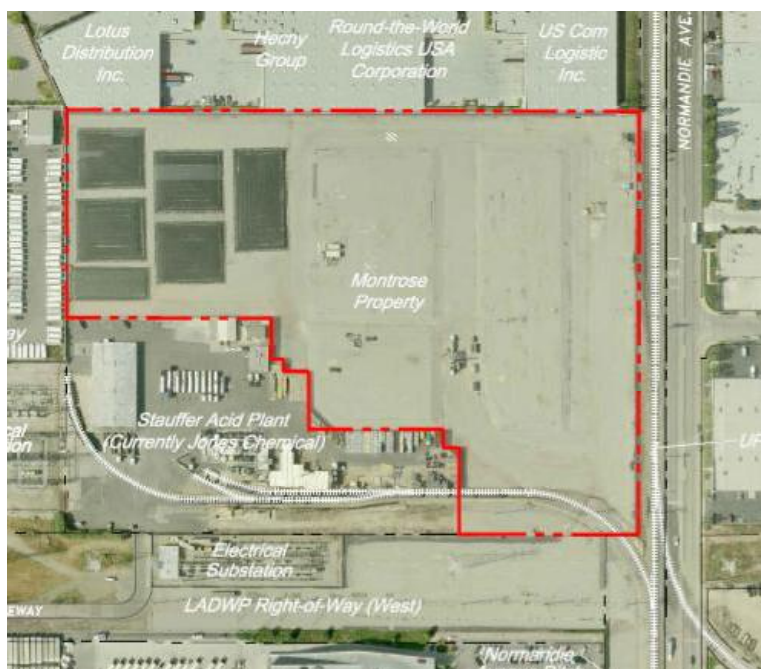
Mark on Figure below:

- A - Location of excavation (exclusion zone) Treatment plant pad area
- B- Wind Sock (one on trailer, also Stauffer property SW, and a flag on property directly S
- C – Upwind Dust Monitor located along south fence approx extension of main pipe trench
- D – Downwind Dust Monitor located along north fence approx ext of main pipe trench
- E- Stockpiled Soils mostly directly west of trailer but east of black covered stockpiles
- > General direction of wind during visit was south to north and SW to NE

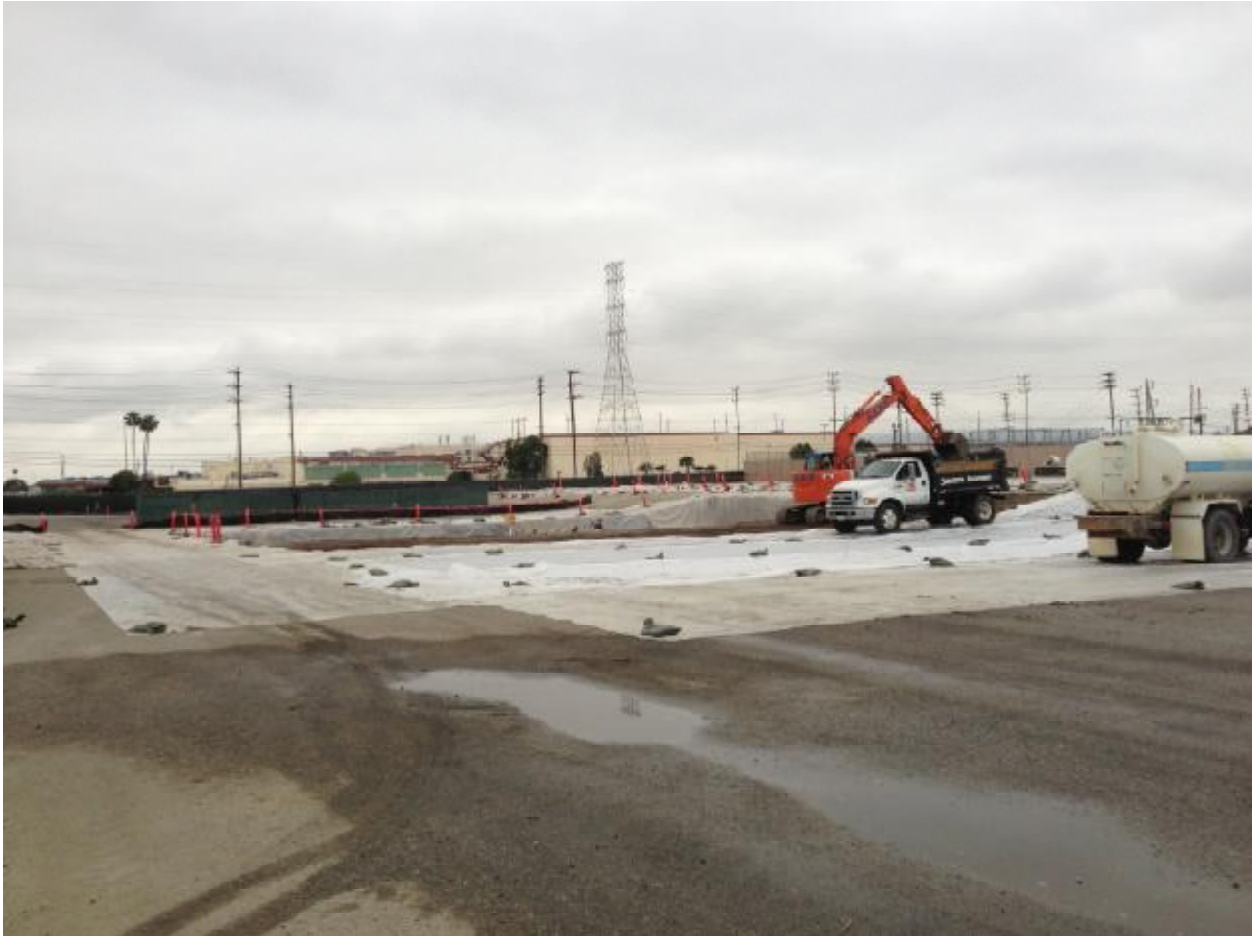
- Water truck actively wetting ground during visit
- All trenches and soil piles covered with plastic, except the current excavation area and the soil pile in the southwest portion of the site that was being worked on by a loader during visit.
- Worker periodically spraying excavation area with water from a hose
- Rumble strips (large, ribbed metal sheets) at entrance of site to reduce vehicle speed

Excavation area. Taken facing southwest.

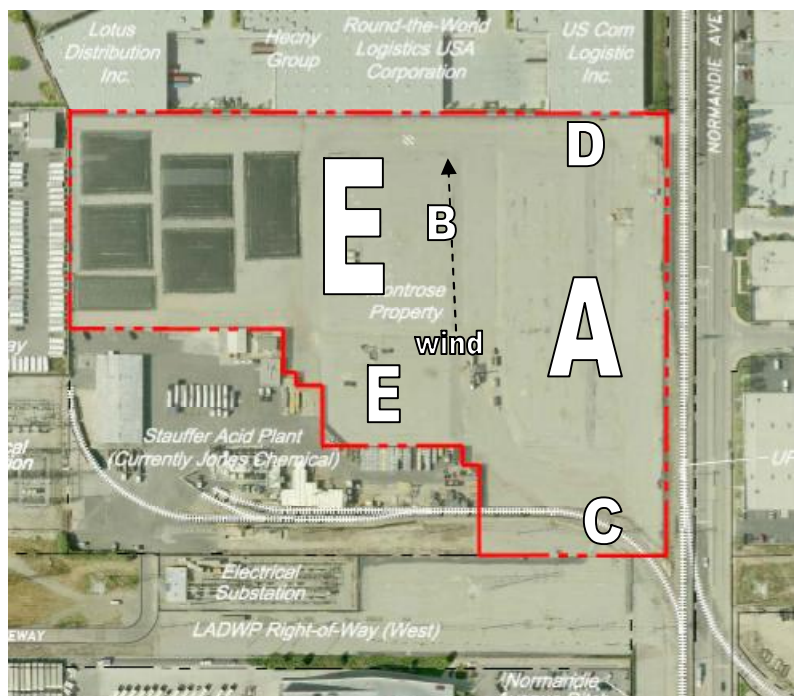
Mark on Figure below:

- A - Location of excavation (exclusion zone)
- B- Wind Sock - (on top of trailer)
- C – Upwind Dust Monitor
- D – Downwind Dust Monitor
- E- Stockpiled Soils
- > General direction of wind during visit

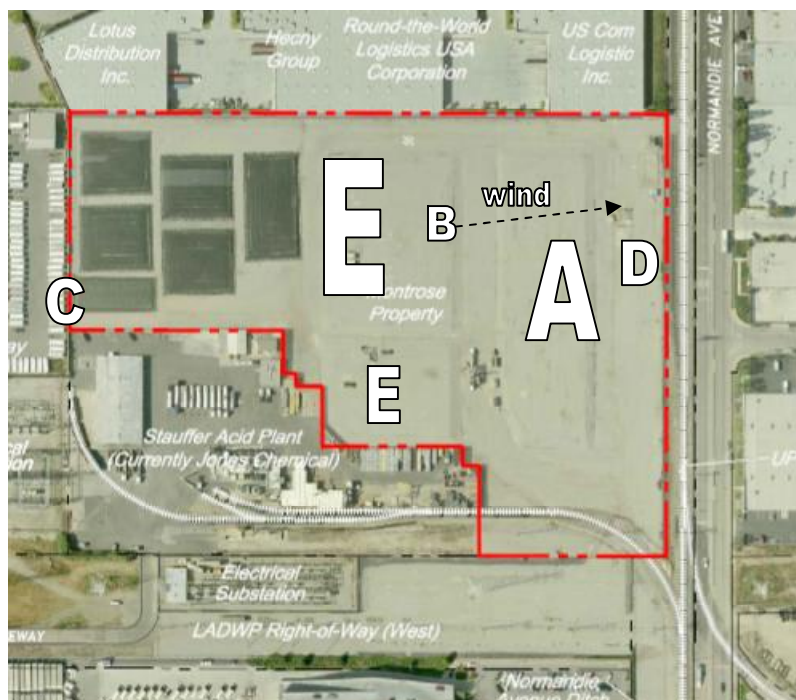
Mark on Figure below:

- A - Location of excavation (exclusion zone)
- B- Wind Sock - (on top of trailer)
- C – Upwind Dust Monitor
- D – Downwind Dust Monitor
- E- Stockpiled Soils
- > General direction of wind during visit
