**Preliminary Assessment/Site Inspection Report
Santa Susana Field Laboratory
Simi Valley, California**

**EPA ID No.: CAN000908498
USACE Contract No.: W91238-06-F-0083
Document Control No.: 12767.063.419.1650**

November 30, 2007

**Prepared by:
Weston Solutions, Inc.
1575 Treat Blvd, Suite 212
Walnut Creek, CA 94598**

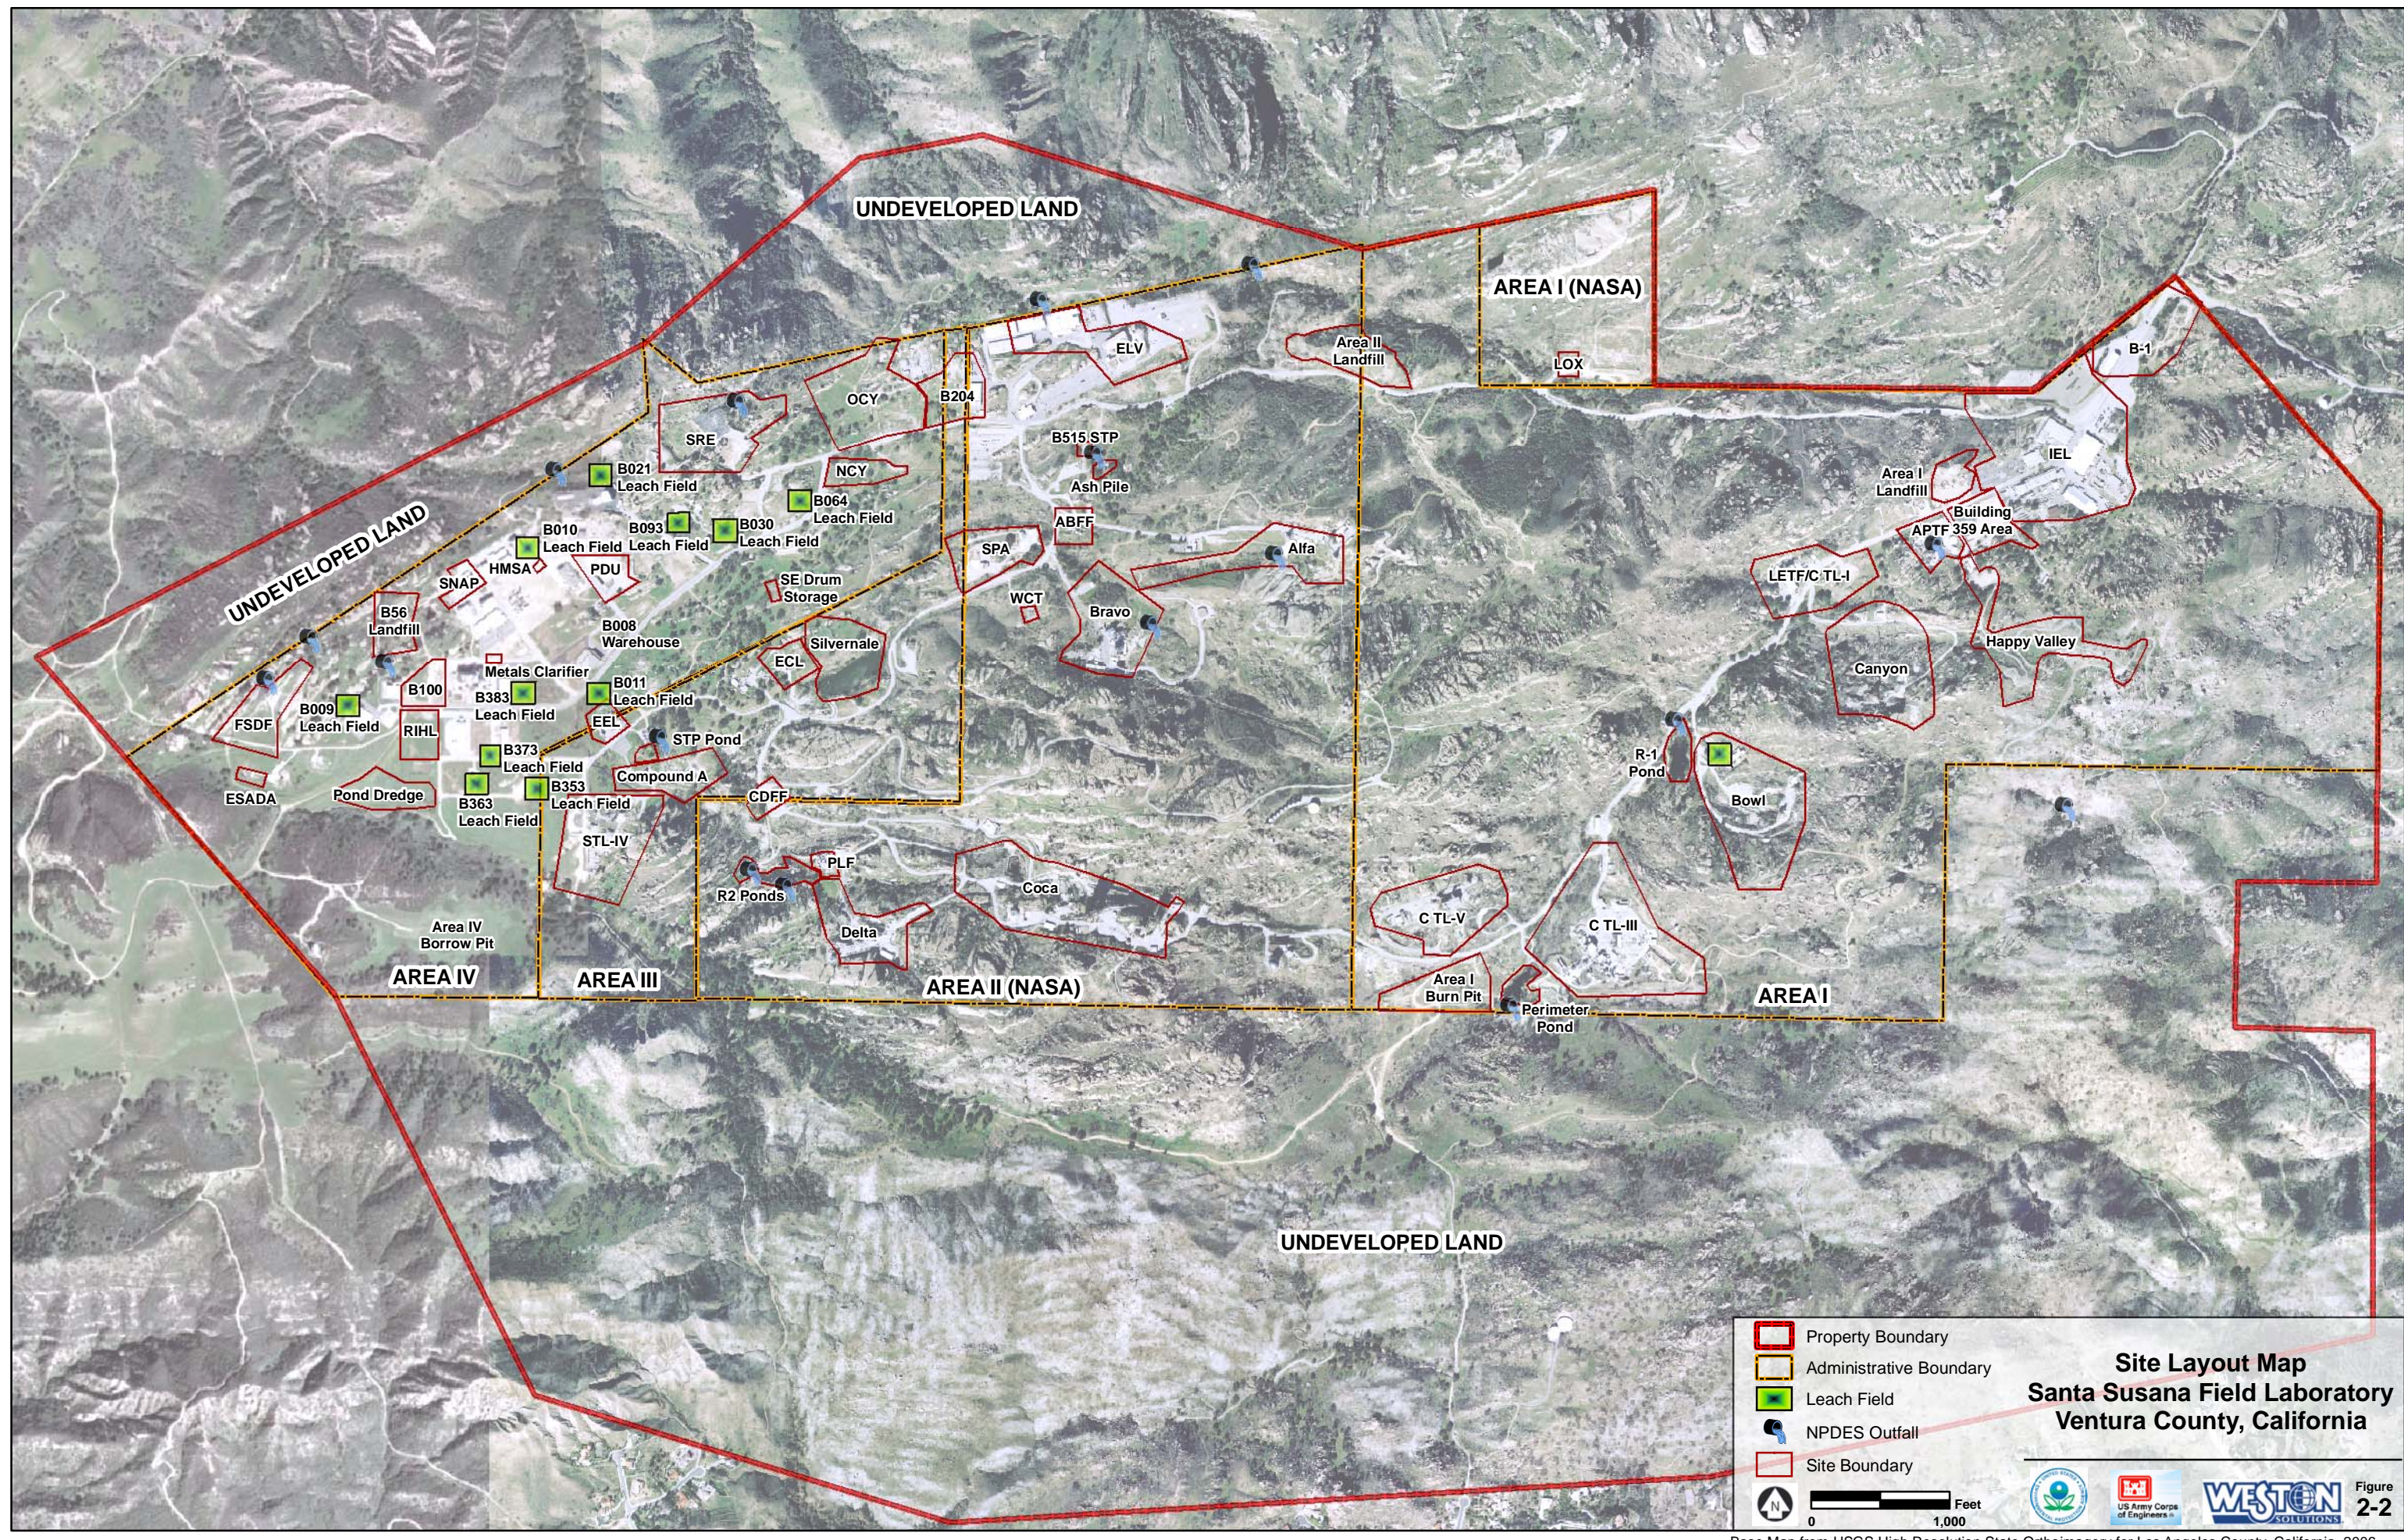
Site Layout Map
Santa Susana Field Laboratory
Ventura County, California

The SSFL site is divided into four administrative areas (Areas I, II, III, and IV), with undeveloped land acting as buffer zones to the northwest and south, as shown in Figure 2-2. The size, location, and current ownership of these areas are as follows:

- Property Boundary
- Administrative Boundary
- Leach Field
- NPDES Outfall
- Site Boundary
