Airborne Thermal Infrared Remote Sensing Eel River, CA

Survey Date: August 11-12 2005
Draft Report Date: October 15, 2005

Background

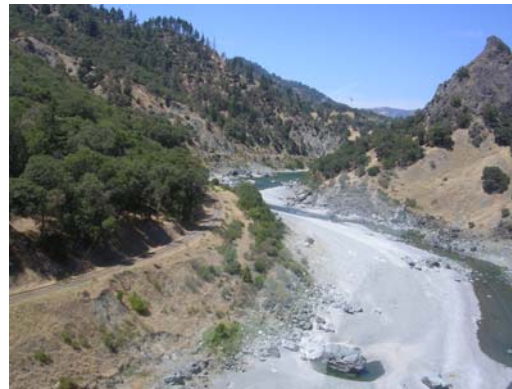
Weather conditions recorded at the Eel Camp RAWs stations during the dates of the survey.

Weather conditions were considered ideal with clear skies, air temperatures in the mid 90's (°F), low humidity, and calm winds.

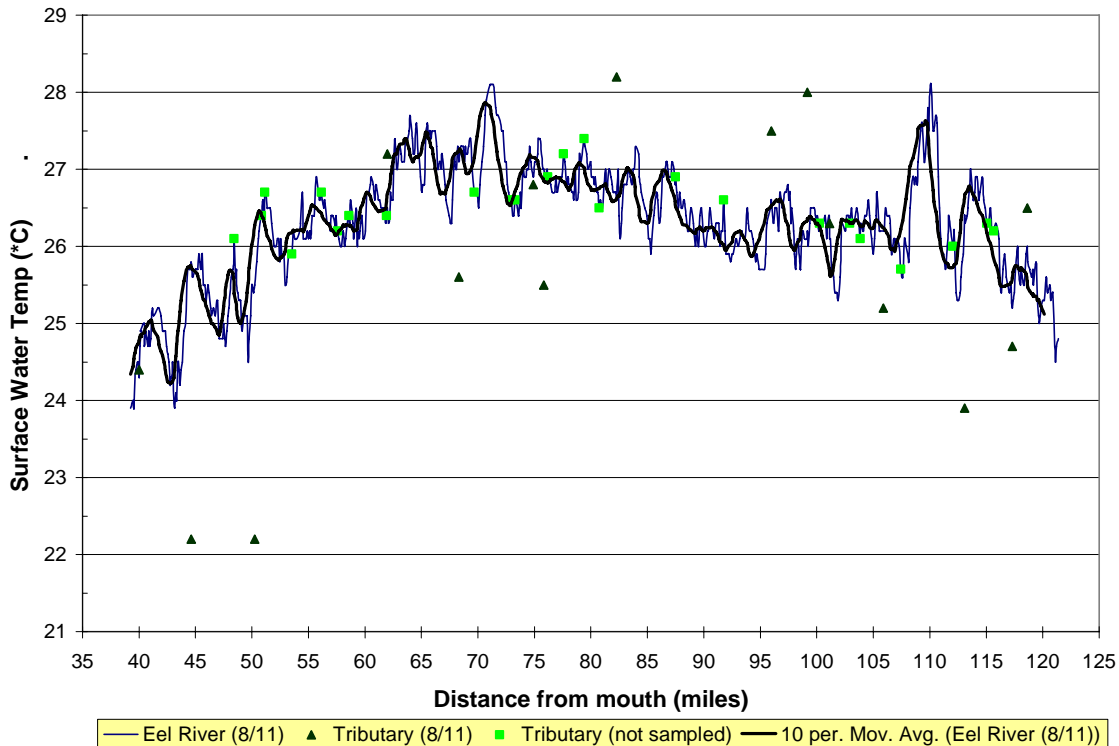
Figure 7 - Longitudinal profile with both sampled and detected (not sampled) tributaries along Middle Main Eel River. The plot also shows a moving average trend line derived from the sampled data.

Radiant water temperatures in the Middle Main Eel River ranged from 23.9°C to 28.2°C over the 82-mile survey extent (Figure 7). A total of 15 tributaries were sampled during the analysis, of which 7 contributed cooler water to the main stem. A number of other tributaries were detected, but were too small (*relative to pixel size*) to obtain an accurate temperature sample. In some cases, surface flow was detected within the tributary channel, but disappeared in the alluvial floodplain prior to reaching the active channel.

Inspection of the longitudinal profile shows two prominent spikes between miles 110.8-108.3 and miles 72.2-70.5 where radiant temperatures reached maximums of greater than 28°C. Inspection of the TIR imagery did not show any evidence of thermal stratification or other artifacts of remote sensing that would account for these gains. Such rapid longitudinal heating is often observed in smaller streams where surface flow is lost (*e.g. withdrawal or to the sub-surface*) or in the absence of a buffering source (*e.g. hyporheic discharge*). Review of the imagery between river mile 110.8 and 108.3 shows small seeps along a gravel bar (mile 110.3) and cooler water from a side channel at mile 109.7. The spatial temperature pattern at these locations suggest that surface flow is lost, resulting in a lower surface flow volume and increased downstream heating followed by discharge back into the channel and subsequent cooling.

In order to highlight reach scale patterns, a trend line (10-sample moving average) was generated from the sample points (Figure 7). The trend line shows that in addition to the local variability, general temperature patterns were also observed in the Middle Main Eel River. At the upstream end of the survey near Dos Rios, water temperatures were ~25.0°C and showed a general warming trend, reaching ~27.4°C at mile 62.7. Moving downstream, water temperatures exhibited a general cooling trend reaching ~24.3°C at the South Fork confluence. The reason for this cooling trend was not directly apparent from the imagery. However, this trend has been observed on other coastal streams in Northern California (*Redwood Creek, Mattole River*). The trend is presumably due to morning fog and generally cooler air temperatures as the river moves closer to the coast.
