**United States  
Environmental Protection Agency  
Region 9**

**Ventura River Reaches 3 and 4  
Total Maximum Daily Loads For  
Pumping & Water Diversion-Related  
Water Quality Impairments**

**Draft December 2012**

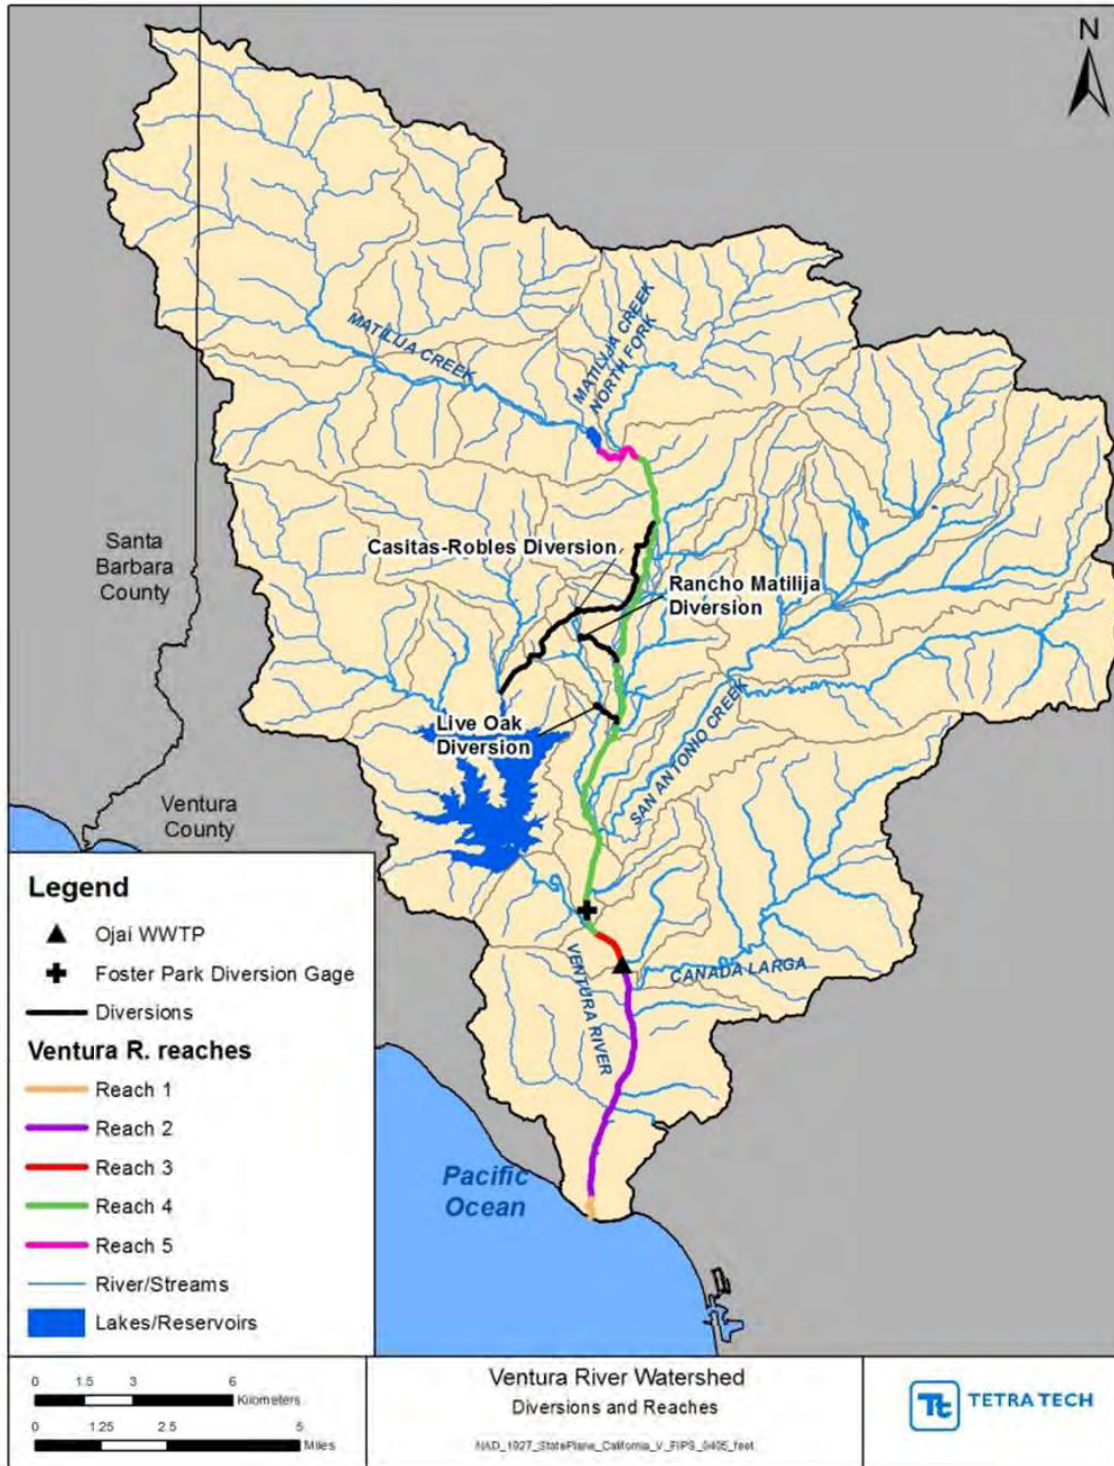
Figure 1-1. Major surface waters in Ventura River Watershed

The Ventura River Watershed (Figure 1-1) is located in the northwestern portion of Ventura County with a small portion in the southeastern portion of Santa Barbara County. The watershed drains a fan-shaped area of about 220 square miles with an elevation from 6,000 feet to sea level. The Ventura River has several major tributaries, including Matilija Creek, North Fork Matilija Creek, San Antonio Creek, Coyote Creek and Cañada Larga. Matilija Creek (15 miles) drains the Santa Ynez Mountains as it flows to the Matilija Reservoir and the Matilija Dam. The creek continues below the dam for about one half mile before it joins North Fork Matilija Creek. North Fork Matilija Creek, which is about 12 miles long, generally follows Highway 33 in the Los Padres National Forest until it joins Matilija Creek.

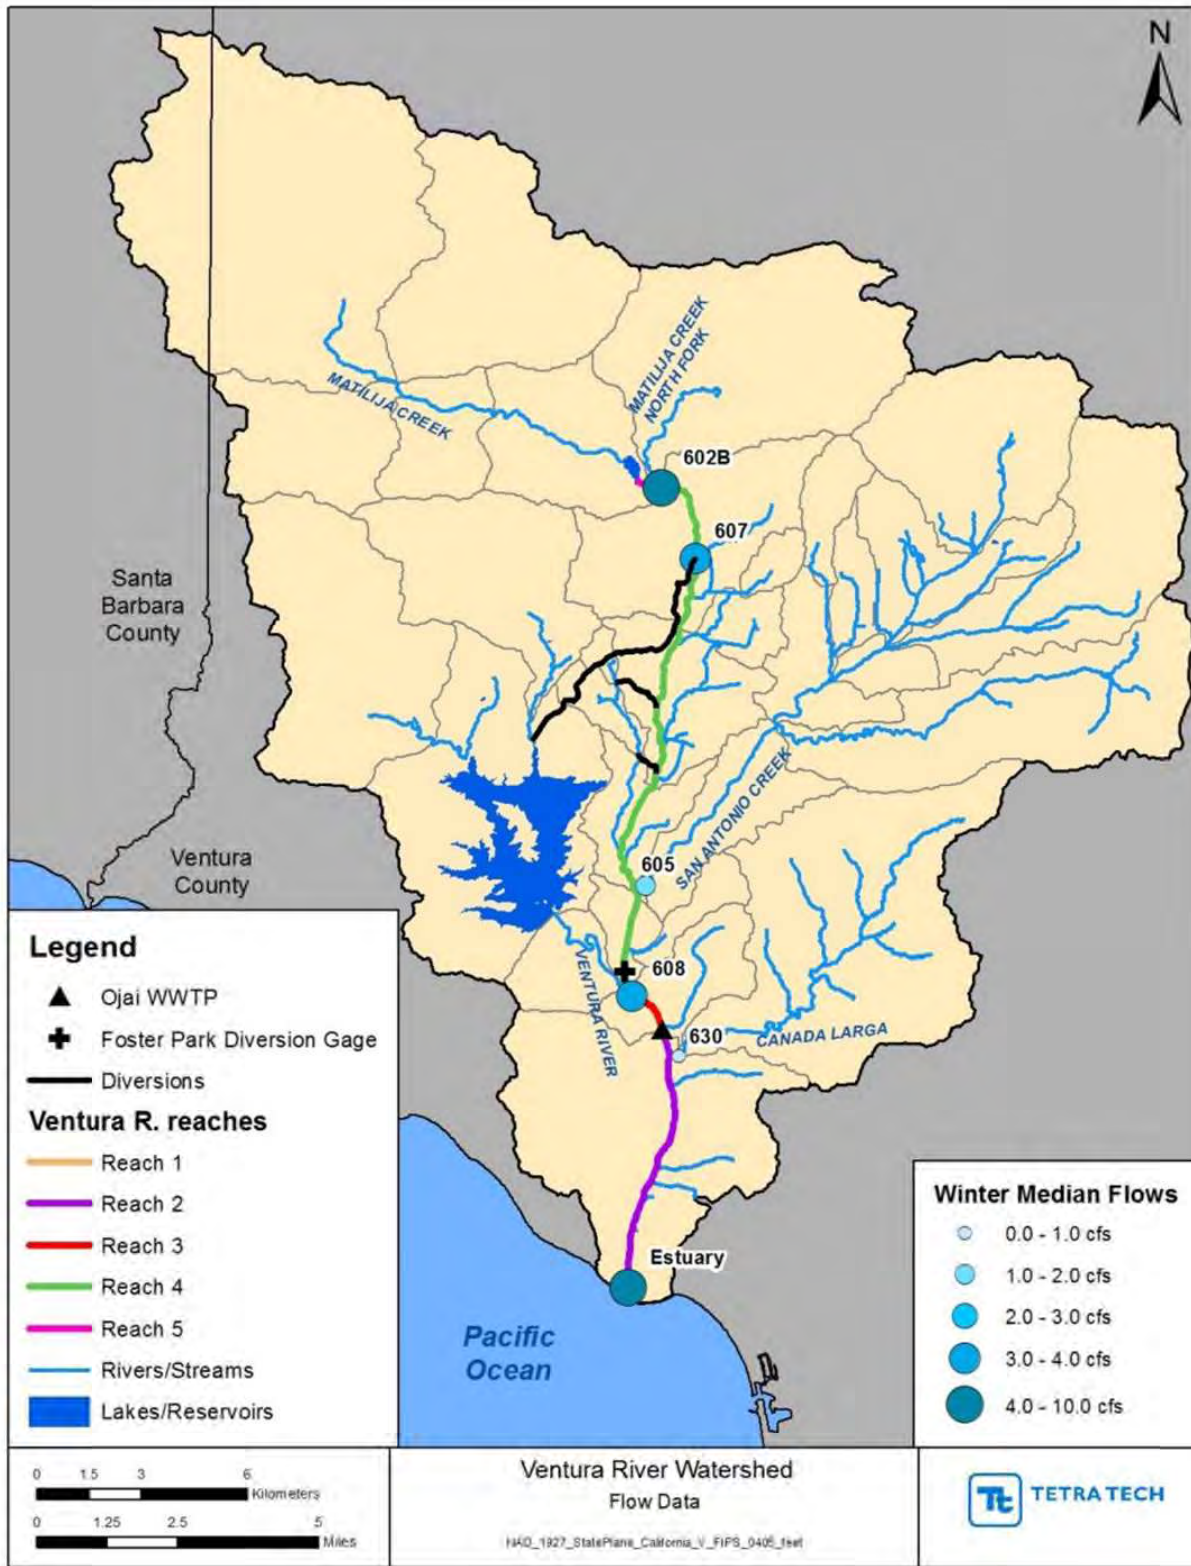
Figure 5-2. Winter median flows within the Ventura River

For a conservative hydrologic evaluation of the Ventura River system, median winter flows and median summer flows were examined, as illustrated in Figure 5-2 and Figure 5-3, respectively. Direct comparison of seasonal median flows is illustrated in Figure 5-4. As shown, flows are generally higher during winter season with the exception of a few sites. In both seasons, flow is reduced at Gage 607 when compared to Gage 602B, which is located a few miles upstream. This gage is downstream of the Casitas-Robles diversion and may reflect the effects of water diversions. There is then a long span on the mainstem without long-term flow data. The next gage downstream is Gage 608, which is downstream of both the Foster Park Diversion and Coyote Creek. Gage 608 demonstrates increased flows when compared to Gage 607, which can be attributed to input from Coyote Creek. Ultimately, the diversions near the end of Reach 4 have minimal impact on overall stream flow during the wet and dry seasons, when considering

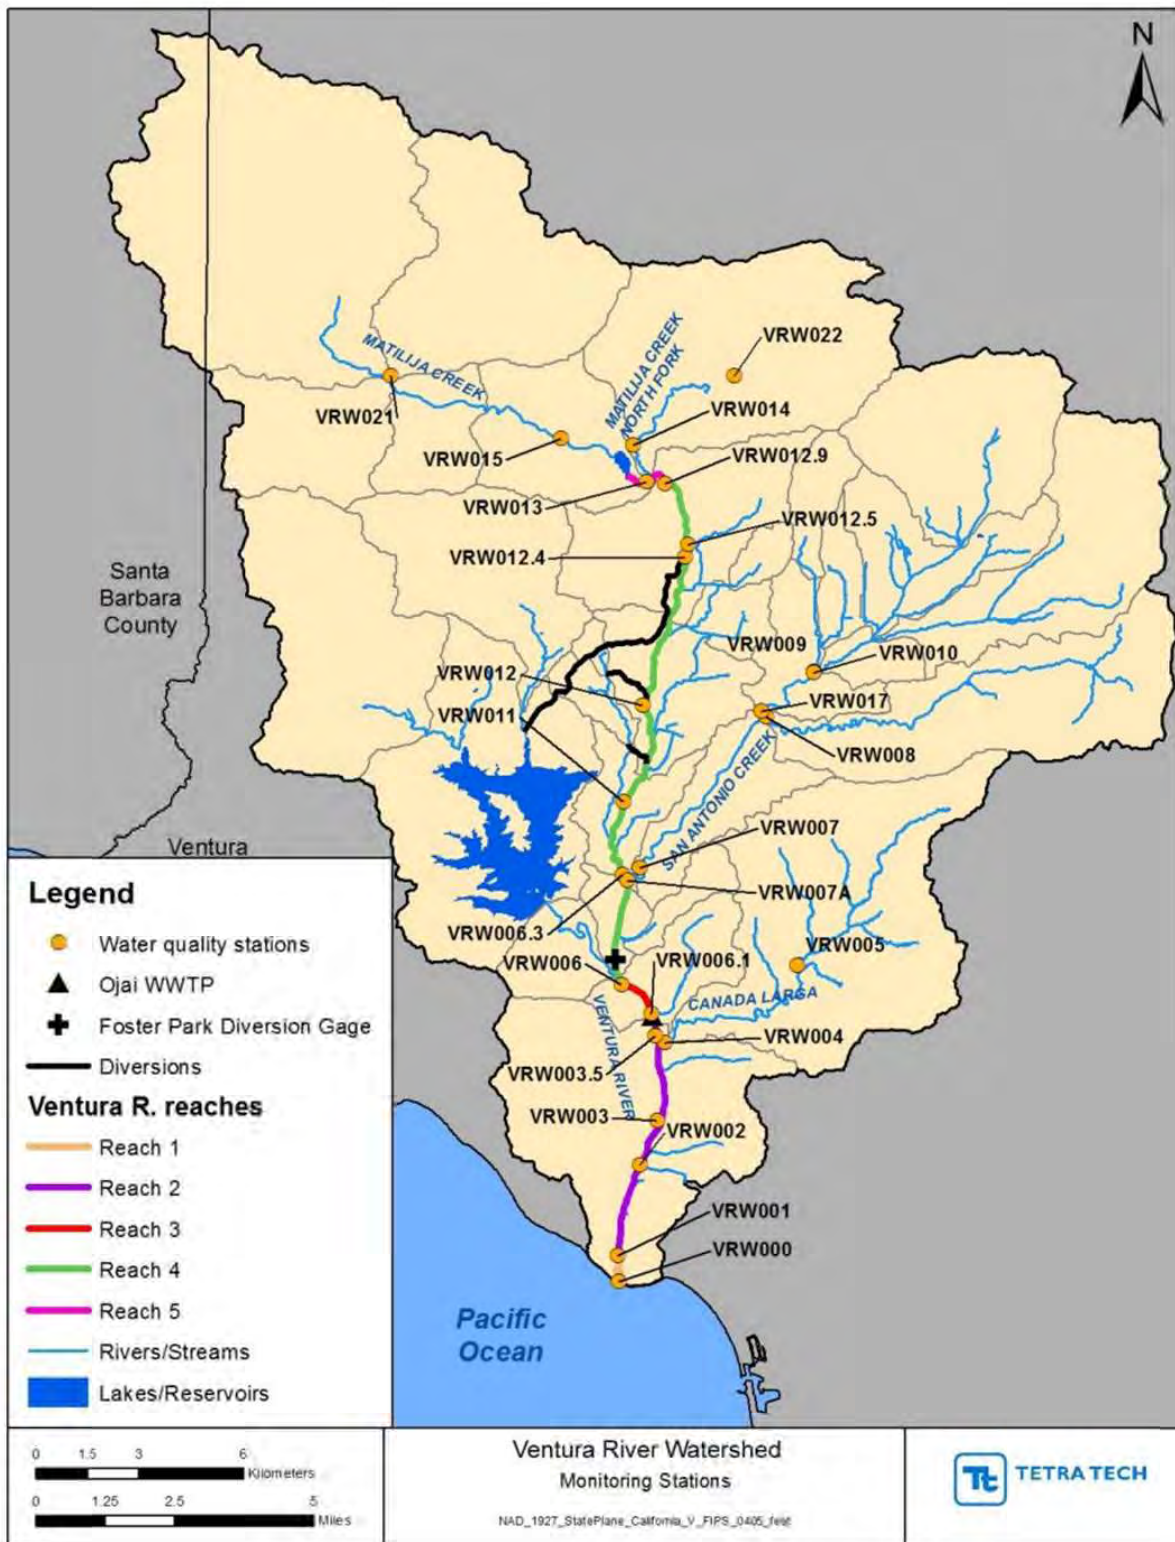
Figure 5-5. Water quality monitoring locations in the Ventura River Watershed

Site ID	Site Location	SBCK Data (Nutrients)	SBCK Data (pre-dawn DO)
VRW000	Ventura @ Estuary	x	x
VRW000E	Ventura Estuary, East		x
VRW00W	Ventura Estuary, West		x
VRW001	Ventura @ Main St. Bridge	x	x
VRW002	Ventura @ Stanley Ave	x	
VRW003	Ventura @ Shell Bridge	x	x
VRW03.5	Ventura @ above Cañada Larga confluence	x	x
VRW004	Cañada Larga @ confluence (@ Ventura Ave., @ bicycle Bridge, Lower Cañada Larga)	x	x
VRW005	Cañada Larga @ upper crossing (Upper Cañada Larga)	x	
VRW006	Ventura @ Foster Park	x	x
VRW06.1	Ventura @ above OVSD	x	x
VRW06.3	Ventura @ above S. Antonio confluence (@ San Antonio Creek Confluence)	x	x
VRW007	San Antonio @ Old Creek Rd. (Lower San Antonio Creek)	x	x
VRW007A	San Antonio @ confluence (bike path)	x	x
VRW008	Lion Canyon Creek (Close to VR017, 50m up from San Antonio Creek)	x

Site ID	Site Location	SBCK Data (Nutrients)	SBCK data (pre-dawn do)
VRW009	Stewart/Fox (Pirie Cr.)	x	x
VRW010	Upper San Antonio Creek	x	x
VRW011	Ventura @ Santa Anna Blvd. (@ Santa Ana Rd Bridge)	x	x
VRW012	Ventura @ Hwy 150	x	x
VRW12.4	Ventura @ below Robles Diversion (VR12.4)	x	
VRW12.5	Ventura @ above Robles Diversion (VR12.5)	x	
VRW12.9	Ventura @ Camino Cielo, below Matilija Forks	x	x
VRW013	Matilija Creek below dam (250m up from confluence)	x	x
VRW014	N. Fork Matilija Creek	x	x
VRW015	Matilija Creek above dam (Upper Matilija)	x	x
VRW017	San Antonio @ Lion Canyon, above or below (Middle San Antonio Creek)	x	x
VRW021	Matilija @ Wilderness Boundary (Upper N. Fork Matilija)	x	
VRW022	N. Fork Matilija @ near FS Campground (At Wheeler Gorge)	x

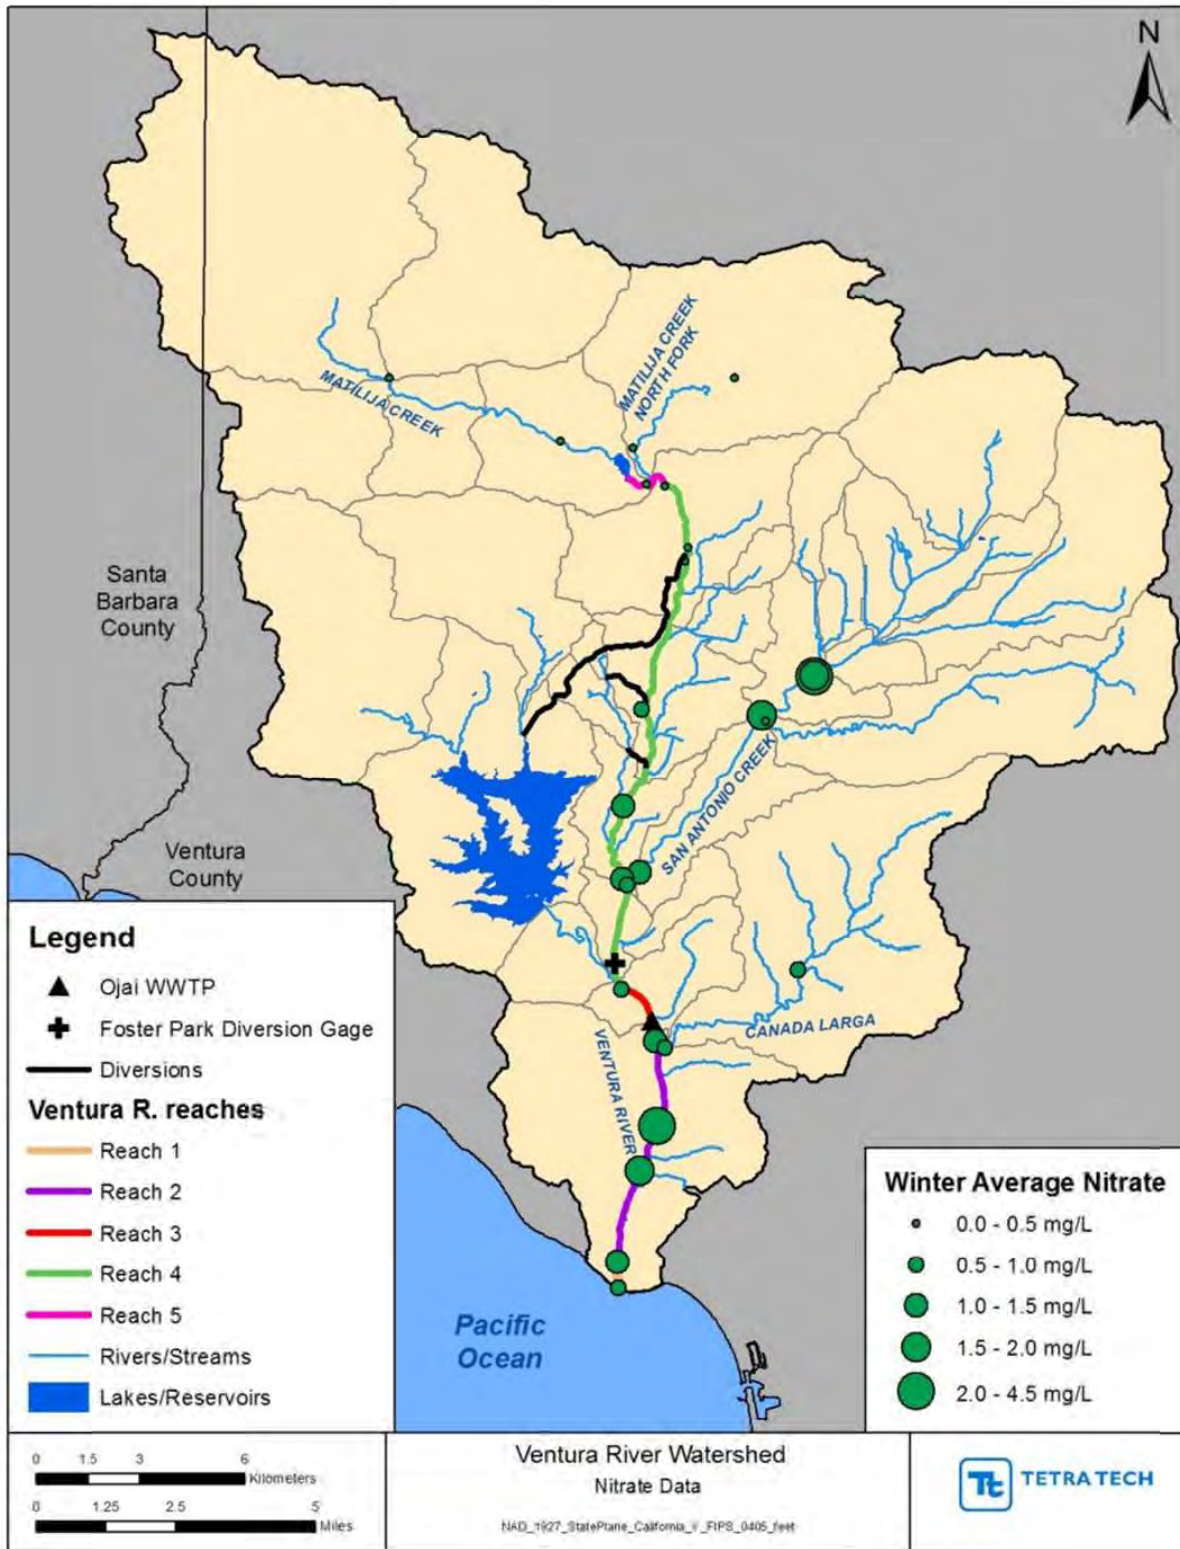
Figure 5-6. Average nitrate concentrations during winter season

Average winter and summer nitrate concentrations are illustrated in Figure 5-6 and Figure 5-7, respectively. The assessment of nutrients in the Ventura River system illustrates that the Matilija Creek and the Matilija Creek North Fork headwaters do not significantly influence nutrient levels in the Ventura River. Comparatively, some of the highest nutrient levels in the system are observed in the headwaters of San Antonio Creek, which may be attributed to the agricultural and developed land uses in that subwatershed. Winter season nitrate concentrations begin to increase throughout Reach 4, upstream and downstream of the San Antonio Creek confluence, while during the dry season, the nitrate concentrations typically increase only below this confluence (Figure 5-6 and Figure 5-7).

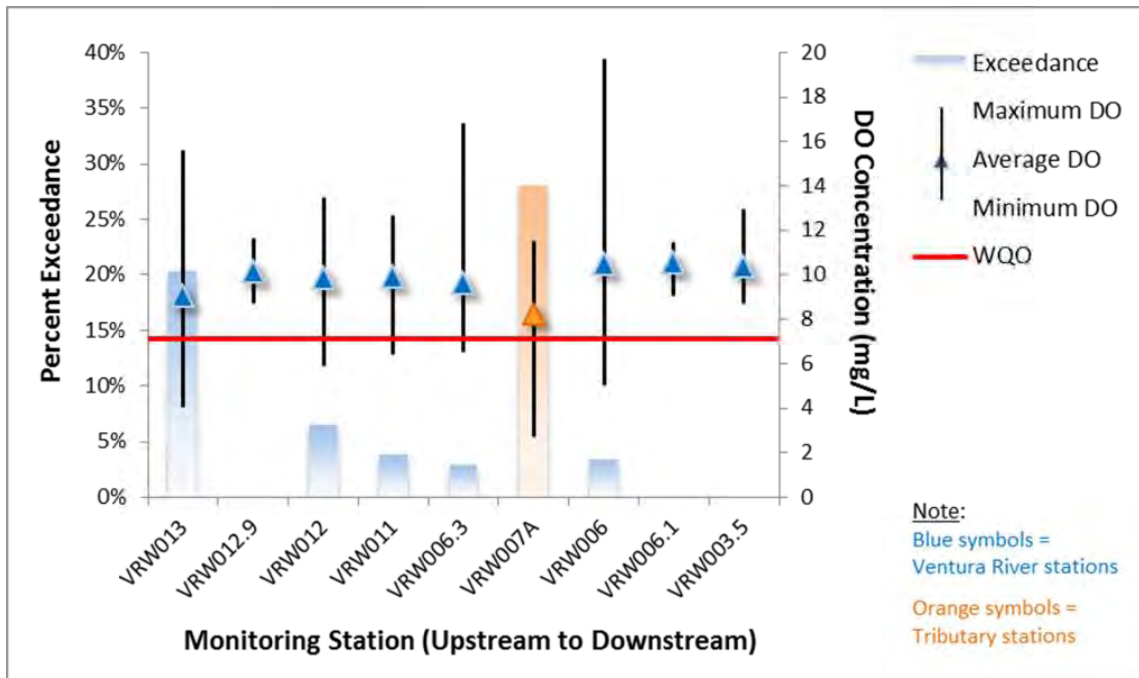
Figure 5-12. Mid-morning and afternoon DO data summary (all data)

DO data were also evaluated at times later in the day when natural overnight conditions represented in the pre-dawn data no longer impact the receiving waters. These data are illustrated in Figure 5-12 through Figure 5-14. These figures present the percent exceedance and minimum, average, and maximum concentrations at several stations moving upstream to downstream from just above Reach 4 through just below Reach 3 (blue symbols in graphs). In addition, one station is shown for San Antonio Creek (orange symbols in graphs) as this tributary is a significant source of loading to Reach 4. Figure 5-12 shows data at all of these stations, while Figure 5-13 and Figure 5-14 present wet and dry season data, respectively.

Notes on Ventura River station identification numbers: VRW013 = Matilija Creek below Dam; VRW012.9 = Camino Cielo; VRW012 = Hwy 150; VRW011 = Santa Ana Blvd./Bridge; VRW06.3 = above San Antonio confluence; VRW07A = San Antonio Creek at confluence (*tributary to Ventura River*); VRW006 = Foster Park; VRW06.1 = above OVSD (WWTP); VRW003.5 = above Cañada Larga confluence
