Assessment Report on Tetra Tech's Support of California's Industrial Stormwater Program

Produced for:
U.S. EPA Region IX

Produced by:
Tetra Tech, Inc.
www.ttwater.com

July 12, 2006

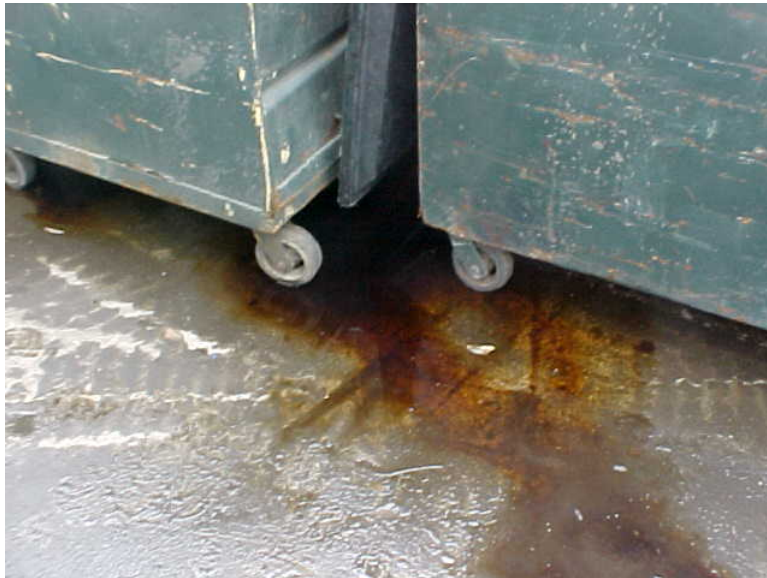
Anecdotal information suggests that facilities rely on nonstructural BMPs

(e.g., good housekeeping, spill cleanup) until it becomes clear (through an inspection, for example) that benchmark values cannot be attained without the implementing structural BMPs. In addition, structural BMP implementation appears to be positively correlated with facility size and market capitalization.

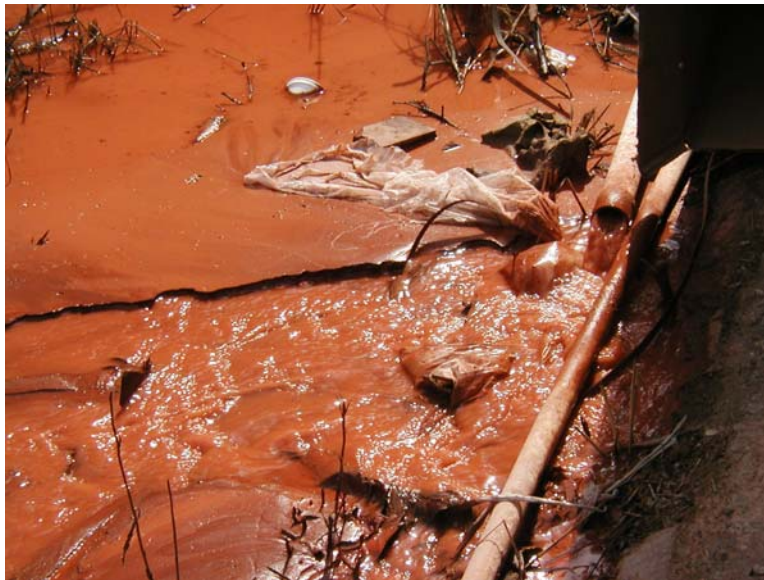
Detailed data analysis is not presented for observed unauthorized non-stormwater discharges. The inspectors observed 158 facilities with unauthorized non-stormwater discharges, fewer than 10 percent of the facilities inspected. In these cases, the facilities were directed to “cease and desist” and the Water Board was immediately notified.

Of these 158 facilities, 1 facility in the Los Angeles Water Board was assessed the largest financial penalty associated with a Tetra Tech industrial stormwater inspection. Cemex Construction Materials, L.P., was assessed a penalty of \$86,500 for unauthorized non-stormwater discharge (Complaint No. R4-2004-0068); however, the calculated potential maximum penalty was \$4,360,000 based on the number of days between the NOI

submittal and the date the illicit drain was sealed (436 days x \$10,000 per day).⁷ Tetra Tech employee Steve Hruby conducted the initial inspection on December 18, 2003, and Jonathon Bishop (Interim Executive Director) signed the complaint on July 2, 2004.

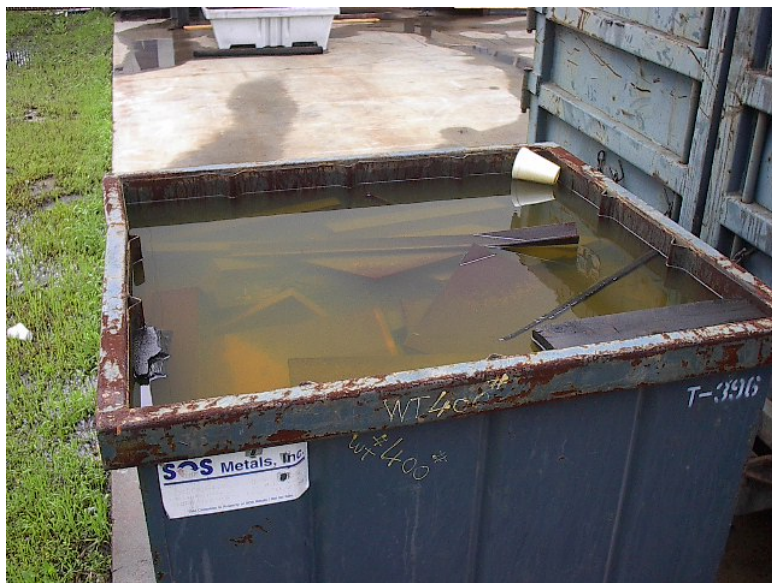
particular BMPs common to the trucking industry. BMP analysis was based on visual inspection; historical stormwater sampling data were not evaluated.

Structural and nonstructural BMP evaluations were conducted at 38 freight transportation facilities selected by the Water Board. Common industrial activities included waste disposal, maintenance, fueling, and truck washing. BMPs were visually evaluated to judge their effectiveness in mitigating pollutant runoff from these activities. Structural BMPs included overhead cover, secondary containment, spill kit presence, berms, slot drains (to convey wash water) and clarifiers (used to reduce suspended material and hydrocarbons in discharges to surface waters). Nonstructural BMPs included maintenance schedules of structural BMPs and general housekeeping practices. A
