# Assessment of Dam Safety

## Coal Combustion Surface Impoundments (Task 3)

Allegheny Energy

R. Paul Smith Station

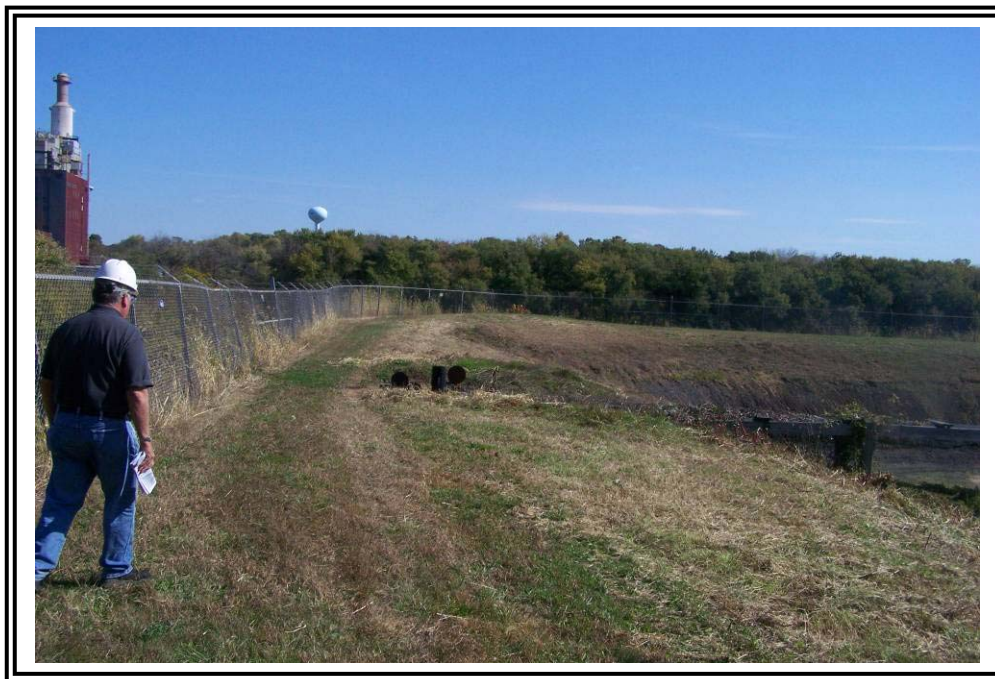
2

In general, the alignments of the crest of Ash Pond #3 dikes do not show signs of change in horizontal alignment. The crest is typically about 12 feet wide and is grass covered as shown in Photos 2, 6, and 15. The crest is slightly wider at the west end of the north dike because of ash left against the upstream slope during past dredging operations.

Crest of north dike at Pond #3, looking east.

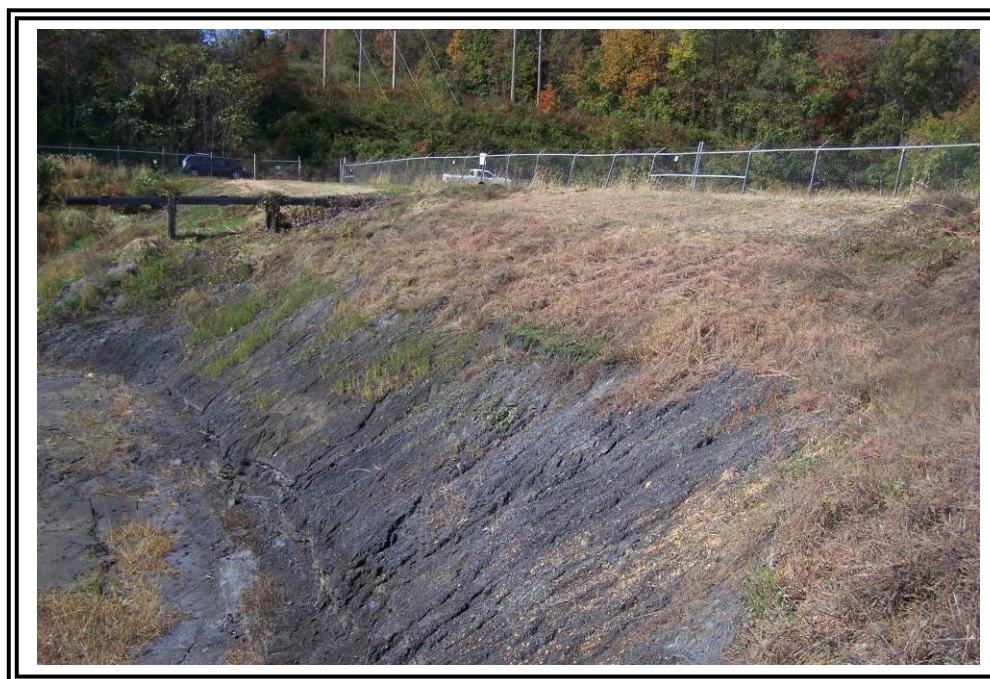
4

Upstream slope of north dike at Pond #3, looking west. Pond was dredged in 2008.

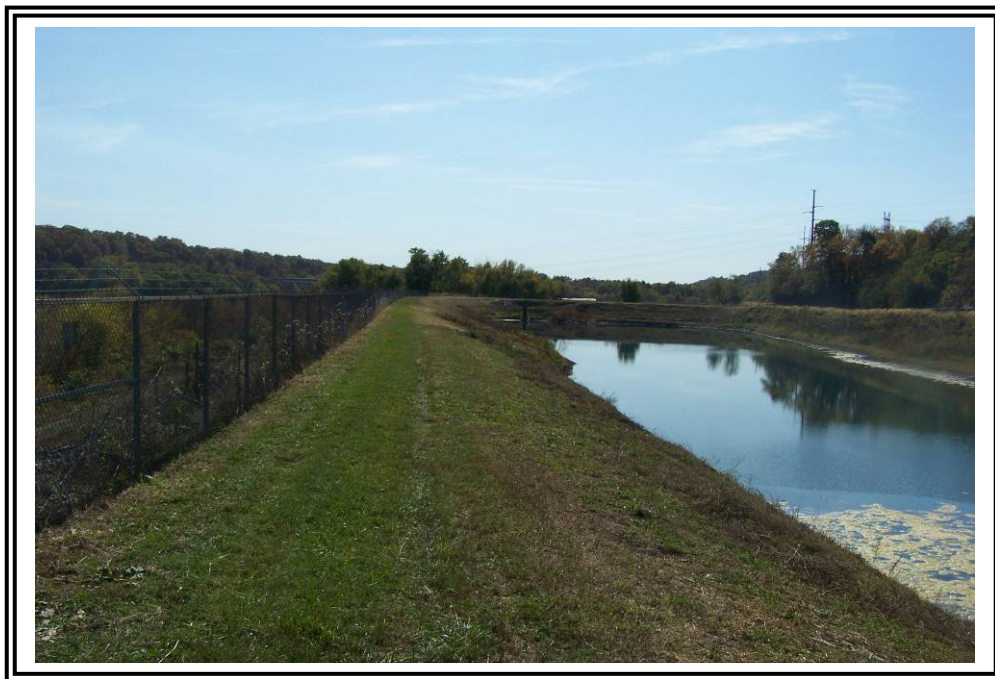
6

Crest of east dike at Pond #3, looking south

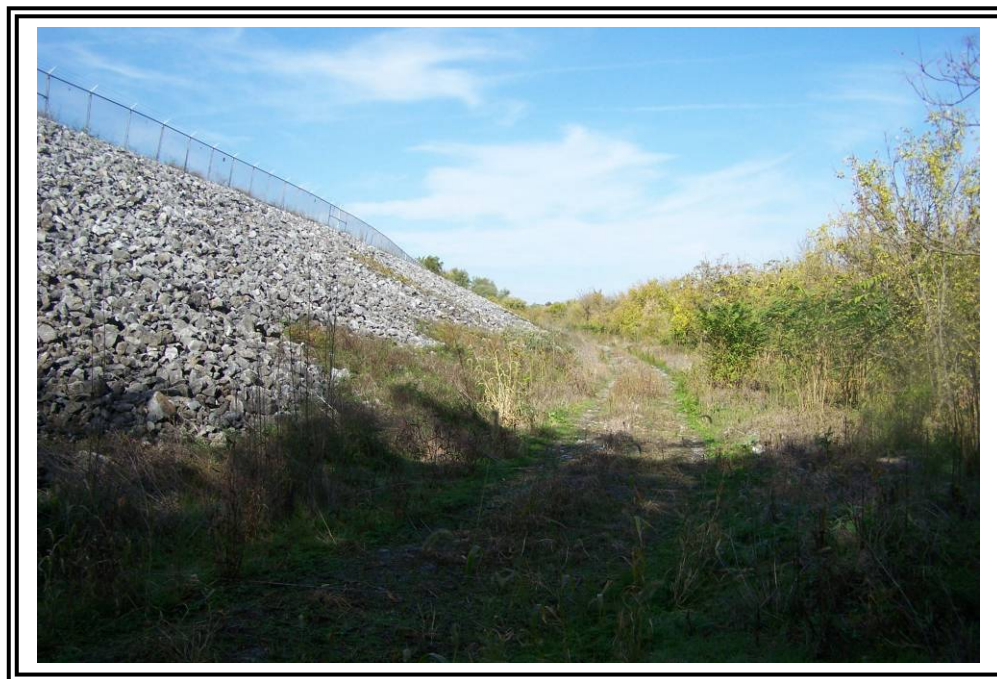
8

Downstream slope of east dike at Pond #3 looking north.

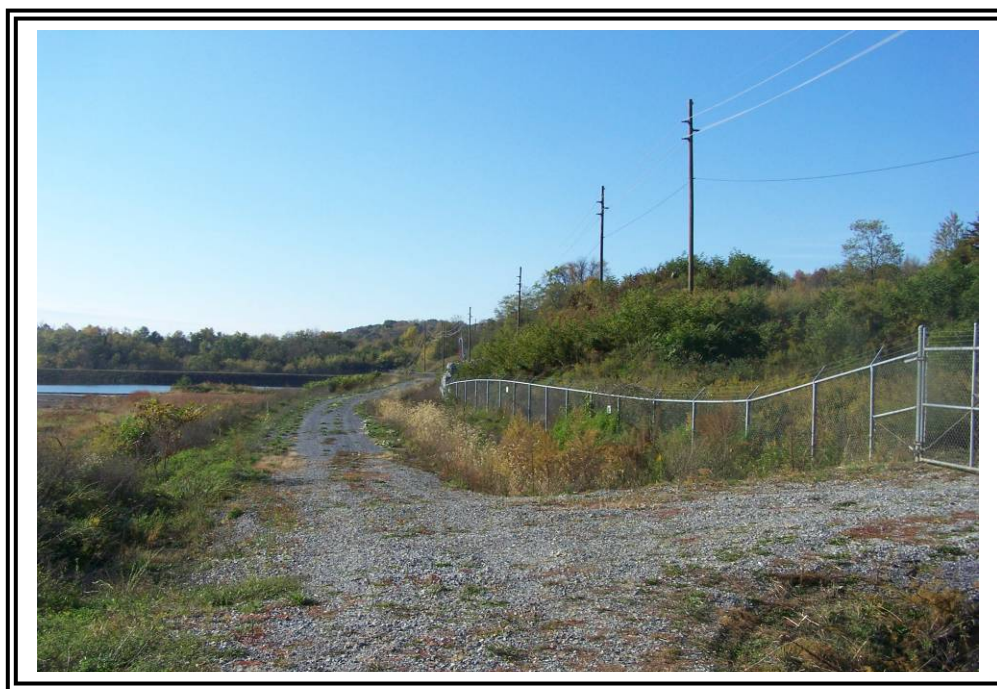
25

West side of Pond #4 is in natural ground, looking south.

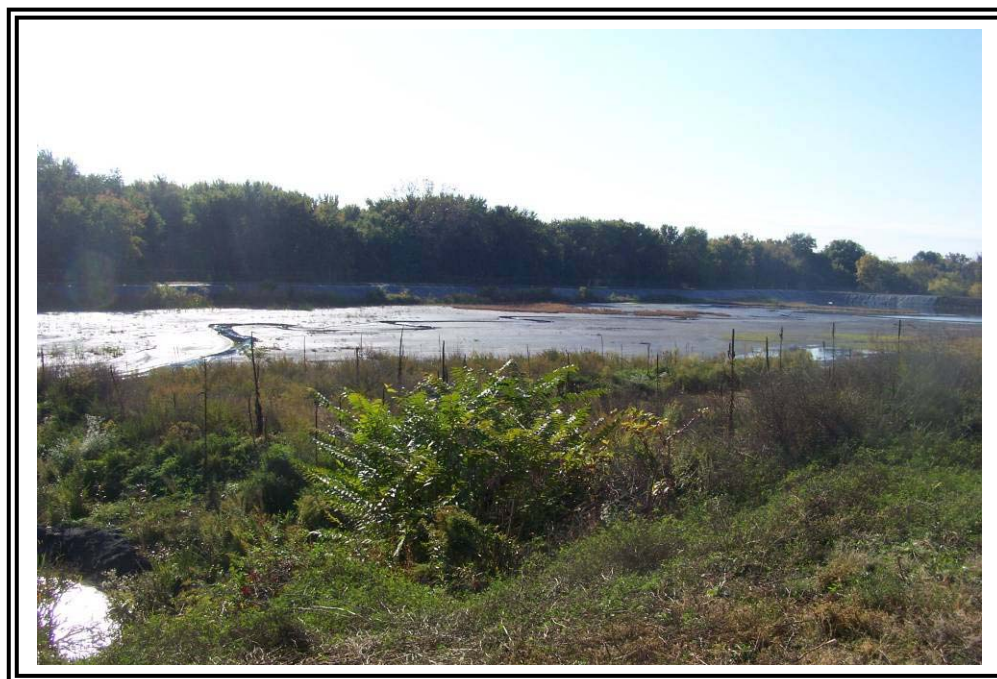
26

Pond #4, looking southeast.

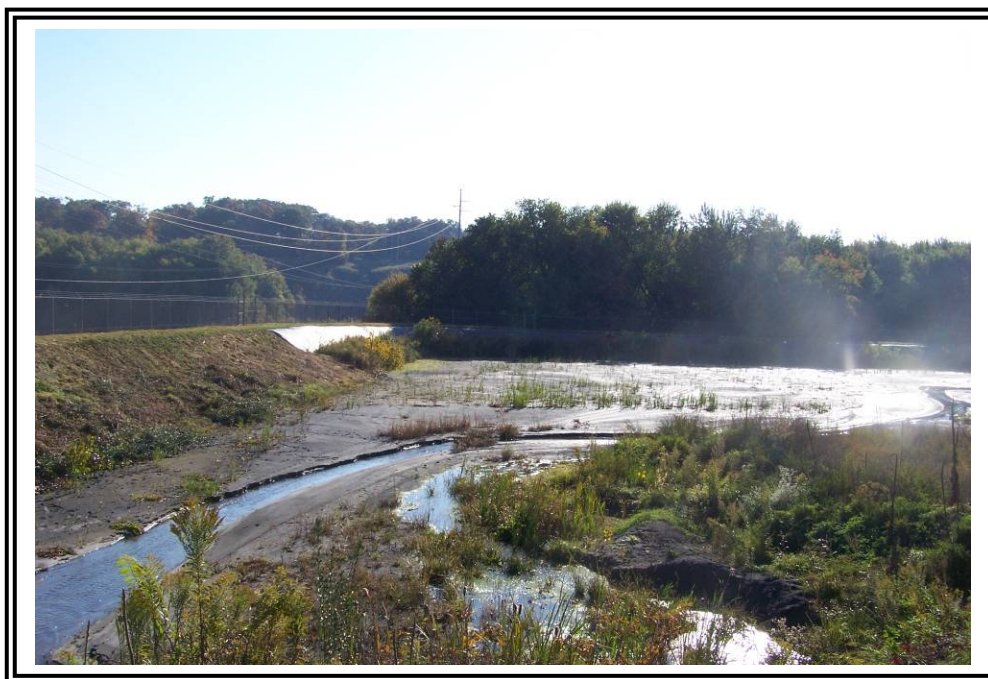
28

Upstream slope of north dike at Pond #4, looking northeast.

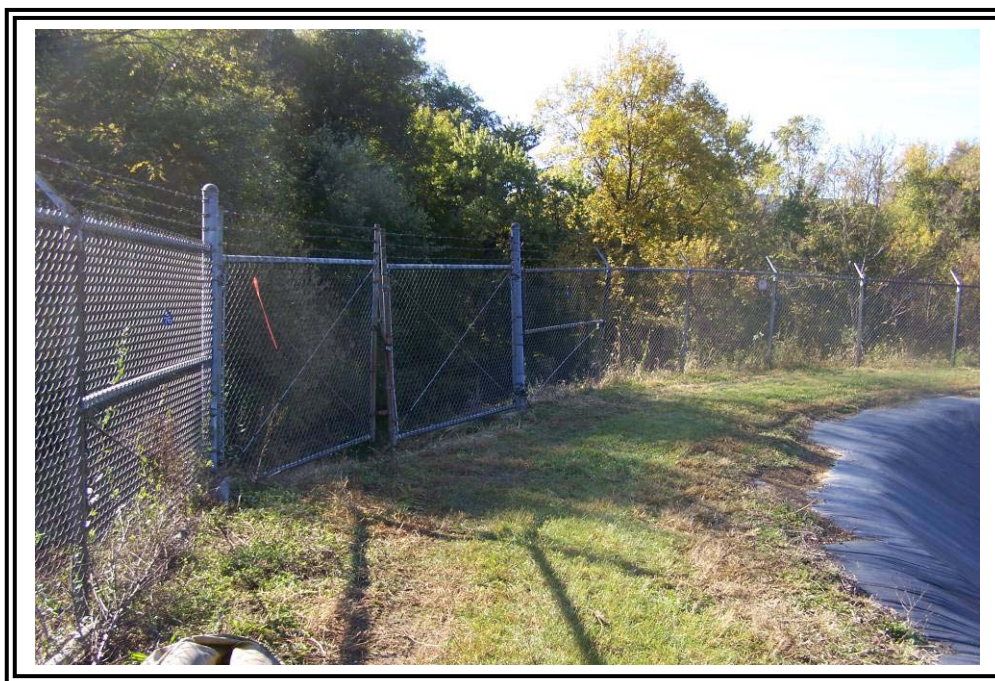
42

In general, the alignments of the crest of Ash Pond #4 dikes do not show signs of change in horizontal alignment. The crest is about 10 feet wide and is grass covered as shown in Photos 27, 33, 34 and 42. The surface has moderate rutting from vehicle traffic on the crest. An approximately 14-inch diameter, 2-inch deep depression was observed on the crest in the area where the discharge pipe passes beneath the east dike. The discharge pipe was slip-lined in 1997, as described in Section 1.3.2.

Crest at southeast corner of Pond #4.

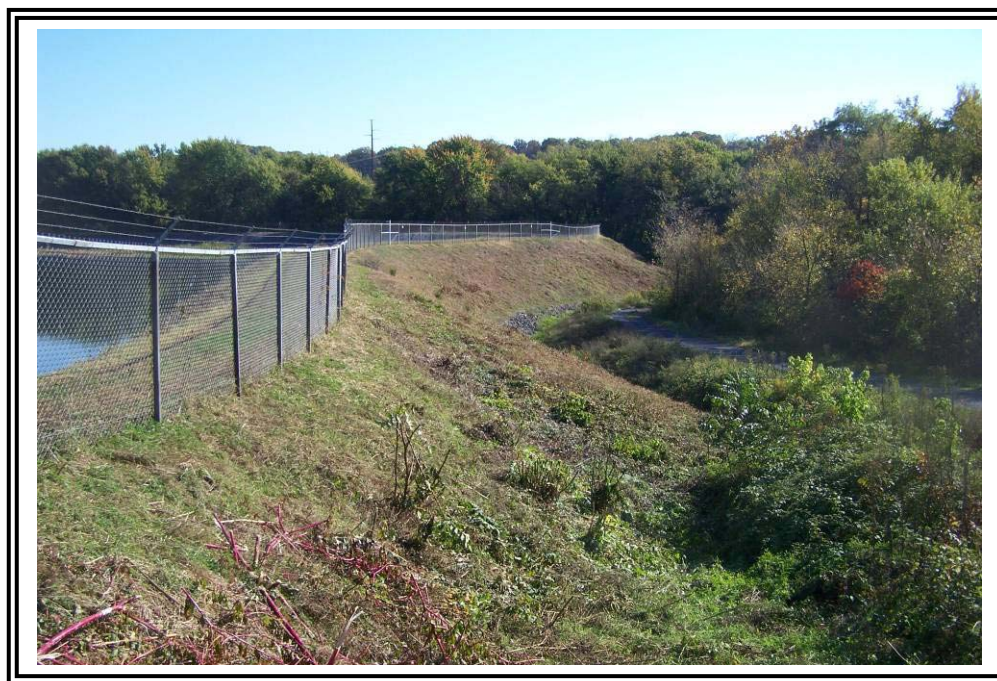
The downstream slopes are weed covered which was freshly cut at the time of our site visit. Photo Nos. 31, 35, and 46 show the general condition of the downstream slope. Many features of deterioration of the downstream slopes were noted as listed below:

Downstream slope of the south dike at Pond #4, looking east.
