Assessment of Dam Safety Coal Combustion Surface Impoundments (Task 3) Final Report

Allegheny Energy

R. Paul Smith Station

April 21, 2010

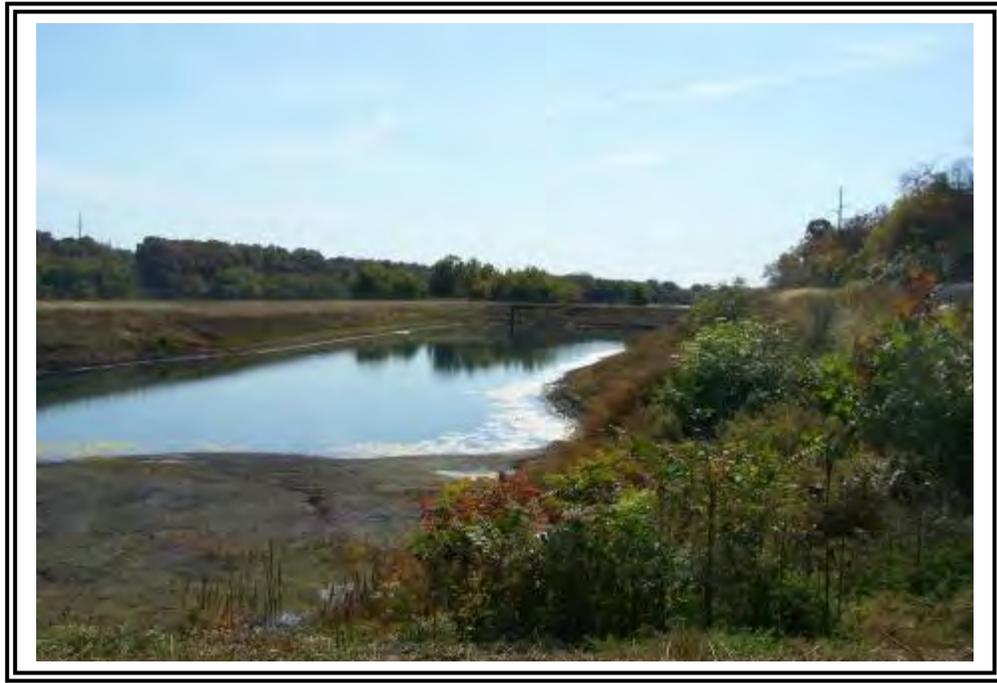
1

Pond #3, looking southeast from the north abutment. West side of pond (right side of photo) is in natural ground.

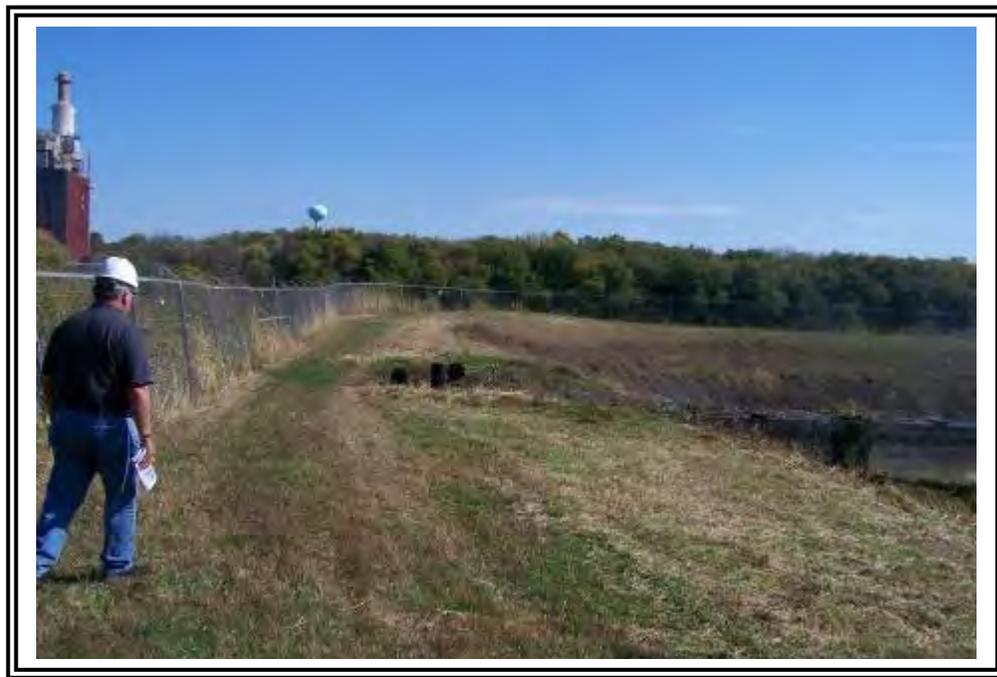
2

In general, the alignments of the crest of Ash Pond #3 dikes do not show signs of change in horizontal alignment. The crest is typically about 12 feet wide and is grass covered as shown in Photos 2, 6, and 15. The crest is slightly wider at the west end of the north dike because of ash left against the upstream slope during past dredging operations.

Crest of north dike at Pond #3, looking east.

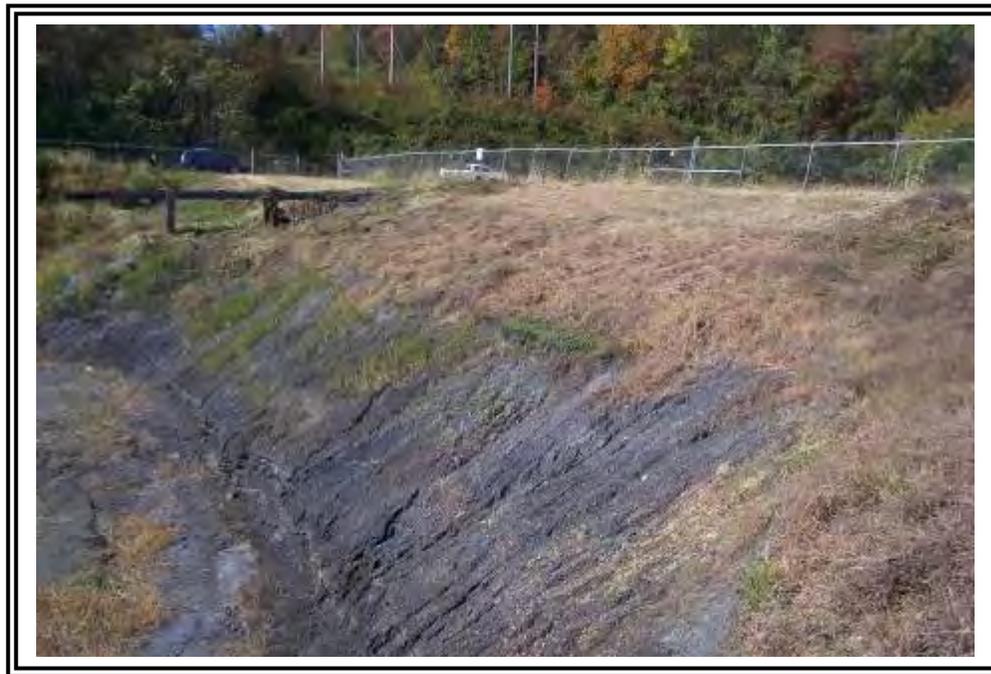
4

The upstream slope is grass covered to the elevation corresponding to maximum storage, and exposed ash below that elevation due to recent 2008 dredging operations. The upstream slope of the north dike is shown in Photo 4, the upstream slope of the east dike is shown in Photo 7, and the upstream slope of the south dike is shown in Photos 16 and 17. The north end of the east dike was over excavated to an overly steep slope during recent dredging operations. This over excavation during dredging operations appears, from reports reviewed, to occur frequently. The 2009 GAI report notes that this condition was discussed in a 1978 and 1995 stability reports. Non-disturbed slopes are about 3H:1V. A bench remains in the southeast corner of the pond adjacent to the outlet structure. This bench is a remnant of access ramps constructed to perform upgrades to the outlet structure in 1999. The upstream slope between the top of the ramp and the crest of the dike is quite steep, with contours on a May 2009 survey showing the slope at about 1.3 to 1.4 horizontal to 1 vertical. The remaining portions of the south dike upstream slope are about 2.5H:1V.

Upstream slope of north dike at Pond #3, looking west. Pond was dredged in 2008.

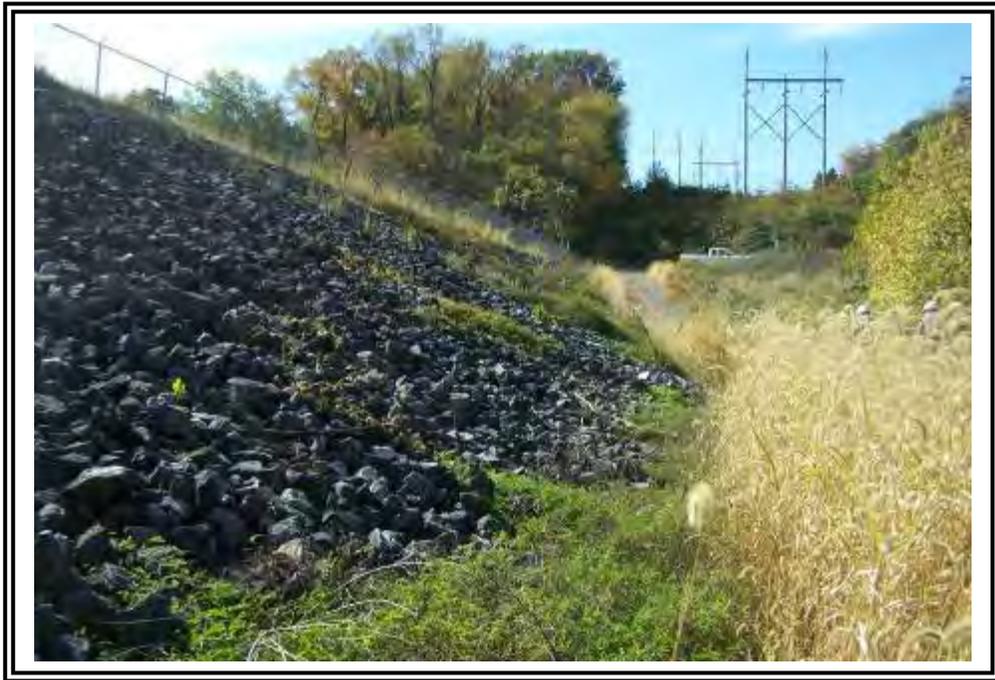
5

Downstream slope of north dike at Pond #3, looking west towards north abutment.

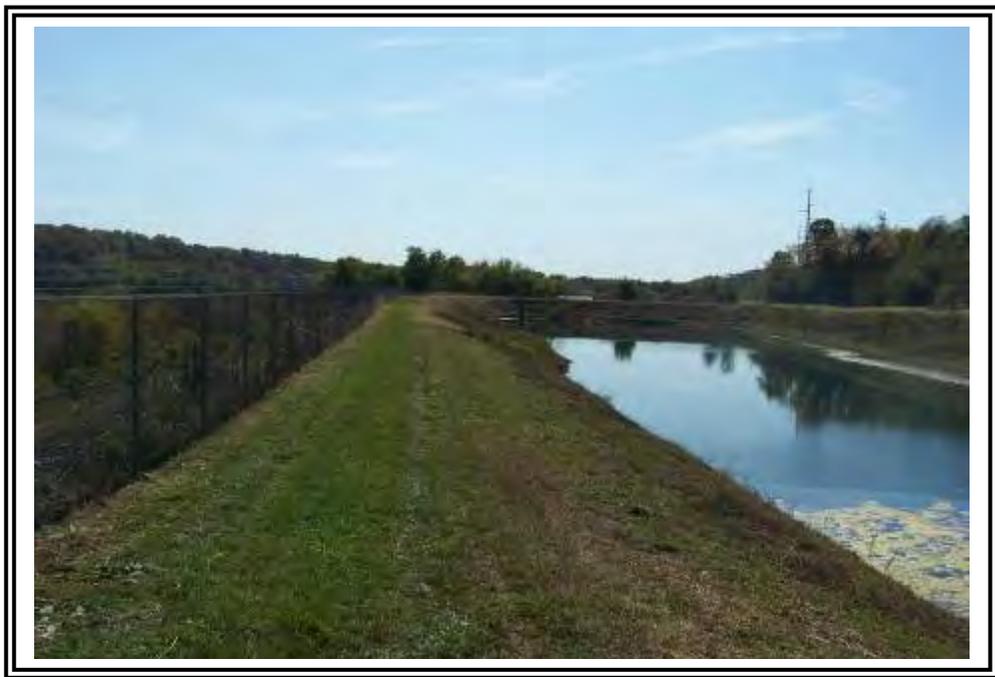
6

Crest of east dike at Pond #3, looking south

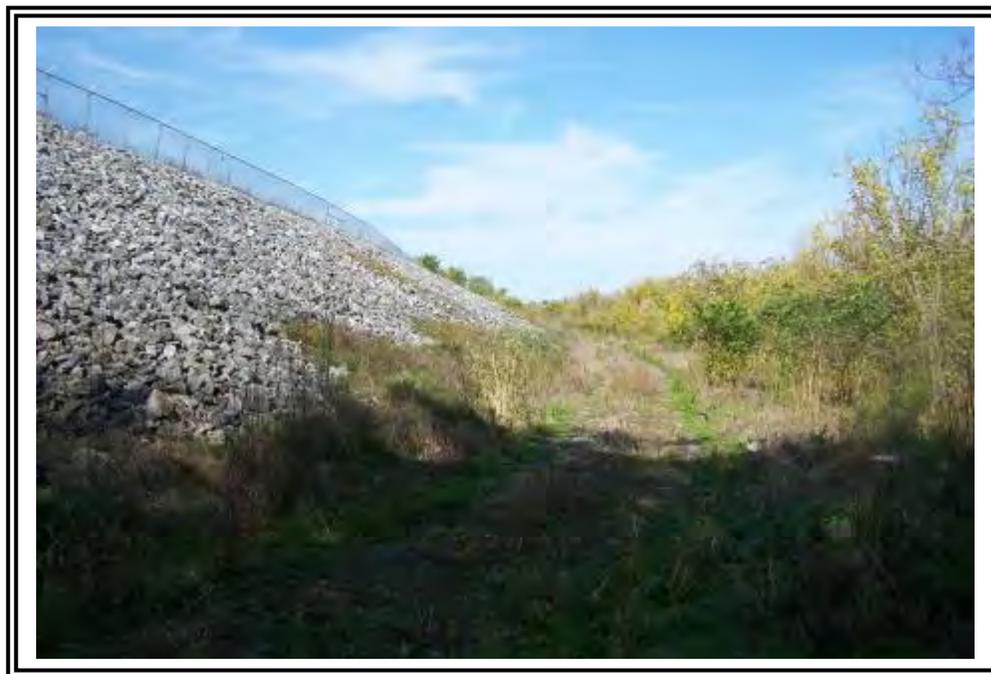
8

Downstream slope of east dike at Pond #3 looking north.

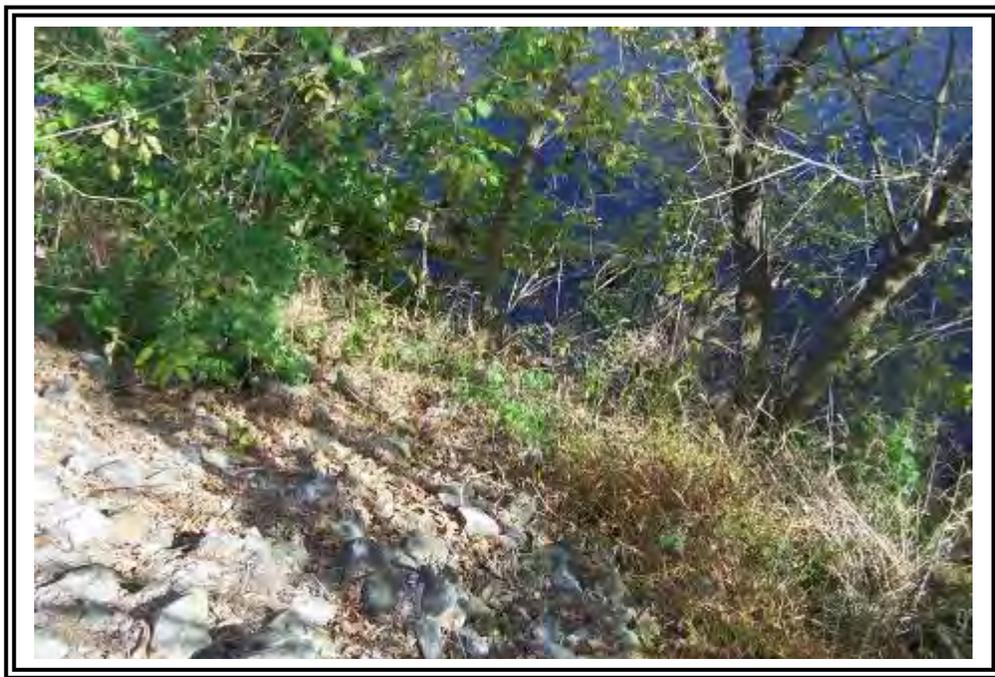
10

Stone buttress on east dike of Pond #3 extends to the edge of the Potomac River.

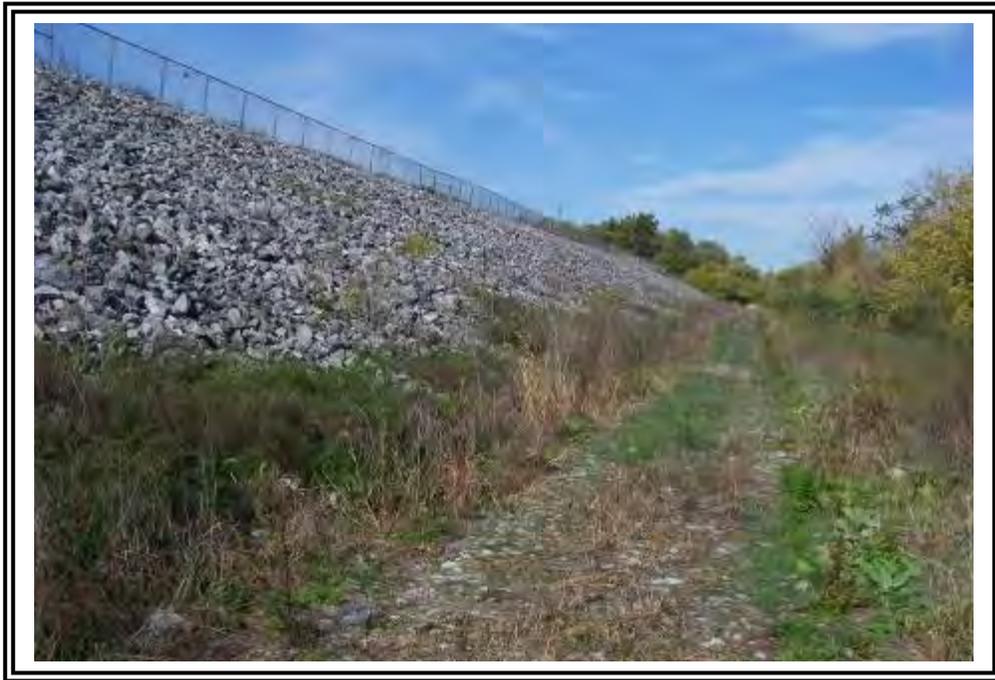
11

Downstream slope of east dike at Pond #3, looking north.

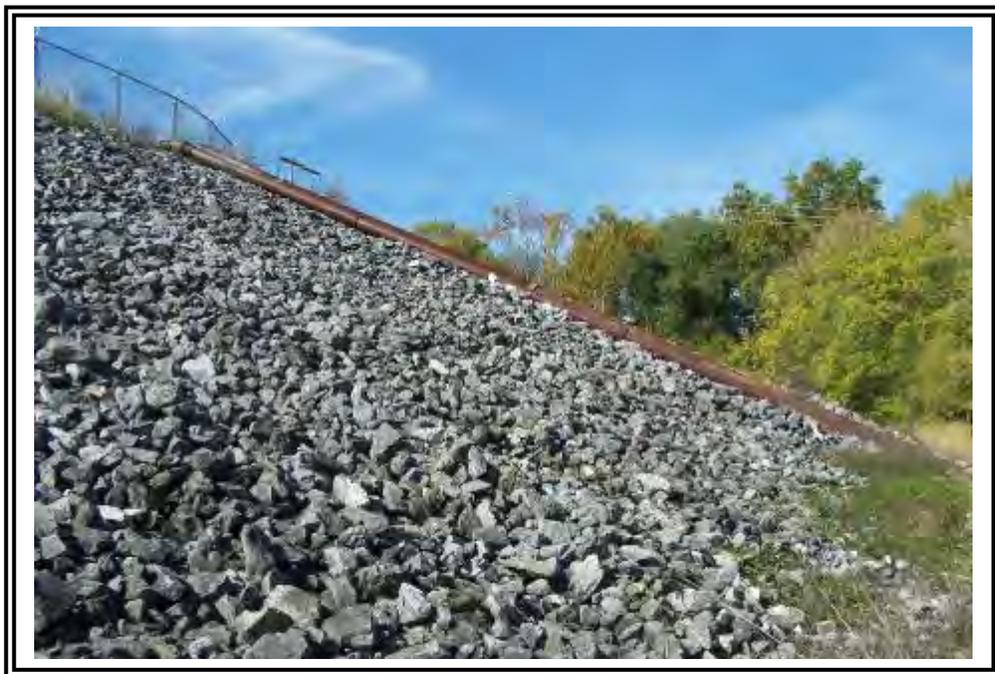
12

Sluice lines from R. Paul Smith Station at northeast corner of Pond #3 service both Pond #3 and Pond #4. Hardened steel lines to dike crest and they are replaced approximately every 15 years as routine maintenance.

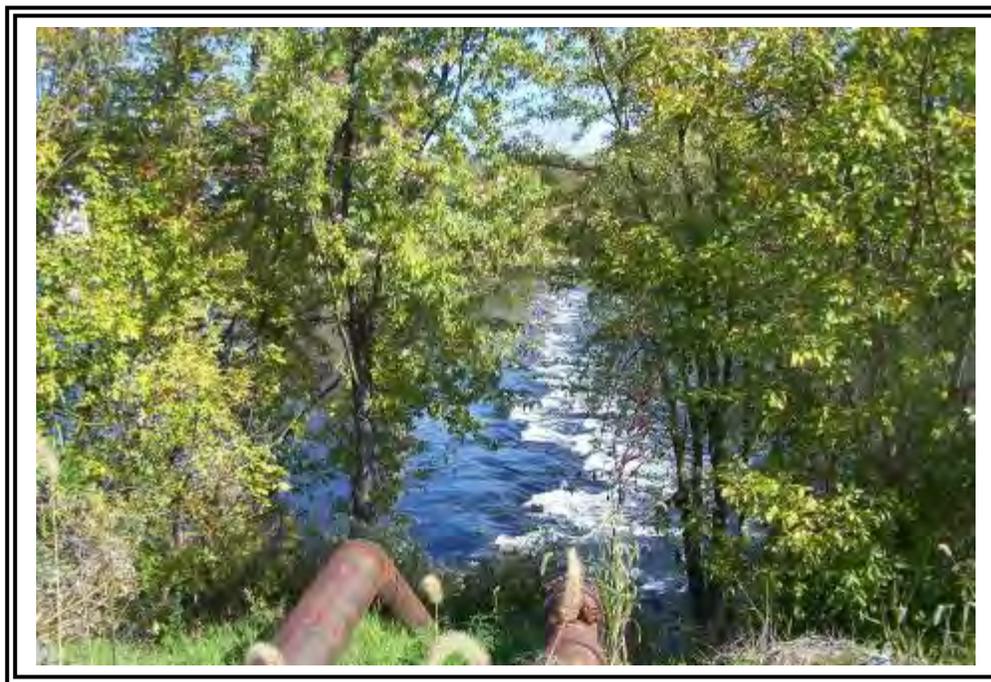
13

Slice lines from R. Paul Smith Station traverse the Potomac River are hardened steel and protected with rip rap. The sluice lines are replaced approximately every 15 years as routine maintenance.

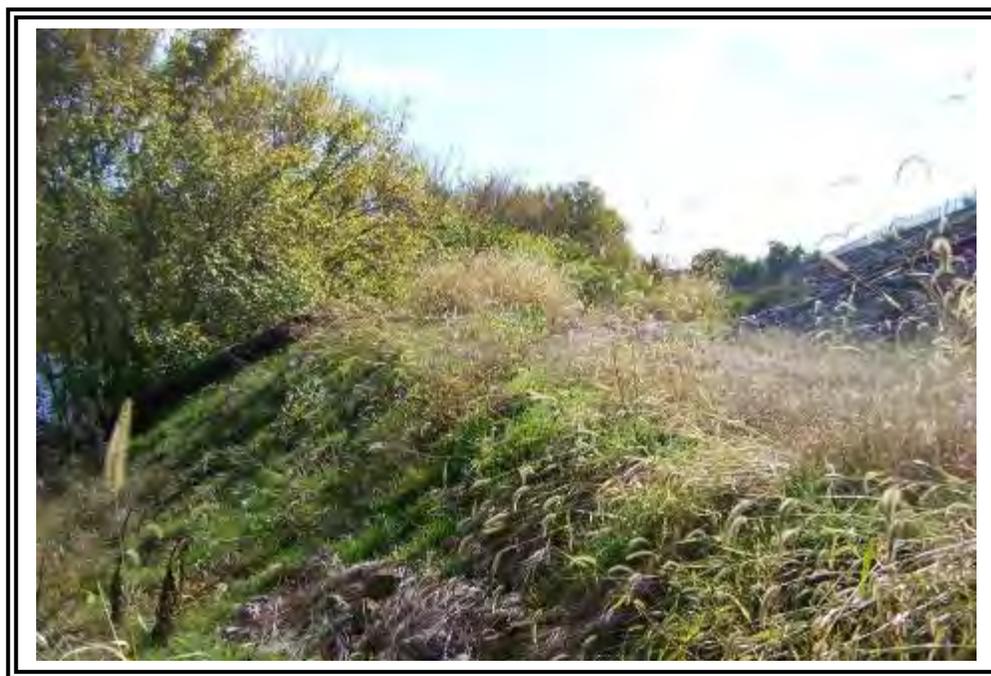
14

Stone buttress looking south from northeast corner of Pond #3.

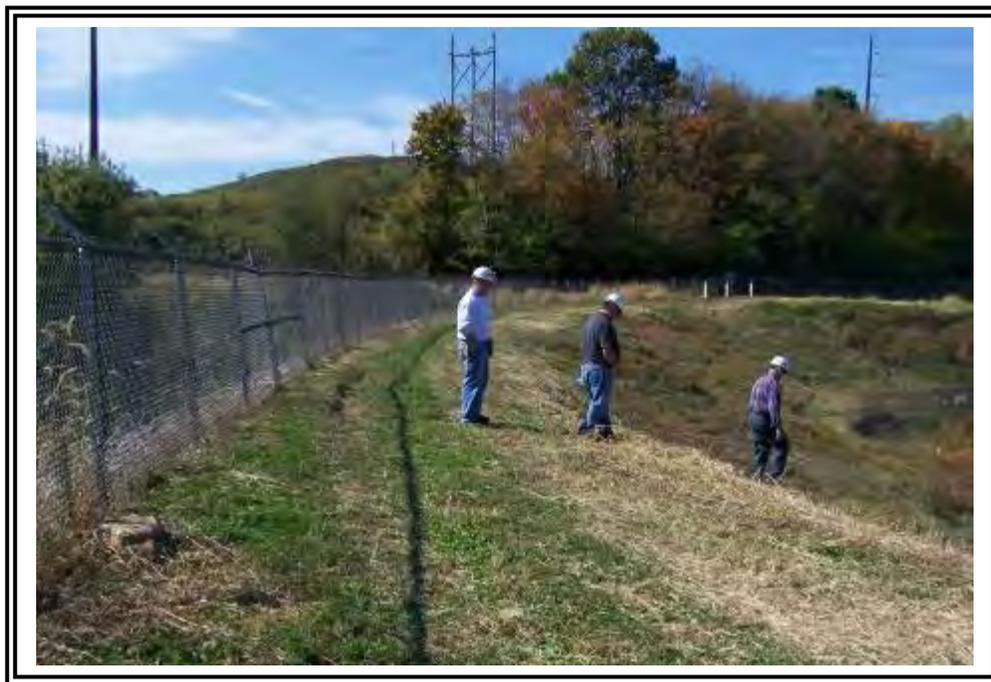
15

Crest of south dike at Pond #3, looking west toward south abutment.

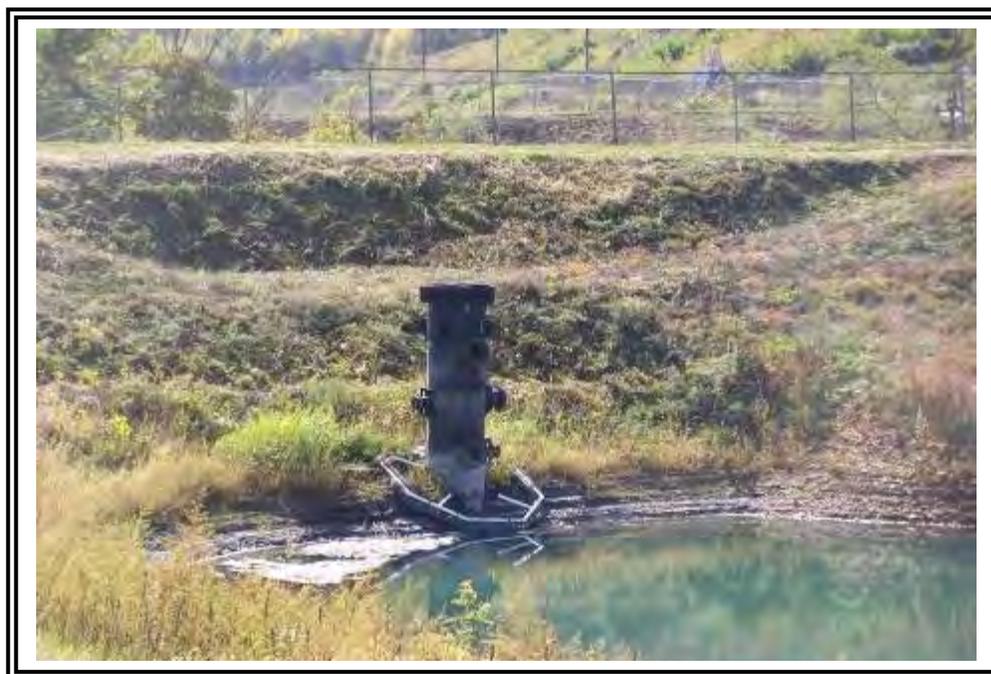
16

Upstream slope of south dike of Pond #3 looking south and decant structure. Bench is remnant of an access road built when the decant structure was replaced in 1997.

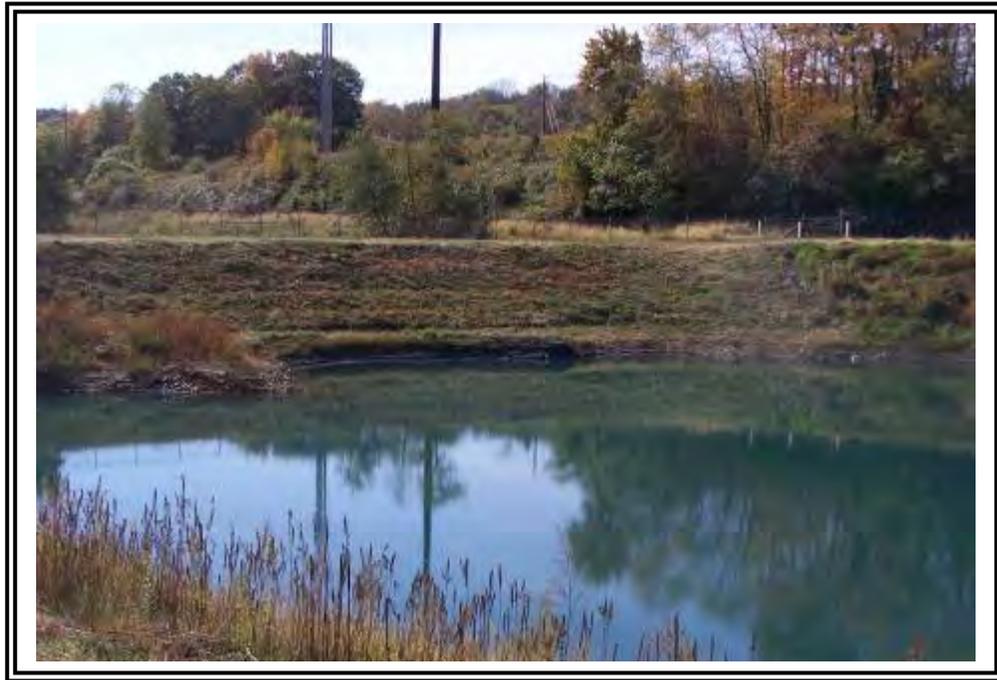
17

Upstream slope of south dike of Pond #3 looking southwest. South abutment at right of photo.

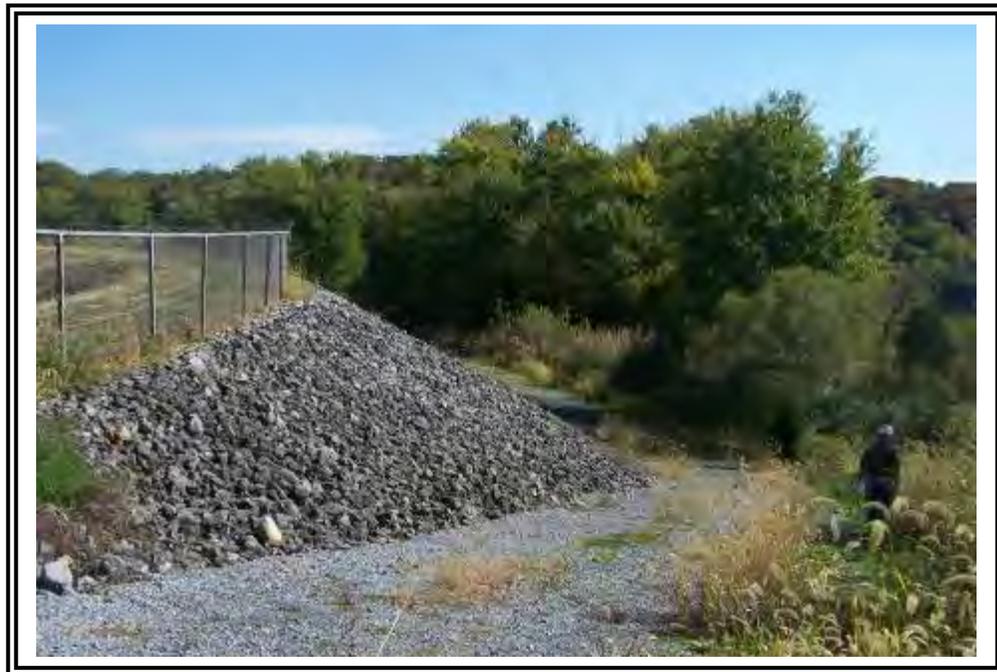
18

Downstream slope of south dike of Pond #3, looking east.

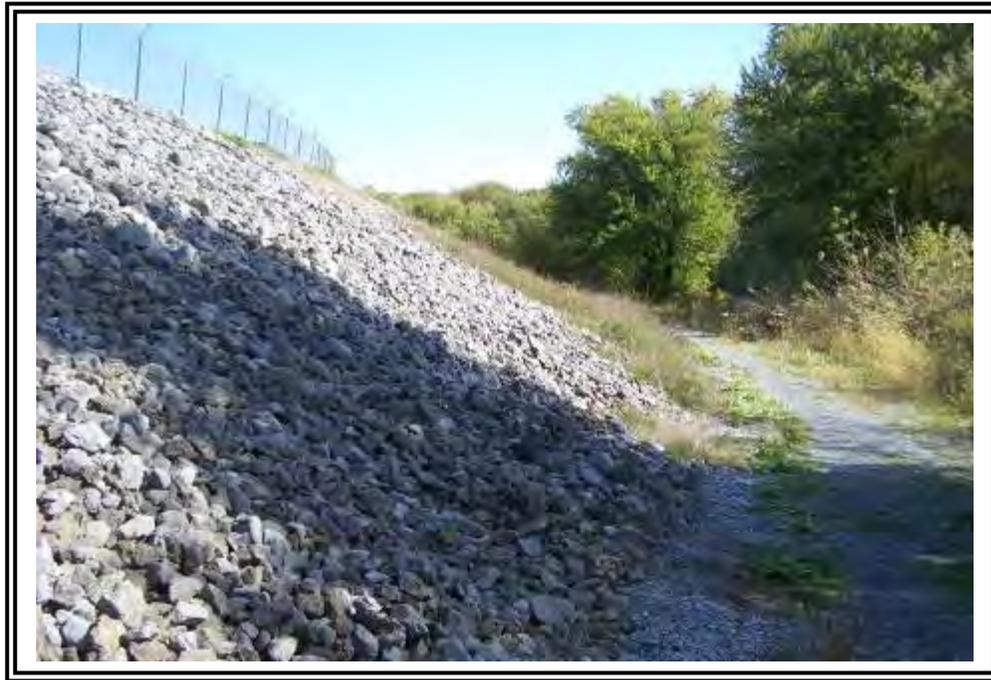
19

Downstream slope of south dike of Pond #3, looking east.

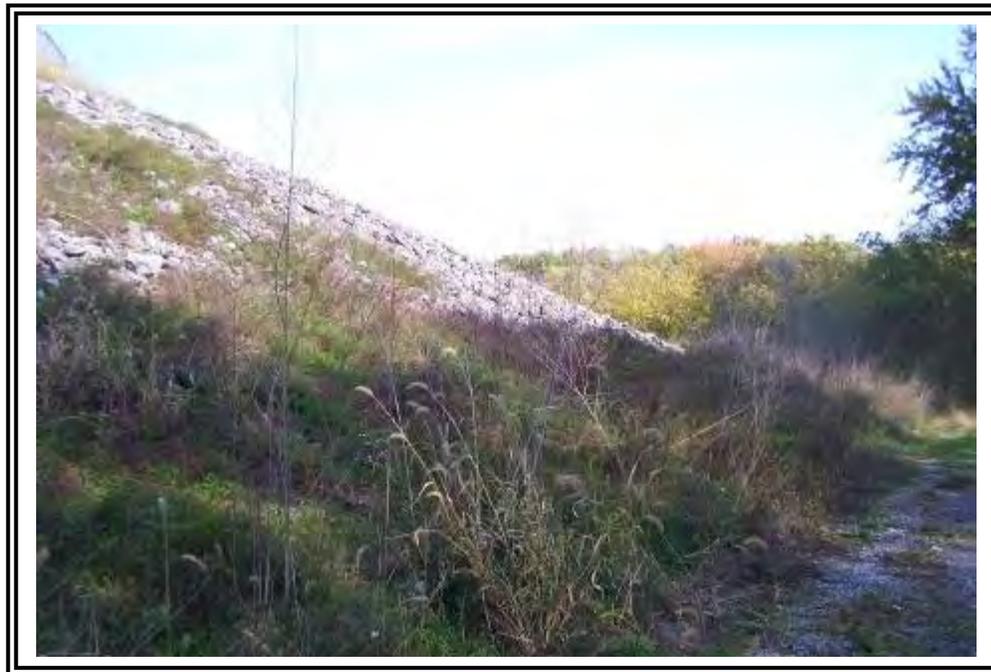
20

Typical patchy vegetation on rip rap armor of downstream slopes of Pond #3. Mostly grasses, occasional saplings.

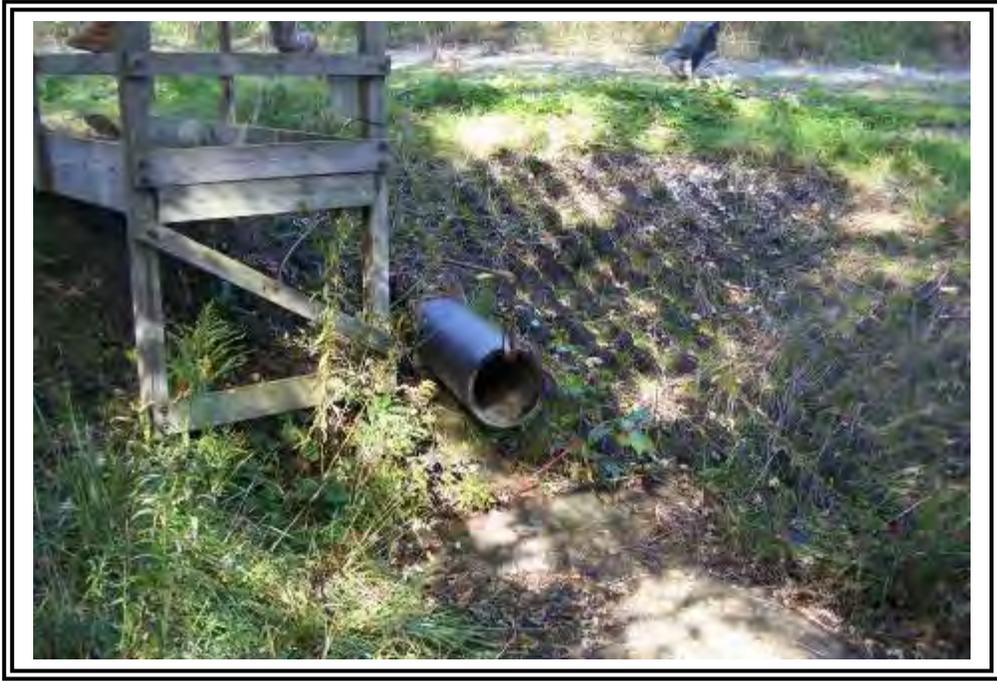
23

Outlet pipe from the decant structure. Pond currently dewatered/dredged below the decant elevation.

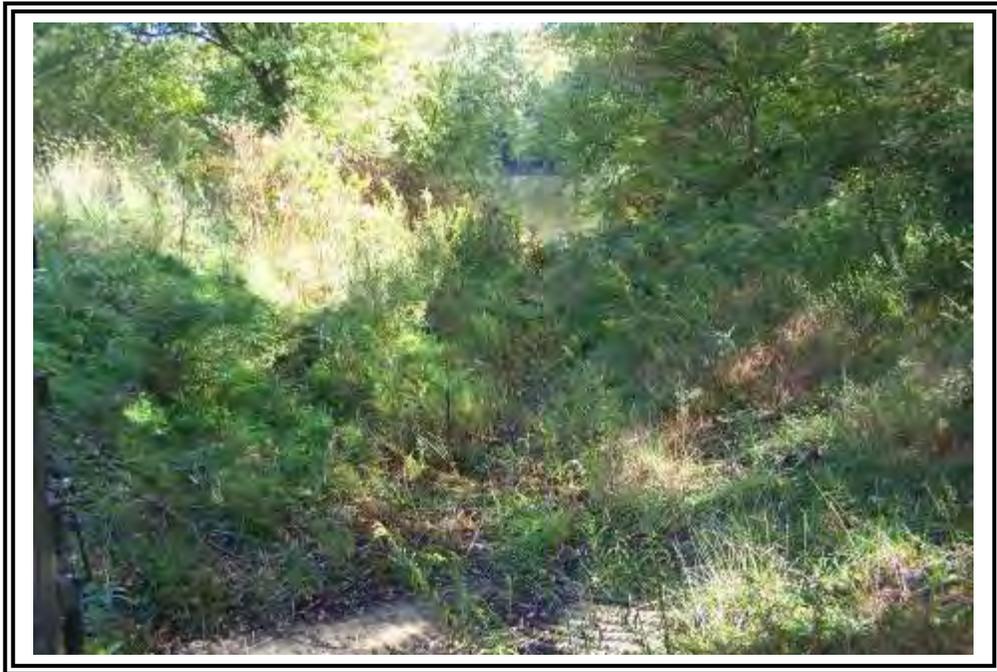
24

Fabriform lined discharge channel from Pond #3 to the Potomac River.

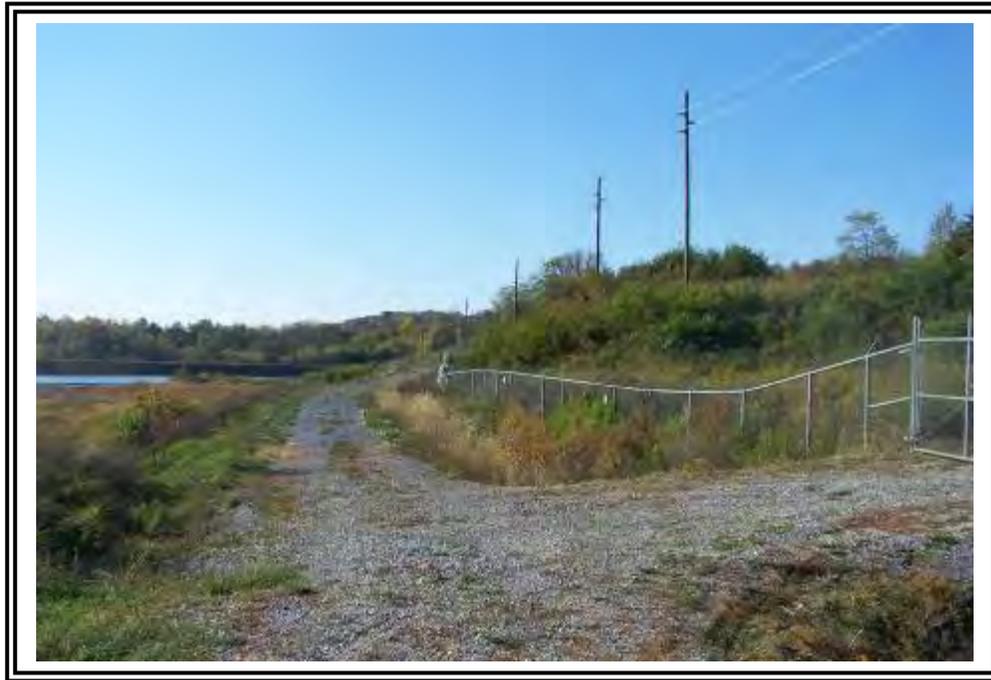
25

West side of Pond #4 is in natural ground, looking south.

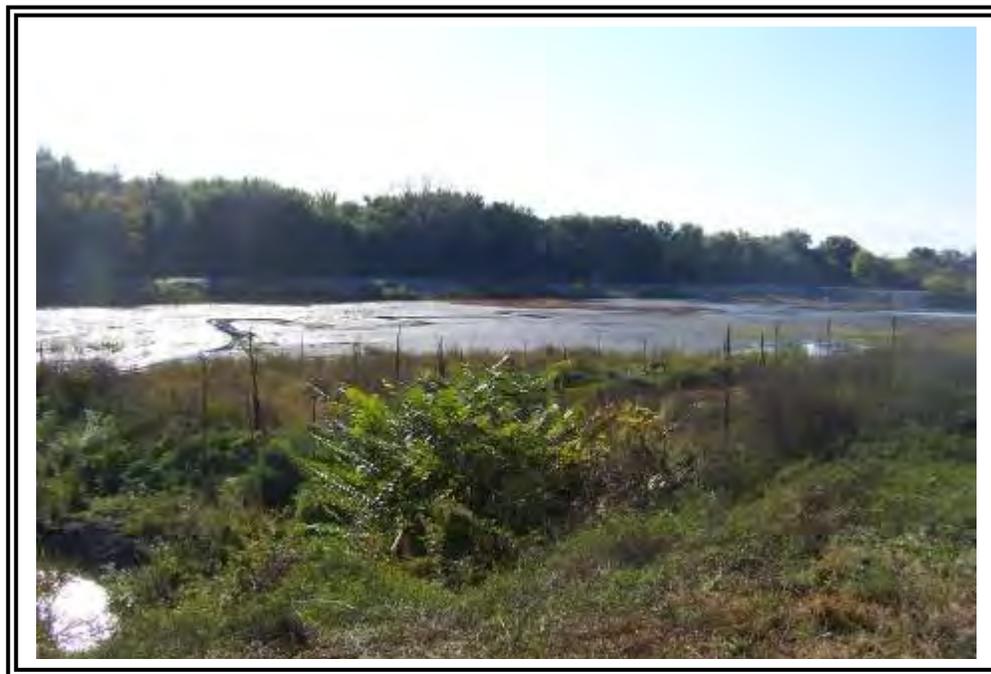
26

Pond #4, looking southeast.

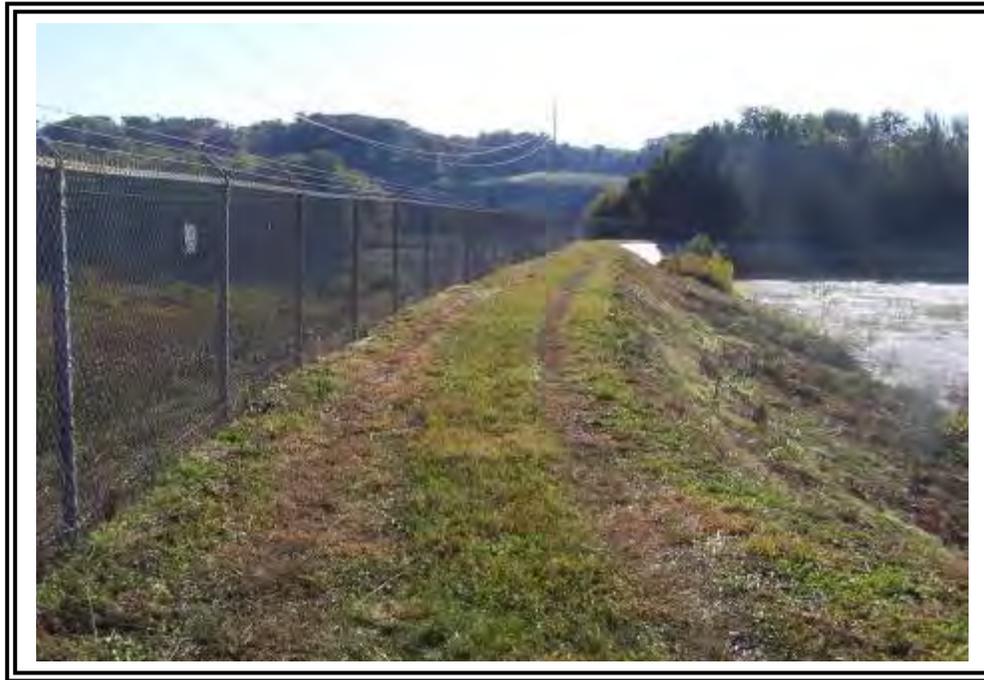
27

In general, the alignments of the crest of Ash Pond #4 dikes do not show signs of change in horizontal alignment. The crest is about 10 feet wide and is grass covered as shown in Photos 27, 33, 34 and 42. The surface has moderate rutting from vehicle traffic on the crest. An approximately 14-inch diameter, 2-inch deep depression was observed on the crest in the area where the discharge pipe passes beneath the east dike. The discharge pipe was slip-lined in 1997, as described in Section 1.3.2.

Crest of the north dike at Pond #4, looking east.

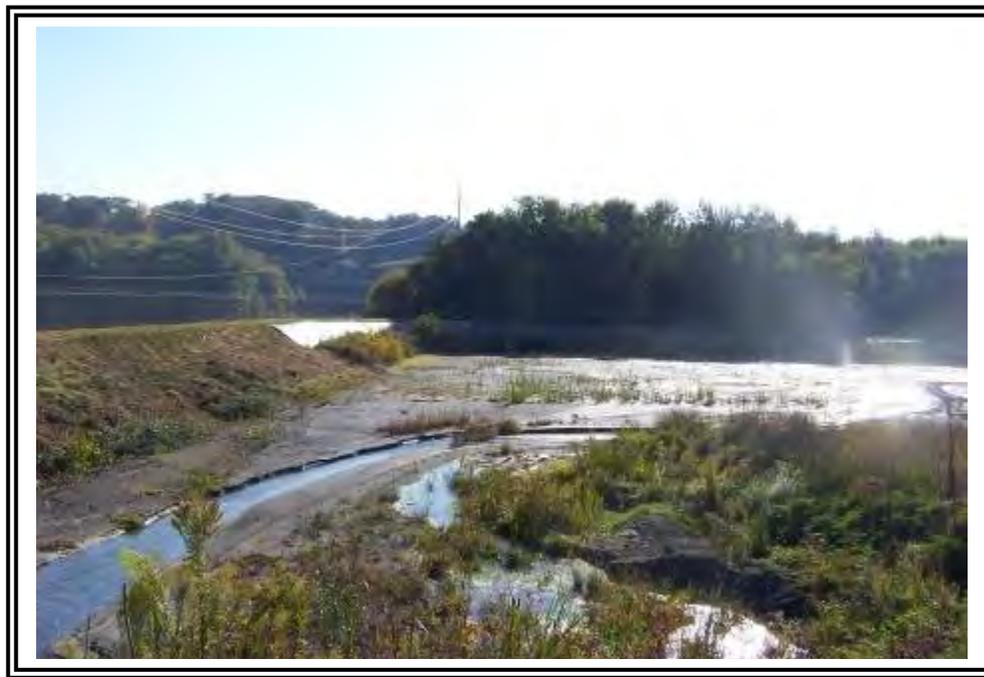
28

Upstream slope of north dike at Pond #4, looking northeast.

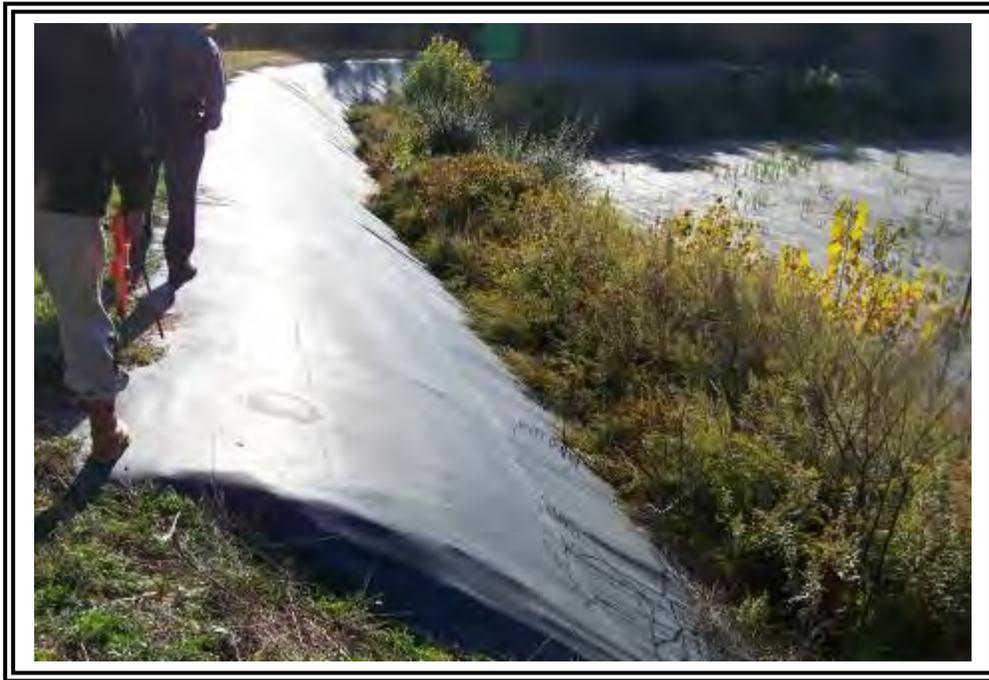
29

Hypalon liner on the upstream slope of the north dike at Pond #4.

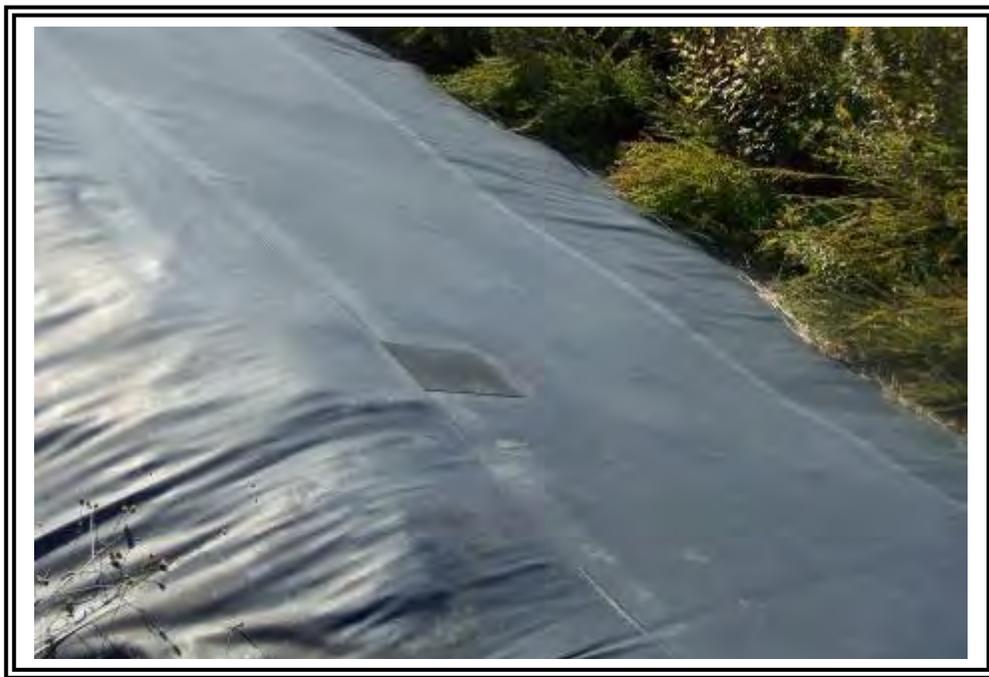
30

Routine maintenance includes patching holes on the hypalon liner created by animals walking on the liner.

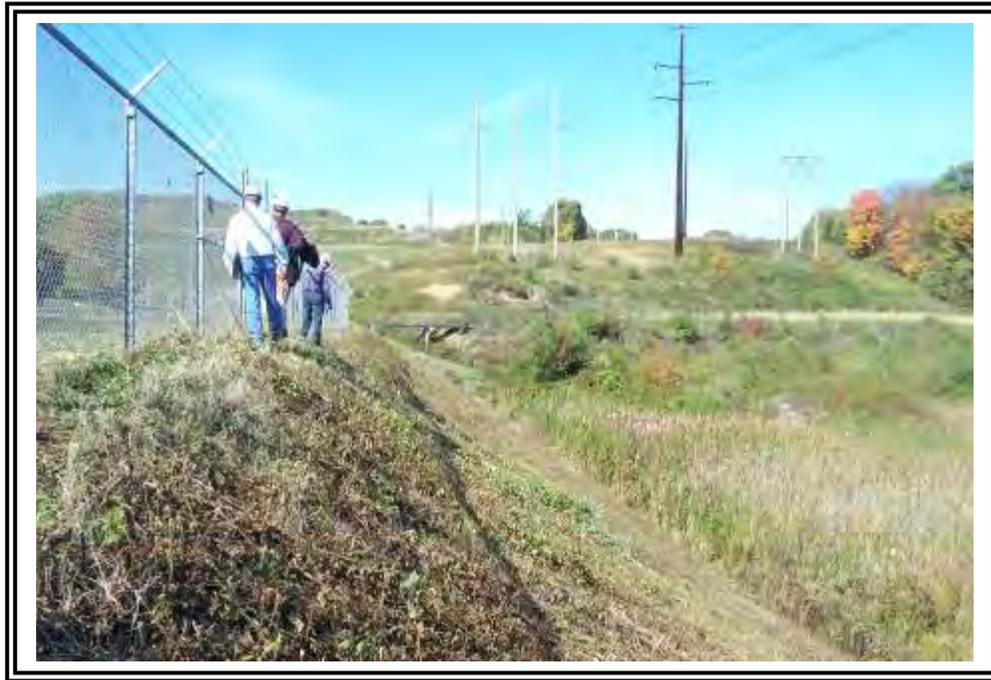
31

The downstream slopes are weed covered which was freshly cut at the time of our site visit. Photo Nos. 31, 35, and 46 show the general condition of the downstream slope. Many features of deterioration of the downstream slopes were noted as listed below:

Downstream slope of north dike at Pond #4, looking north.

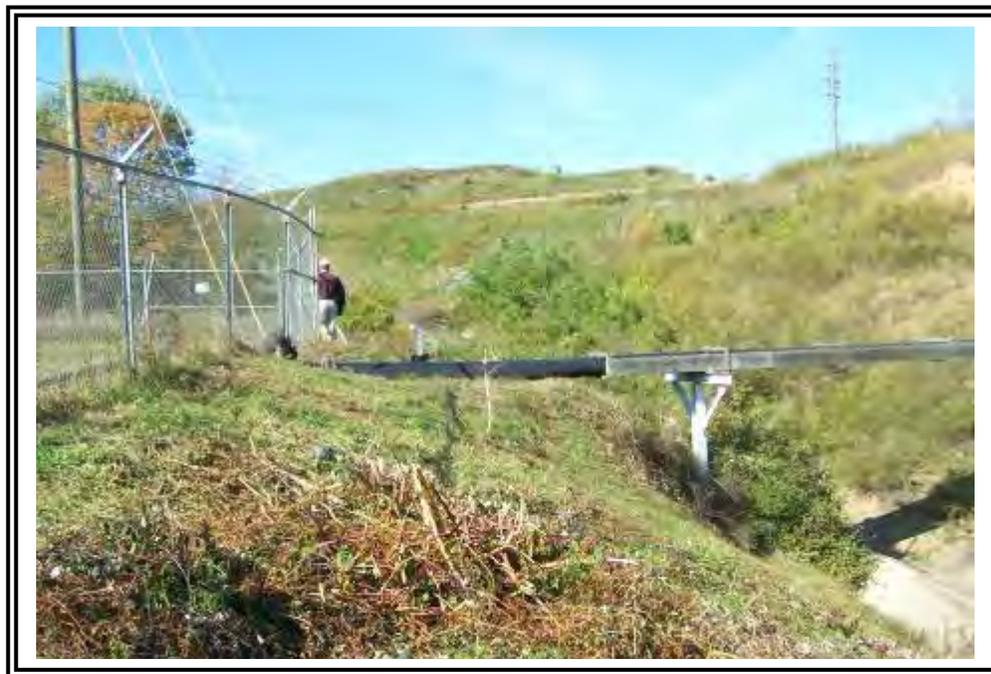
32

Sluice lines at north abutment.

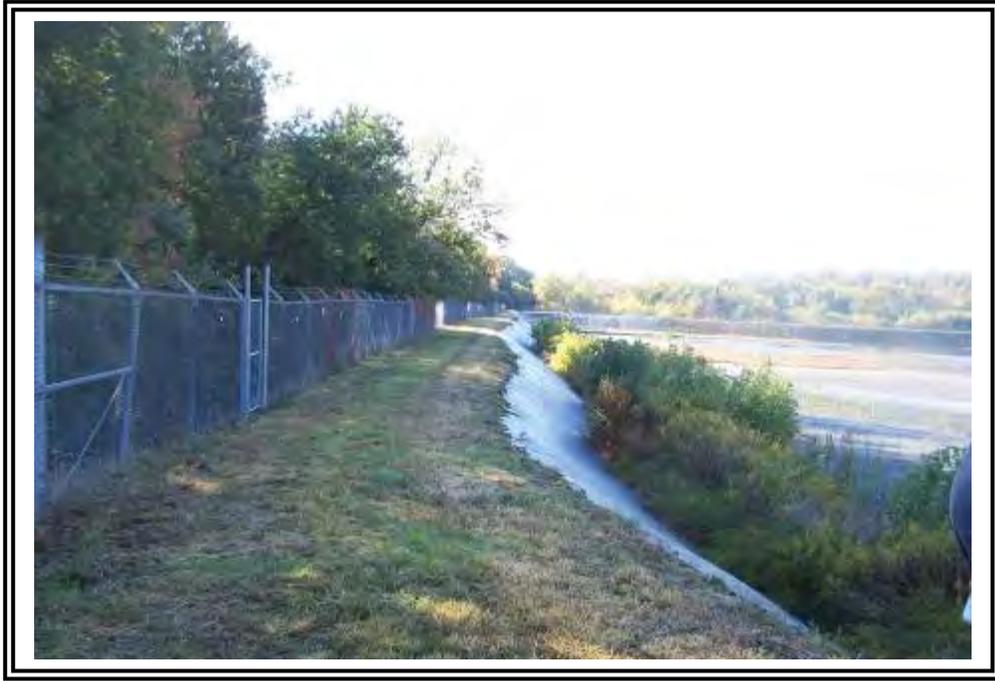
33

Crest of east dike at Pond #4, looking south.

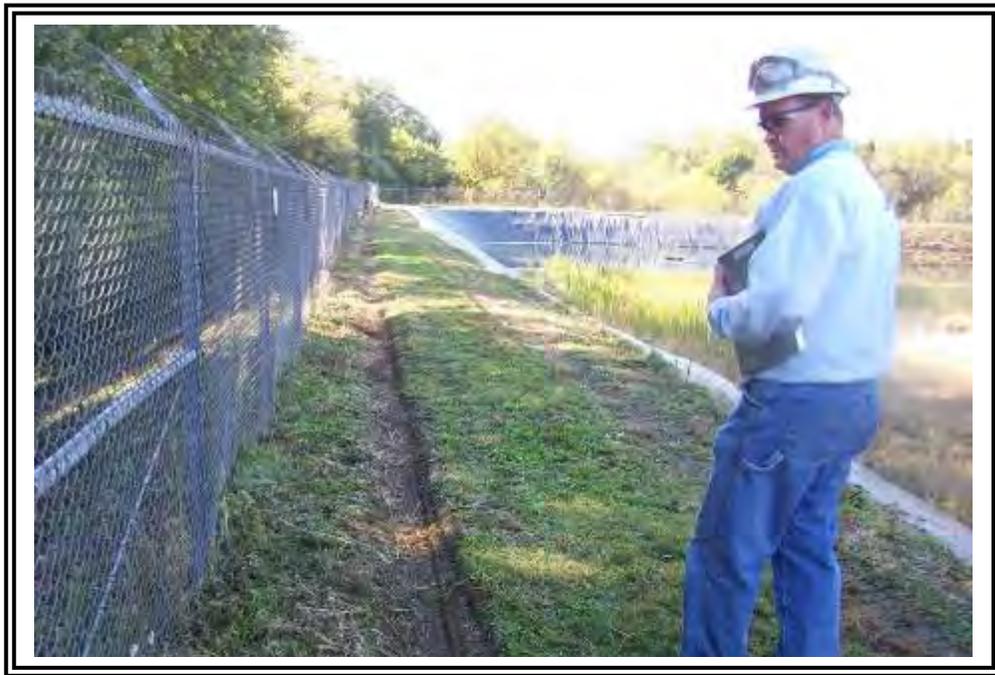
34

Crest of east dike at Pond #4, looking south.

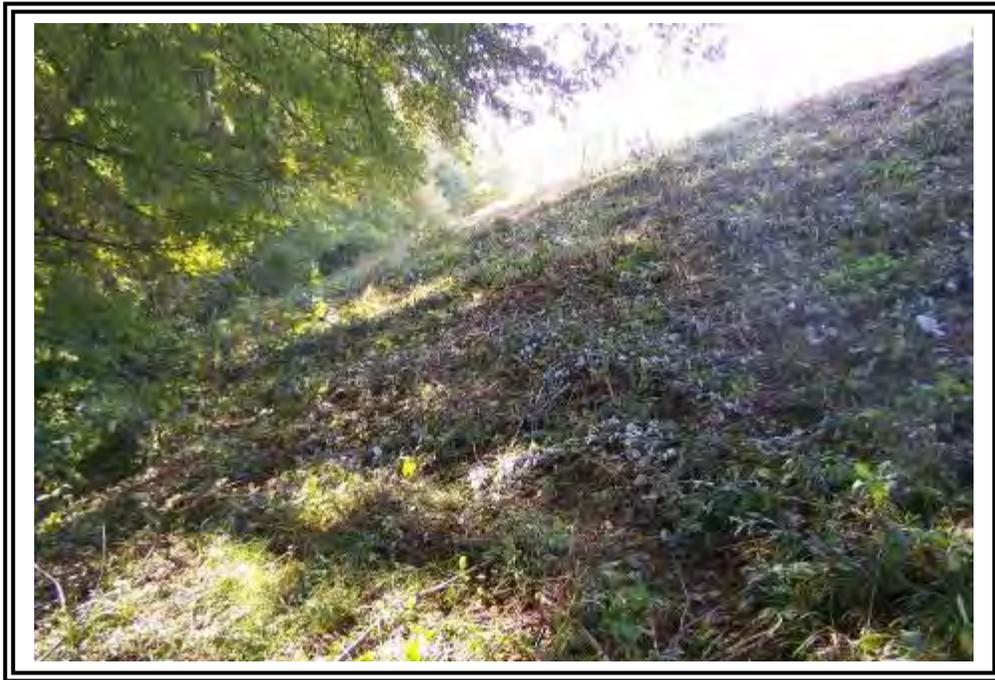
35

Downstream slope of east dike at Pond #4, looking south.

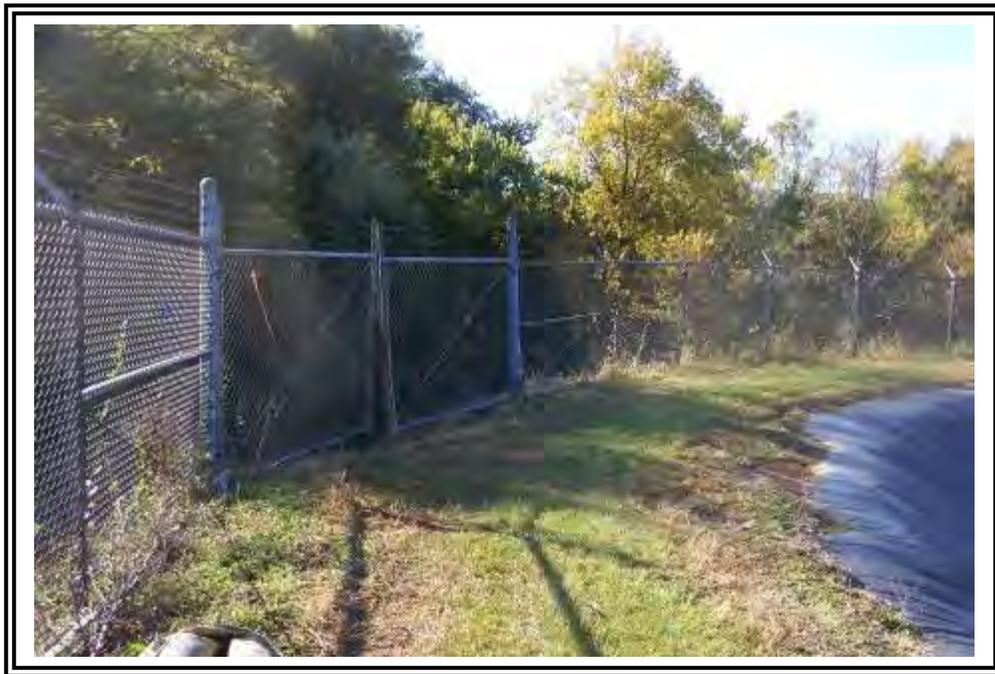
42

Crest at southeast corner of Pond #4.

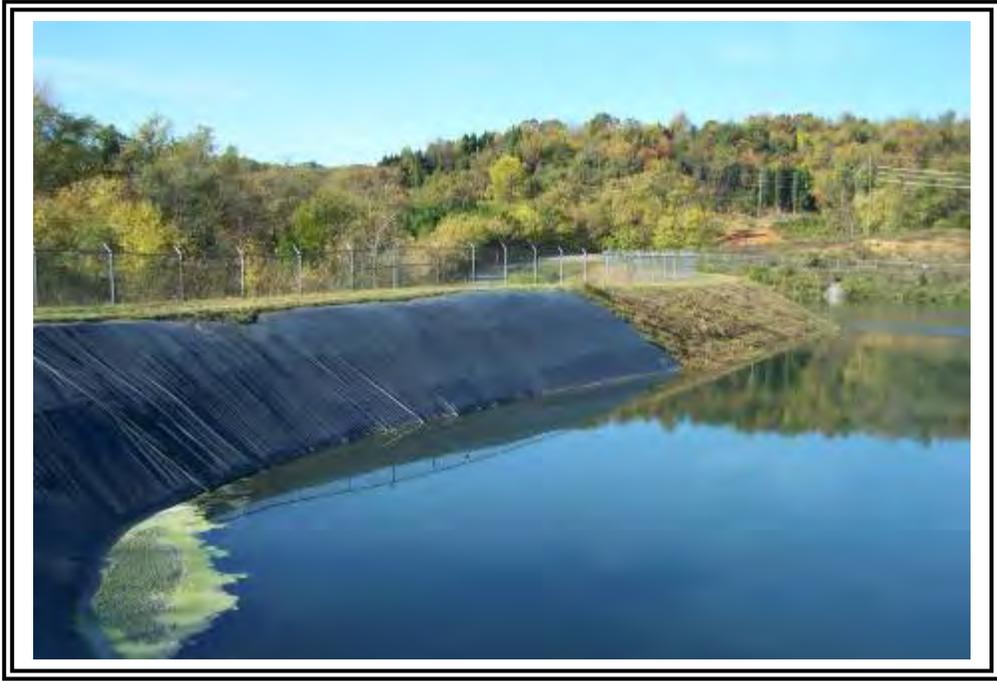
43

Upstream slope of south dike at Pond #4, looking southwest.
