Assessment of Dam Safety Coal Combustion Surface Impoundments (Task 3) Final Report

Allegheny Energy

R. Paul Smith Station

April 21, 2010

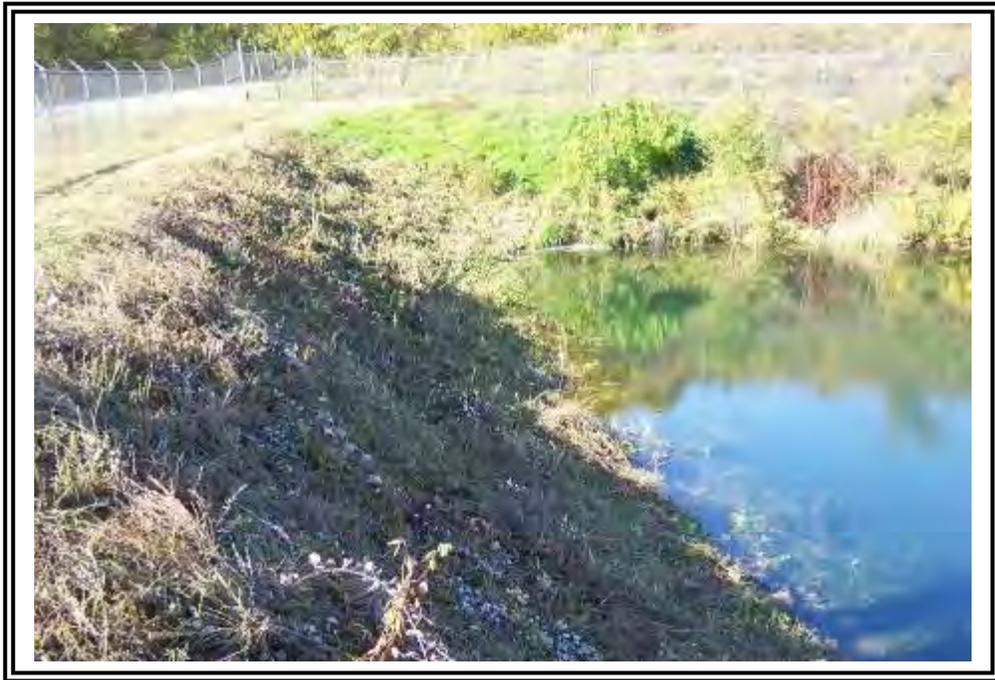
45

Upstream slope of the south dike at Pond #4, looking west toward the south abutment.

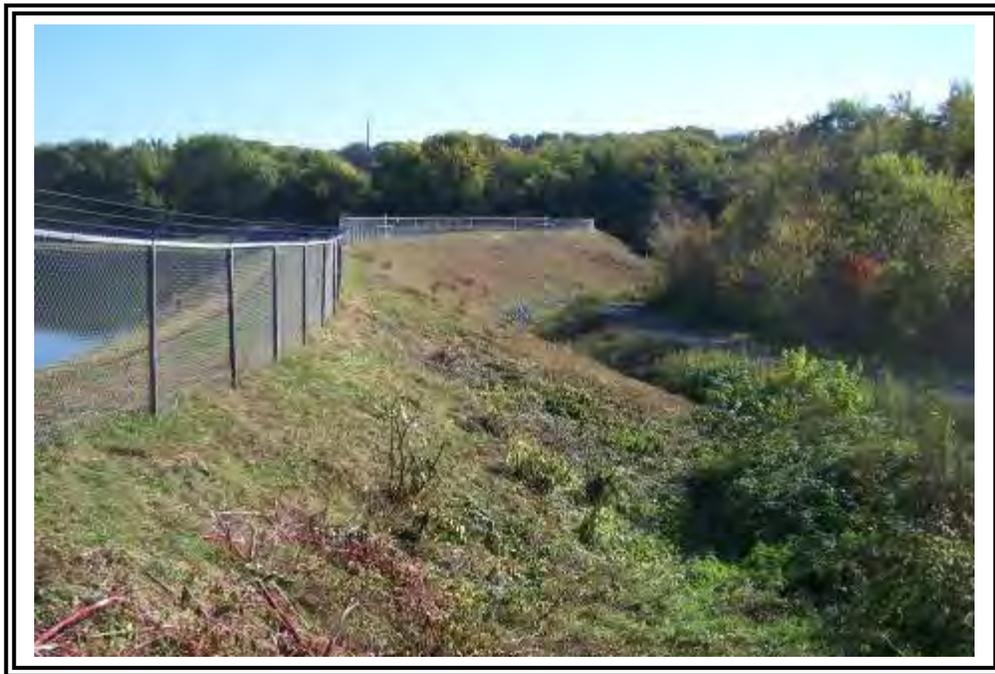
46

Downstream slope of the south dike at Pond #4, looking east.

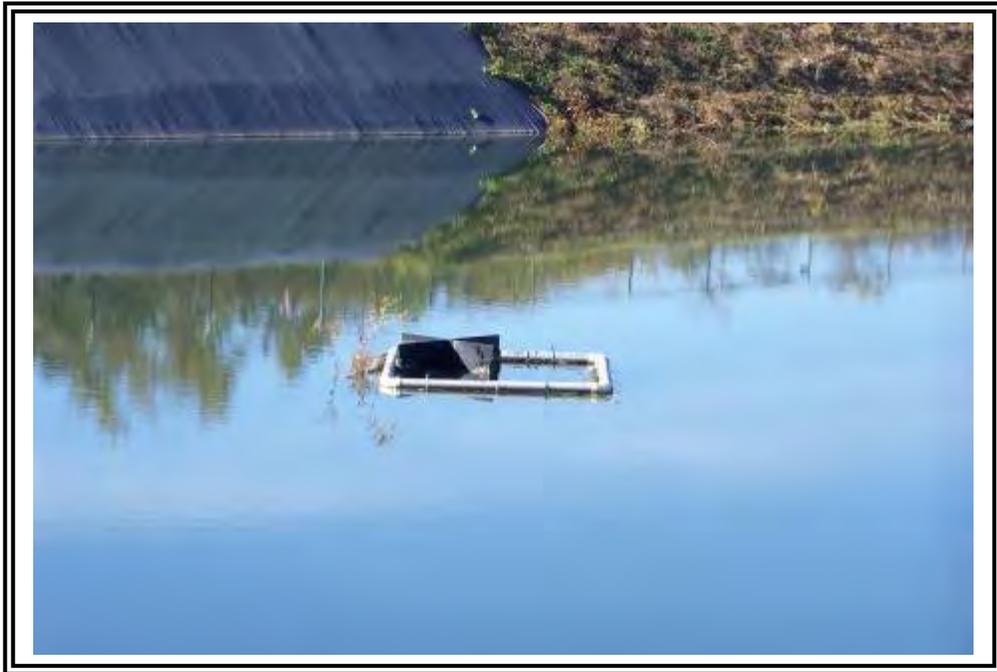
48

Decant structure in the southeast corner of Pond #4.

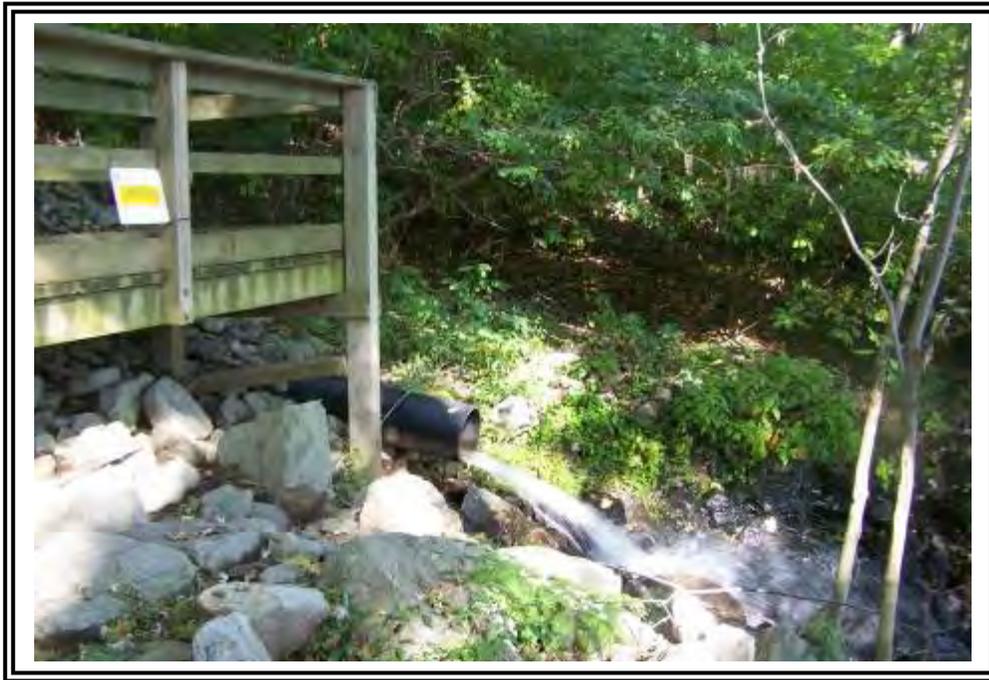
49

Discharge pipe from Pond #4.

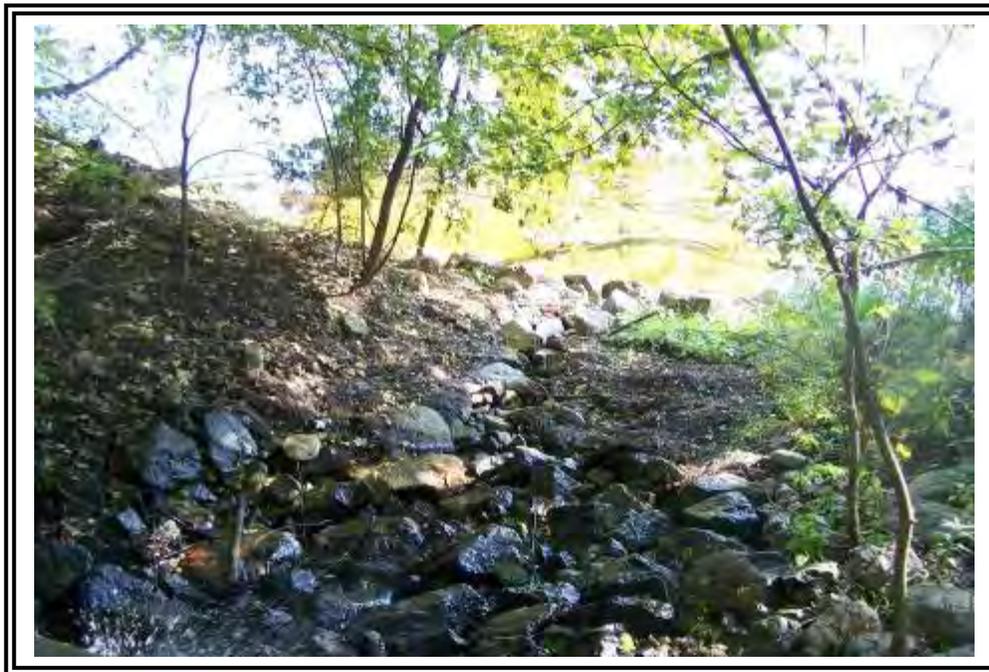
50

Rip rap channel from the Pond #4 outlet to the Potomac River.
