**DRAFT REPORT
ROUND 7 DAM ASSESSMENT
ASSOCIATED ELECTRIC COOPERATIVE, INC.
NEW MADRID POWER PLANT
ASH POND 1 & 2 AND SLAG POND 1 & 2 IMPOUNDMENTS
NEW MADRID COUNTY, MISSOURI**

January 14, 2011

Re: Round 7 Dam Assessment - Draft Report
EPA Contract No. EP10W001313
Associated Electric Cooperative, Inc. New Madrid Power Plant
Ash Pond 1 and 2 Impoundments and Slag Pond 1 and 2 Impoundments
New Madrid County, Missouri

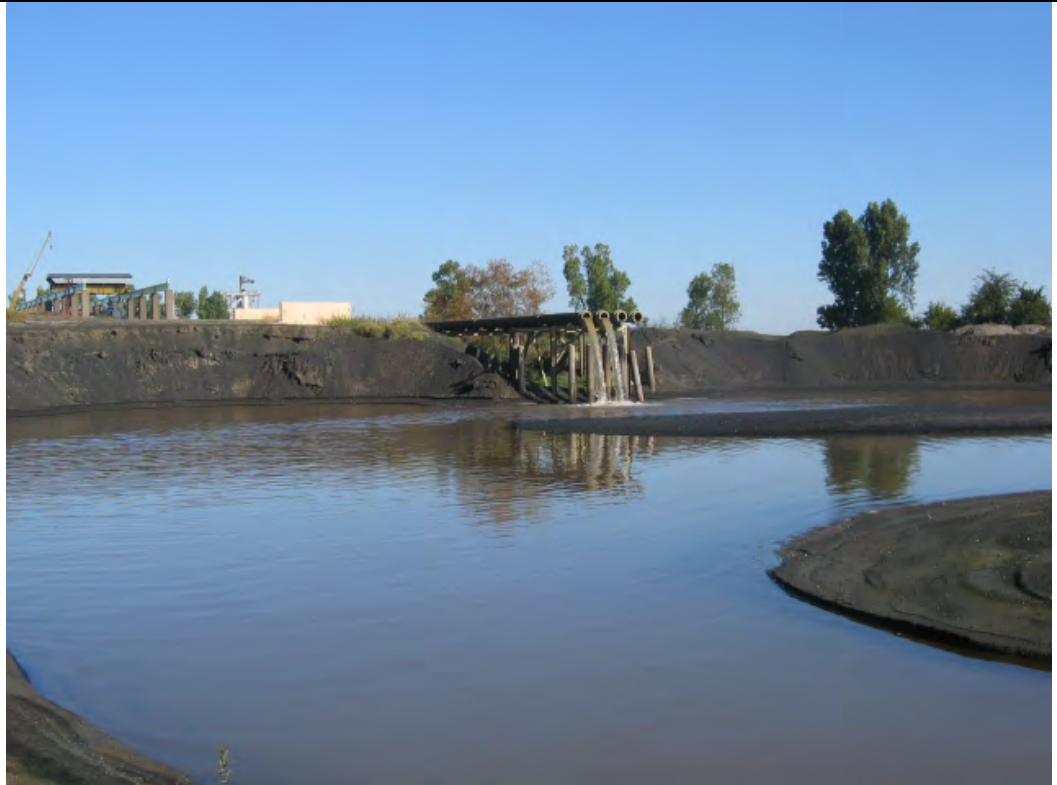
Upstream slope and
discharge pipelines of the
SP2.

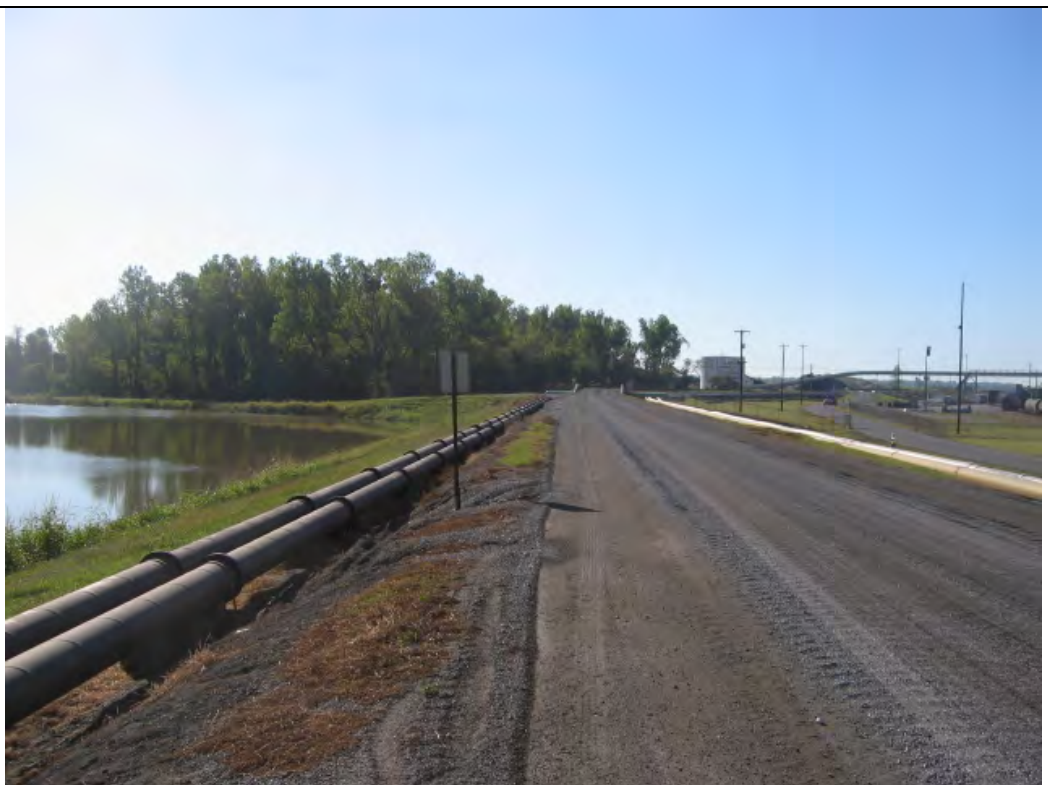
Photo No. 10	Date: 10/6/10
Direction Photo Taken: Southeast

Description:
Crest of the SP2 showing erosion along the access road.

1. Repair sloughed soil on the western embankment of the AP1 Impoundment.
2. Repair areas of erosion on the AP1 Impoundment, SP1 Impoundment, AP2 Impoundment, and SP2 Impoundment.
3. Repair rutting present on the SP2 Impoundment crest access road.

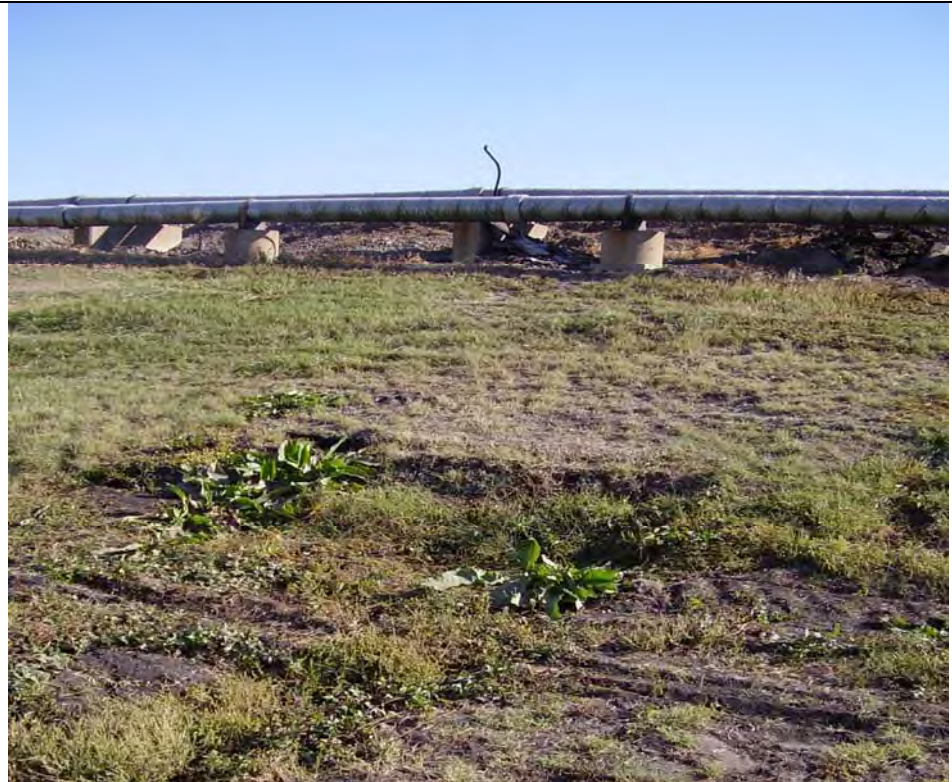
Photo No.
18

long as shown in Photo 16. In addition, surface water runoff also appears to be eroding the gravel surface present on the upper portion of the downstream slope as shown in Photo 18.

Description:
Downstream slope of the
SP2 showing eroded slope.

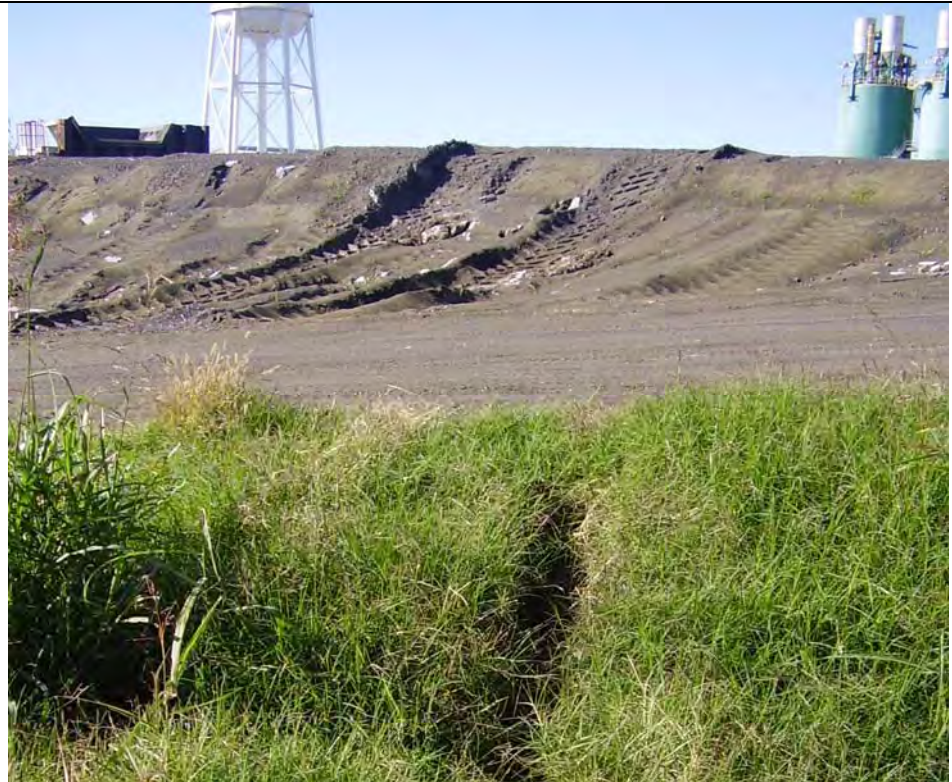
Photo No.
24

Description:
Erosion on the downstream
slope of the SP2.

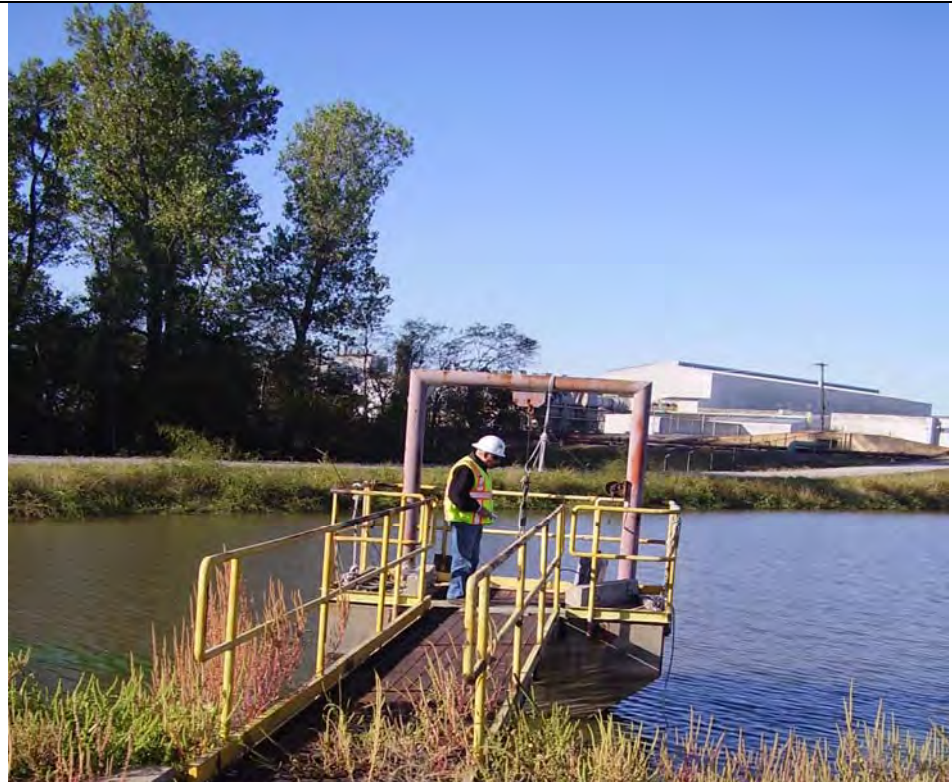
Photo No.
28

Four 10-inch diameter pipelines discharge ash and water into the SP2 Impoundment. There were no leaks observed in the discharge pipes and there were no observed defects or areas of these structures that required repair. Water is removed from the SP2 Impoundment through a decant structure near the southeast portion of the impoundment. The water level in the pond is controlled by concrete stop logs in the decant entrance. Water that enters the decant structure is discharge via an 18-inch diameter pipe along the lower banks of the Mississippi River as shown in Photo 29. The decant structure appeared to be in good condition with no observed defects that required repair.

Description:
Decant structure in SP2.

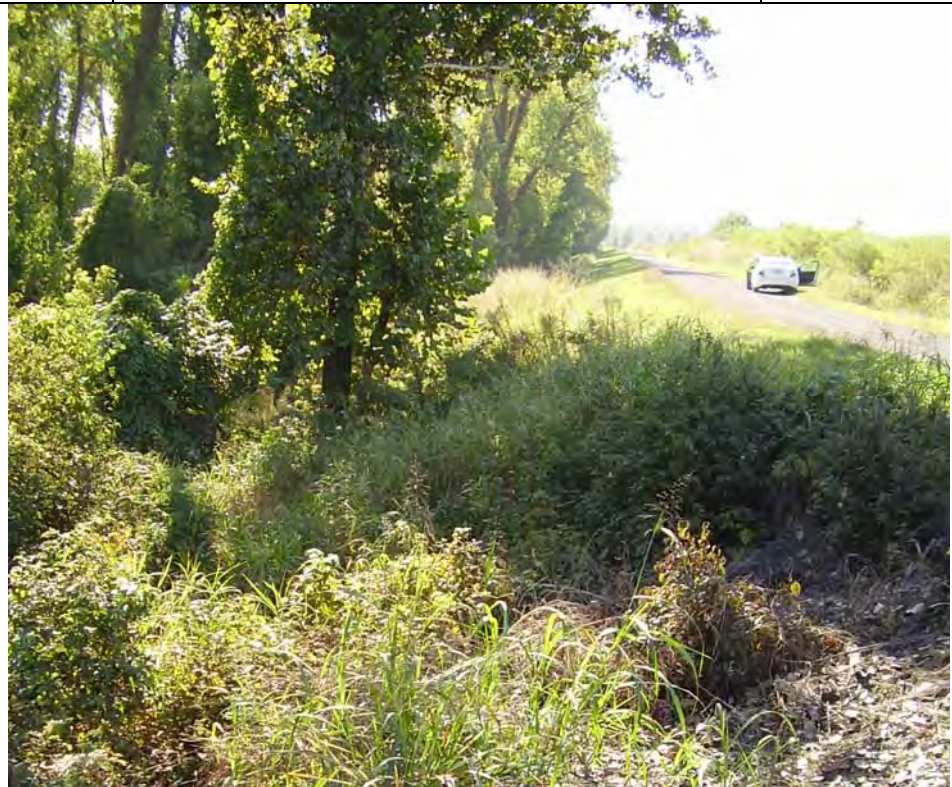
Photo No. 39	Date: 10/6/10
Direction Photo Taken: Southeast

Description:
Erosion and trees on downstream slope of the SP1.

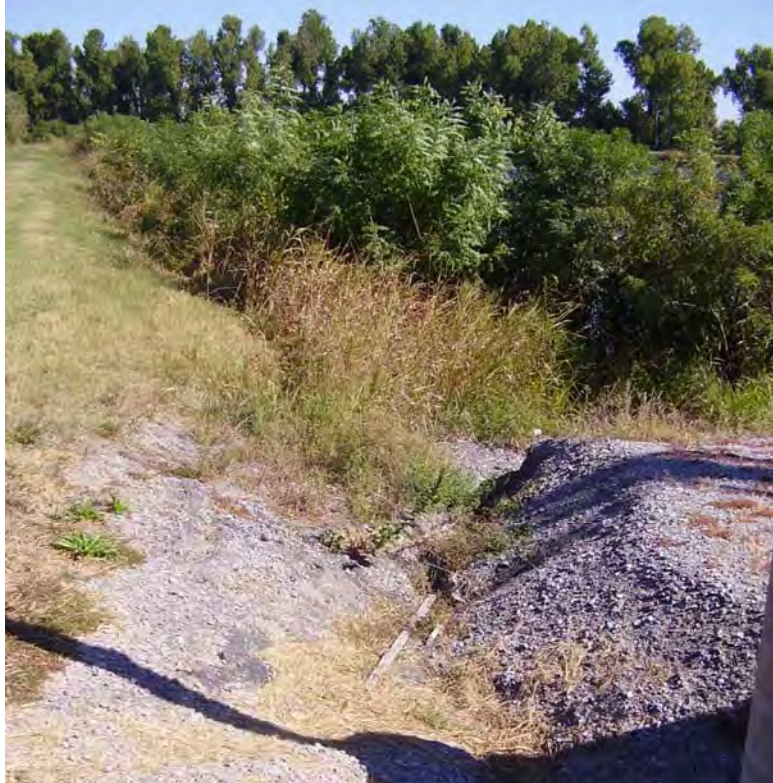
Description:
Eroded ditch on downstream
slope of SP1.

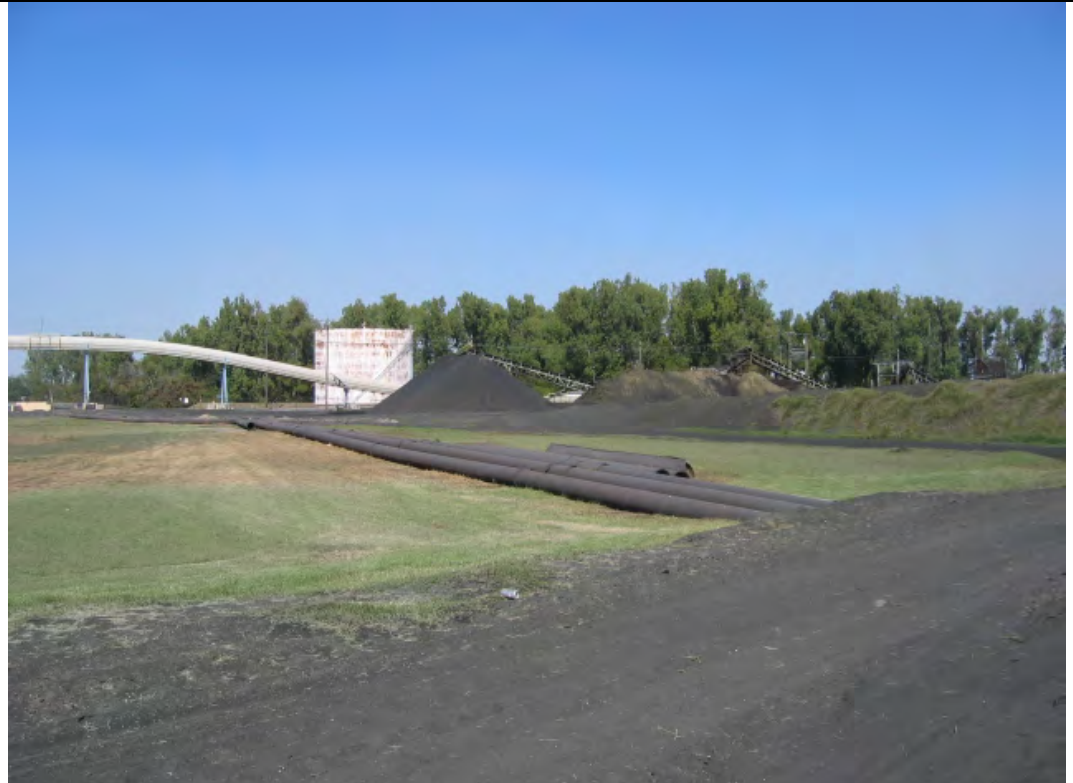
Photo No. 43	Date: 10/6/10
Direction Photo Taken: Northeast

Description:
Upstream area of the Ash Pond Impoundment (AP1).

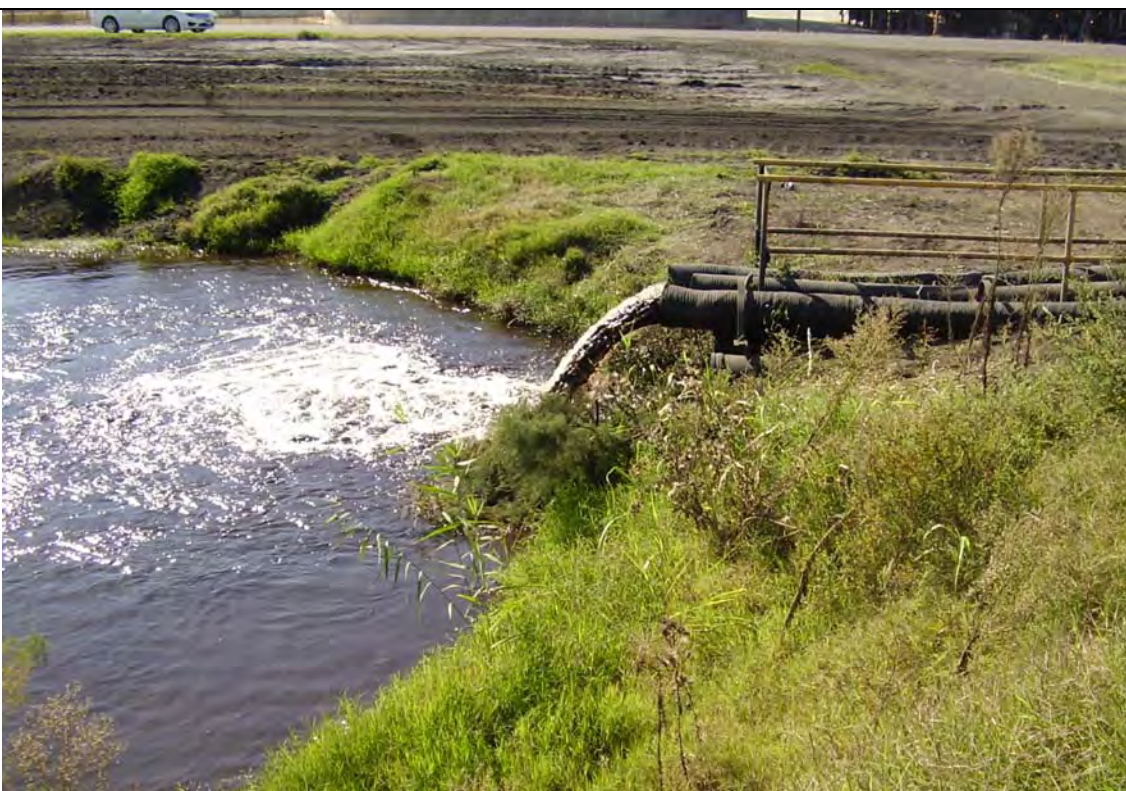
Photo No. 44	Date: 10/6/10
Direction Photo Taken: Upstream area within the AP1 showing the pipelines discharging material.

Description:
Upstream

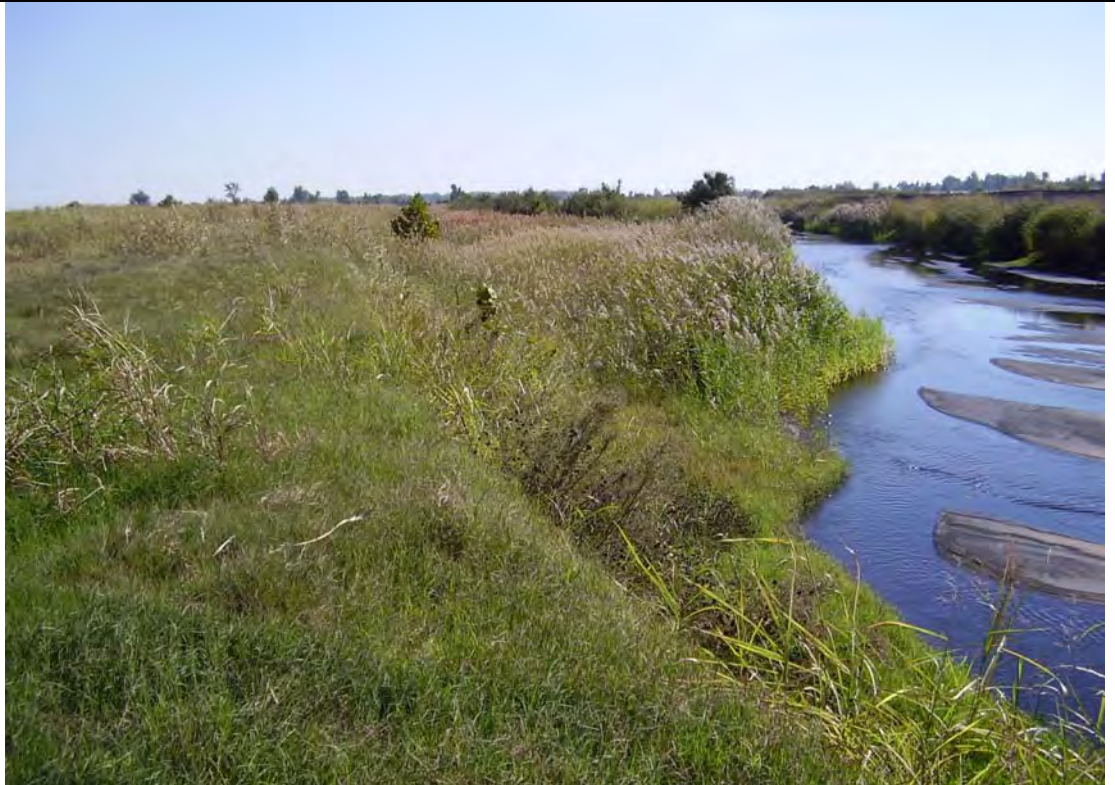
Description:
Area within AP1 showing
water drainage channel.

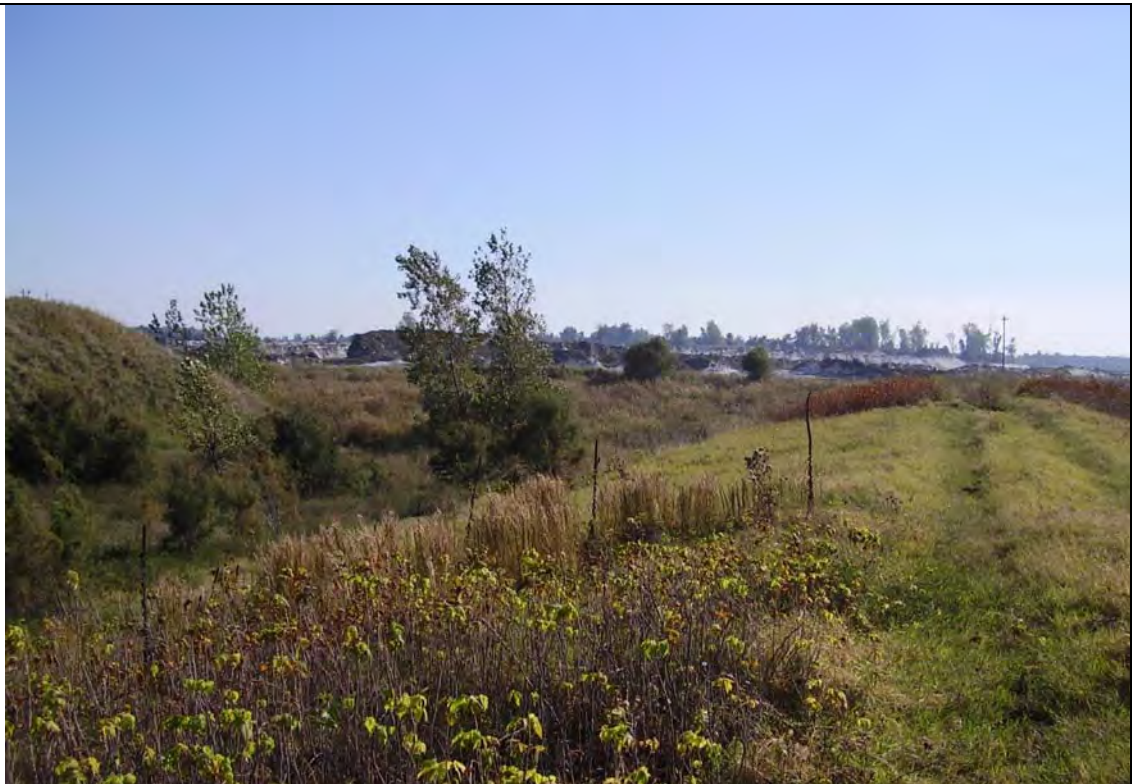
Photo No.
46

Description:
Mounded ash with
vegetation with the AP1.

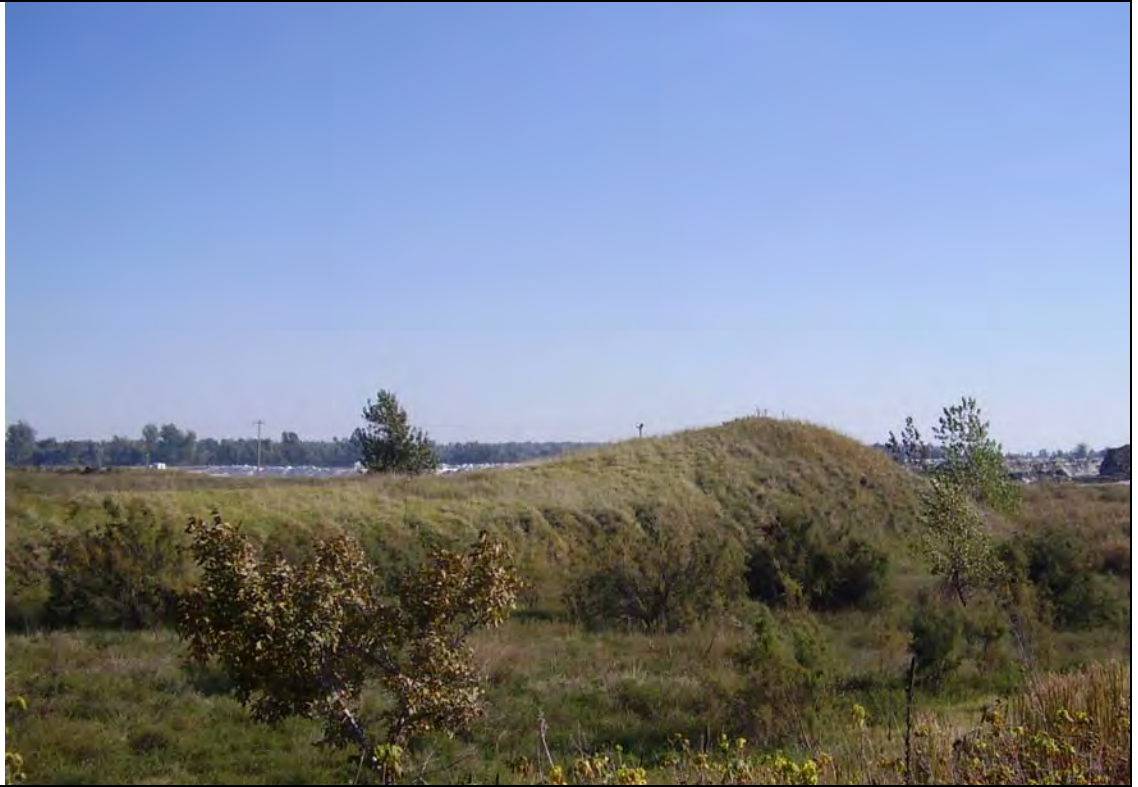
Description:
Mounded ash with
vegetation with the AP1.

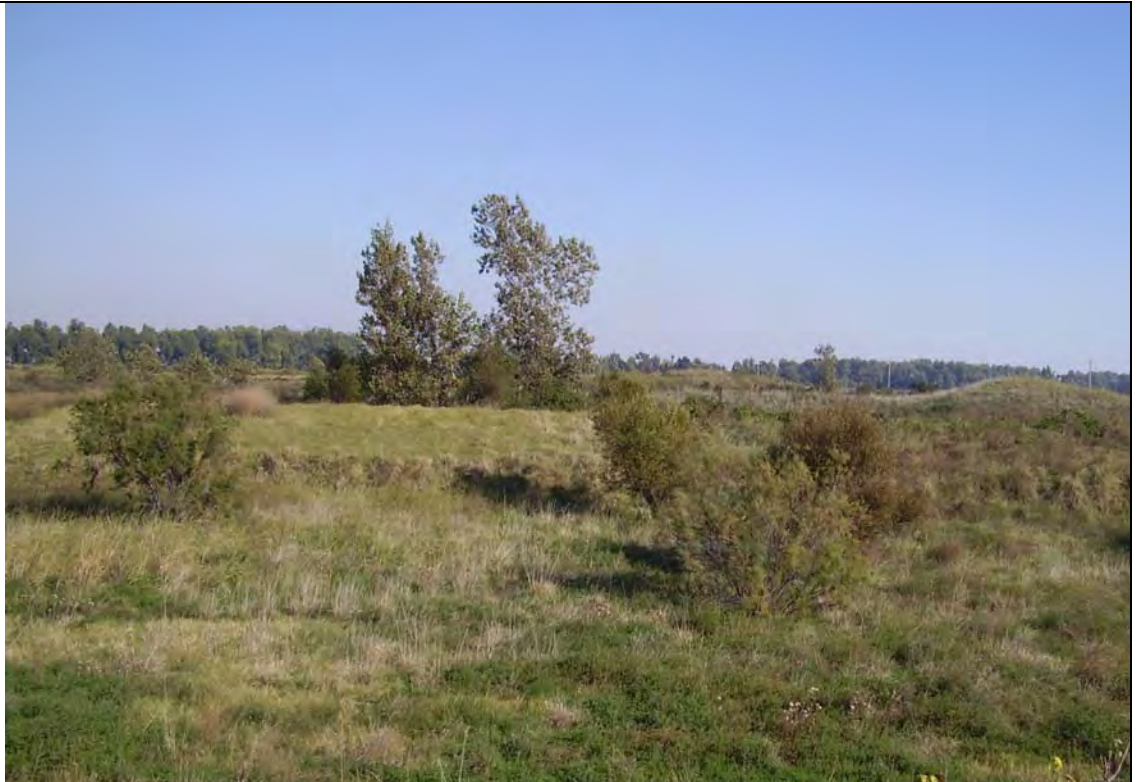
Photo No.
48

Description:
Mounded ash with
vegetation with the AP1

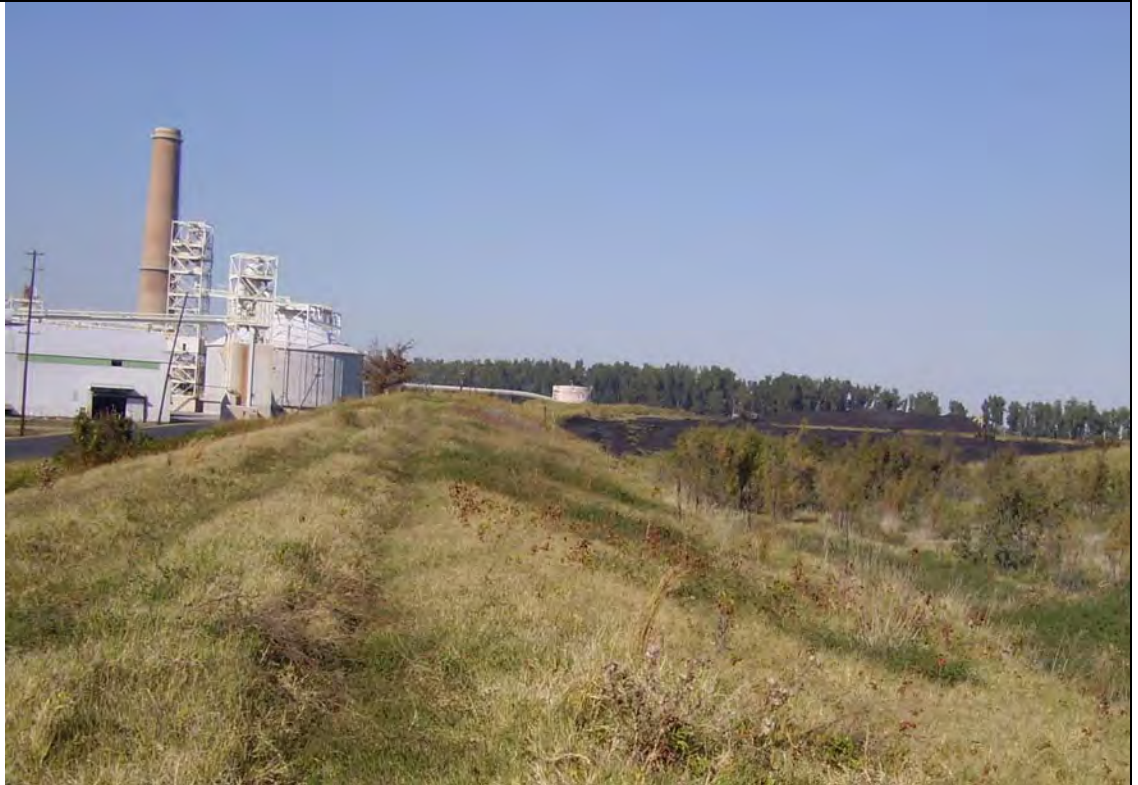
Description:
Mounded ash with
vegetation with the AP1

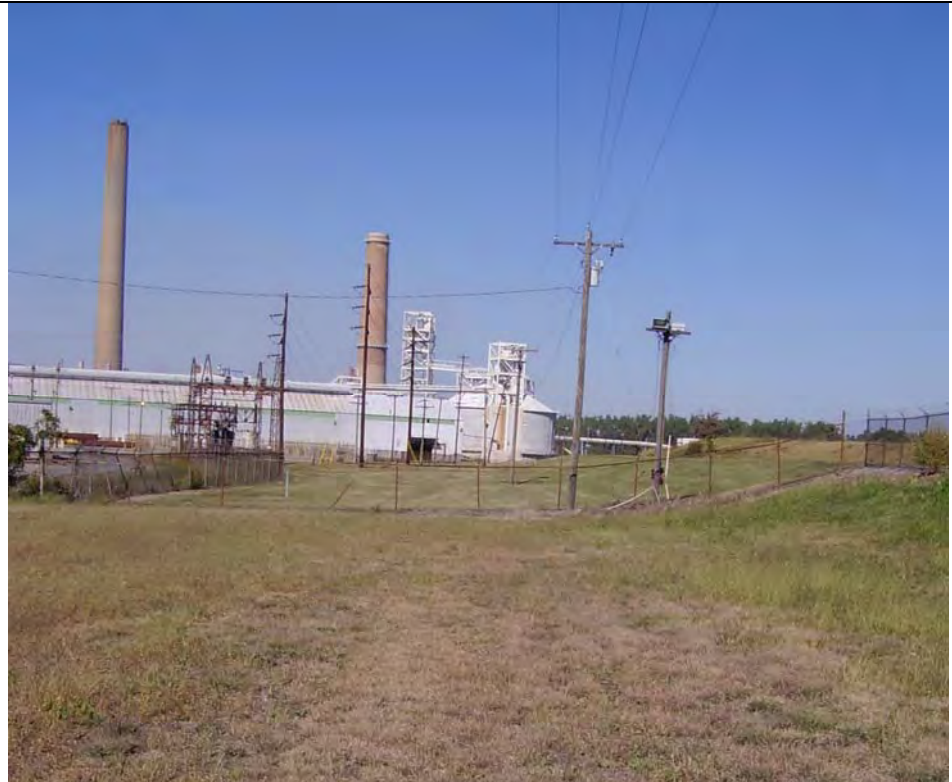
Photo No.
50

Description:
Downstream slope of the
AP1.

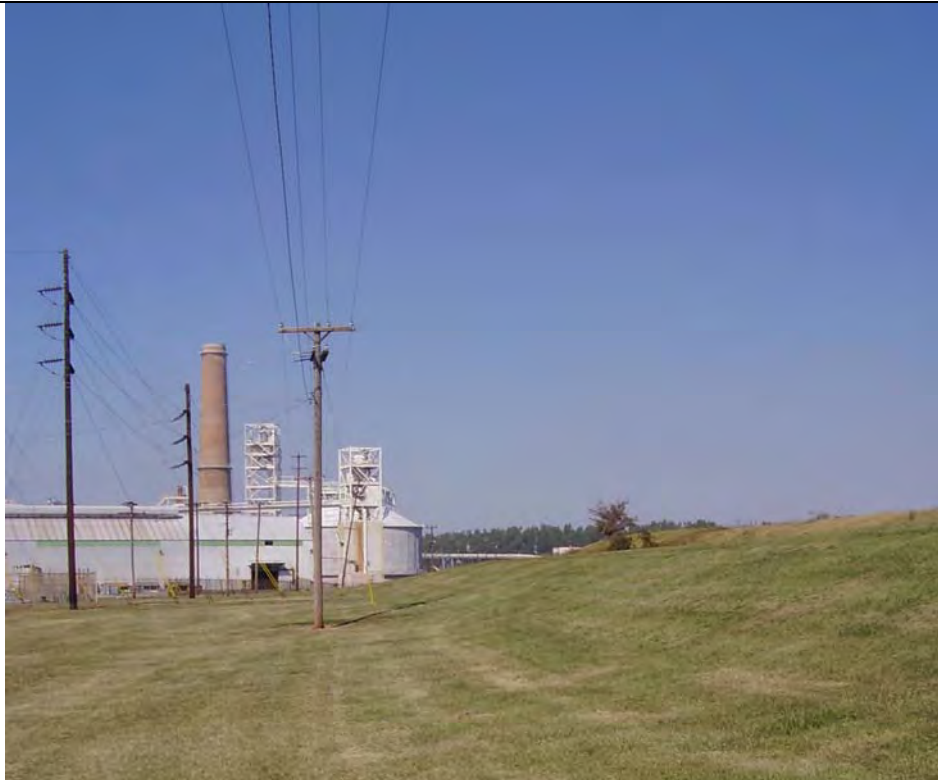
Description:
Downstream slope of the
AP1.

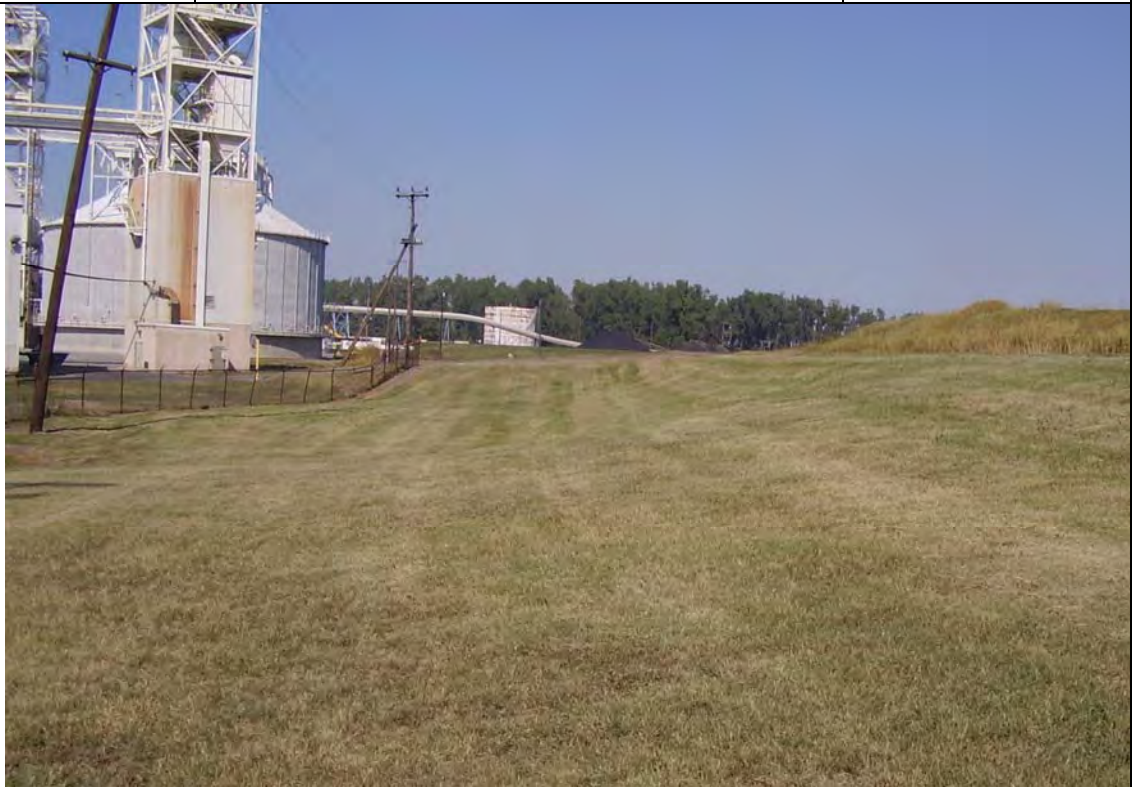
Downstream slope of the
AP1.

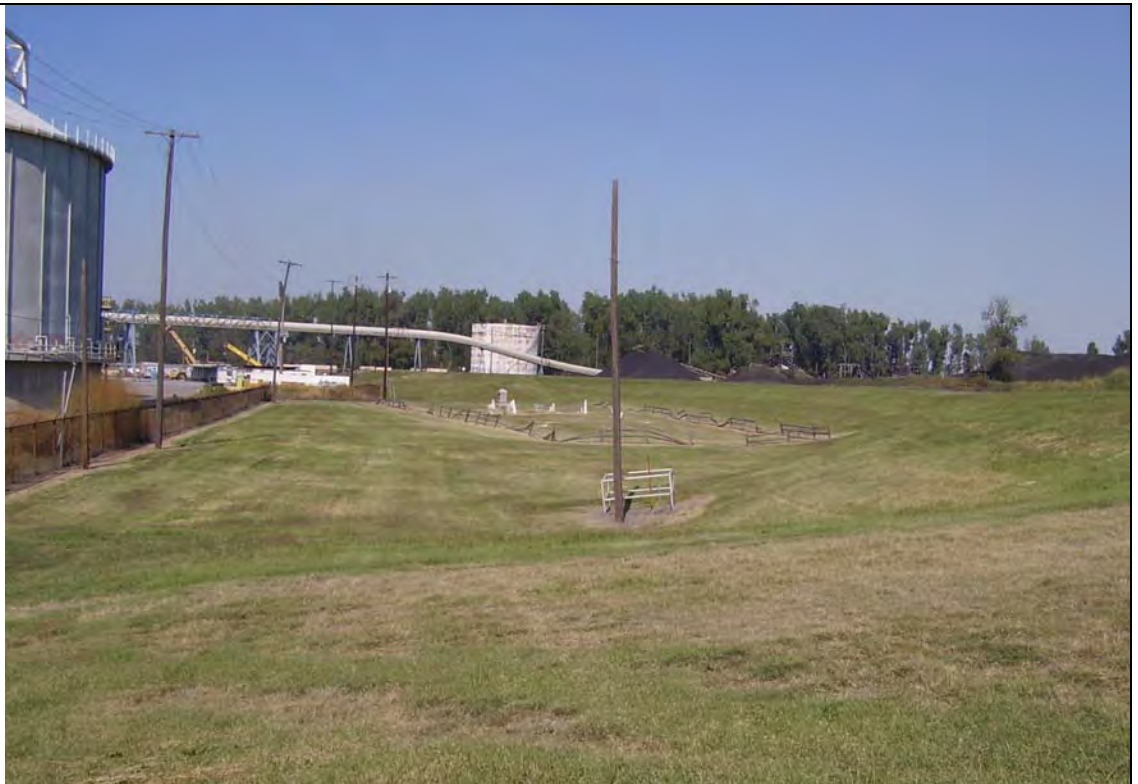
Photo No.
54

Downstream slope of the
AP1.

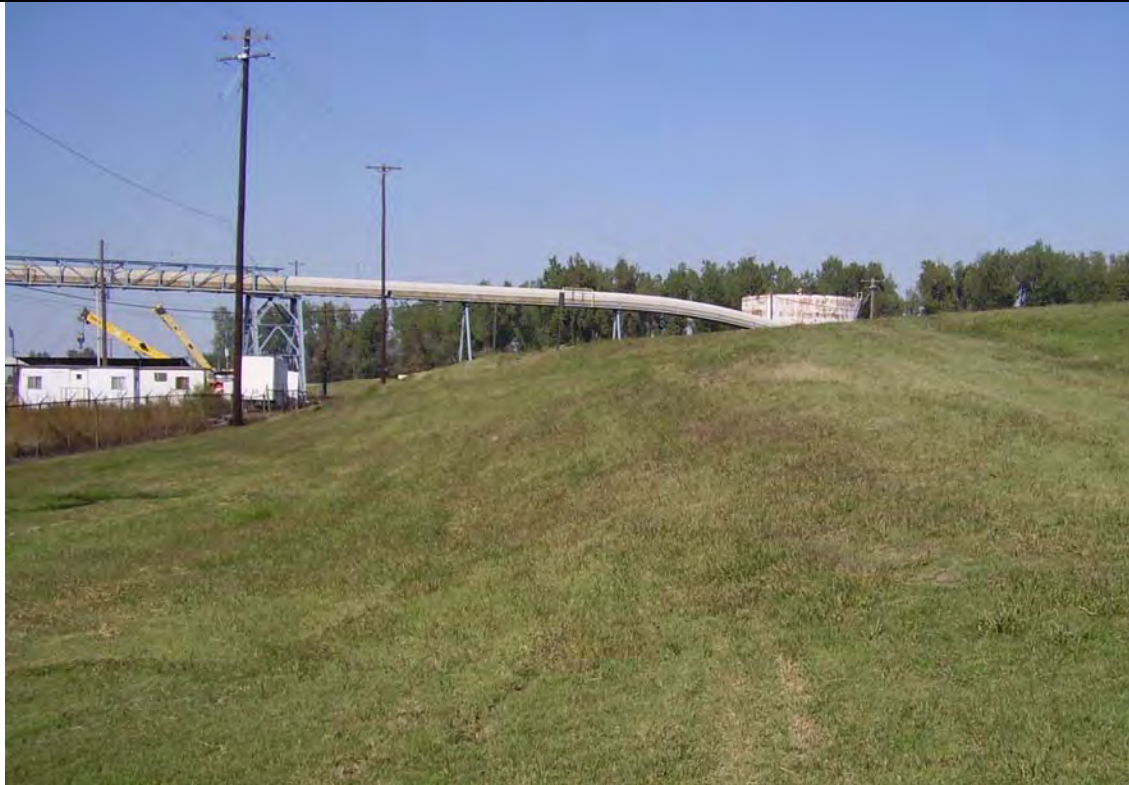
Photo No. 55	Date: 10/6/10
Direction Photo Taken: North

Description:
Downstream slope of the AP1.

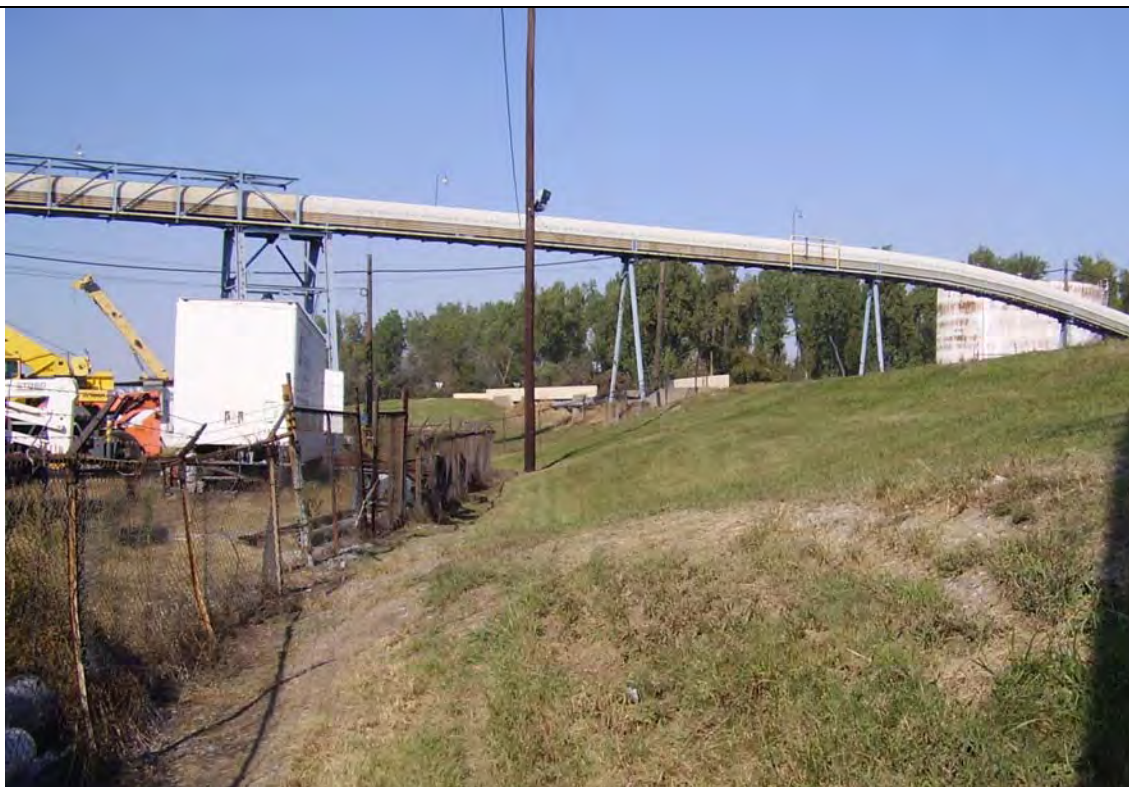
Photo No. 56	Date: 10/6/10
Direction Photo Taken: Northeast

Description:
Downstream slope of the AP1.

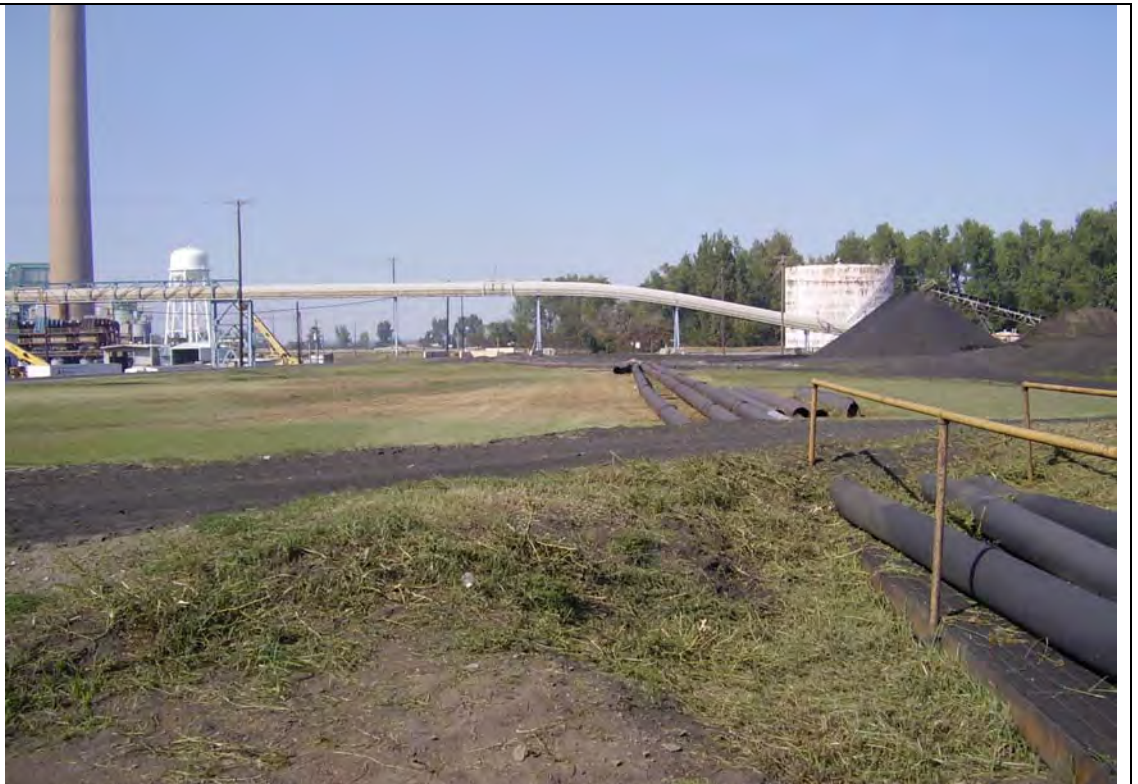
Discharge pipelines located on surface within the AP1.

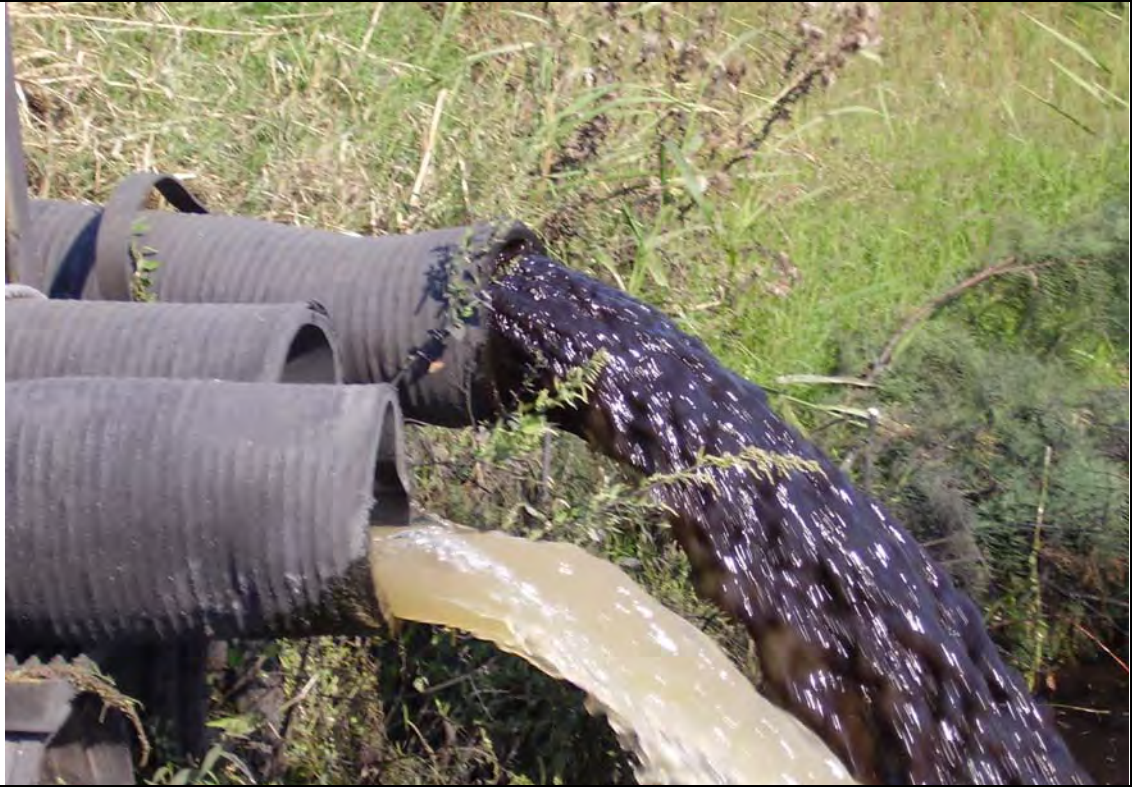
Description:
Pipelines discharging
materials into the AP1.

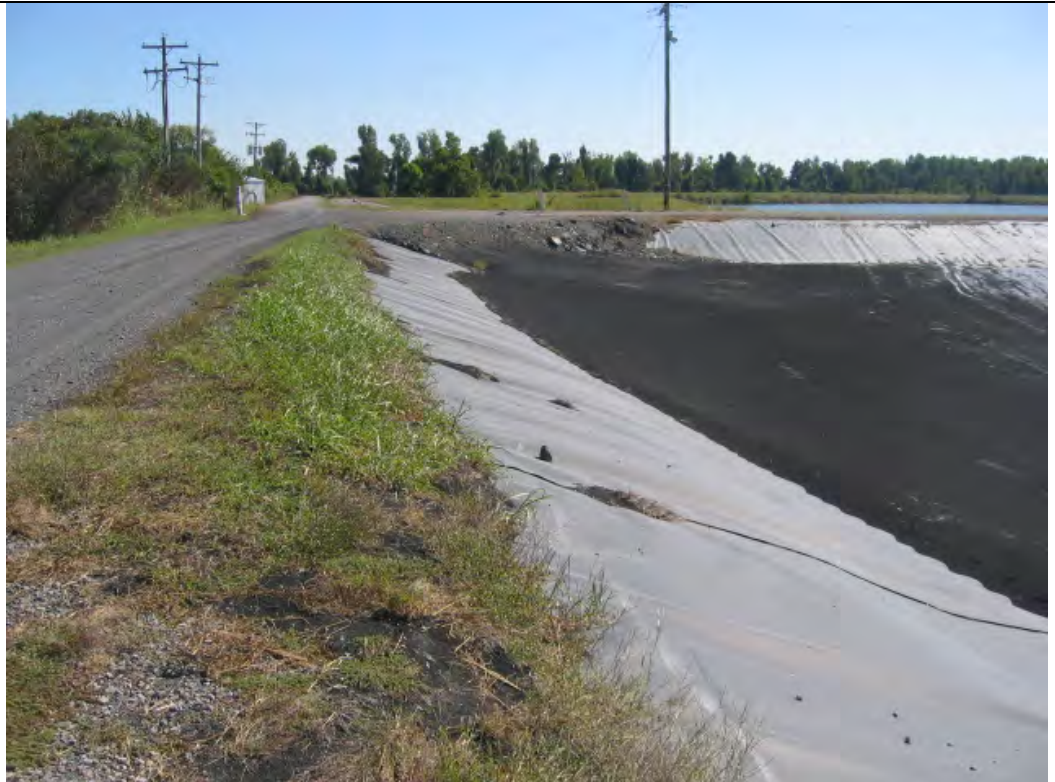
Photo No.
60

Description:
Upstream slope of the Ash
Pond 2 Impoundment (AP2).

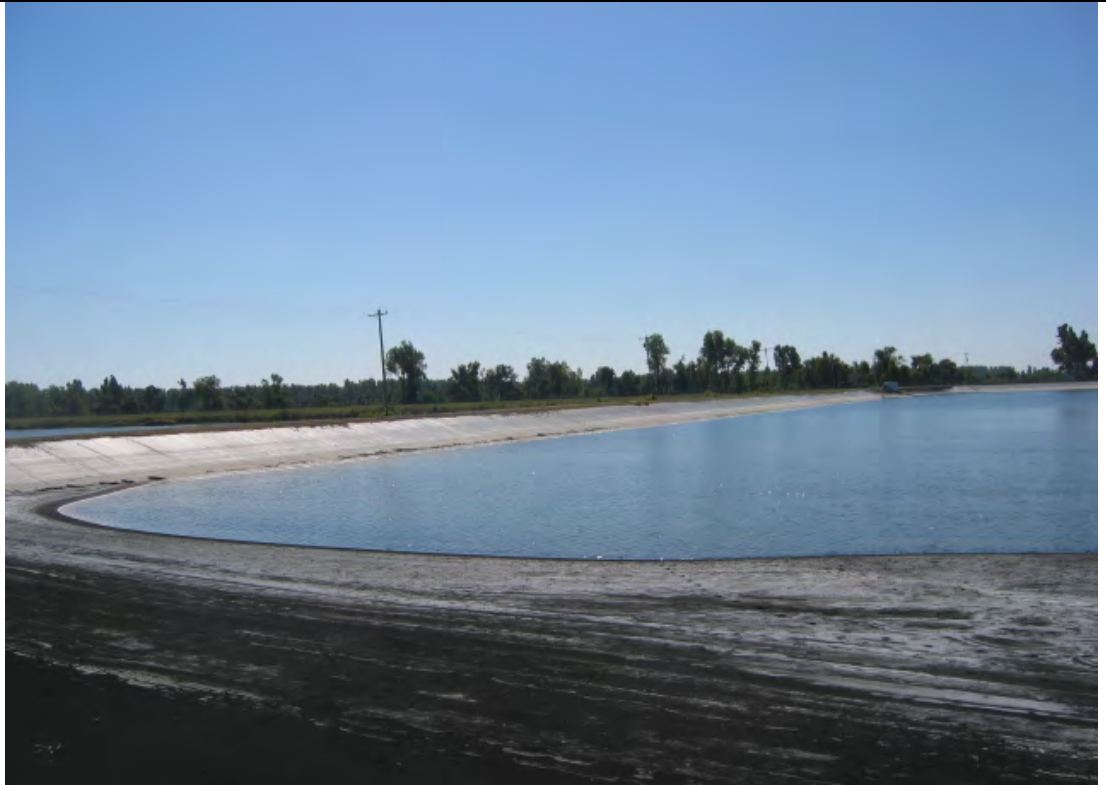
Description:
Upstream slope of the AP2.

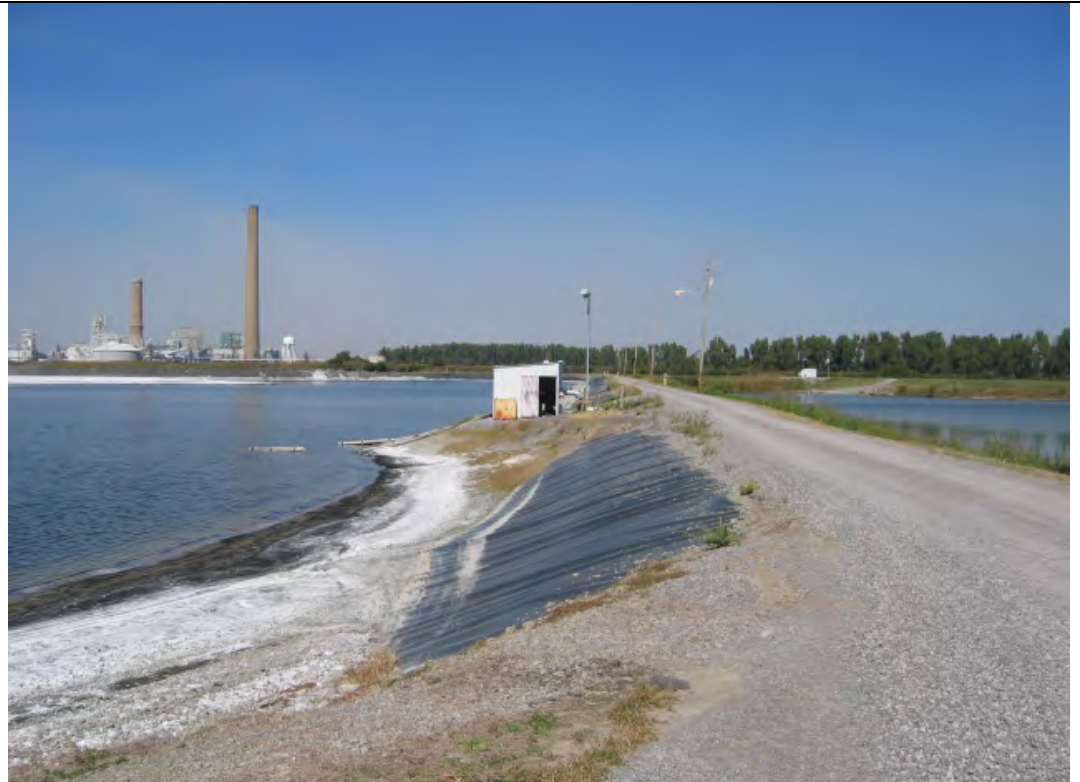
Photo No.
62

Description:
Upstream slope of the AP2
and the Pump Control
building.

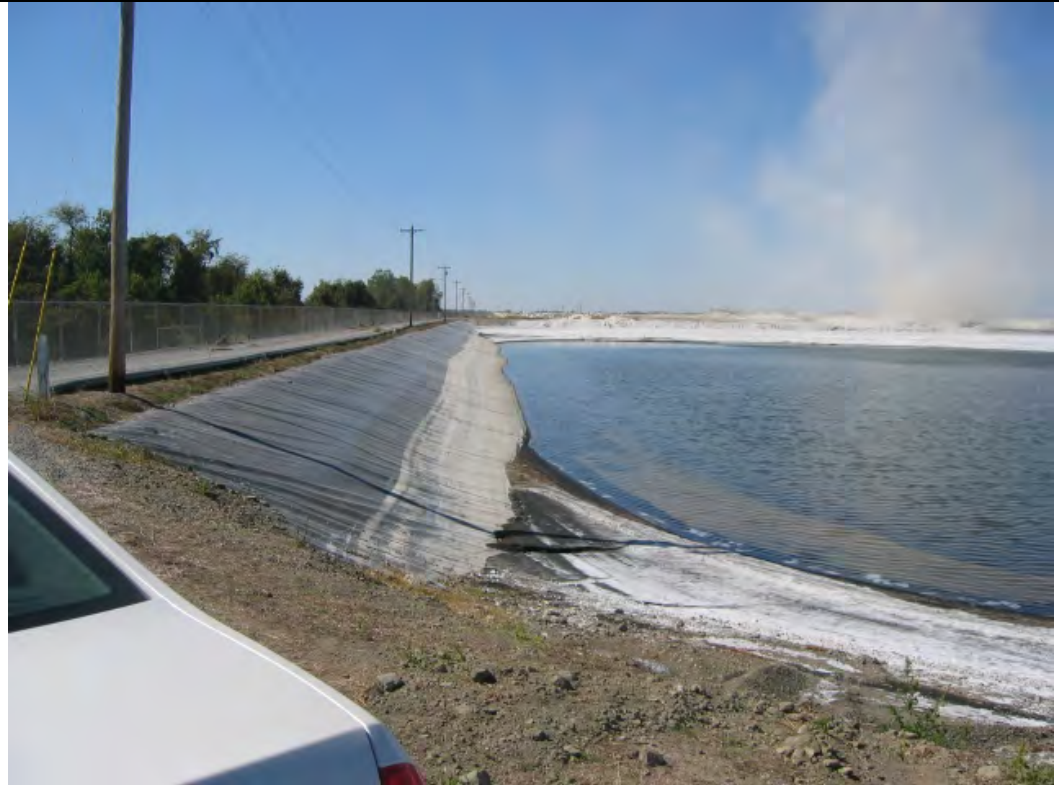
Description:
Upstream slope of the AP2.
