**DRAFT REPORT
ROUND 7 DAM ASSESSMENT
ASSOCIATED ELECTRIC COOPERATIVE, INC.
NEW MADRID POWER PLANT
ASH POND 1 & 2 AND SLAG POND 1 & 2 IMPOUNDMENTS
NEW MADRID COUNTY, MISSOURI**

January 14, 2011

Re: Round 7 Dam Assessment - Draft Report
EPA Contract No. EP10W001313
Associated Electric Cooperative, Inc. New Madrid Power Plant
Ash Pond 1 and 2 Impoundments and Slag Pond 1 and 2 Impoundments
New Madrid County, Missouri

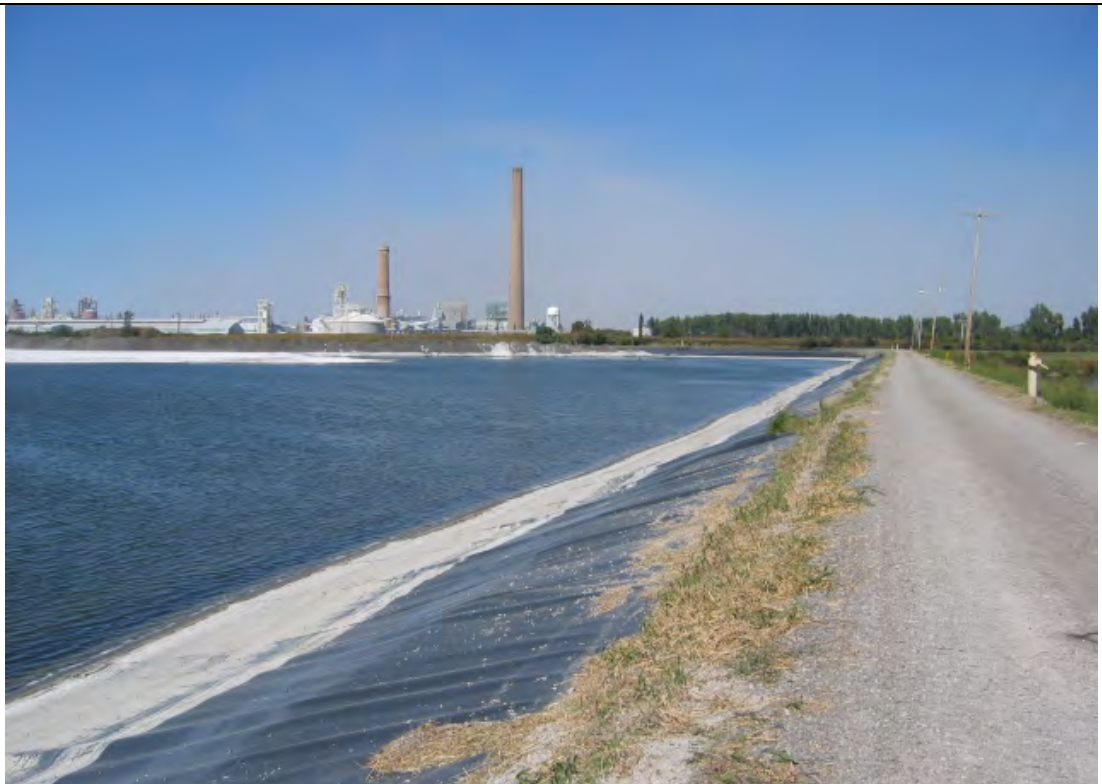
Photo No.
64

Description:
Upstream slope of the AP2.

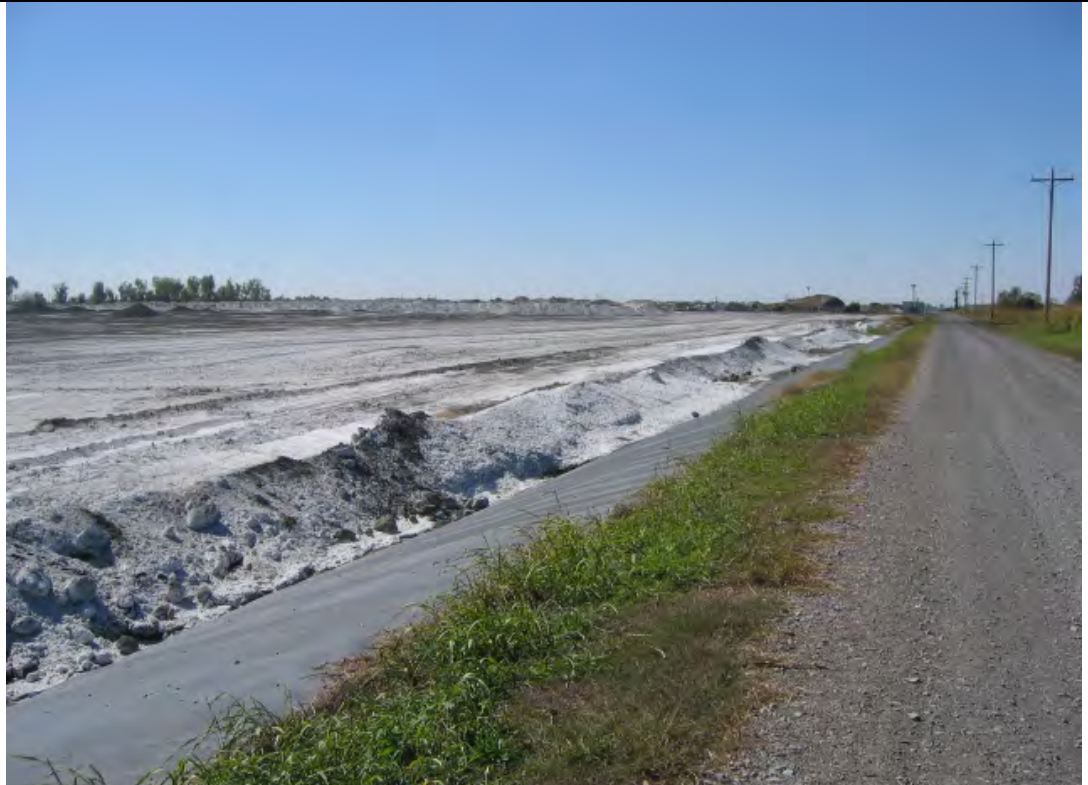
Upstream slope and crest of
the AP2.

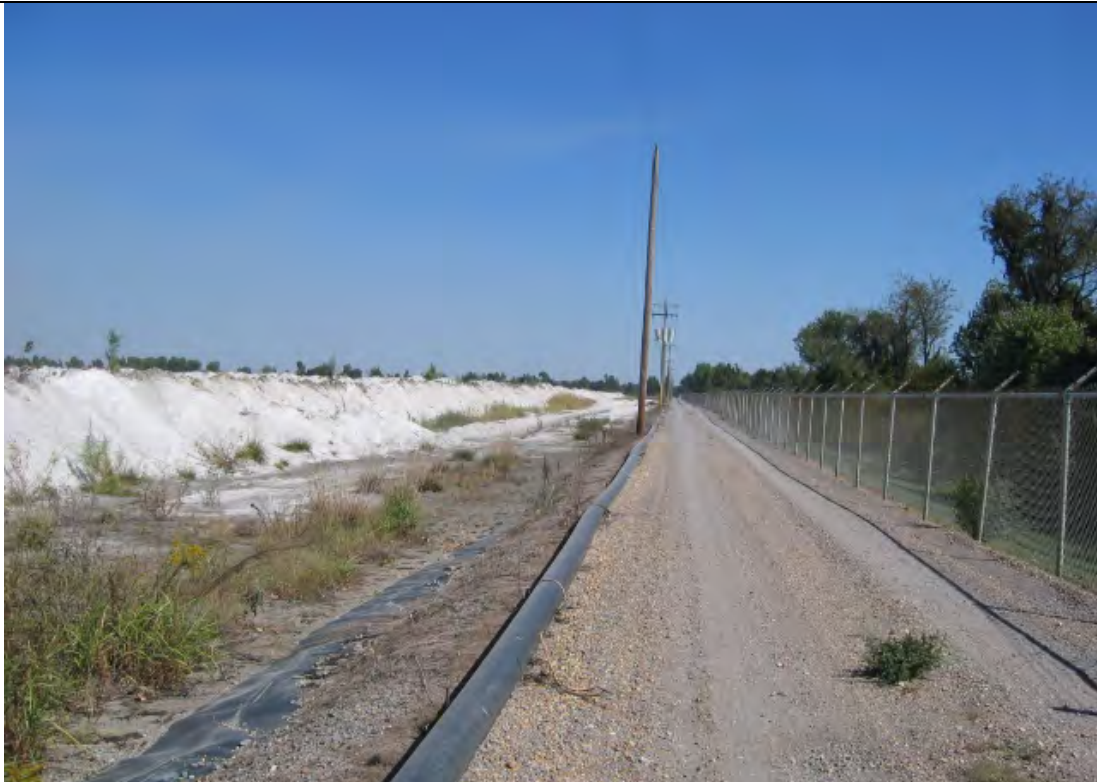
Photo No.
66

Upstream slope and crest of
the AP2.

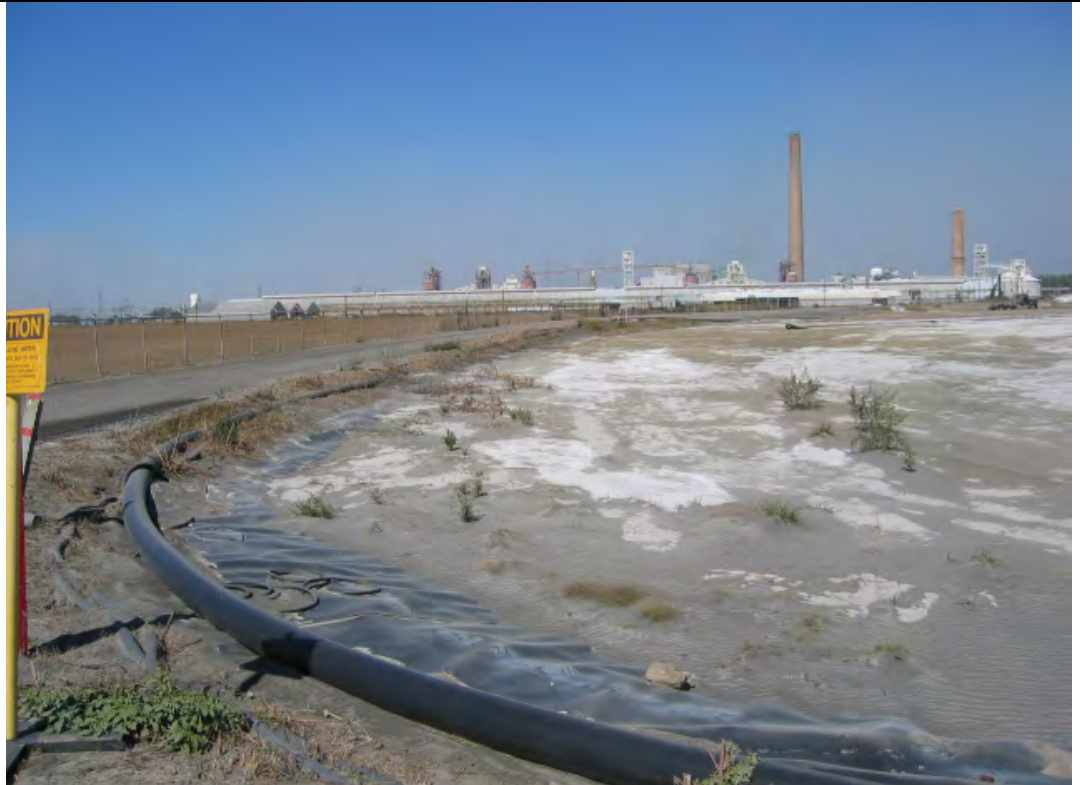
Description:
Upstream slope of the AP2.

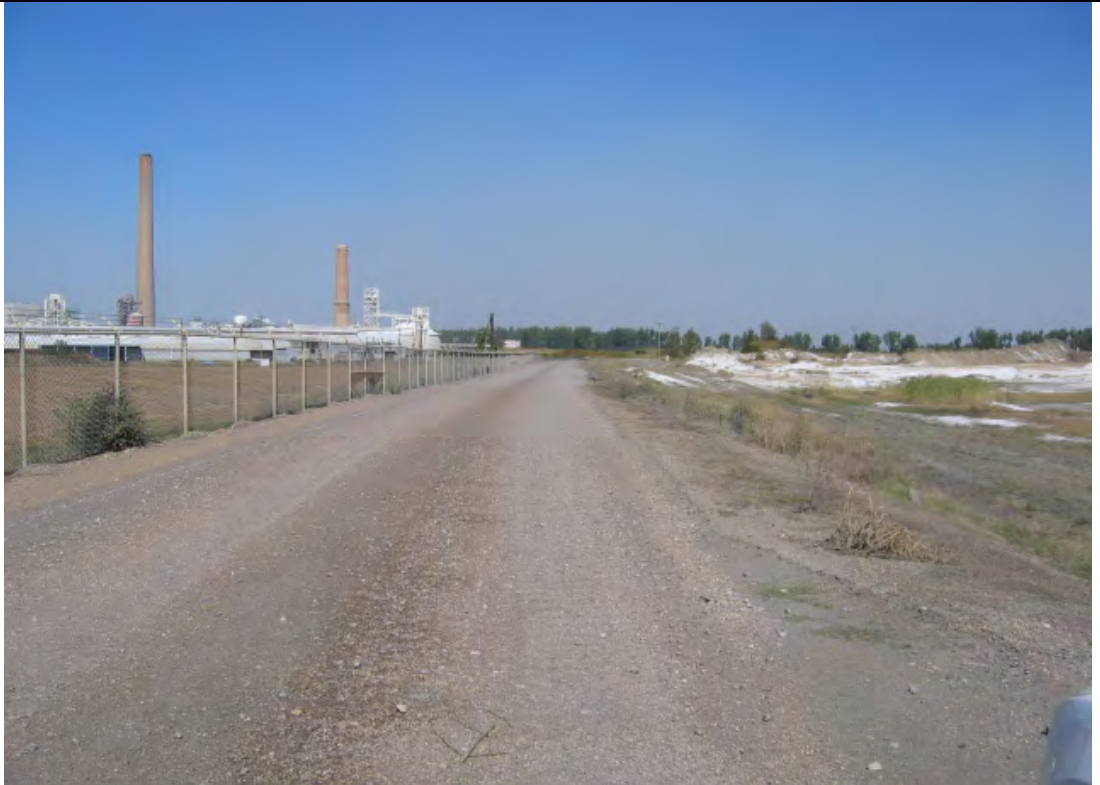
Description:
Upstream slope and crest of
AP2.

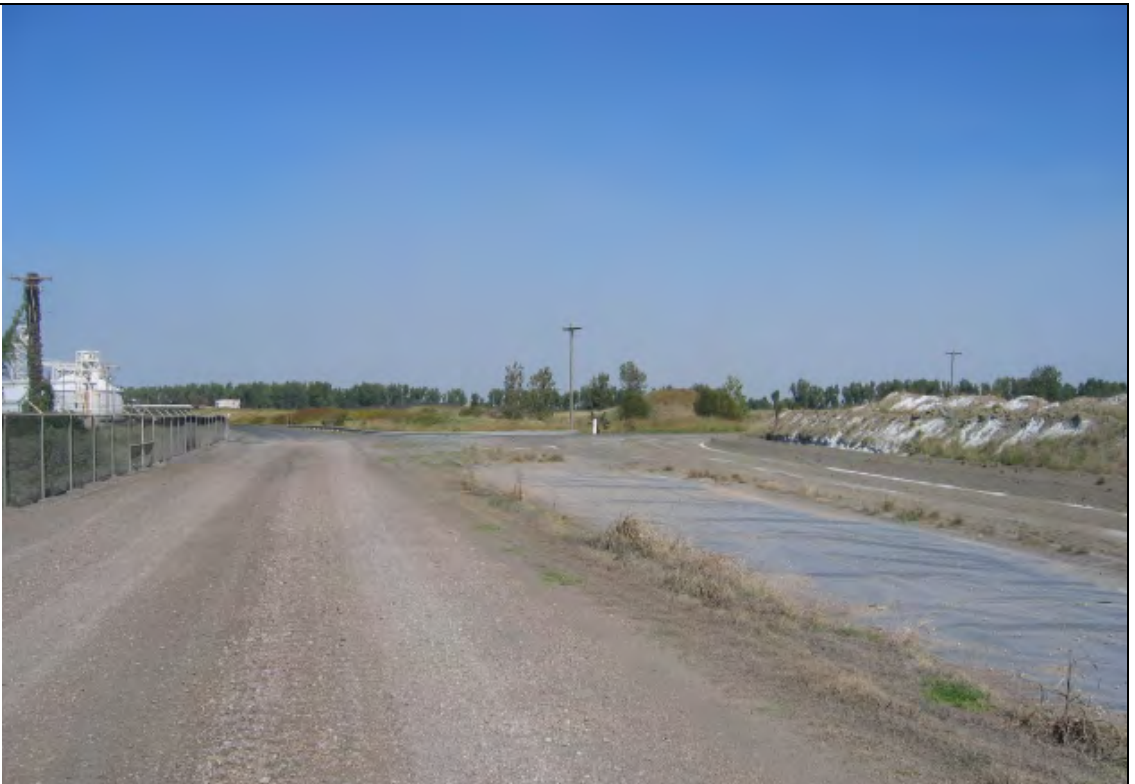
Photo No.
70

Description:
Upstream slope and crest of
the AP2.

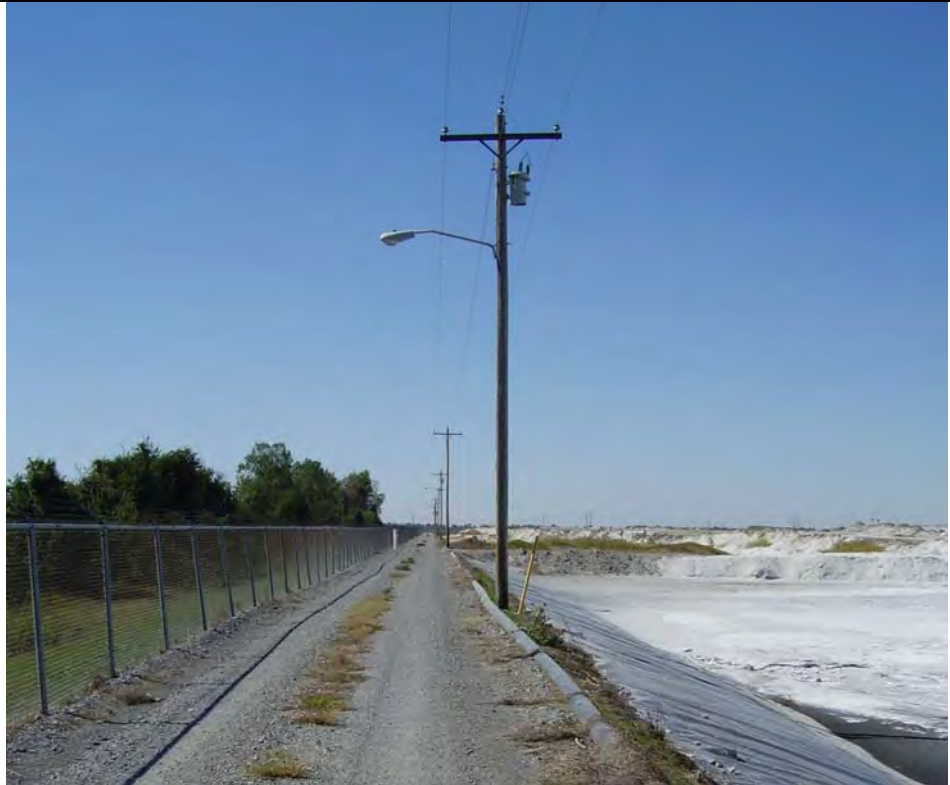
Description:
Crest of the AP2.

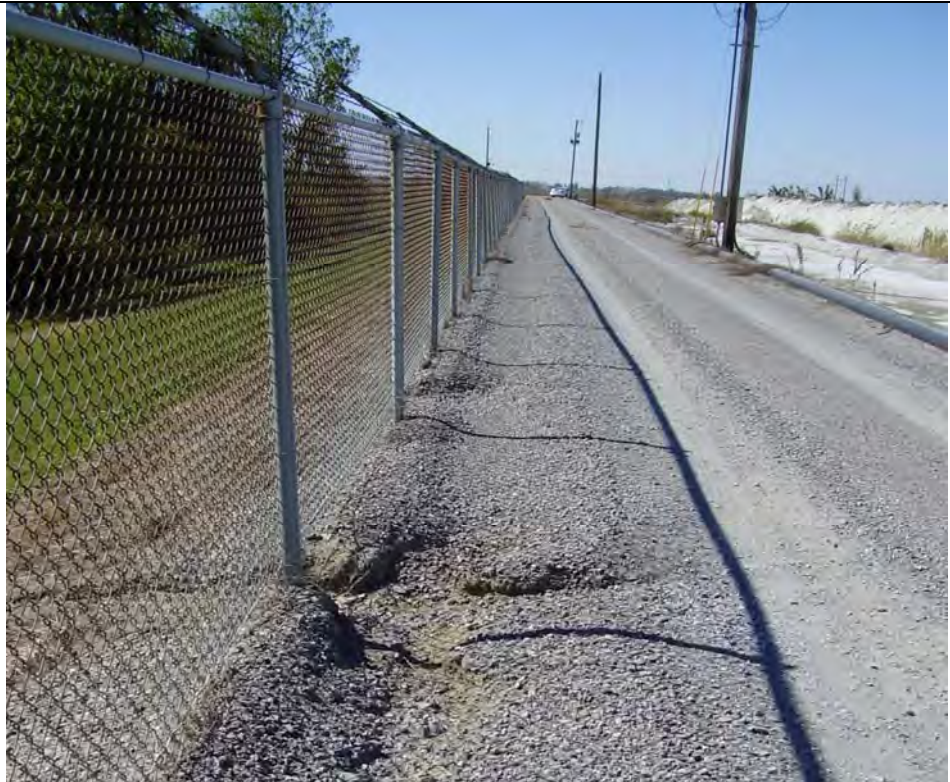
Photo No.
72

The crest of the AP2 Impoundment consisted of a gravel access road. The crest alignment appeared generally level, with no depressions or irregularities observed. Based on information provided by NMPP, the crest elevation is +/- 307 feet MSL. No significant settlement was observed at the time of our inspection. There was erosion in several areas of the gravel access road on the southern embankment as shown in Photos 72 and 73. There was approximately 7 feet of free board at the time of our inspection.

ADDITIONAL COMMENTS: Erosion noted in several areas of the gravel access road on the southern embankment

Description:
Crest of the AP2 showing an
example of the erosion of the
gravel access road.

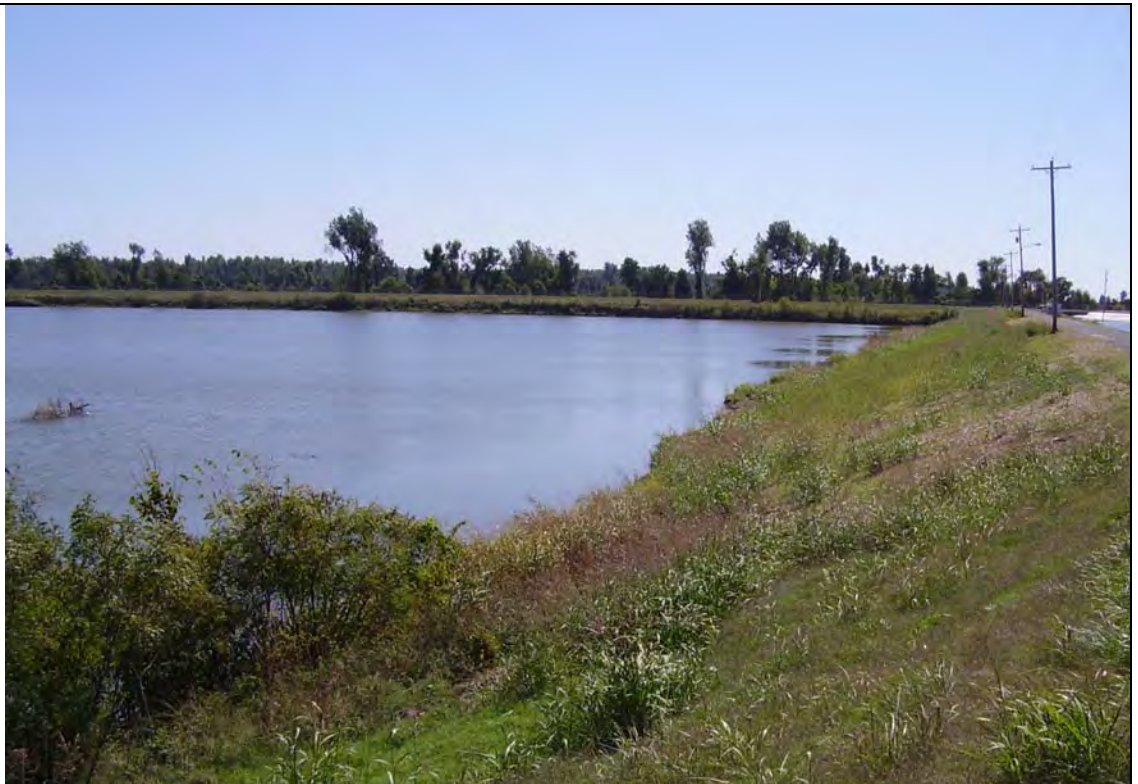
Downstream slope of the
AP2.

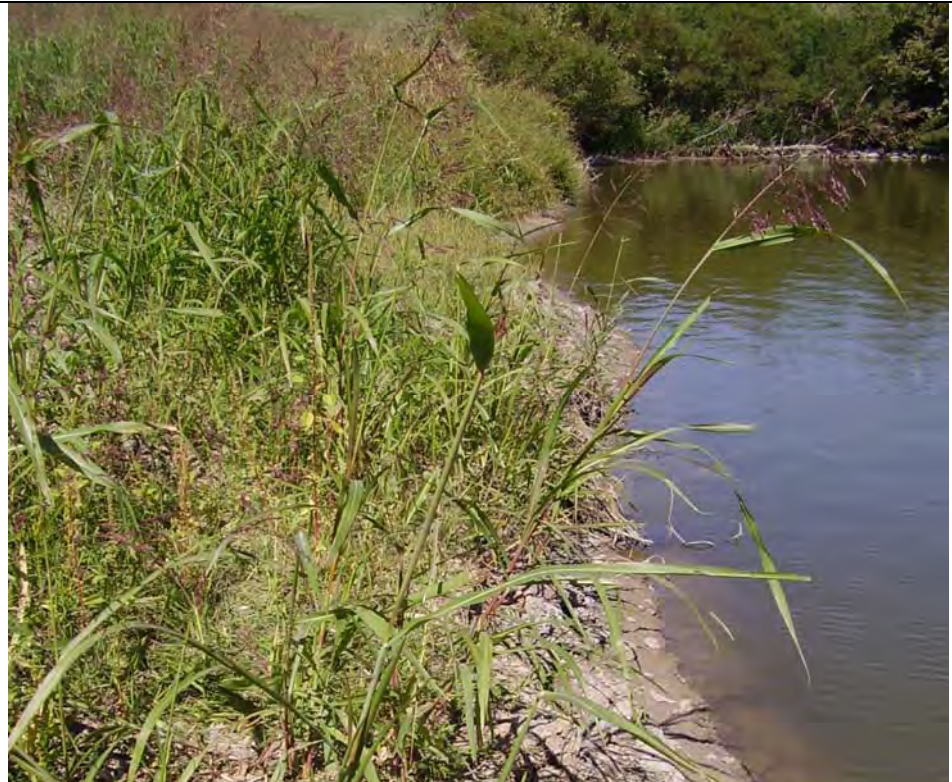
The eastern embankment of the AP2 Impoundment separates the AP2 Impoundment from the MUW Pond. The water in the MUW Pond covered the lower portion of the downstream slope. The downstream slope of the eastern embankment was vegetated with sparse vegetation that appeared to be regularly mowed. Wave action erosion was present on the slope from waves in the MUW Pond. On the southern portion of the slope, wave action erosion has created a vertical slope which is approximately 3 feet in height. Ruts from equipment operation were also present on the slope at the approximate location shown on **Figure 4**. Two 18-inch diameter pipelines are present in the downstream slope of the eastern embankment as shown in Photo 86. The pipelines are used to transfer water from the MUW Pond to the AP2 Impoundment during high water events associated with the Mississippi River to provide positive downward pressure on the AP2 Impoundment liner.

Wave action erosion on the
downstream slope of the
AP2.

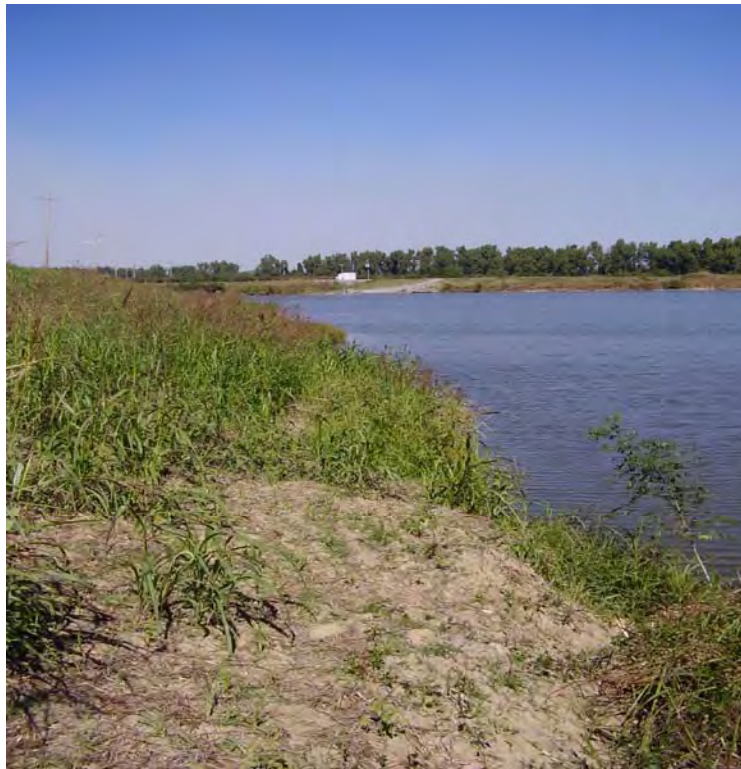
Description:
Downstream slope near
showing wave action erosion
in southeast corner of the
AP2.

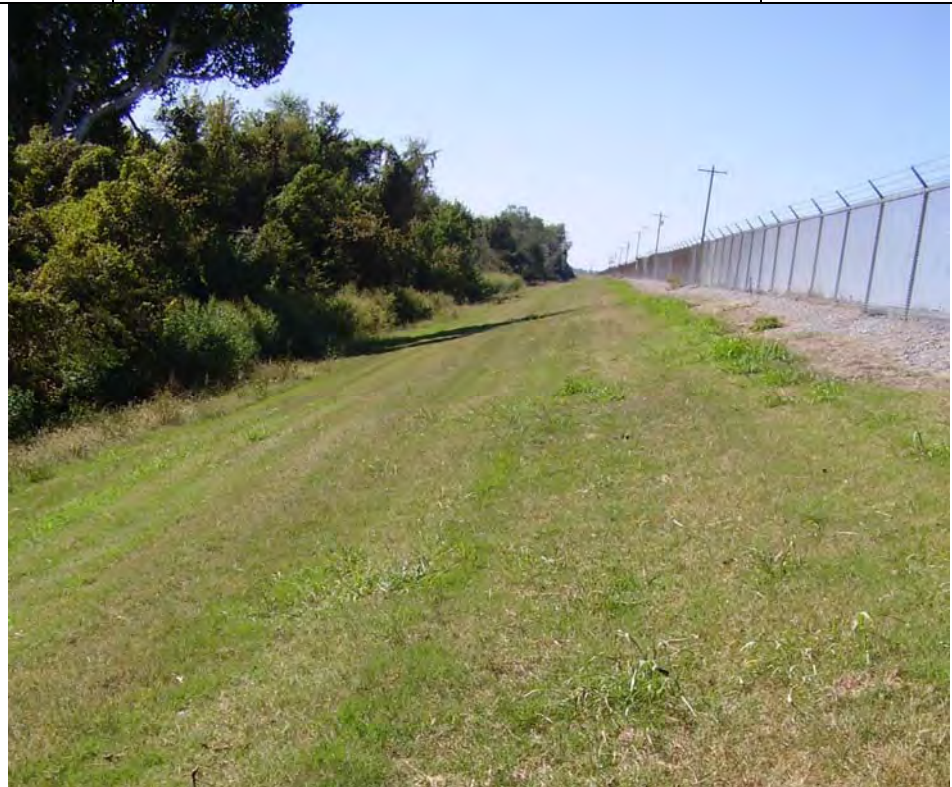
Description:
Downstream slope of the
AP2.

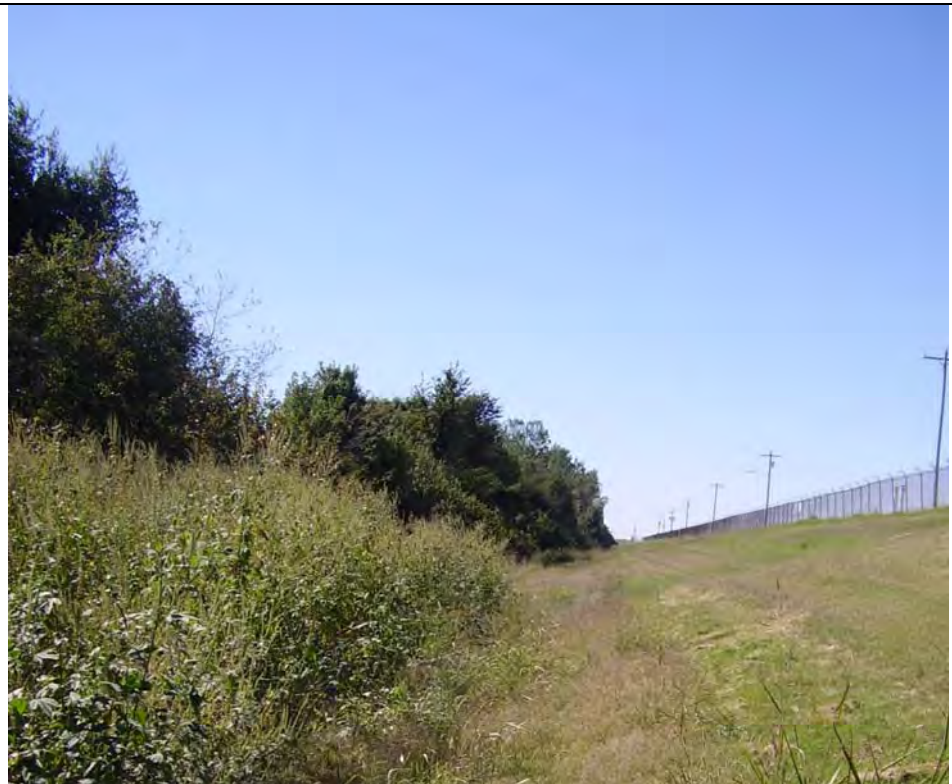
Photo No.
80

Description:
Downstream slope of the
AP2.

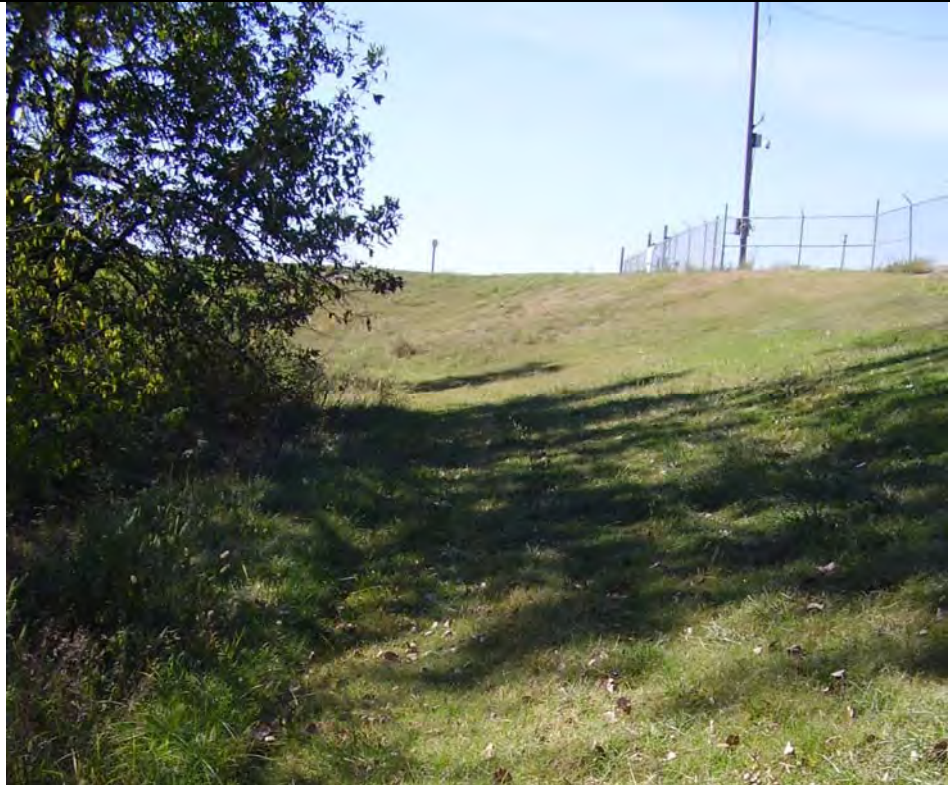
Description:
Downstream slope of the
AP2.

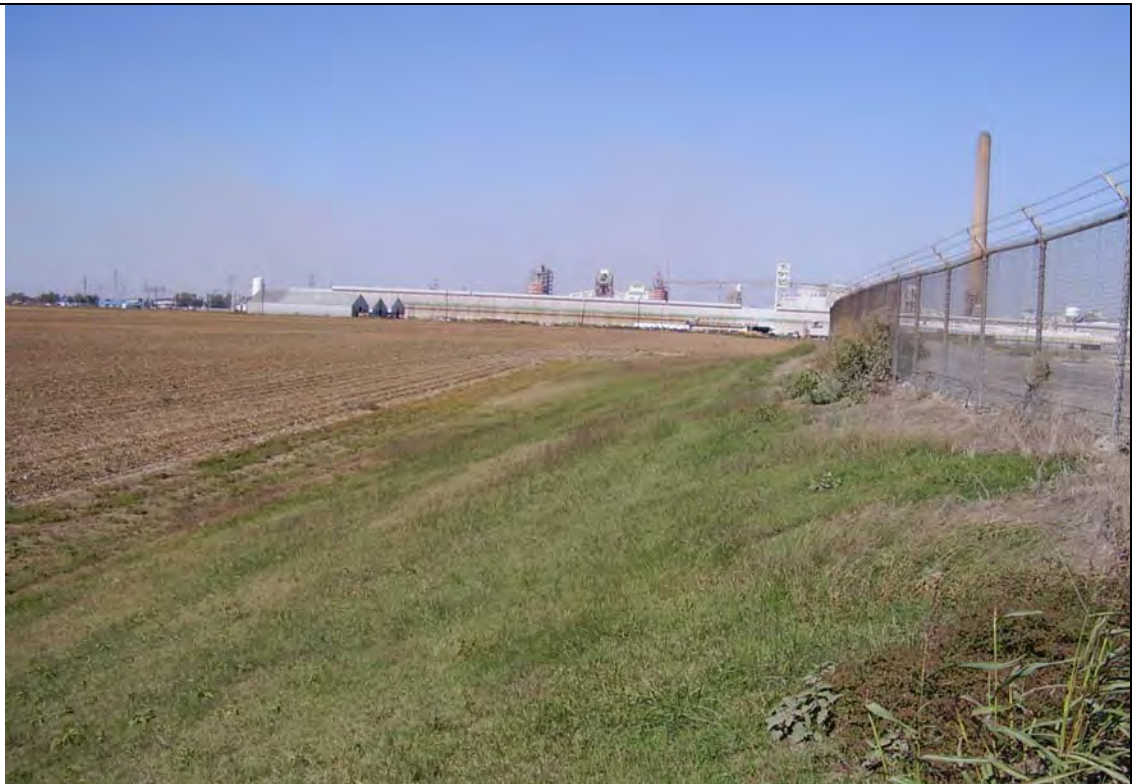
Photo No.
82

Description:
Downstream slope of the
AP2.

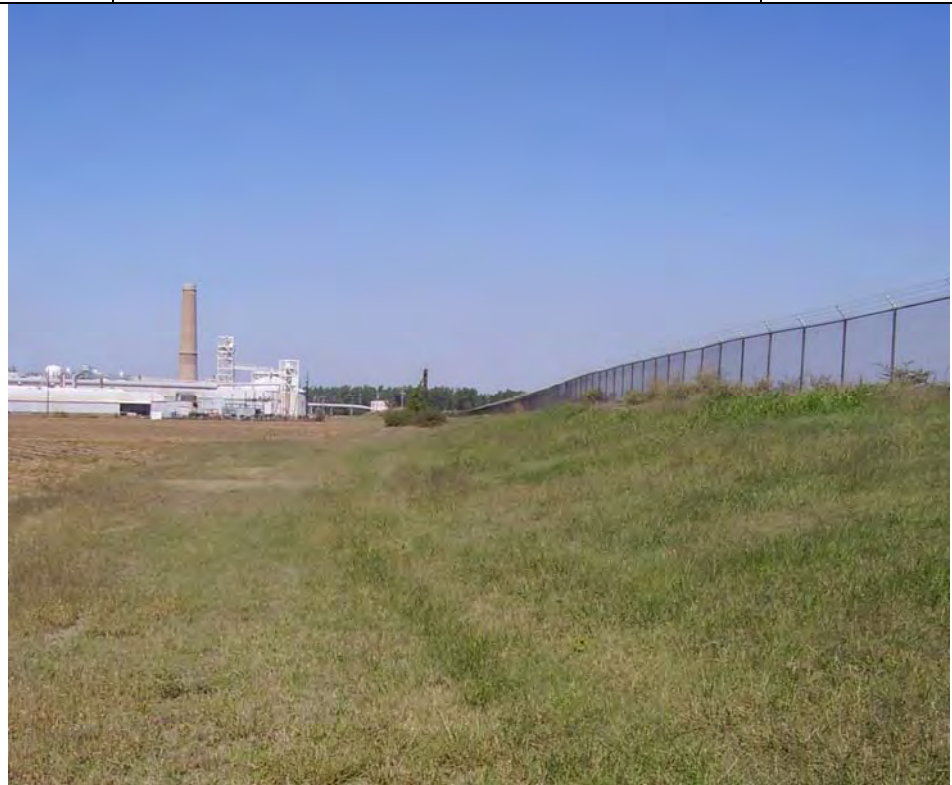
Description:
Downstream slope of the
AP2.

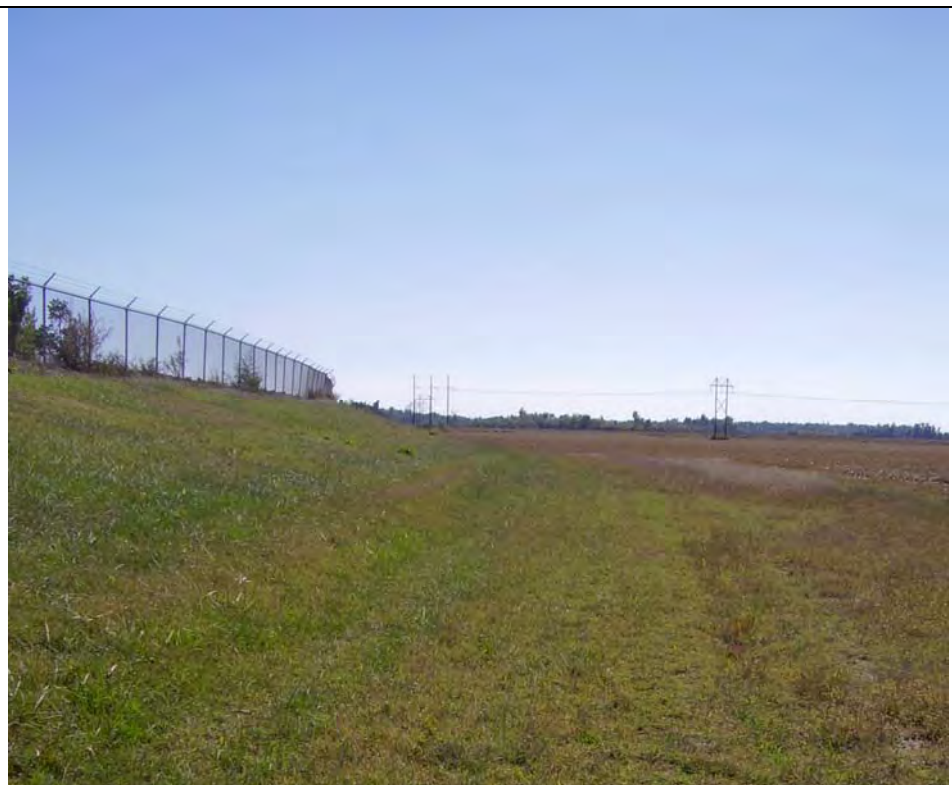
Photo No.
84

Description:
Downstream slope of the
AP2.

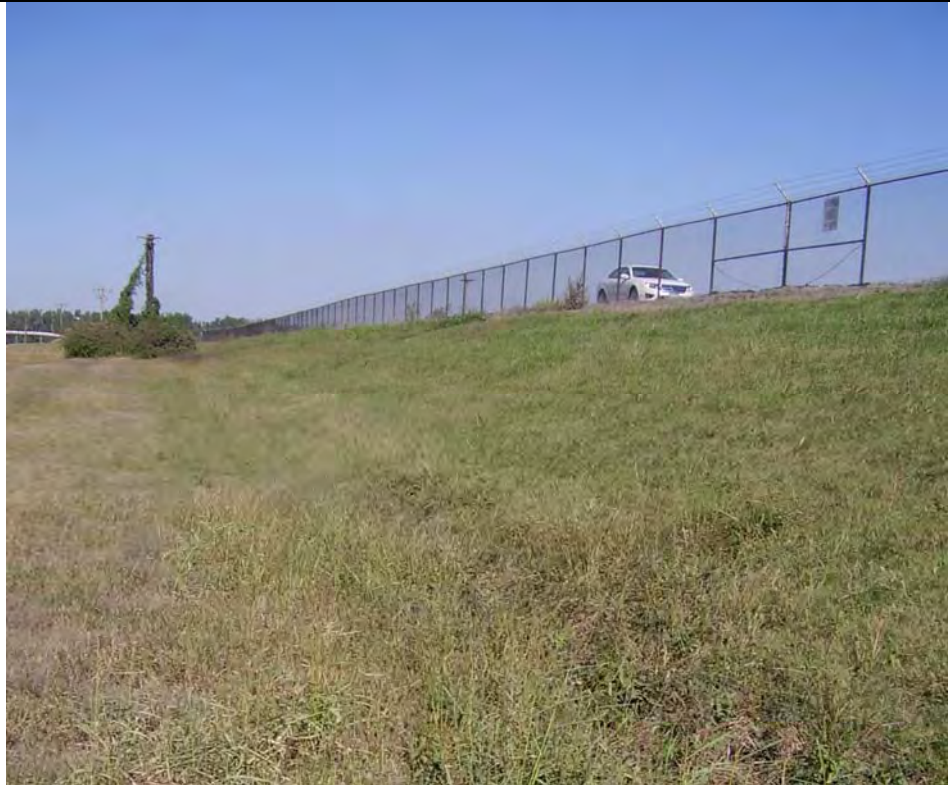
Description:
Downstream slope of the
AP2 showing sloughing of
the slope.
