Assessment of Dam Safety Coal Combustion Surface Impoundments (Task 3) Final Report

American Electric Power
Cardinal Power Plant
Brilliant, Ohio

December 9, 2009

CHA Project No. 20085.1080.1510

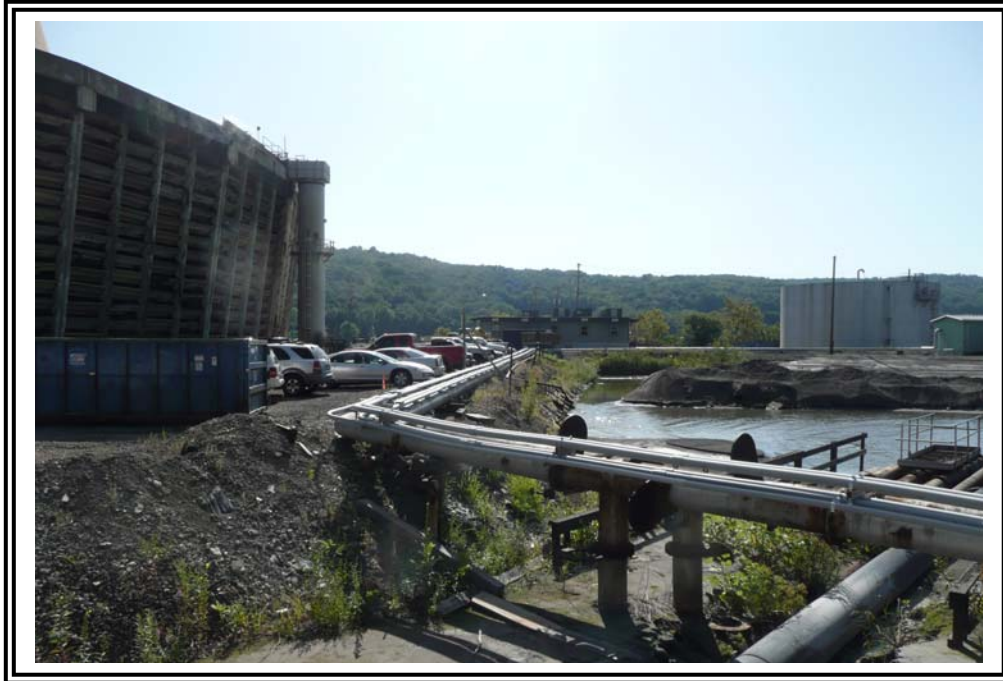
3

Upstream slope of the north rim, looking east.

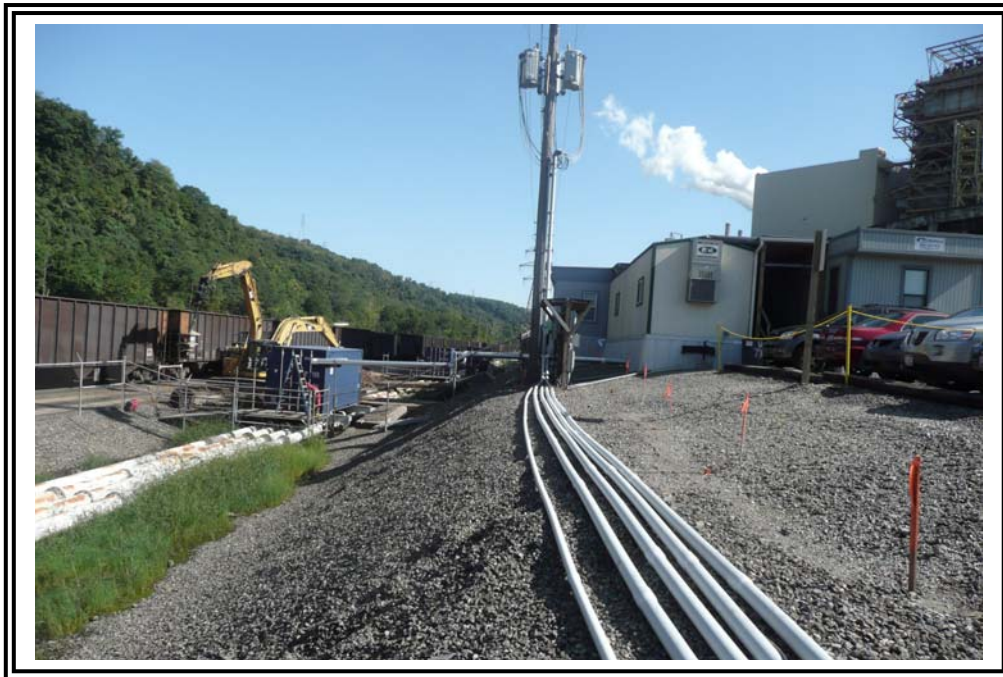
4

Downstream slope of the west dike, looking north. Note gravel surface and grass in drainage swale.

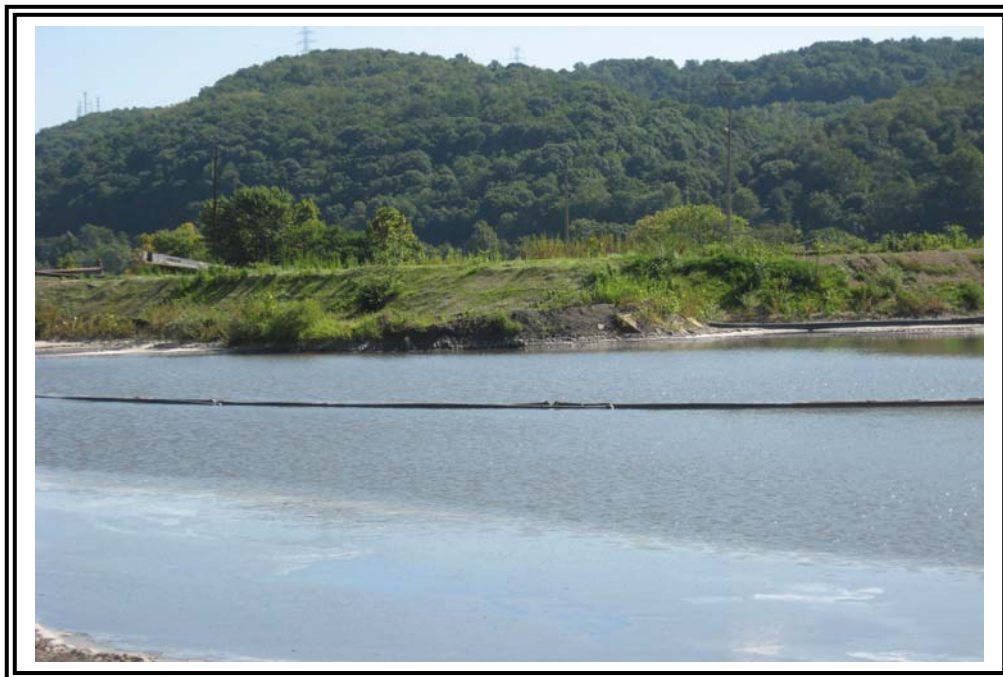
6

Looking east from west dike at interior dike structure used for temporary bottom ash dredge spoil storage.

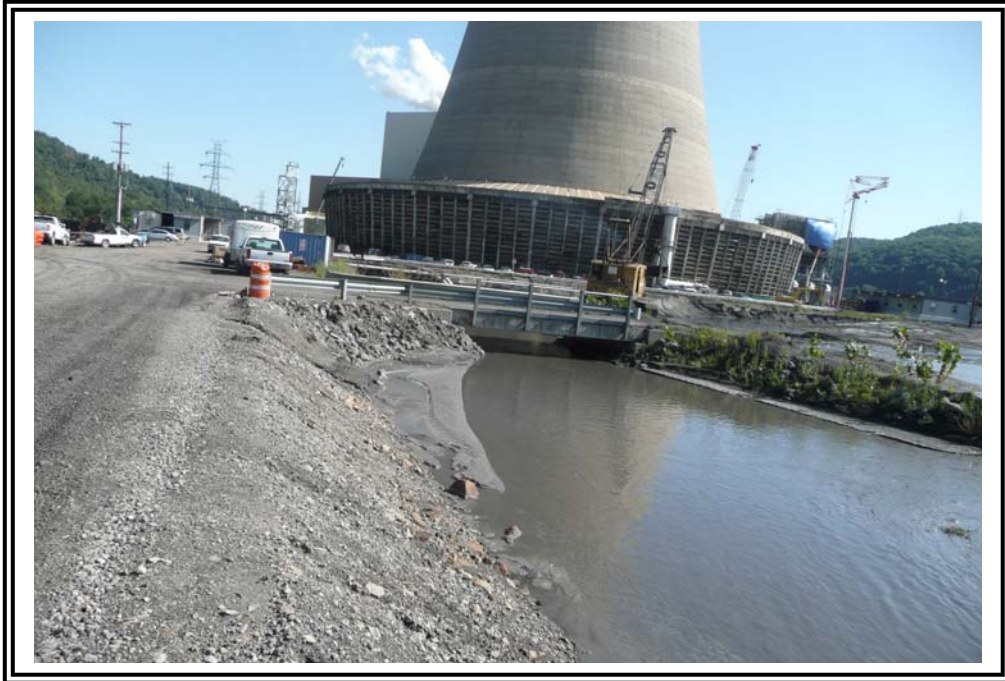
7

Upstream slope of west dike looking north.

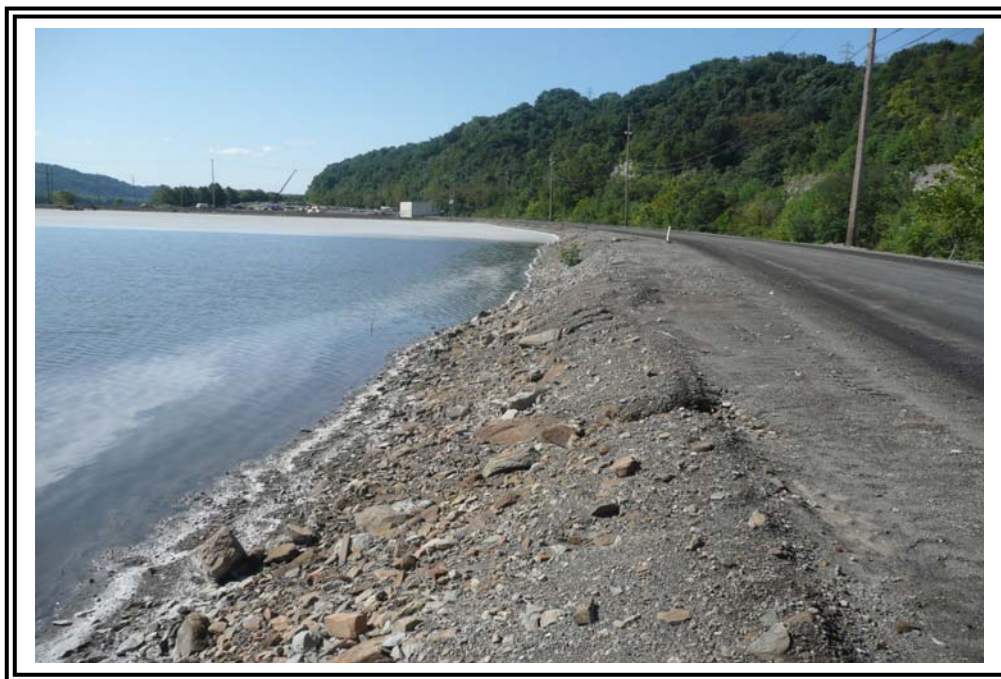
10

Photos 9 through 12 show the granular surface and erosion rills at the crest-slope interface and slope surface.

Upstream slope of the west dike, looking south. Note erosion at crest and sparse vegetation in background.

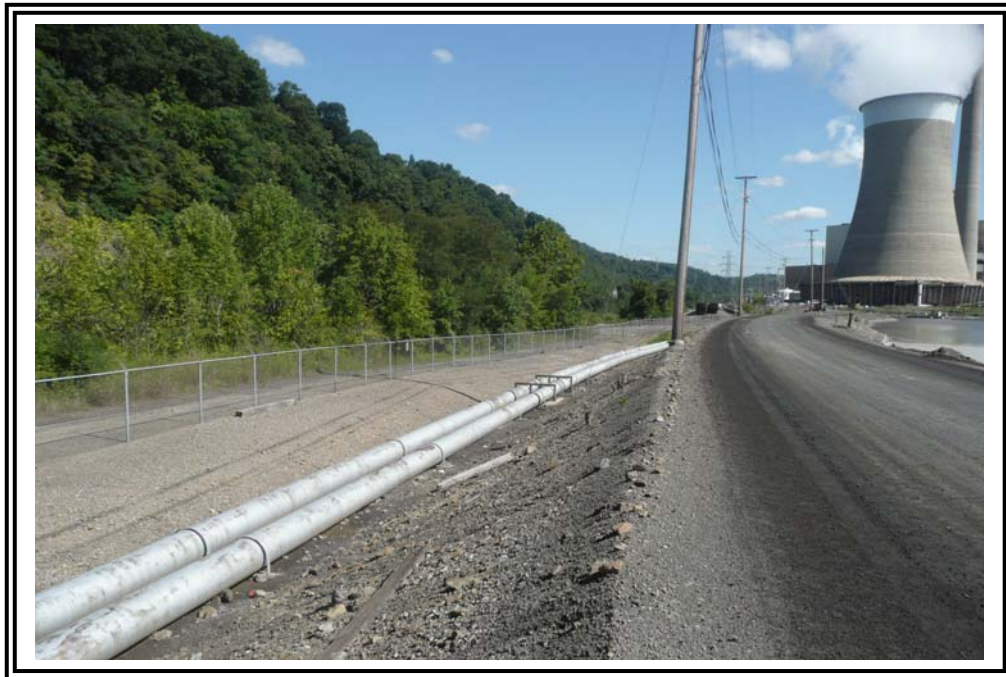
14

Downstream slope and crest of west dike, looking north.

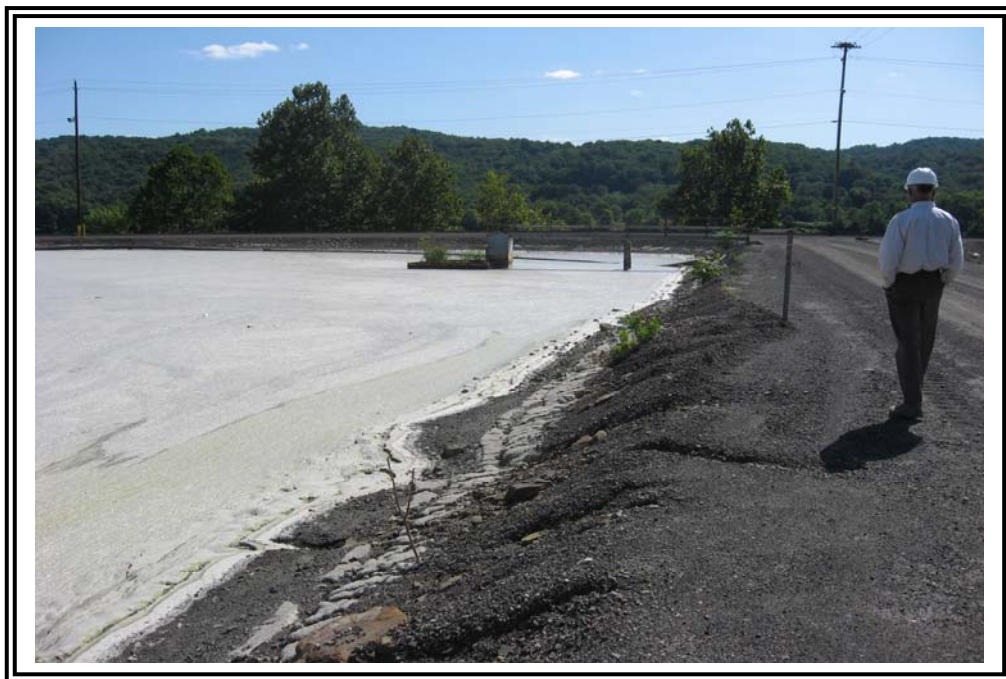
The separator dike has a general granular surface and is sparsely vegetated in similar fashion to the west dike as shown in Photos 16 and 34. Erosion features typical of the west dike are evident on this dike which is also about 10 feet wider at the crest than shown in the original site drawings (total measured width of approximately 31 feet). No unusual slumps or bulges were observed in the upstream or downstream slope.

Upstream slope of separator dike, looking east. Sparse vegetation and erosion rills evident.

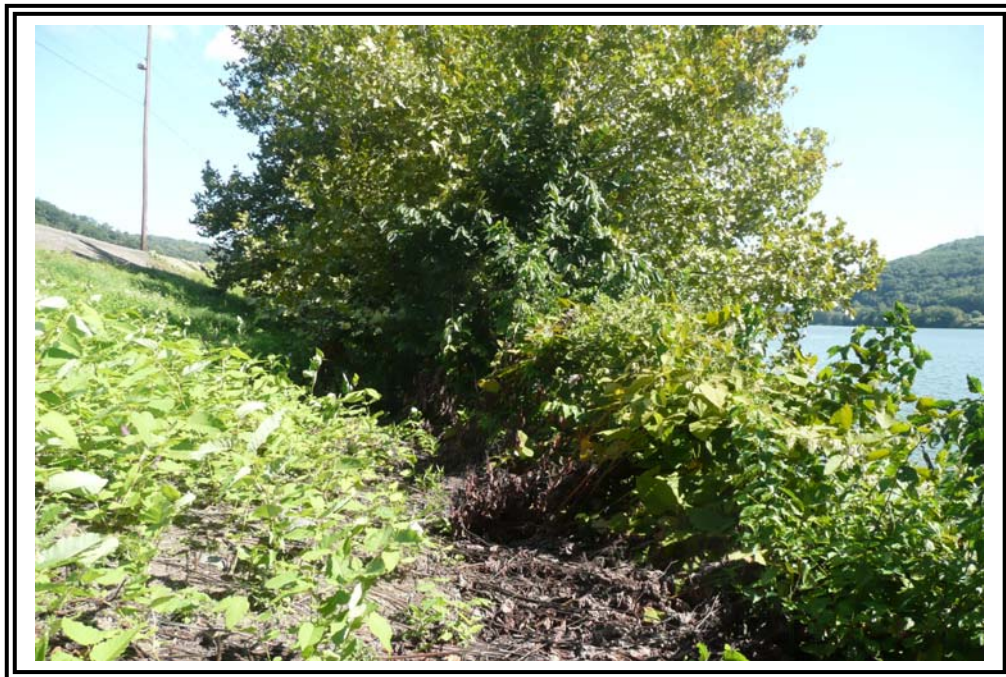
24

Downstream toe of east dike showing change in vegetation at slope toe-river bank contact.

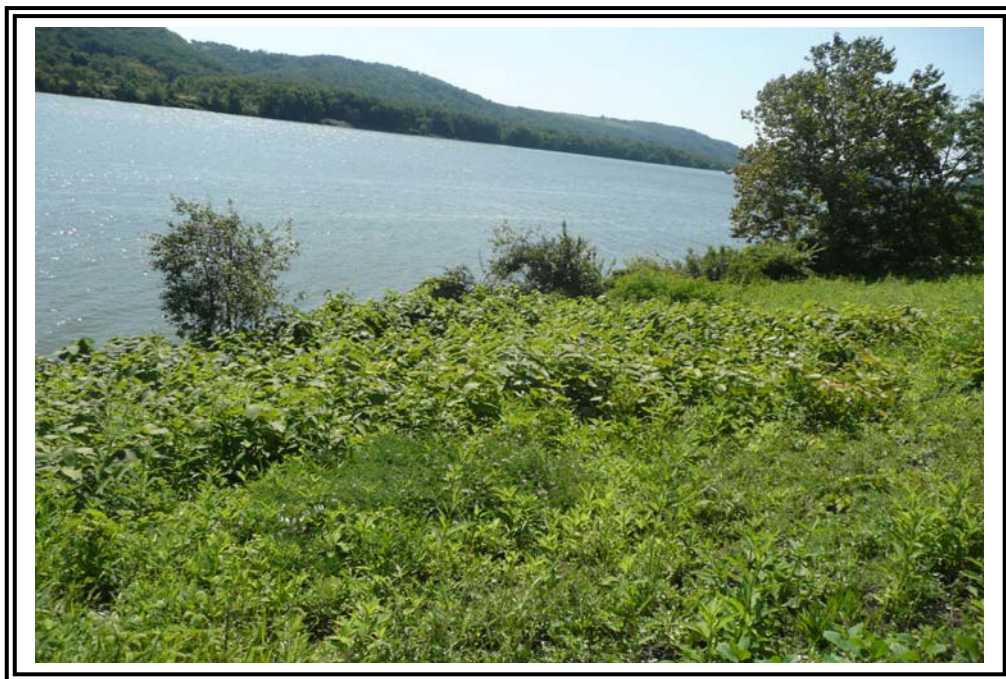
28

Closer view of change to leafy vegetation at river bank. Soils were firm and dry to touch in this area.

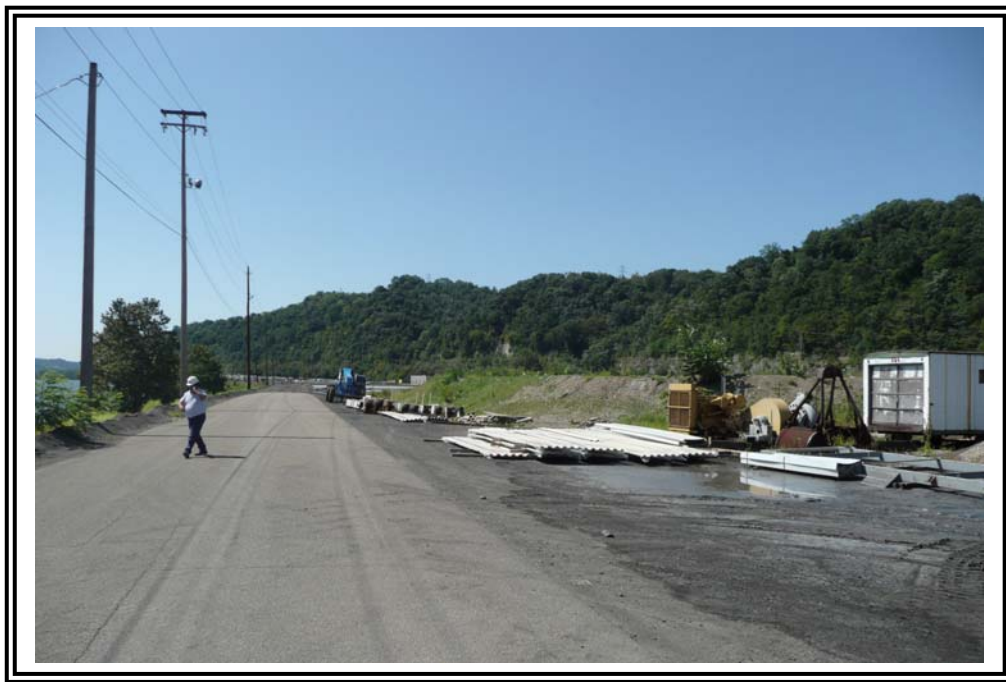
32

East dike crest alignment and portion of interior dike, looking south.

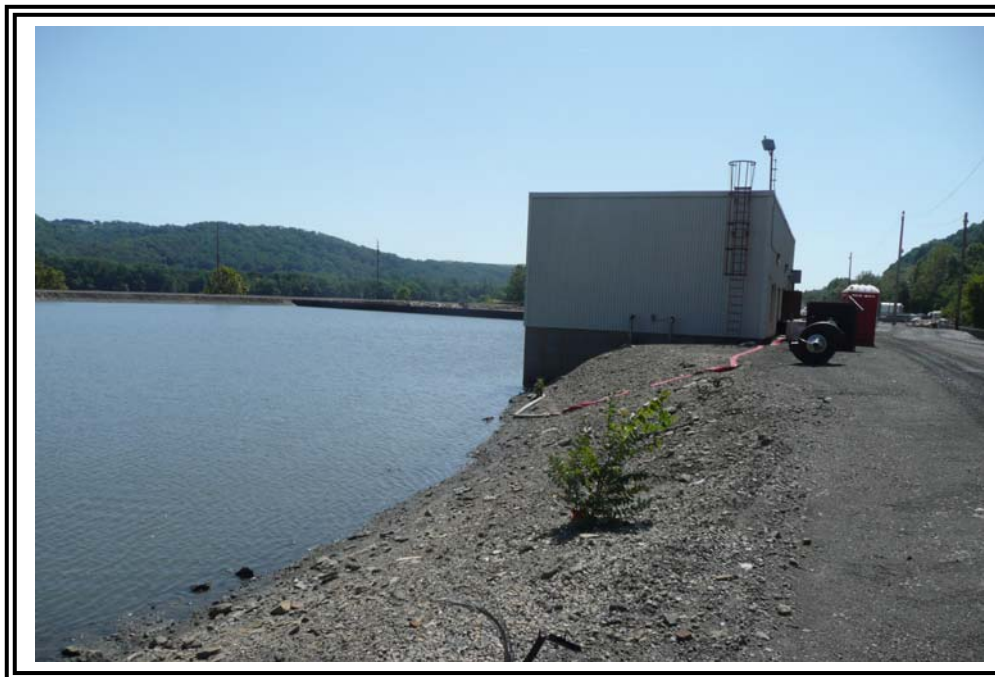
36

Upstream slope and crest on west dike adjacent to pump house, looking south.
Slope is fairly gentle but steepens adjacent to pump house.

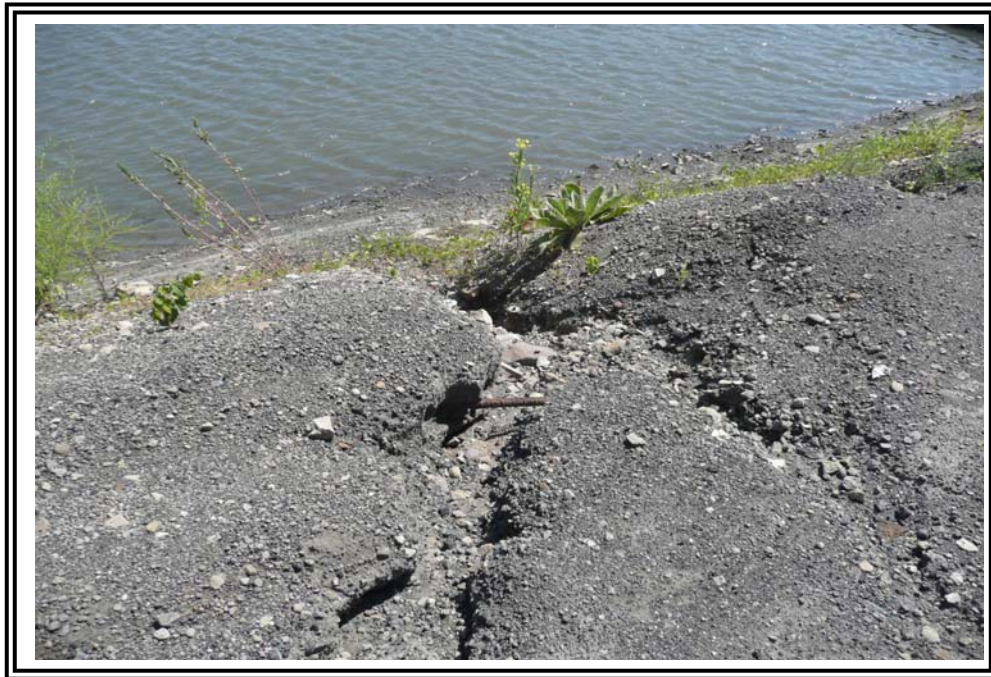
38

Closer look at erosion feature in Photo #36. Note exposed rebar debris in erosion gully.

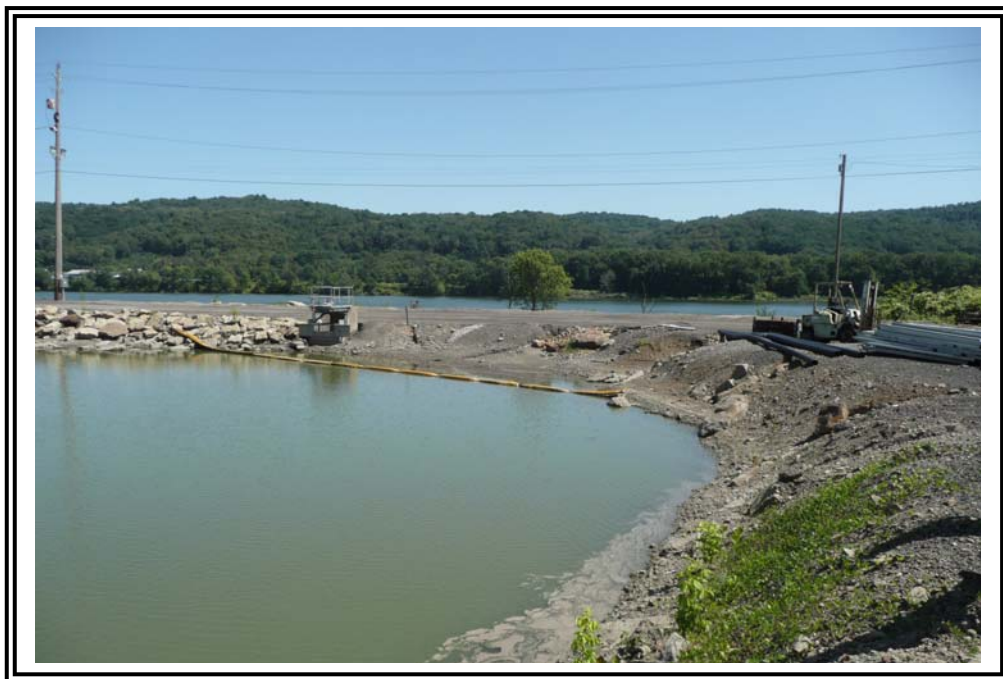
The crest area of the east dike does not show indications of abrupt changes in horizontal alignment and the slope areas show no obvious signs of slope instability such as scarps or sloughs. Little to no vegetation cover was observed on the upstream face and large slope protection stone has been placed on the slope face in areas adjacent to the outfall. Minor erosion features as a result of concentrated water flow could be observed on the upstream face on most of the dike. Photos 47, 48, and 42 show the typical conditions of the crest and upstream slope.

Looking east at upstream face of east dike. Note large armor stone adjacent to outlet structure and large erosion gullies adjacent to equipment at south wall - east dike interface.

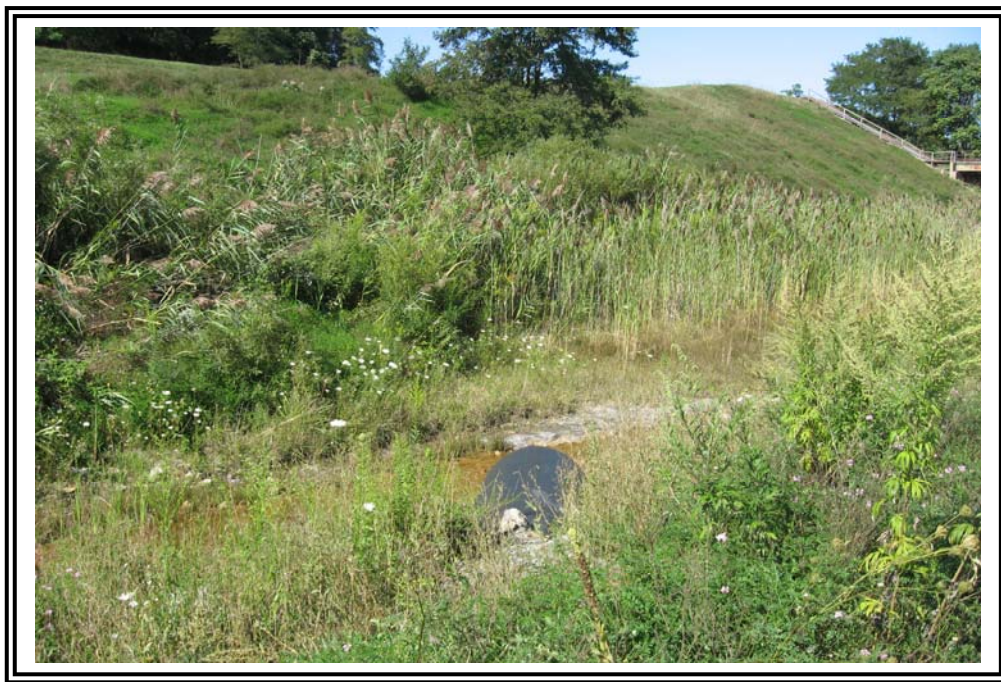
62

Storm runoff and site drainage outlet from landfill operation and old basin surface to emergency spillway.

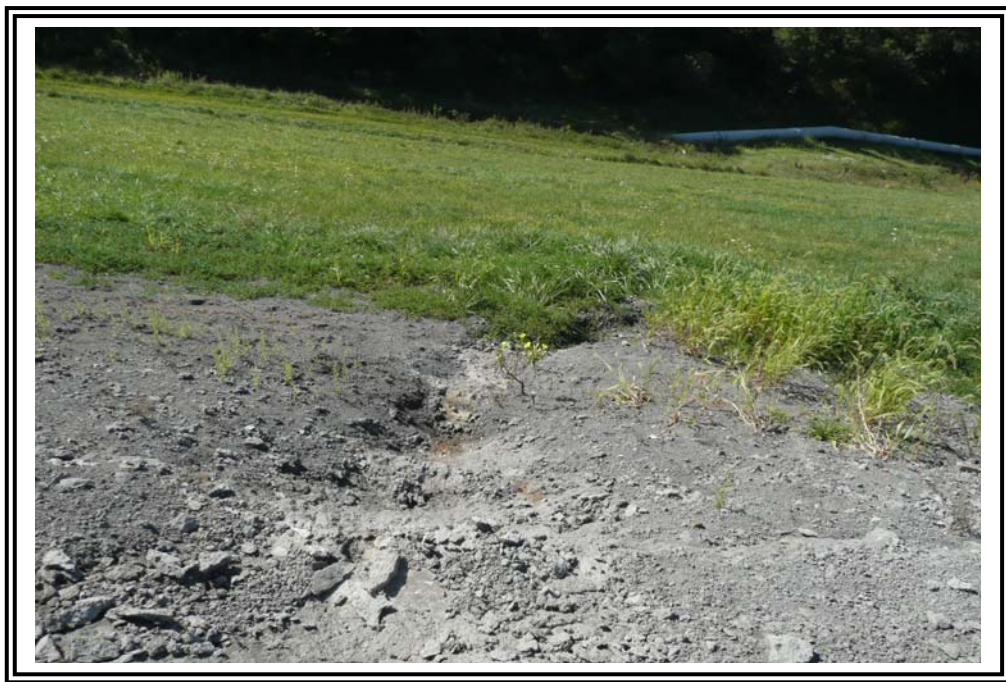
72

Weathering effects were also observed in the roller compacted concrete surface during the site assessment. These occurred in the form of edge spalling and isolated erosion (Photos 69 and 72) in the outer surfaces of the material.

Example of weathering and erosion in RCC material.

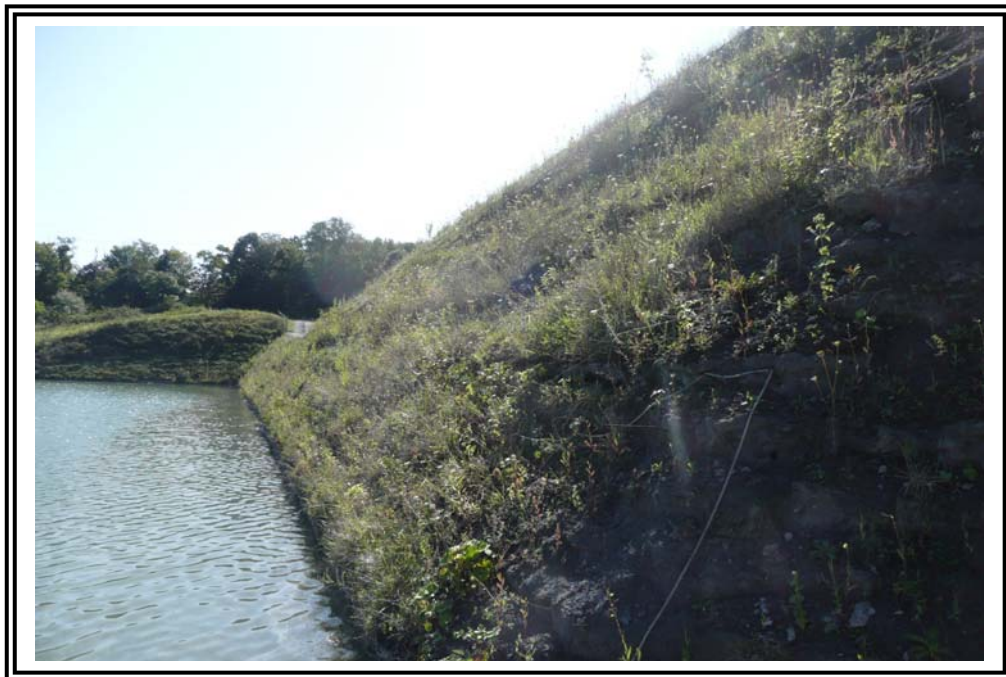
The upstream slope of the roller compacted concrete (RCC) crest is fairly steep and generally appears to be in good condition. Sparse vegetation has slowly started to establish itself (Photos 76 and 77). Due to the nature of the upstream slope, only a limited portion could be directly viewed during the site visit.

Upstream slope looking east from spillway.

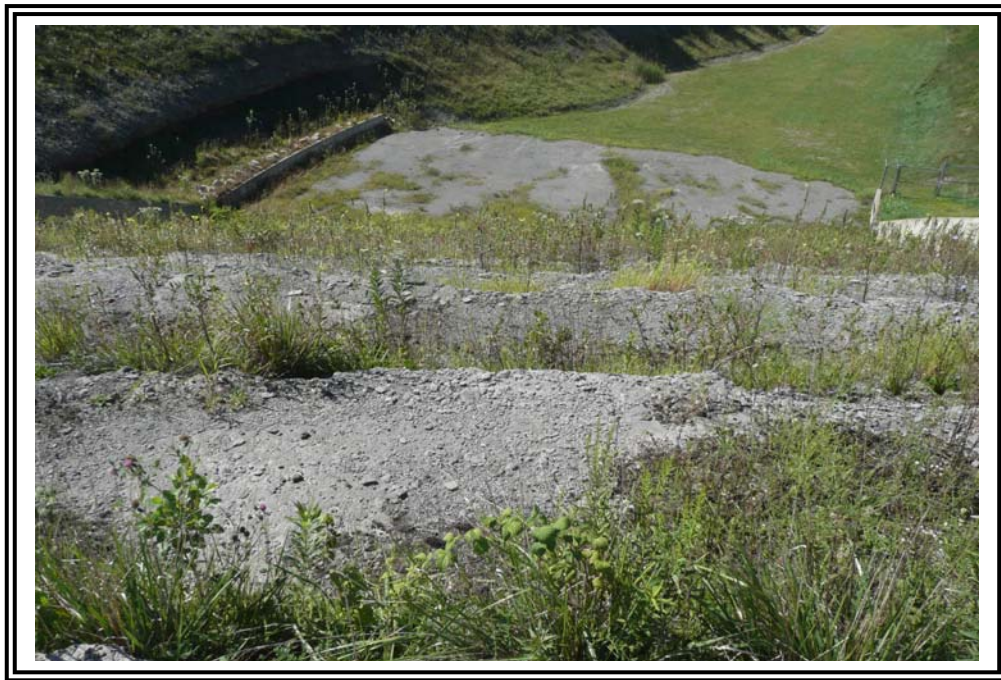
80

Close-up view of emergency spillway showing RCC steps for energy dissipation, vegetation, and weathering.

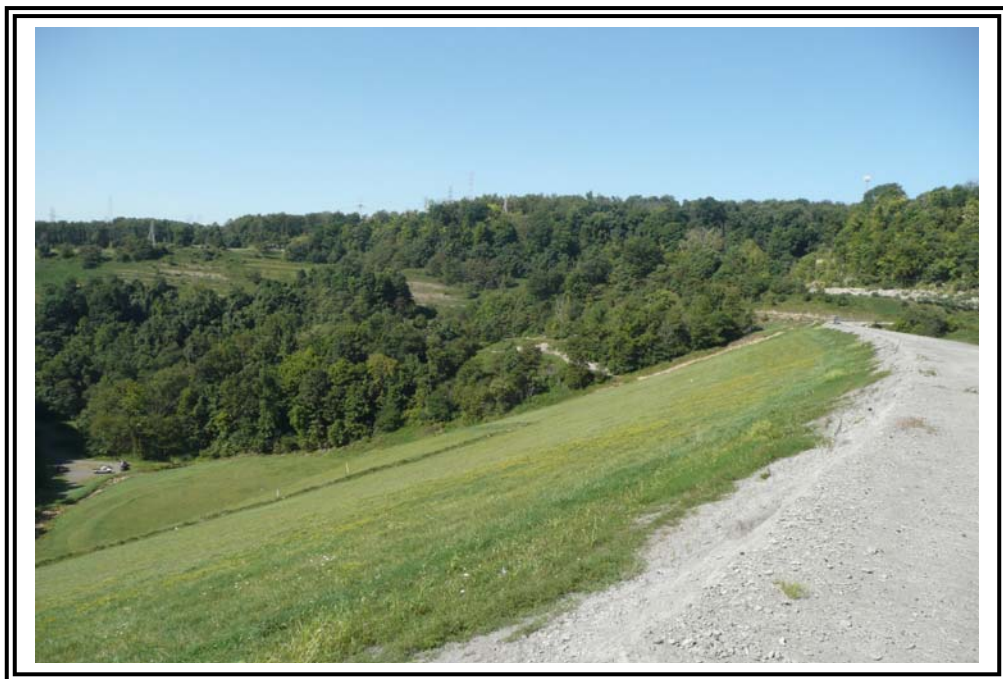
84

Overall downstream slope showing lower benches looking west from crest adjacent to spillway.

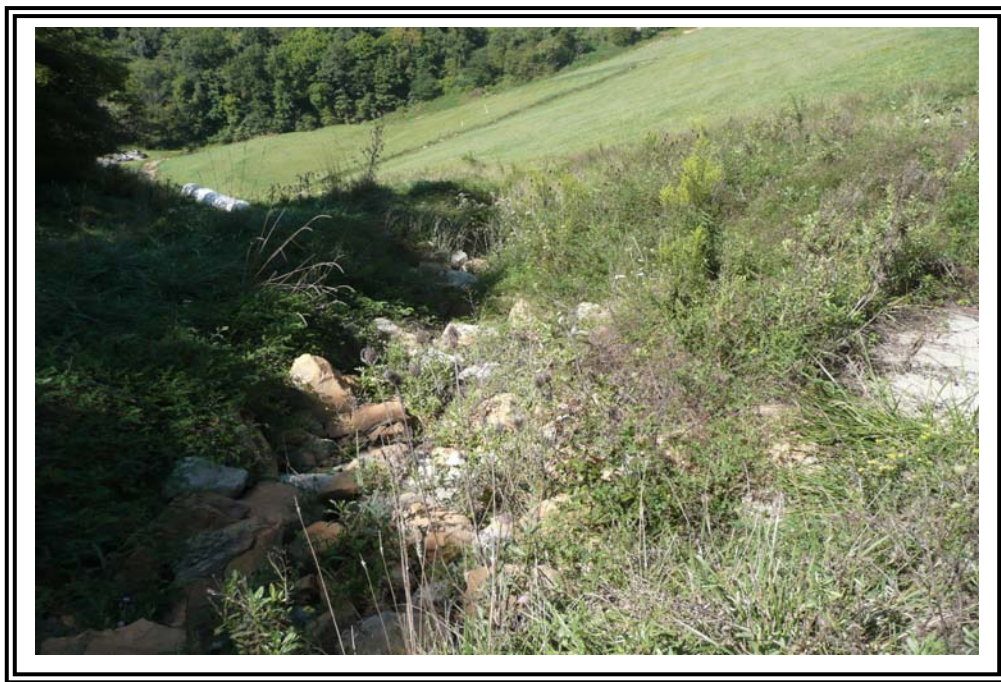
86

Closer view of rock groin at east abutment where spillway outlet transitions to welded steel pipe.

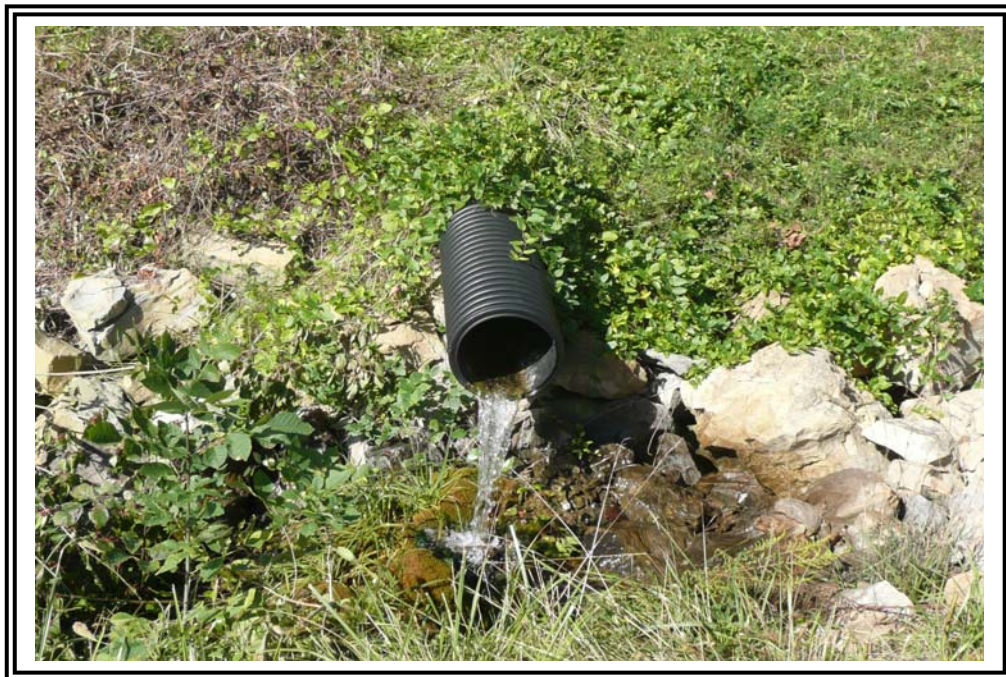
88

Active outlet from 12" pipe into west abutment rock groin from trench drain in natural hillside. Appears to supply most of the water flowing in the groin below about elevation 900.

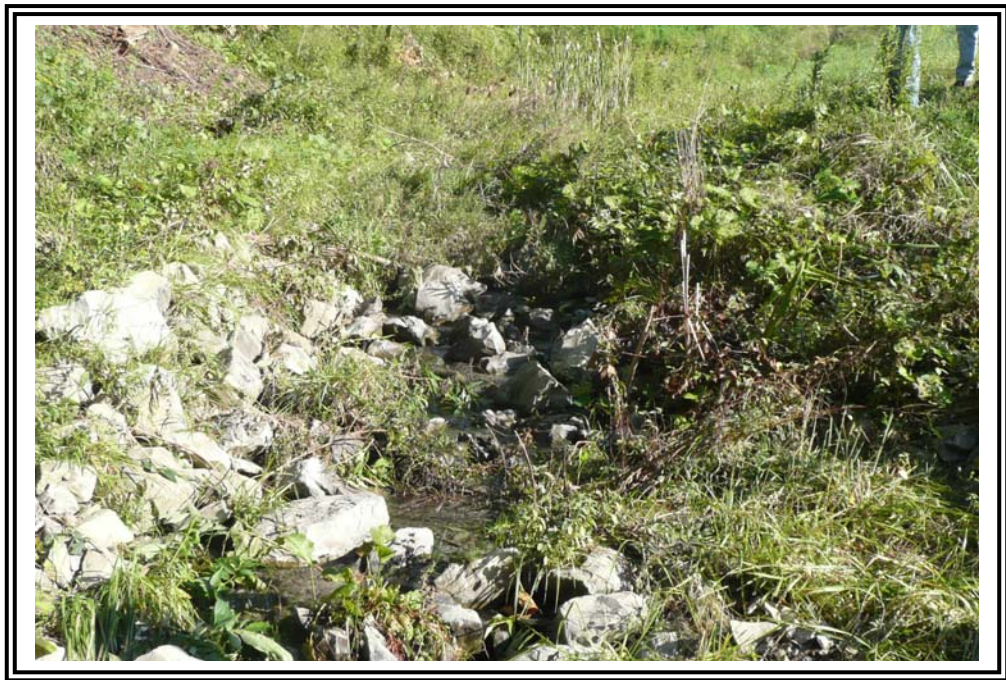
90

Water in right (west) groin adjacent to lower benches flowing toward toe drain.

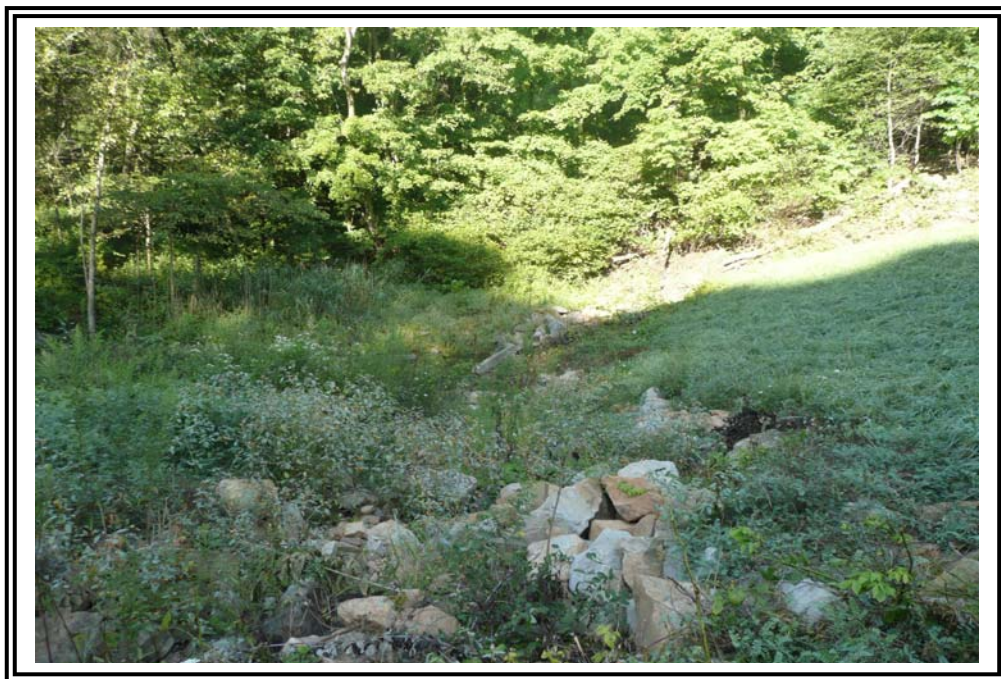
92

The toe drain is armored with 18-inch diameter rip rap, roughly 5 to 6 vertical feet of which is exposed at the slope toe (Photo 92). This toe terminates in a collection pool where additional drainage pipes actively convey water to the pool (Photos 93 and 94) which in turn empties into a

Looking west at rock toe and seepage pool in background. Note rip rap placement and vegetation.

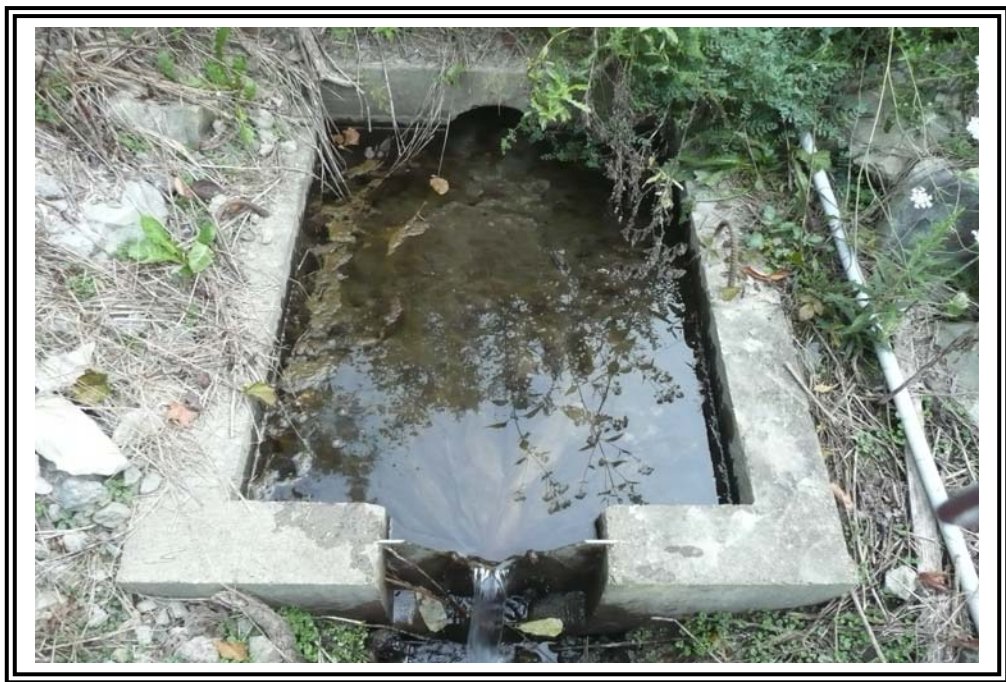
98

V-notch weir at original (Pre RCC) toe drain.

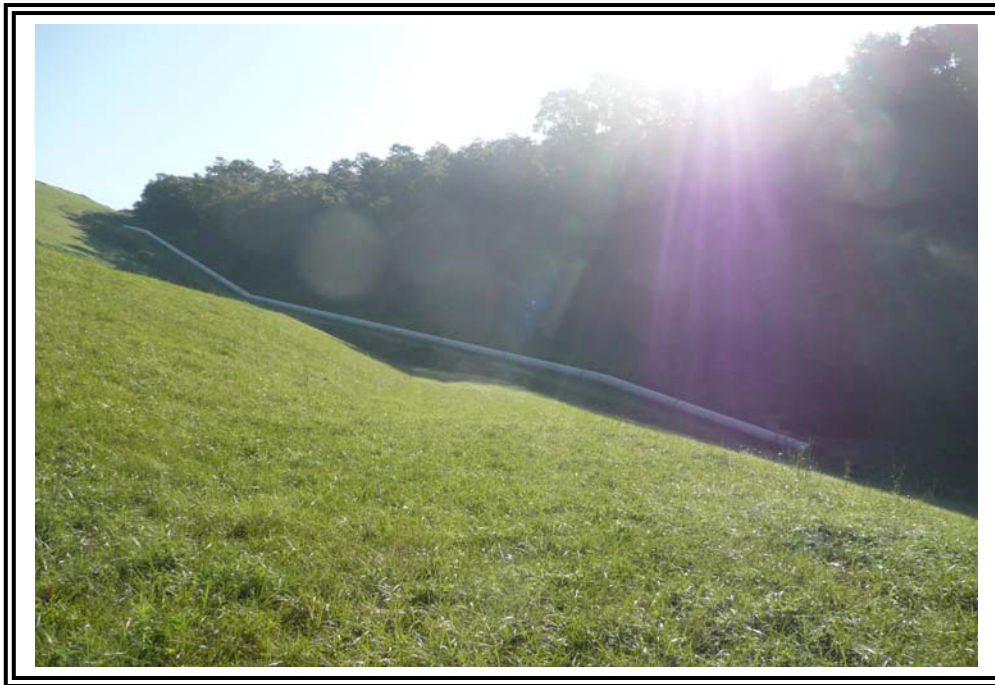
99

Downstream slope looking east on lower bench.

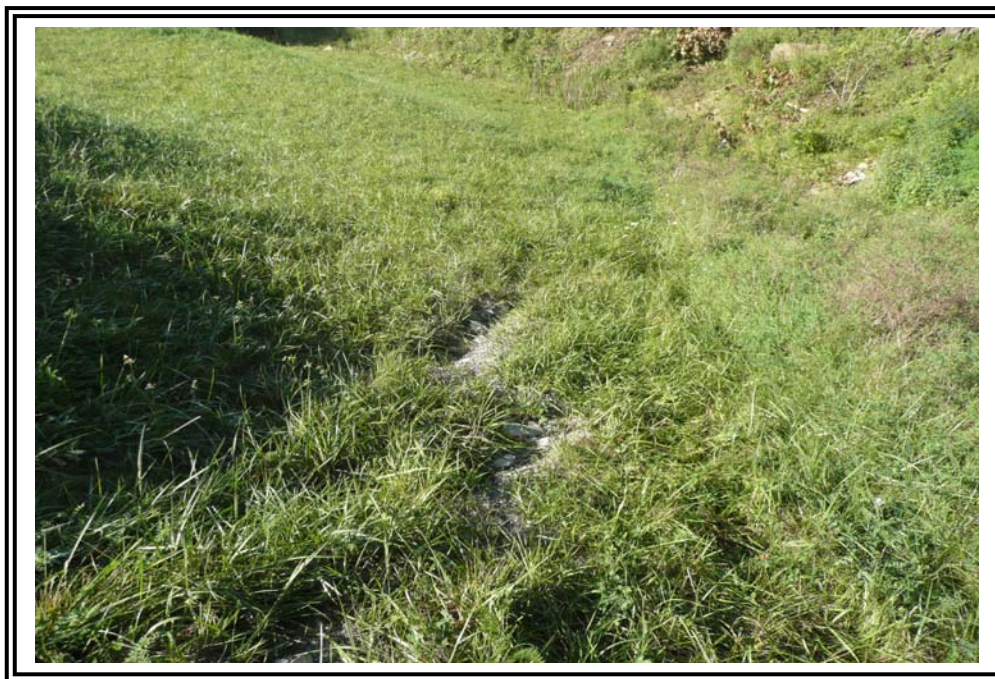
100

Erosion feature on downstream slope next to west groin at upper bench.

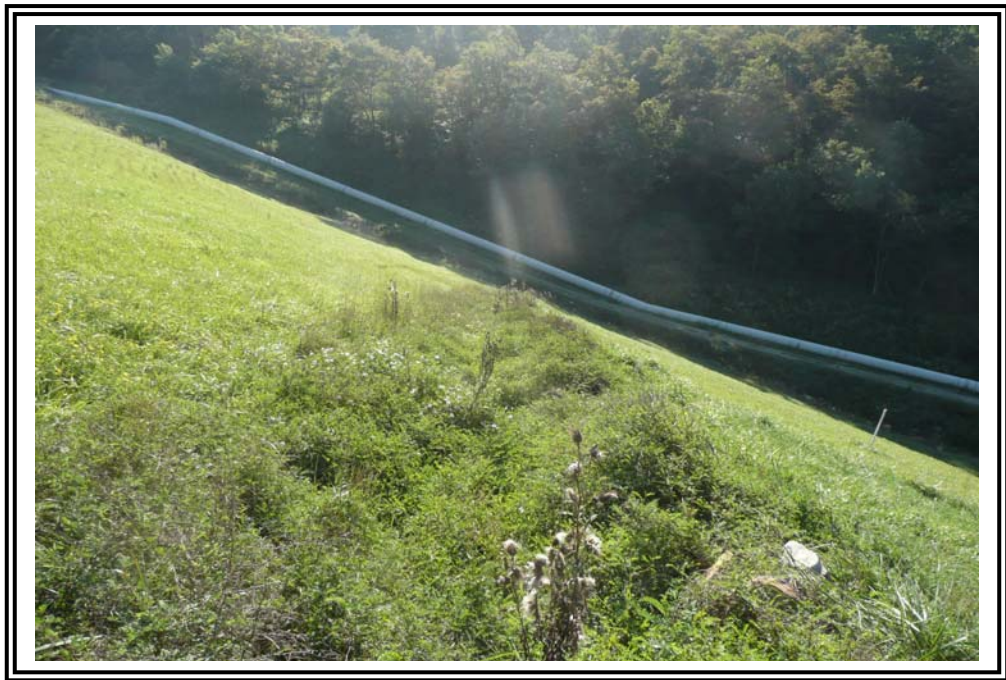
104

Looking east at slope drainage groin. Vegetation obscures rip rap.

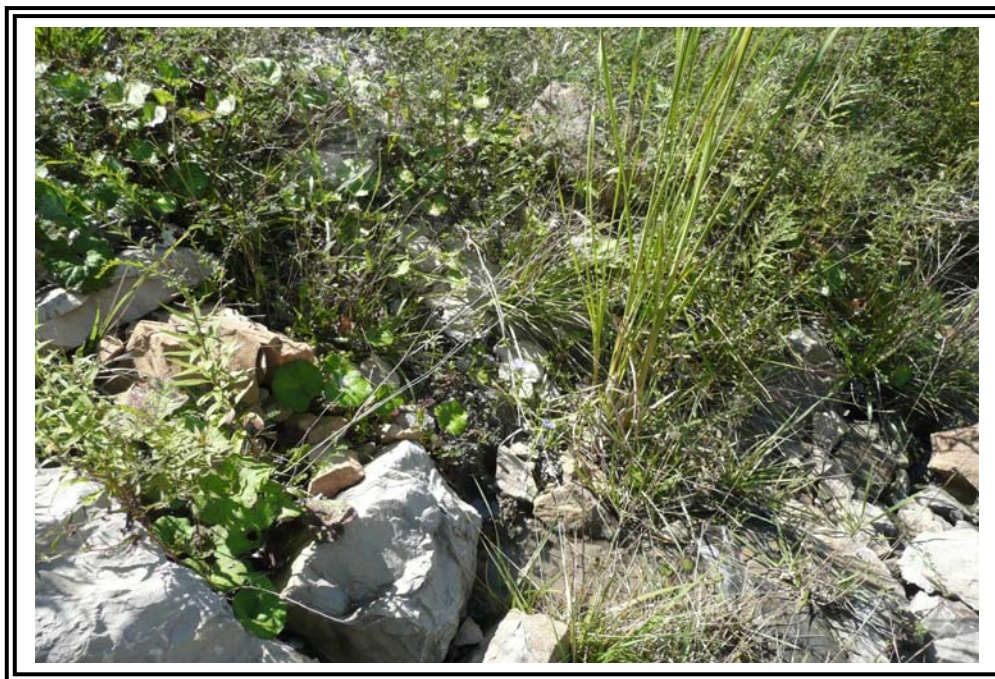
106

Area of small seep in left (east) abutment groin at approximate intersection with slope groin.

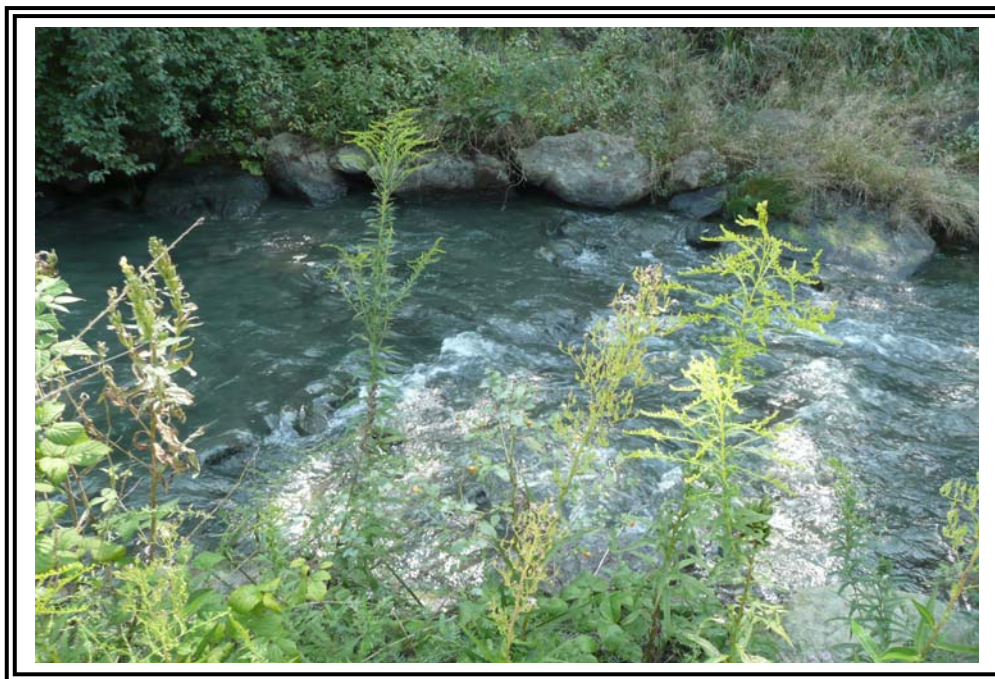
108

Downstream outfall creek channel.
