# Assessment of Dam Safety

## Coal Combustion Surface Impoundments (Task 3)

American Electric Power

Conesville  
Generating Station

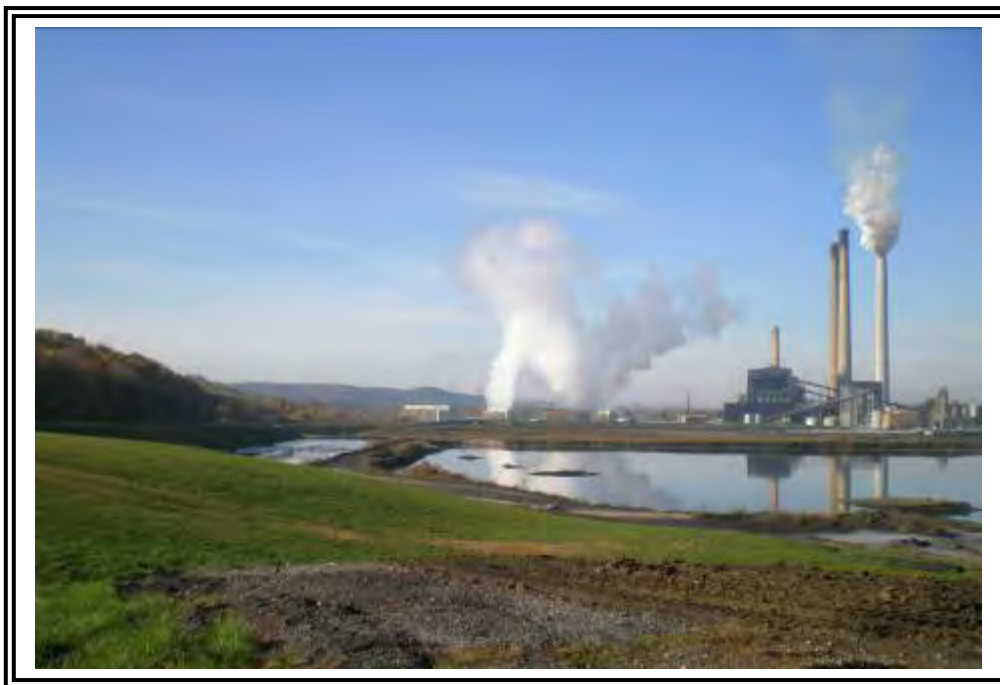
2

Looking southwest across the Ash Pond Complex.

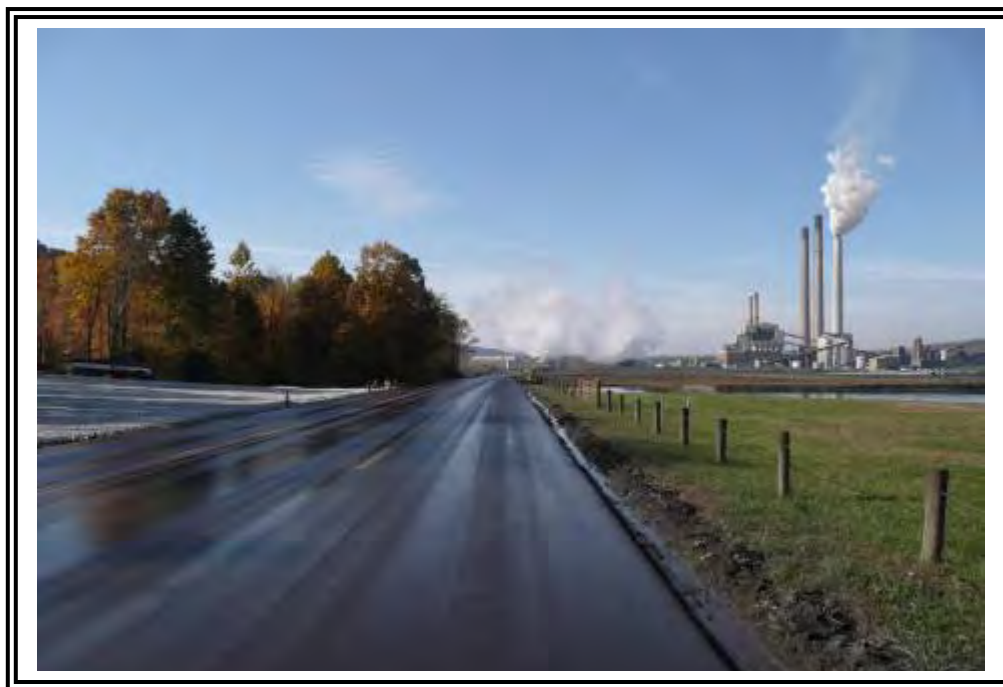
In general, the alignment of the Coal Haul Road and Secondary Dike crests do not show signs of change in horizontal alignment. No evidence of prior releases, failures or patchwork was observed at the time of the site visit. Photo Nos. 15 and 16 show the general condition of the dike crest.

Looking southwest along the Coal Haul Road. Road is wet to keep the dust from trucks down.

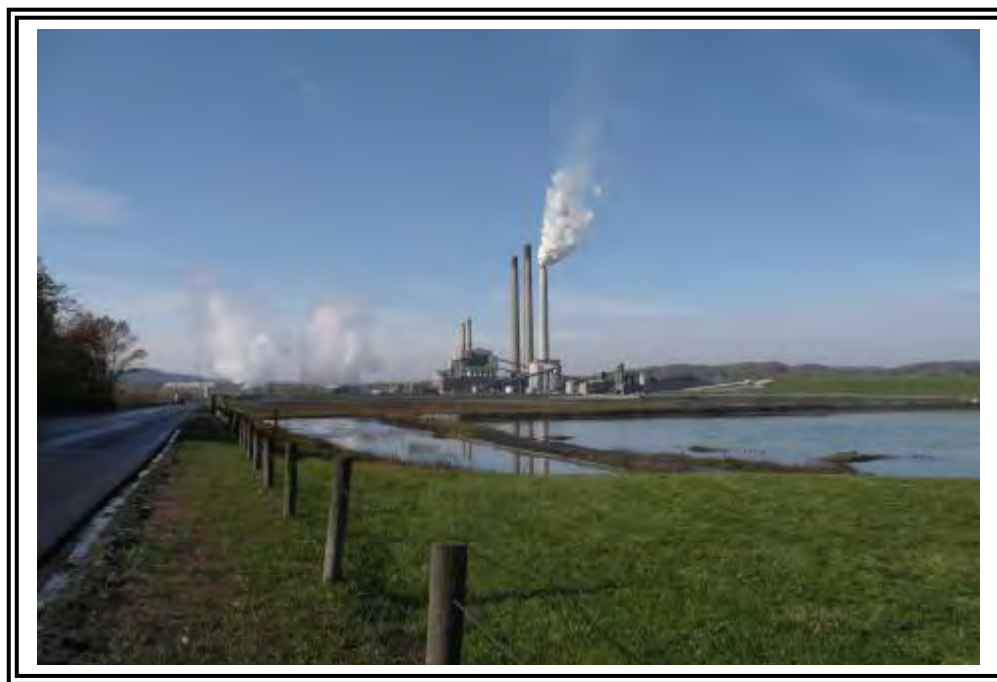
16

Looking southwest along the northeast crest and upstream slope of the Coal Haul Road Dike.

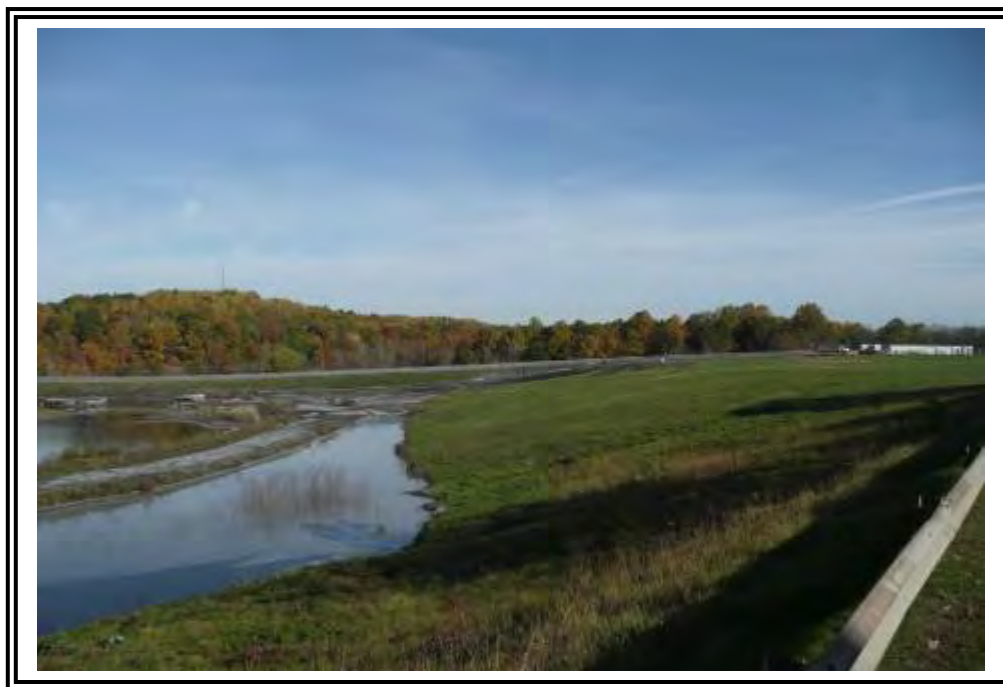
17

Looking northeast along upstream slope of the Coal Haul Road Dike.

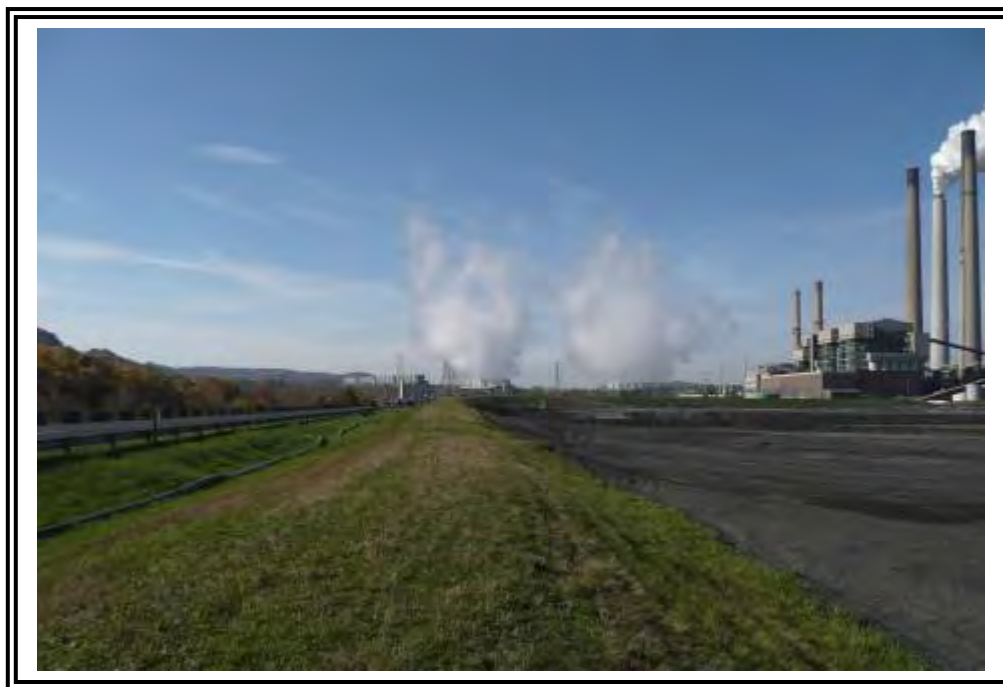
19

The upstream slope along the Fly Ash Pond created by the Coal Haul Road and Secondary Dikes, was relatively uniform and covered with appropriate grass cover. Photos 16 through 18 shows the general condition of the upstream slope in this area. The crest and upstream slope of the Secondary Dike adjacent to the Clearwater Pond is reasonably uniform as shown in Photo 19.

Looking southwest along the crest of the Coal Haul Road Dike where its alignment leaves the haul road and runs parallel to it.

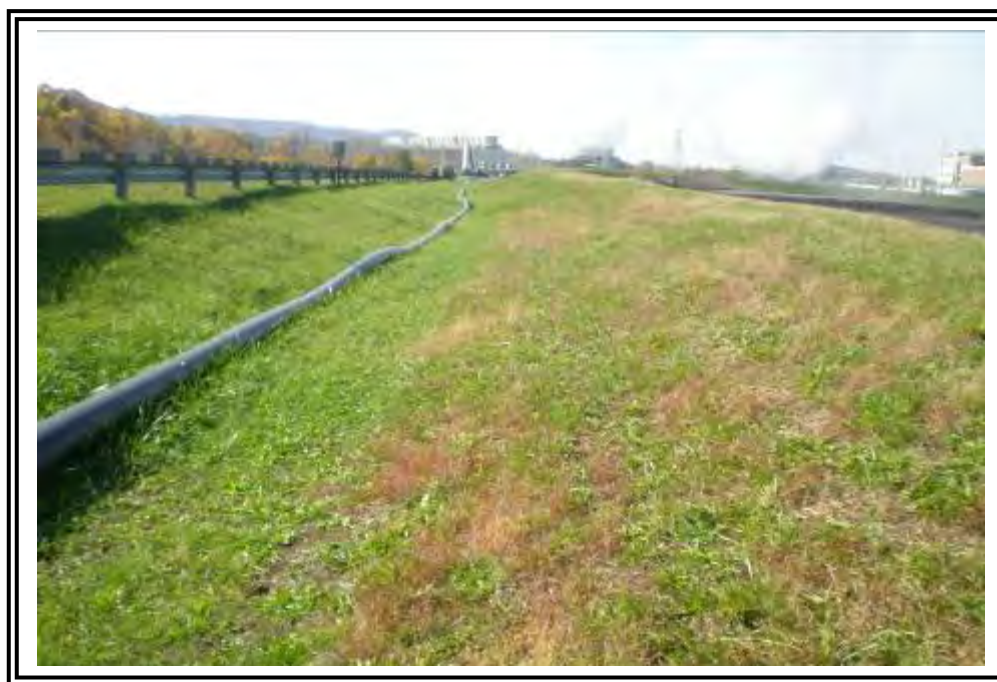
Photos 24 and 28 shows the downstream slope of the Secondary Dike adjacent to the Clearwater Pond was uniformly graded with appropriate grass cover. Photo 27 shows the upstream slope of the Secondary Dike adjacent to the Clearwater Pond. Isolated rutting and loss of the grass cover from mowing operations, as seen in Photo 29, were observed during the inspection.

Looking southwest along downstream slope of the dike where the dike runs parallel to the west of the coal haul road.

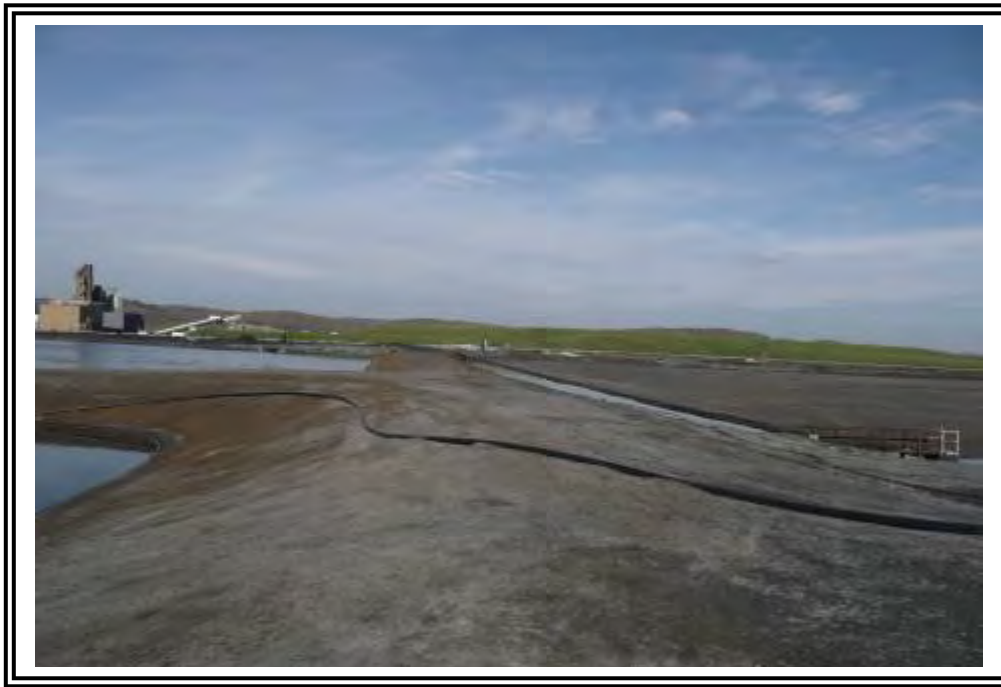
The crest of the splitter dikes appeared reasonably uniform as shown in Photos 25 and 32. Most of these splitter dikes were generally void of vegetation where activity in the pond area is ongoing or has been fairly recent. Less active areas, as noted in Photo 61, begin to support moderate weedy and small brushy vegetation. An approximately 1 to 3 foot difference in the water level on opposite sides of the splitter dikes was observed. No evidence of prior releases, failures or patchwork was observed at the time of the site visit

Looking northwest along crest of the splitter dike between the Fly Ash Pond to the north and the Bottom Ash Pond and Clearwater Pond to the south. The Fly Ash Pond outfall structure is on the right side of photo.

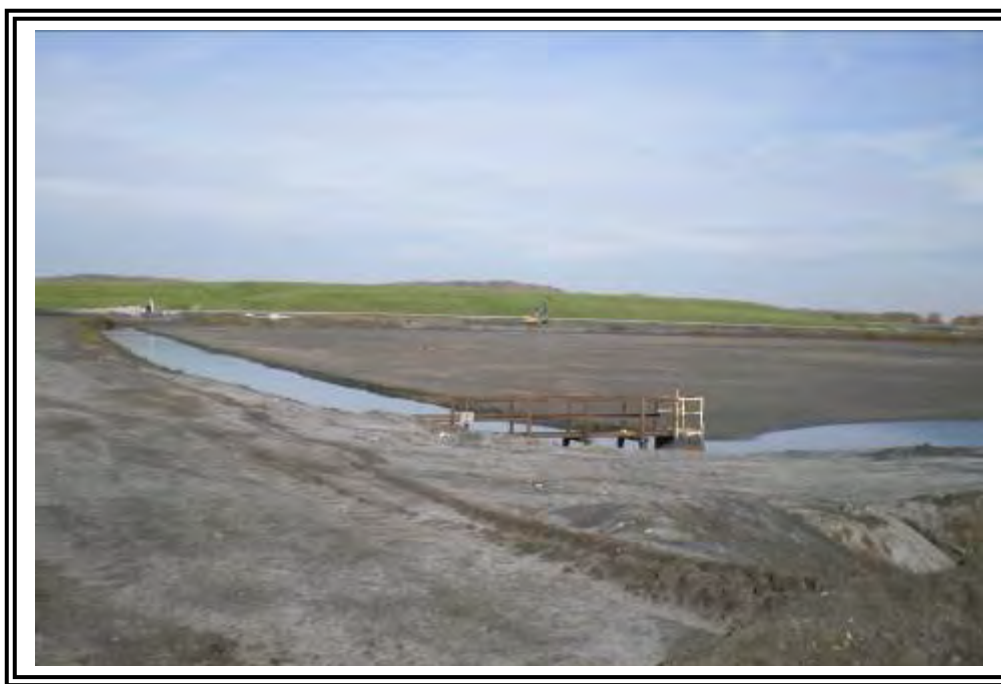
26

Close up of the Fly Ash Pond outfall structure.

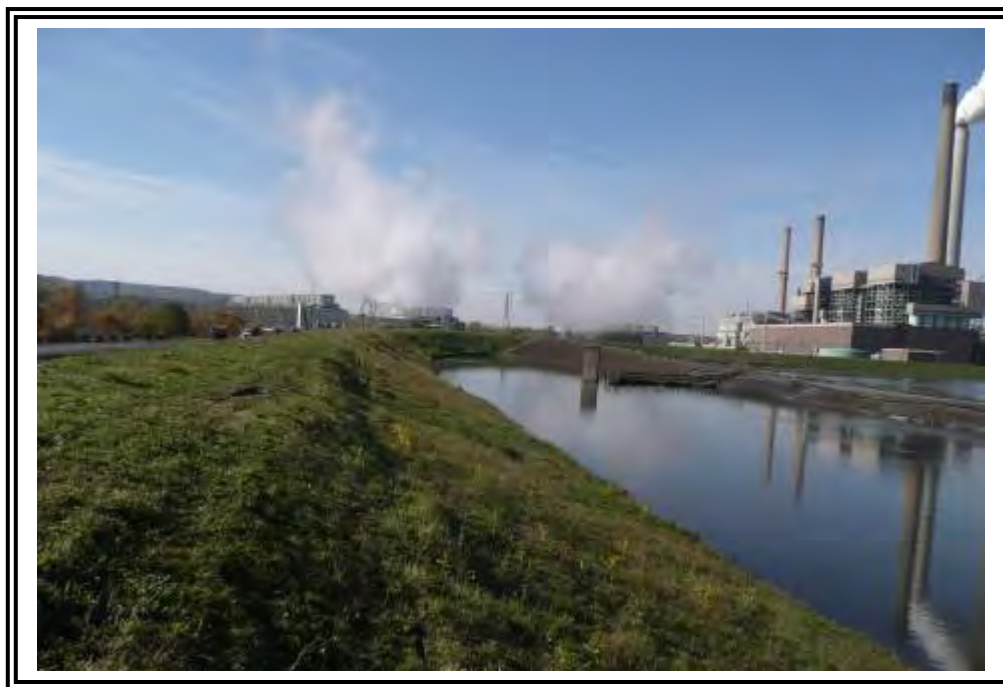
27

Looking southwest along upstream slope of the Coal Haul Road Dike adjacent to the Clearwater pond.

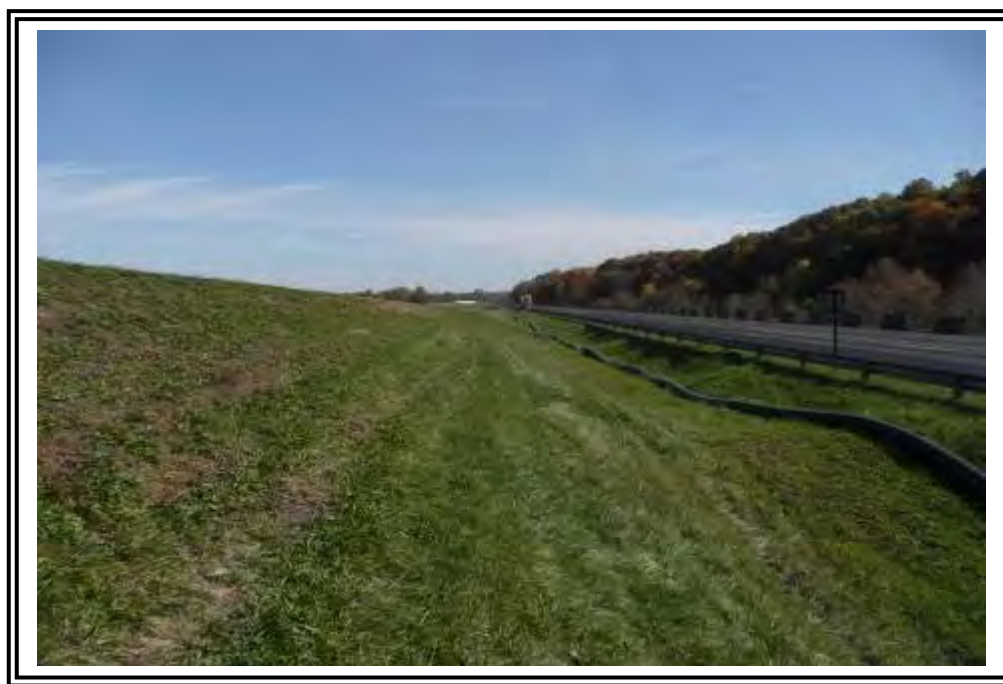
28

Looking northeast along the downstream slope of the Coal Haul Road Dike adjacent to the Clearwater Pond.

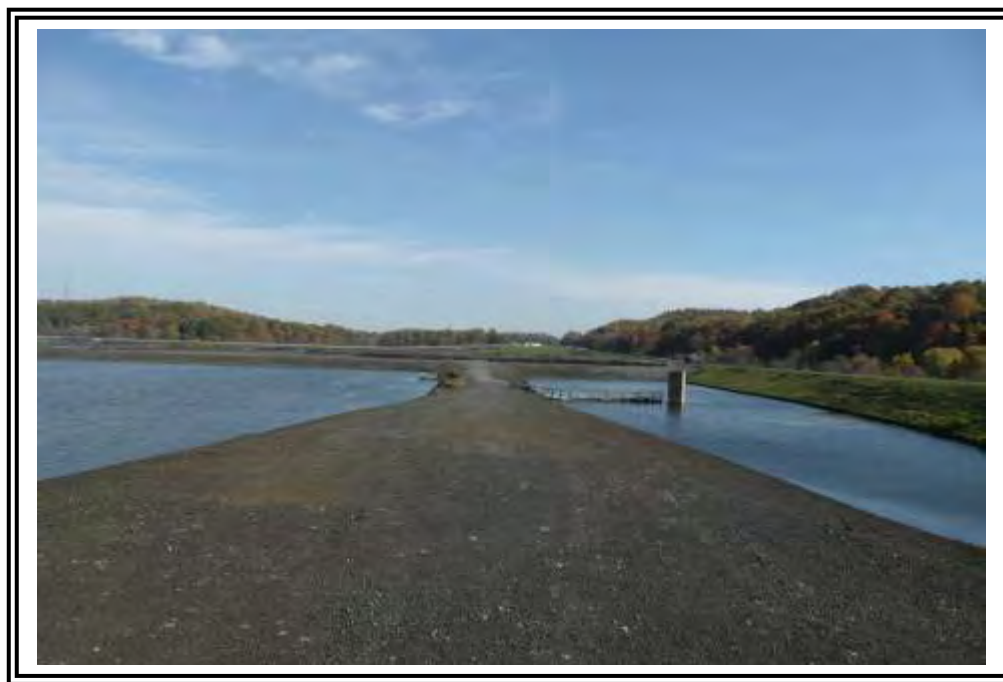
32

Looking northeast along crest of the splitter dike between the Bottom Ash Pond (left) and the Clearwater Pond (right).

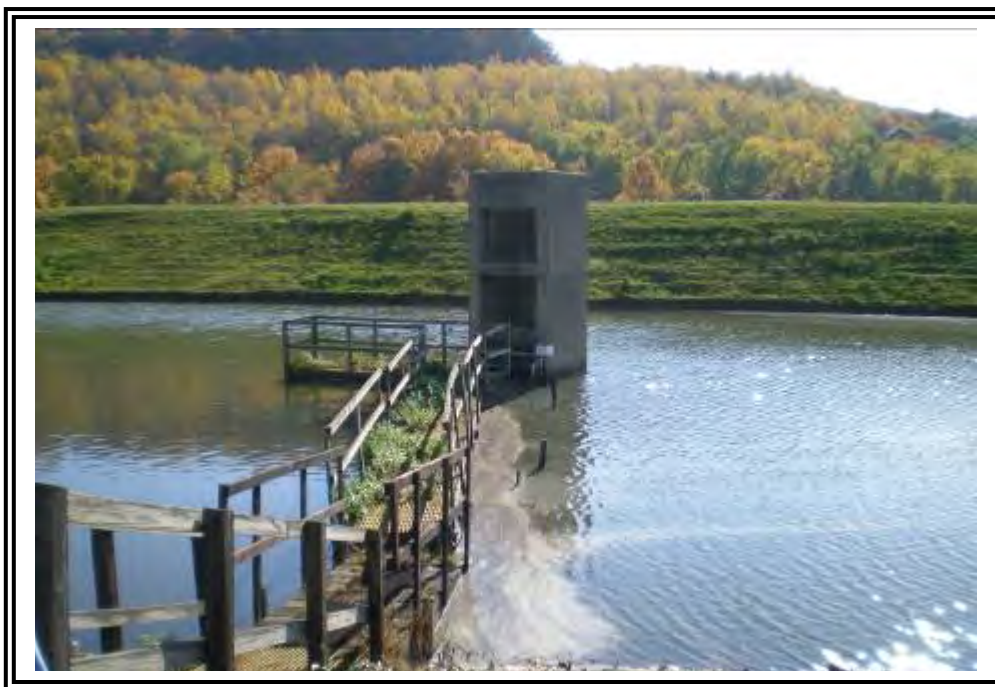
33

The Clearwater Pond outfall structure.

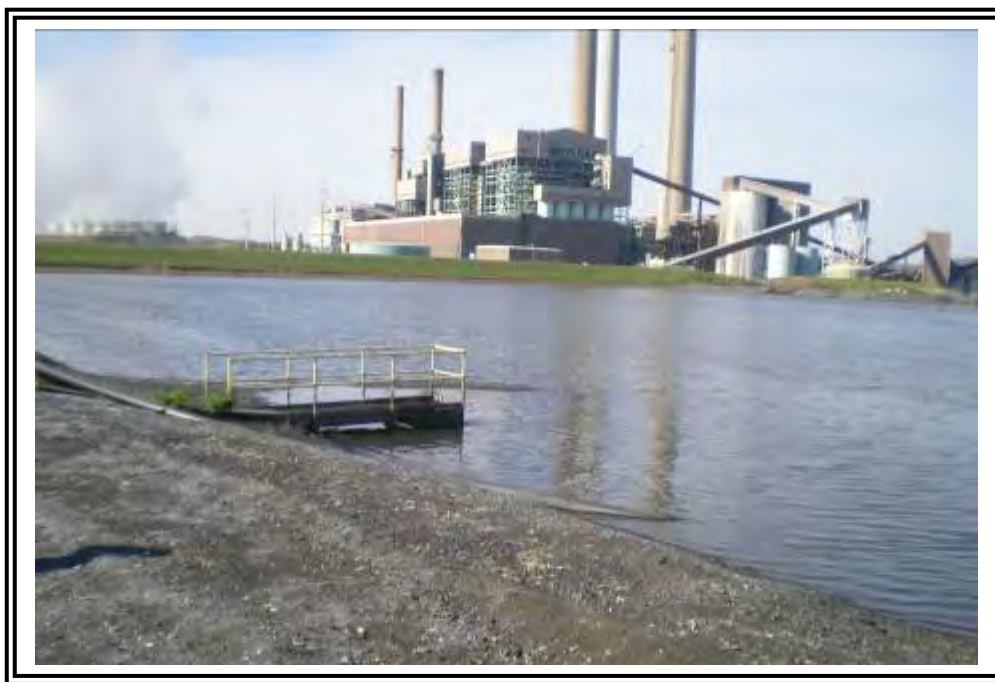
34

The Bottom Ash Pond outfall structure.

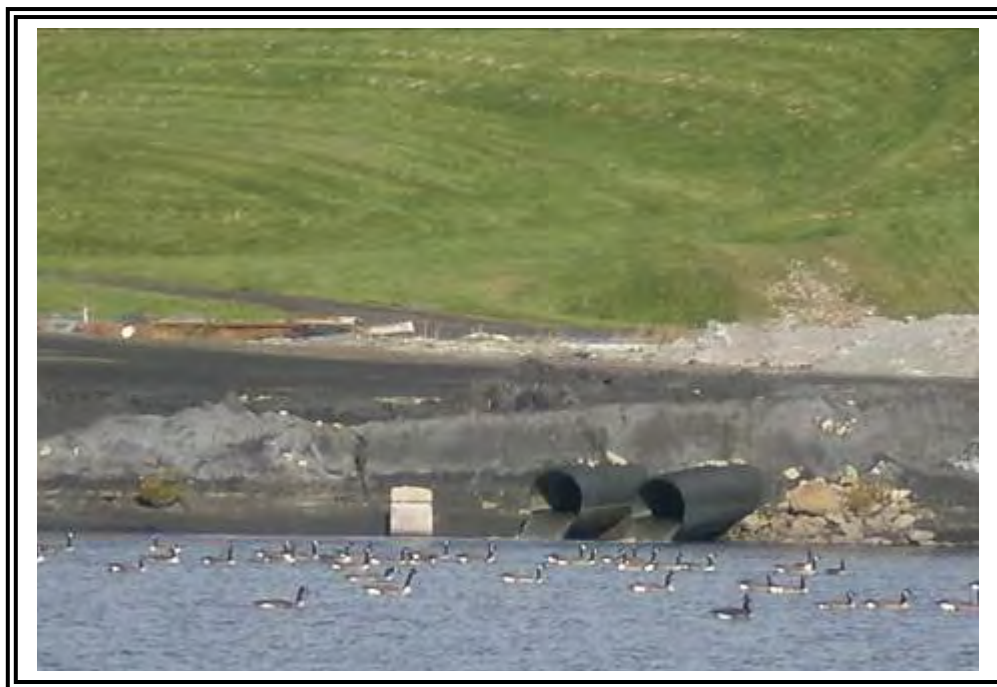
35

Looking across the bottom ash pond at sluice lines into the pond.

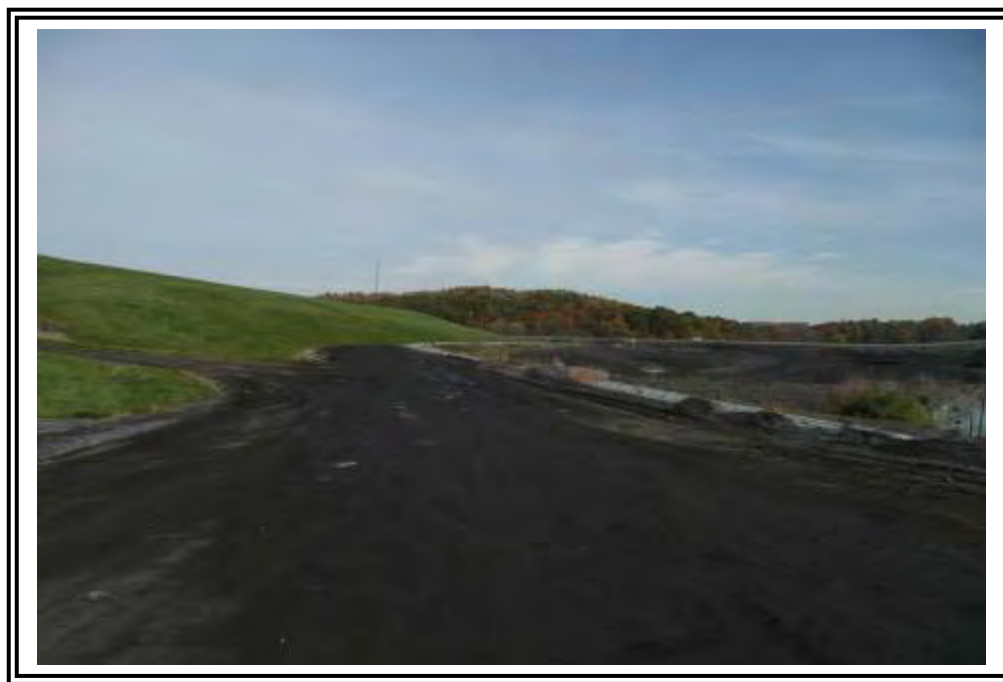
40

Looking northeast from the northwest end of the Southwest Dike along western side of the complex.  
The closed FGD area is to the left of the photo.

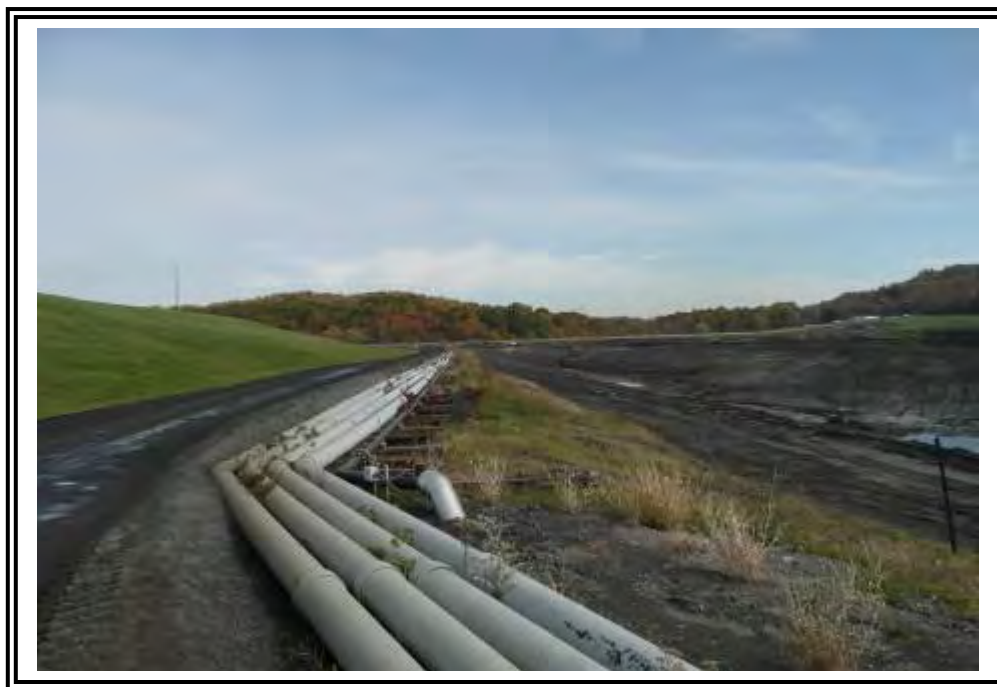
41

Sluice lines running to the Fly Ash Pond along the western side of the complex.

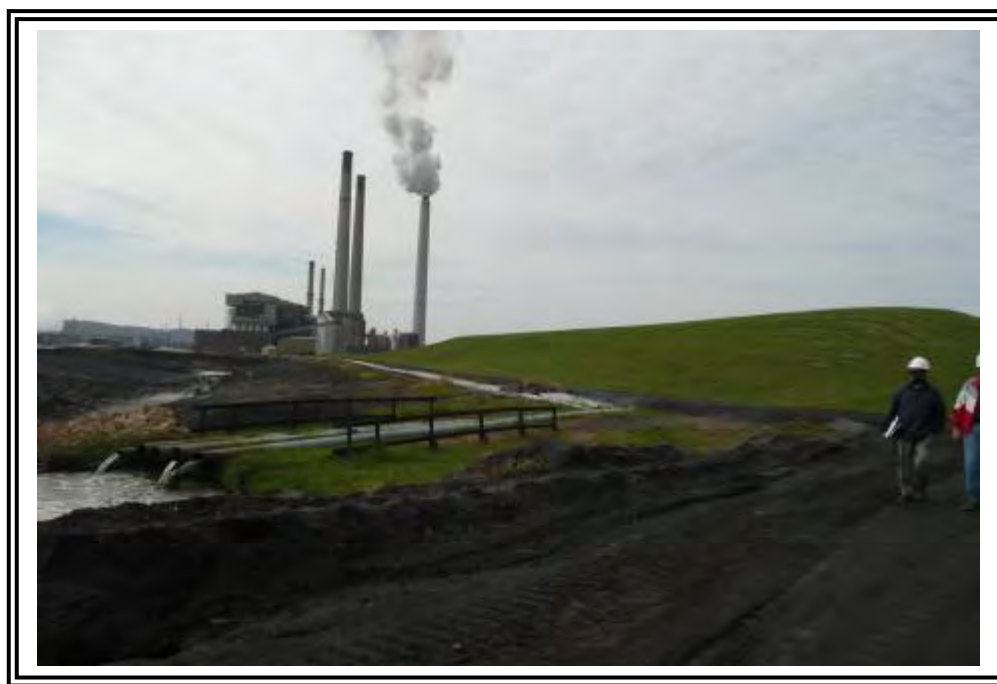
42

Sluice lines running into the Fly Ash Pond.

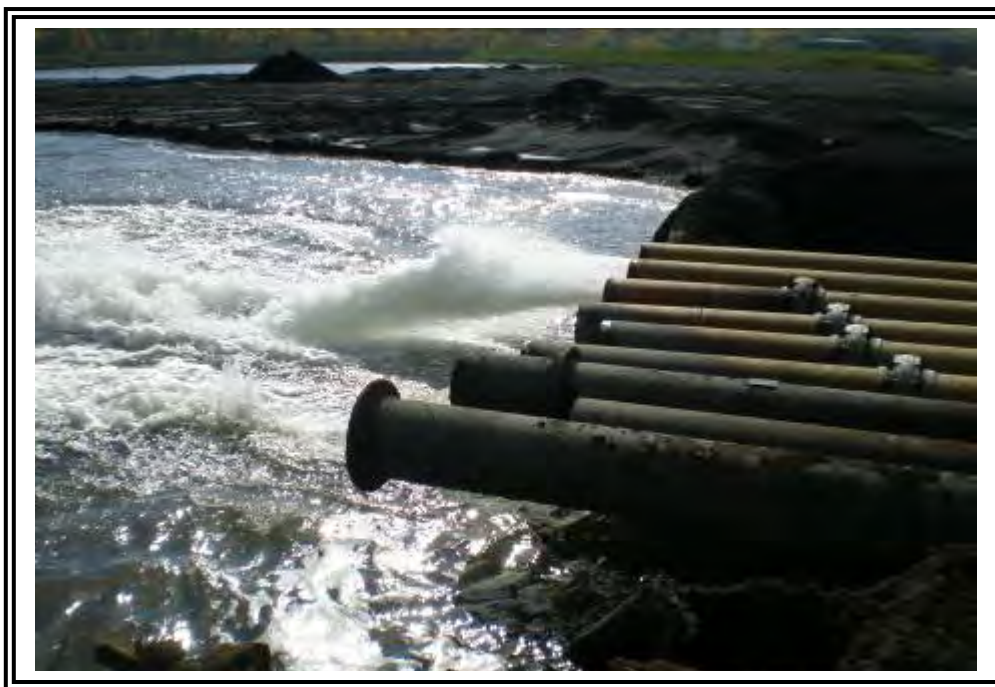
43

Close up of sluice lines running into the Fly Ash Pond.

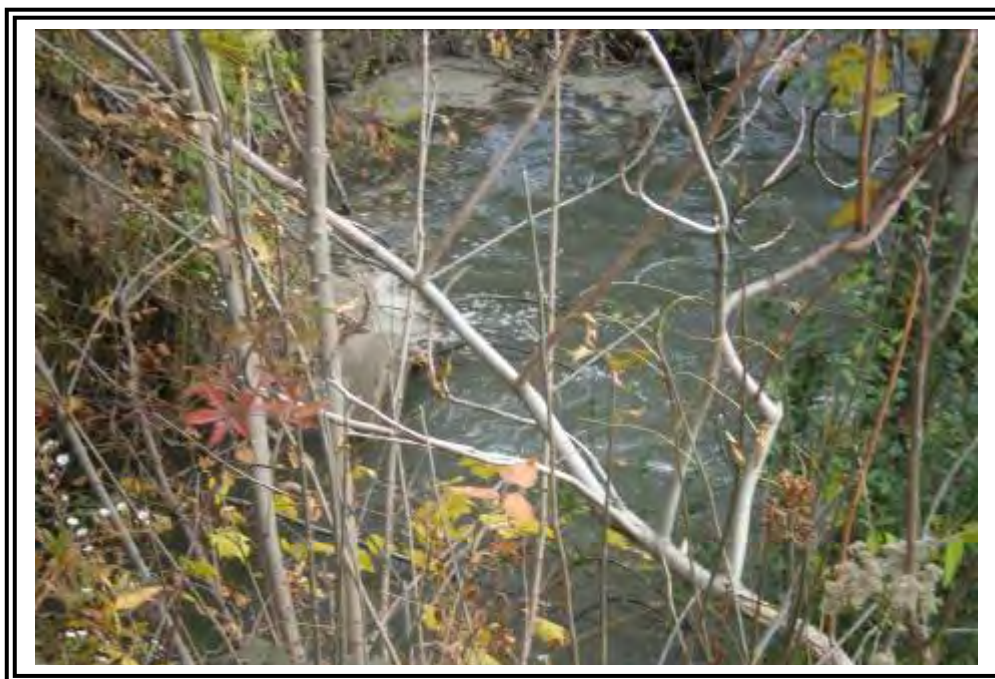
44

Outfall from Clearwater Pond into nearby creek. Heavy vegetation in this area

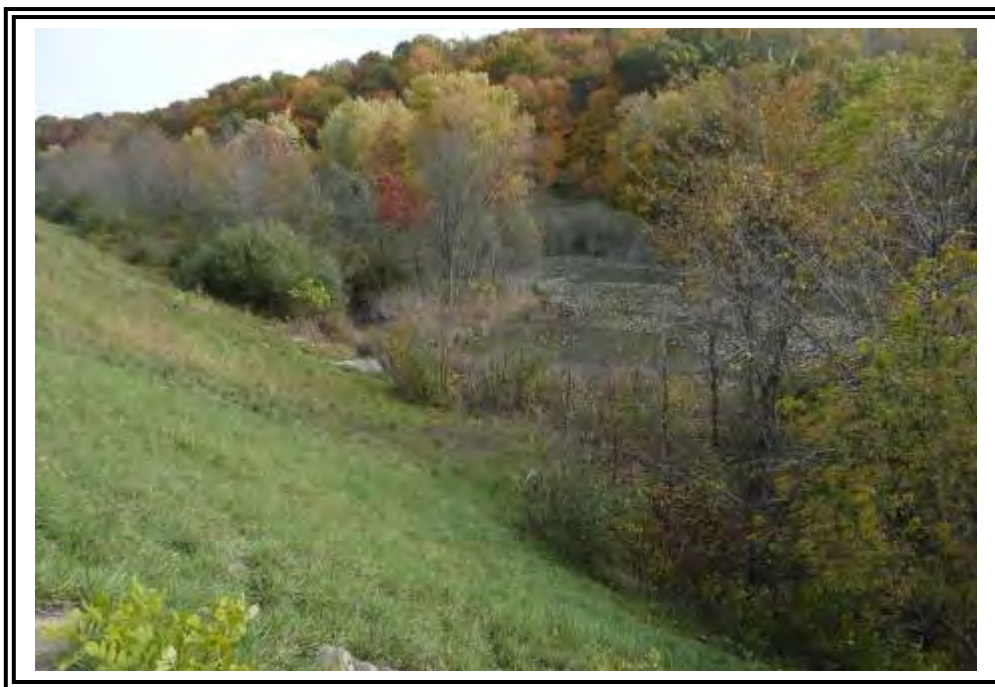
45

Looking northeast along downstream slope of the Coal Haul Road embankment near the Ash Pond Complex outfall.

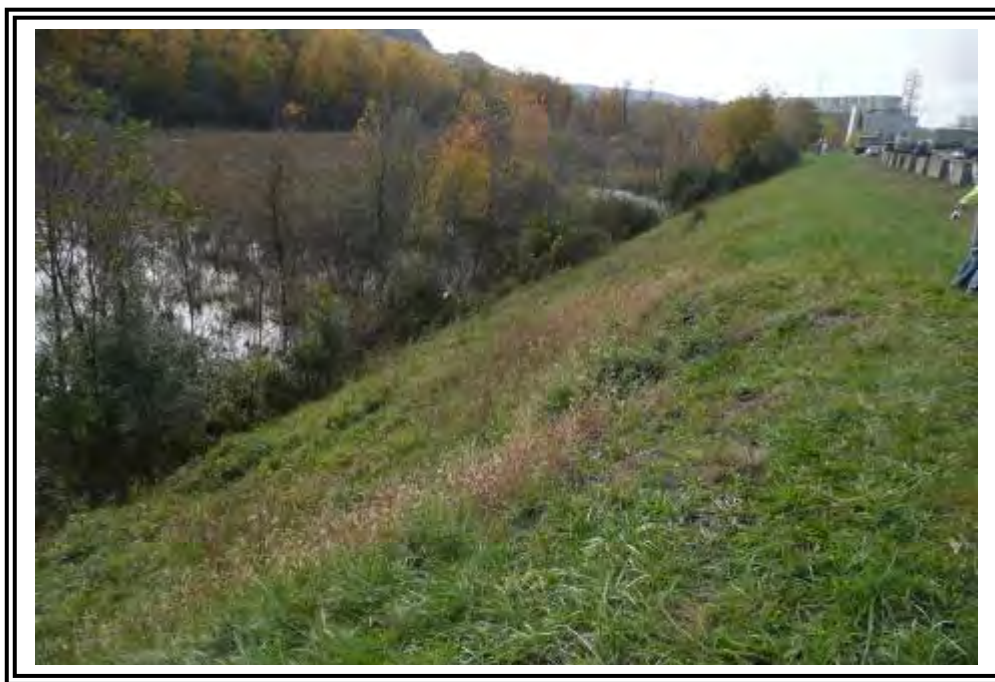
46

Looking southwest along Coal Haul Road embankment.

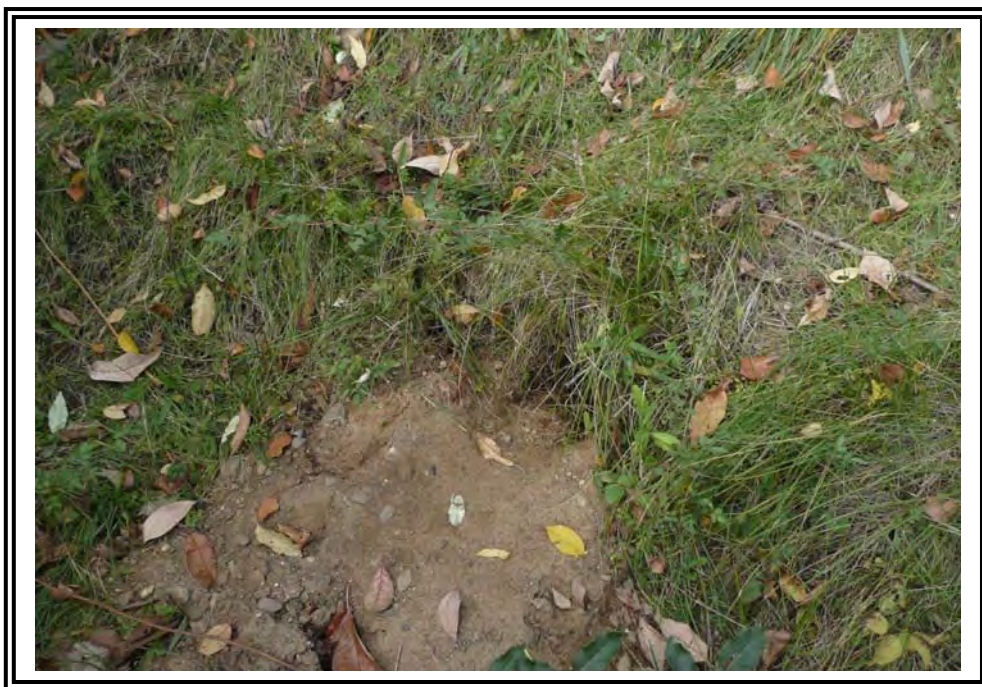
55

More recent rodent burrow in Coal Haul Road Dike with exposed soil spoil.

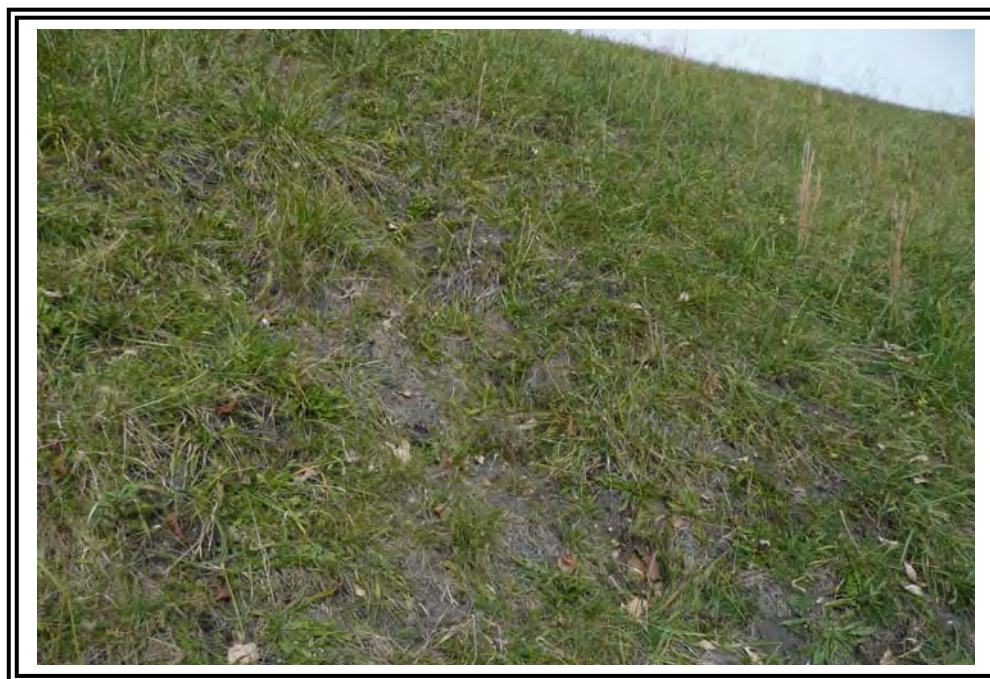
58

In addition to the erosion features, a scarp with an adjacent depression and slump was also observed on the downstream slope along with older grass covered deformation features likely the result of surficial soil softening, concentrated runoff from the roadway, and dust control efforts. In the case of the latter, finer grained coal dust, soil, and other debris is washed or swept from the road onto the slope and build up over time. These are shown in Photos 47, 48, and 56. Examples of the soil and dust transport from the roadway with subsequent grass cover loss can be seen in Photos 57 and 58.

Soil and coal dust transport with intermittent grass cover loss on downstream slope of Coal Haul Road Dike.

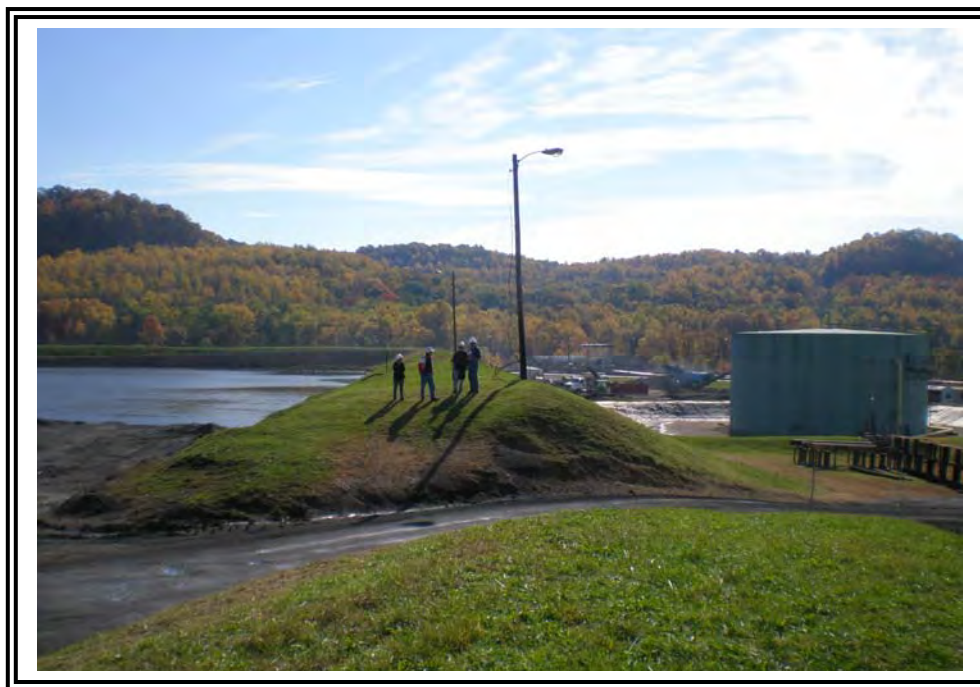
59

Maintenance road cut in Southwest Dike near the plant's water treatment facility, looking southeast.

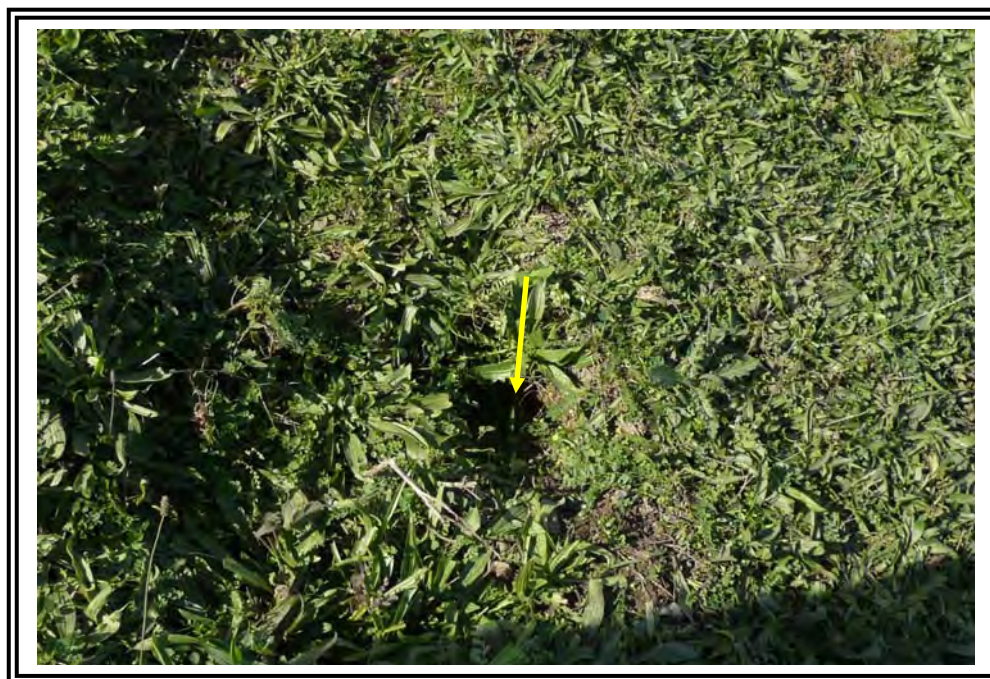
Collapsed, vegetated rodent burrow on upstream slope of Southwest Dike, likely abandoned (See arrow).

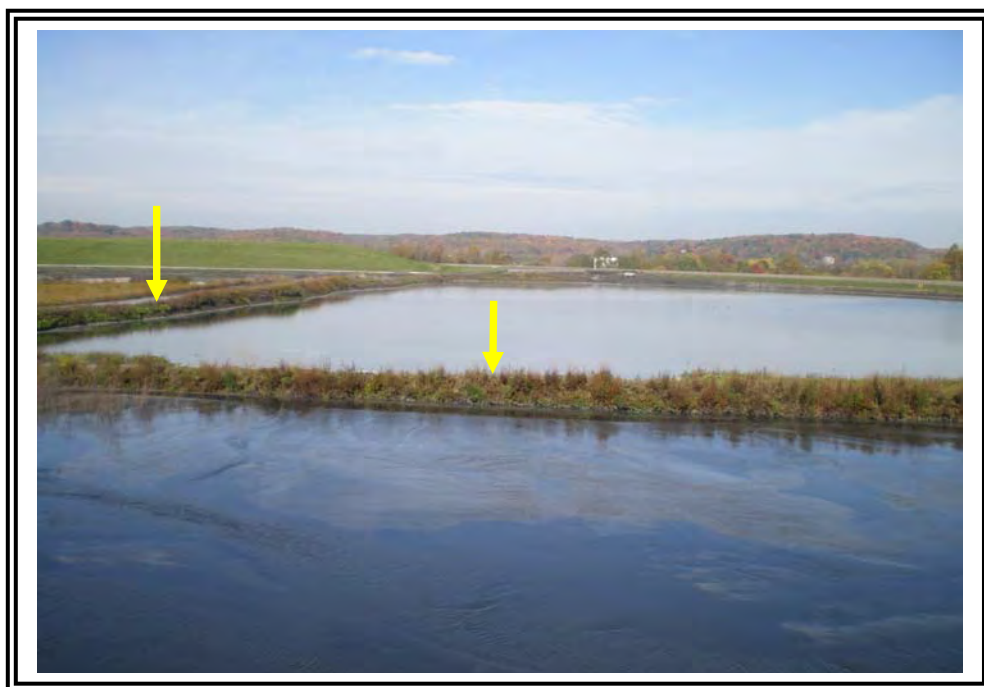
Closer view of interior divider dikes (see arrows) the Fly Ash Storage Area and Central Fly Ash Pond area.
