Report of Dam Safety Assessment of Coal  
Combustion Surface Impoundments  
American Electric Power (AEP) and Southwest  
Electric Power Company (SWEPCO)  
H.W. Pirkey Power Plant, Hallsville, TX

AMEC Project No. 3-2106-0183.0003

November 2010

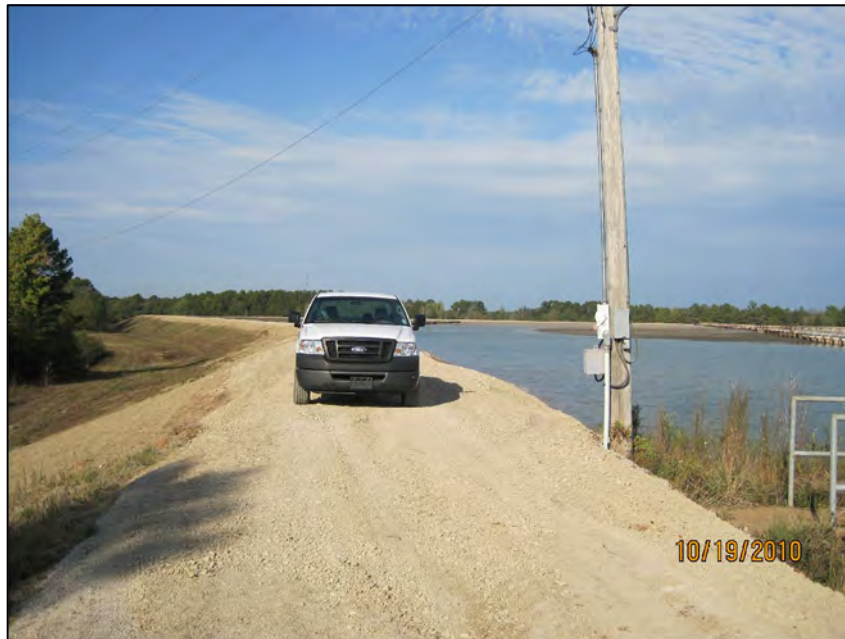
**WAP-1**  
**CREST AT SOUTHEAST CORNER CREST LOOKING WEST**

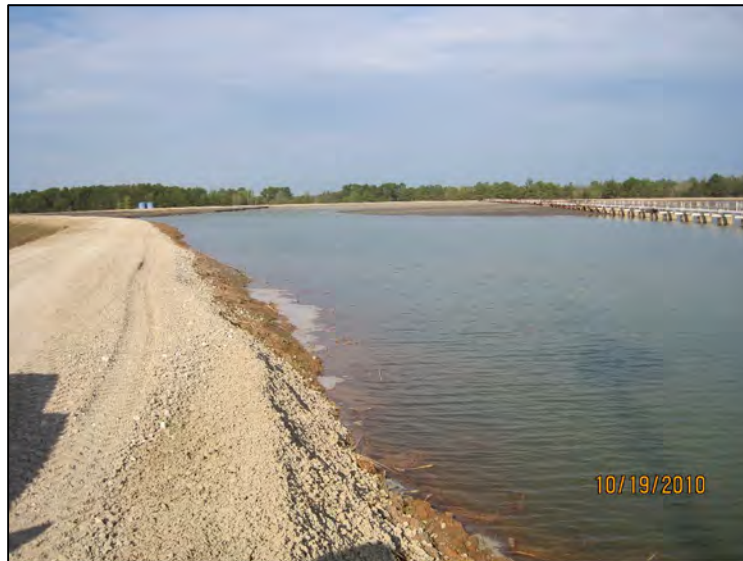
**WAP-4  
UPSTREAM SLOPE AT SOUTHEAST CORNER LOOKING WEST**

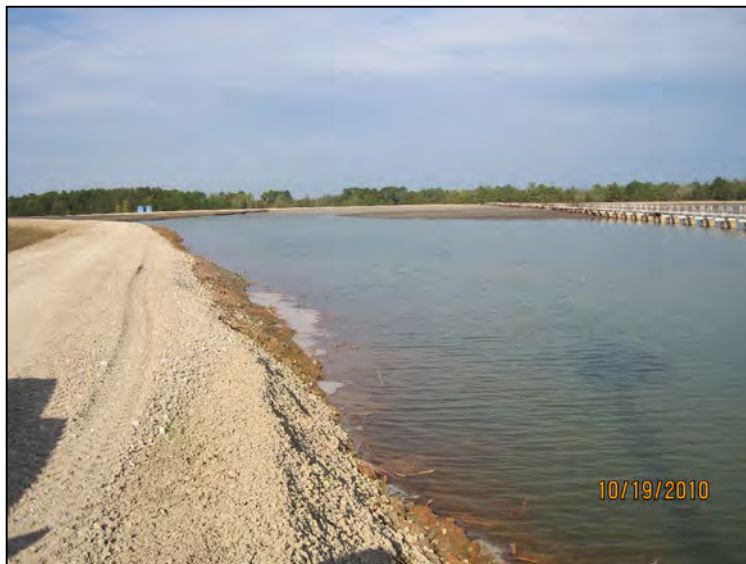
**WAP-4  
UPSTREAM SLOPE AT SOUTHEAST CORNER LOOKING WEST**

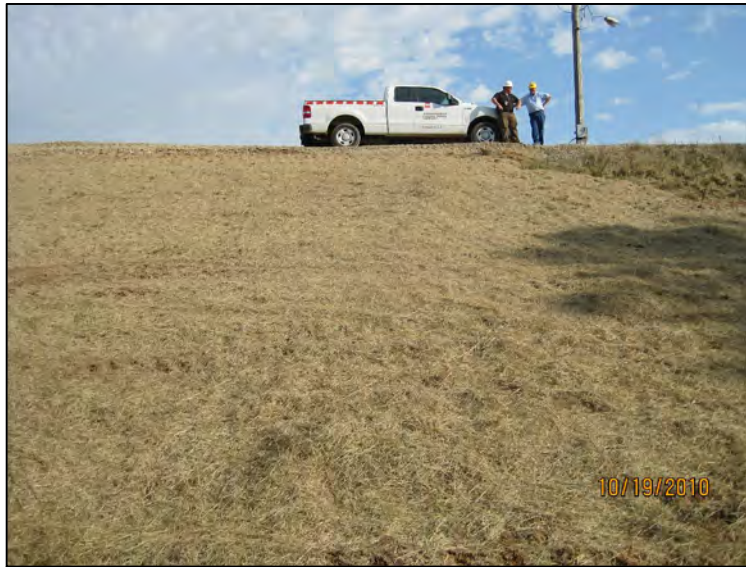
**WAP-5**  
**LOOKING NORTH UP DOWNSTREAM SLOPE AT SOUTHEAST CORNER**

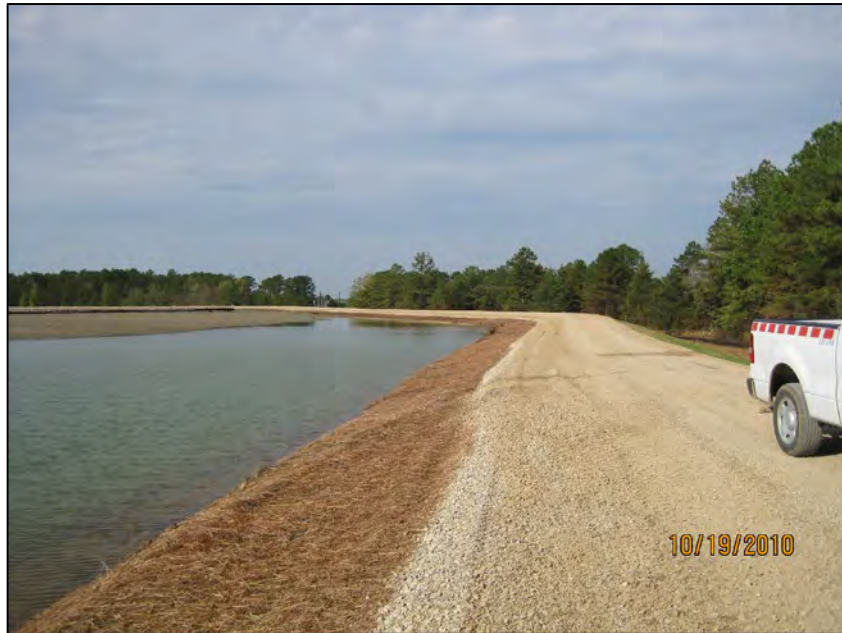
**WAP-13**  
**LOOKING WEST FROM CREST OF NORTHERN EMBANKMENT**

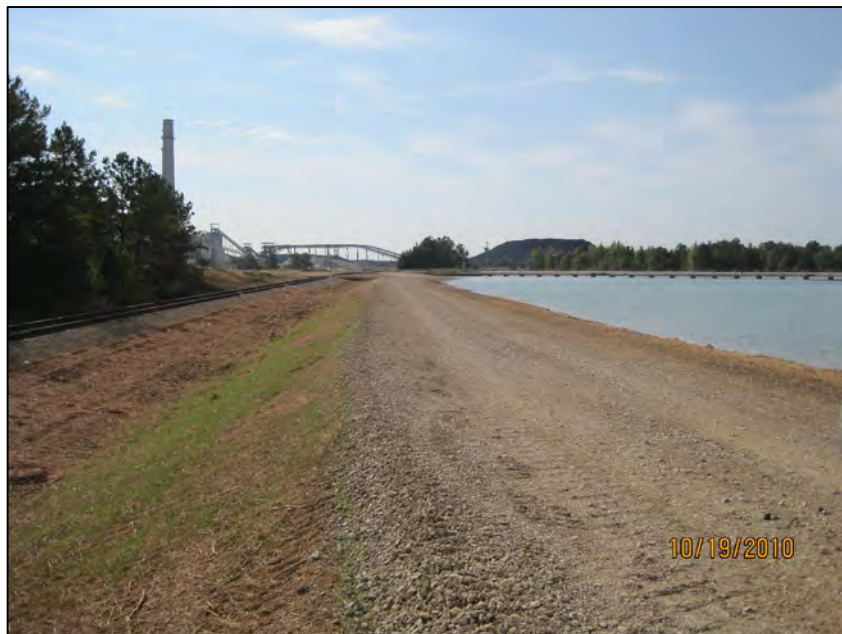
**WAP-14**  
**LOOKING SOUTH FROM CREST OF EASTERN EMBANKMENT**

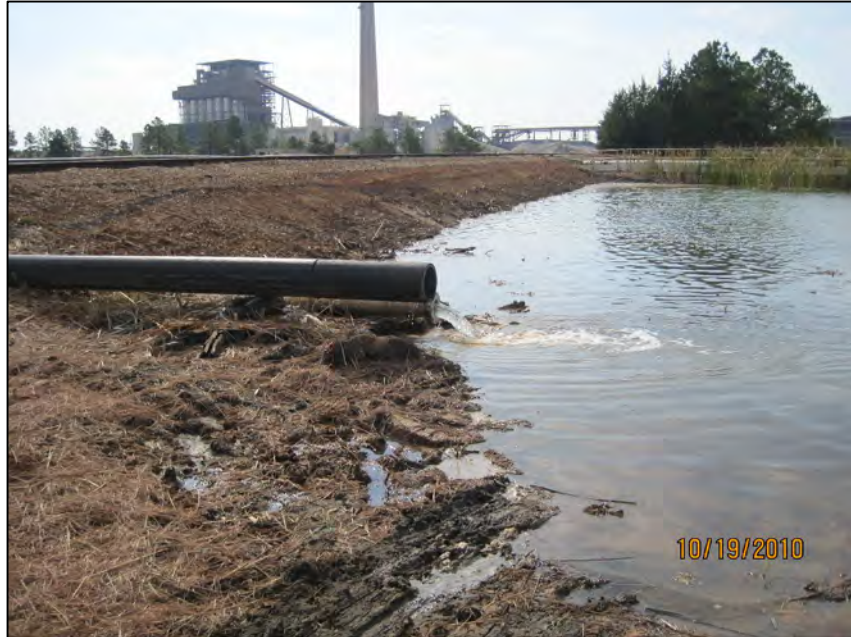
**WAP-15**  
**LOOKING SOUTH AT INFLUENT PIPE-NEUTRALIZED**  
**WASTE FROM DEMINERALIZER**

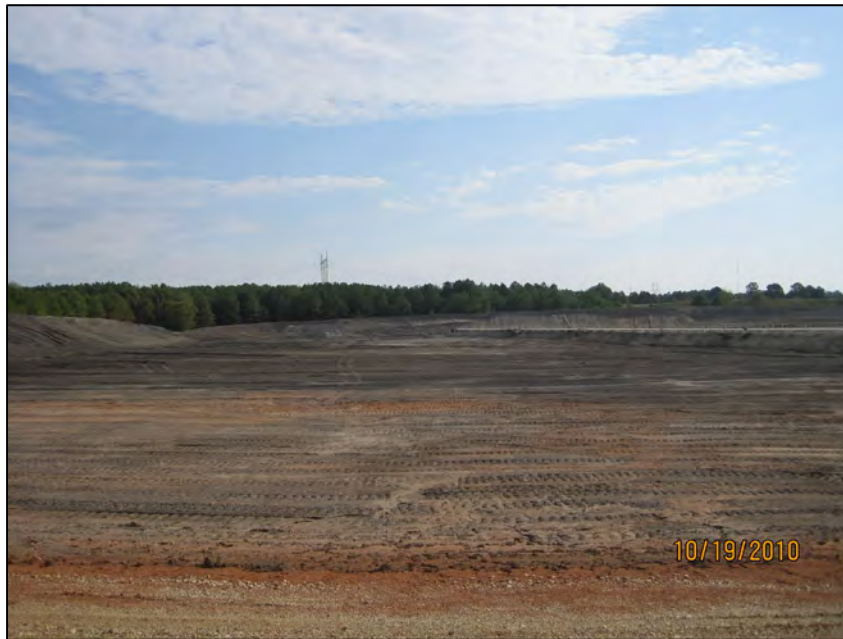
**EAP-1**  
**LOOKING EAST ACROSS POND FROM WESTERN CREST**

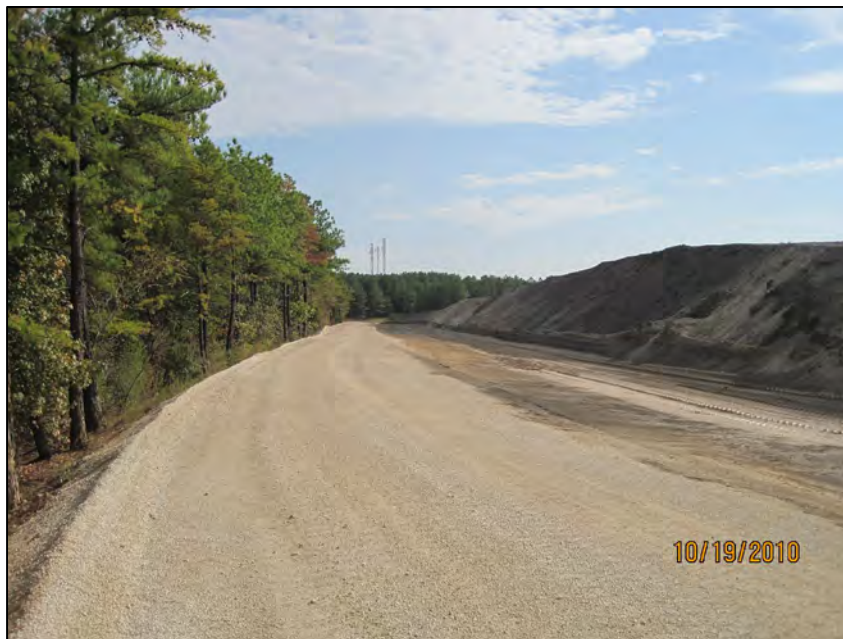
**EAP-2**  
**LOOKING NORTHEAST FROM**  
**CREST OF NORTHERN EMBANKMENT**

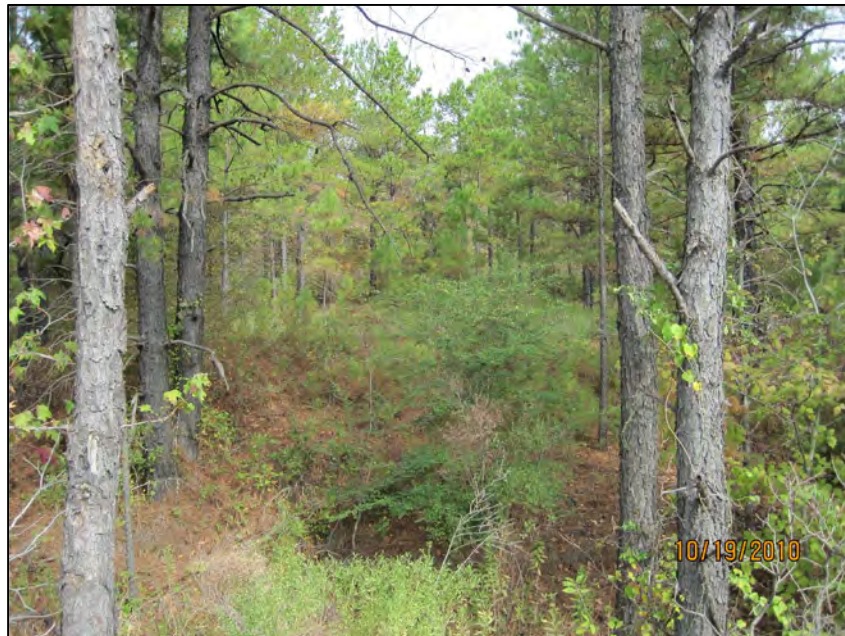
**EAP-4**  
**LOOKING NORTH FROM NORTHERN EMBANKMENT AT HIGHER GROUND**

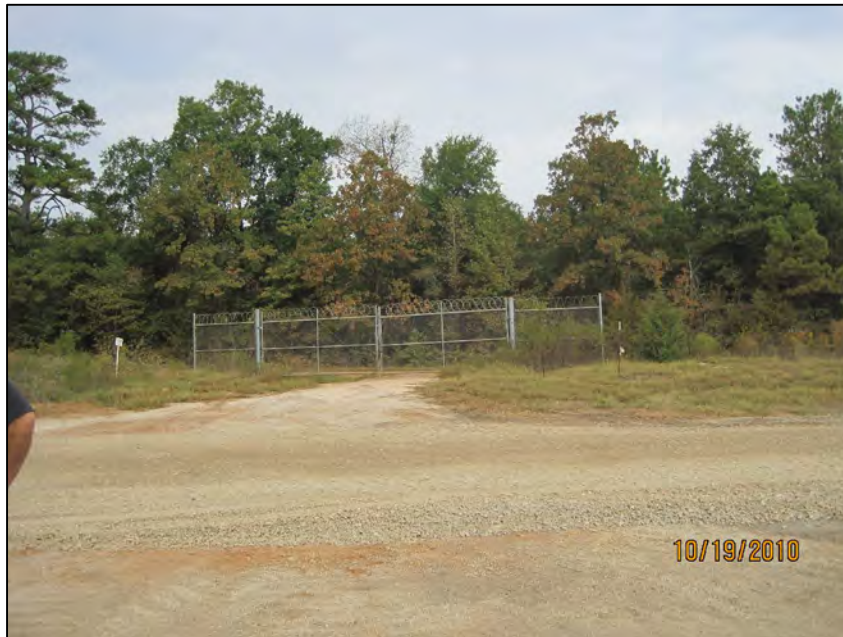
**EAP-7**  
**GATE TO ROAD NORTH OF NORTHERN EMBANKMENT**

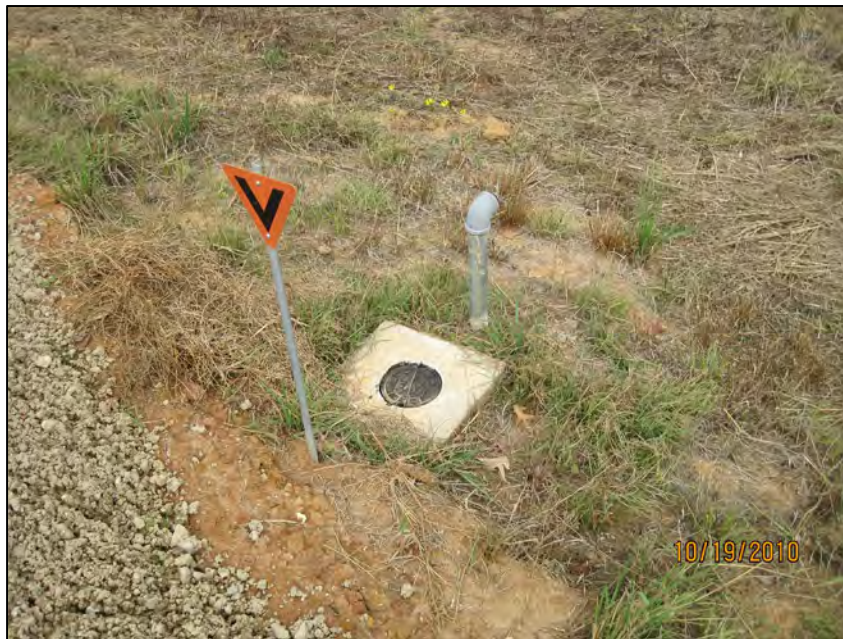
**EAP-8**  
**GAS PIPELINE ON NORTHEAST CORNER ?????? ASK DON**

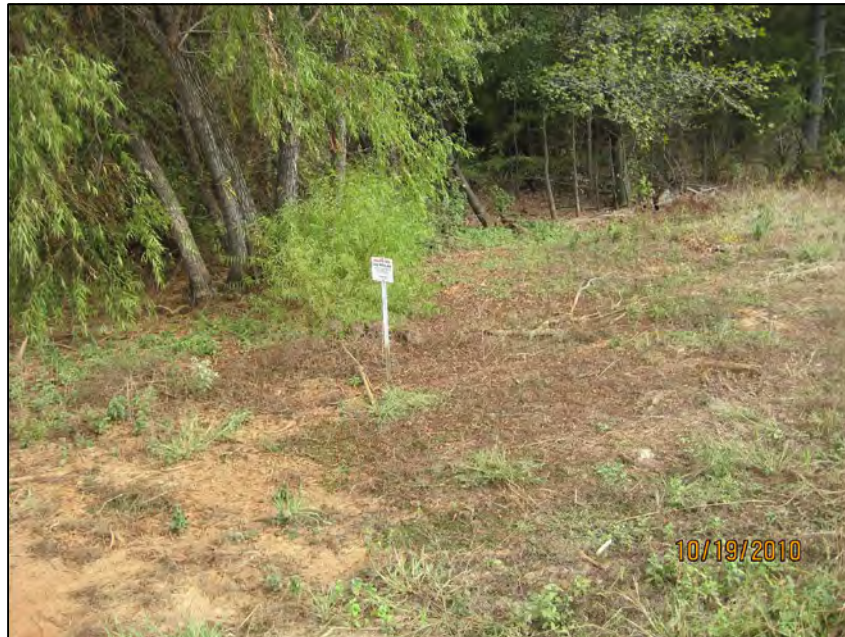
**EAP-9**

**???????? AT NORTHEAST CORNER ??????? ASK DON**

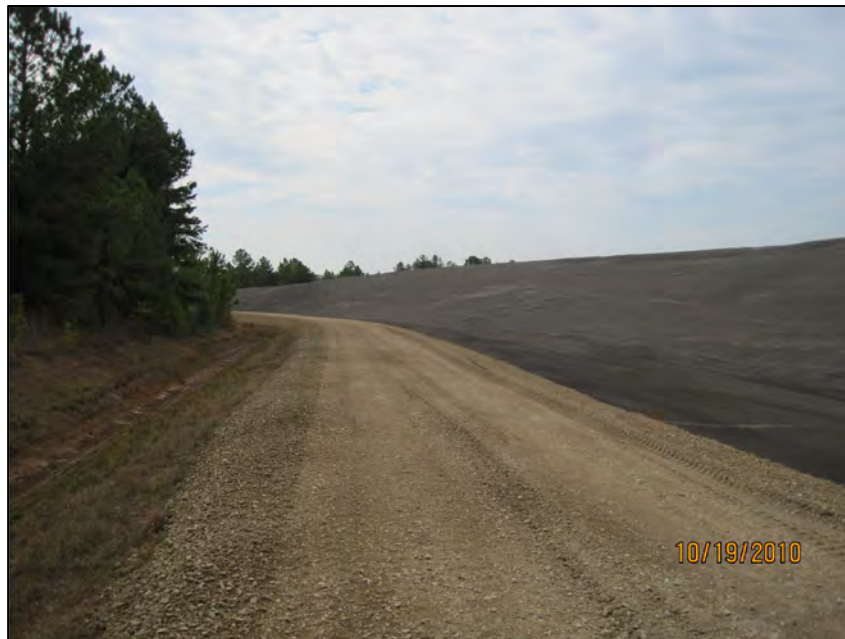
**EAP-10**

**LOOKING SOUTH FROM EASTERN CREST AT  
ASH STACK AND HIGHER GROUND TO EAST**

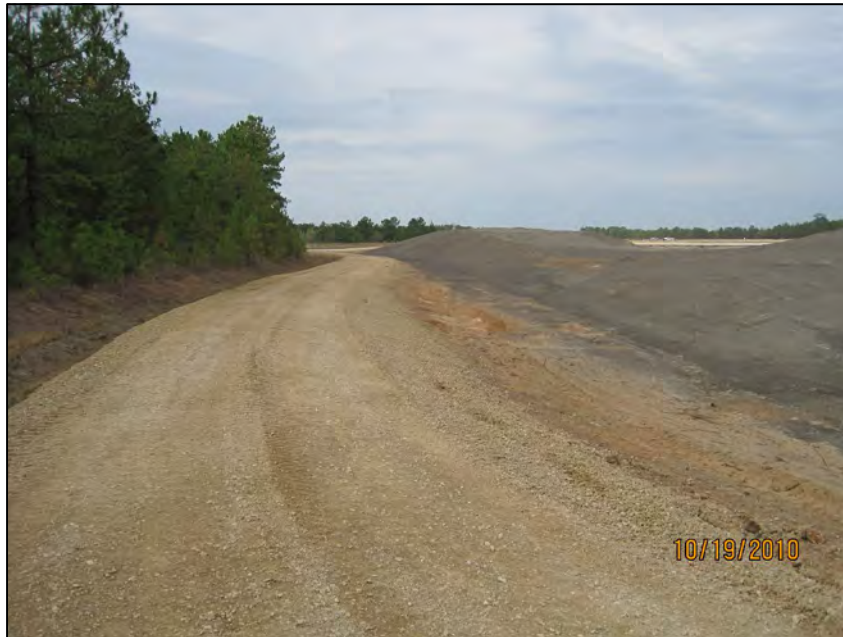
**EAP-11**  
**LOOKING WEST FROM SOUTHEAST CORNER CREST**

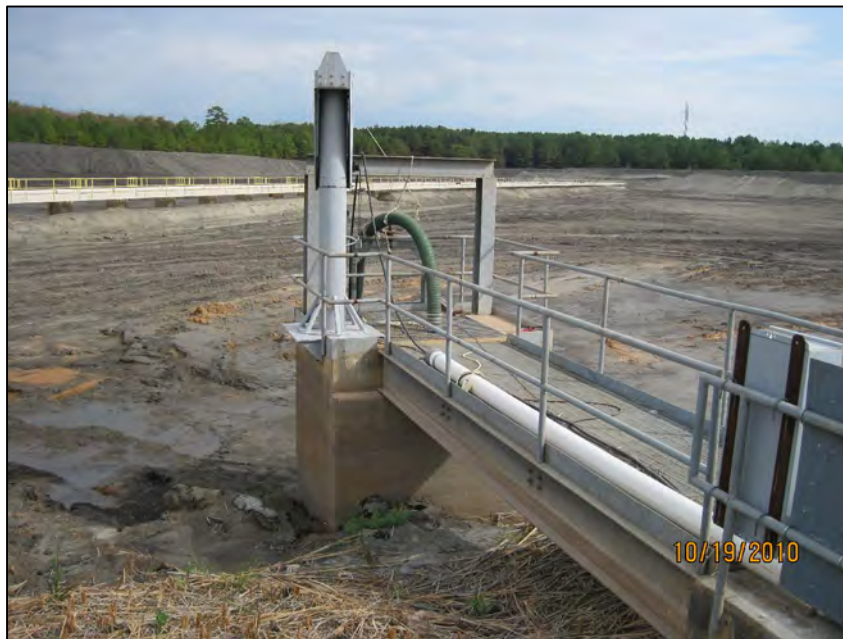
**EAP-12**  
**LOOKING NORTHEAST FROM SOUTHWEST  
 CORNER ACROSS DISCHARGE STRUCTURE**

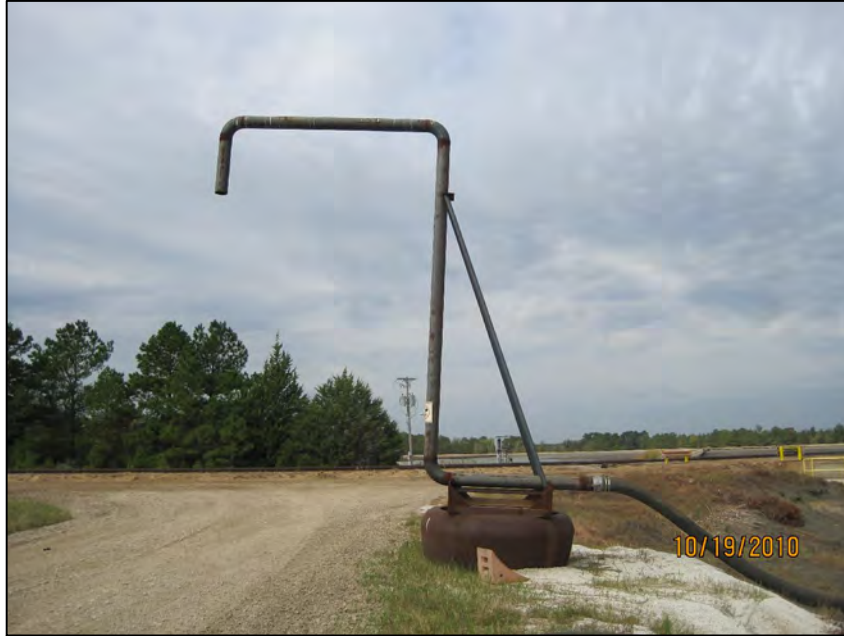
**EAP-13**  
**SOUTHWEST CREST LOOKING NORTHWEST**  
**PAST DUST CONTROL LOAD OUT PIPE**

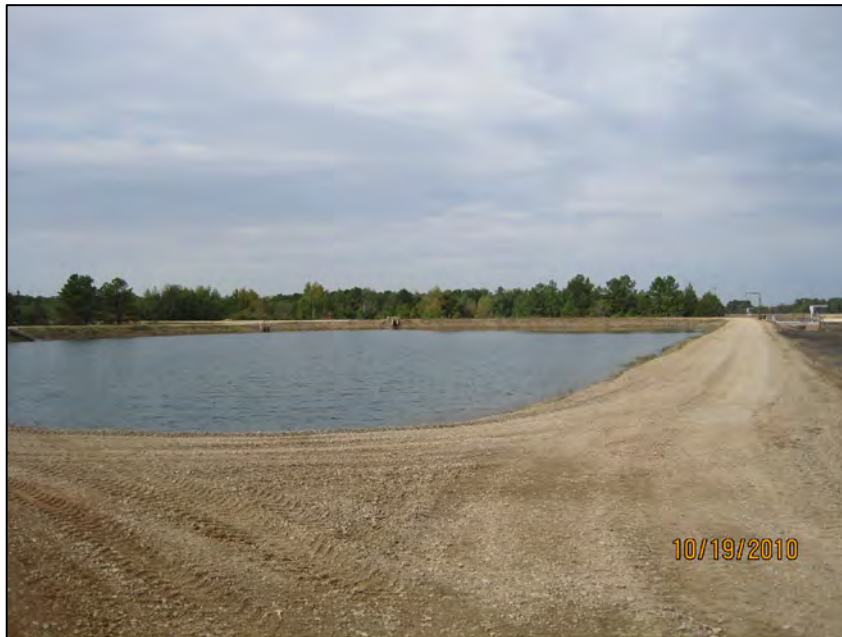
**SAP-1**  
**LOOKING WEST ACROSS POND FROM NORTHEAST CORNER**

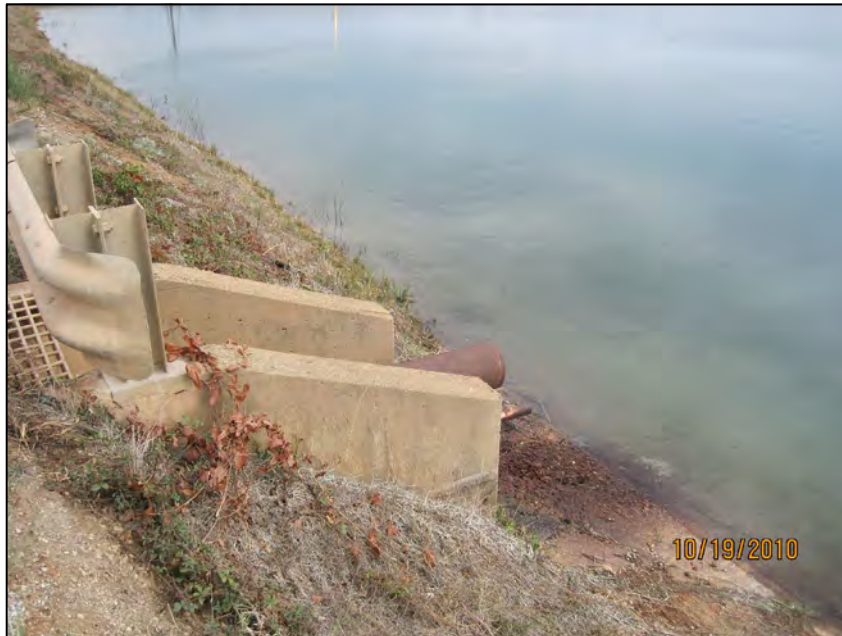
**SAP-2**  
**INFLUENT OF BOILER BLOWDOWN**  
**DISCHARGE PIPE AT SOUTHWEST CORNER**

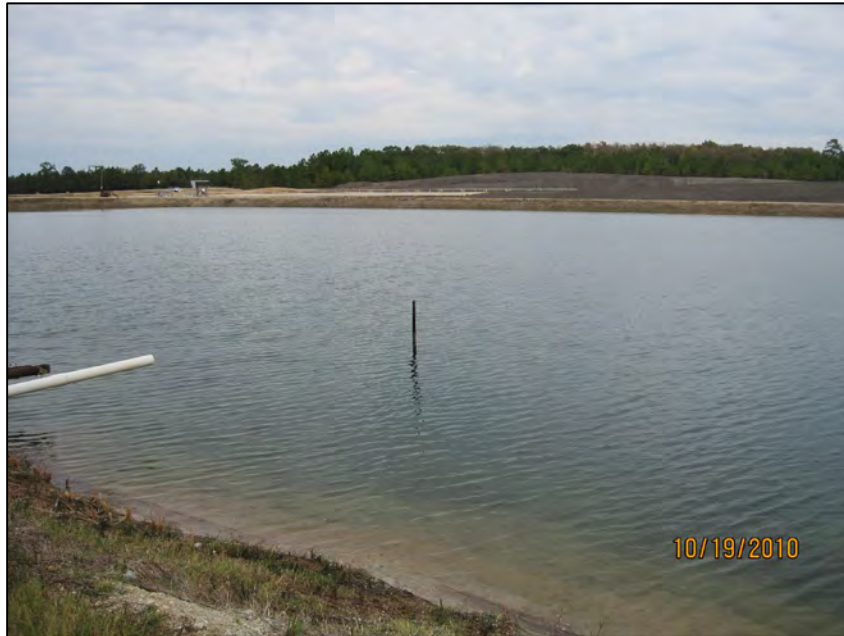
**SAP-6  
FROM SOUTHEAST CORNER LOOKING NORTHWEST AT  
MARKER INDICATING LOCATION OF PLANT REUSE PIPE**

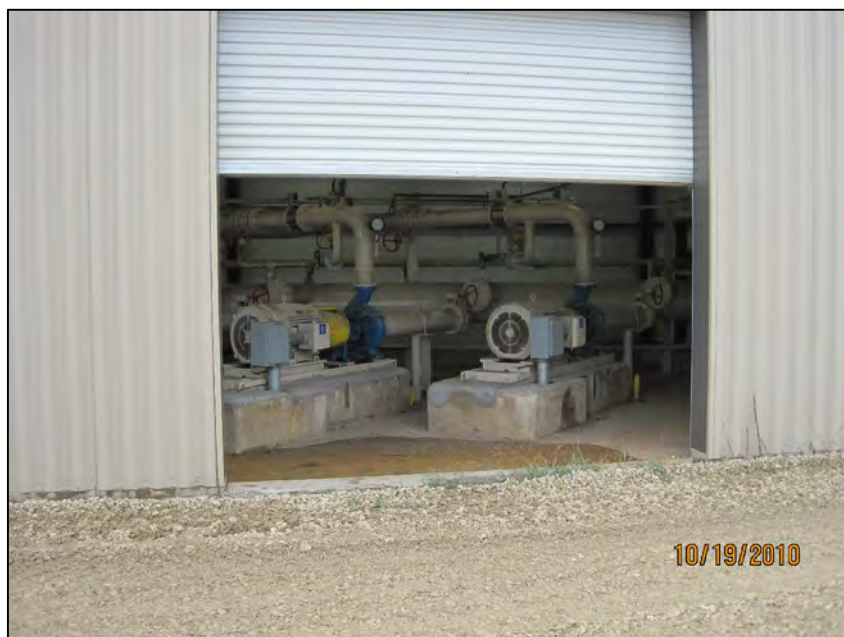
**SAP-7**  
**REUSE PUMP HOUSE ON SOUTH SHORE OF POND**

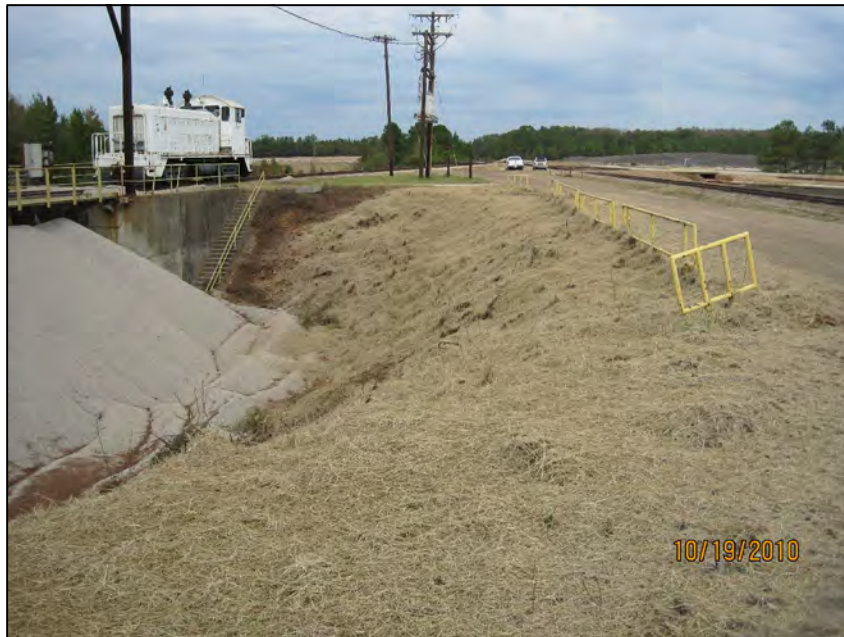
**SP-3**  
**WEST OF SURGE POND LOOKING NORTHWEST**  
**AT LIMESTONE UNLOADING AREA**

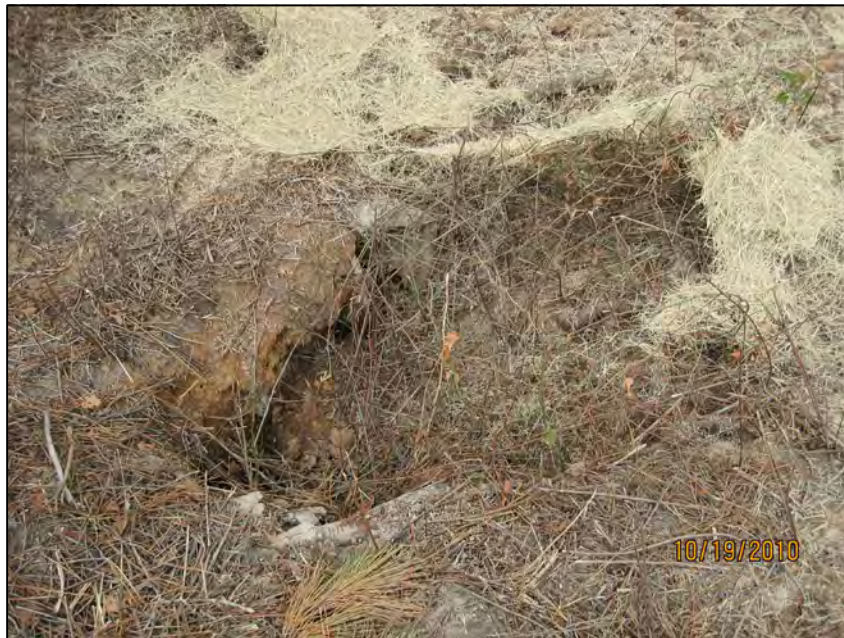
**SP-4**  
**STORM WATER CULVERT (18-INCH) THROUGH**  
**EMBANKMENT SOUTH OF LIMESTONE UNLOADER**

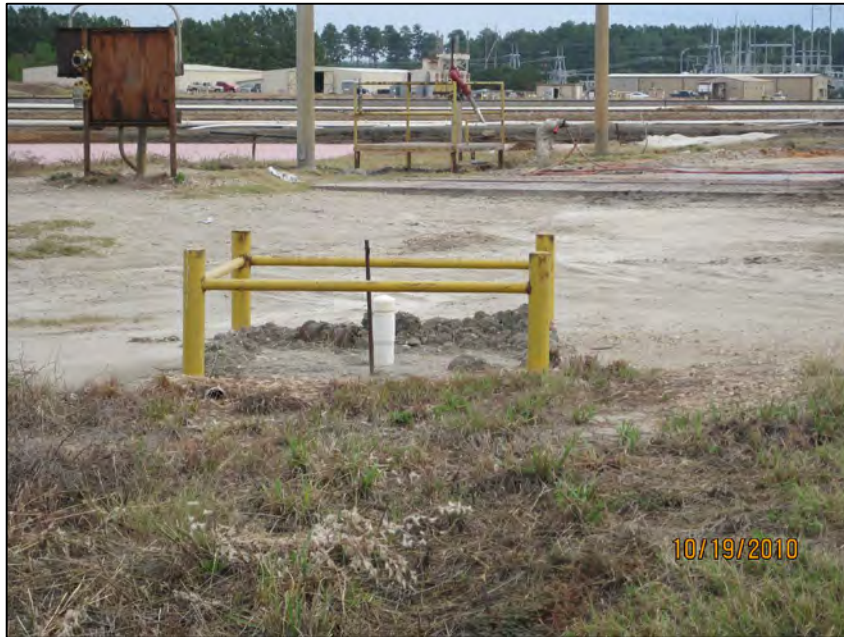
**SP-5**  
**MONITORING WELL LOCATED ADJACENT**  
**TO SOUTHWEST CORNER OF POND**

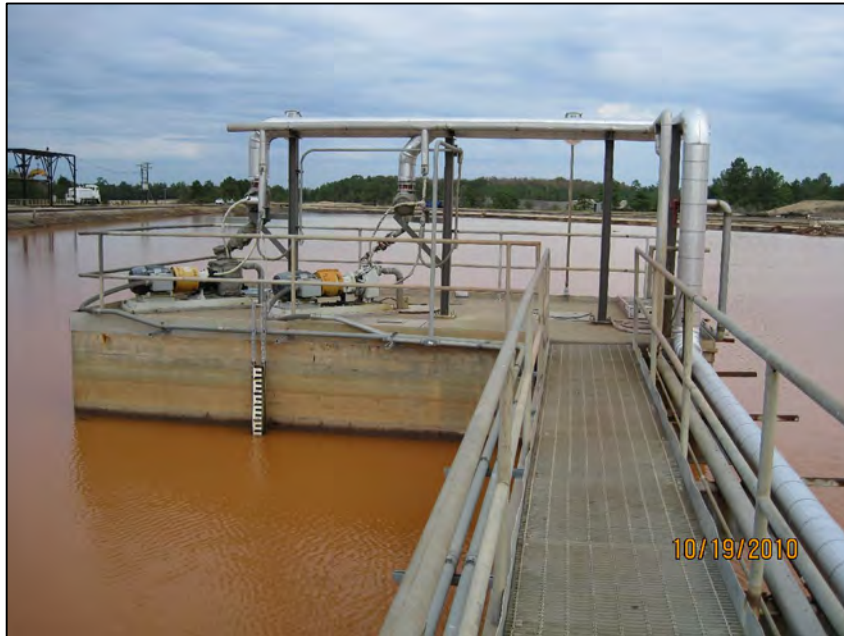
**SP-6**  
**LOOKING NORTH SOUTH EDGE OF POND**  
**AT FACILITY REUSE PUMP STATION**

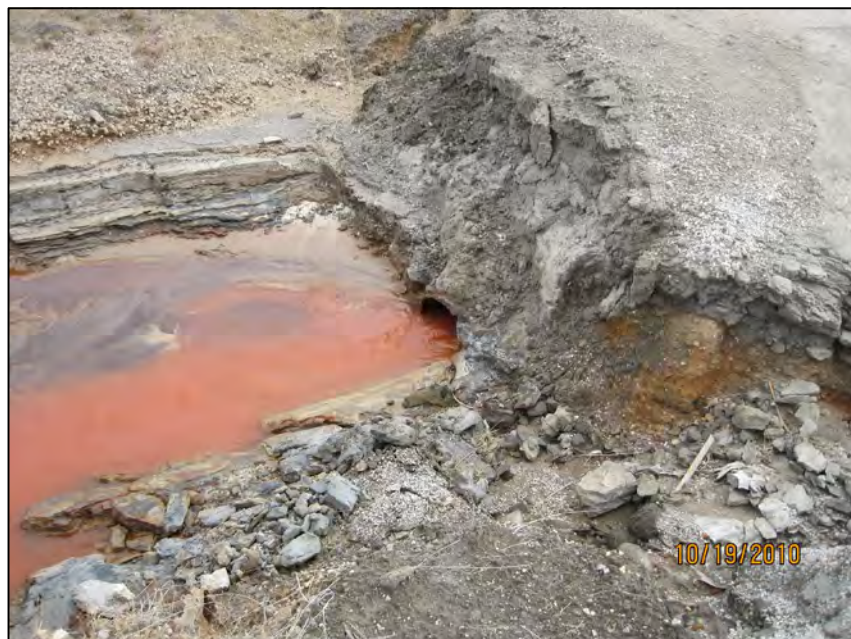
**SP-7**

**SOUTHEAST CORNER OF POND LOOKING AT FLOWING FLUE  
GAS DESULFURIZATION PROCESS INFLUENT PIPE (18-INCH)**

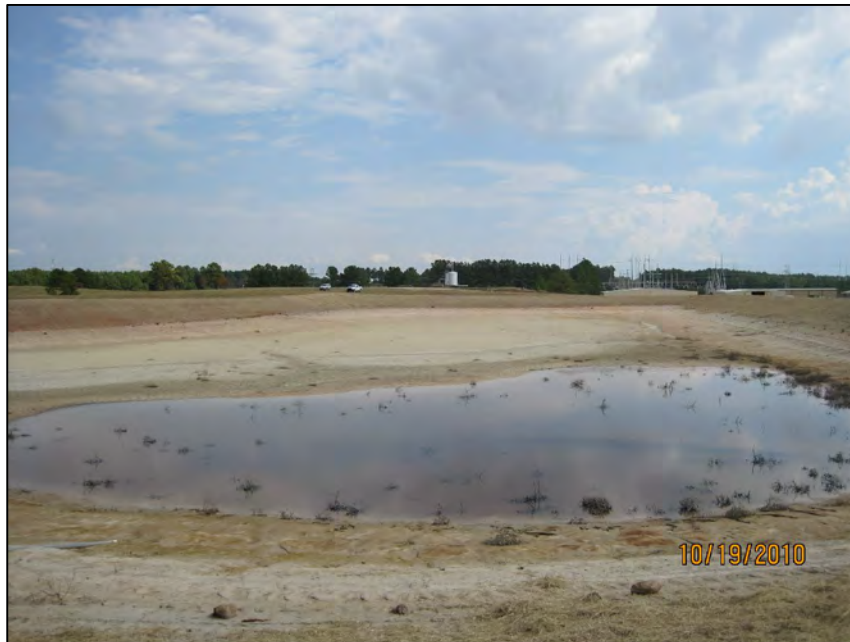
**ASP-2**  
**LOOKING EAST ACROSS POND**  
**FROM WESTERN EMBANKMENT**

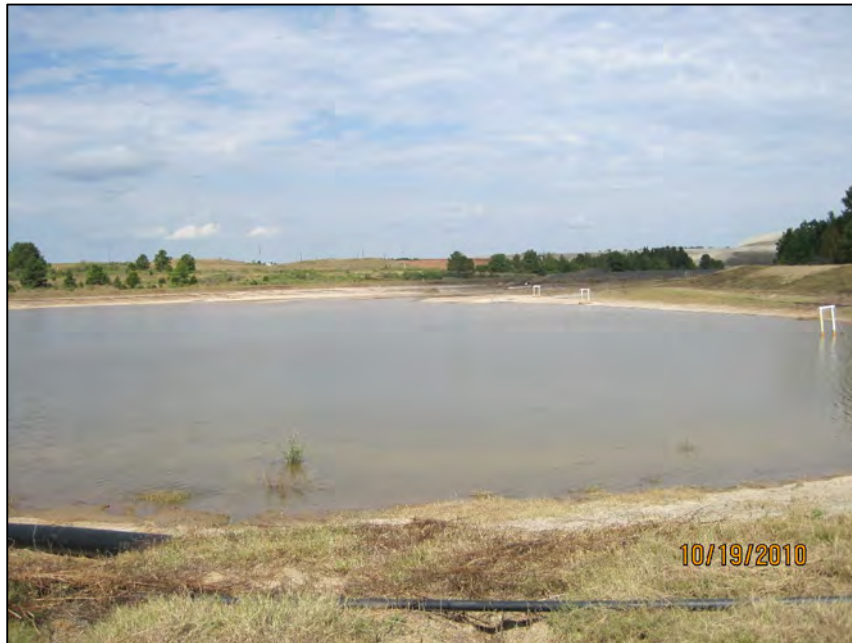
**LRP-1**  
**LOOKING NORTH ACROSS POND FROM**  
**SOUTHEASTERN EMBANKMENT CREST**

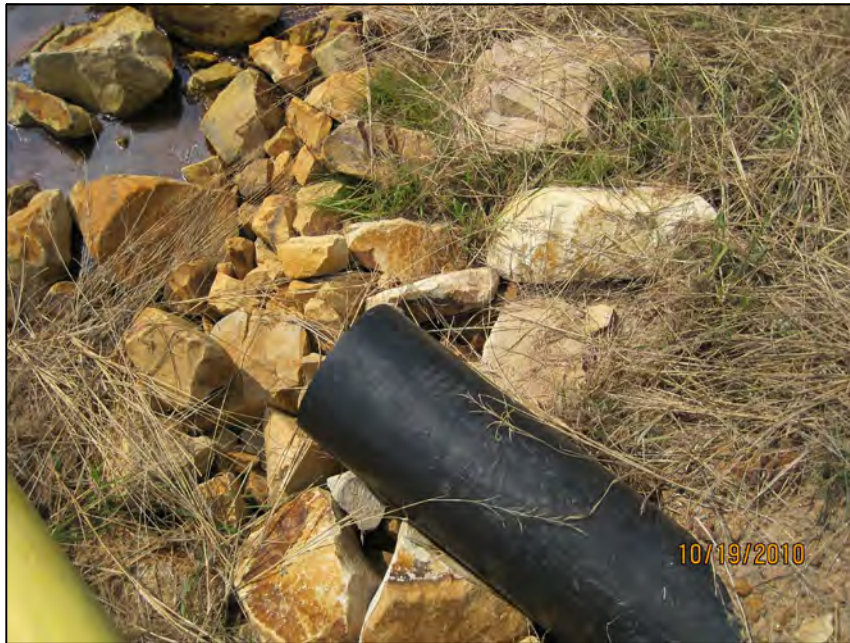
**LRP-3**  
**DOWNSTREAM DISCHARGE-NPDES OUTFALL 004**

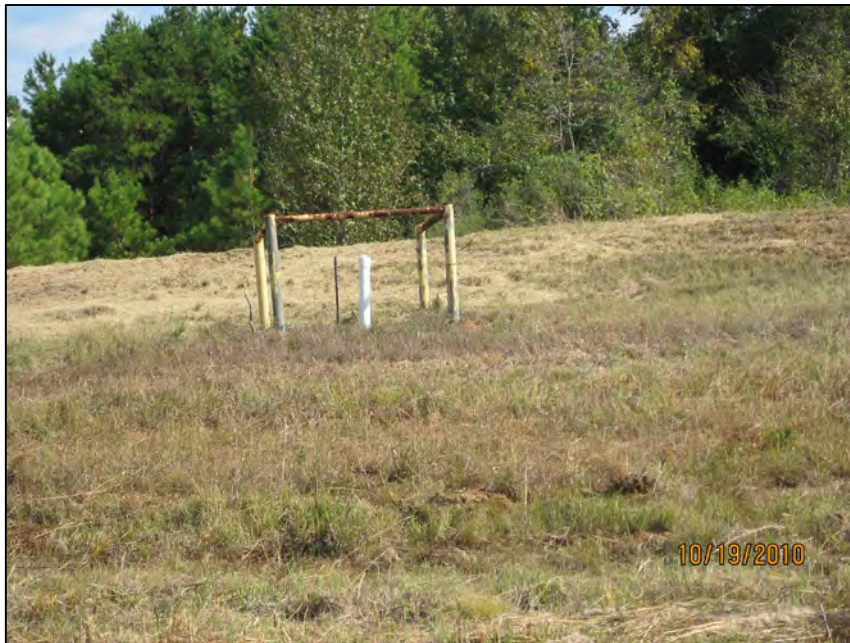
**LRP-7**  
**MONITORING WELL ADJACENT TO**  
**NORTHEASTERN CORNER OF POND**

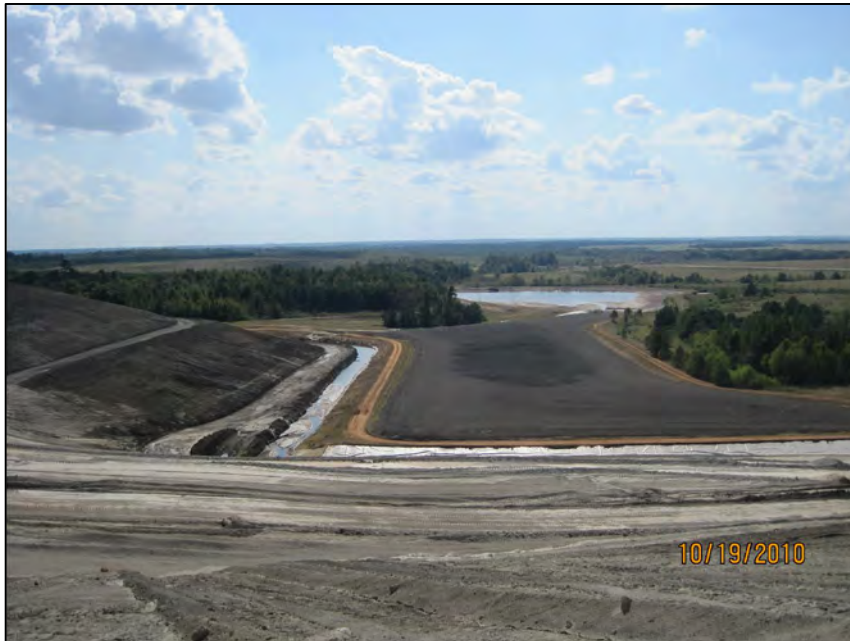
**LRP-9**  
**ATOP LANDFILL LOOKING SOUTHWEST AT LANDFILL**  
**PERIMETER CHANNEL AND LANDFILL RUNOFF POND**
