Report of Dam Safety Assessment of Coal  
Combustion Surface Impoundments  
American Electric Power (AEP) and Southwest  
Electric Power Company (SWEPCO)  
H.W. Pirkey Power Plant, Hallsville, TX

AMEC Project No. 3-2106-0183.0003

June 2011

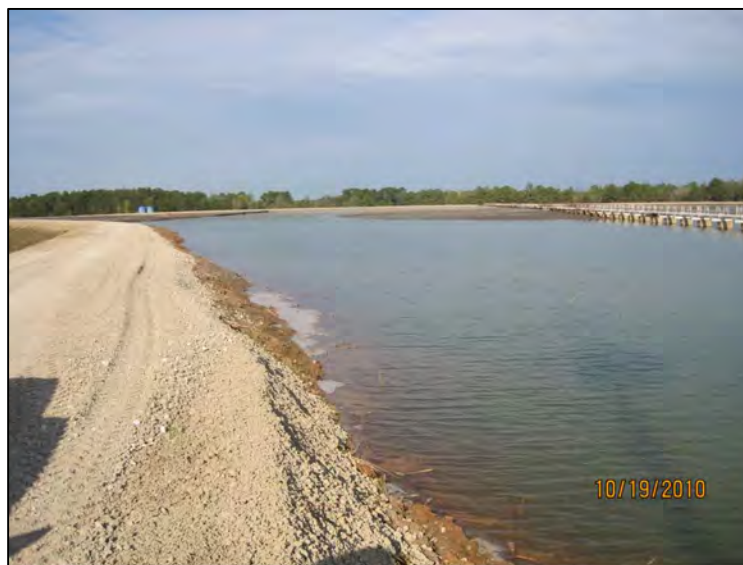
WAP-4  
UPSTREAM SLOPE AT SOUTHEAST CORNER LOOKING WEST

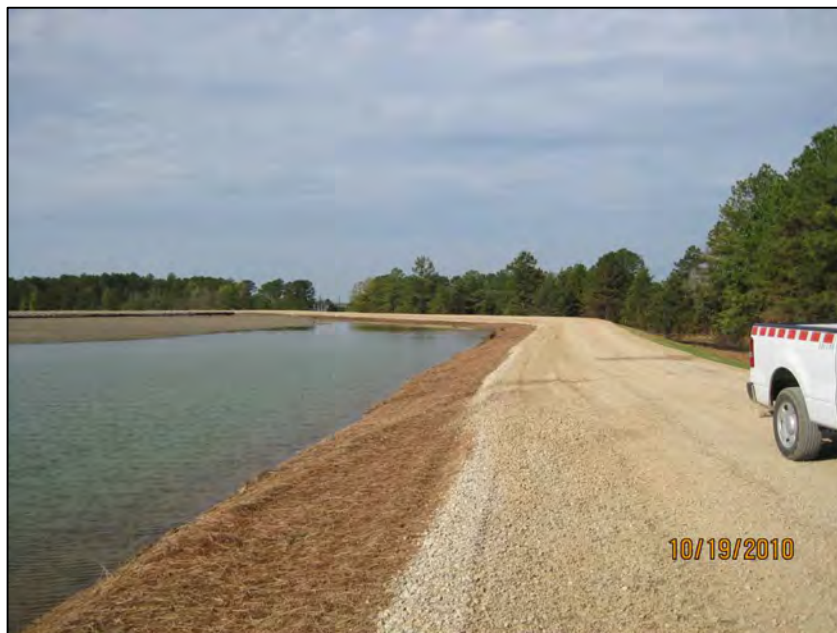
WAP-13

LOOKING WEST FROM CREST OF NORTHERN EMBANKMENT

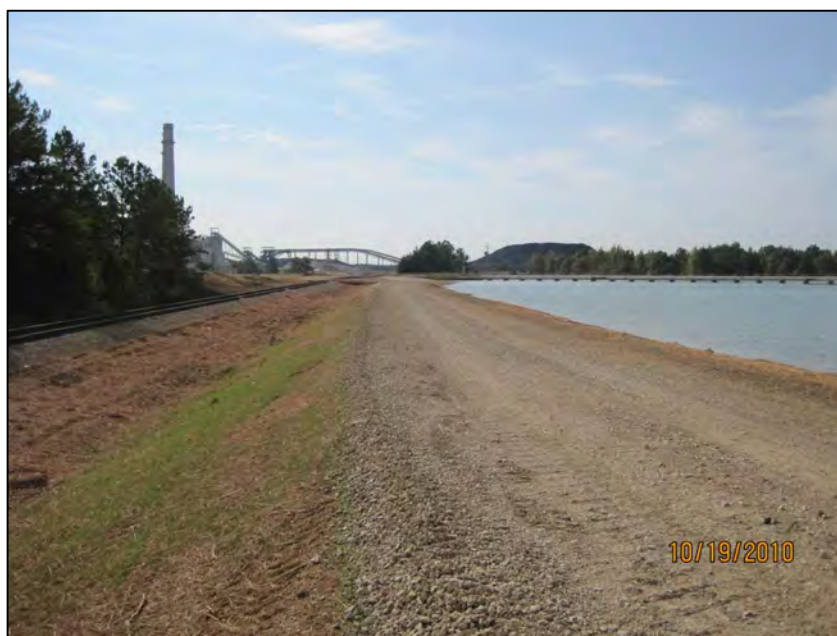
WAP-14

LOOKING SOUTH FROM CREST OF EASTERN EMBANKMENT

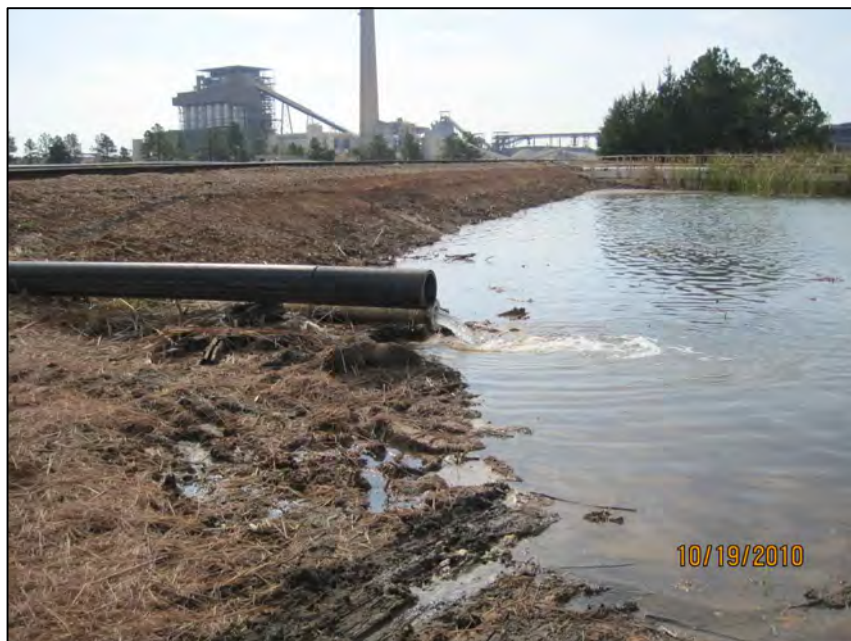
WAP-15  
LOOKING SOUTH AT INFLUENT PIPE-NEUTRALIZED  
WASTE FROM DEMINERALIZER

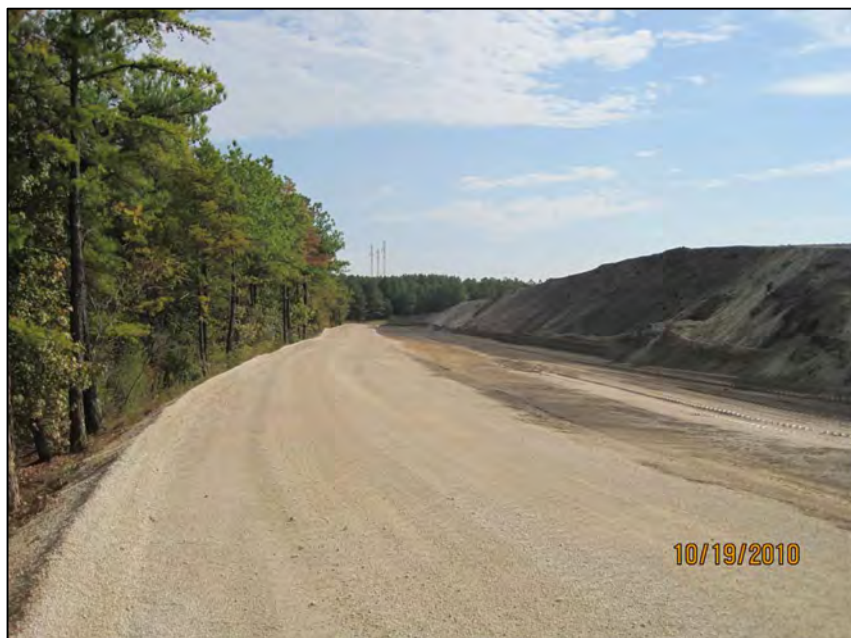
EAP-2  
LOOKING NORTHEAST FROM  
CREST OF NORTHERN EMBANKMENT

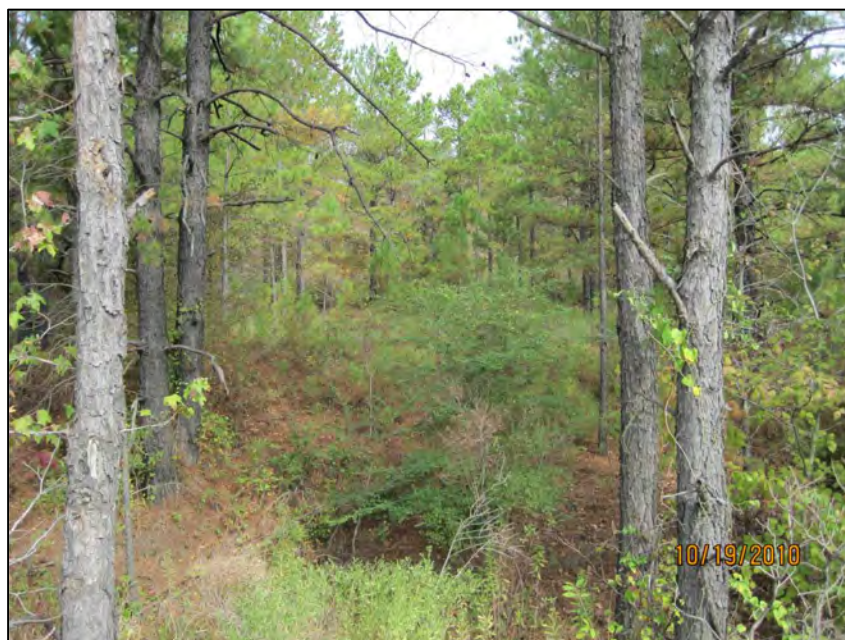
EAP-4  
LOOKING NORTH FROM NORTHERN  
EMBANKMENT AT HIGHER GROUND

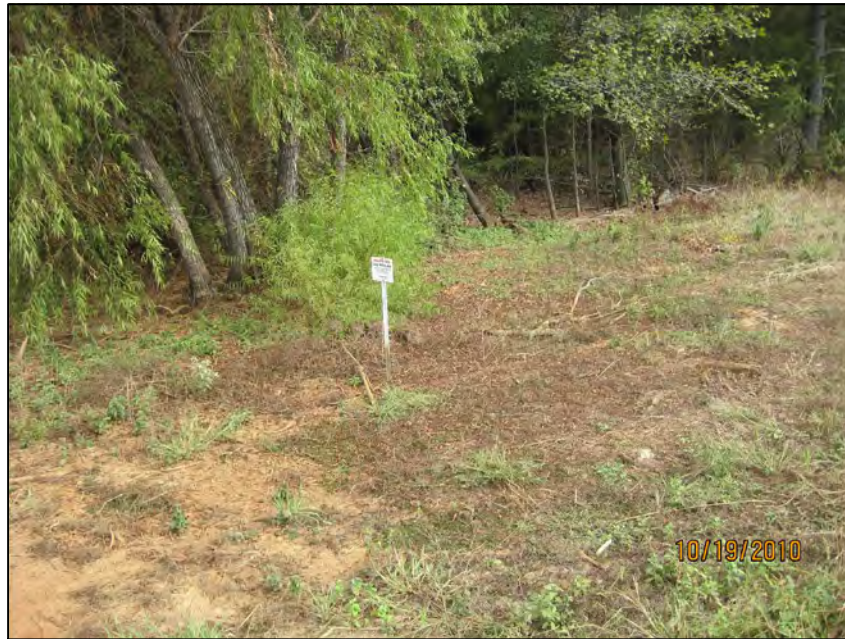
This pond is completely incised and was not in service during the site visit. Photos EAP-1, EAP-5, and EAP-6 show the interior of the East Ash Pond, as well as areas of stacked ash. A drainage swale, to redirect runoff flows away from the pond, exists outside the pond's southeast, east and north perimeter crest road. The crest road is gravel covered as shown on Photos EAP-2, EAP-10, and EAP-11. A piezometer was noted on the northwest crest road (Photo EAP-3). Photo EAP-8 illustrates a gas pipeline indicator located off the northeast crest road.

**EAP-9**  
**GAS PIPE LINE MARKER AT NORTHEAST CORNER OF POND**

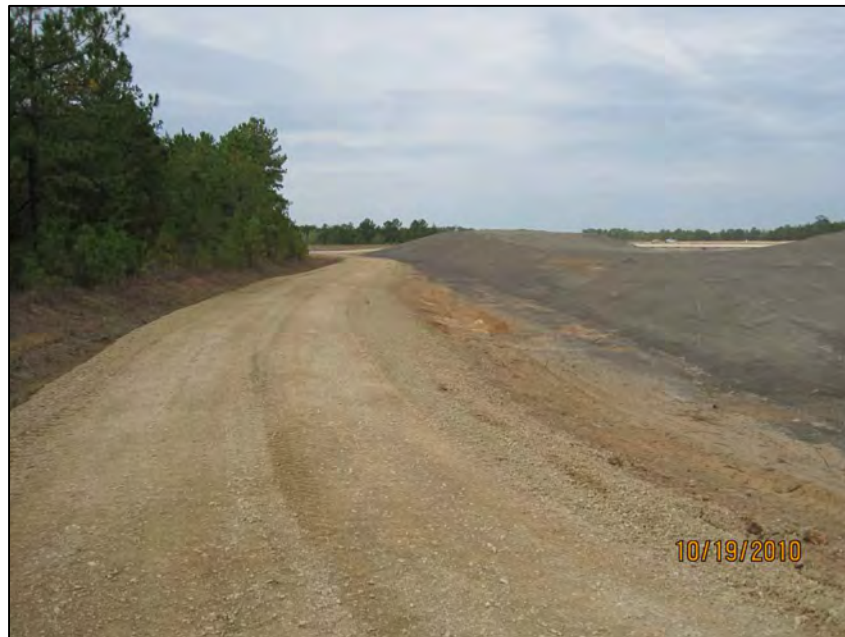
EAP-11  
LOOKING WEST FROM SOUTHEAST CORNER CREST

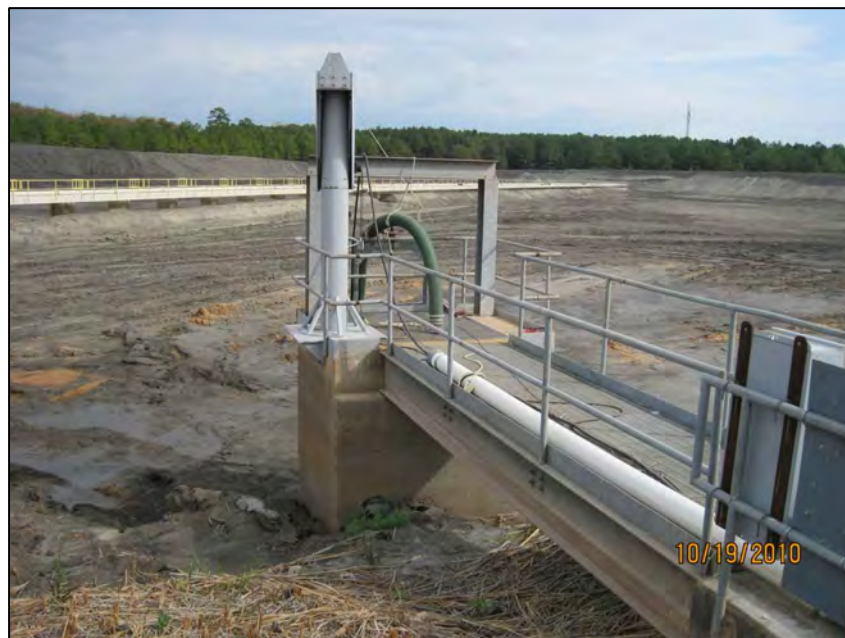
EAP-12  
LOOKING NORTHEAST FROM SOUTHWEST  
CORNER ACROSS DISCHARGE STRUCTURE

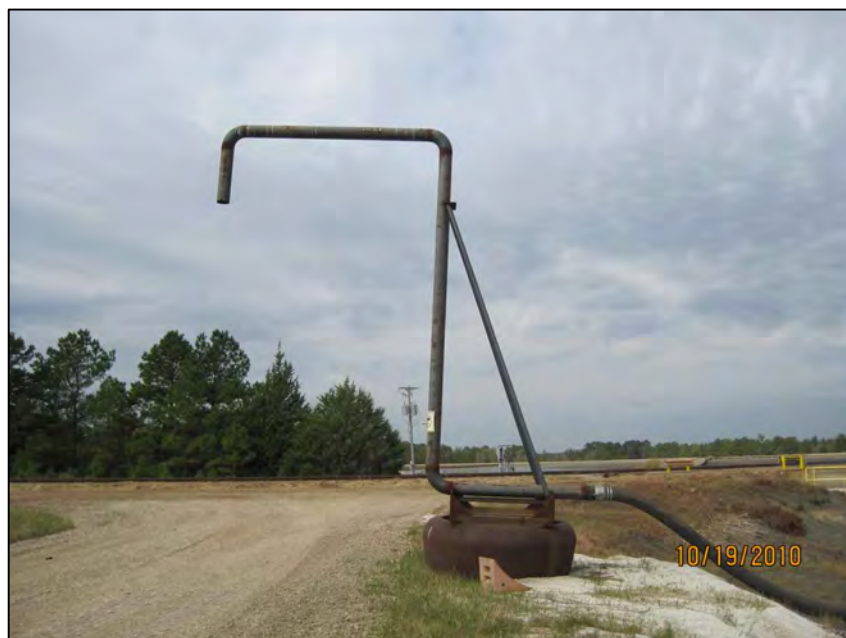
EAP-13  
SOUTHWEST CREST LOOKING NORTHWEST  
PAST DUST CONTROL LOAD OUT PIPE

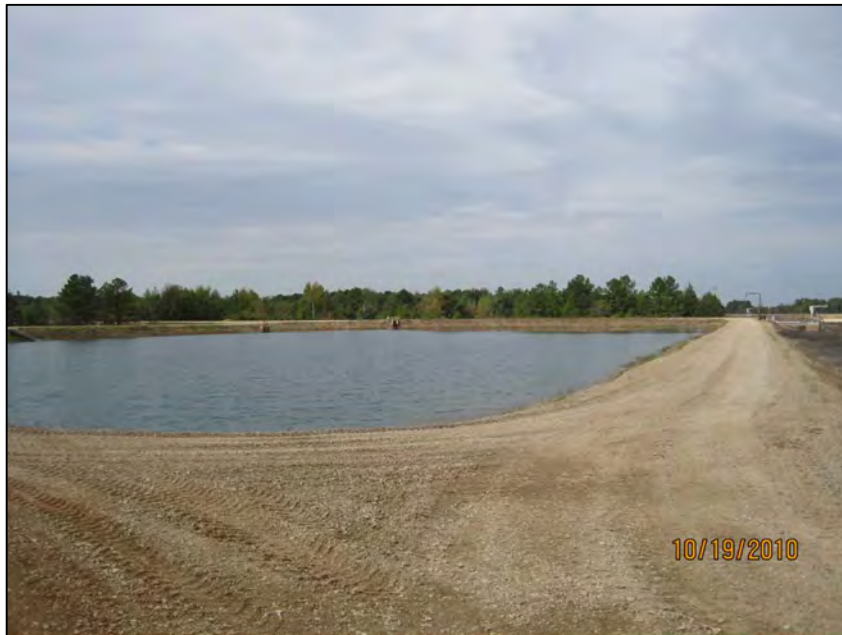
SAP-1

LOOKING WEST ACROSS POND FROM NORTHEAST CORNER

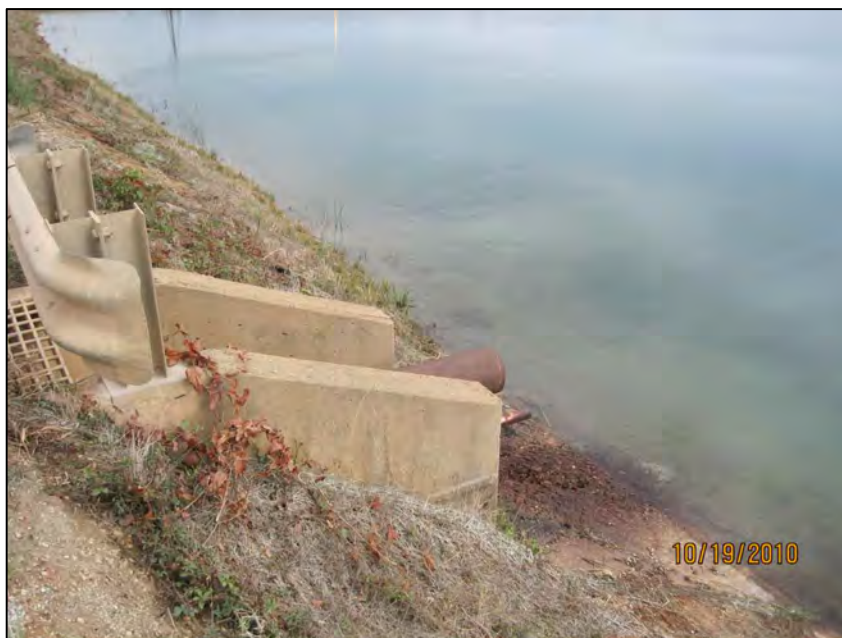
SAP-2

INFLUENT OF BOILER BLOWDOWN  
DISCHARGE PIPE AT SOUTHWEST CORNER**AMEC Earth & Environmental**690 Commonwealth Center  
11003 Bluegrass Parkway  
Louisville, Ky 40299  
(502) 267-0700

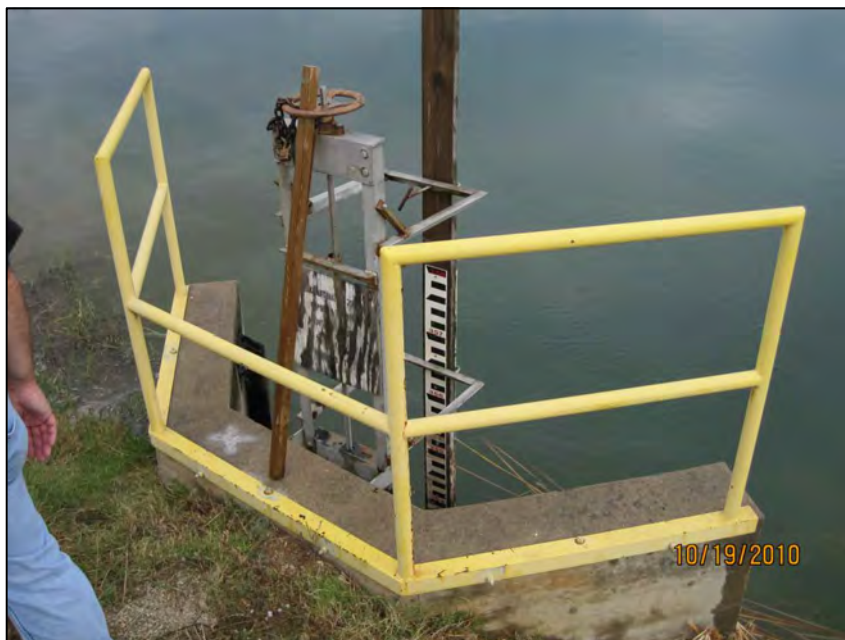
SAP-3

NPDES DISCHARGE OUTFALL 006 AT SOUTHWEST CORNER

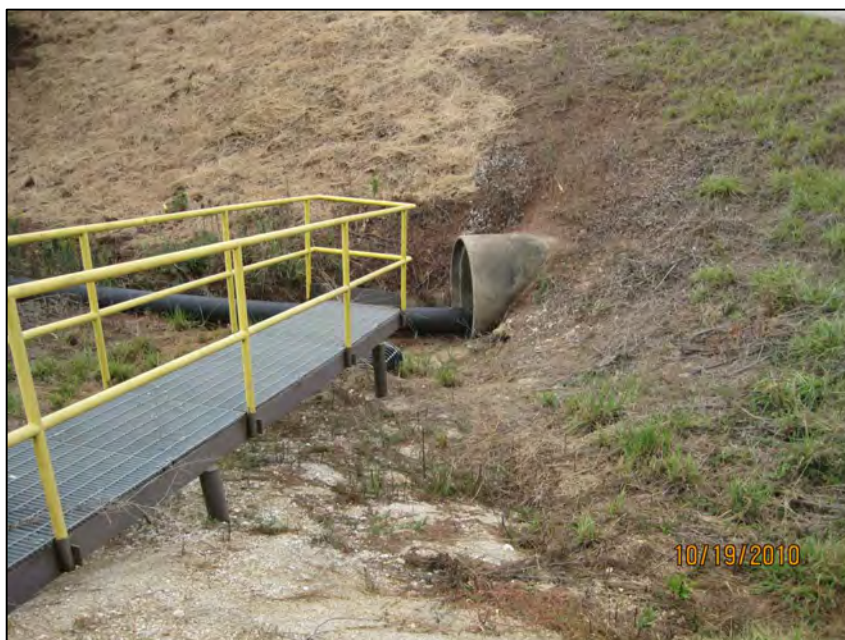
SAP-4

TRANSFER PIPE CARRYING REUSE  
FLOW TO ADJADENT LIGNITE MINE**AMEC Earth & Environmental**690 Commonwealth Center  
11003 Bluegrass Parkway  
Louisville, Ky 40299  
(502) 267-0700

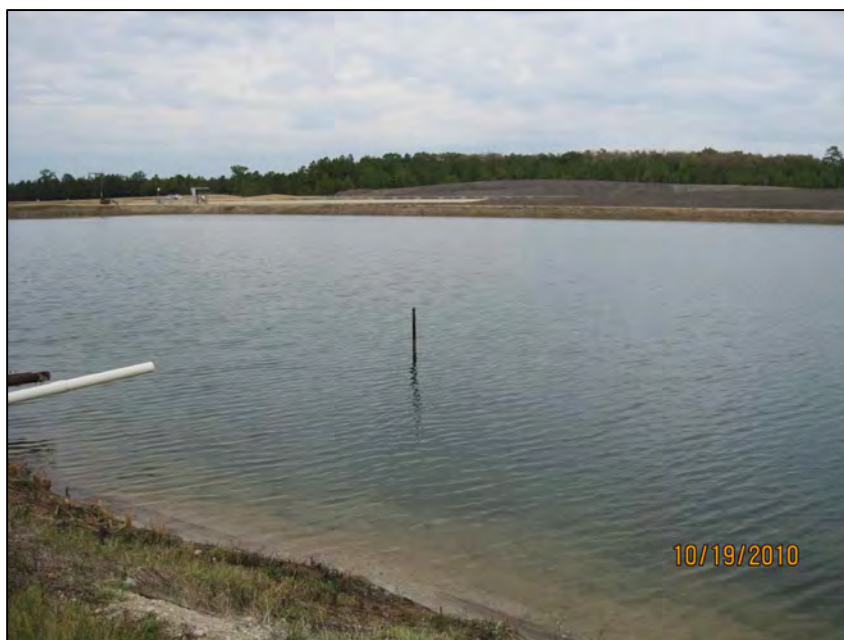
SAP-6  
FROM SOUTHEAST CORNER LOOKING NORTHWEST AT  
MARKER INDICATING LOCATION OF PLANT REUSE PIPE

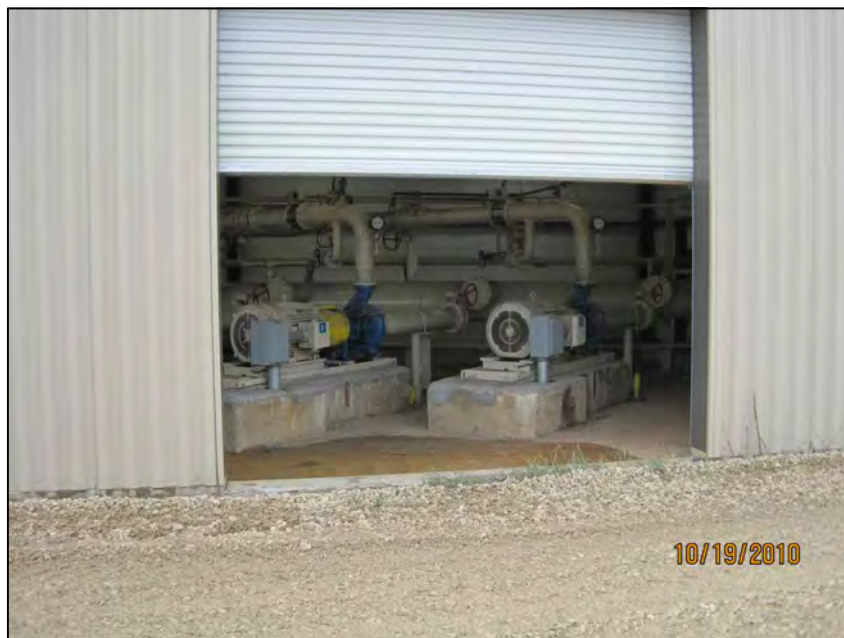
SAP-7  
REUSE PUMP HOUSE ON SOUTH SHORE OF POND

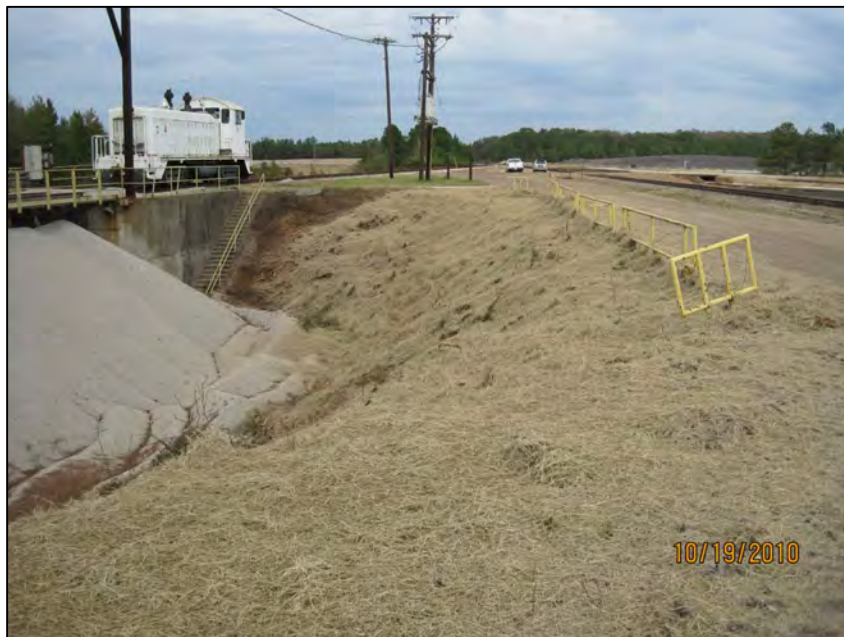
SP-3

WEST OF SURGE POND LOOKING NORTHWEST  
AT LIMESTONE UNLOADING AREA

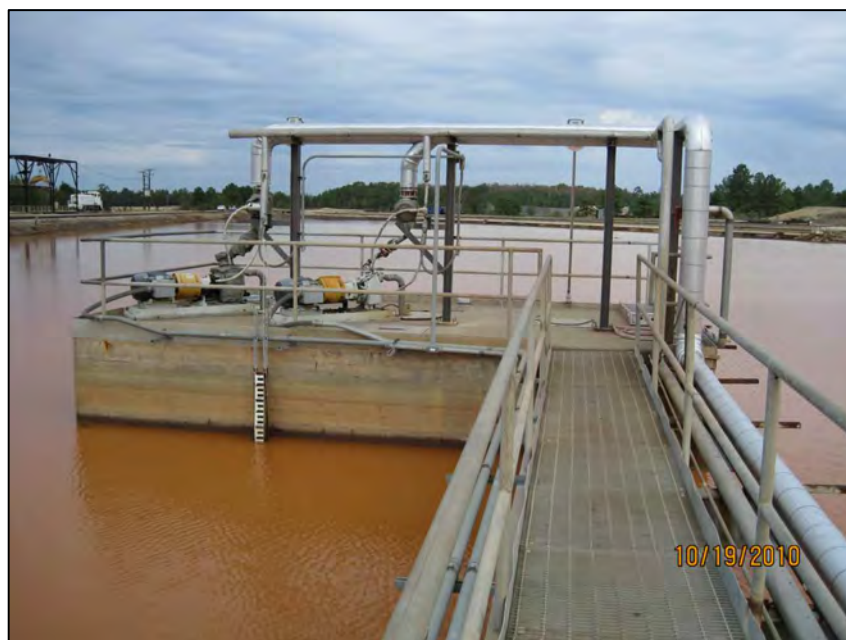
SP-6  
LOOKING NORTH SOUTH EDGE OF POND  
AT FACILITY REUSE PUMP STATION

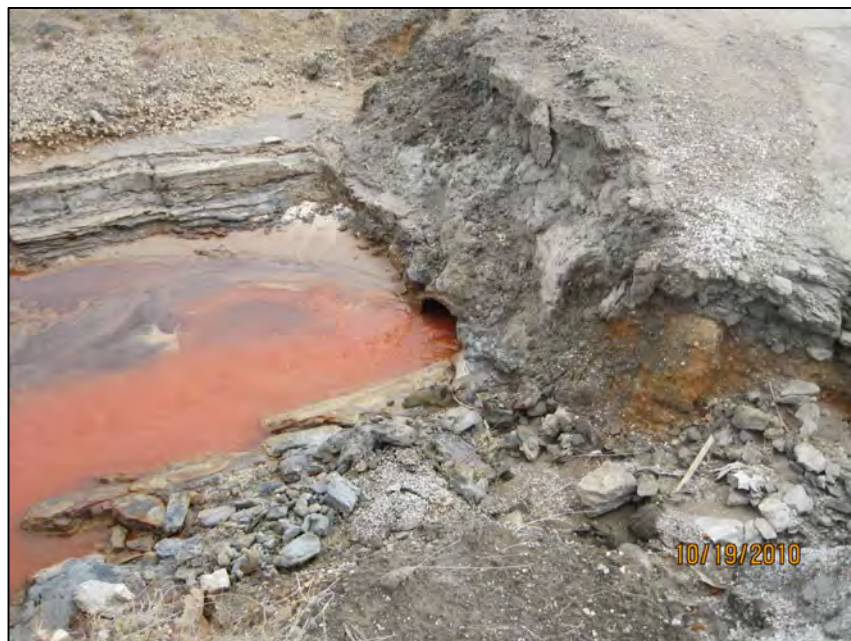
SP-7

SOUTHEAST CORNER OF POND LOOKING AT FLOWING FLUE  
GAS DESULFURIZATION PROCESS INFLUENT PIPE (18-INCH)

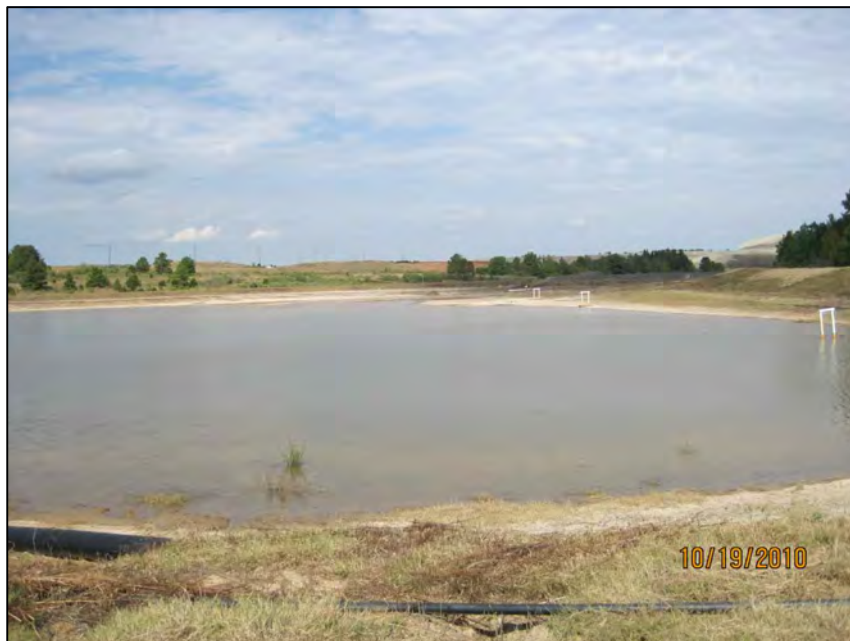
LRP-1  
LOOKING NORTH ACROSS POND FROM  
SOUTHEASTERN EMBANKMENT CREST

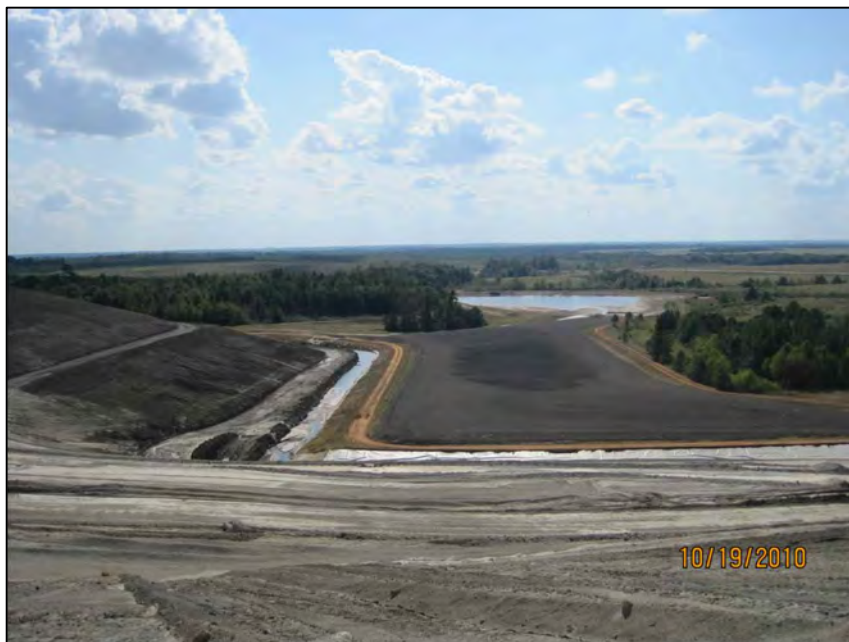
LRP-9  
ATOP LANDFILL LOOKING SOUTHWEST AT LANDFILL  
PERIMETER CHANNEL AND LANDFILL RUNOFF POND
