Assessment of Dam Safety Coal Combustion Surface Impoundments (Task 3) Final Report

American Electric Power
Big Sandy
Generating Station
Louisa, Kentucky

February 17, 2010

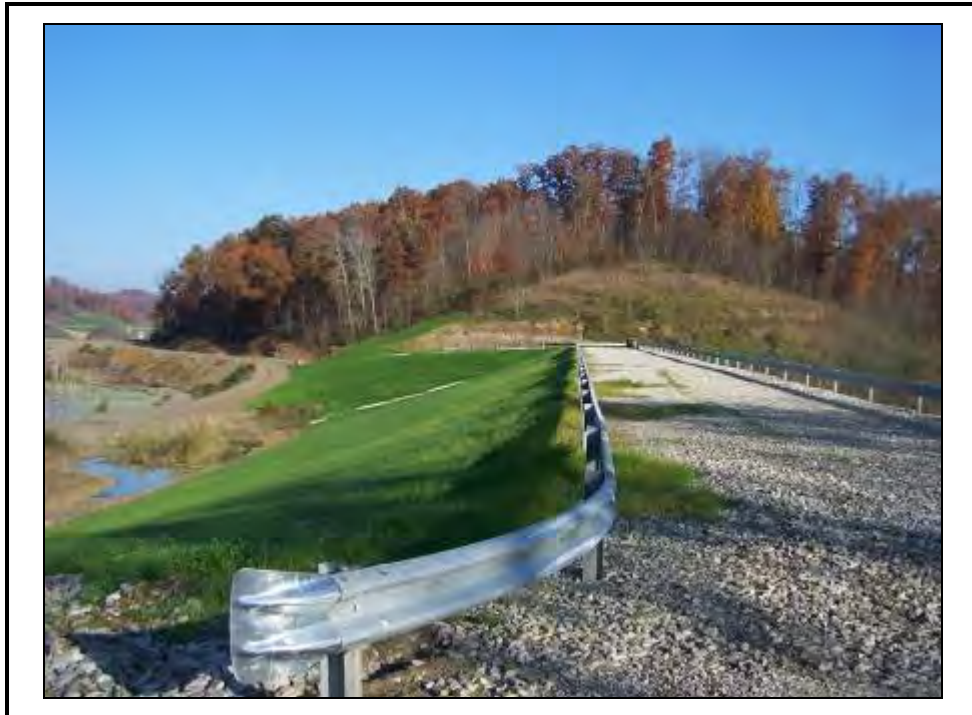
1

Crest and upstream slope of Saddle Dam, looking north.

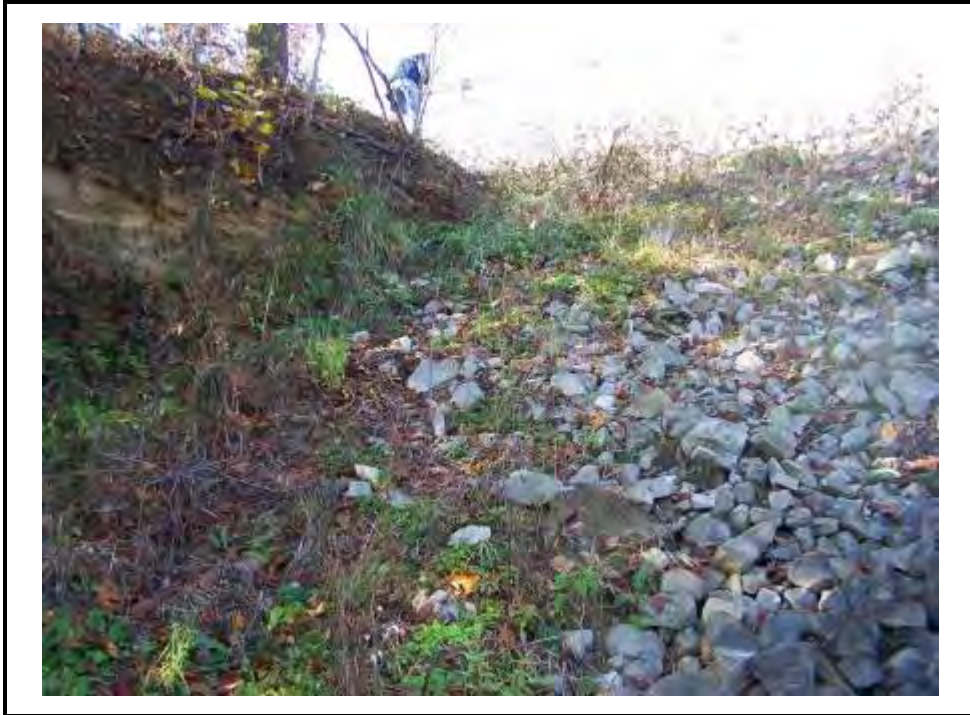
3

South groin of downstream slope and abutment at Saddle Dam.

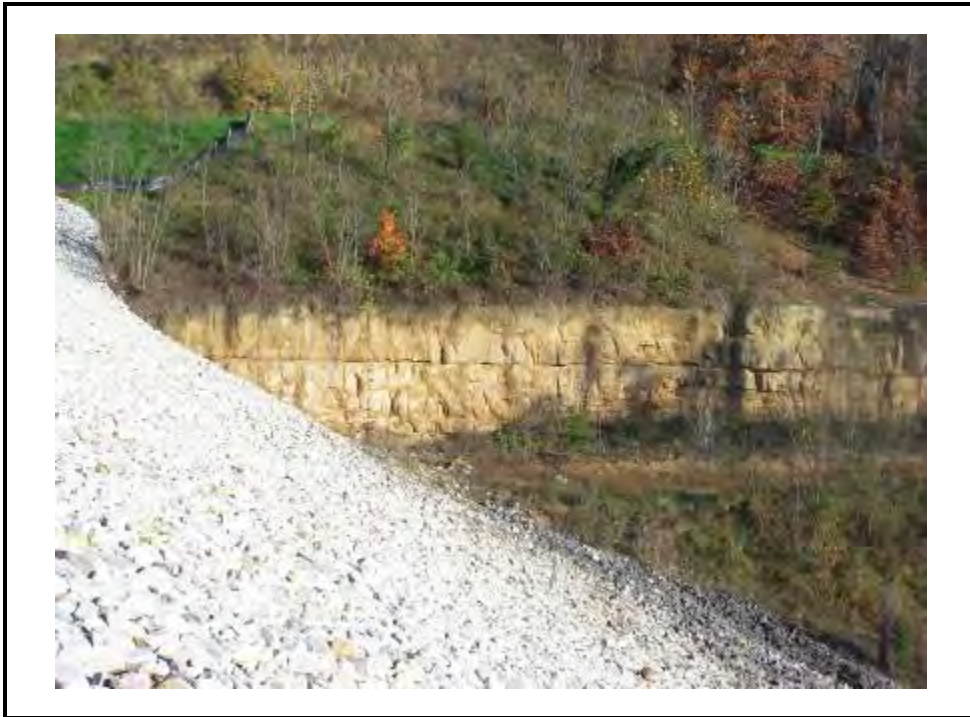
6

Downstream slope in original emergency spillway, looking north.

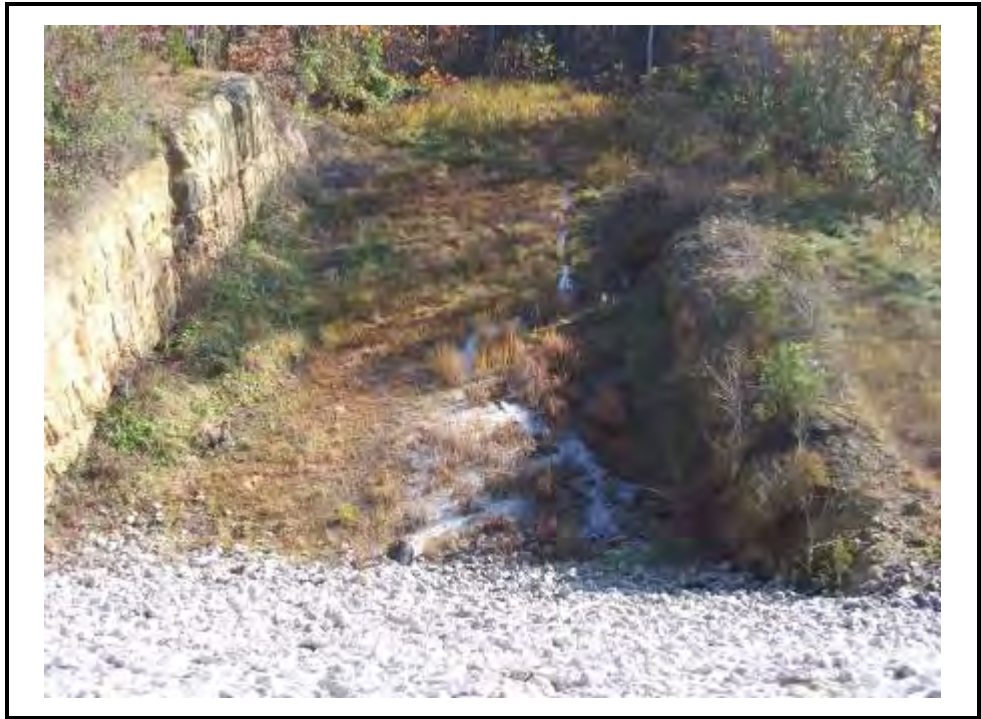
7

Original emergency spillway.
Seepage drain at approximate midpoint of channel.

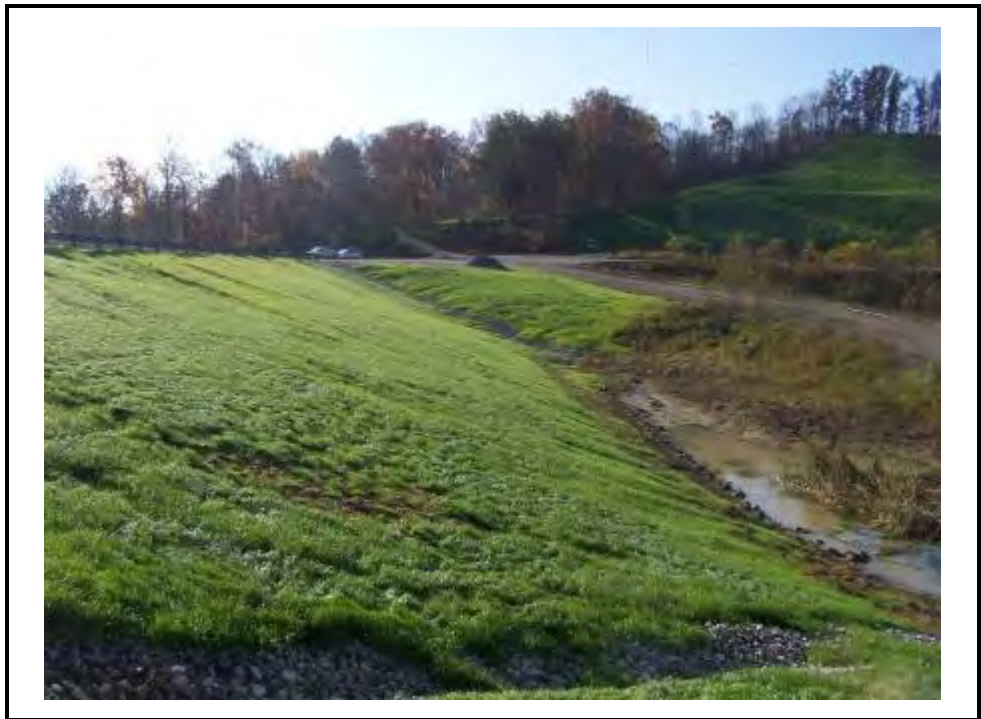
8

Upstream slope of Saddle Dam, looking south.

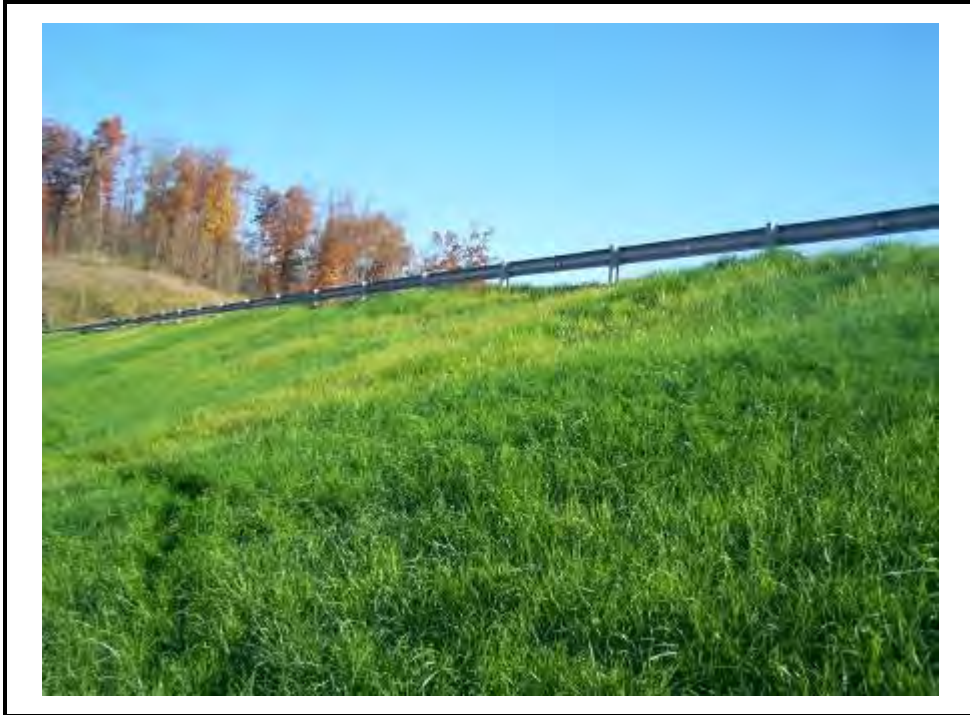
9

Irregularity to grading at upstream slope/crest intersection on Saddle Dam.

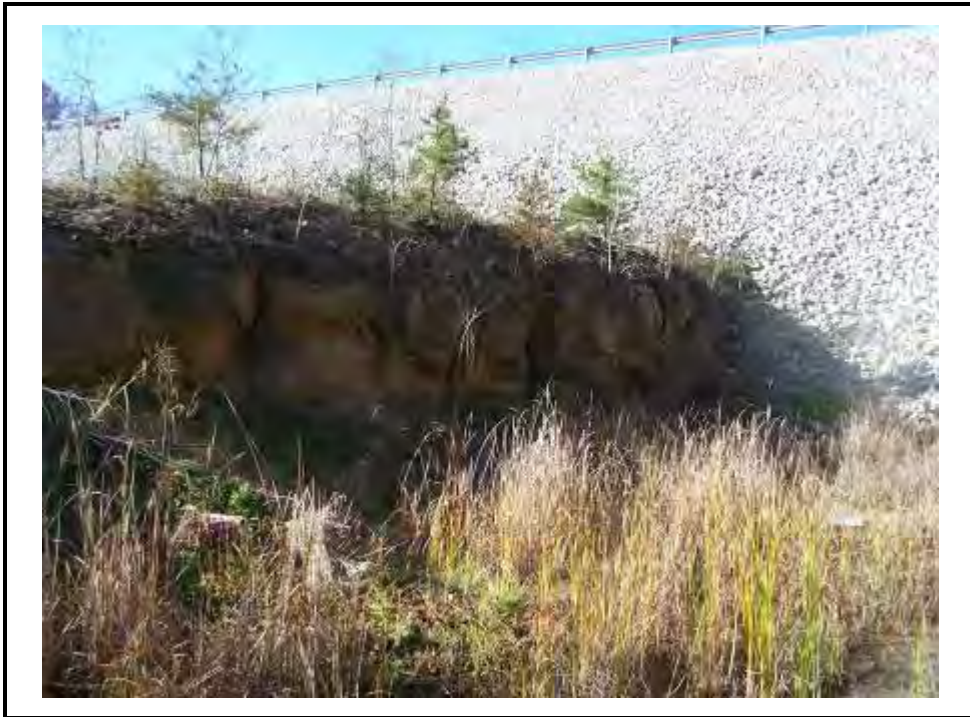
12

Downstream slope of Saddle Dam filling original emergency spillway.

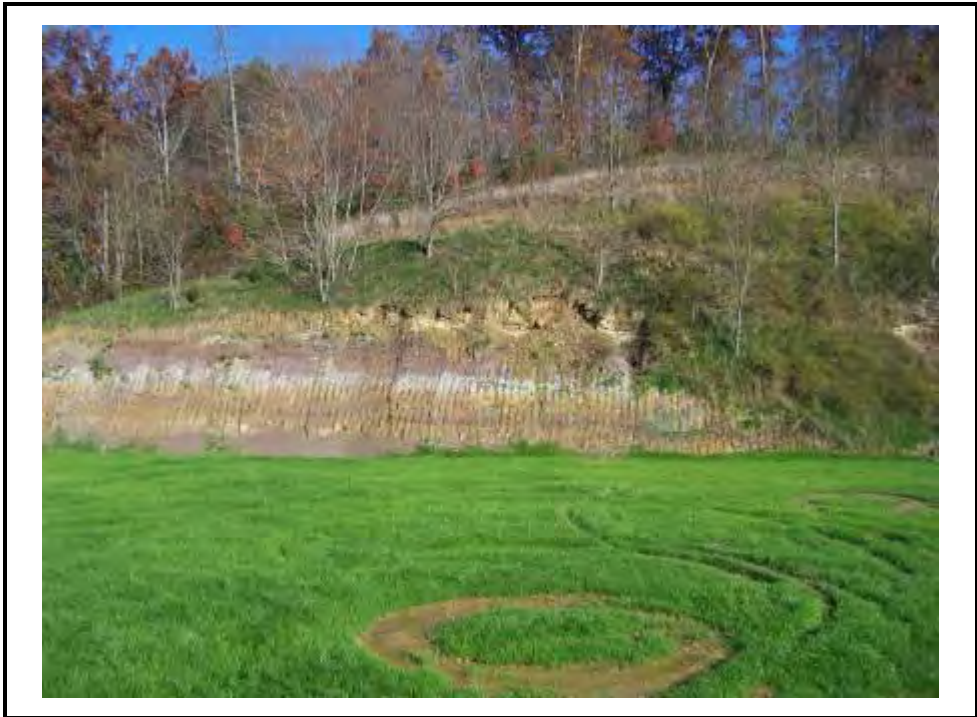
16

North abutment contact of “new” emergency spillway.

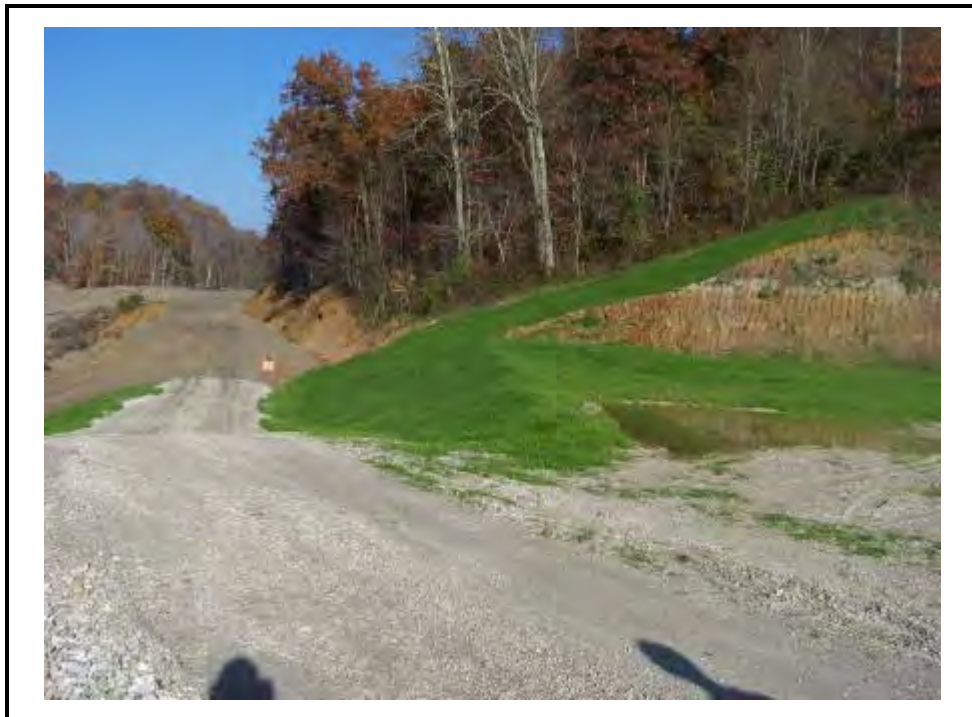
18

Entrance of "new" emergency spillway.

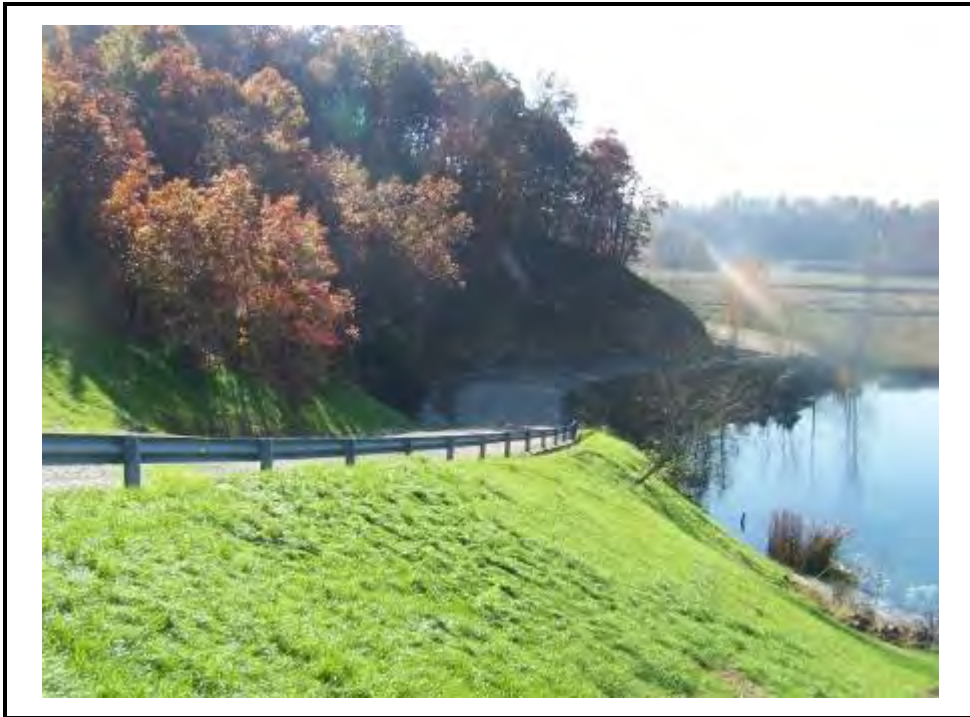
20

Access road up east abutment/Horseford Creek Dam contact, looking east.

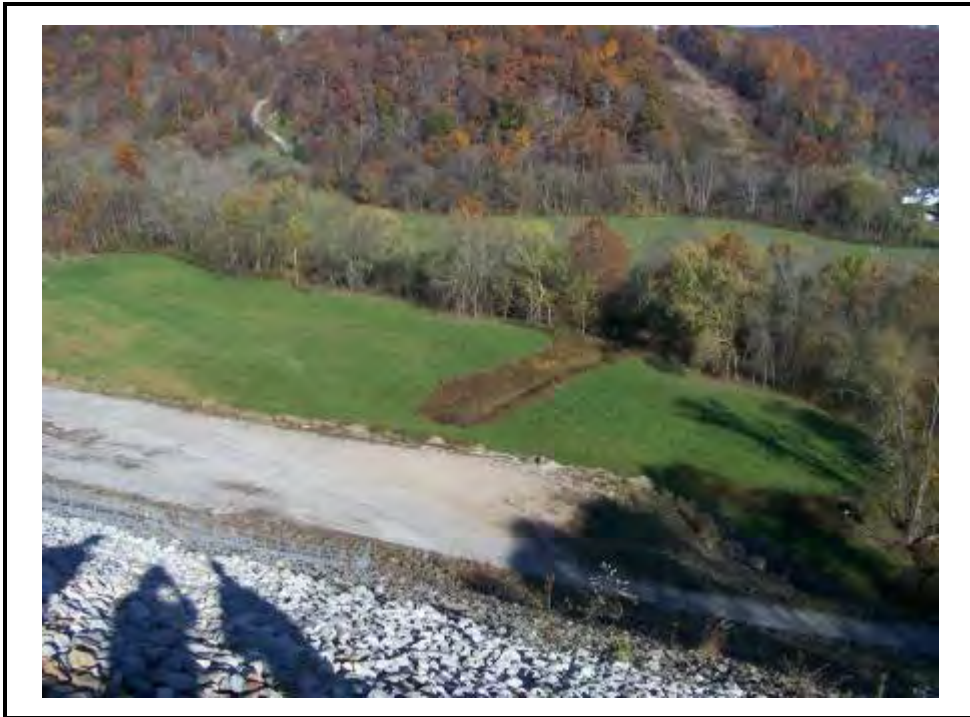
22

Downstream slope and buttress of Horseford Creek Dam looking north. Channel in field is original discharge channel which is now abandoned.

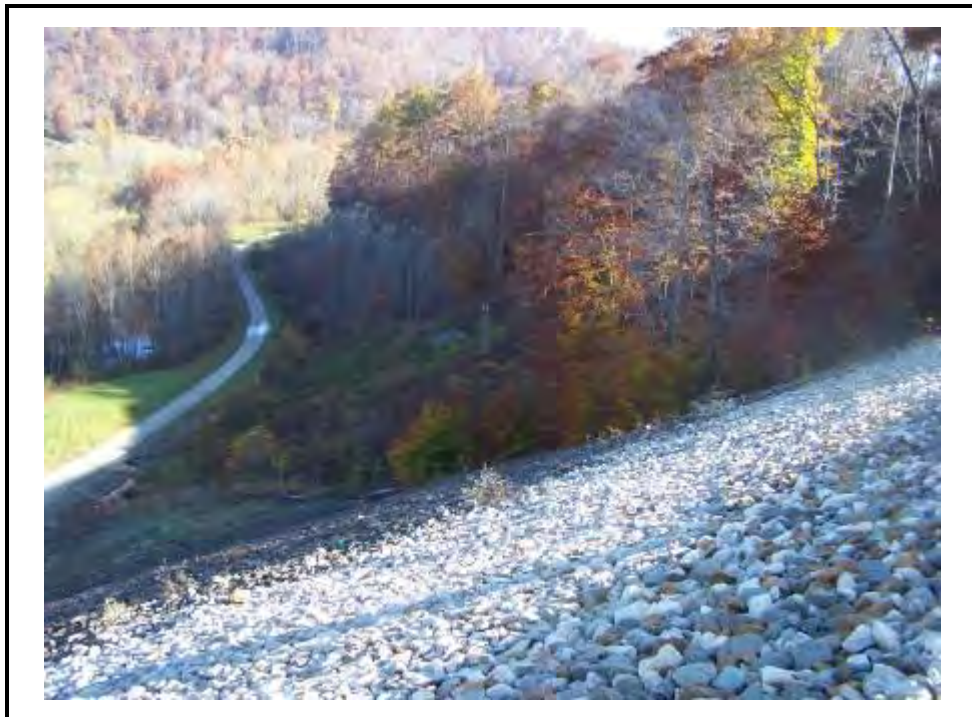
East abutment of Horseford Creek Dam, looking northeast.

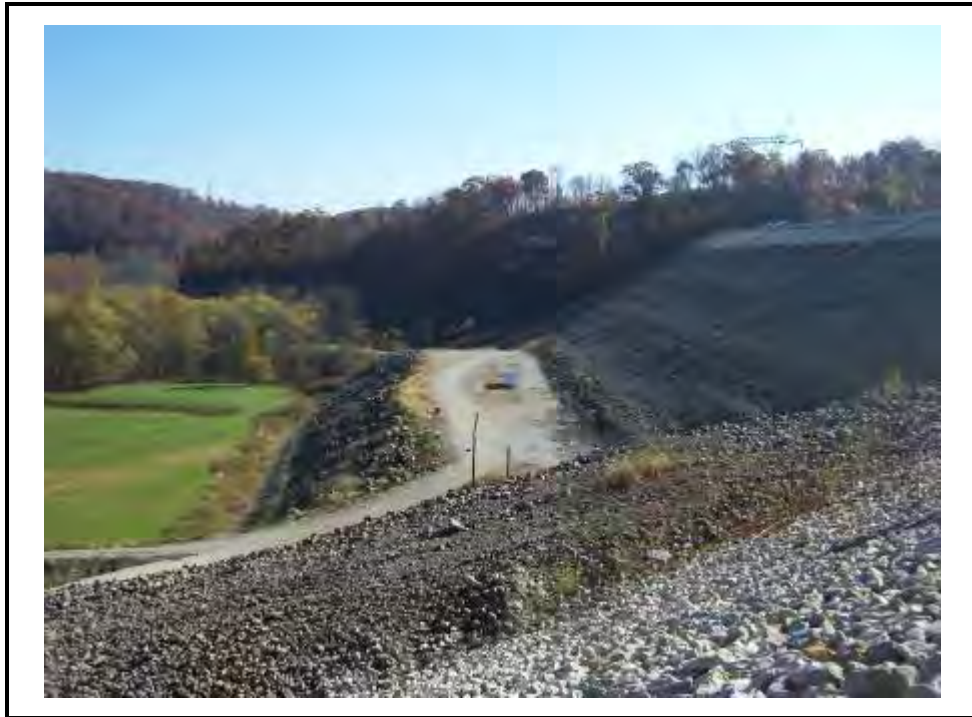
Downstream slope and buttress of Horseford Creek Dam, looking east.

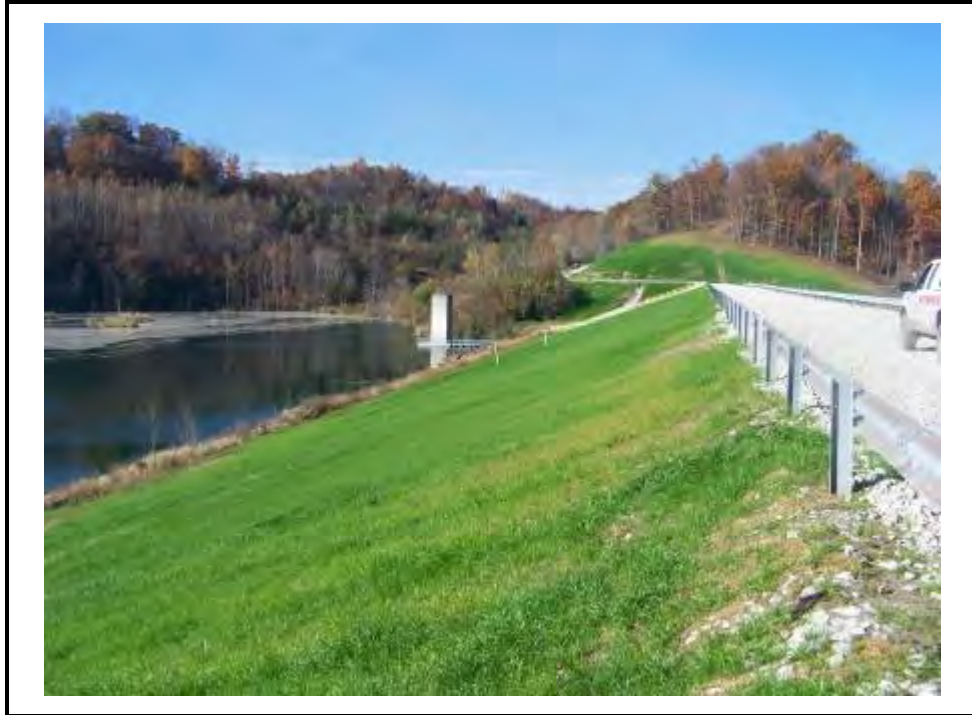
Upstream slope of Horseford Creek Dam, looking east.

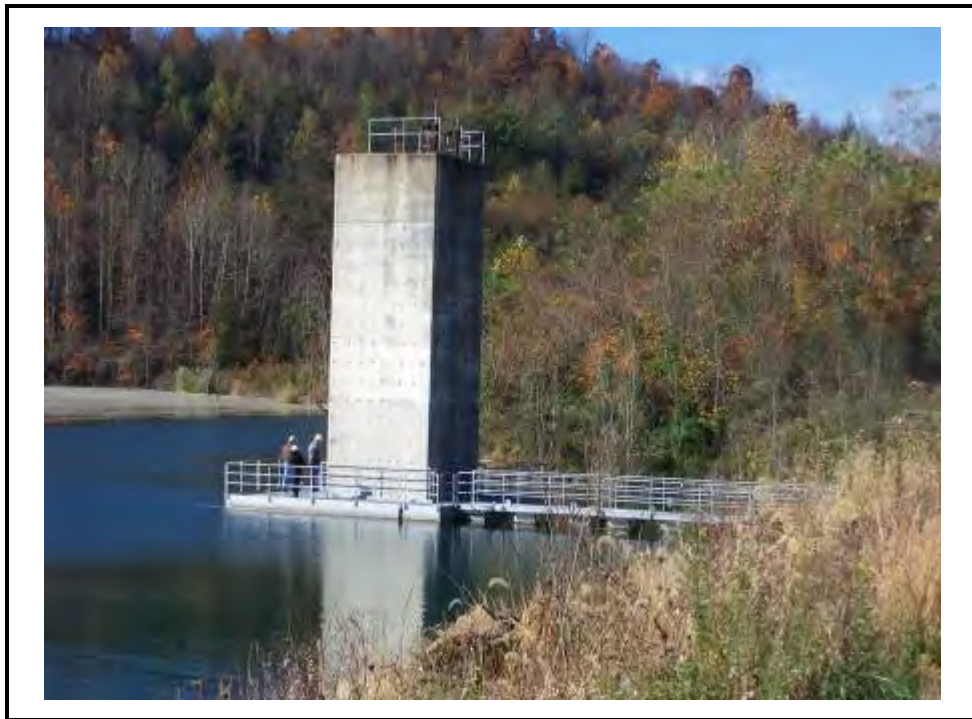
Outlet structure near west end of Horseford Creek Dam.

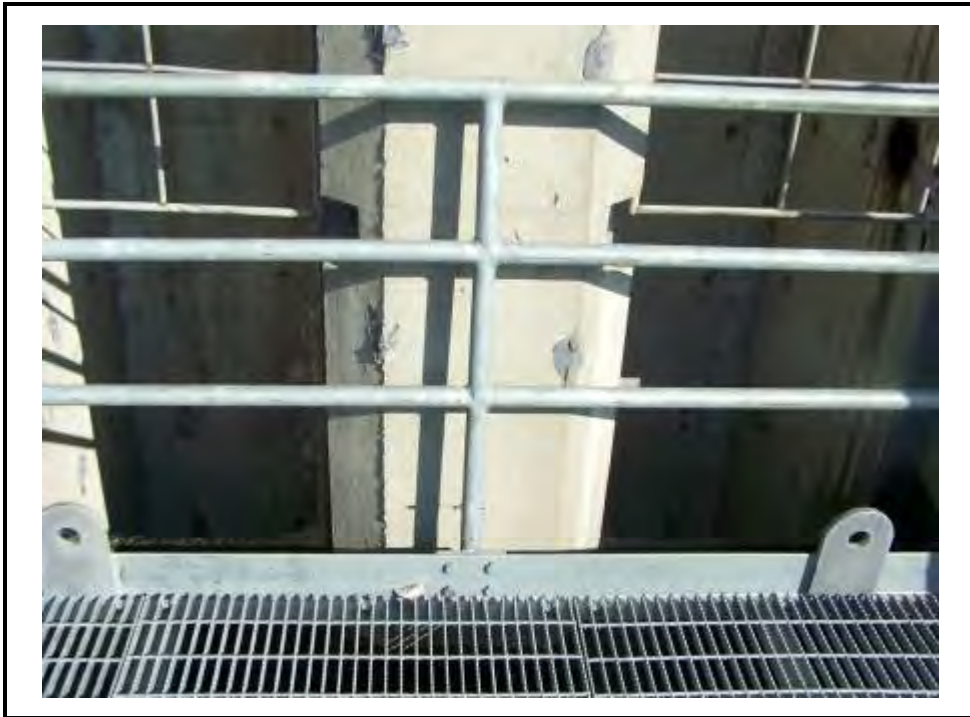
Twin stop log opening at Horseford Creek Dam outlet structure.

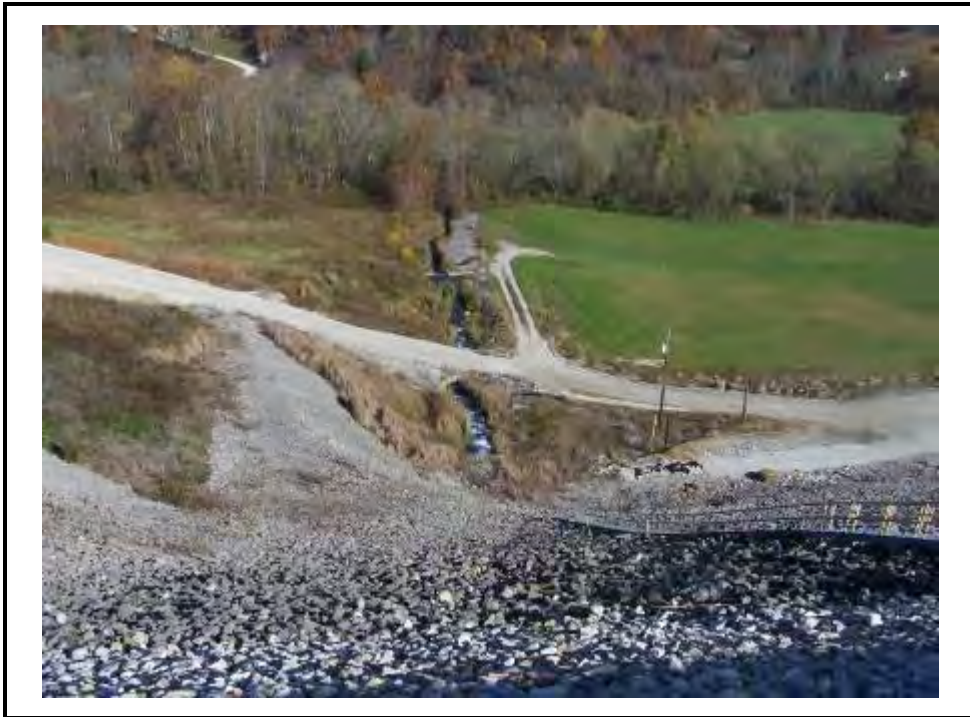
Discharge channel for Horseford Creek Dam.

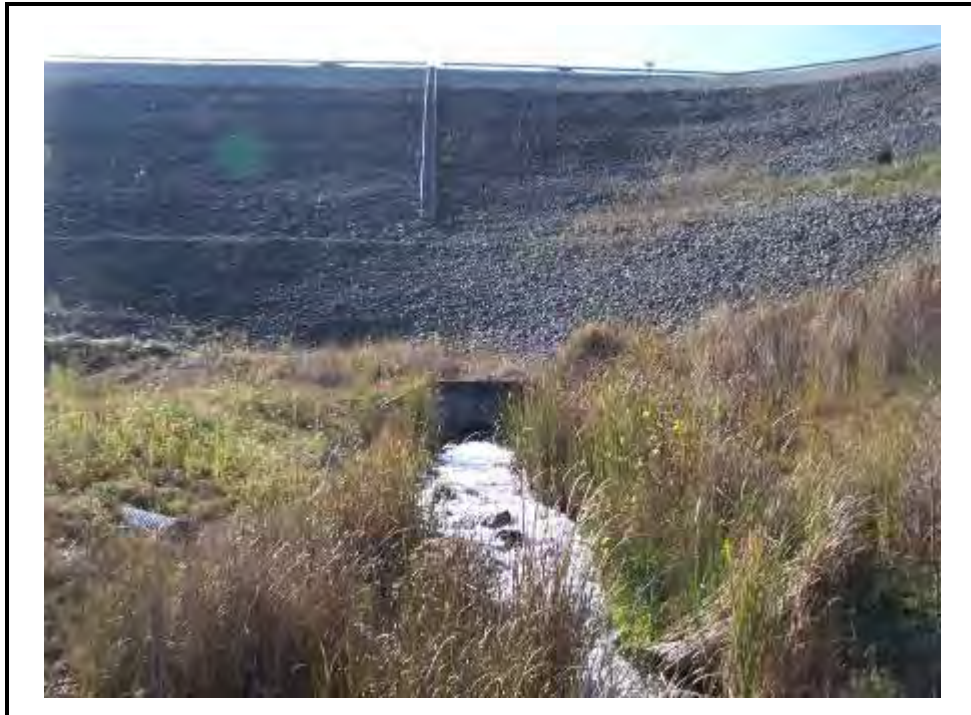
Discharge pipe at toe of Horseford Creek Dam.
Stairs on slope provide access to instrumentation.

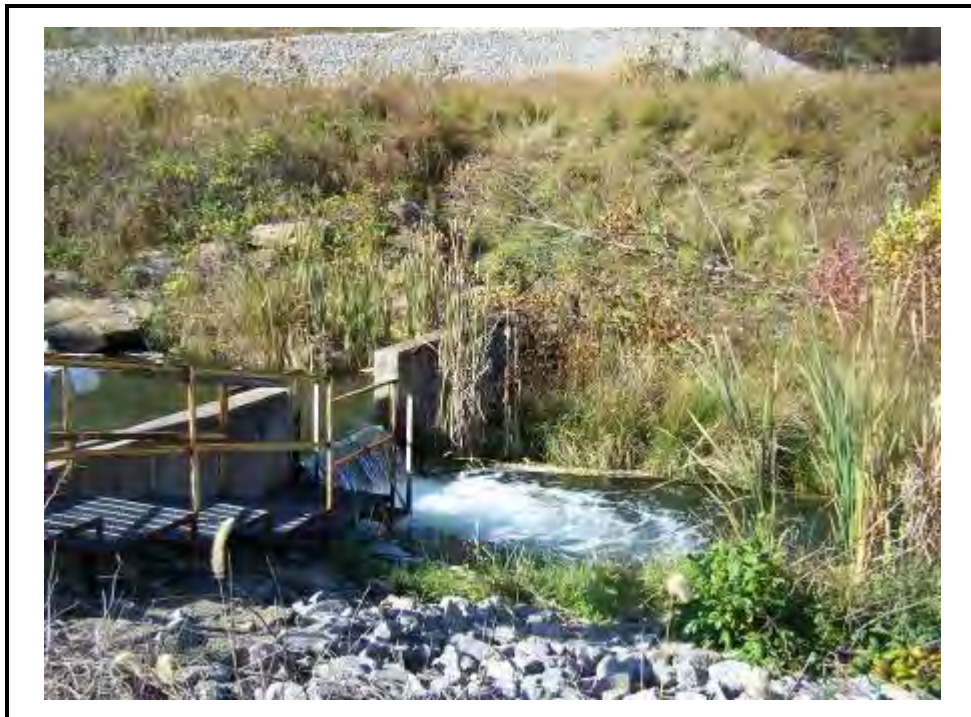
Stilling basin and NPDES outfall for Horseford Creek Dam outlet.

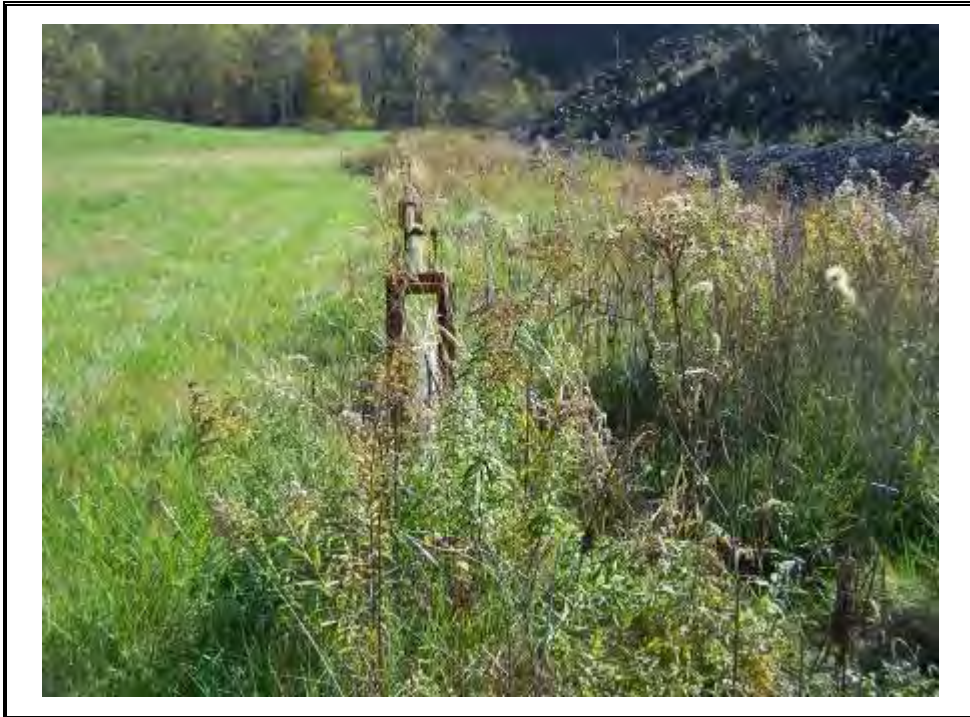
Relief wells part of Horseford Creek Dam toe drain system.
Area in taller grass is wet from seepage.

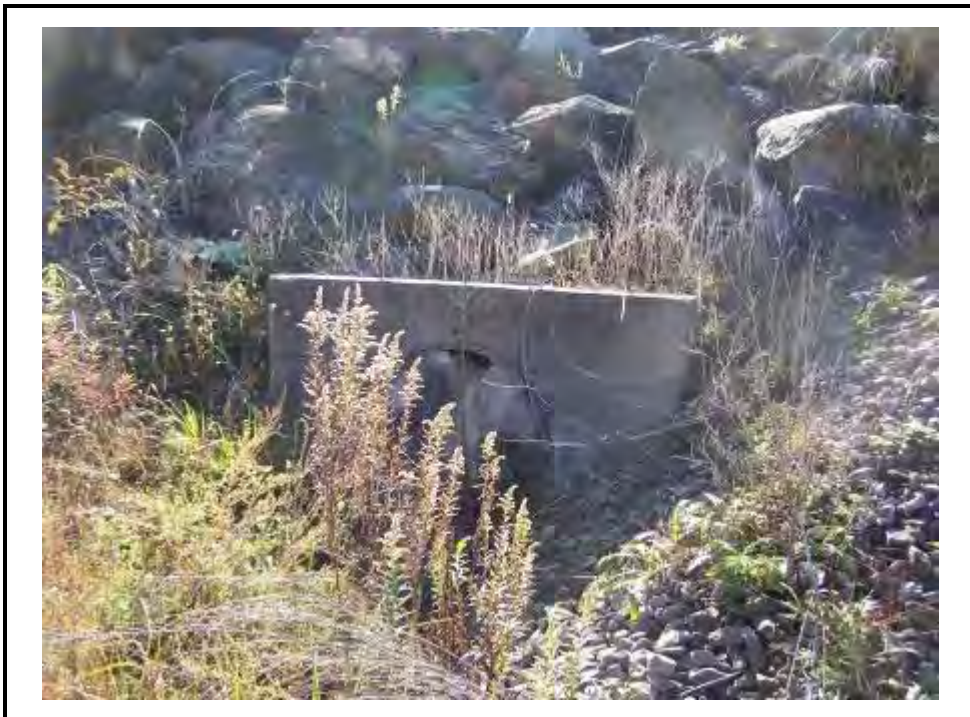
Phase I outlet pipe was abandoned in place.

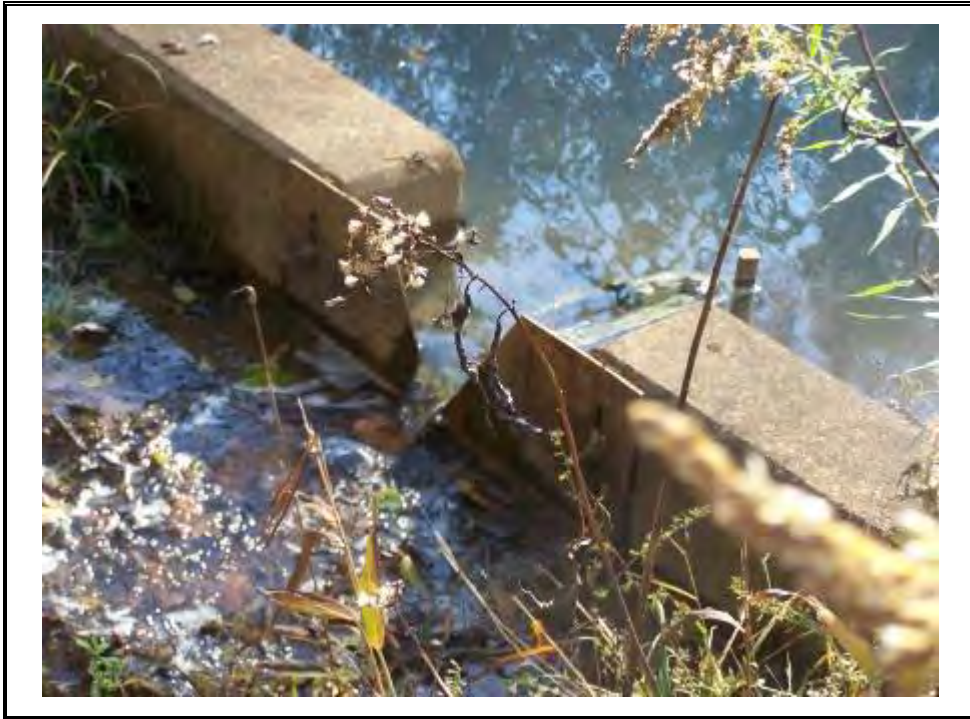
Monitoring weir at east abutment and toe drain discharge area.

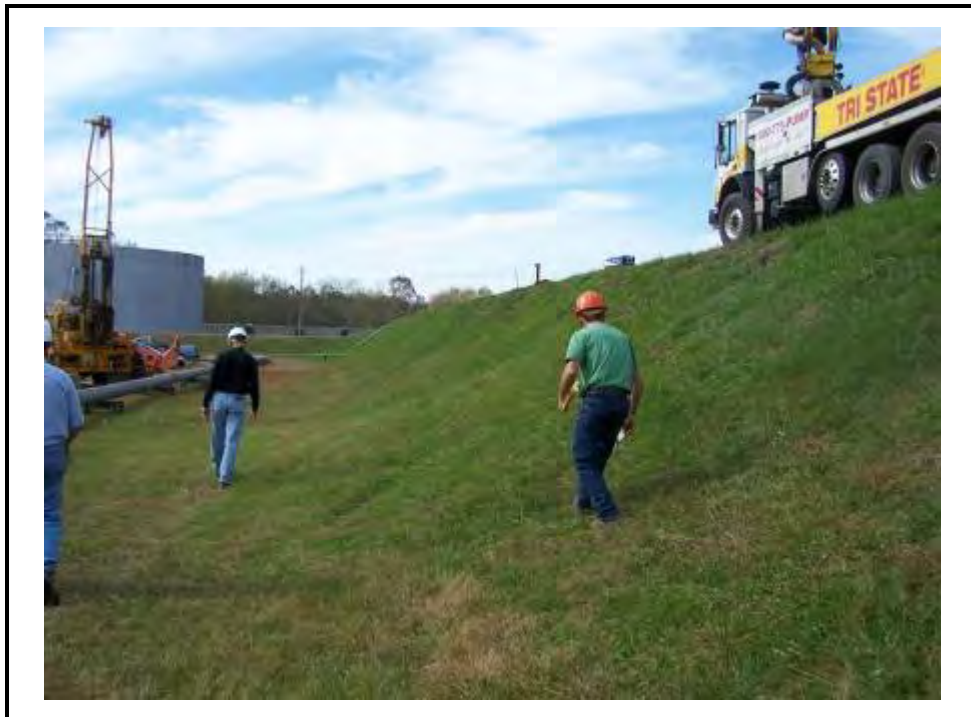
Downstream slope of South Dike at the Bottom Ash Complex along the south Bottom Ash Pond.

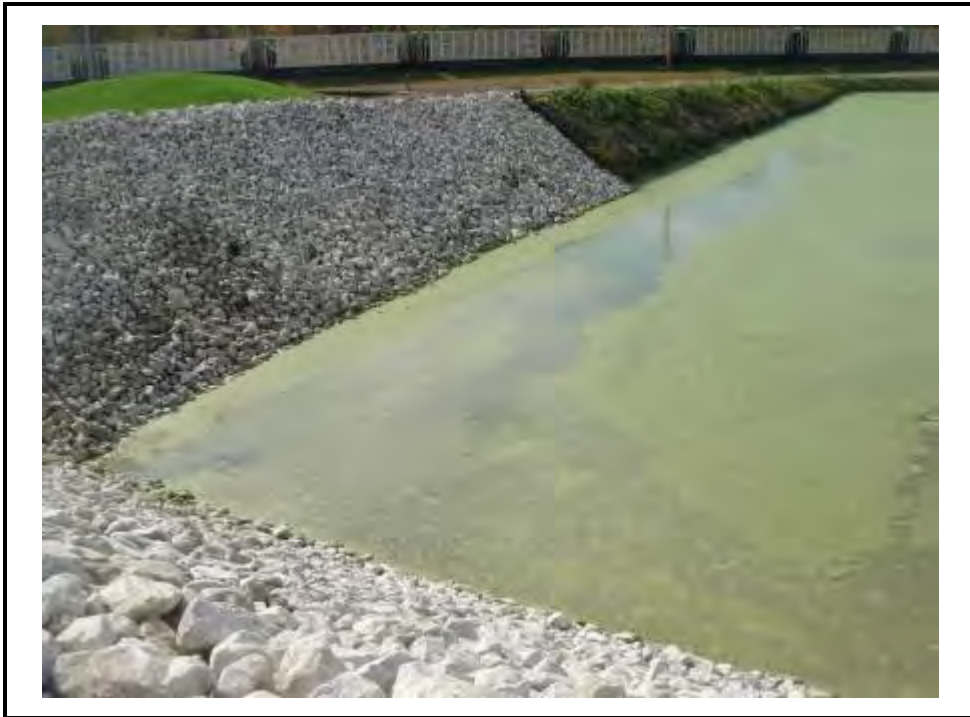
Upstream slope of South Dike of Bottom Ash Complex at south Clearwater Pond, recently placed rip rap protection at east end.

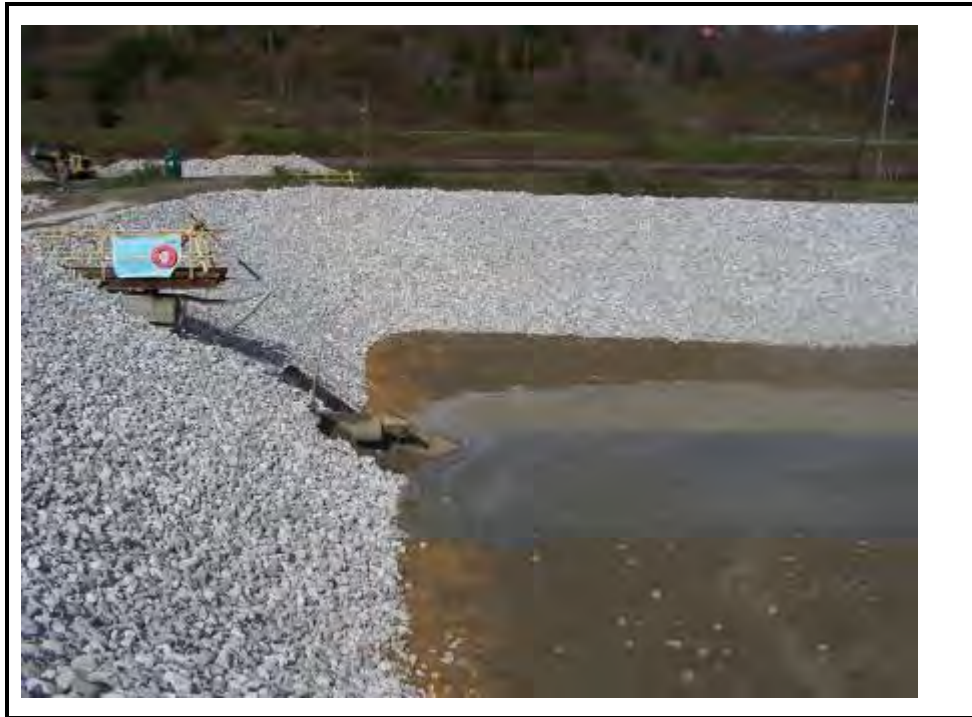
Decant structure (platform near top of slope) and pond drain (pipe near bottom of slope) from south Bottom Ash Pond into south Clearwater Pond.

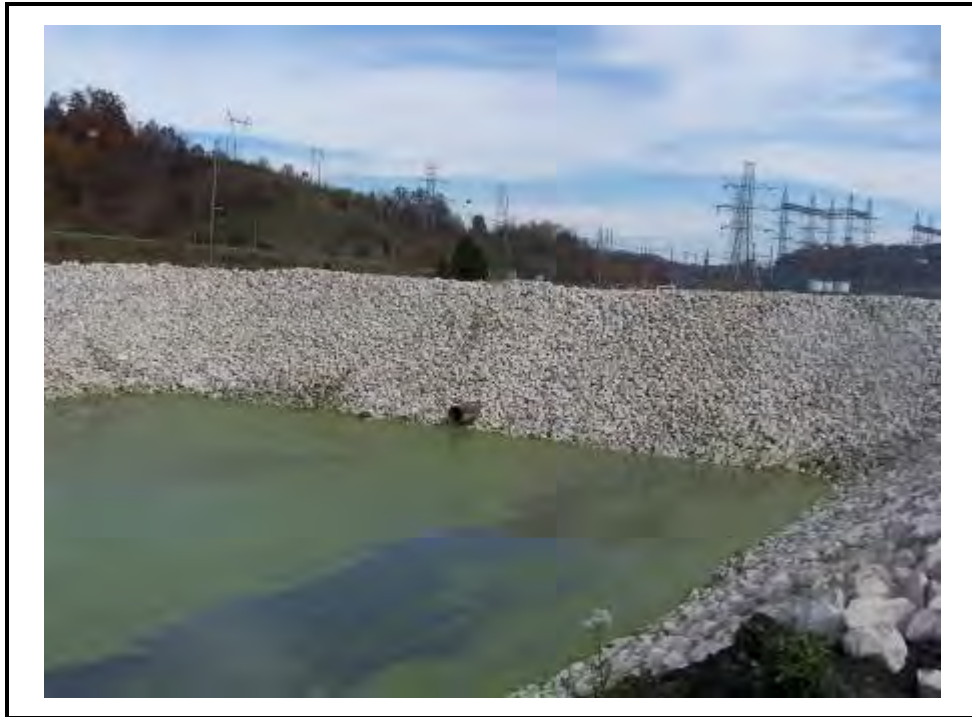
Discharge from South Bottom Ash Pond into South Clearwater Pond.

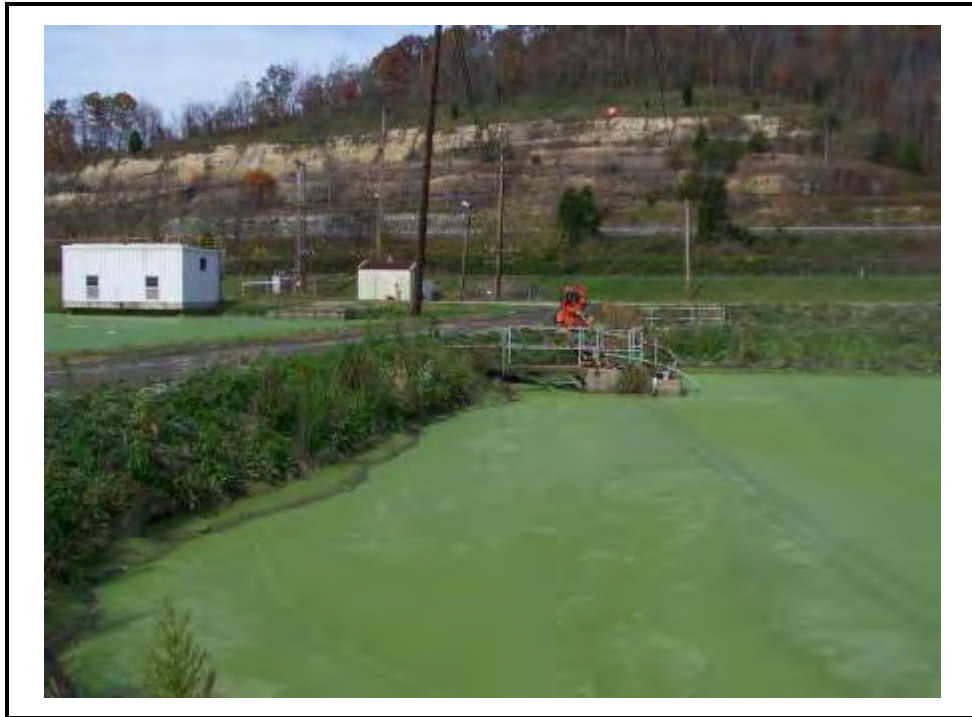
Splitter Dike between south Clearwater Pond (right side of photo) and the Reclaim Pond (upper left of photo).

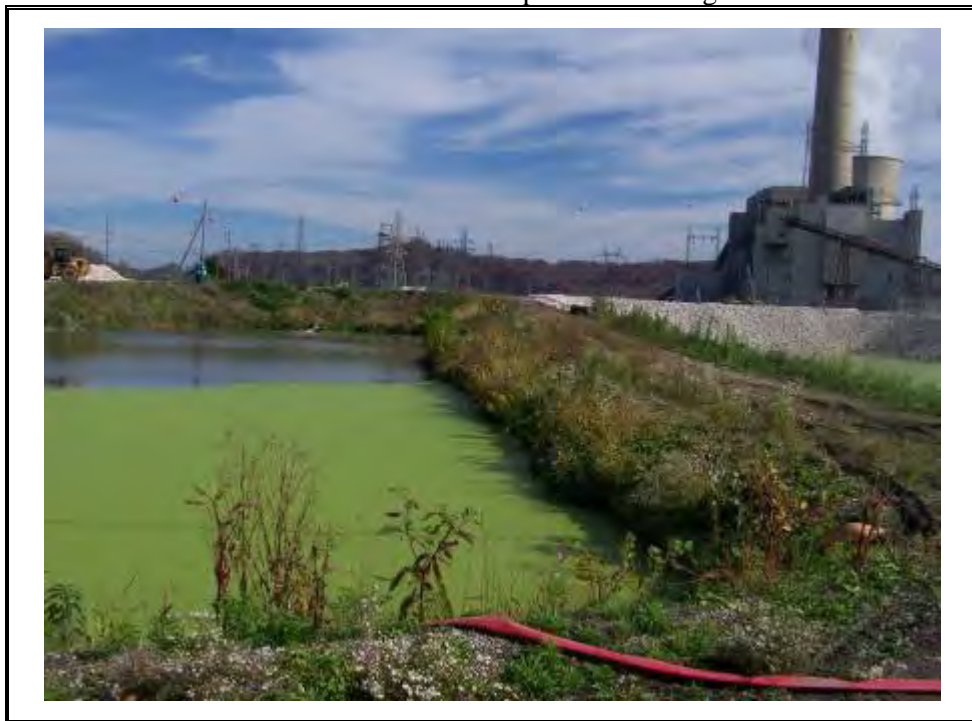
North side of Splitter Dike between north and south Clearwater Ponds, looking east.

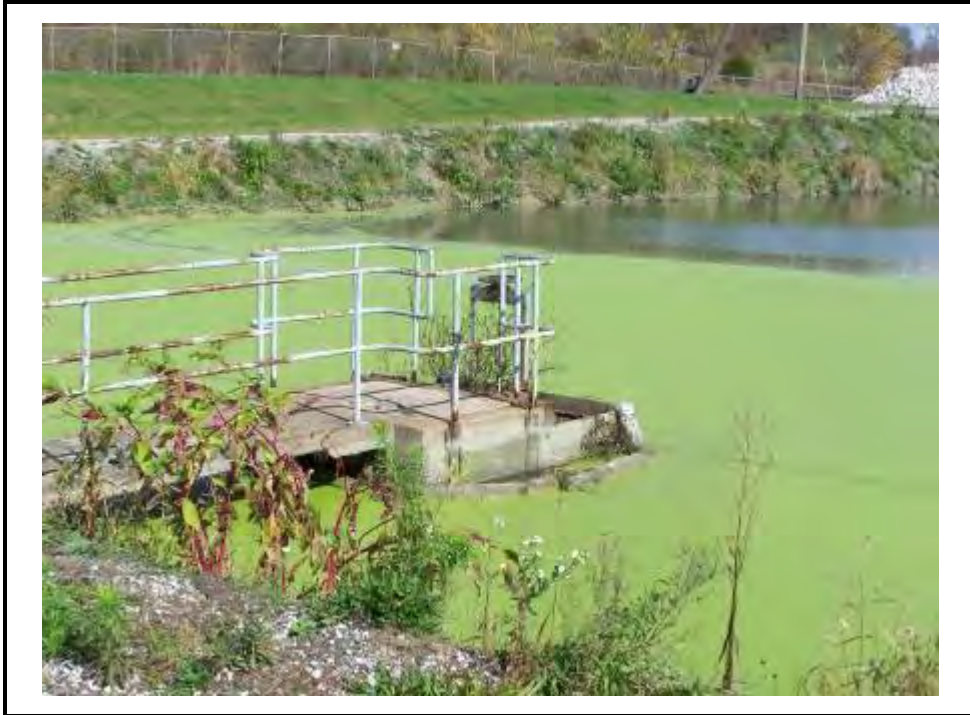
Discharge structure from north Clearwater Pond to Reclaim Pond and upstream slope of North Dike of Bottom Ash Complex. Note crest of North Dike slopes down to the west.

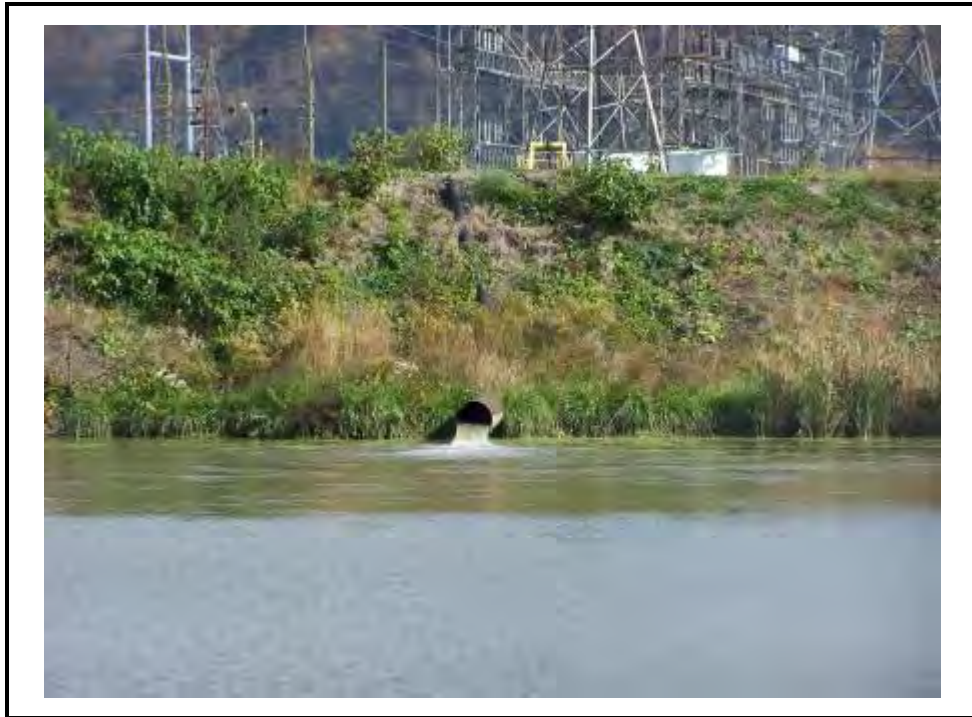
West slope of Splitter Dike between North Bottom Ash and Clearwater Ponds showing discharge pipe from North Bottom Ash Pond.

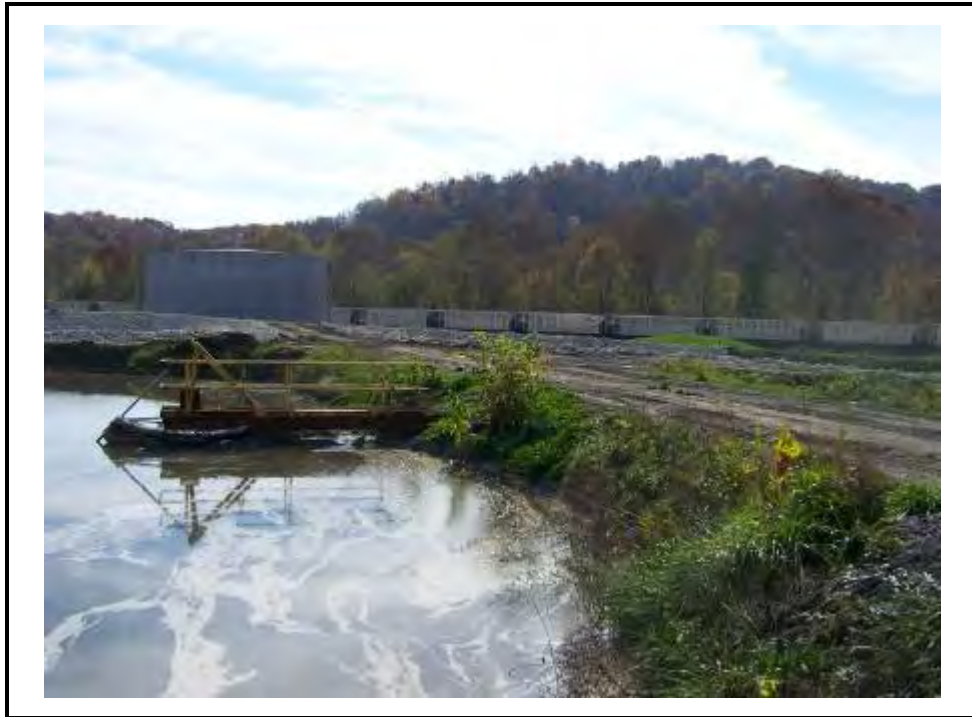
East slope of Splitter Dike between north Bottom Ash and Clearwater Ponds and decant structure.

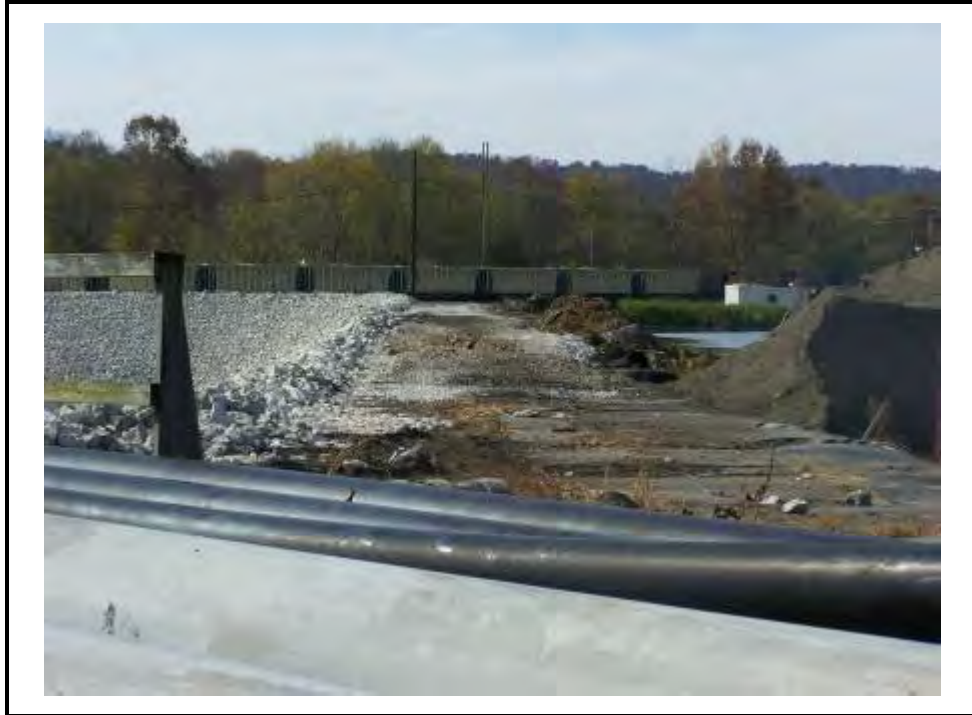
Crest of Splitter Dike between south Bottom Ash and south Clearwater Ponds.
