Assessment of Dam Safety Coal Combustion Surface Impoundments (Task 3) Final Report

American Electric Power
Big Sandy
Generating Station
Louisa, Kentucky

February 17, 2010

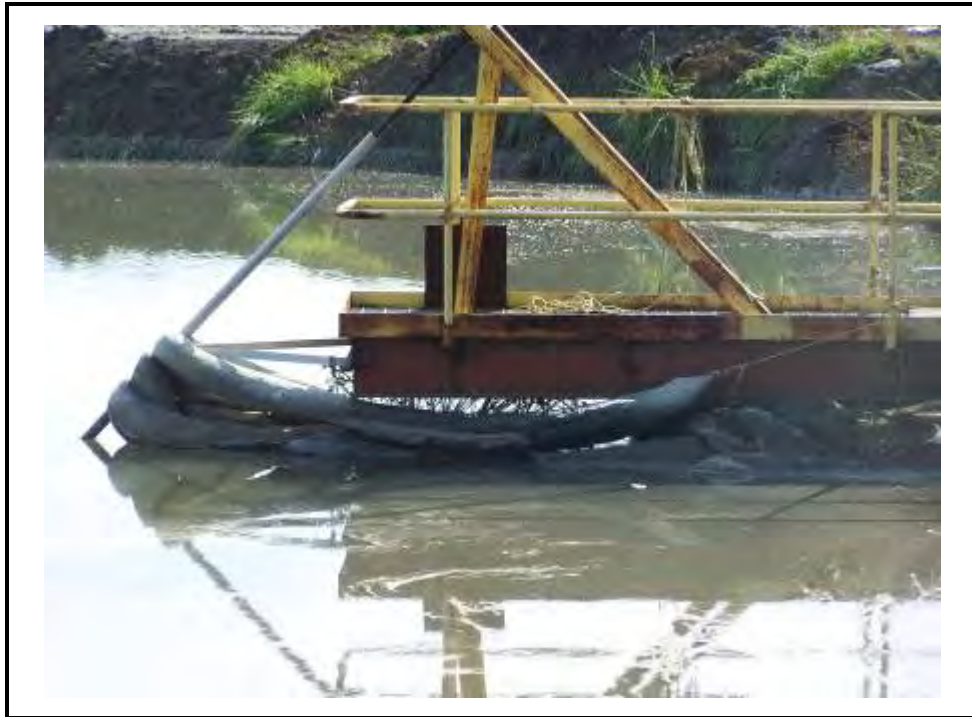
Close-up of decant structure in north Bottom Ash Pond.

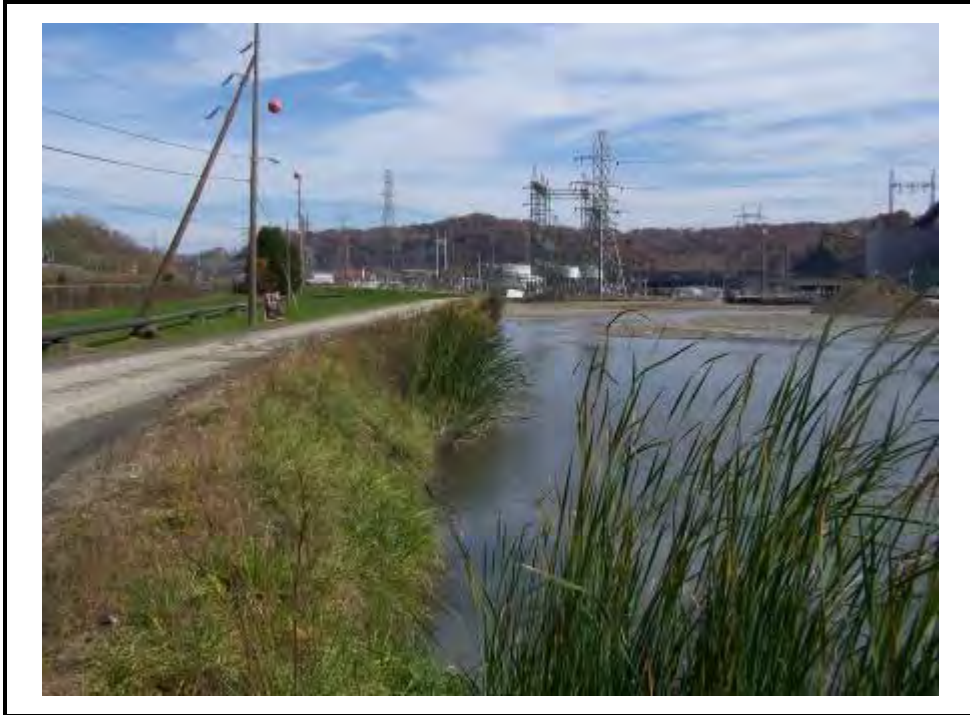
Upstream slope of North Dike at the Bottom Ash Complex adjacent to north Bottom Ash Pond, looking east.

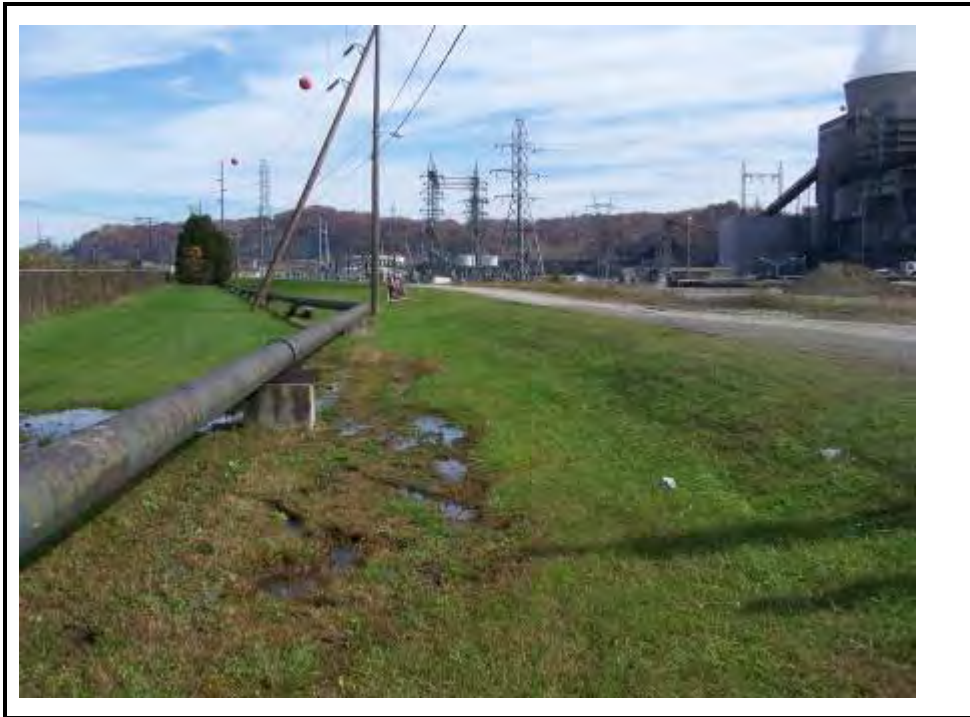
Downstream slope of North Dike and Bottom Ash Complex adjacent to north Bottom Ash Pond, looking east.
Note that the north side of the Bottom Ash Complex is largely incised.

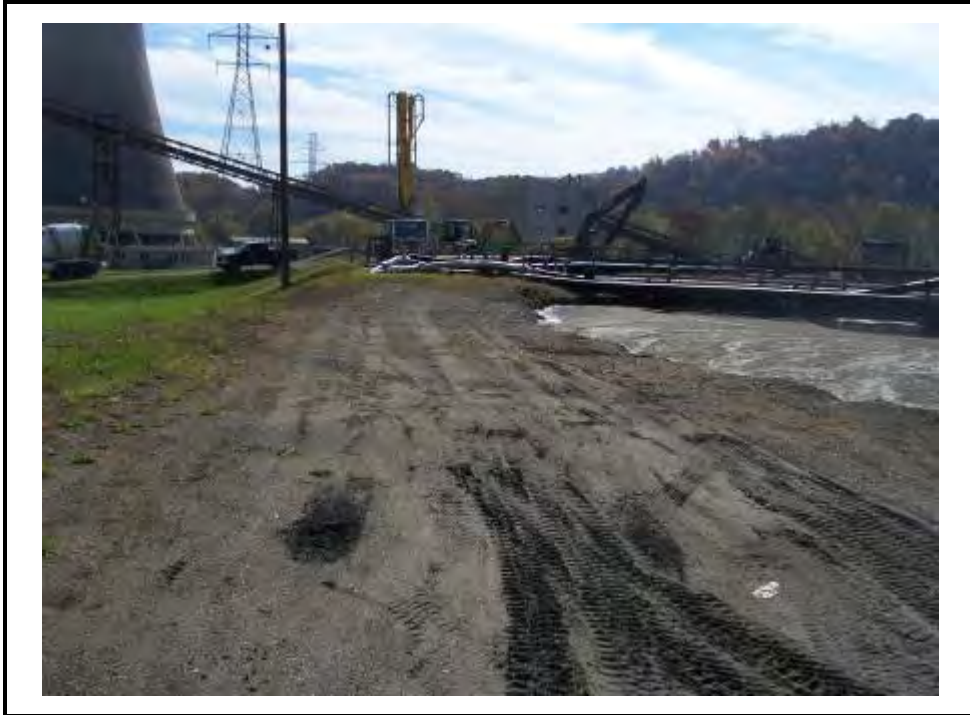
Crest of East Dike of the Bottom Ash Pond, looking south.

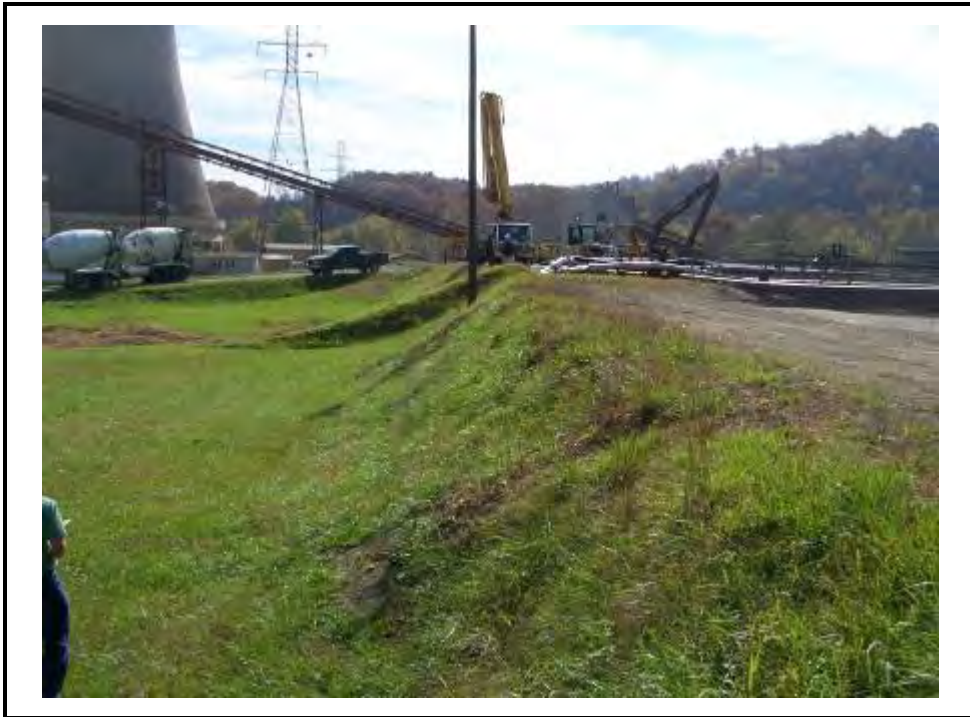
Downstream slope of East Dike of the Bottom Ash Pond, looking south.

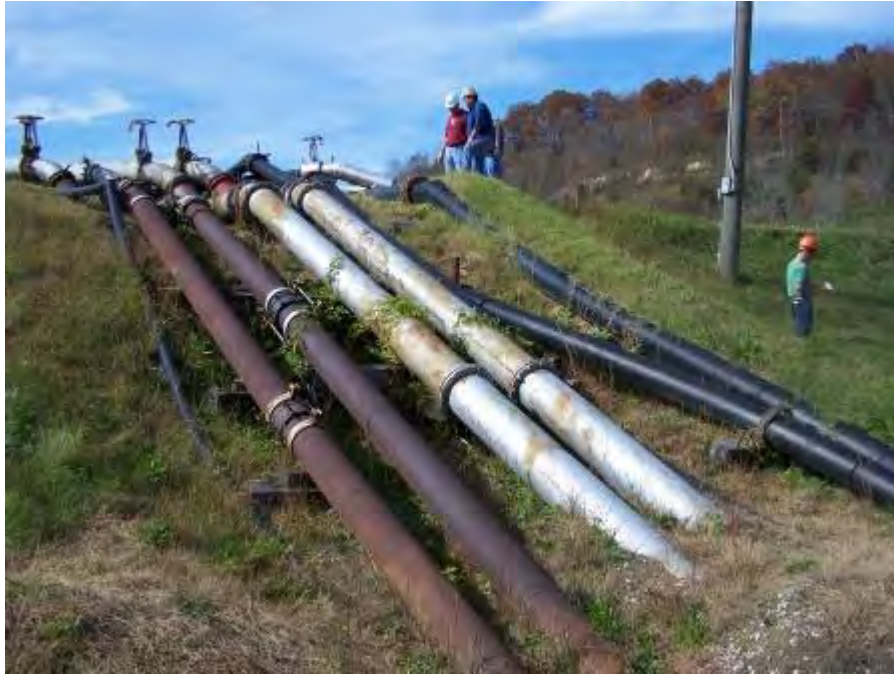
Sluice lines on downstream slope of East Dike.

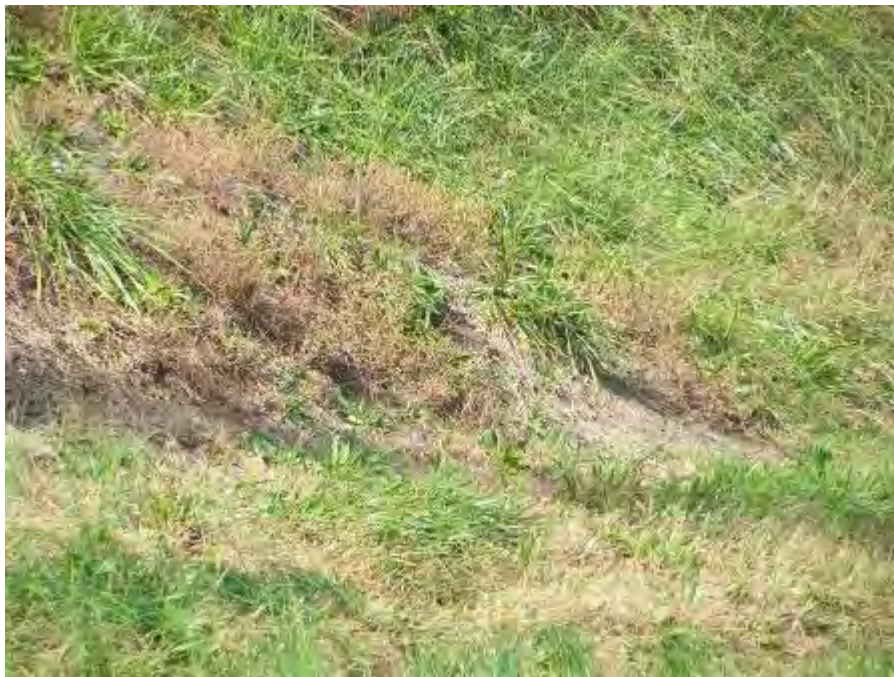
Minor sloughing or erosion on downstream slope of East Dike.
