# Assessment of Dam Safety Coal Combustion Surface Impoundments Draft Report

American Electric Power  
General James Gavin  
Power Plant  
Cheshire, Ohio

July 2, 2009

CHA Project No. 20085.4000.1510

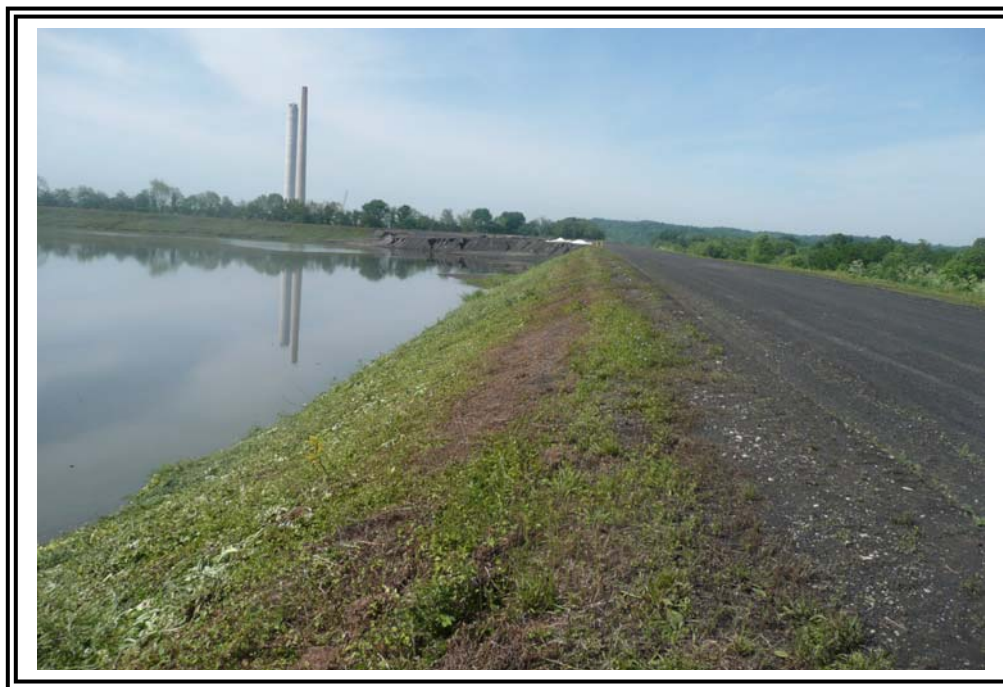
1

Upstream slope of the west dike, looking south.

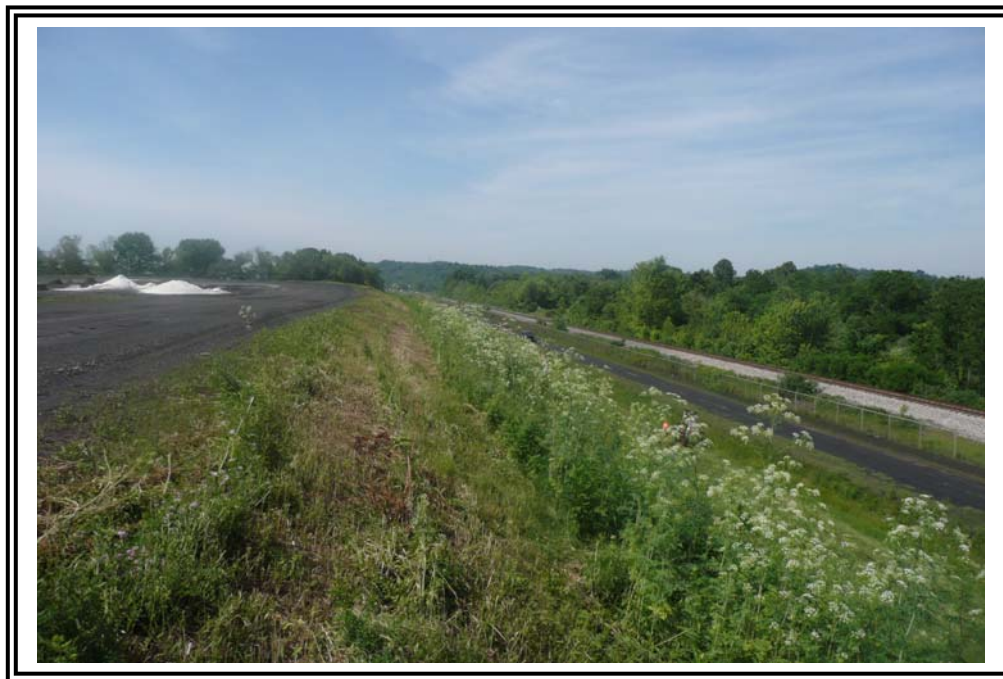
4

Downstream slope of the west dike, looking south. Note that weed-whacking was in progress and is reportedly performed twice a year.

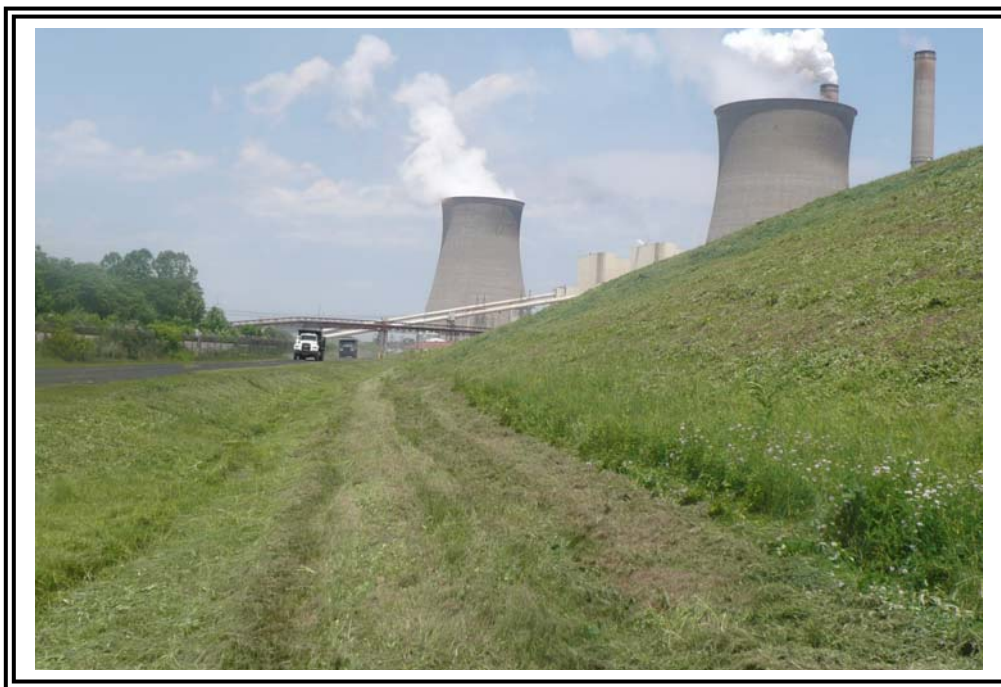
5

Downstream toe of the west dike, looking north.

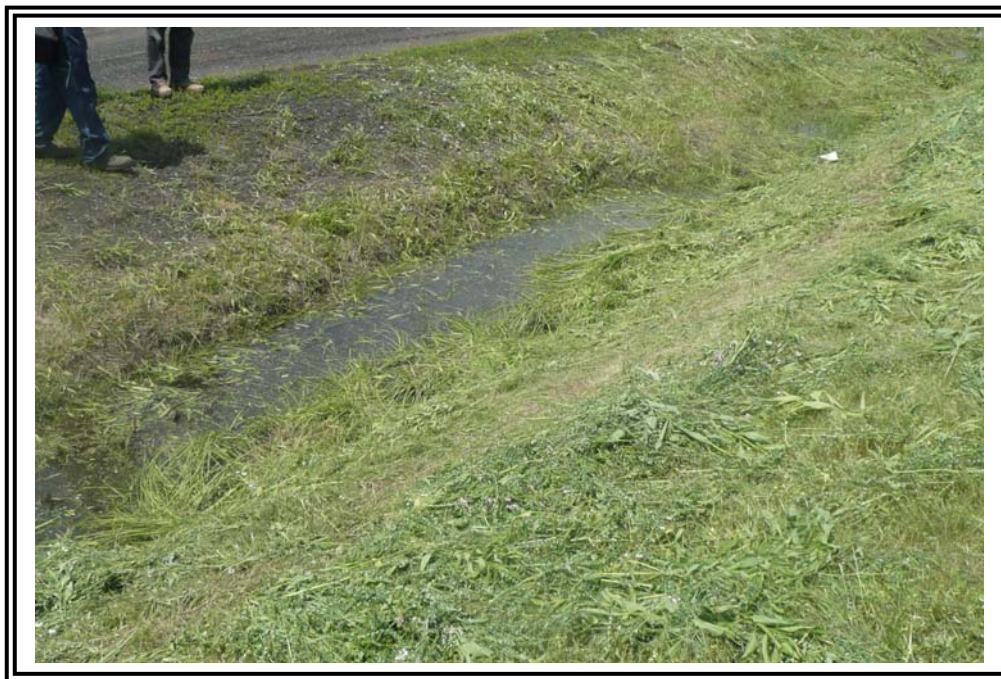
6

Standing water in drainage swale at toe of west dike. Appears related to surface water runoff. Piezometer readings confirm groundwater is well below the ground surface.

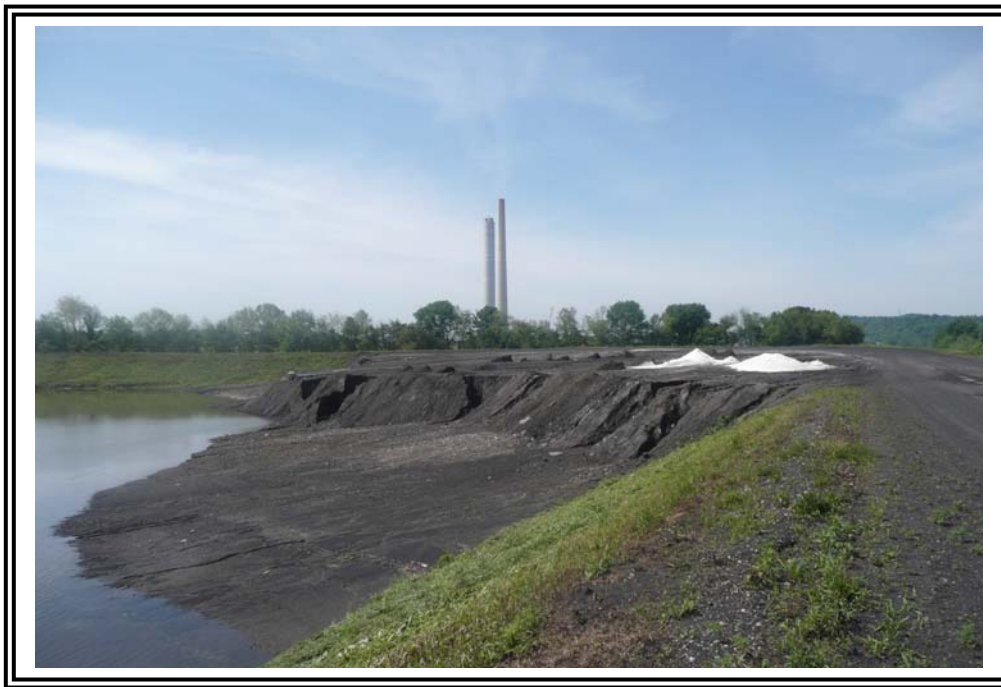
7

Southwest corner of the bottom ash pond. Area used for trucked in bottom ash from various cleaning operations.

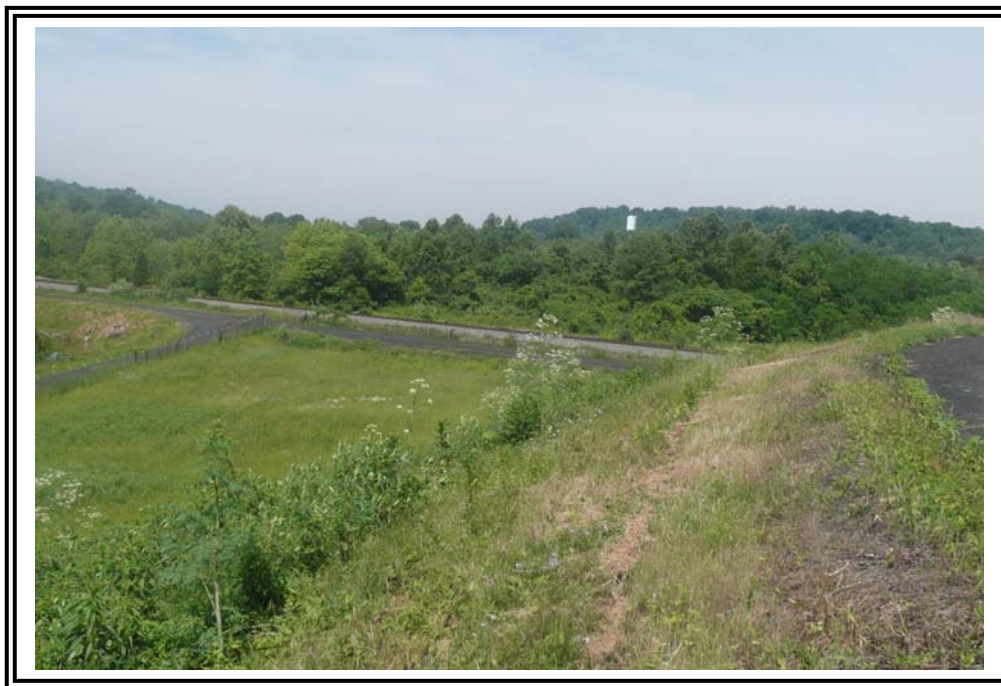
8

Downstream slope at southwest corner, looking west. Note that weed-whacking was in progress and is reportedly performed twice a year.

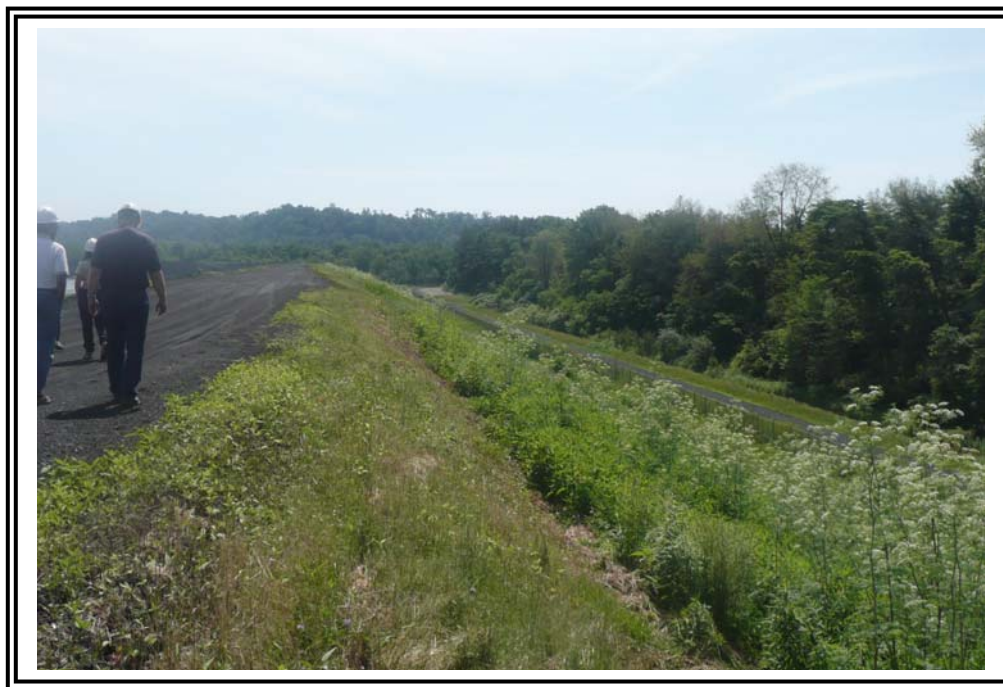
9

Downstream slope of the south berm, looking east. Note that weed-whacking was in progress and is reportedly performed twice a year.

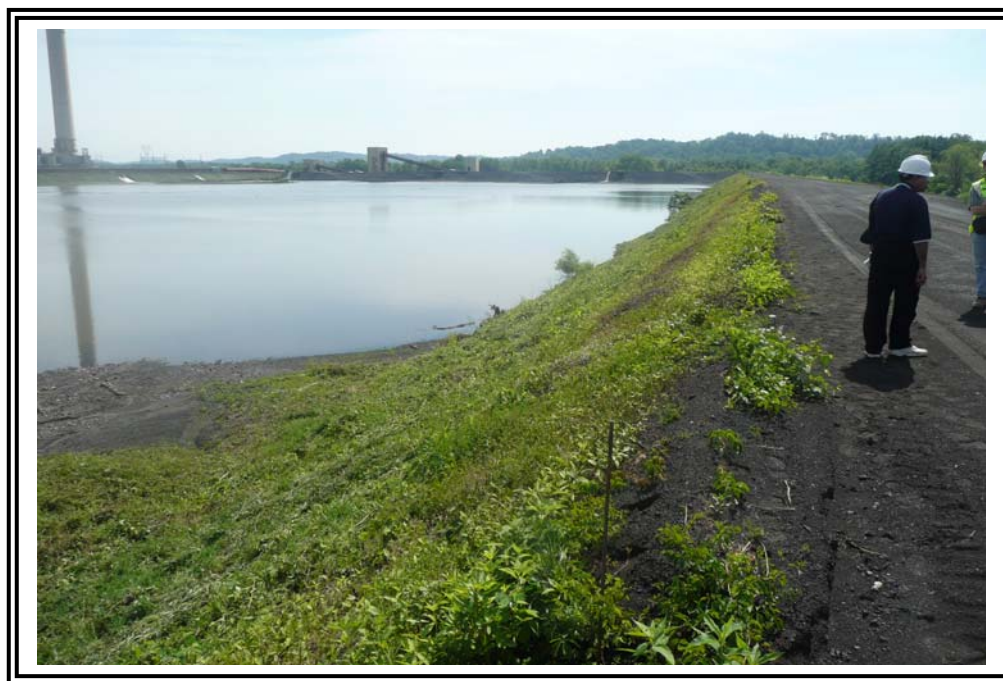
10

Upstream slope of the south dike, looking east.

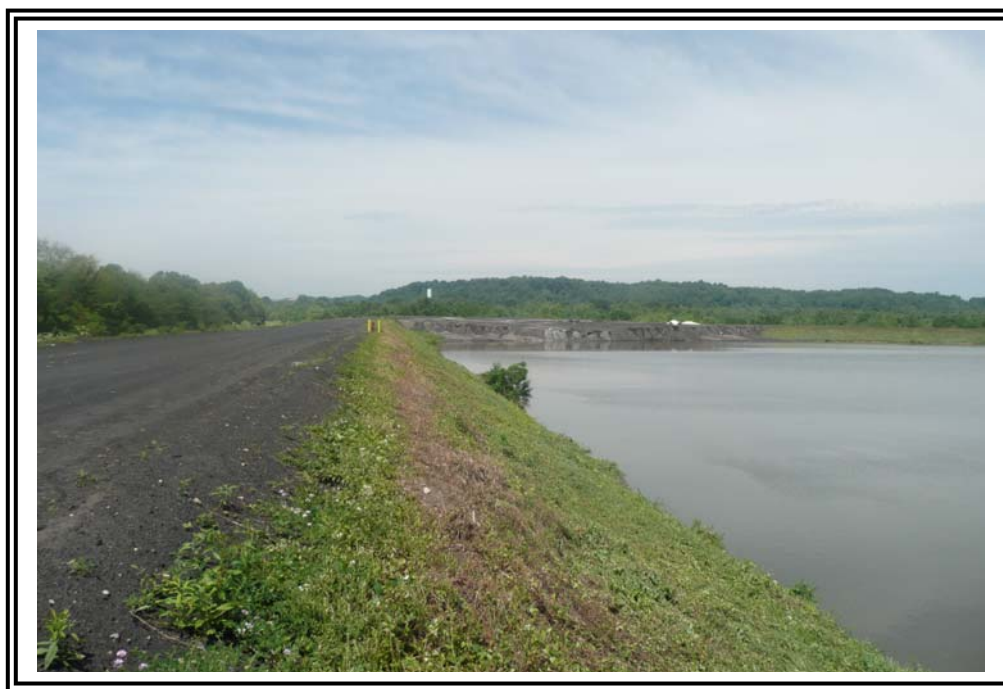
15

Upstream slope of the south dike, looking west.

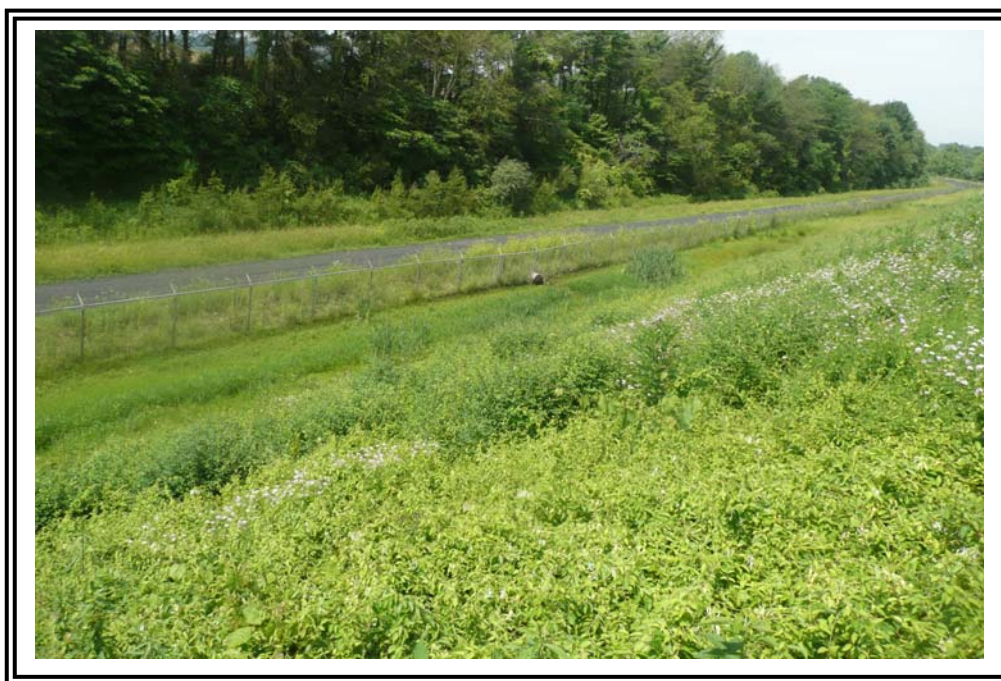
18

Downstream slope of the south dike. Note one of the re-set culverts at the fence line.

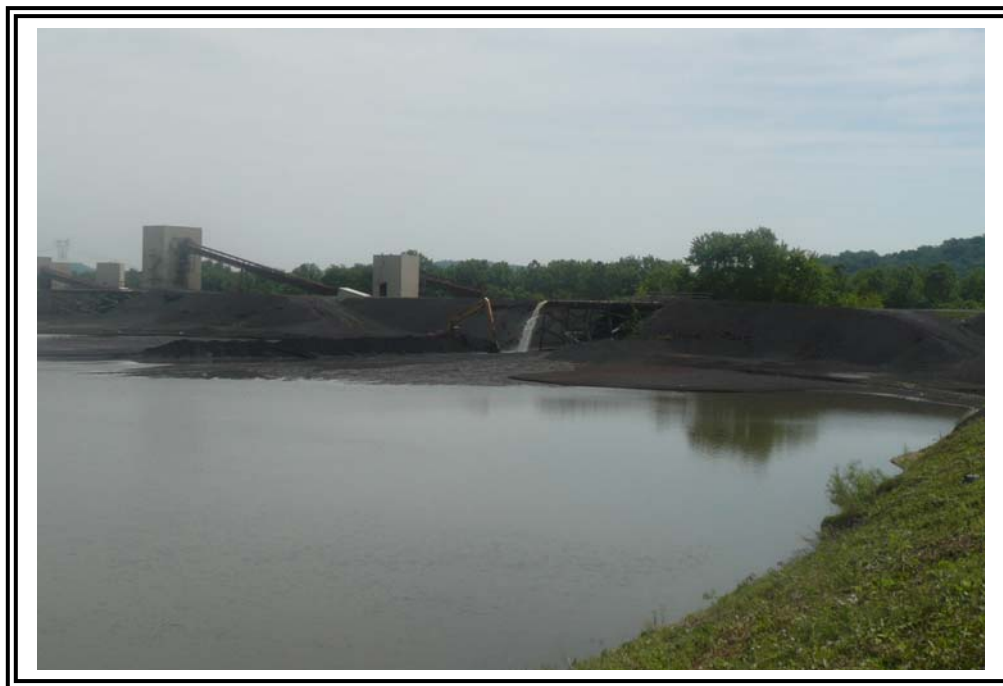
19

South end of the east dike. Bottom ash sluicing area.

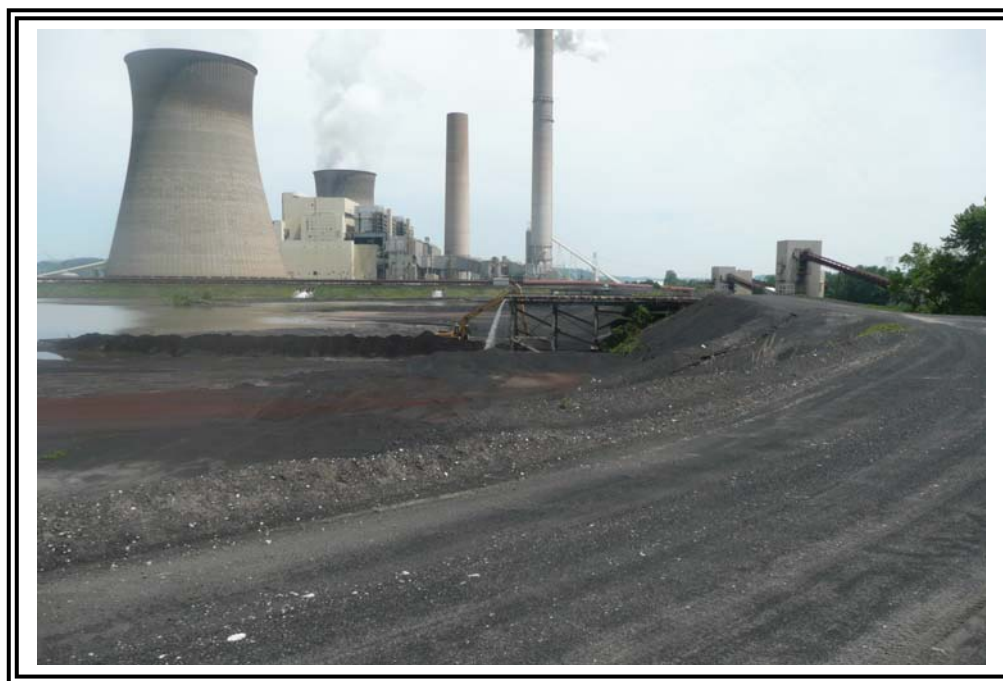
20

East end of the bottom ash pond. Bottom ash sluicing performed throughout this slope area.

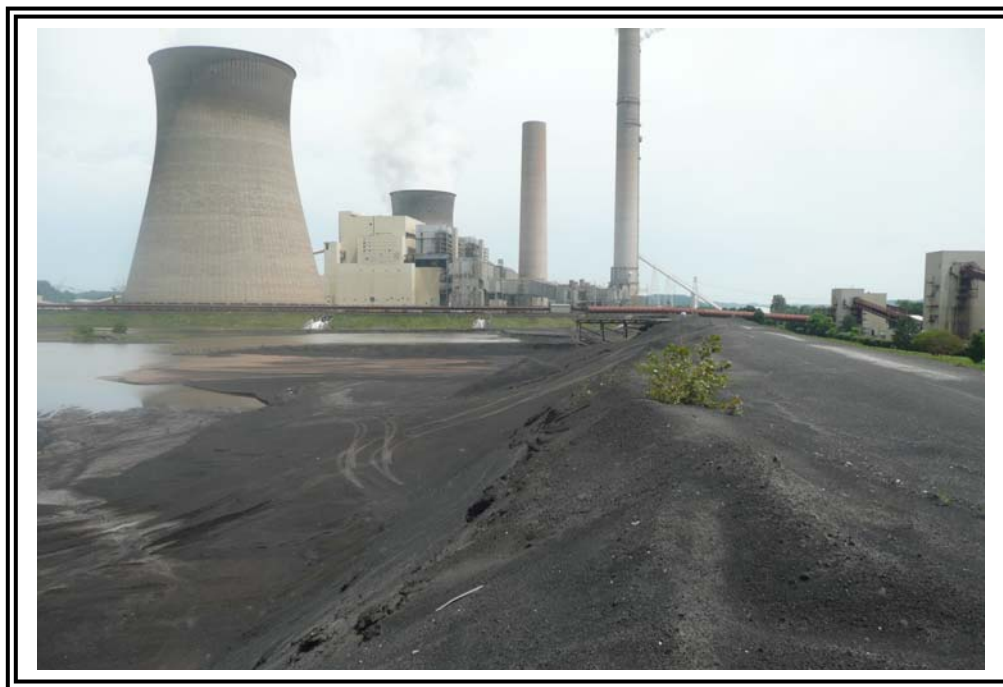
21

Ash disposal along upstream slope of east dike, looking north.

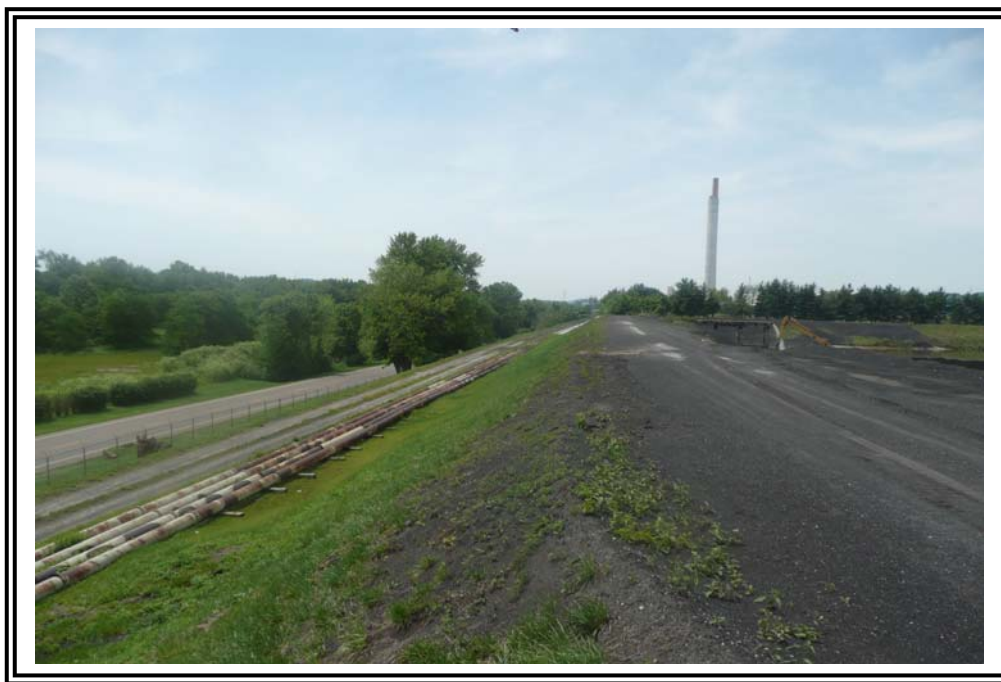
24

Crest and downstream slope alignment of east dike looking south.  
Note east dike is benched to allow an access road and sluice pipe placement.

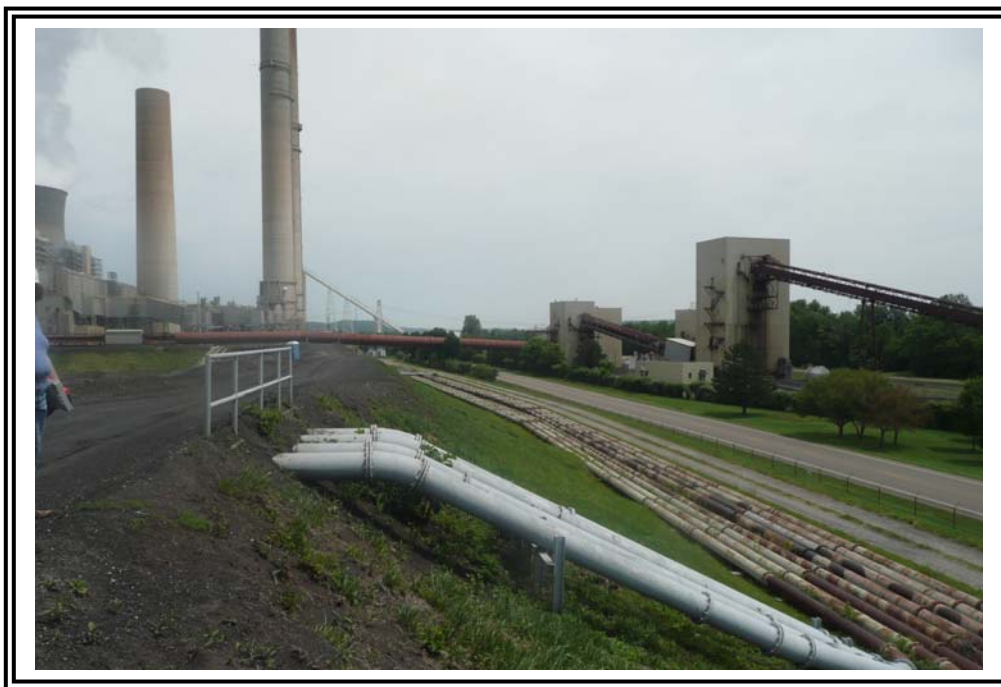
25

Crest and downstream slope alignment of east dike, looking north. Crest is raised at sluice pipe crossings.

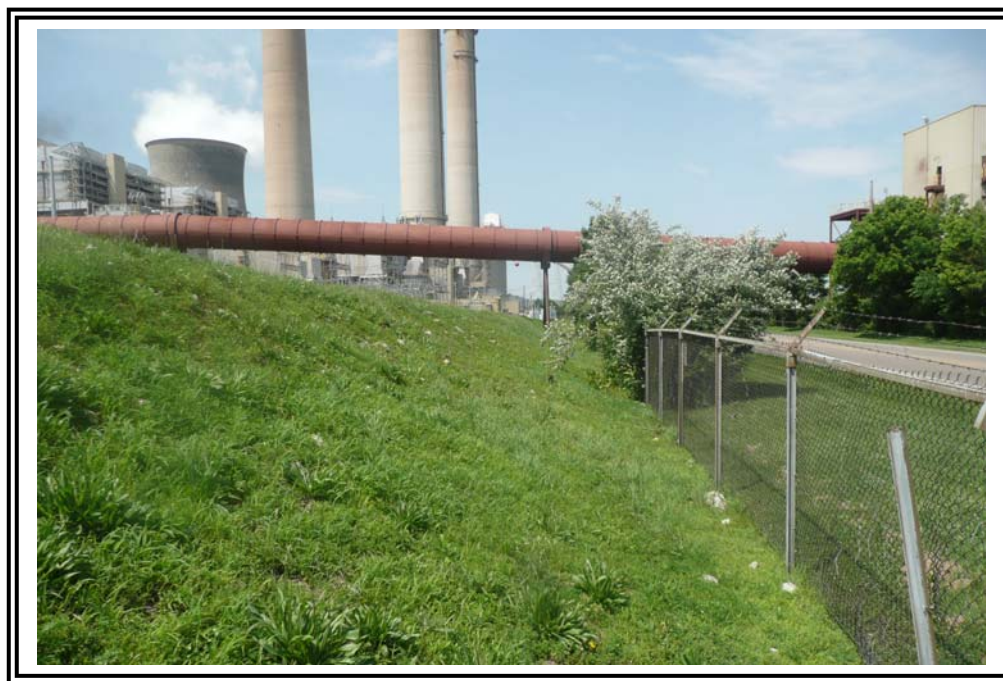
28

North end of east dike, looking north. This portion of the downstream slope is part of the benched out area for the access road.

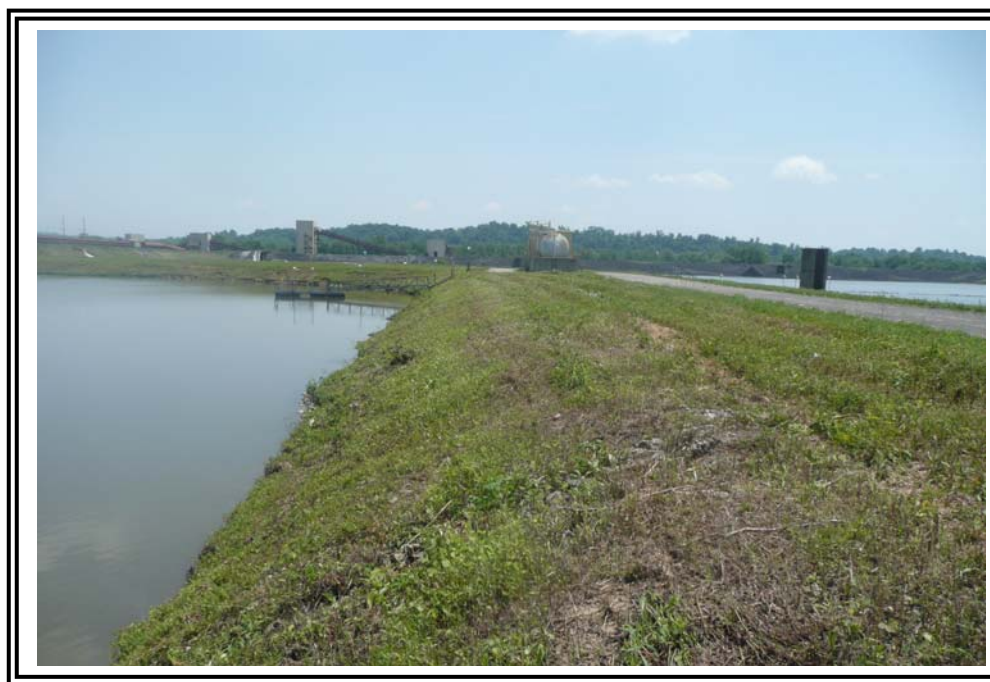
36

South intermediate dike separating primary from secondary ponds, looking east.

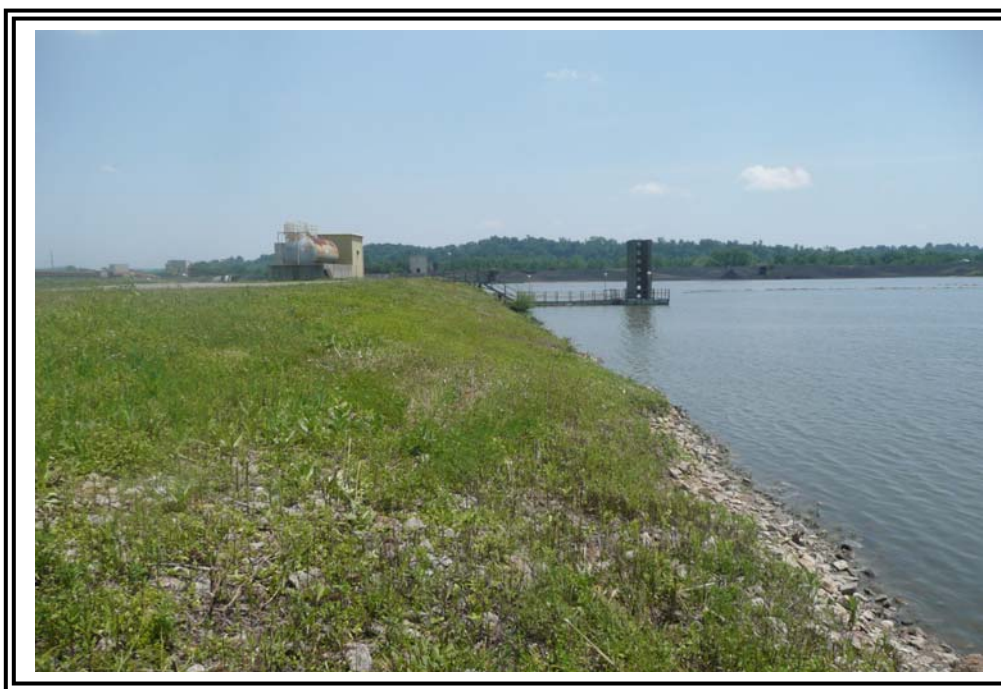
37

There are two outlet control structures in the Bottom Ash Pond. The Primary Outlet is a drop inlet structure with a concrete pipe beneath the intermediate dike. The outlet pipe was submerged and could not be observed. Photos 37, 41 and 42 show this outlet control structure.

South intermediate dike separating primary from secondary ponds, looking east.

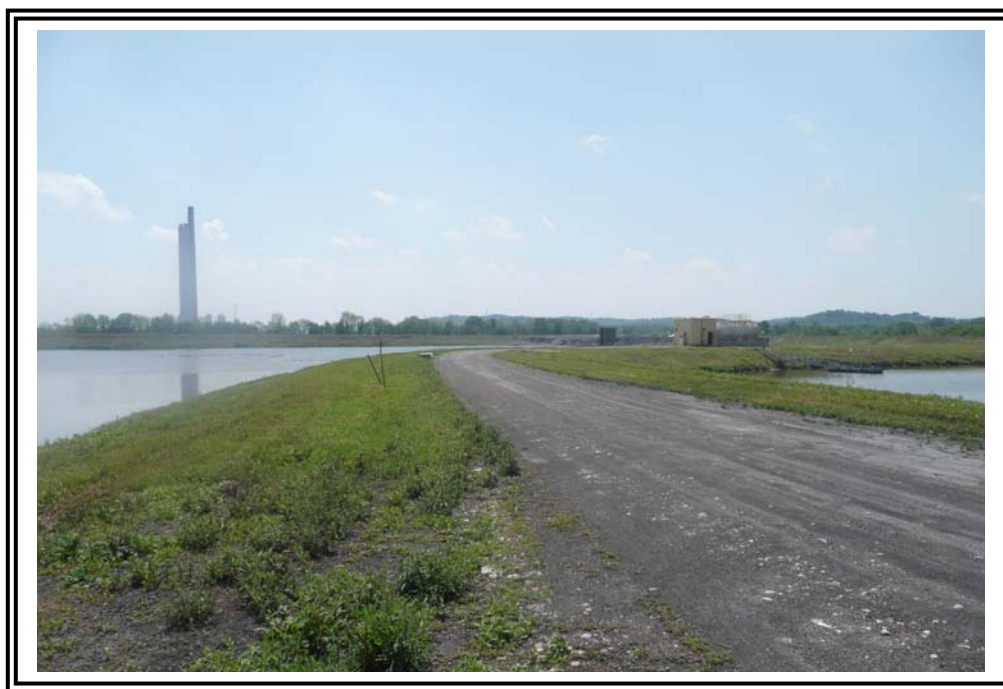
39

East intermediate dike separating primary from secondary ponds, looking south.

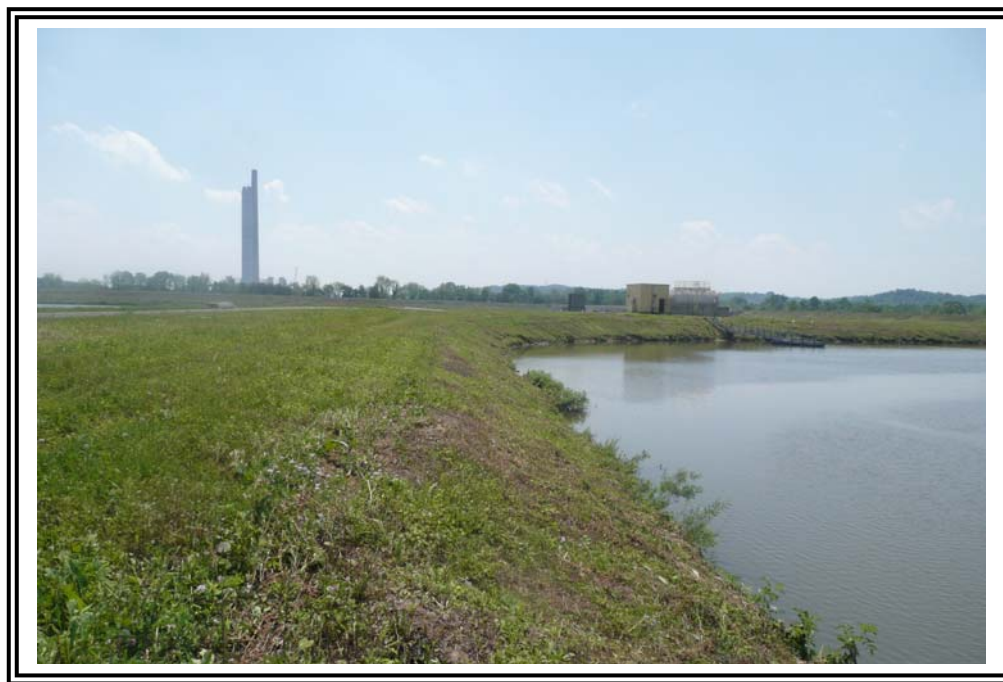
40

East intermediate dike separating primary from secondary ponds, looking south.

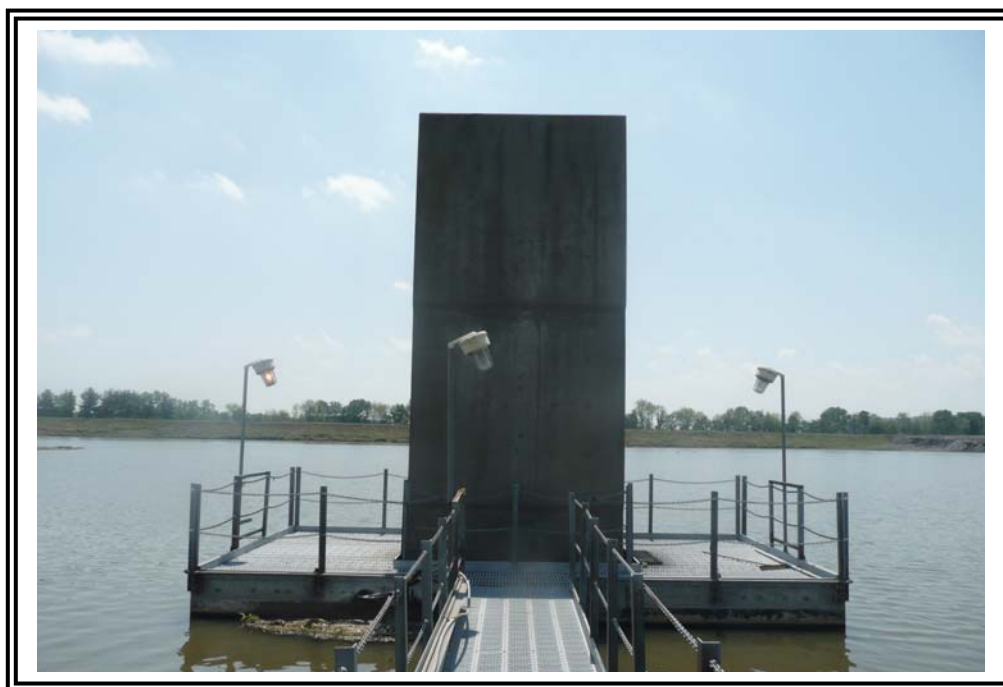
41

Main intake from primary pond to secondary pond.

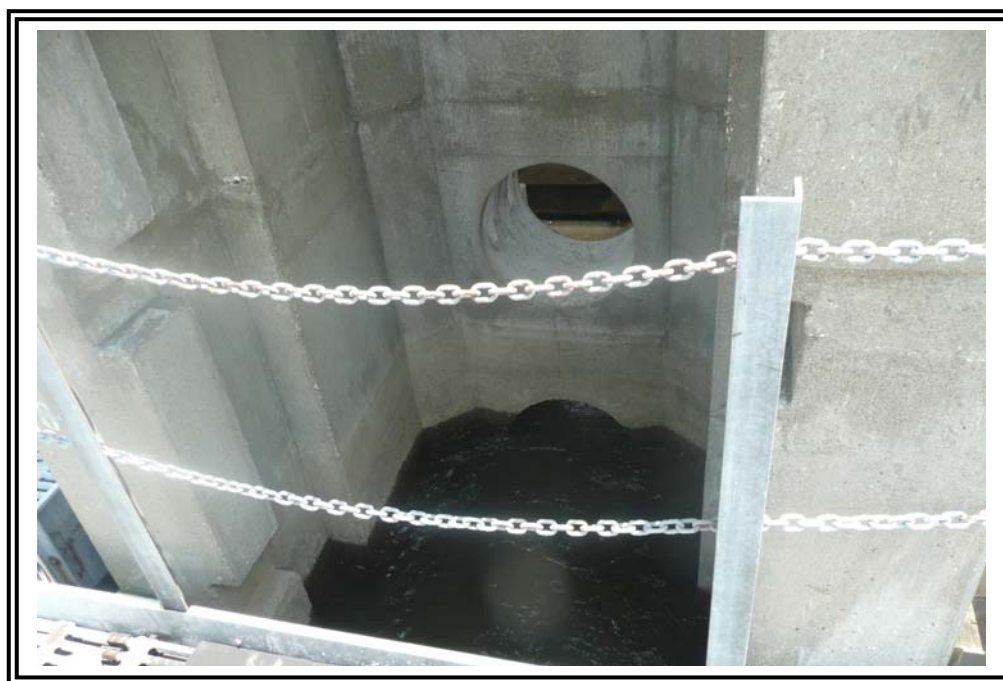
42

Main intake from primary pond to secondary pond.

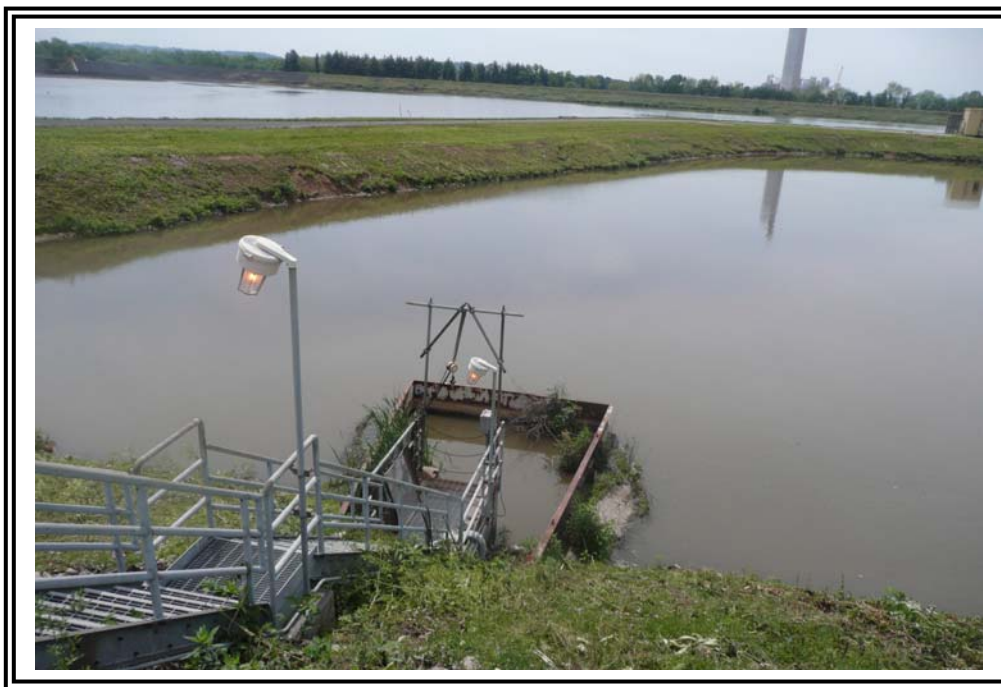
43

Outlet from secondary pond.

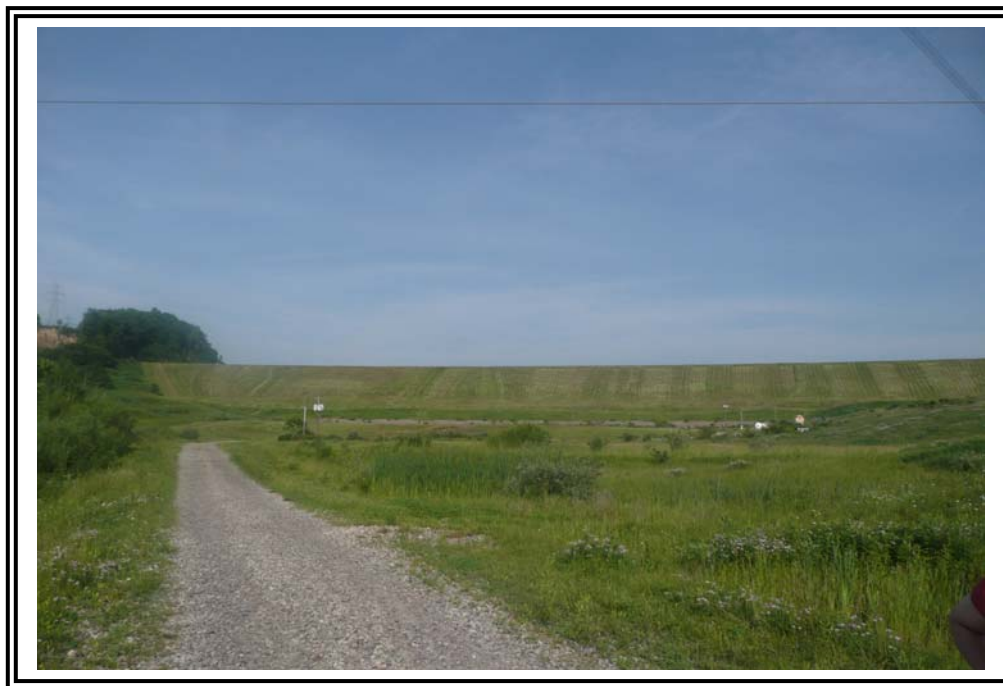
45

Right (south) side of Stingy Creek Dam as seen from downstream.

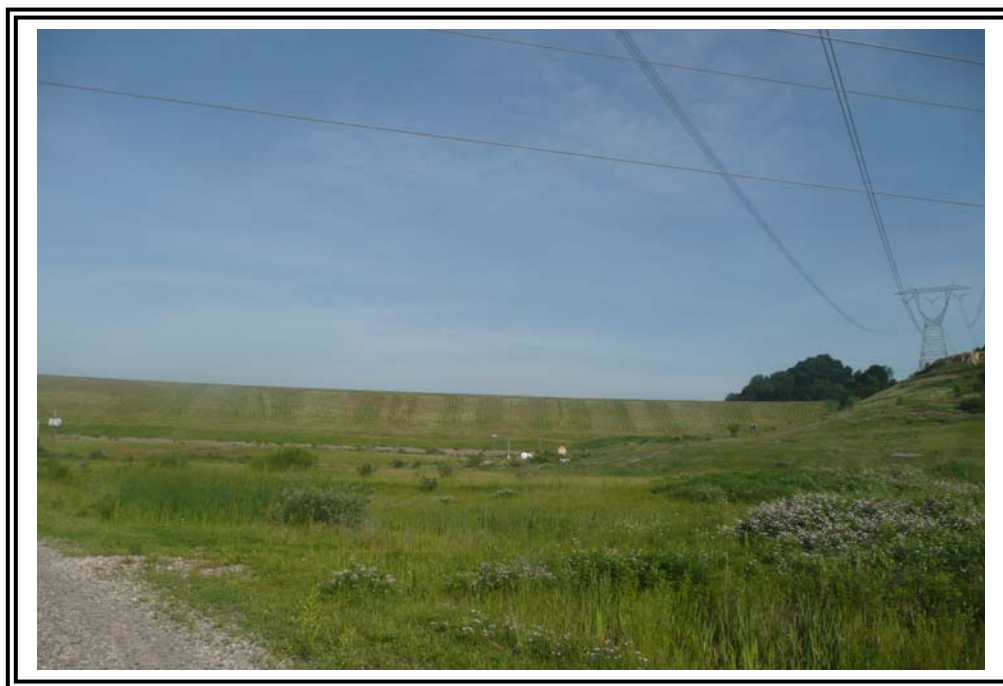
46

Left (north) side of Stingy Creek Dam as seen from downstream.

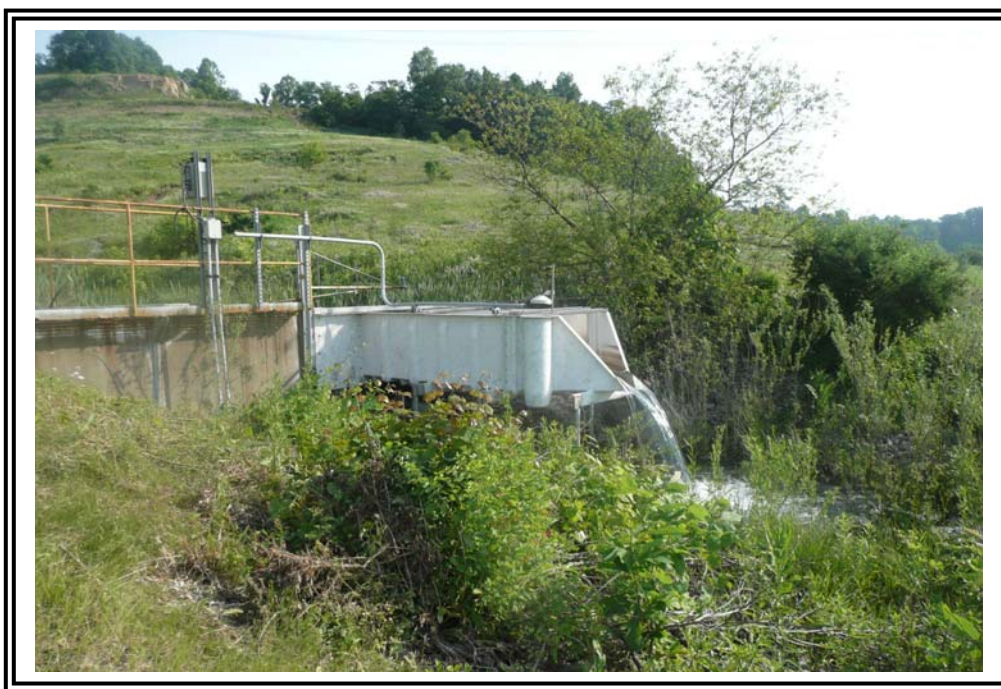
47

Outlet flow from the intake tower within the reservoir.

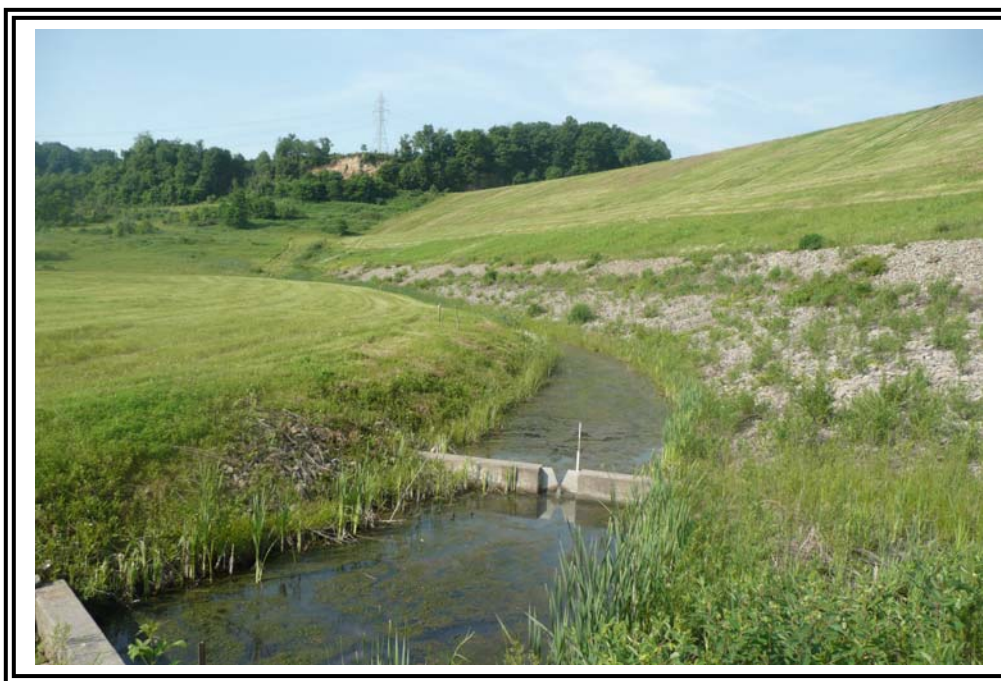
48

Drainage swale along toe of dam. Note monitoring weir structures. Much of the flow observed here was reportedly from recent rainfall runoff.

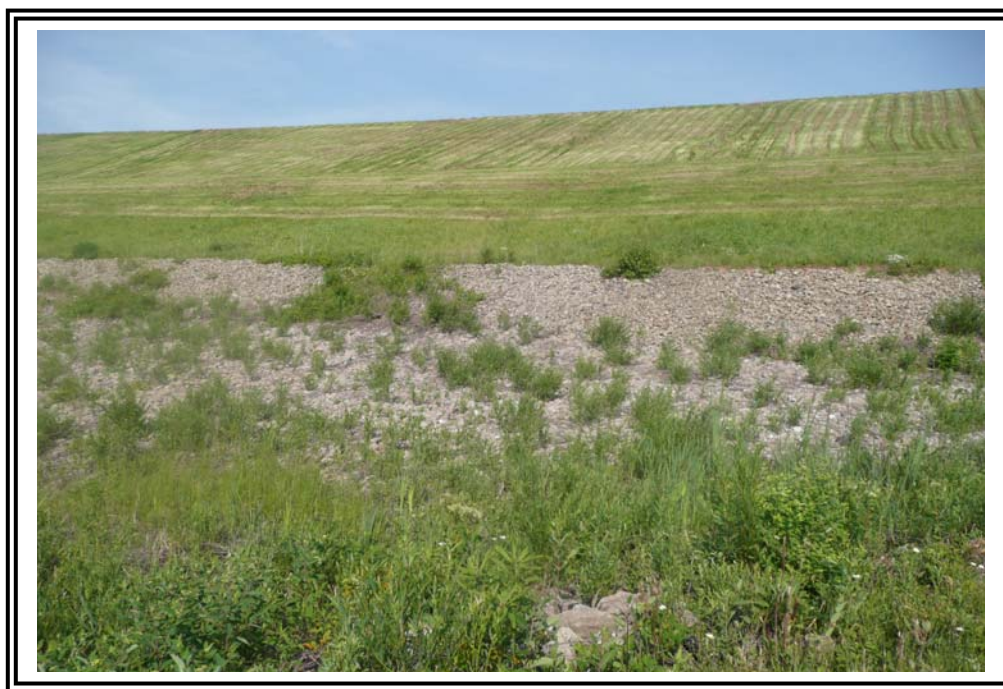
49

Toe drain covered with 6-inch diameter rip rap.

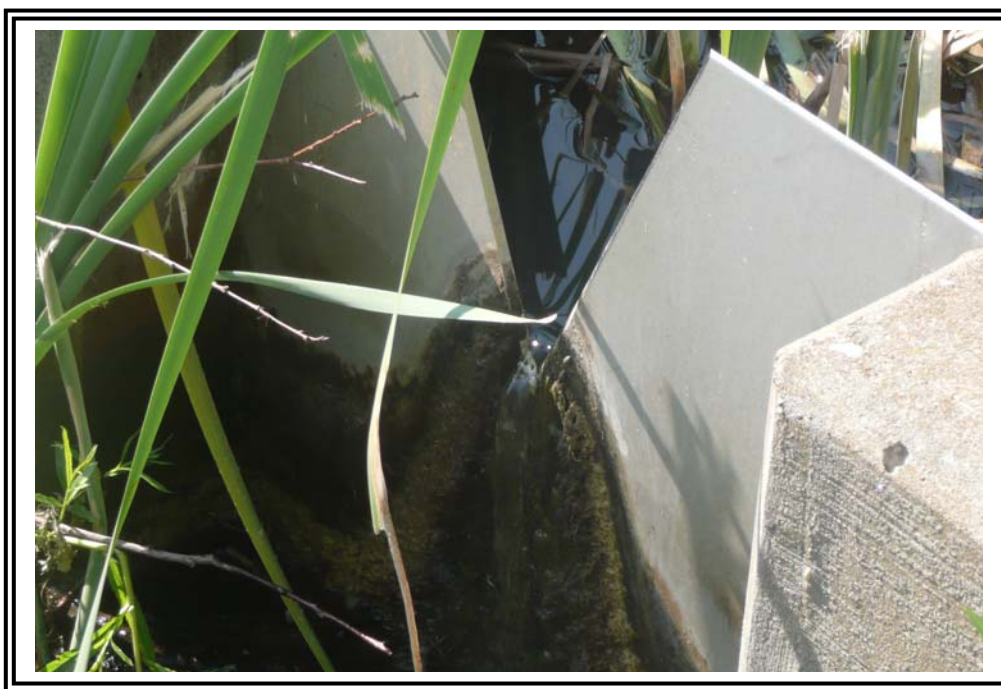
55

Close-up of Weir 3. Note the week prior to CHA's visit the site received approximately 2.9 inches of rain.

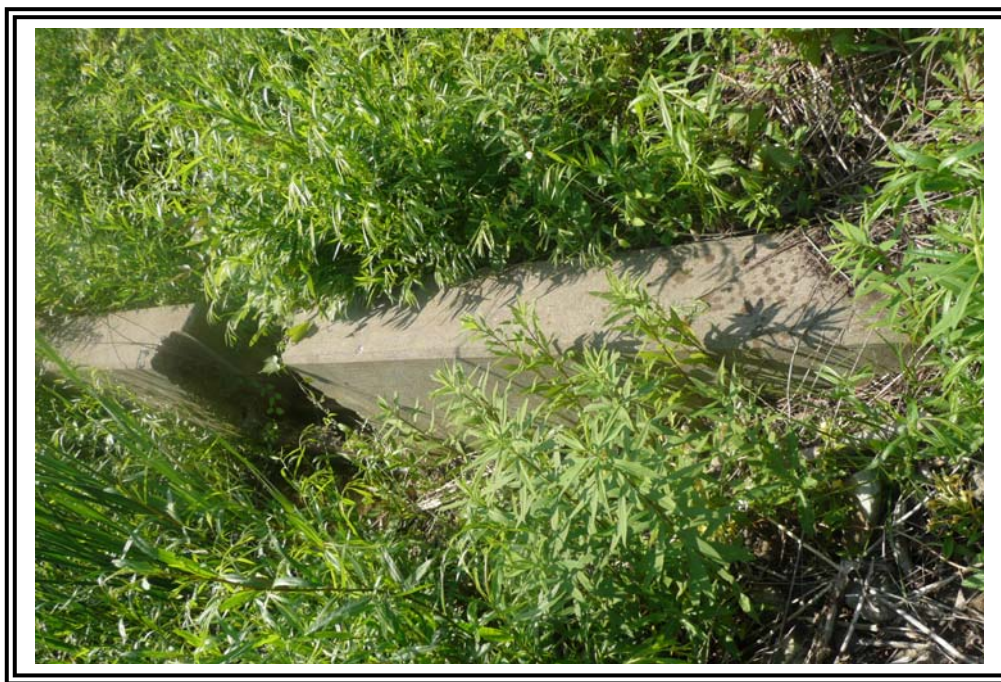
56

Abandoned weir structure located upstream of Weir 3 (appears weir plate was chipped out of the concrete). AEP staff was not aware when this was abandoned.

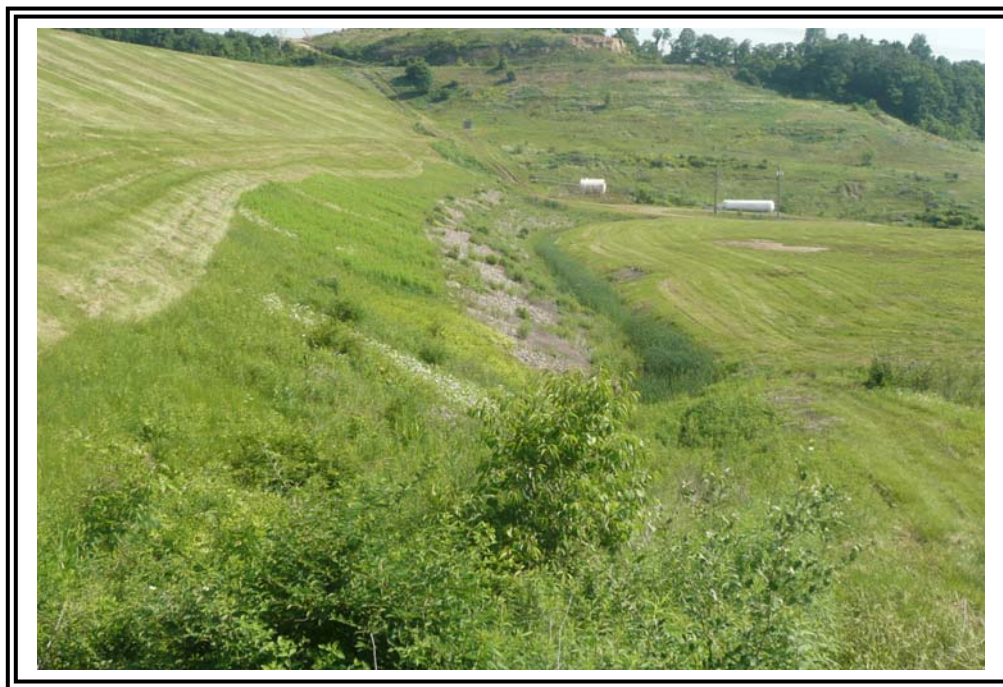
57

View of the dam toe looking north from the south abutment.

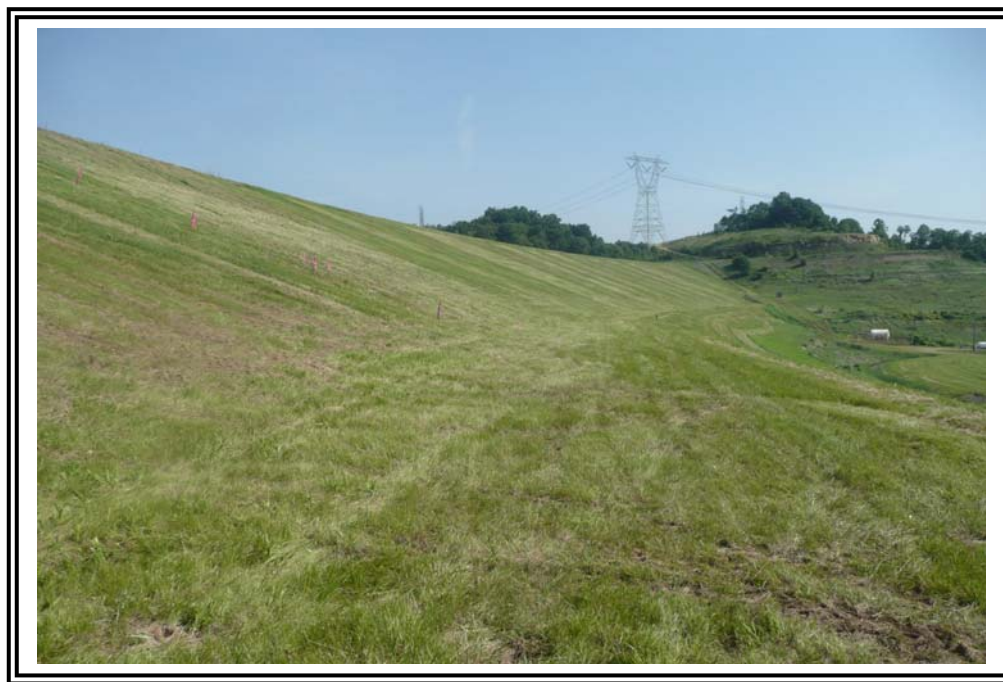
58

View along the bench on the downstream slope looking north.  
Note survey monitoring points, monitoring wells, and inclinometers.
