# Assessment of Dam Safety Coal Combustion Surface Impoundments Draft Report

American Electric Power  
General James Gavin  
Power Plant  
Cheshire, Ohio

July 2, 2009

CHA Project No. 20085.4000.1510

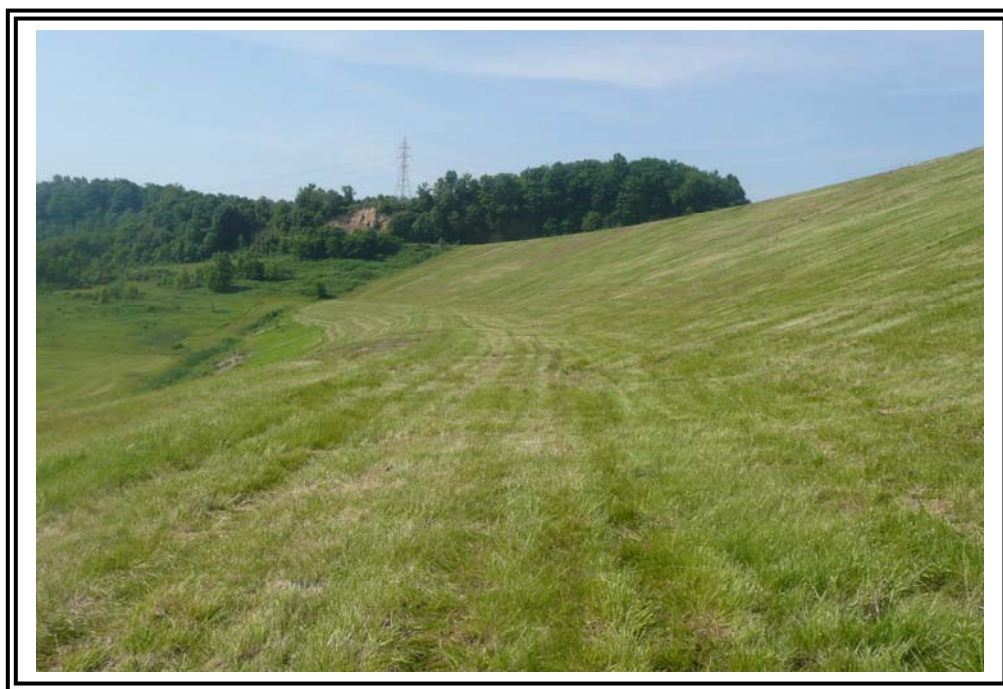
59

View along the bench on the downstream slope looking south.

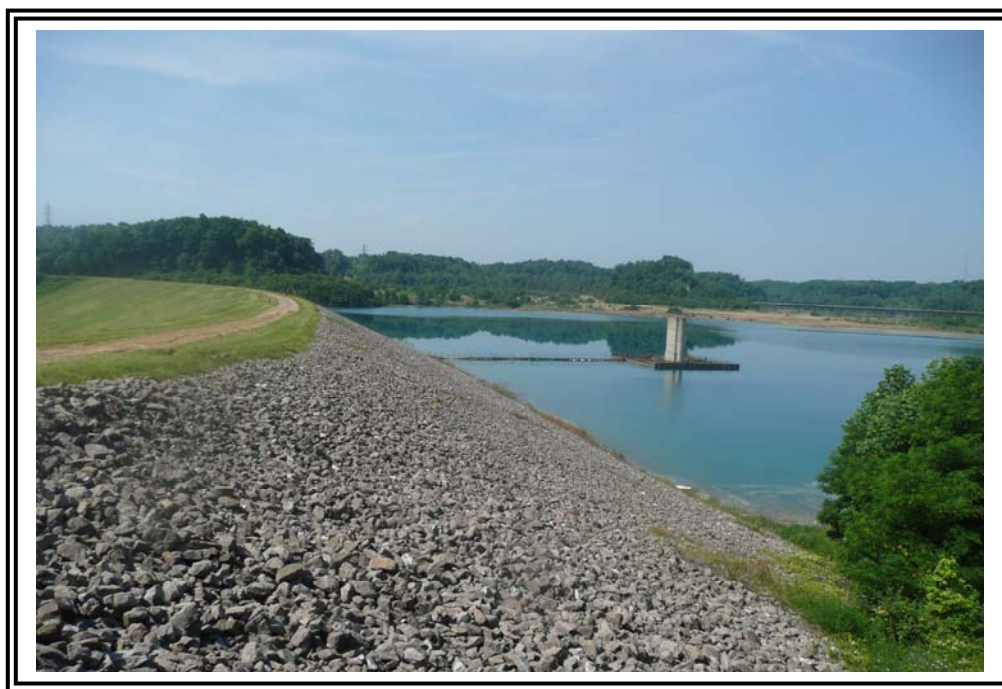
63

Upstream slope covered with 8-inch diameter rip rap.

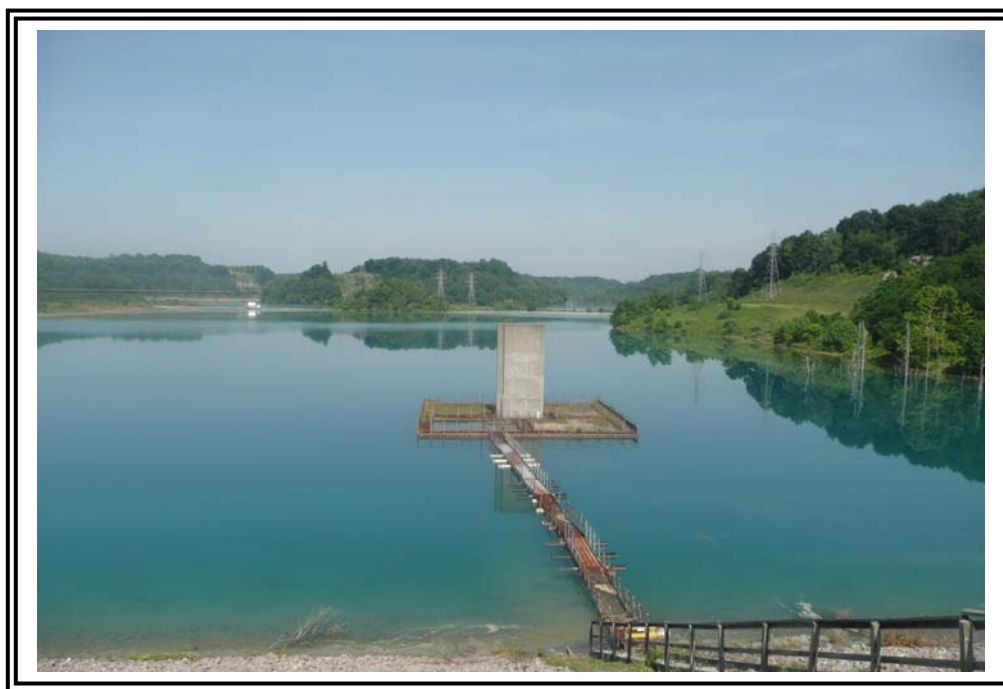
67

Intake tower from the dam crest (looking west).

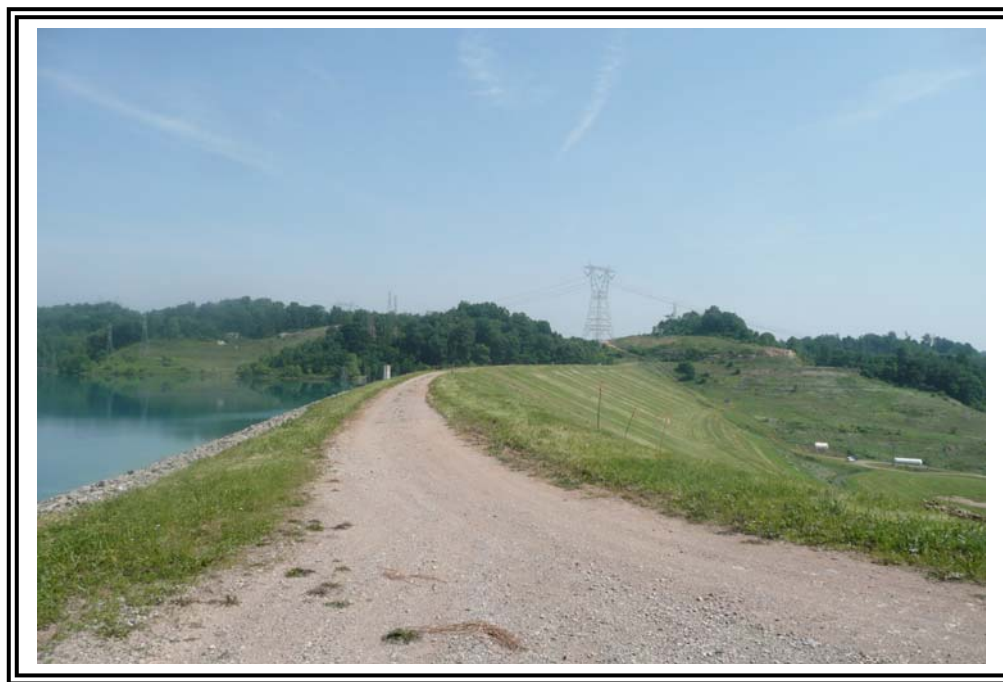
68

Dam crest and downstream slope from the right (south) abutment looking north.

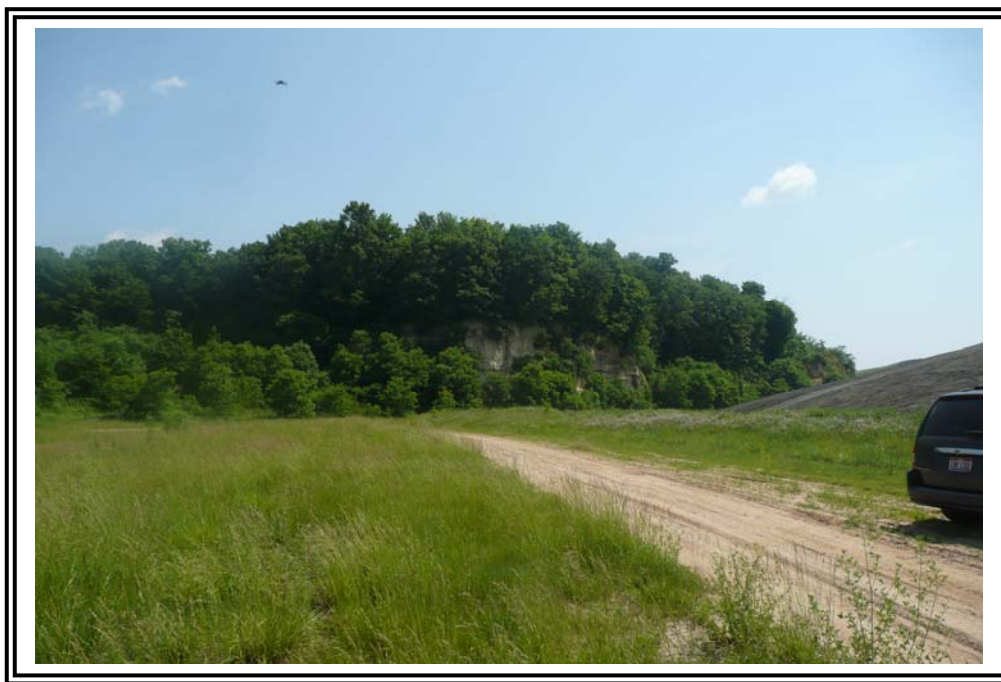
70

Left abutment of abandoned emergency spillway. Note landfill in right of photo.

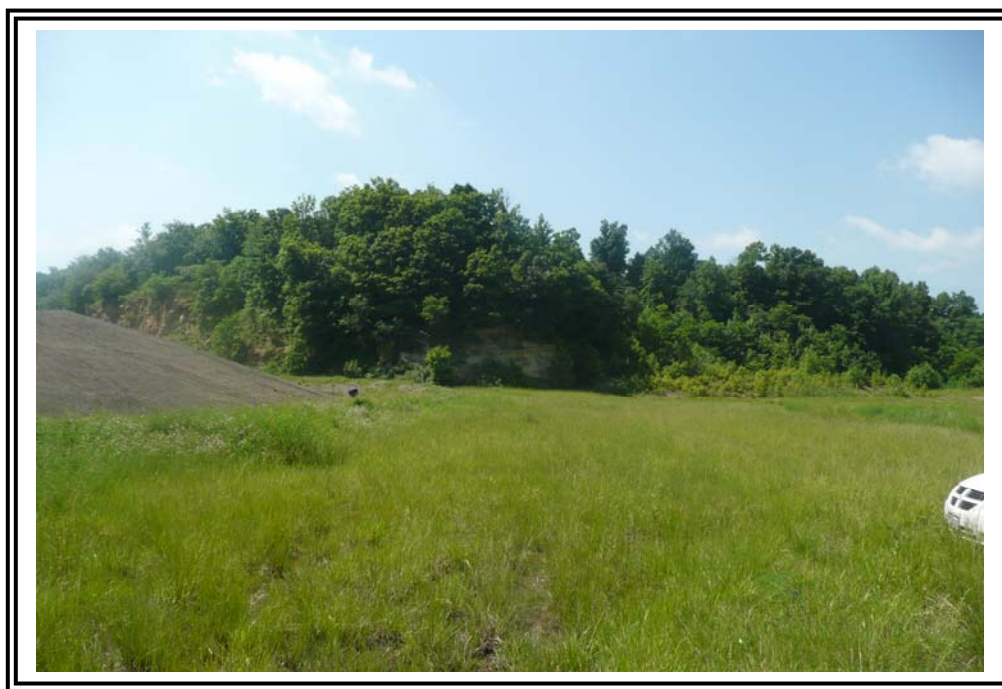
71

Right abutment of abandoned emergency spillway. Note landfill in left of photo.
