# Assessment of Dam Safety

## Coal Combustion Surface Impoundments (Task 3)

### Final Report

American Electric Power  
General James Gavin  
Power Plant  
Cheshire, Ohio

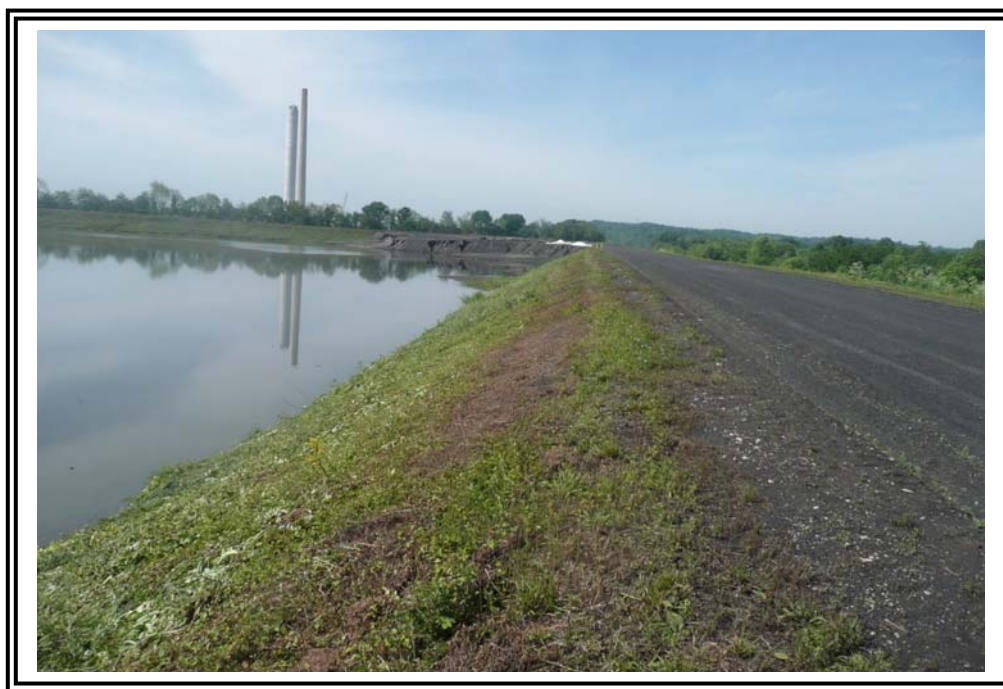
1

Upstream slope of the west dike, looking south.

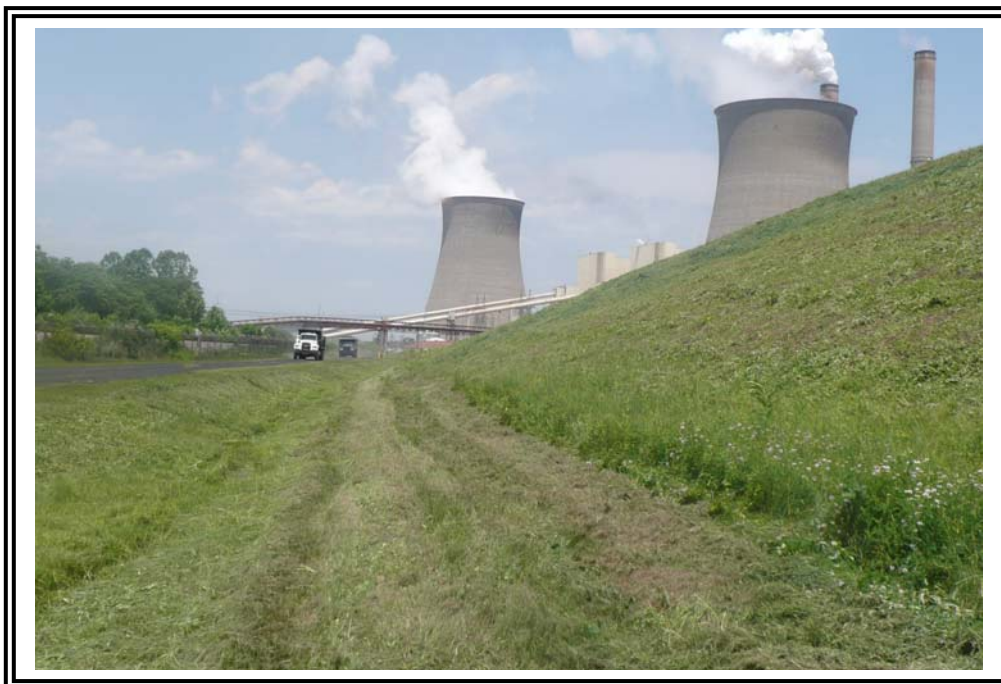
5

Downstream toe of the west dike, looking north.

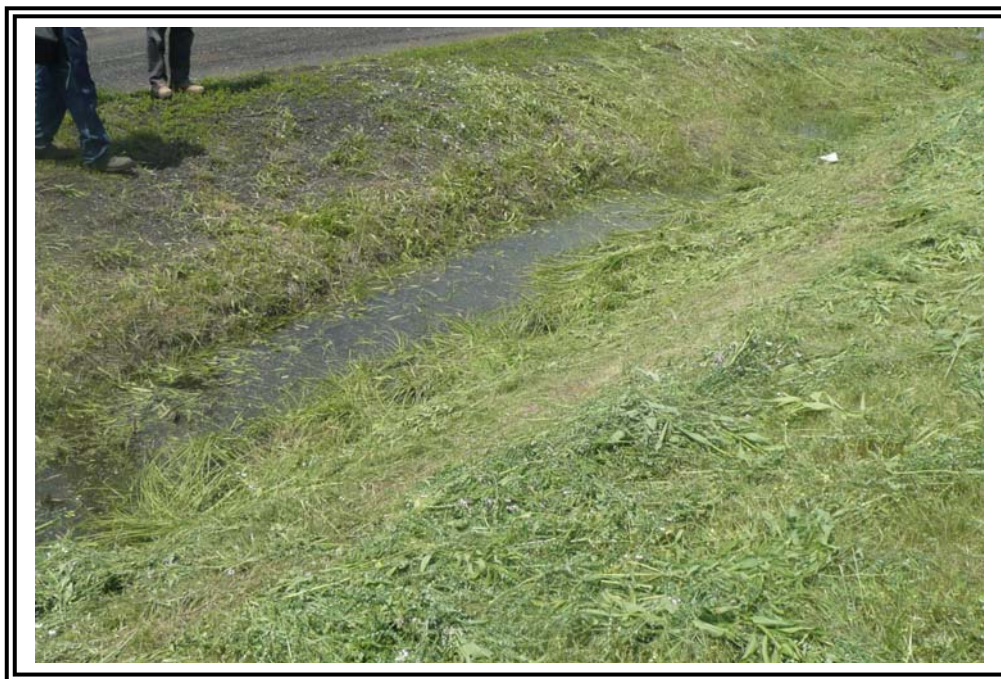
6

Standing water in drainage swale at toe of west dike. Appears related to surface water runoff. Piezometer readings confirm groundwater is well below the ground surface.

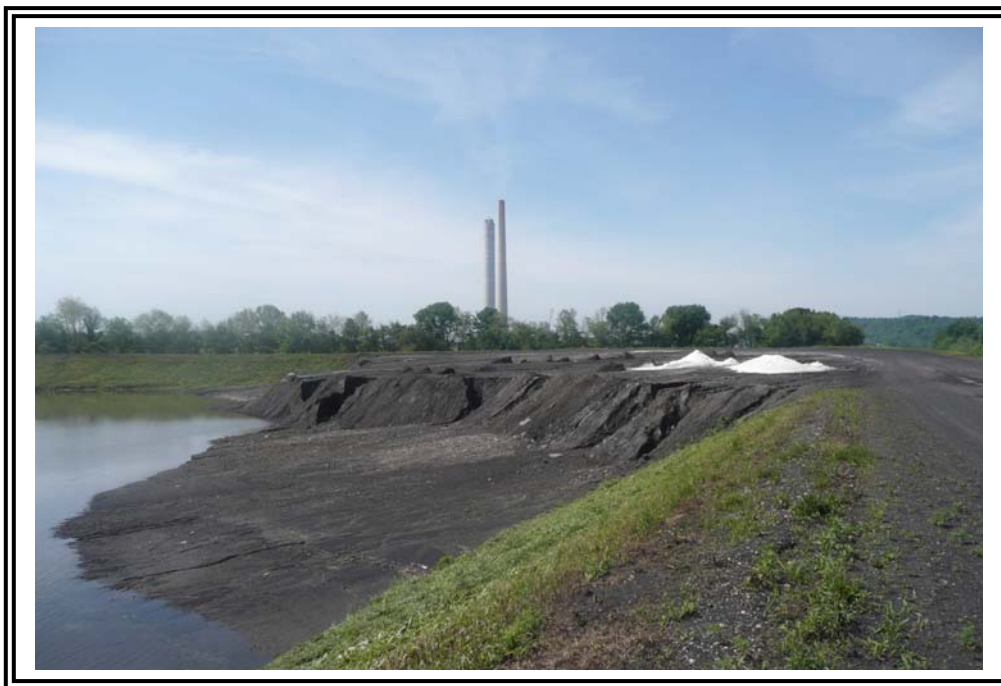
7

Southwest corner of the bottom ash pond. Area used for trucked in bottom ash from various cleaning operations.

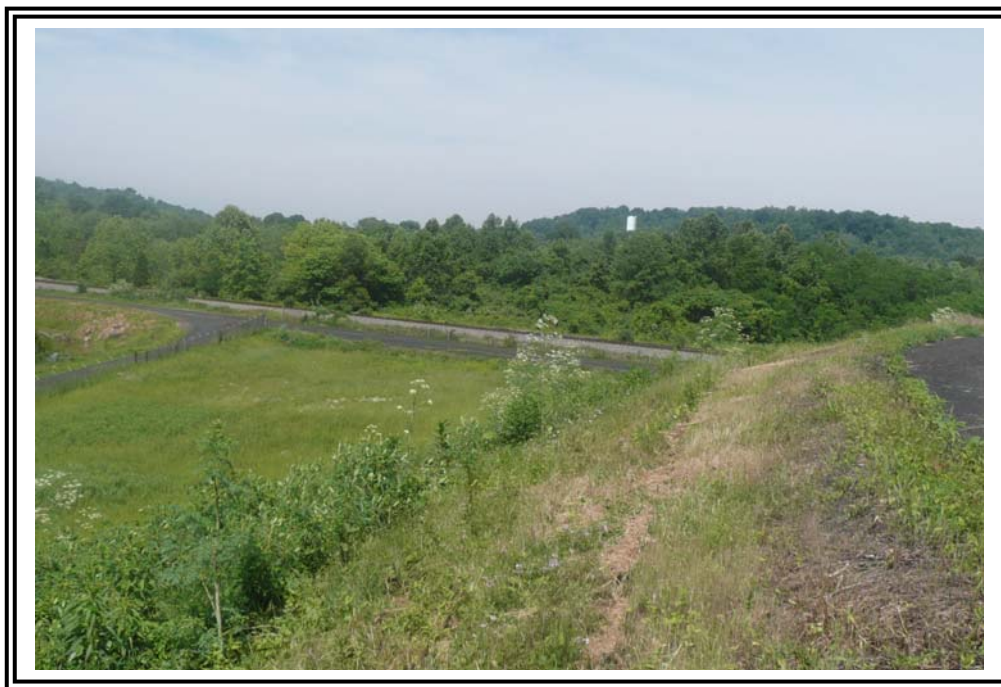
8

Downstream slope at southwest corner, looking west. Note that weed-whacking was in progress and is reportedly performed twice a year.

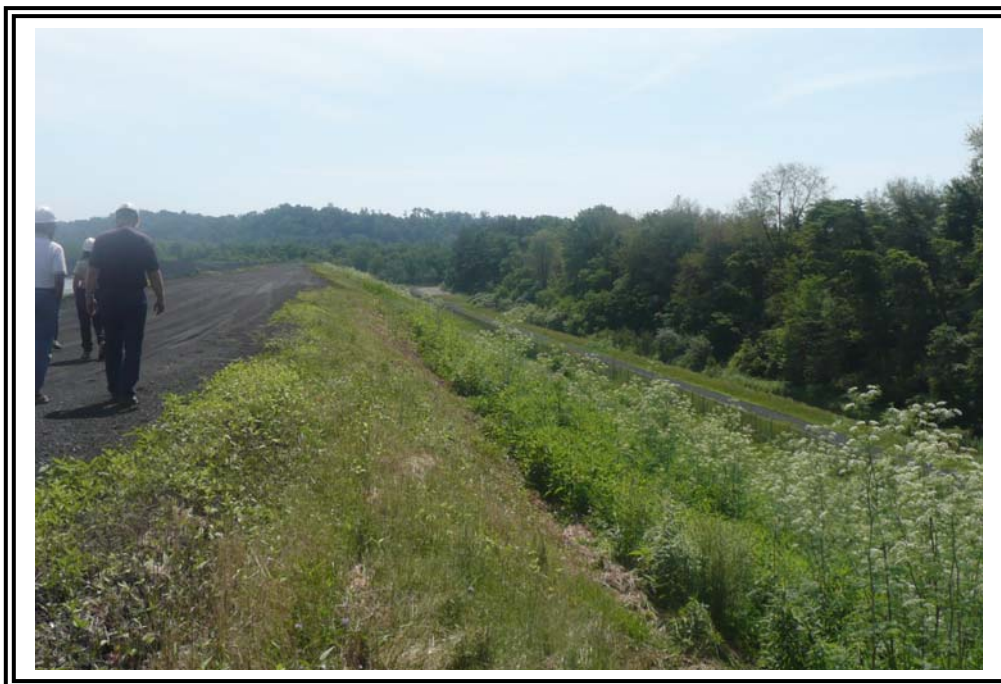
9

Downstream slope of the south berm, looking east. Note that weed-whacking was in progress and is reportedly performed twice a year.

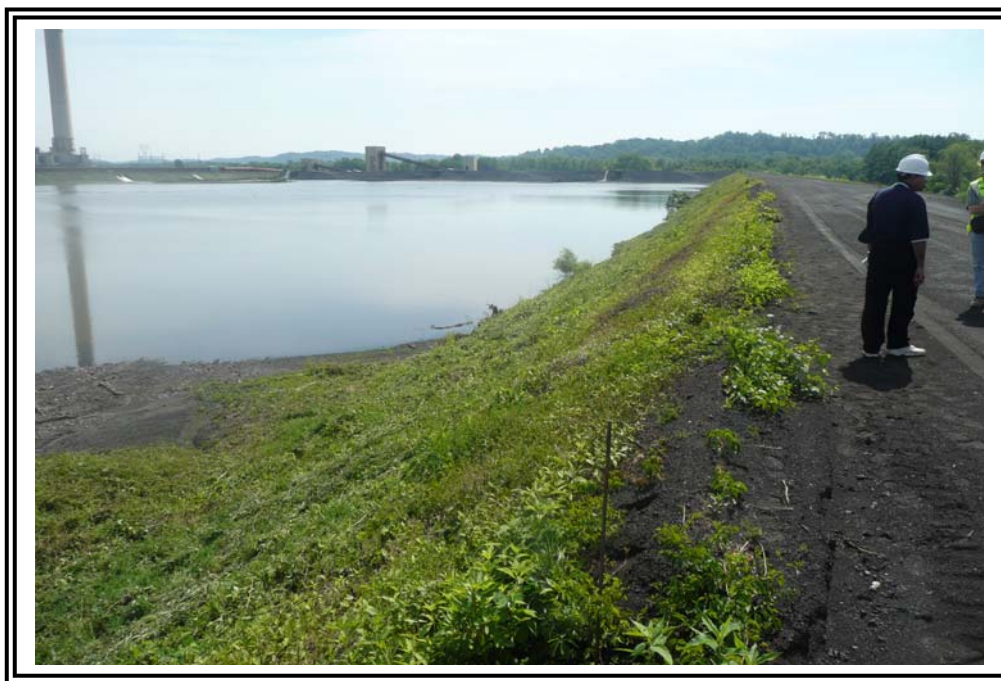
10

Upstream slope of the south dike, looking east.

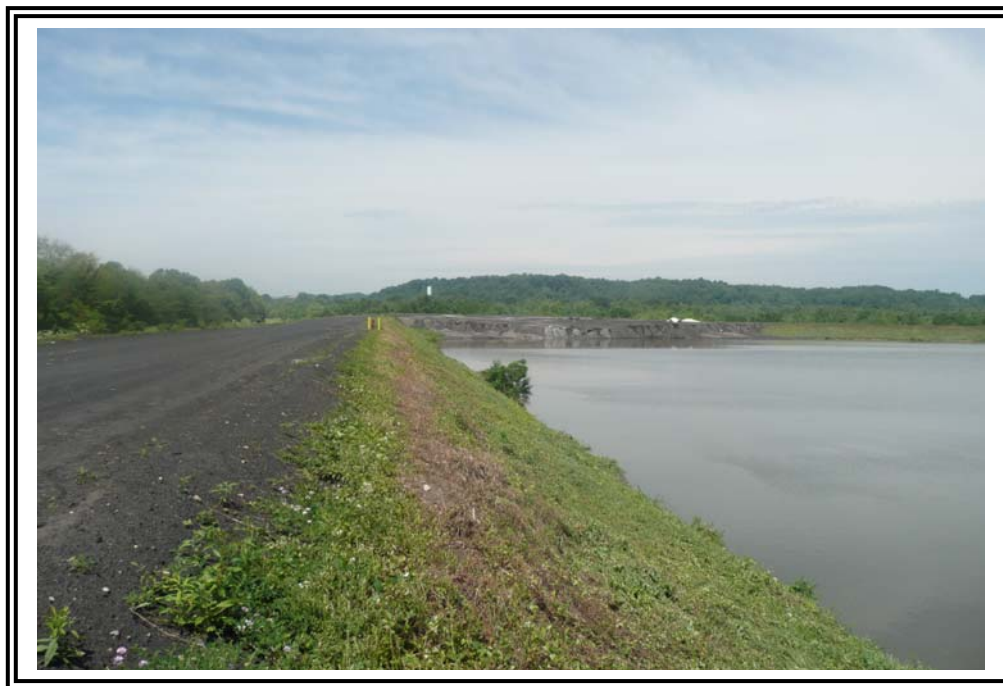
15

Upstream slope of the south dike, looking west.

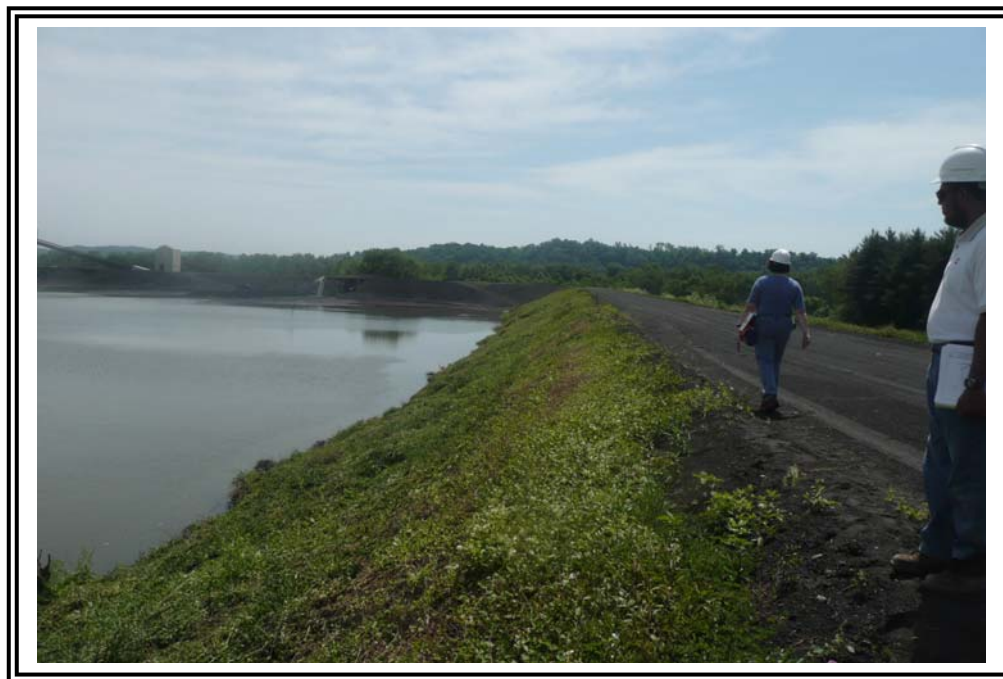
16

Upstream slope of the south dike, looking east.

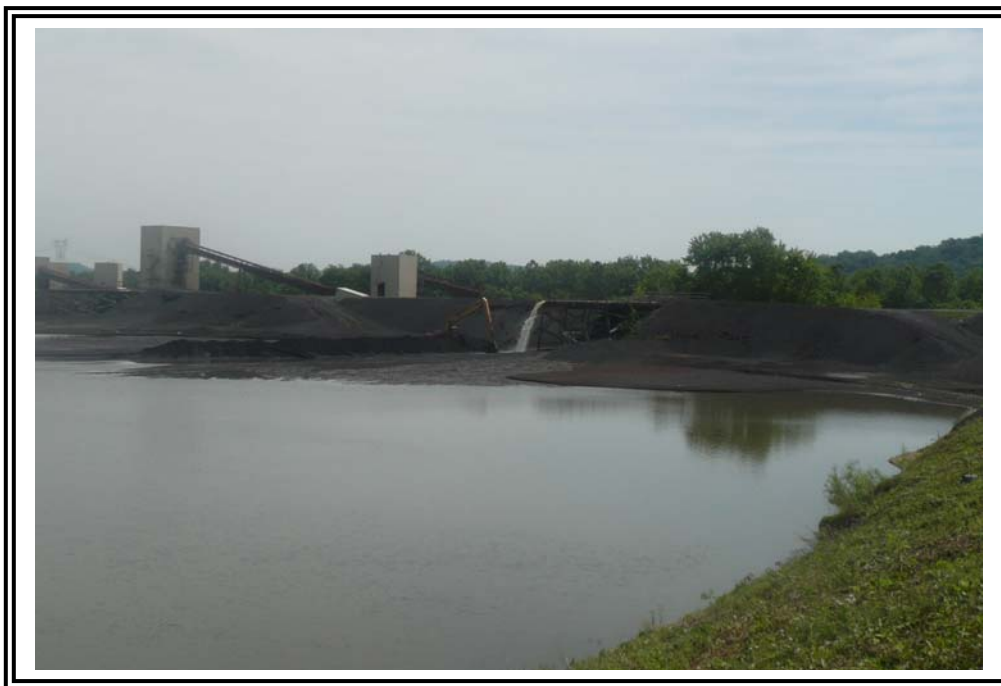
19

South end of the east dike. Bottom ash sluicing area.

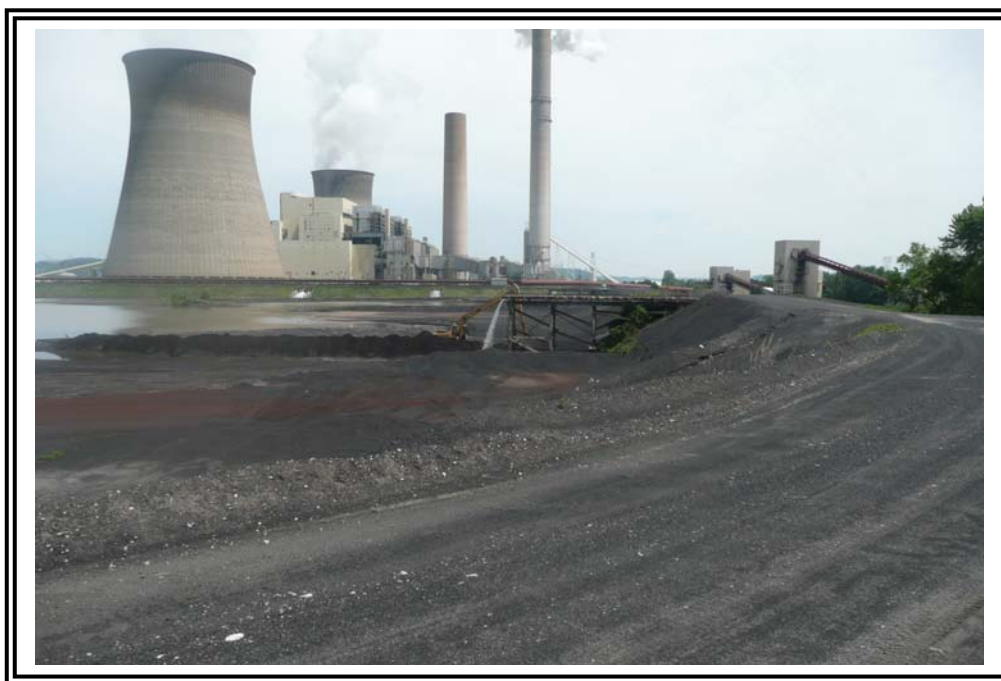
20

East end of the bottom ash pond. Bottom ash sluicing performed throughout this slope area.

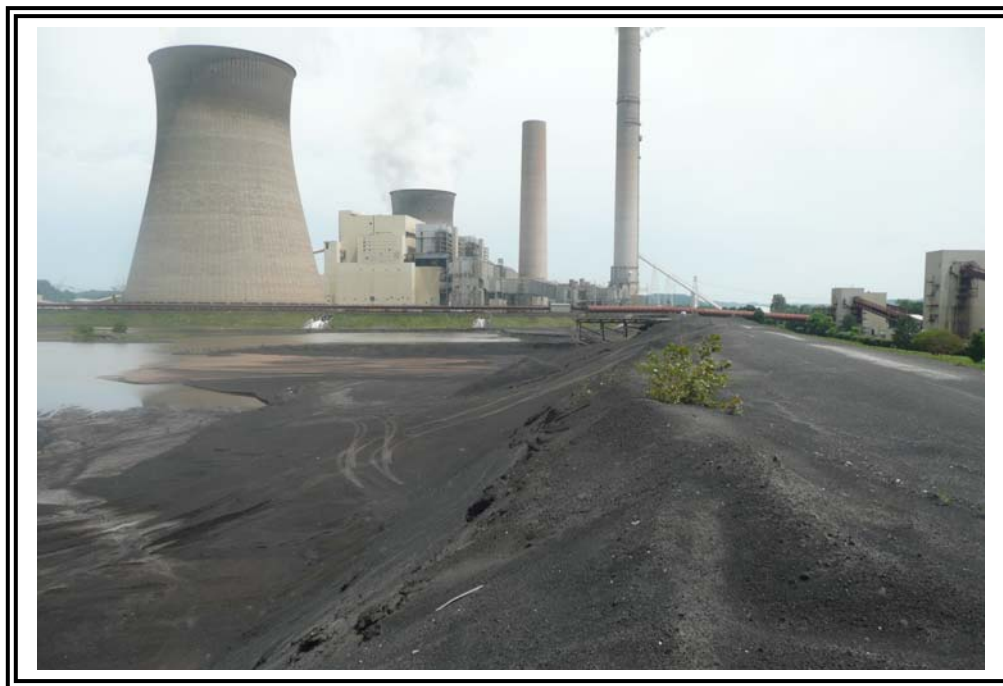
21

Ash disposal along upstream slope of east dike, looking north.

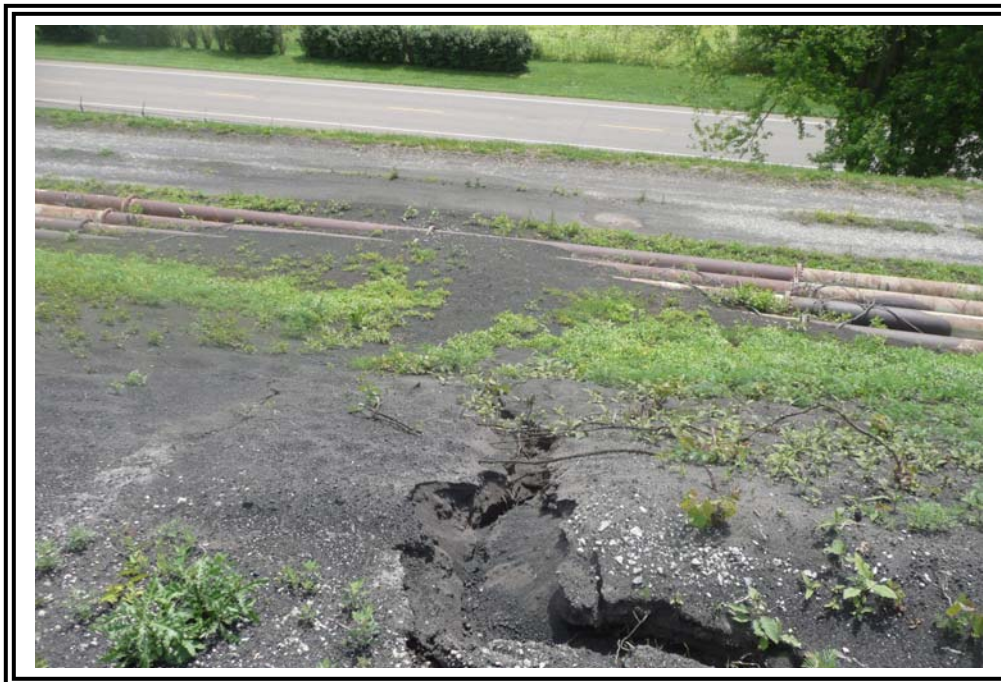
There were many areas of erosion gullies along the transition from the crest to the downstream slope. The deepest of these was 18 inches deep. There was evidence that the development of these is common and that AEP routinely repairs them as part of ongoing maintenance of the dikes. Photos 22 and 23 show a typical representation of these areas on the east dike.

Surface erosion features (typical) along graded ash at east dike upstream slope/crest transition.

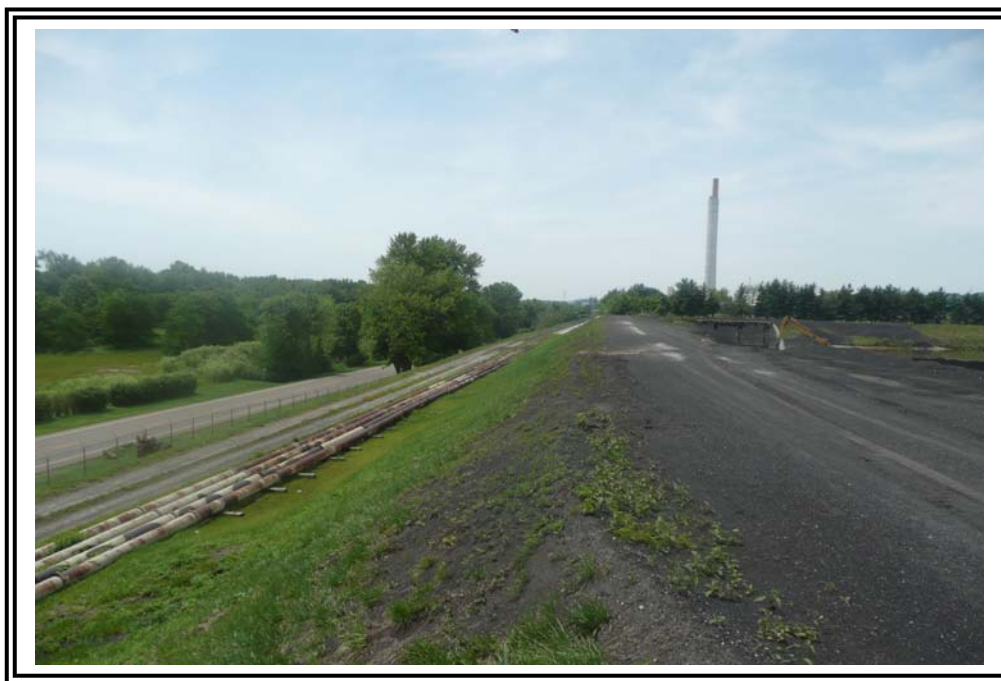
24

Crest and downstream slope alignment of east dike looking south.  
Note east dike is benched to allow an access road and sluice pipe placement.

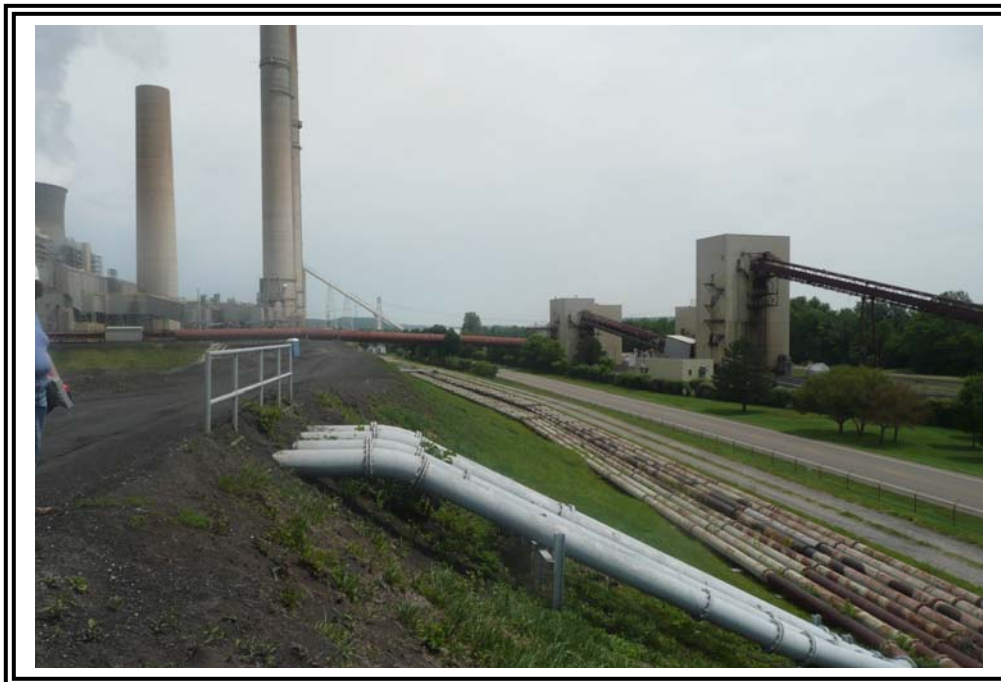
25

Crest and downstream slope alignment of east dike, looking north. Crest is raised at sluice pipe crossings.

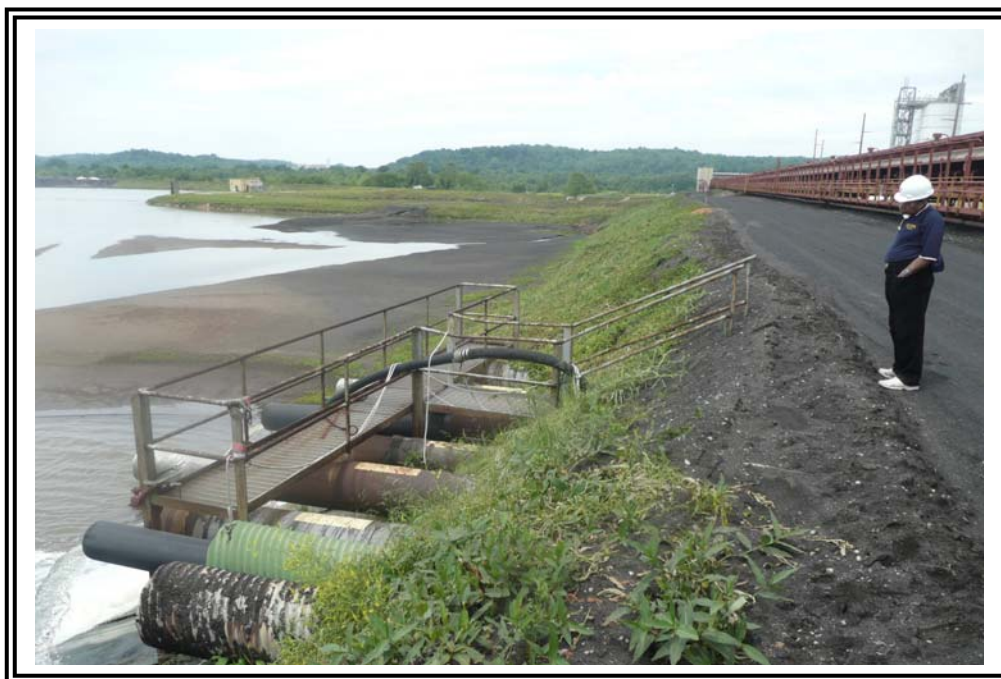
26

Crest and upstream slope alignment of north dike, looking west. Coal conveyor runs the length of the north dike crest.

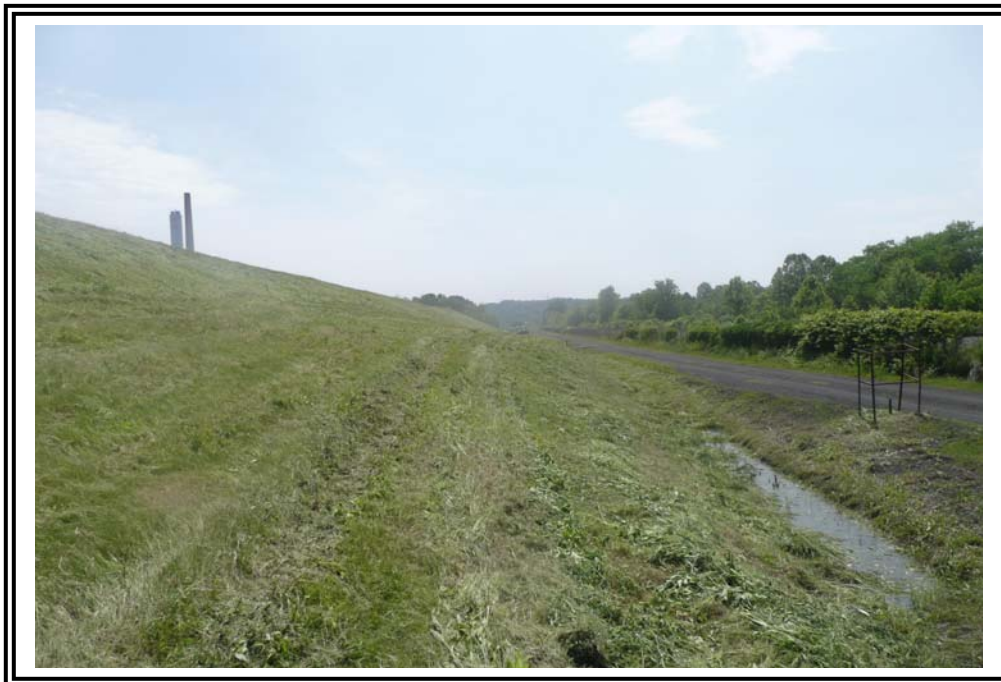
27

Previous reports indicated there is a bulge on the downstream slope of the west dike. CHA observed this area and did not see signs of current movement, nor an area above this slope where it appears that either the bulged soil came from or that the area was repaired. AEP should continue to monitor this area for changes as they have in the past.

Apparent bulge reported in previous reports along west dike. No signs of current movement.

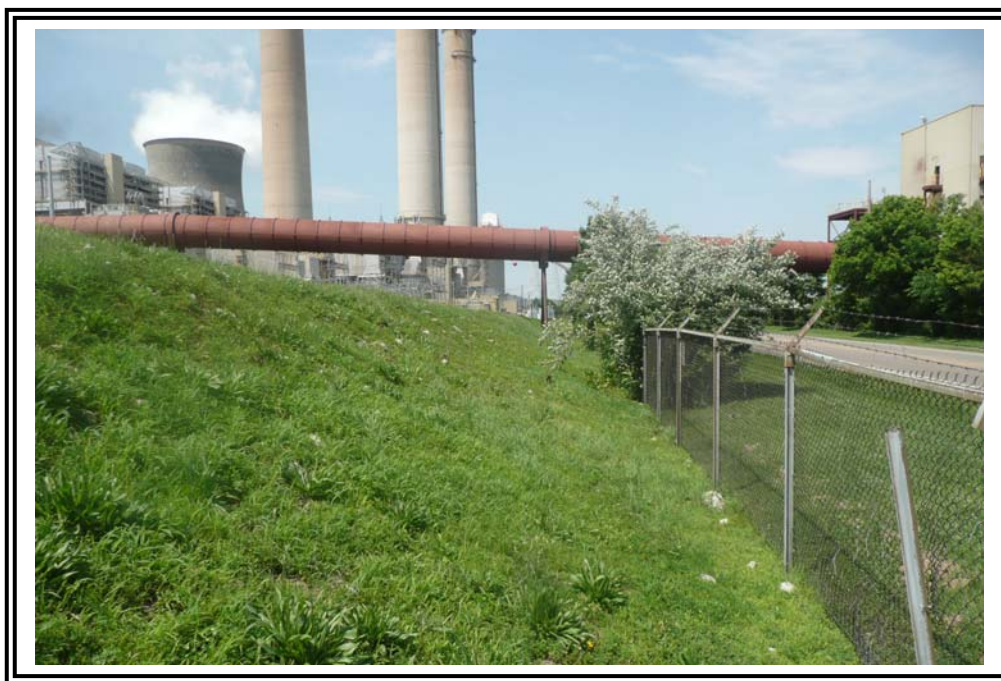
28

North end of east dike, looking north. This portion of the downstream slope is part of the benched out area for the access road.

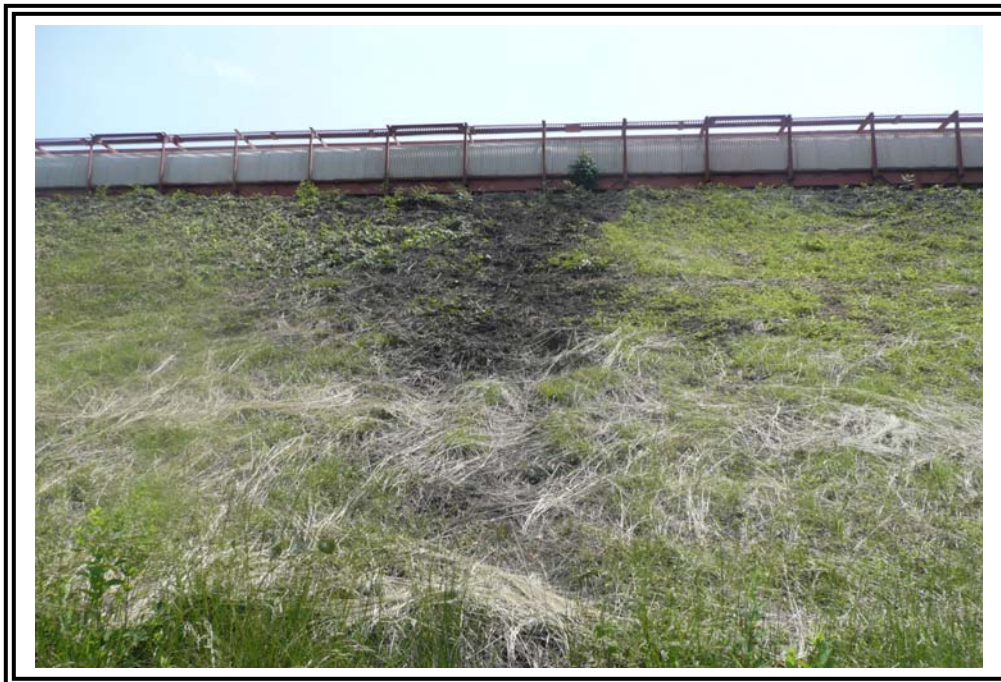
35

Close-up of one area of coal residue from coal conveyor flushing.

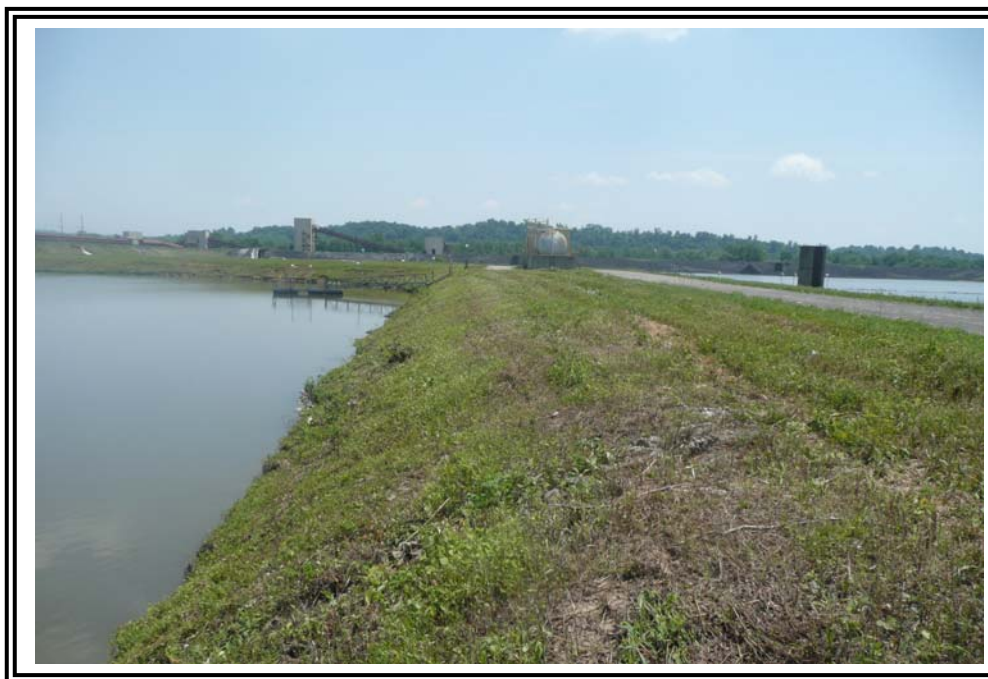
36

South intermediate dike separating primary from secondary ponds, looking east.

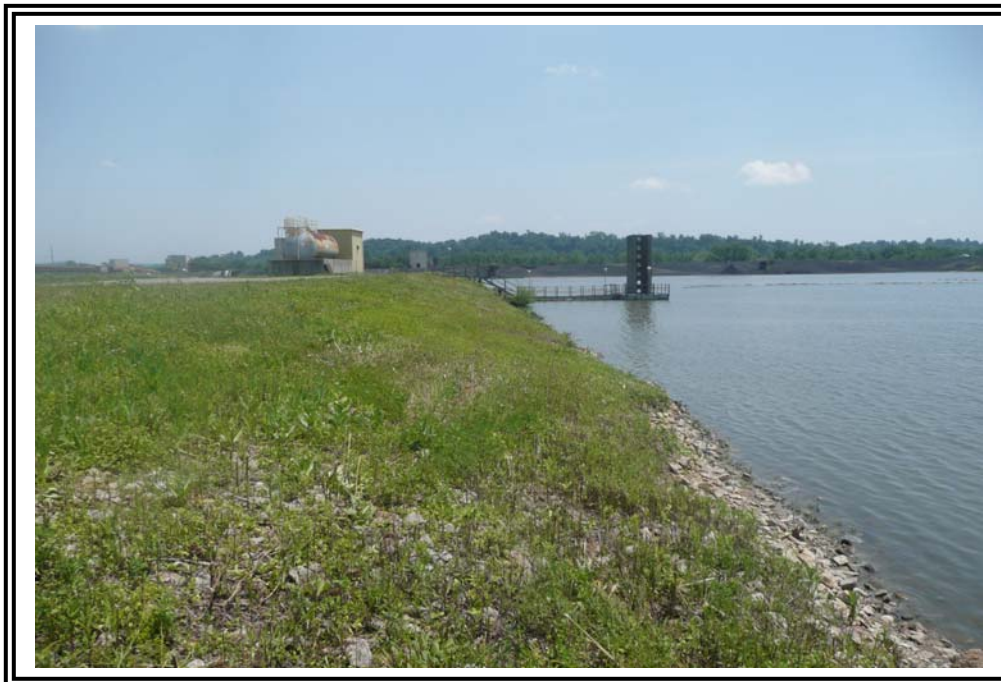
37

There are two outlet control structures in the Bottom Ash Pond. The Primary Outlet is a drop inlet structure with a concrete pipe beneath the intermediate dike. The outlet pipe was submerged and could not be observed. Photos 37, 41 and 42 show this outlet control structure.

South intermediate dike separating primary from secondary ponds, looking east.

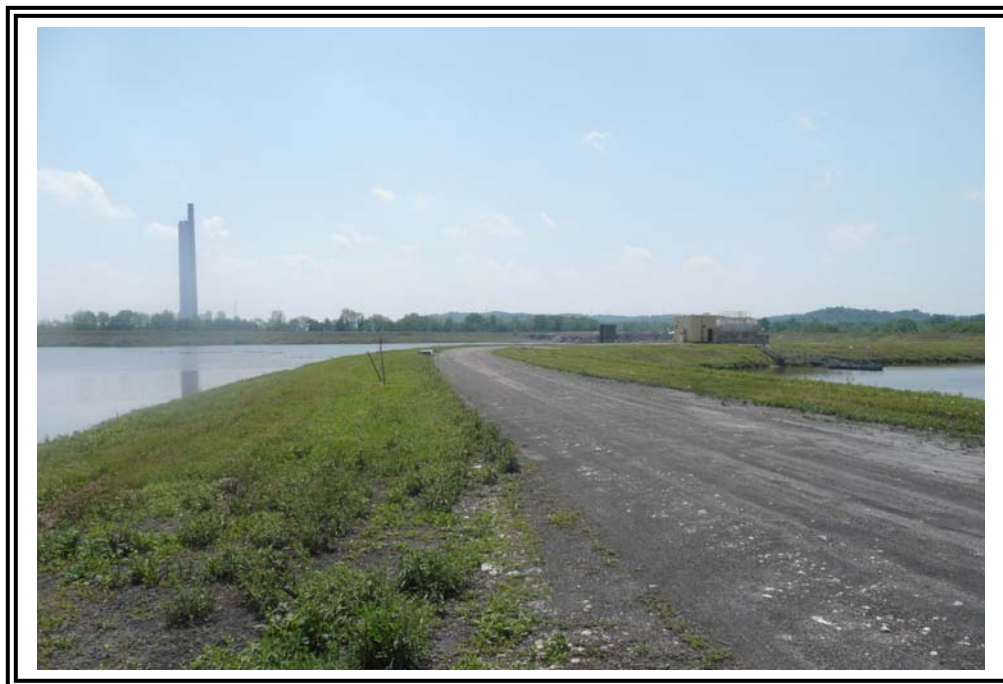
39

East intermediate dike separating primary from secondary ponds, looking south.

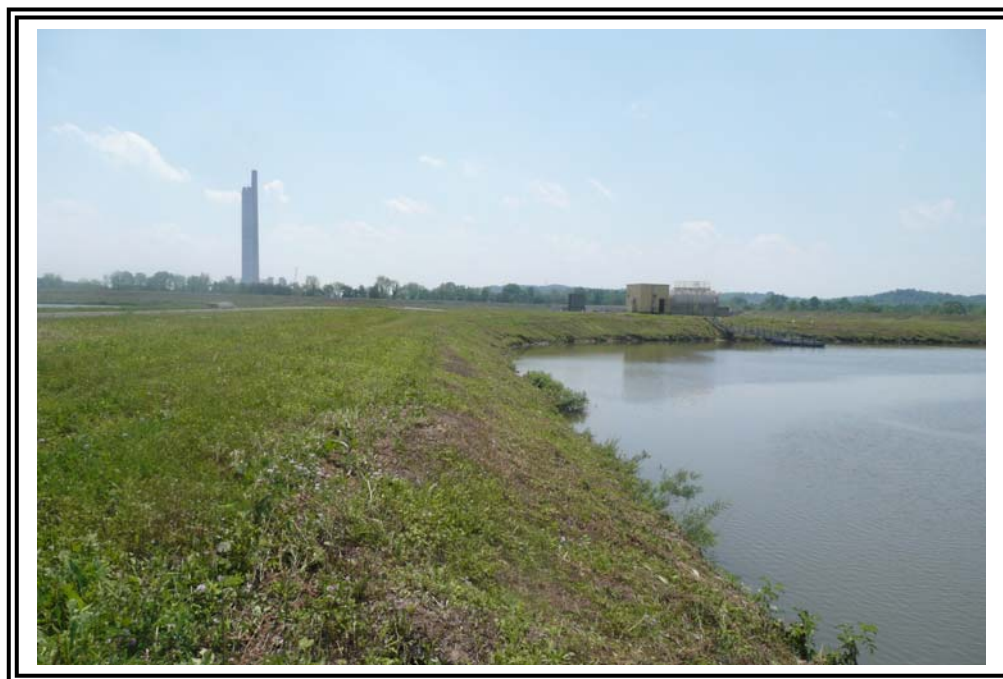
40

East intermediate dike separating primary from secondary ponds, looking south.

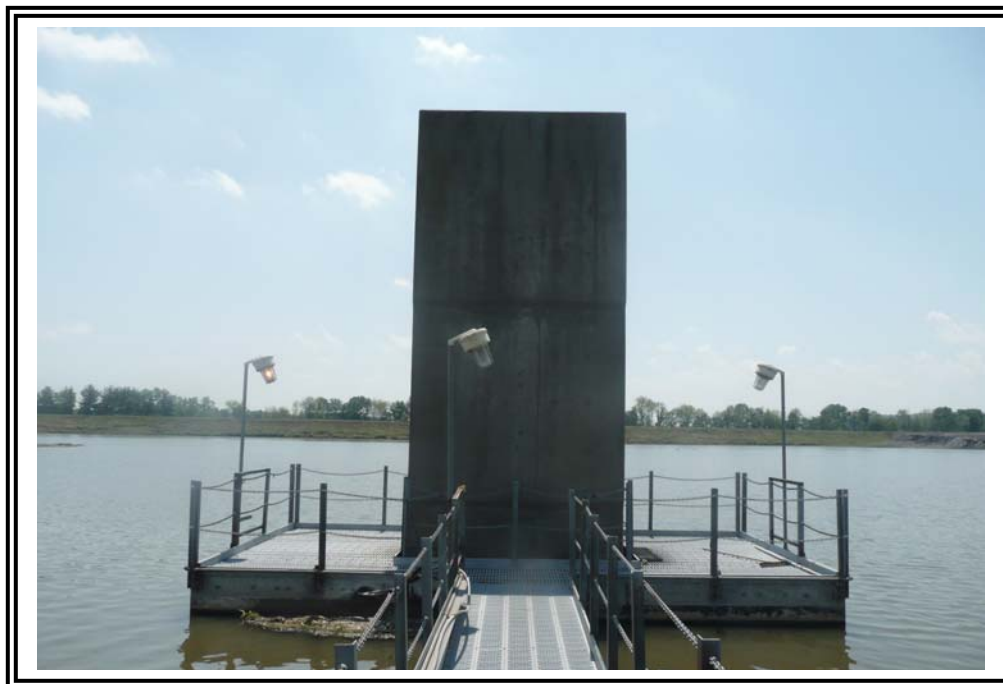
41

Main intake from primary pond to secondary pond.

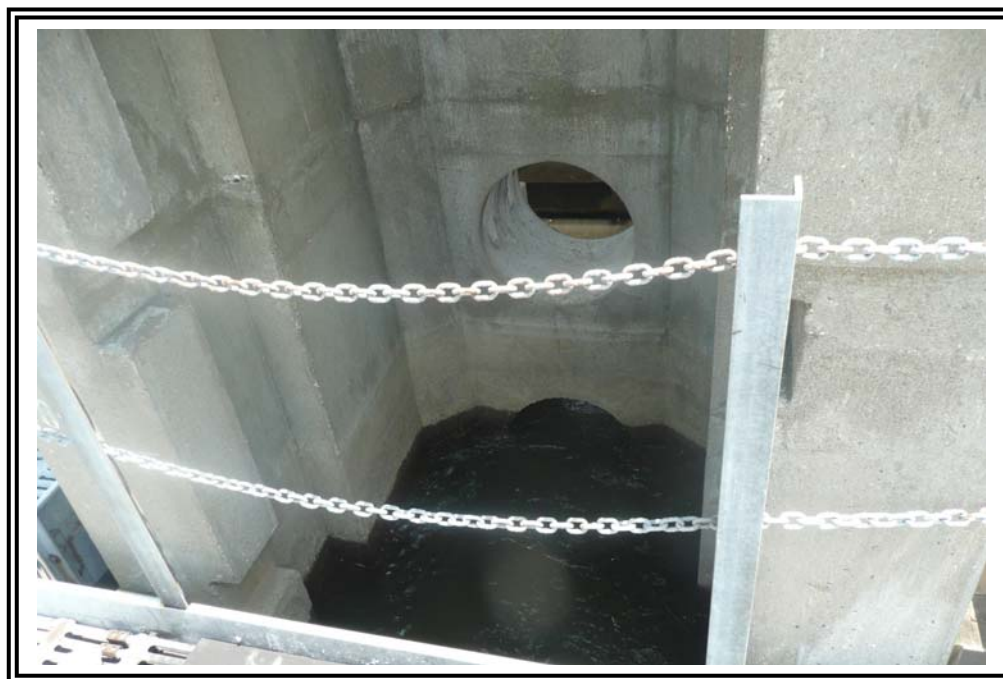
42

Main intake from primary pond to secondary pond.

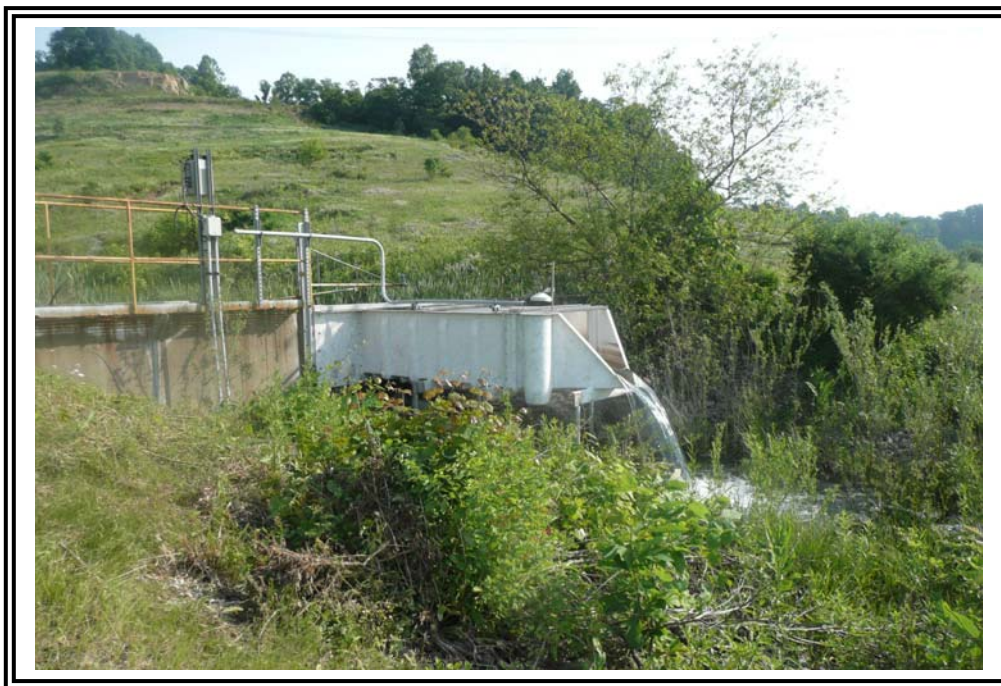
47

Outlet flow from the intake tower within the reservoir.

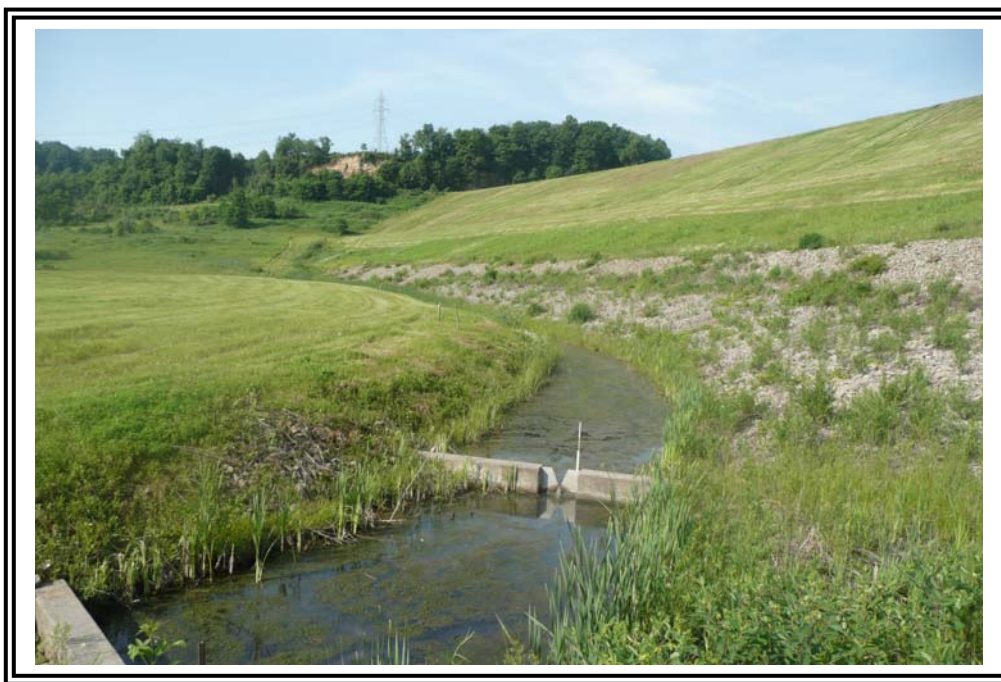
48

Drainage swale along toe of dam. Note monitoring weir structures. Much of the flow observed here was reportedly from recent rainfall runoff.

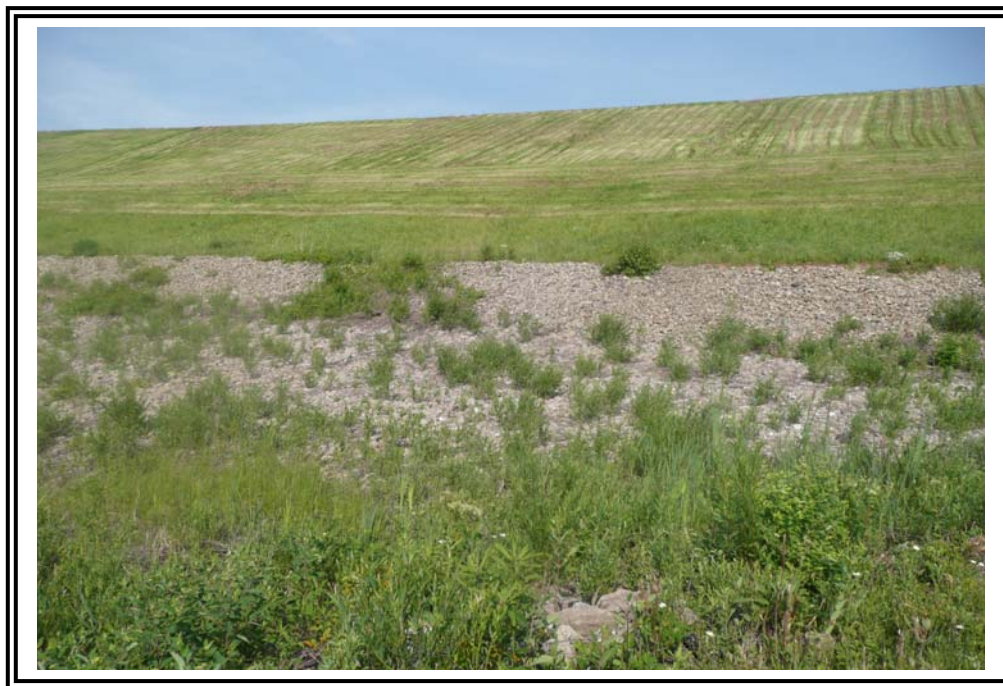
49

Toe drain covered with 6-inch diameter rip rap.

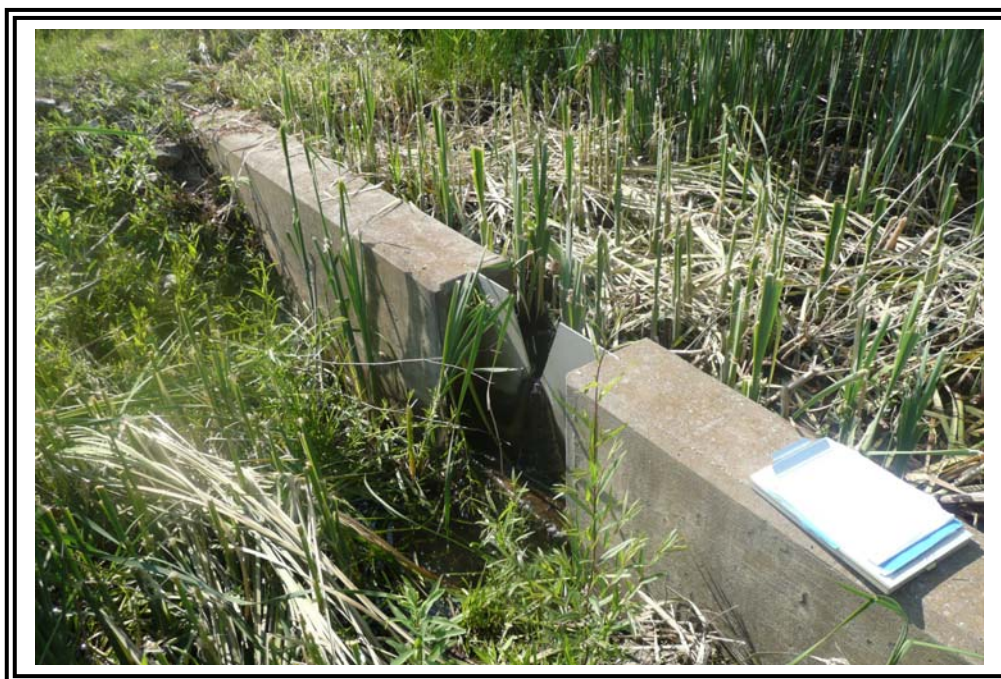
54

Close-up of Weir 3 near right (south) abutment/toe contact. Note significant difference in flow here compared to that shown in Photo (4) where all toe and groin flow for the whole length of the dam cumulates and discharges at Weir 1.

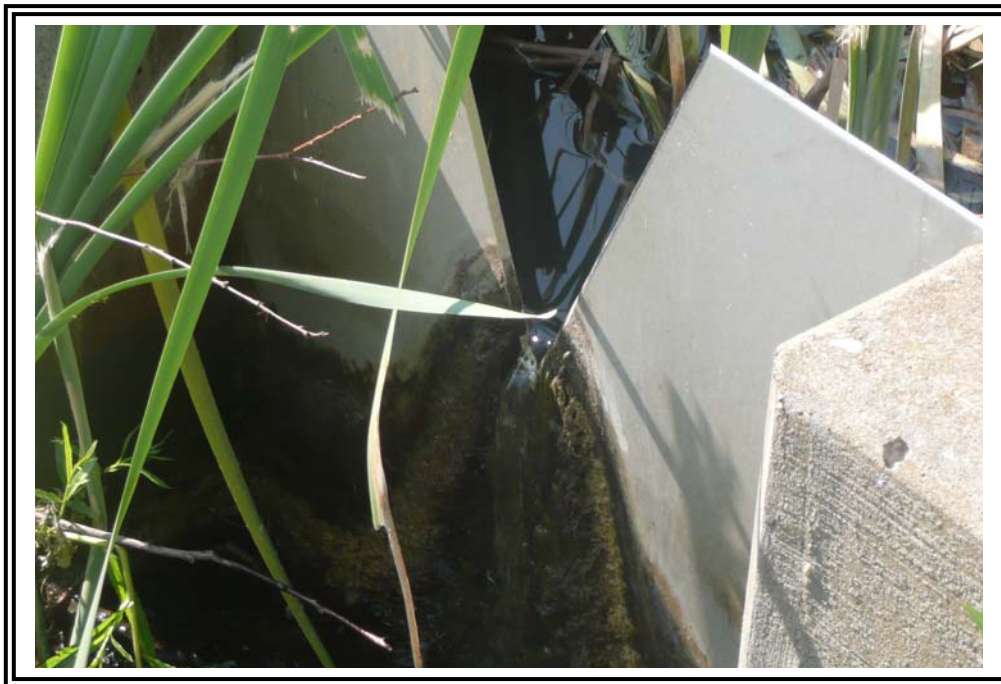
55

Close-up of Weir 3. Note the week prior to CHA's visit the site received approximately 2.9 inches of rain.

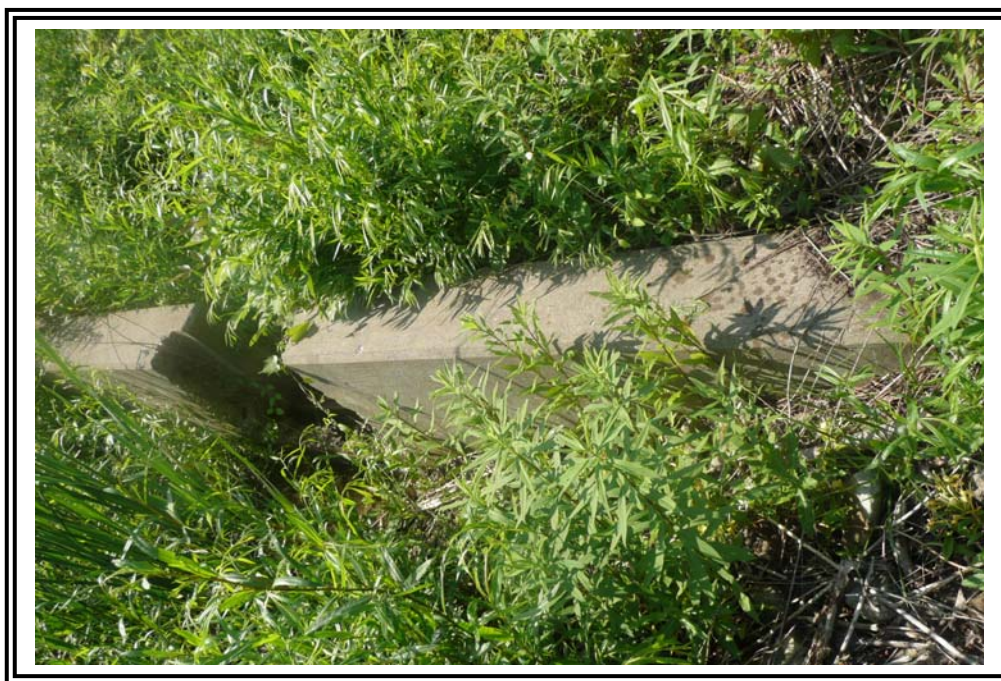
56

Abandoned weir structure located upstream of Weir 3 (appears weir plate was chipped out of the concrete). AEP staff was not aware when this was abandoned.

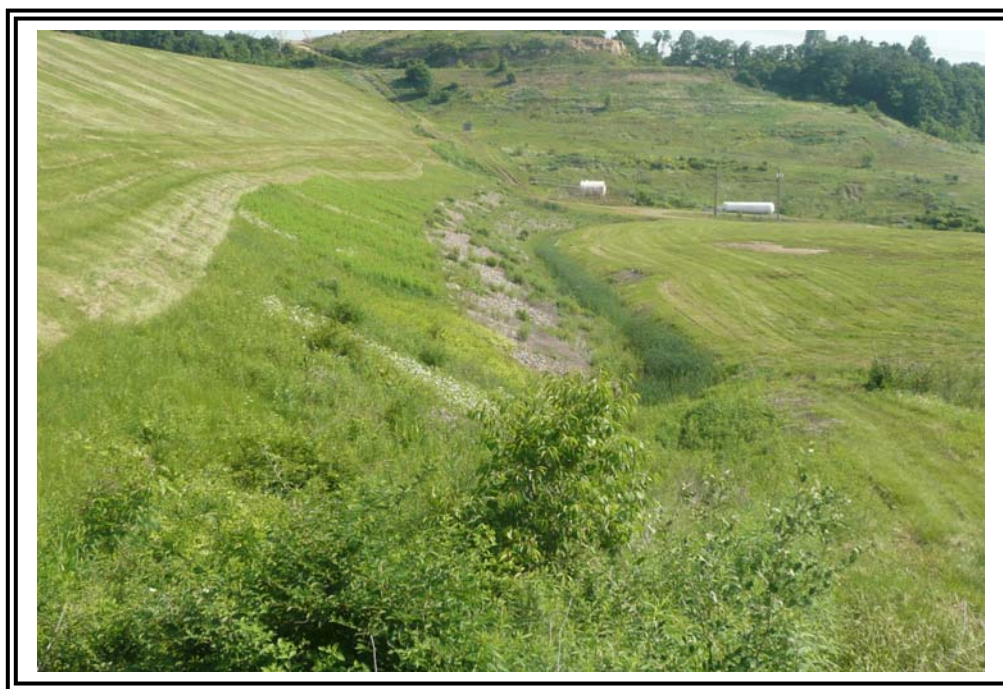
57

View of the dam toe looking north from the south abutment.
