# Assessment of Dam Safety

## Coal Combustion Surface Impoundments (Task 3)

### Final Report

American Electric Power  
General James Gavin  
Power Plant  
Cheshire, Ohio

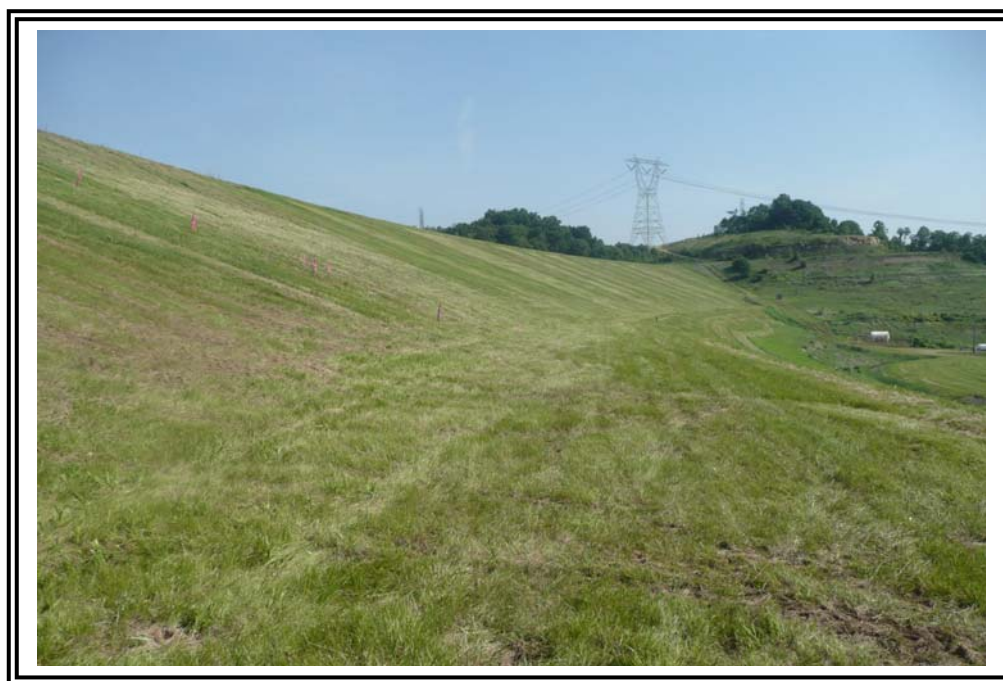
58

View along the bench on the downstream slope looking north.  
Note survey monitoring points, monitoring wells, and inclinometers.

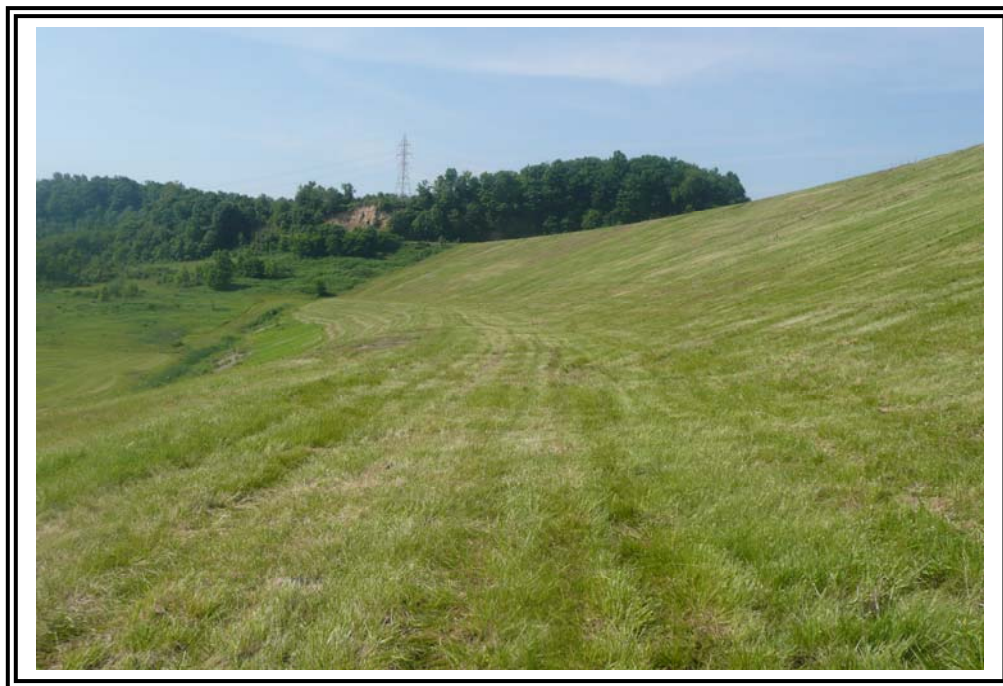
59

View along the bench on the downstream slope looking south.

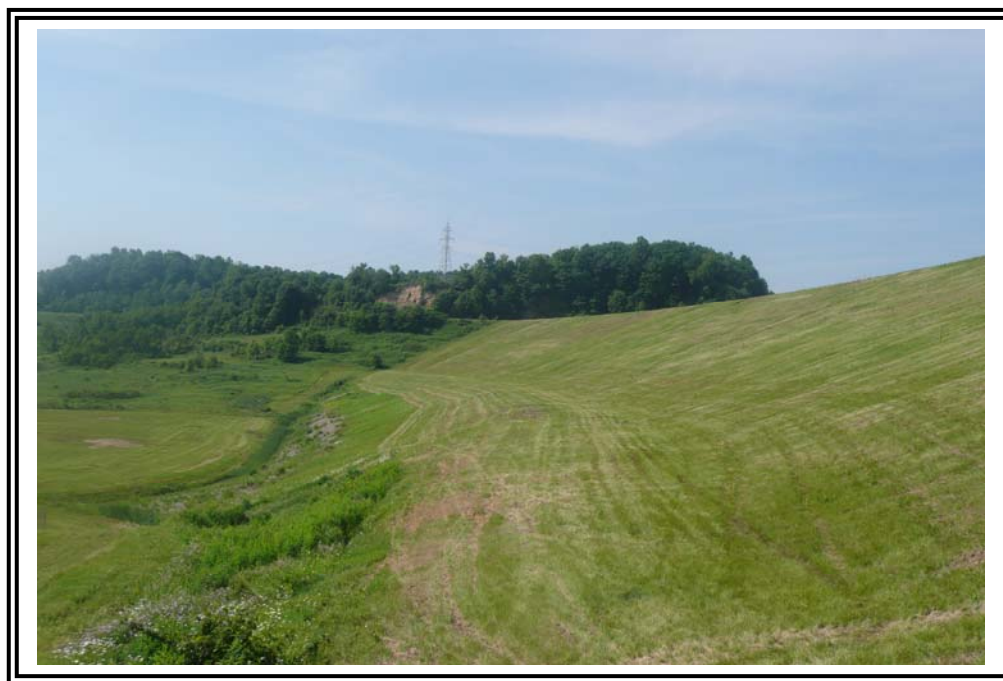
60

Downstream slope looking south (taken from north abutment).

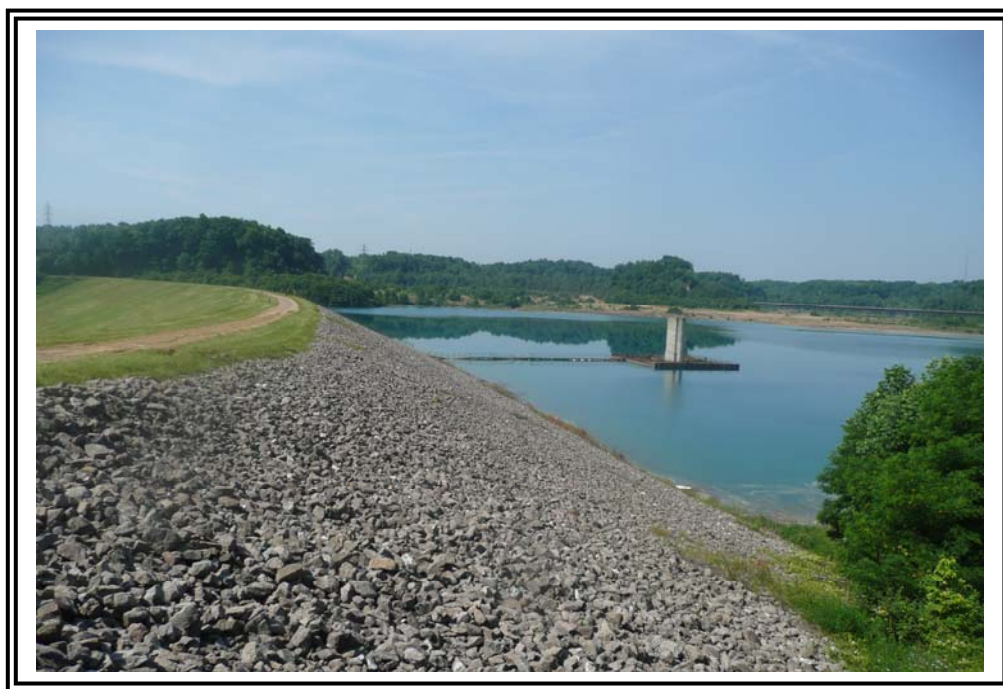
63

Upstream slope covered with 8-inch diameter rip rap.

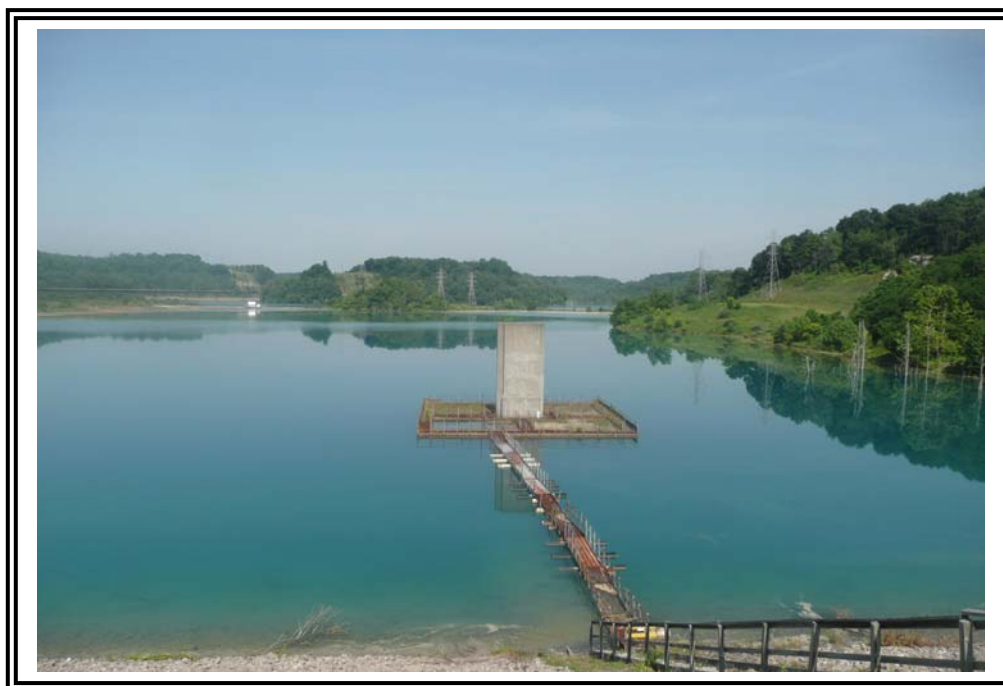
67

Intake tower from the dam crest (looking west).

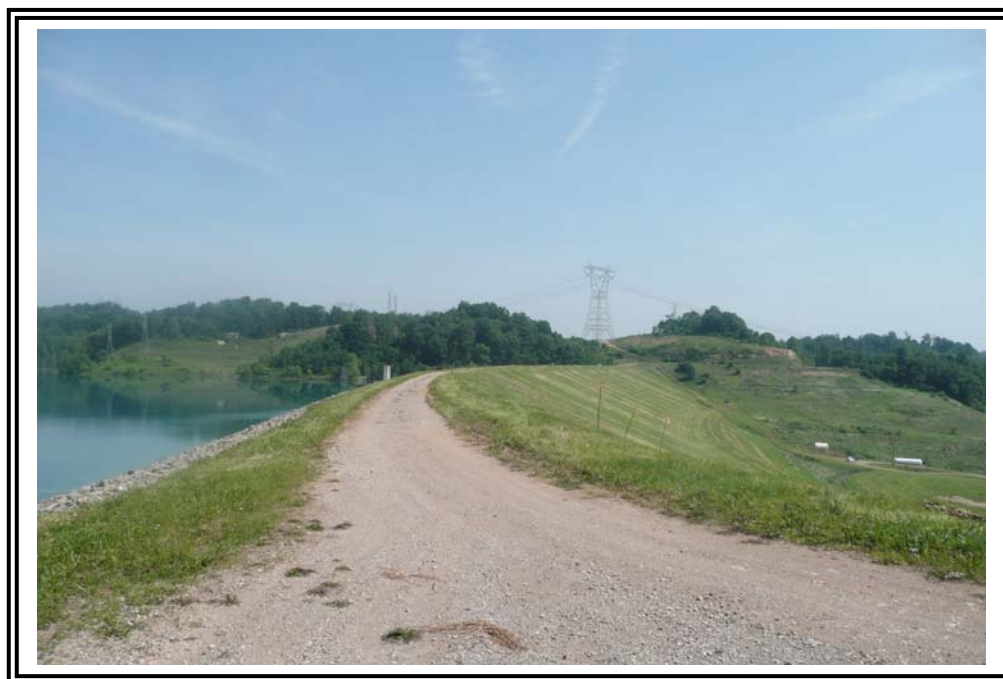
68

Dam crest and downstream slope from the right (south) abutment looking north.

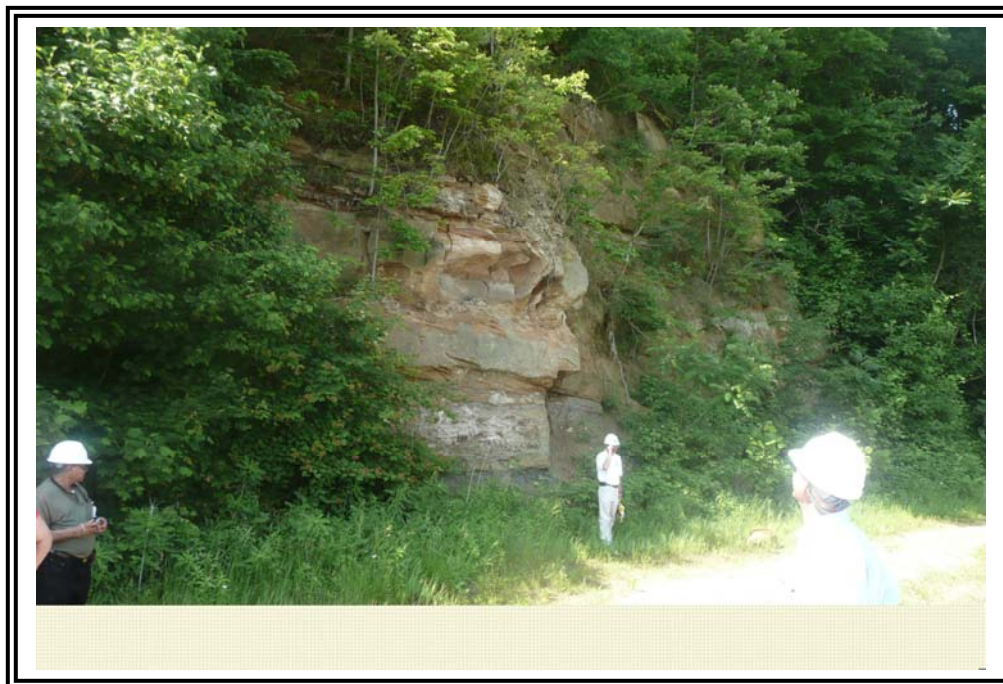
69

Right (south) abutment.

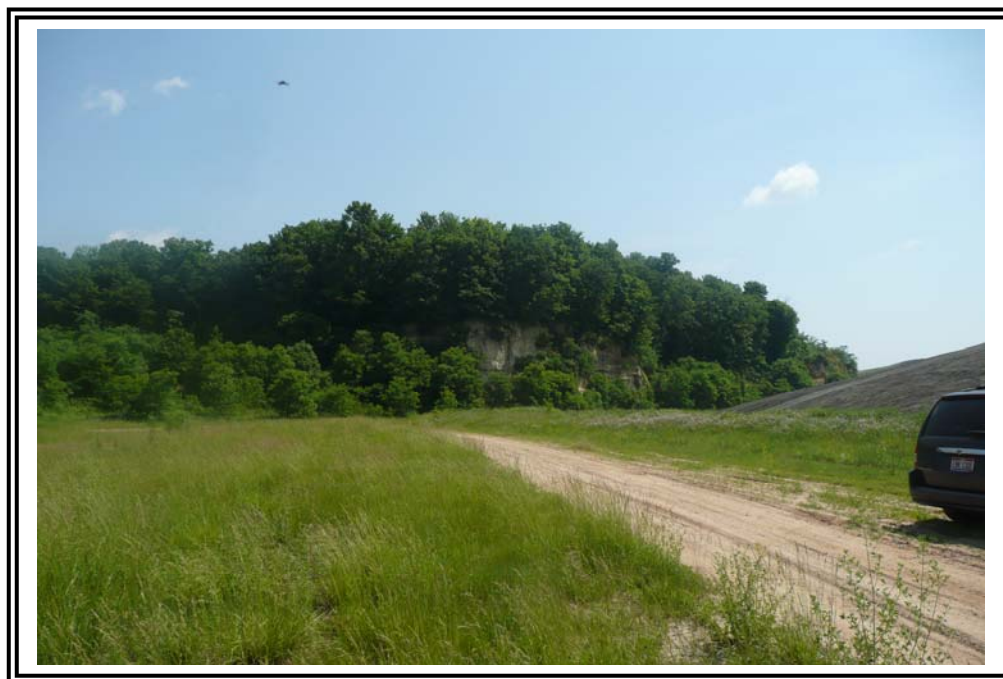
70

Left abutment of abandoned emergency spillway. Note landfill in right of photo.

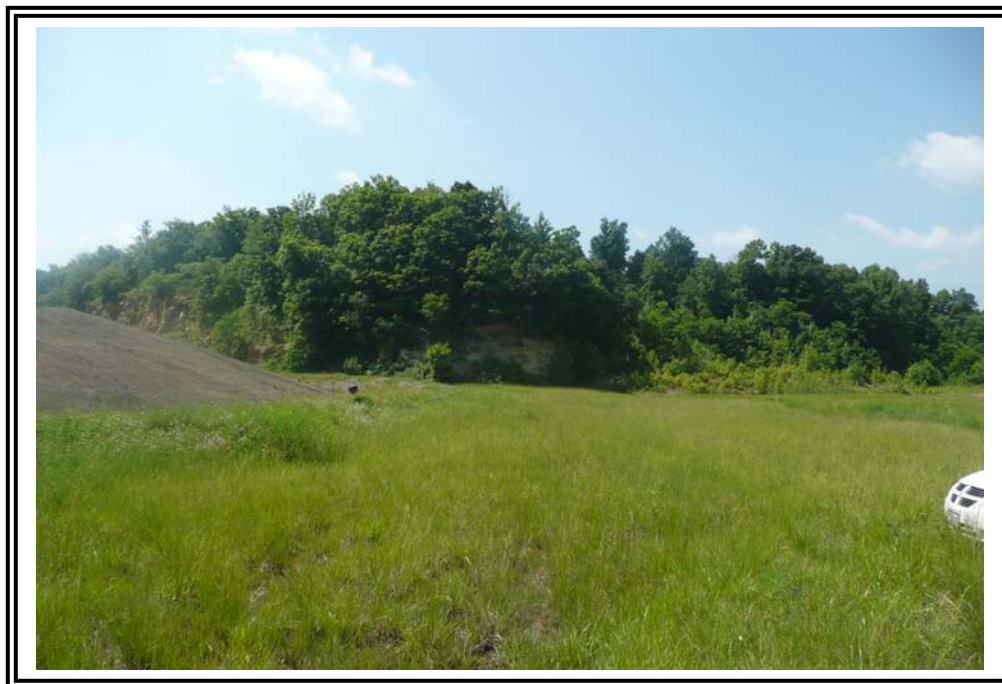
71

Right abutment of abandoned emergency spillway. Note landfill in left of photo.

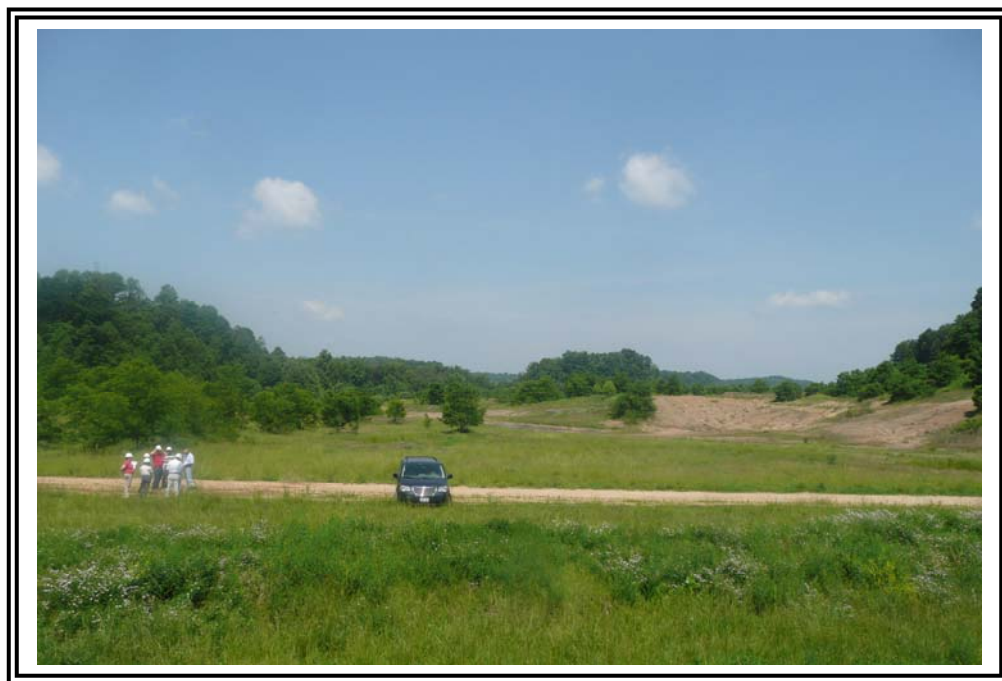
72

Abandoned emergency spillway looking toward reservoir.

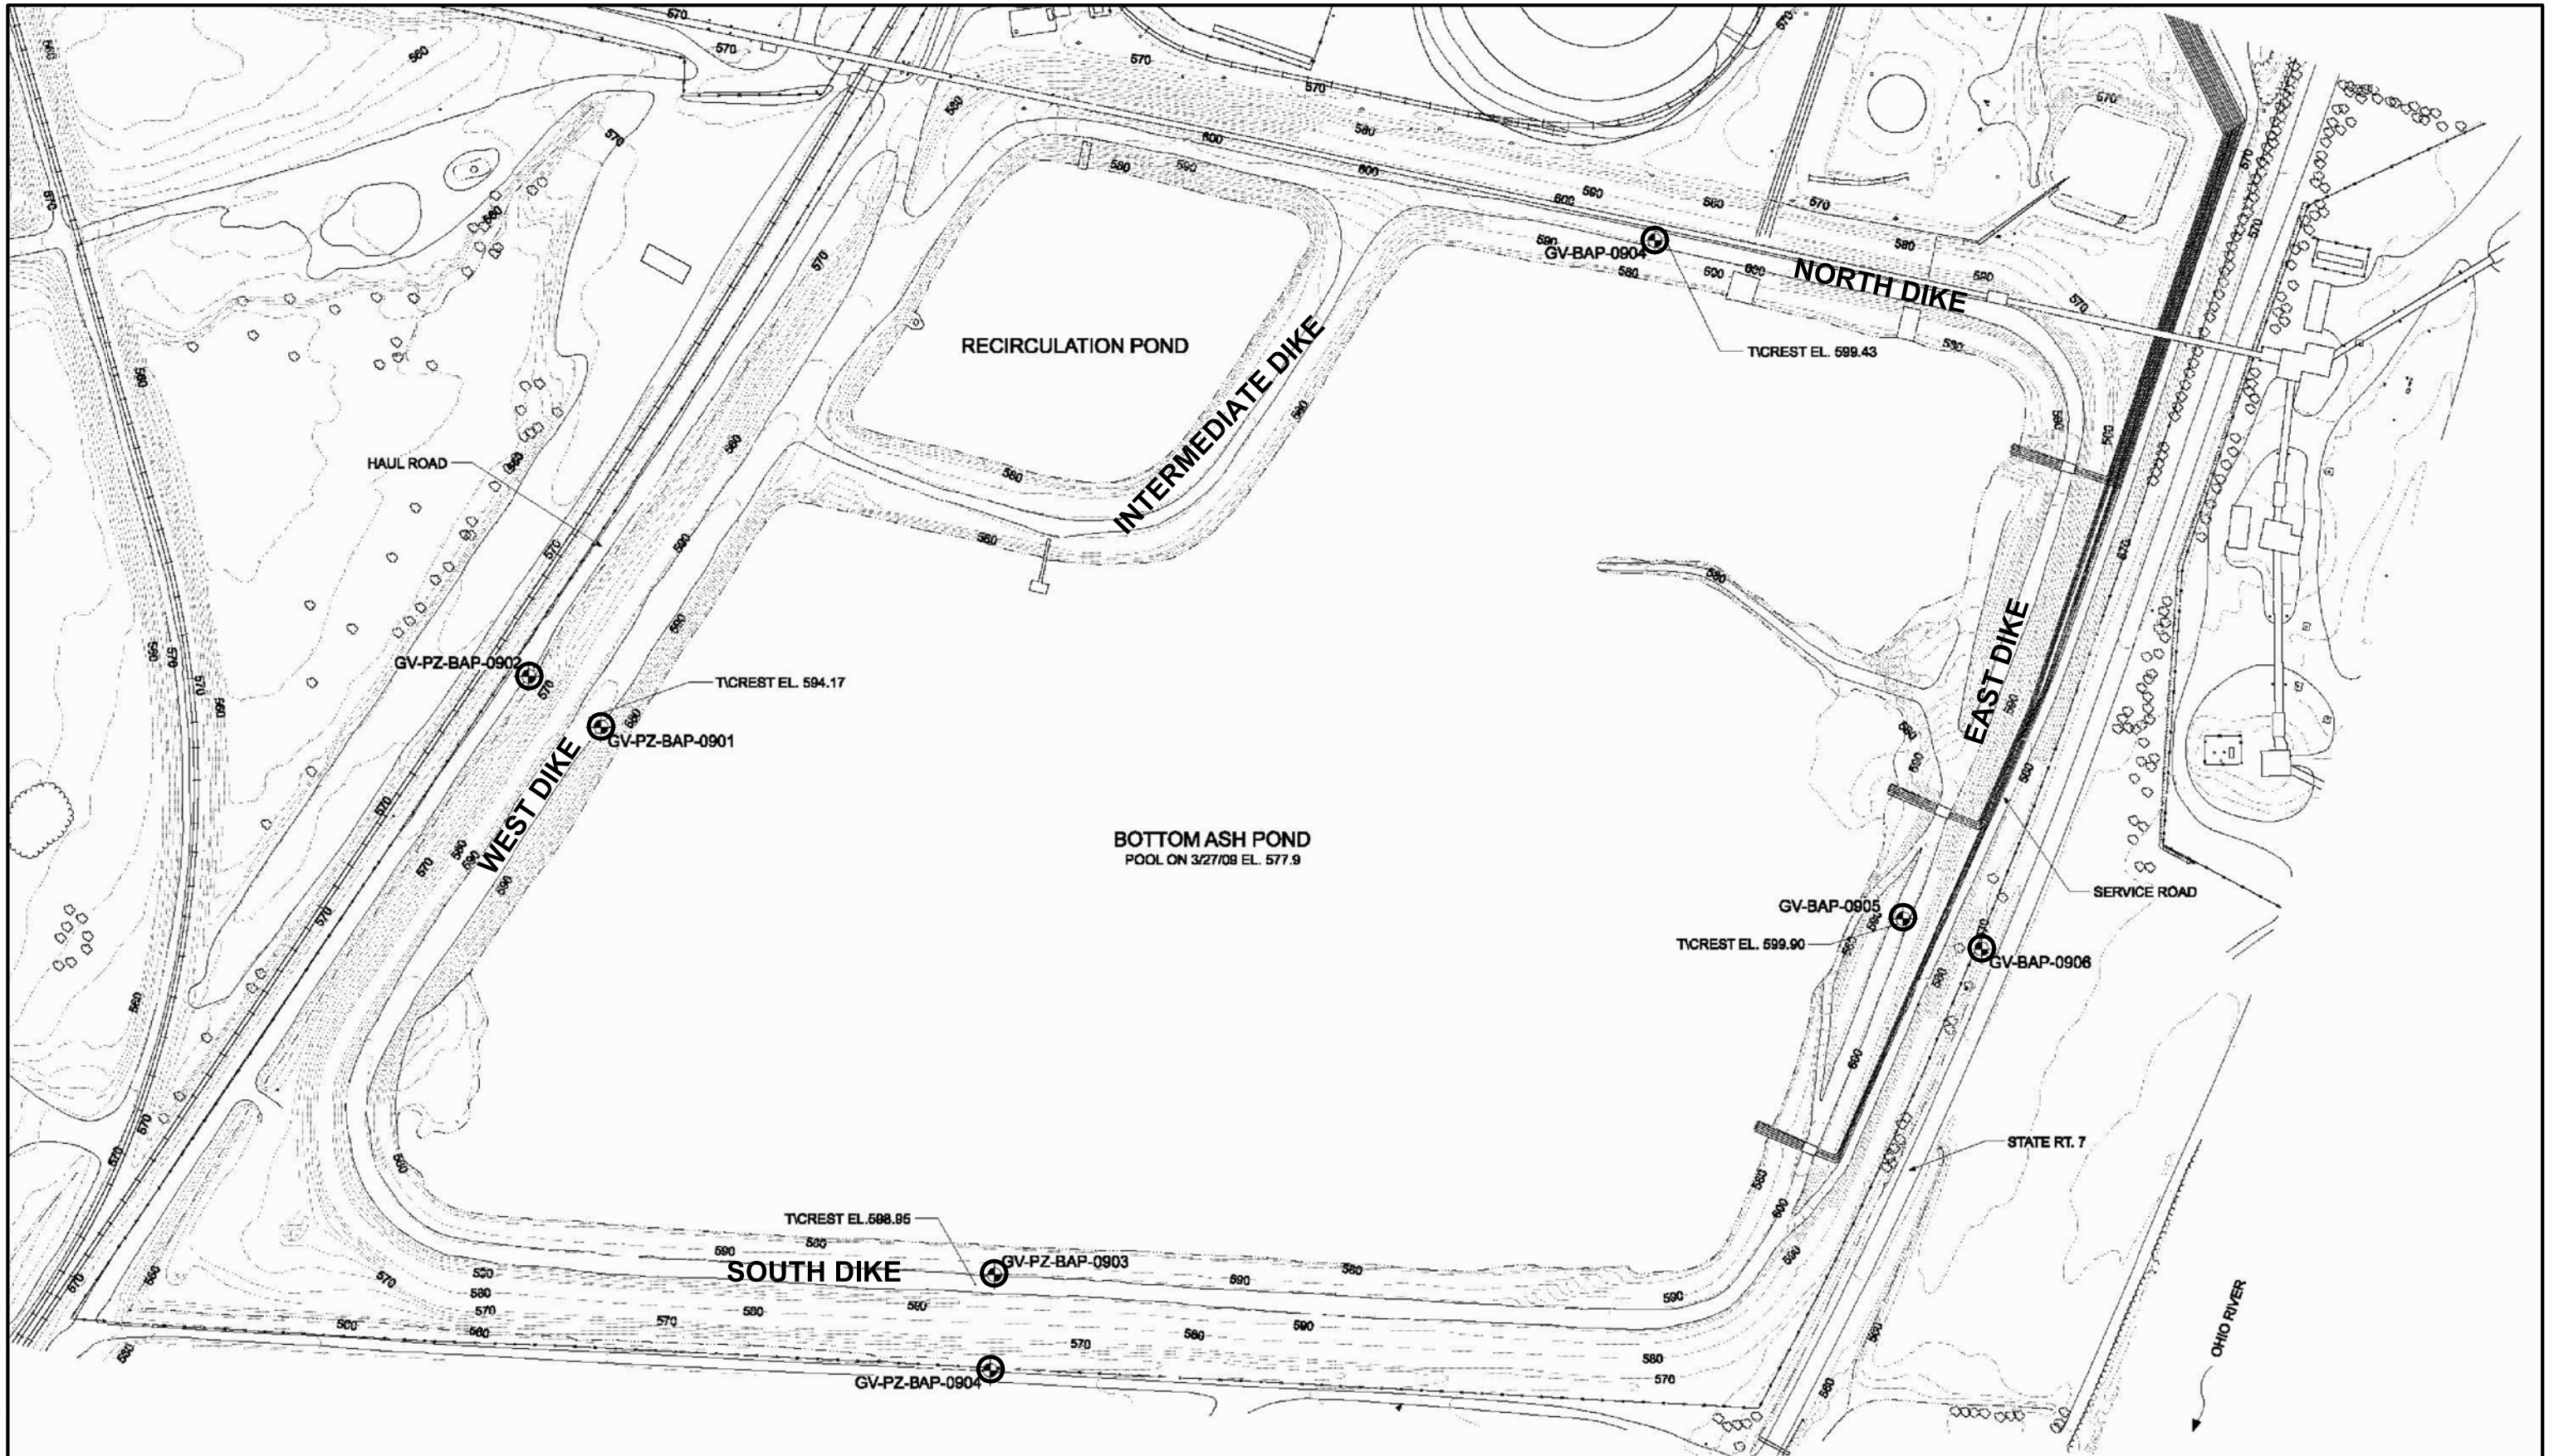
**FIGURE 7A**

There is monitoring instrumentation installed at both the Bottom Ash Pond and Stingy Run Dam. Figure 7A shows the approximate locations of instrumentation at the Bottom Ash Pond, and Figure 7B shows the approximate locations of instrumentation at Stingy Run Dam.

The Bottom Ash Pond is monitored with piezometers. Two “old” piezometers, BAP-1 and BAP-2, are in place at the toe of the west and south dikes, respectively. These piezometers have been monitored for many years although the installation date of these is unknown. Four additional piezometers were installed as part of a recent evaluation of the Bottom Ash Pond initiated by AEP following the TVA incident. Piezometers GV-PZ-BAP-901 through GV-PZ-BAP-904 were installed at the crest and toe of the west and south dikes as shown in Figure 7A.

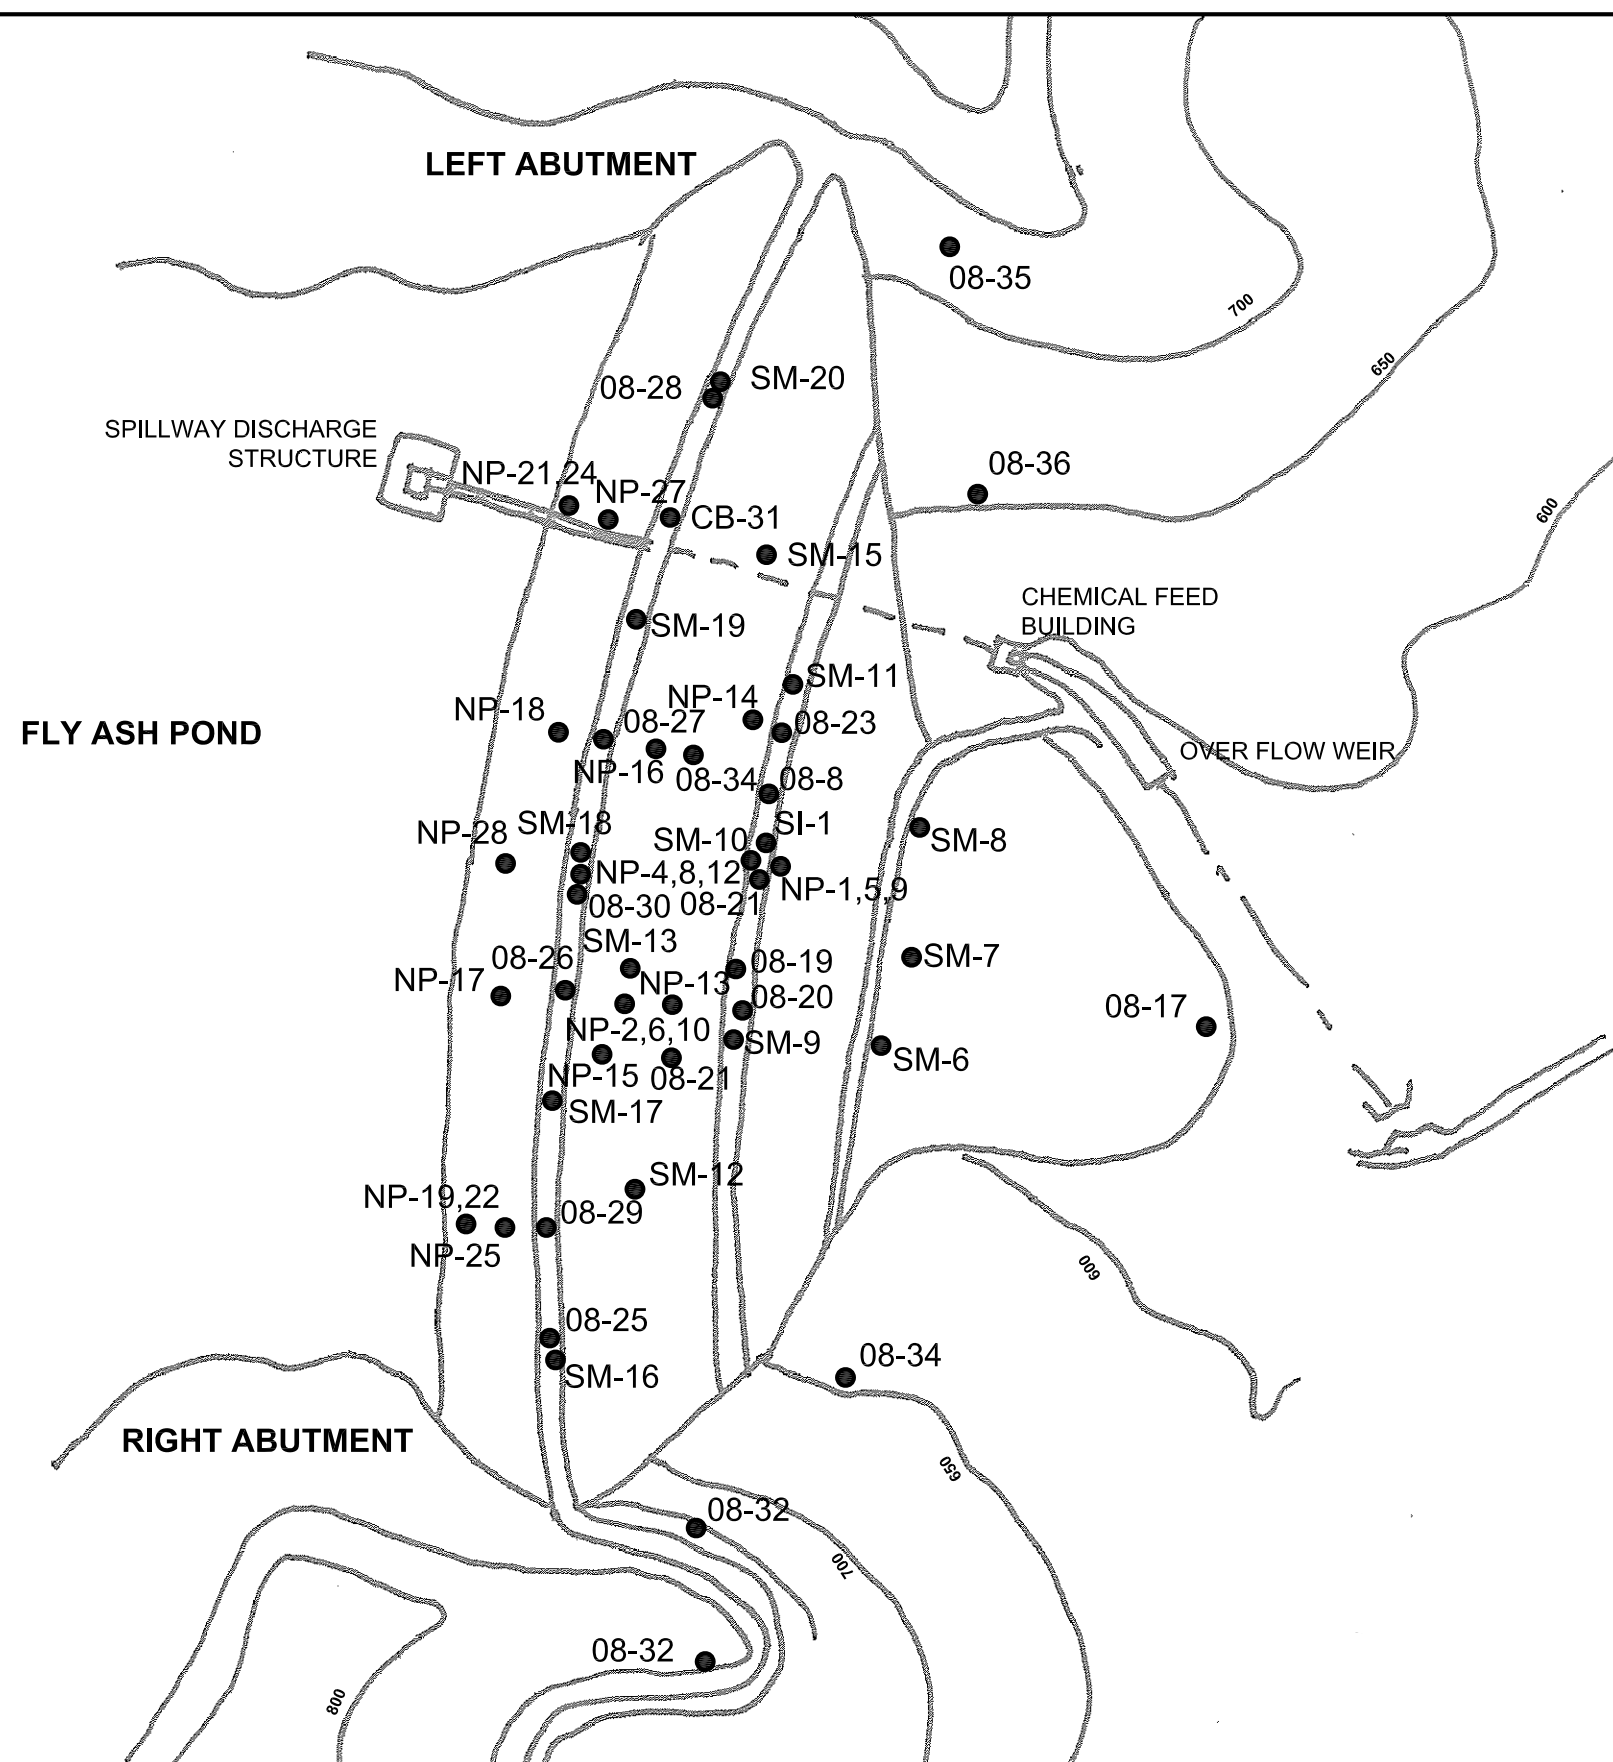
FIGURE 7B

At Stingy Run Dam many piezometers, settlement monitoring monuments, and inclinometers are in place as shown in Figure 7B. The locations shown in Figure 7B represent what was provided to CHA although AEP acknowledged that some of these locations have been destroyed over the years by mowers and vandals. Therefore, this figure should not be considered an accurate depiction of currently operating instrumentation.

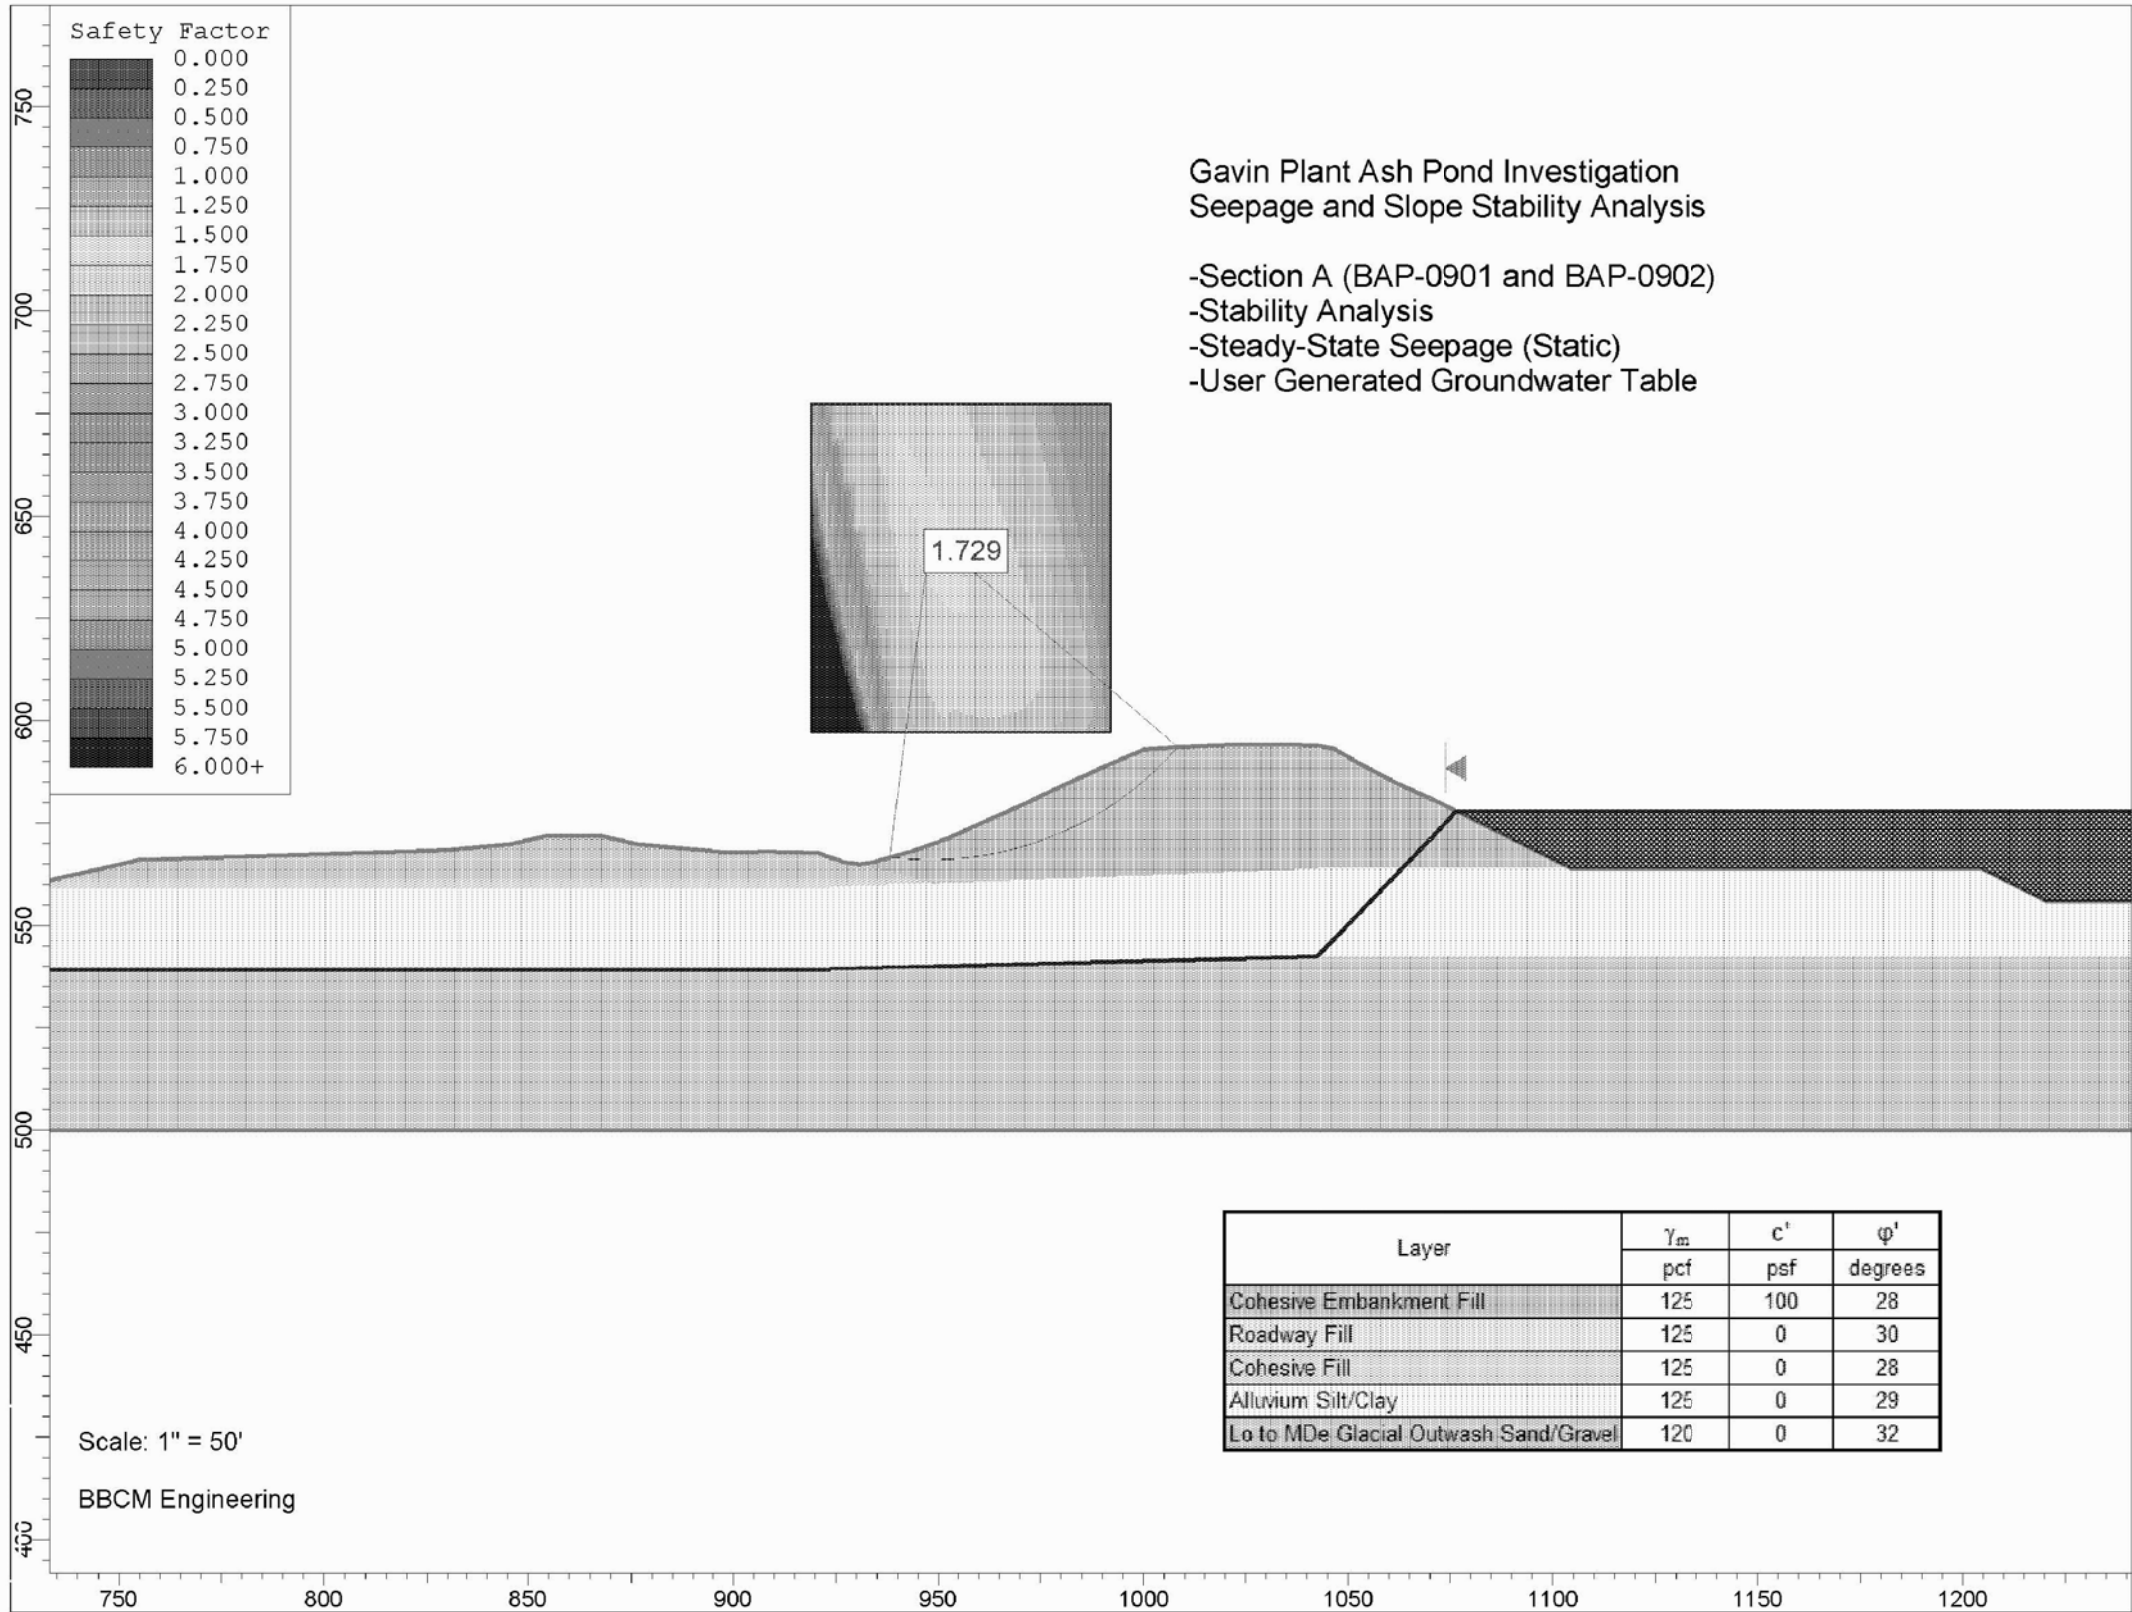
PROJECT NO.  
20085.4000  
DATE: JULY 2009  
FIGURE 8A

| Load Case | Required Minimum Factor of Safety | Calculated Minimum Factor of Safety | |
|---|---|---|---|
| Steady State Conditions at Present Pool or Flood Elevation (Downstream Slope) (See Figures 8A and 8B) | 1.5 | 1.7 | 1.5 |

- The downstream slope stability outputs for the steady state load condition for Cross Sections A and B show failure planes within the embankment soils. If the alluvium silt/clay was modeled with a soft layer at the depth corresponding to the low sample effort, the failure plane may actually fall within the alluvium foundation soils and not the embankment soils.

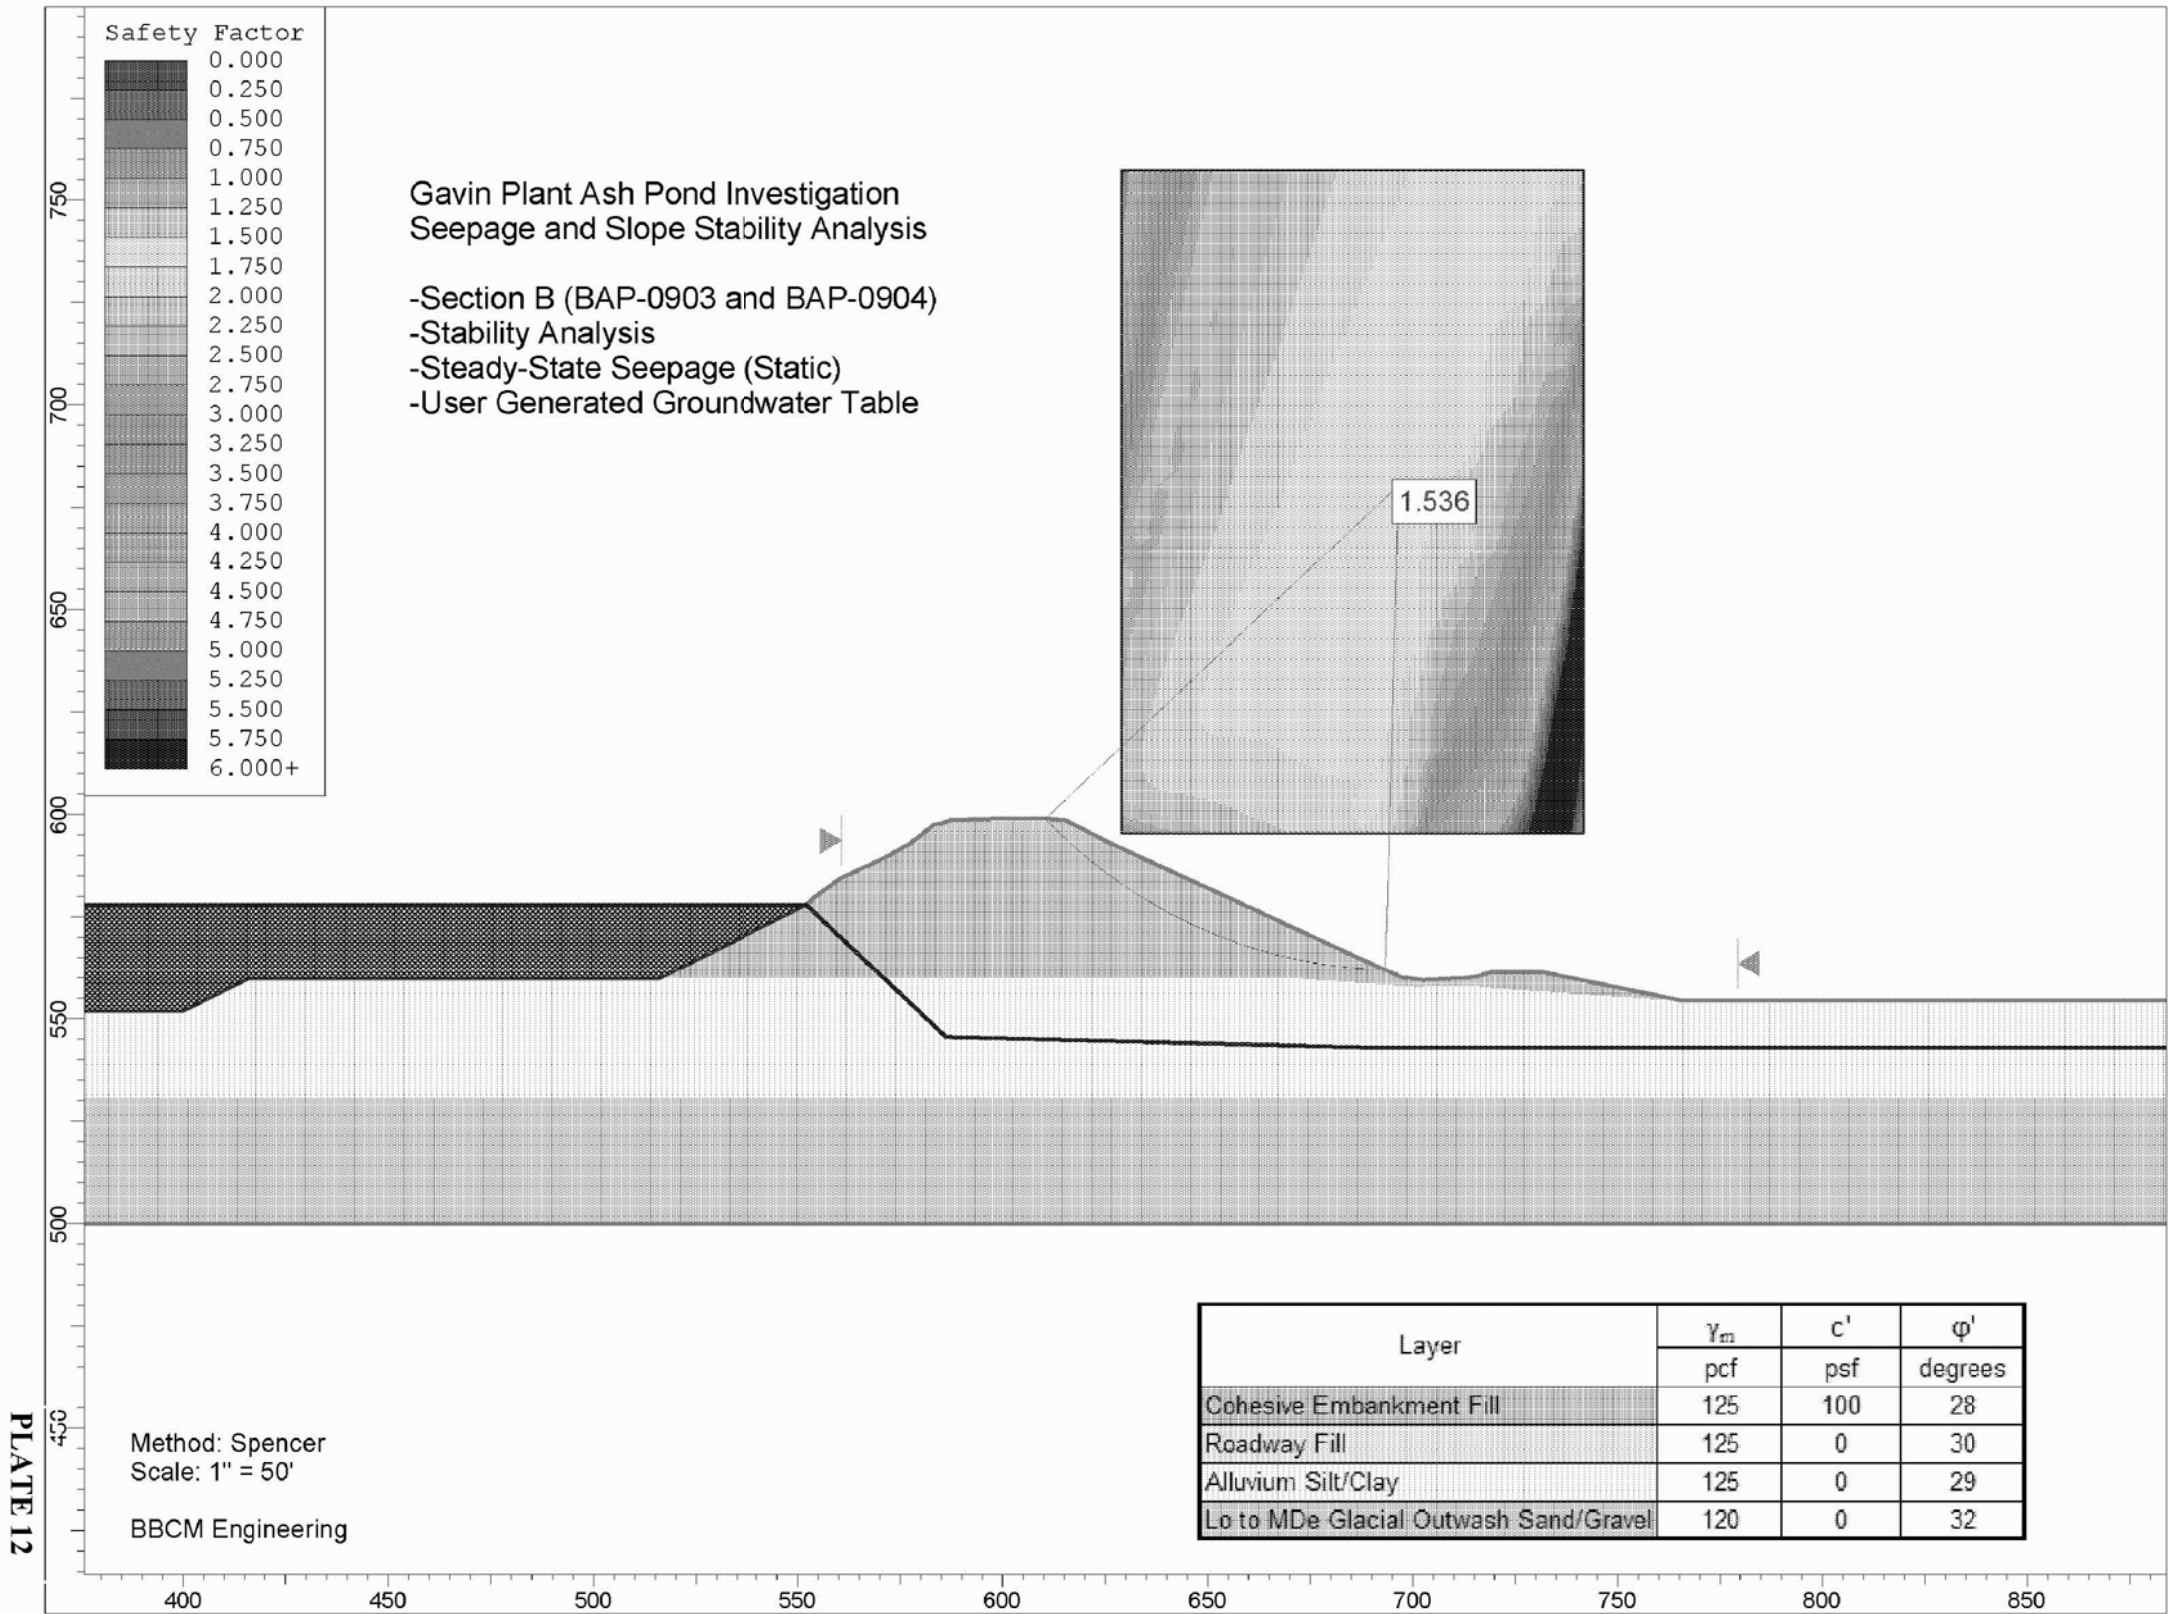
FIGURE 8C

| Load Case | Required Minimum Factor of Safety | Calculated Minimum Factor of Safety | |
|---|---|---|---|
| Seismic Conditions from Present Pool Elevation (See Figures 8C and 8D) | 1.0 | 1.4 | 1.2 |
