# Assessment of Dam Safety

## Coal Combustion Surface Impoundments (Task 3)

### Final Report

American Electric Power  
General James Gavin  
Power Plant  
Cheshire, Ohio

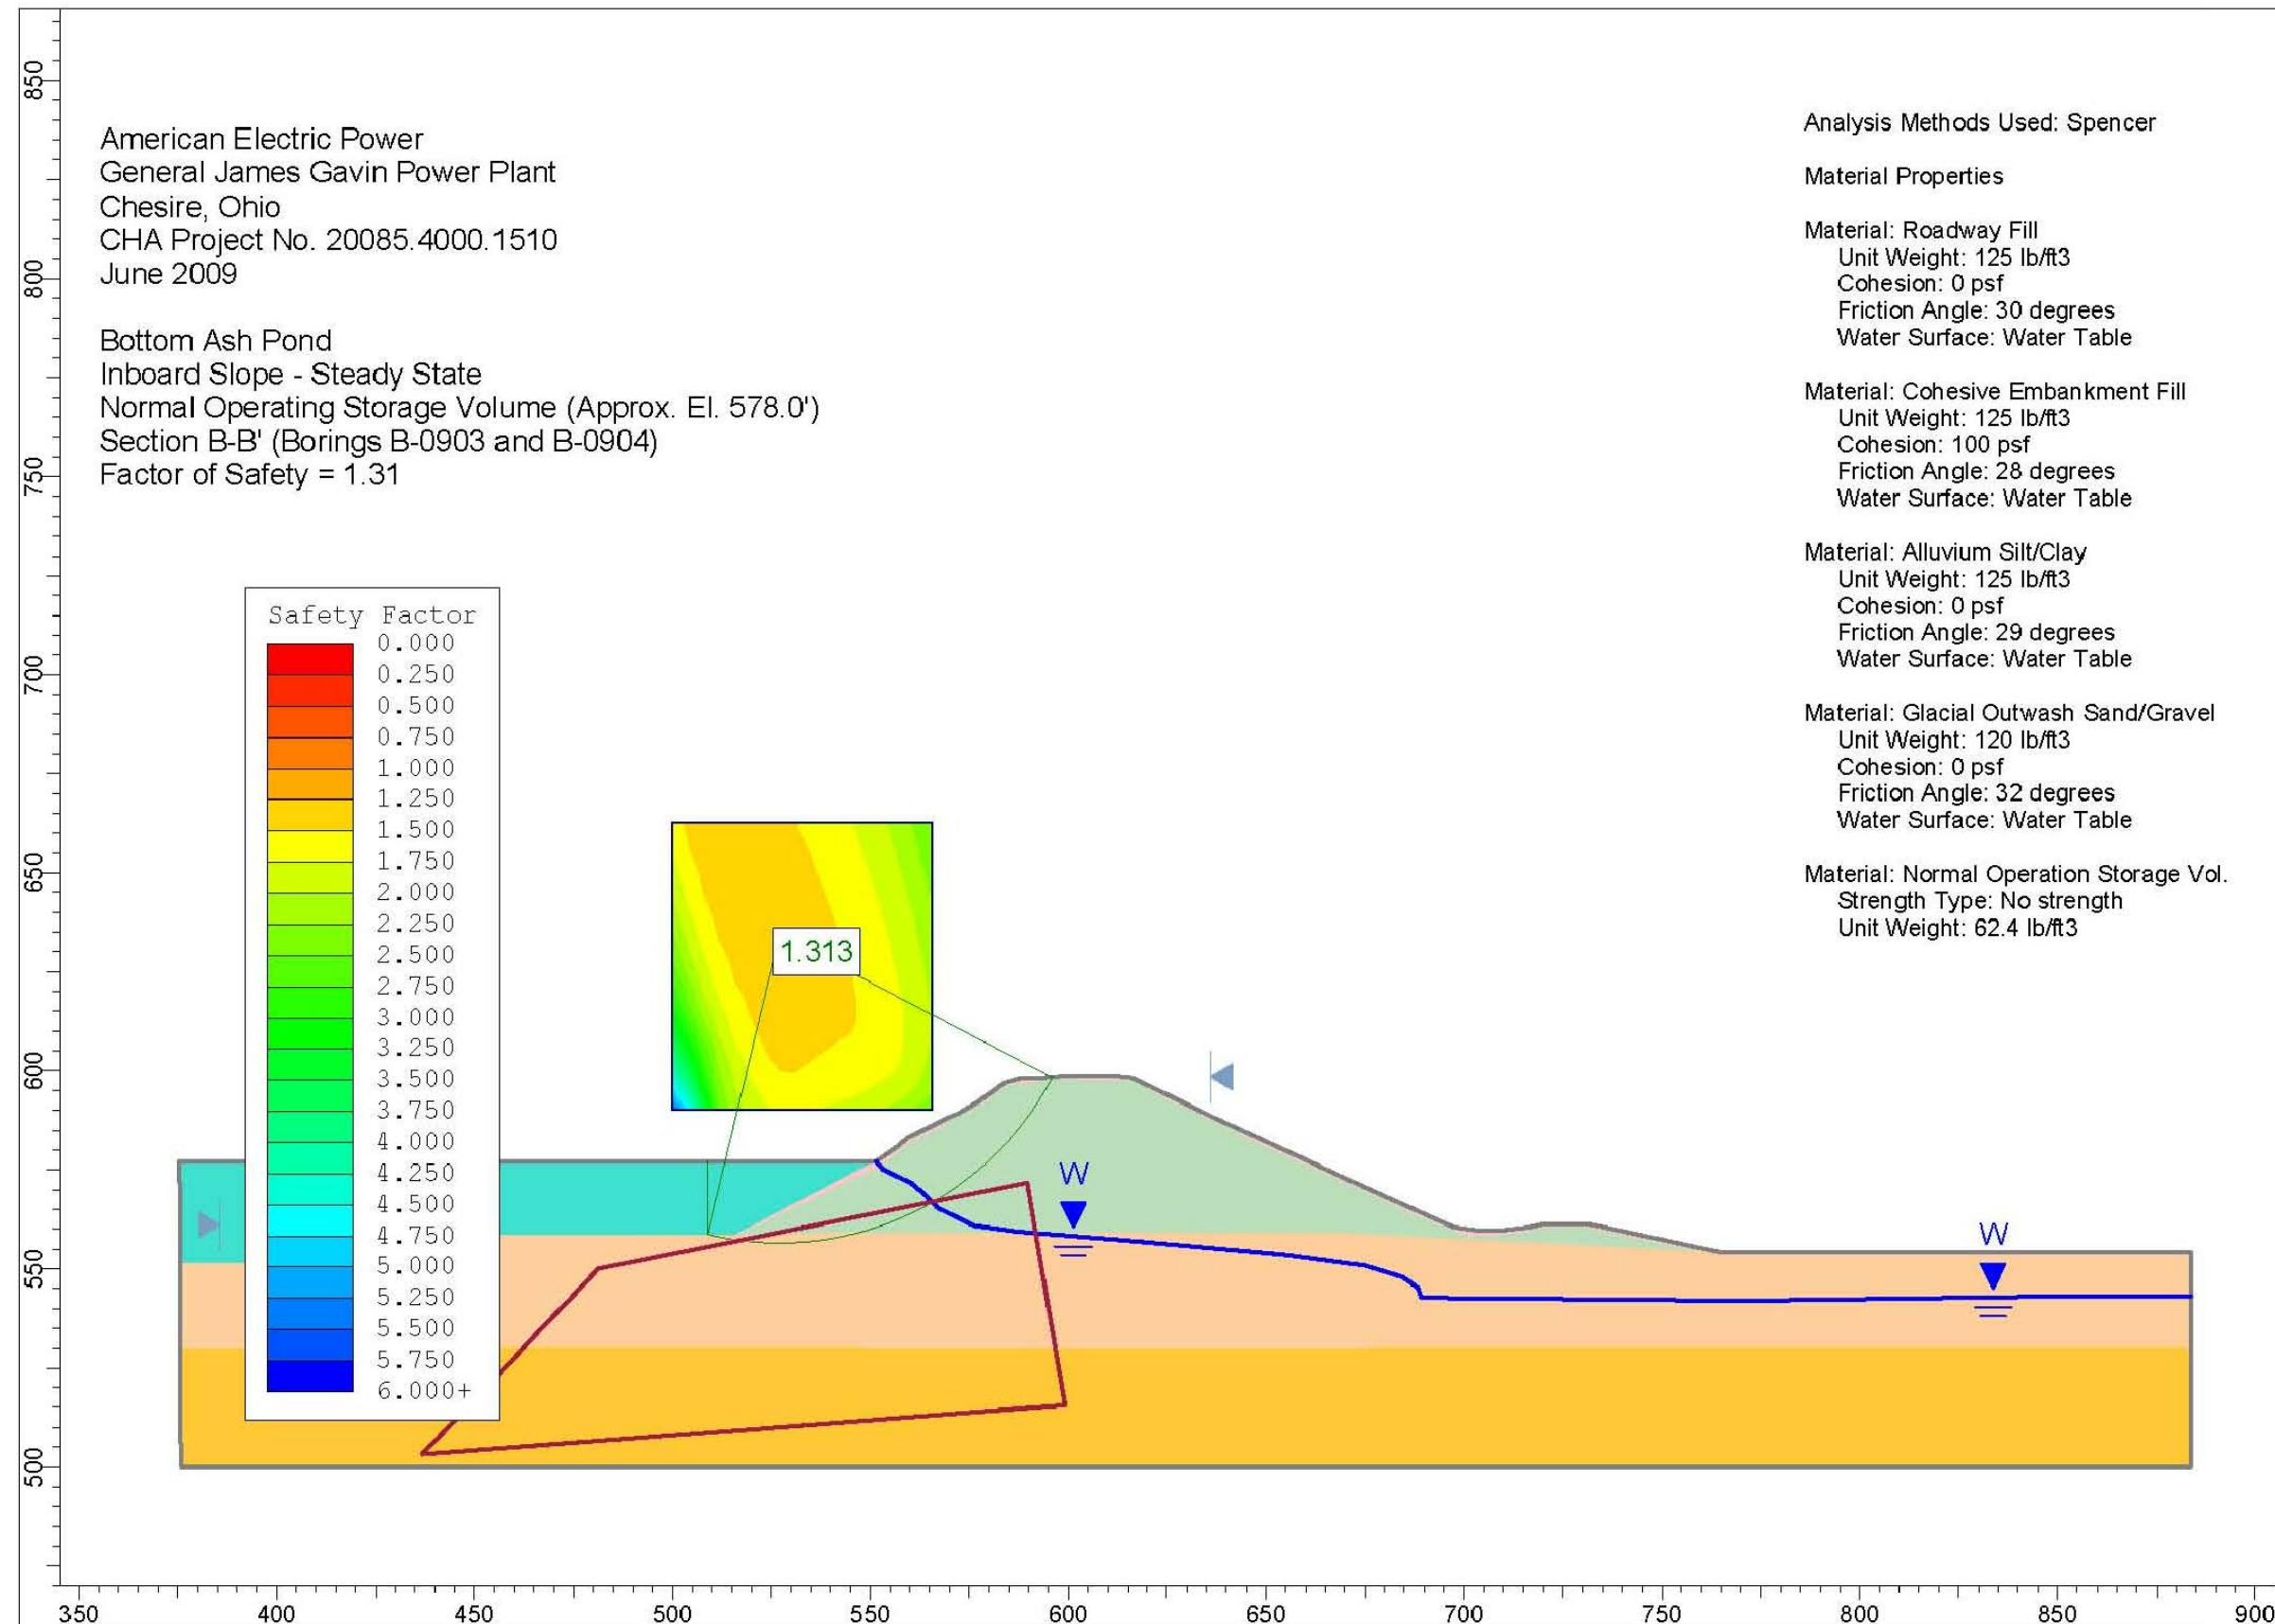
IMAGE REFERENCE: 07-01-09 GAVIN INBOARD STEADY STATE

- The factor of safety for the upstream (inboard) embankment slope of the pond was not evaluated as part of BBCM's June 2009 investigation. CHA modeled the upstream slope using the south embankment geometry and the steady state loading condition (see Figure 9B) and the soil parameter provided in BBCM's report. The calculated factor of safety was 1.3 which is below the minimum required factor of safety (according to the USACOE). This factor of safety is in part the result of the over steepened nature of the

Section 4.10 outlines our recommendations for tasks that should be performed to confirm that the embankments are stable under the loading conditions discussed above.
