**CCW IMPOUNDMENTS
INSPECTION REPORT**

**MITCHELL POWER PLANT
MARSHALL COUNTY,
WEST VIRGINIA**

**PROJECT NO. 09-4157
OCTOBER 2009**

**TRANSMITTAL
ASSESSMENT OF DAM SAFETY OF
COAL COMBUSTION SURFACE IMPOUNDMENTS
DRAFT INSPECTION REPORT
SITE 24 (MITCHELL)**

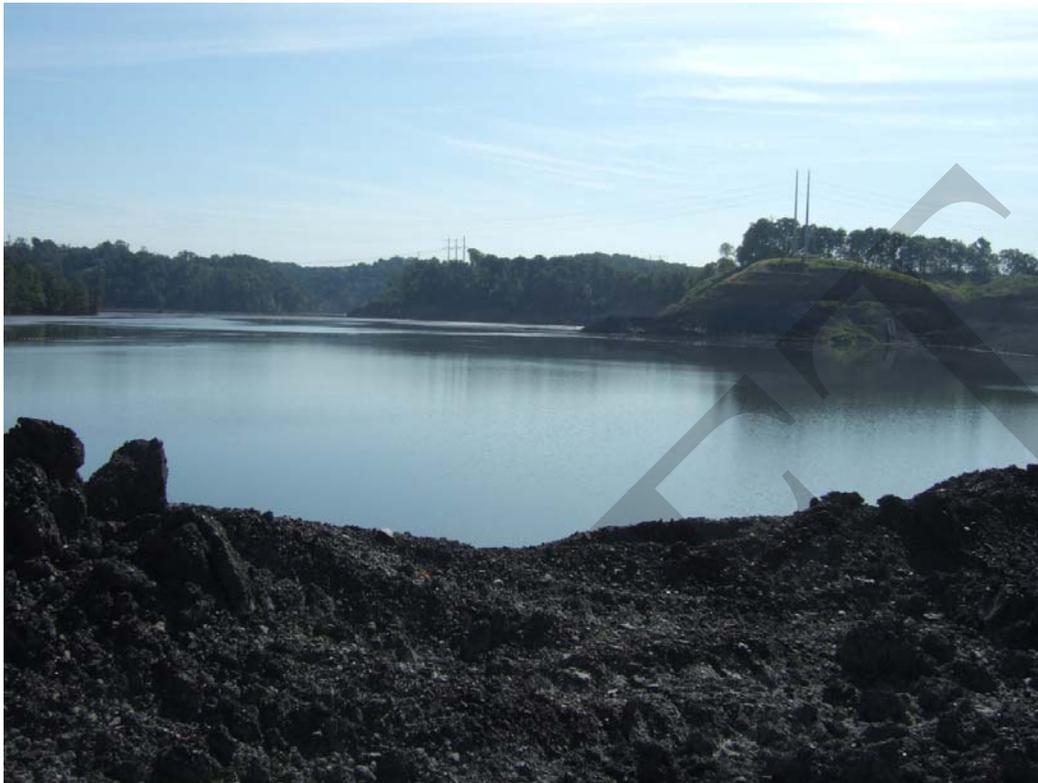
PHOTO 1: FLY ASH IMPOUNDMENT FROM CONNER RUN DAM

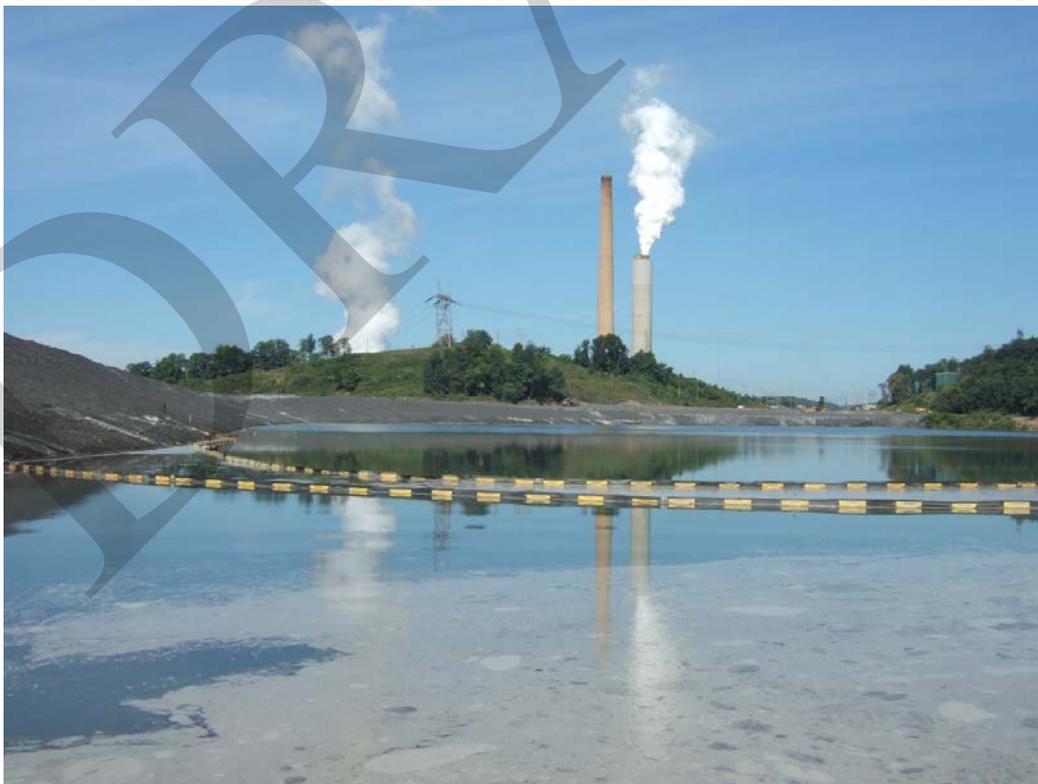
PHOTO 2: UPSTREAM SLOPE OF CONNER RUN FROM SOUTH END

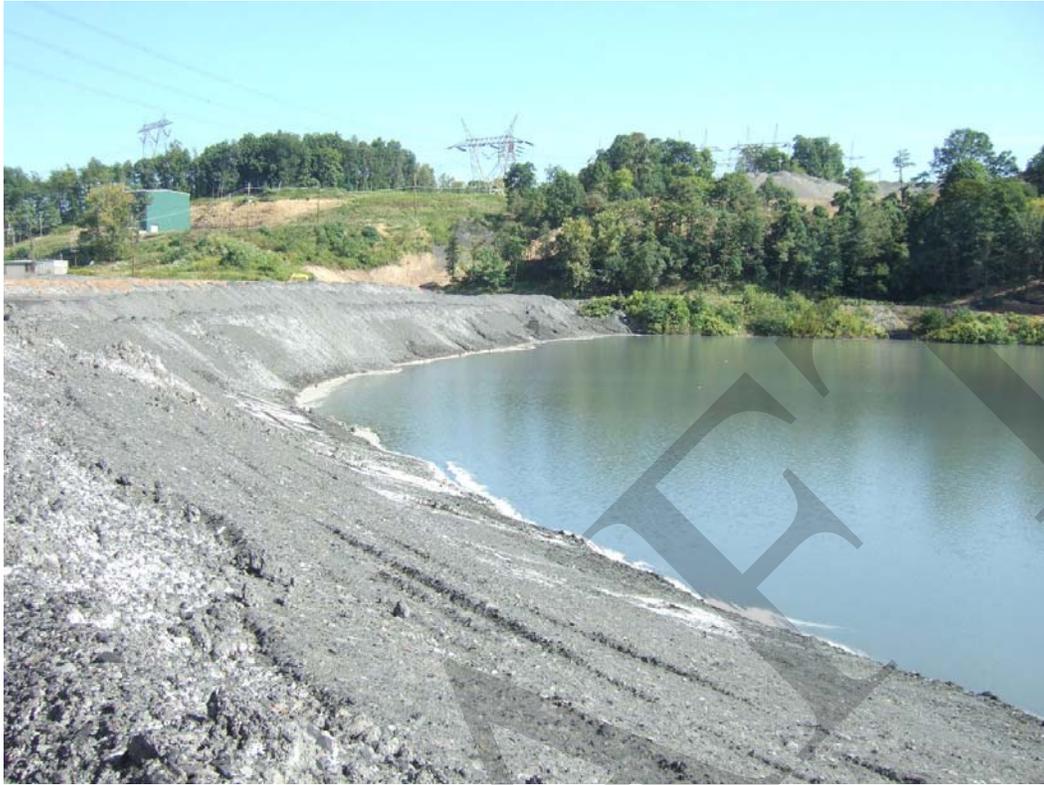
PHOTO 3: UPSTREAM SLOPE OF CONNER RUN DAM

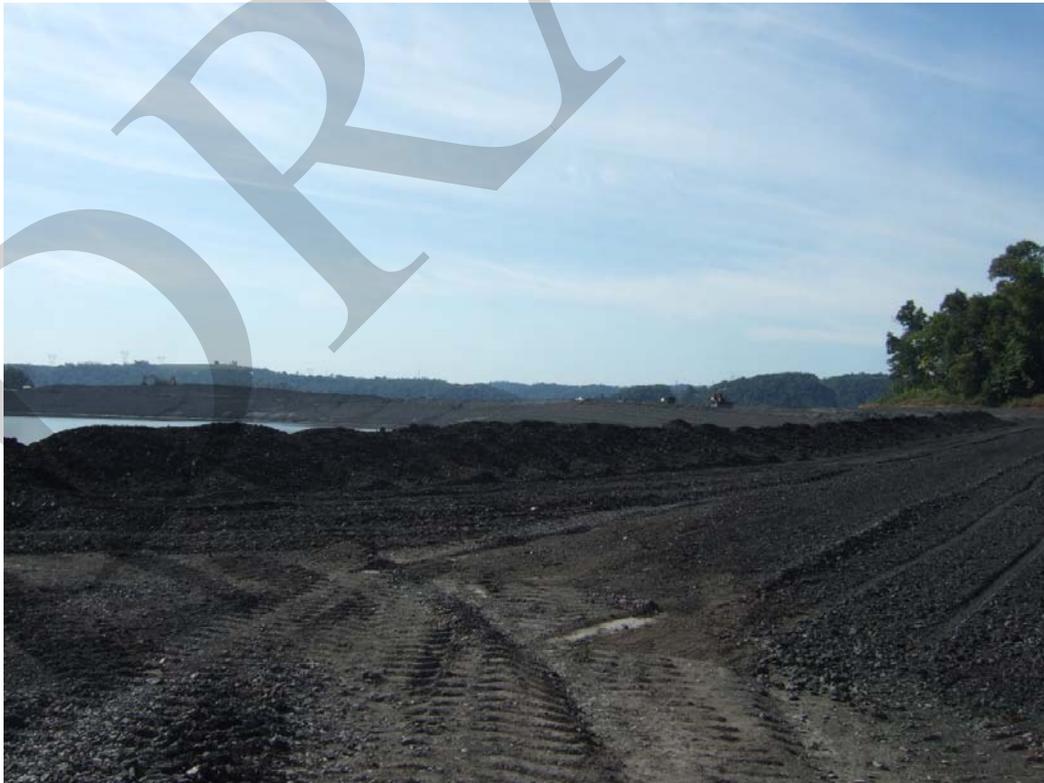
PHOTO 4: CONNER RUN DAM CREST FROM NORTH END

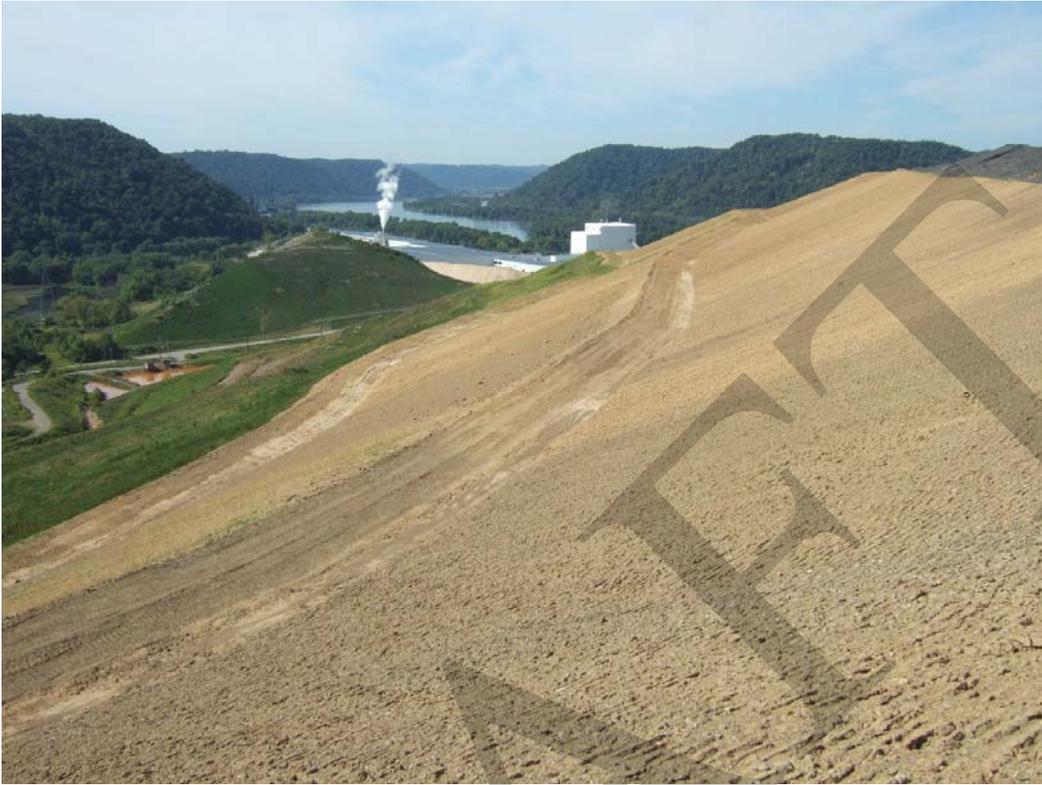
PHOTO 9: DOWNSTREAM COURSE REFUSE BERM FROM SOUTH END

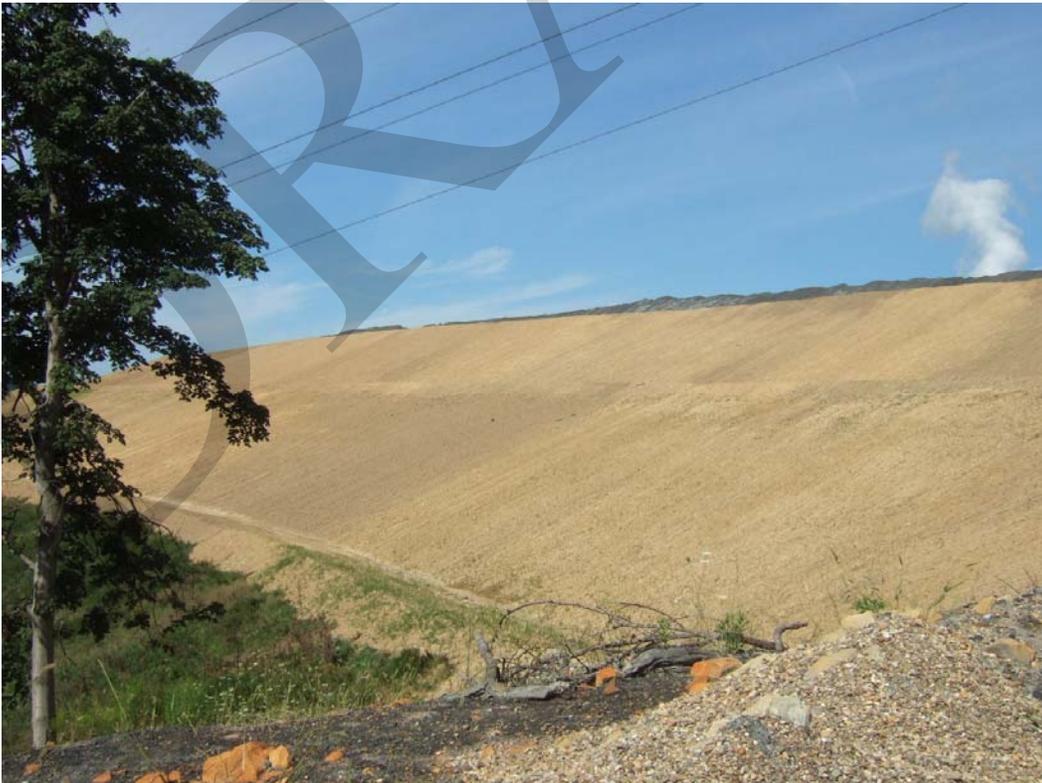
The overflow structure was in good condition (**Photograph 6**). The concrete structure showed no signs of cracking or distress, and the trashrack was free of debris or other obstructions. The concrete tail wall of the outlet was in good condition with no major damage and only minor staining (**Photograph 10**). The grouted riprap of the discharge channel was in good condition with only some minor shrinkage cracks. Some isolated voids of about 3 inches were observed in a few locations, most likely from where pieces of rock or grout broke away. Some vegetation was observed growing in the edge of the grouted riprap and at the waterline in the channel (**Photograph 12**). Thicker vegetation was observed at the inlet and outlet of the impact basin. Some sparse vegetation was observed growing in the impact basin itself (**Photograph 14**). The concrete for the impact basin was in good condition. No major cracks or spalling were observed.

PHOTO 10: OUTLETWORK TAIL WALL

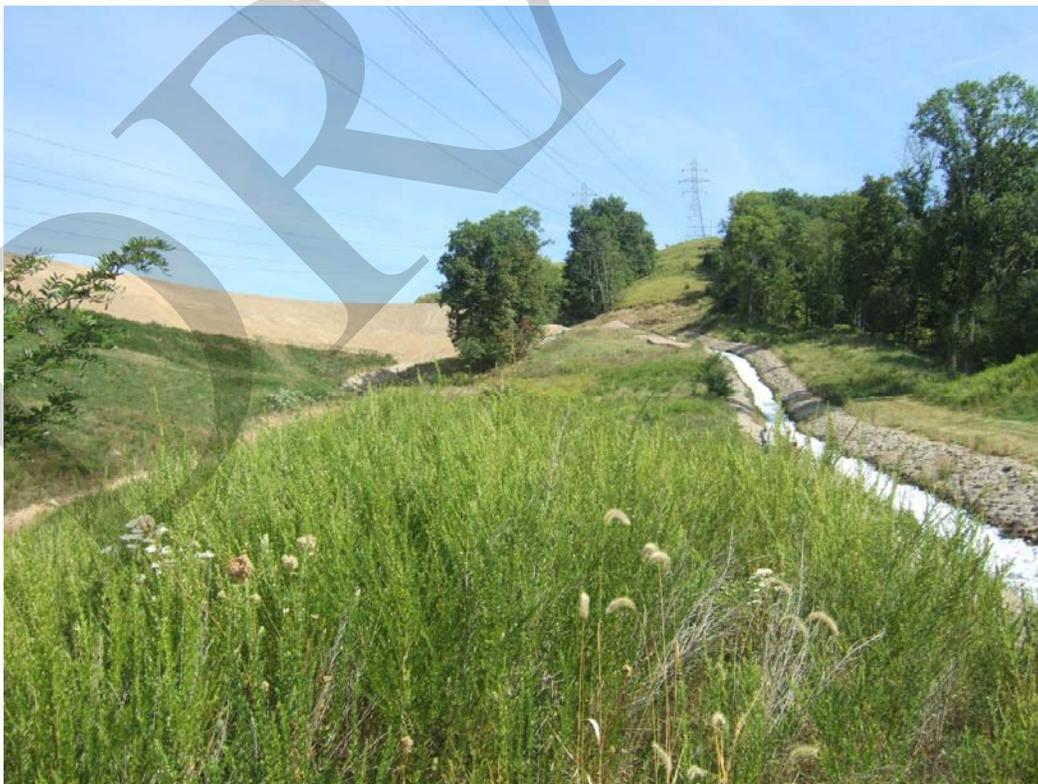
PHOTO 12: CONTROLLED SEEPAGE OUTLET INTO CHANNEL

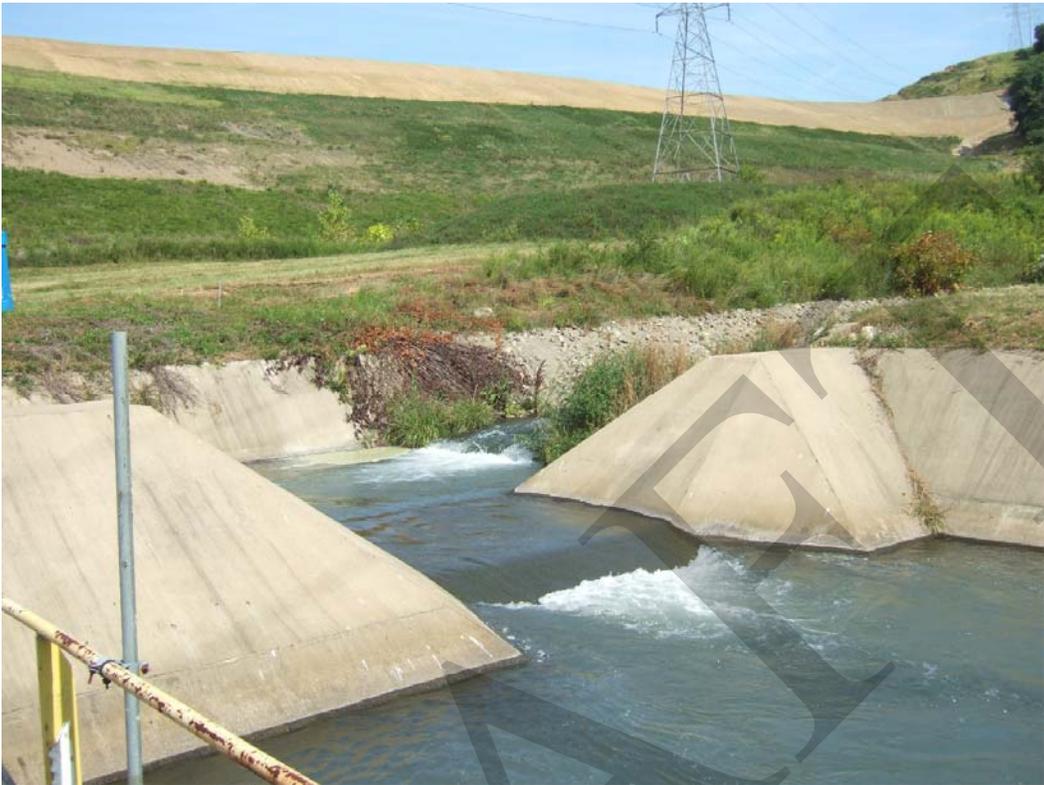
PHOTO 15: SEDIMENTATION POND

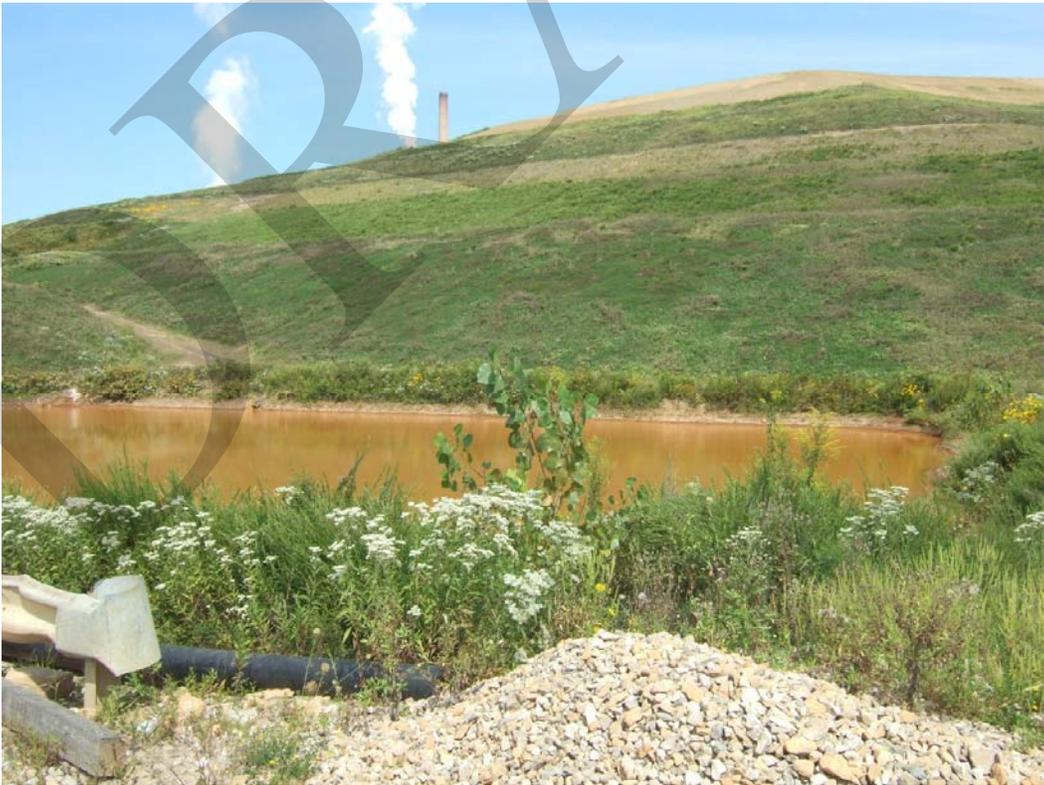
PHOTO 16: BOTTOMASH POND CENTER BERM LOOKING NORTH

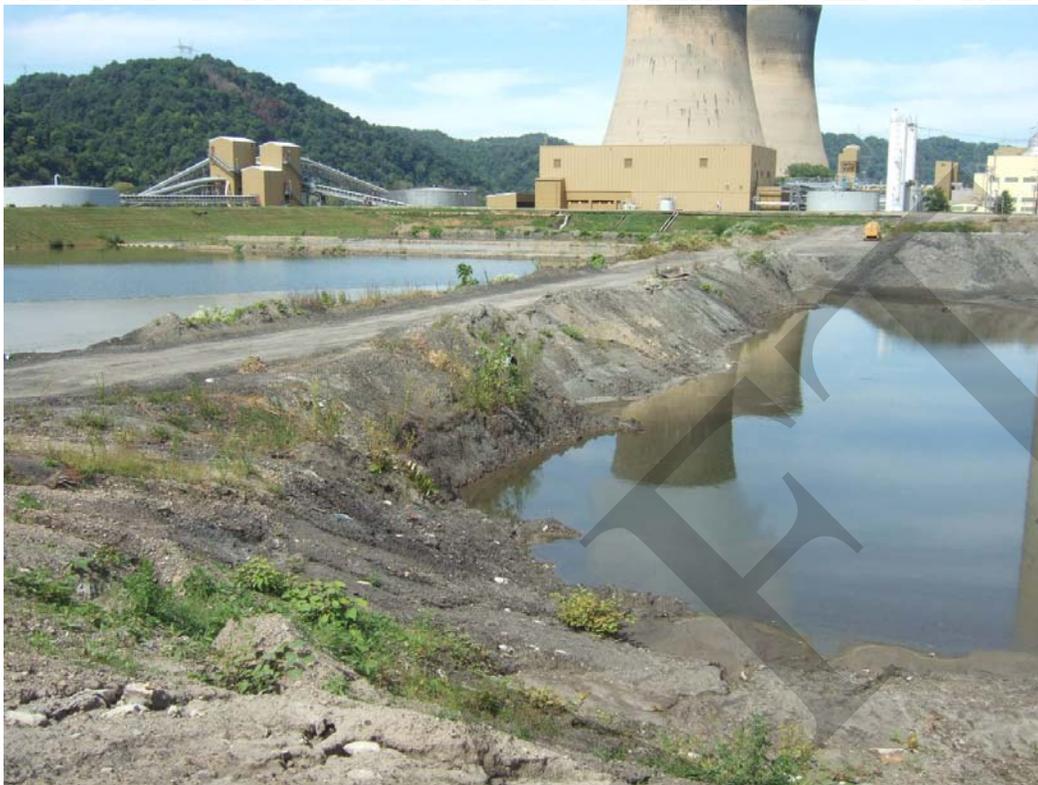
PHOTO 17: BOTTOM ASH POND LOOKING NORTH

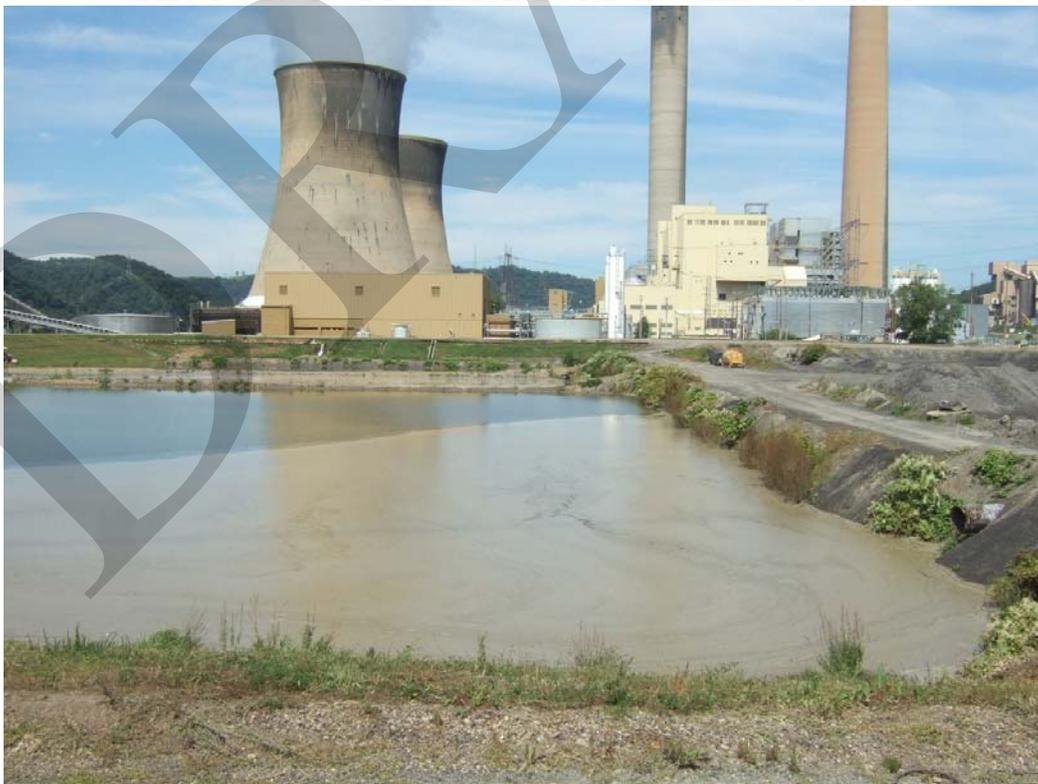
PHOTO 18: BOTTOM ASH HAULING AREA

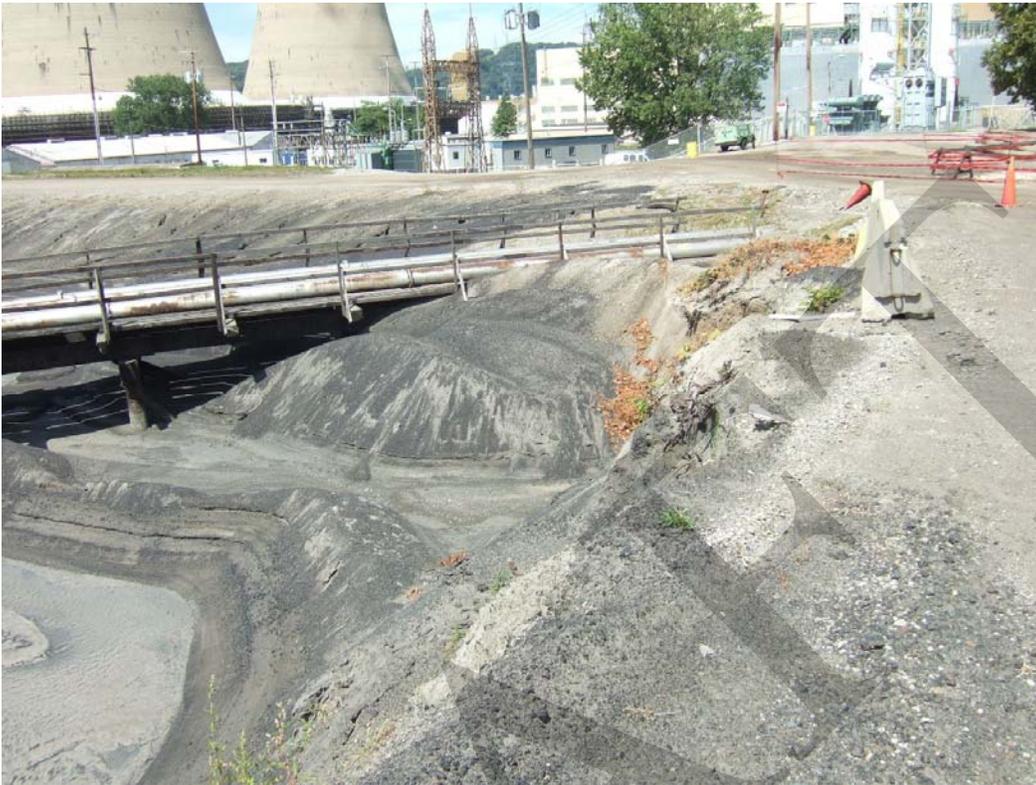
PHOTO 21: REMOVAL OF BOTTOM ASH

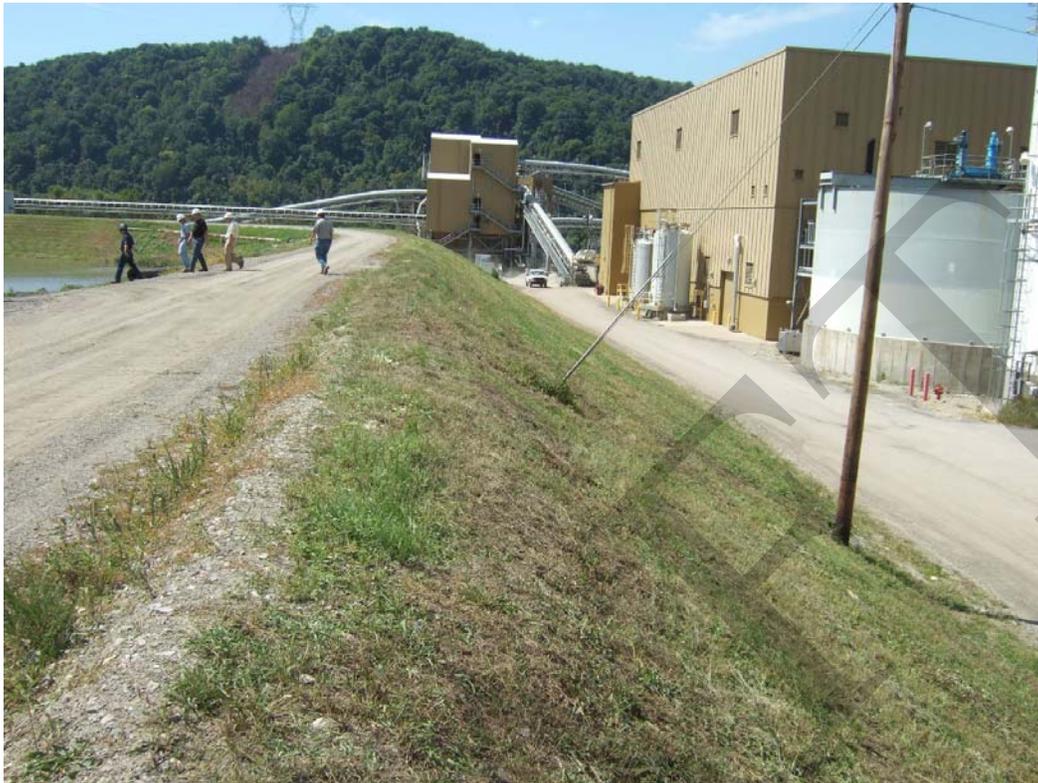
PHOTO 23: NORTH CREST OF BOTTOM ASH POND LOOKING WEST

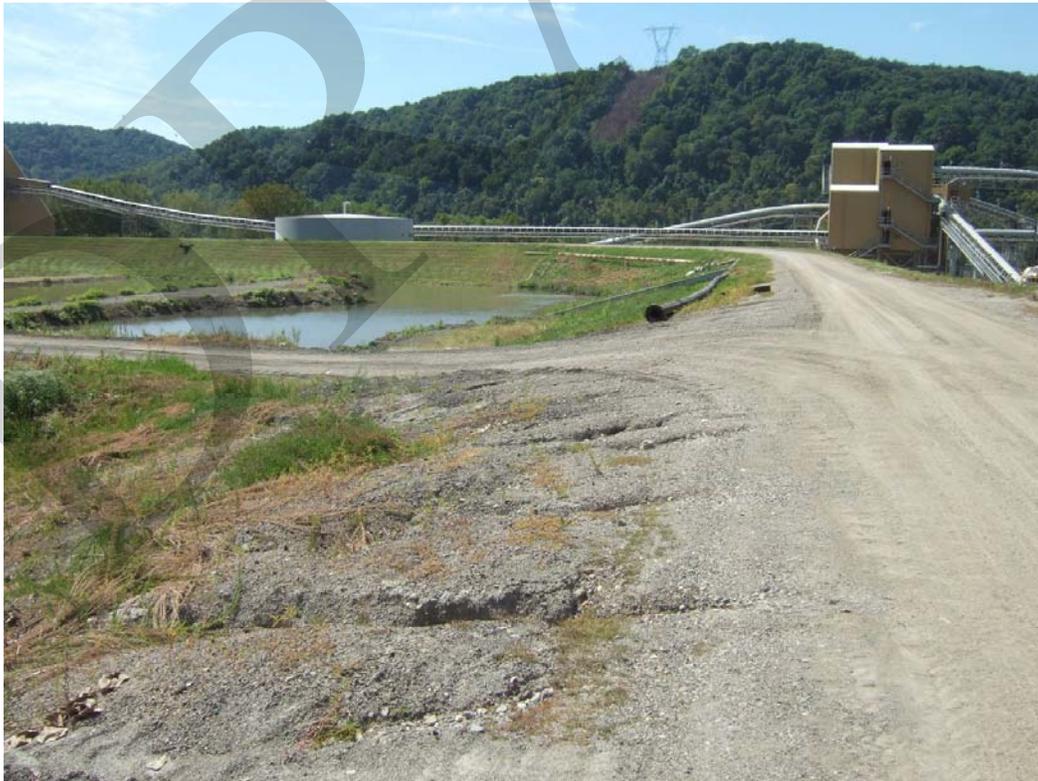
PHOTO 24: BOTTOM ASH POND LOOKING SOUTHWEST

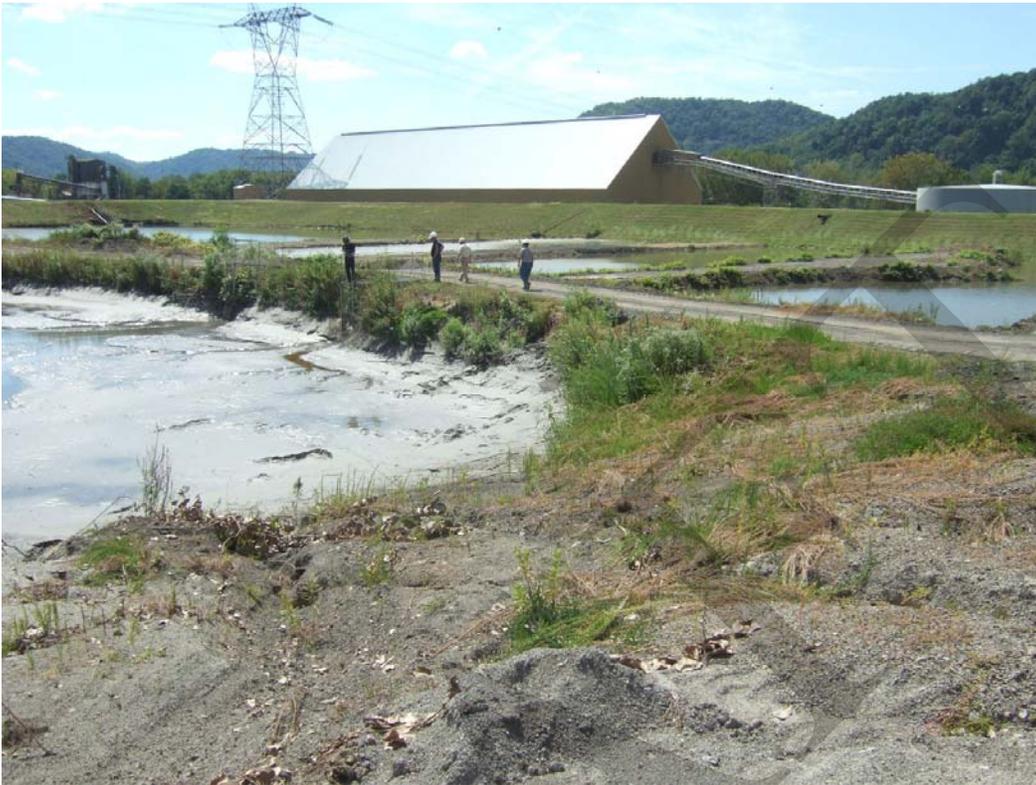
Vegetation control along the upstream and downstream slopes was considered to be good. Some heavier vegetation was observed along the waterline of the pond and at the overflow structure located on the upstream slope of the south embankment (**Photographs 25, 26 and 32**). Significant vegetation and signs of erosion were observed along the center berm and fingers within the impoundment, but are not considered a hazard to the safety of the impoundment. A small wet zone was found at the toe of the northwest corner of the impoundment (**Photographs 28 and 29**). The source of the water is unknown and could just be ponded surface water. No other seepage was observed. A line of trees exists along the downstream slope of east embankment (**Photograph 19**). This slope exists well above the normal pool elevation, and the trees do not pose a hazard to the safety of the impoundment. The upstream slope of the eastern bank (area where the pond is incised) is quite steep, with some more significant erosion in the northeast corner (**Photograph 20**). Though we do not think this is a stability problem for the upstream slope, it could be safety hazard for the equipment operators handling the ash removal in the area.

PHOTO 25: NORTHWEST CORNER OF BOTTOM ASH POND

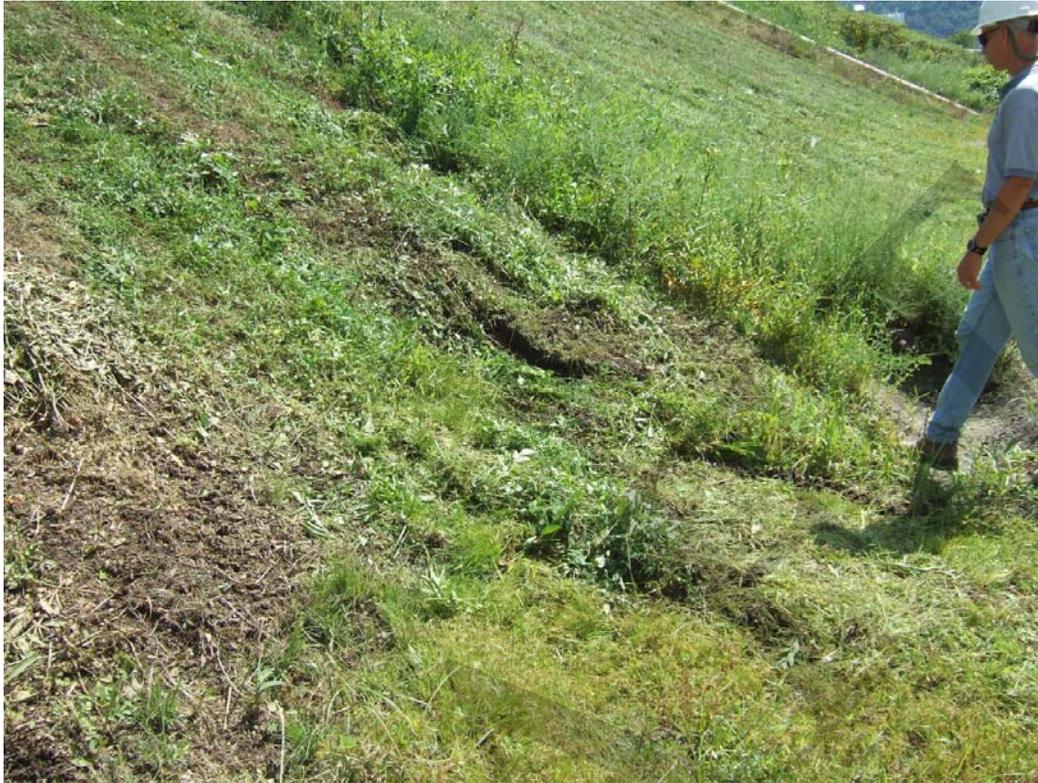
PHOTO 28: WET AREA AT NORTHWEST TOE OF BOTTOM ASH POND

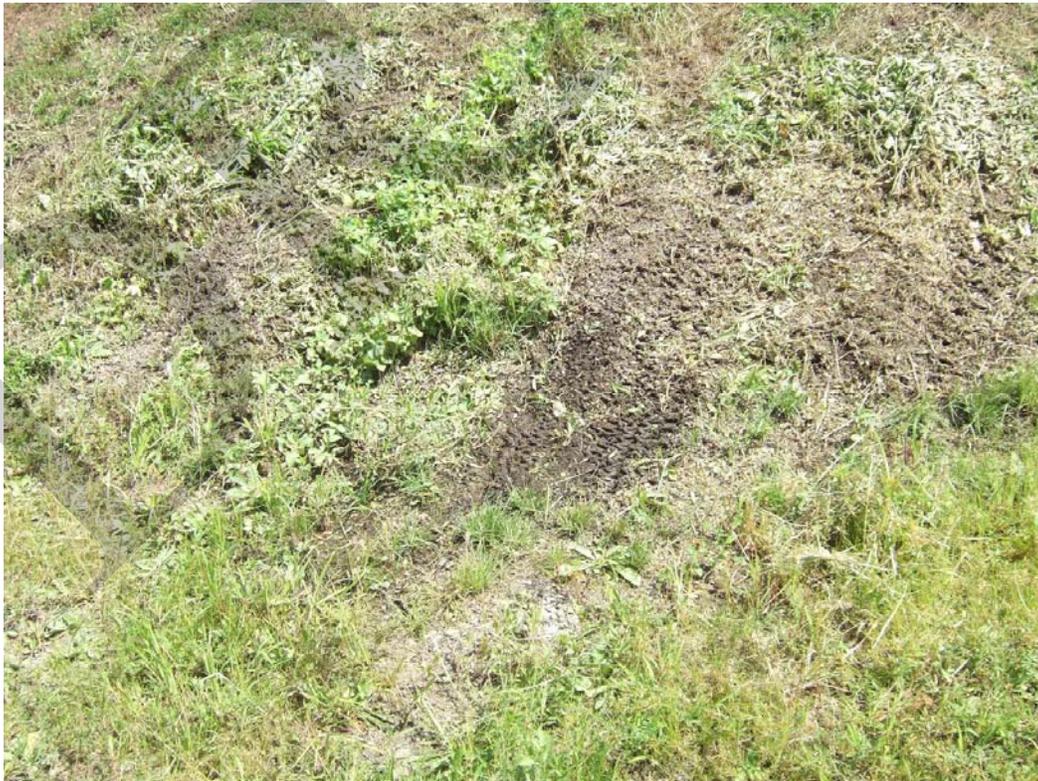
PHOTO 29: WET AREA AT NORTHWEST TOE OF BOTTOM ASH POND

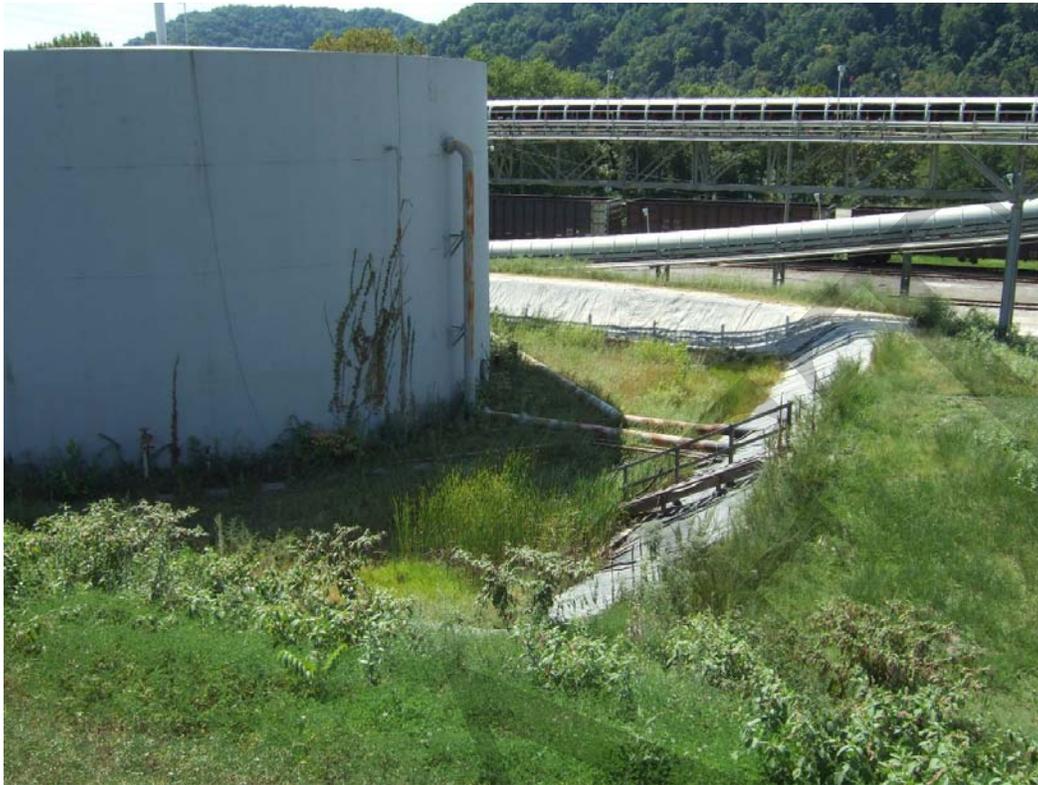
PHOTO 30: METAL CLEAN TANK CONTAINMENT BASIN

The dikes containing the metal cleaning tank secondary containment basin were looked at as well (**Photograph 30**). The vegetation around the secondary containment basin was little heavier, but the embankment looked in good condition, with no signs of erosion or sliding. The exposed PVC liner on the upstream slope looked to be in good condition.

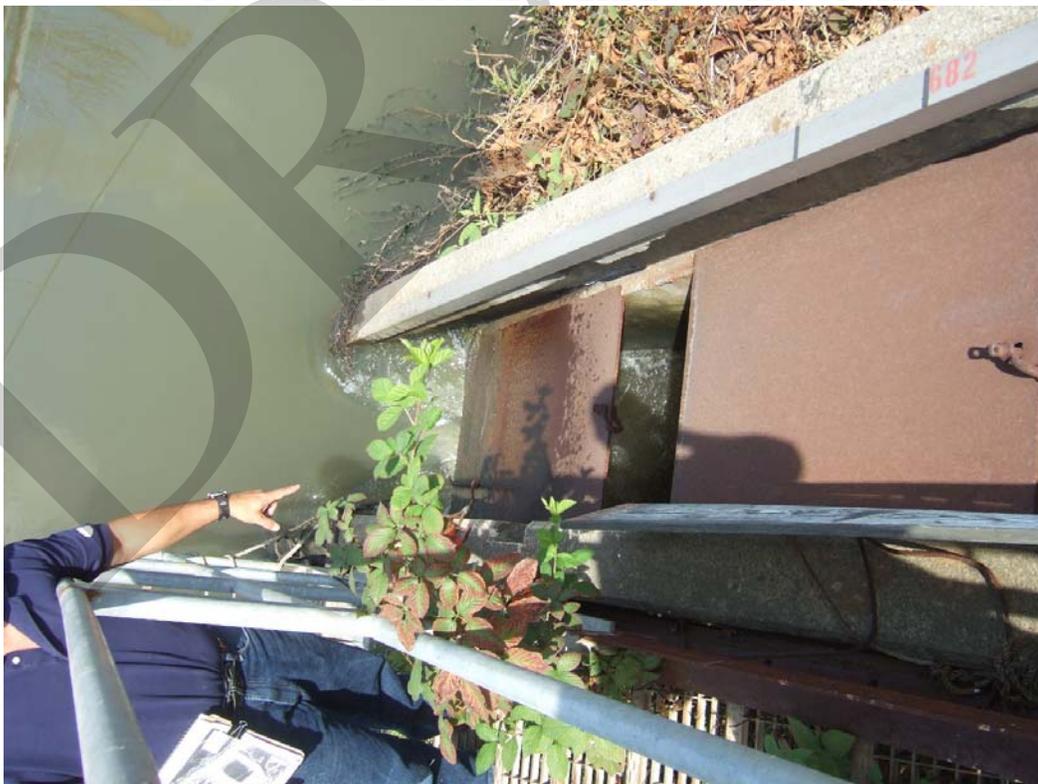
PHOTO 33: BOTTOM ASH OVERFLOW STRUCTURE

The only inflows to the impoundment include the slurry, which is pumped in from the plant, and storm runoff. The overflow structure and skimmer was in good to fair condition (**Photograph 33**). The concrete showed no signs of cracking, and the water was free-flowing. Some rust and corrosion were present on the stop log components.

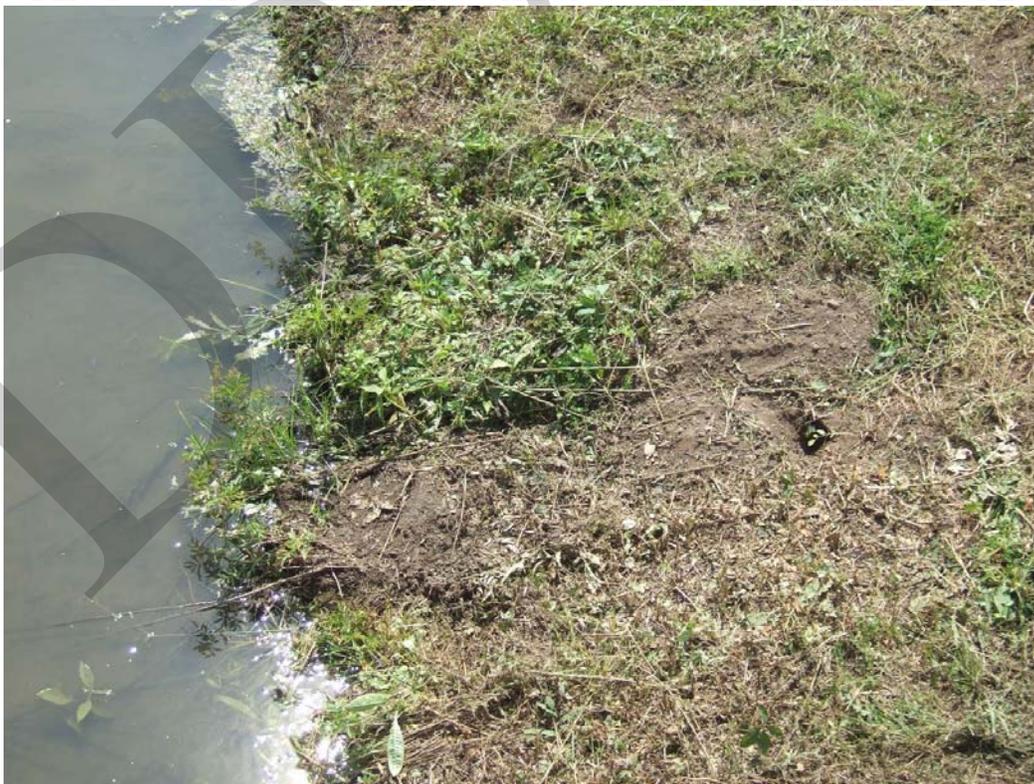
Vegetation control along the upstream and downstream slopes was considered to be good. Some heavier vegetation was observed along the waterline of the pond. No seepage was observed along the toe or along the downstream slope. A small animal borrow was discovered along the west upstream embankment about five feet from the water line that should be taken care of (**Photograph 39**).

PHOTO 39: ANIMAL BURROW ALONG WEST UPSTREAM SLOPE

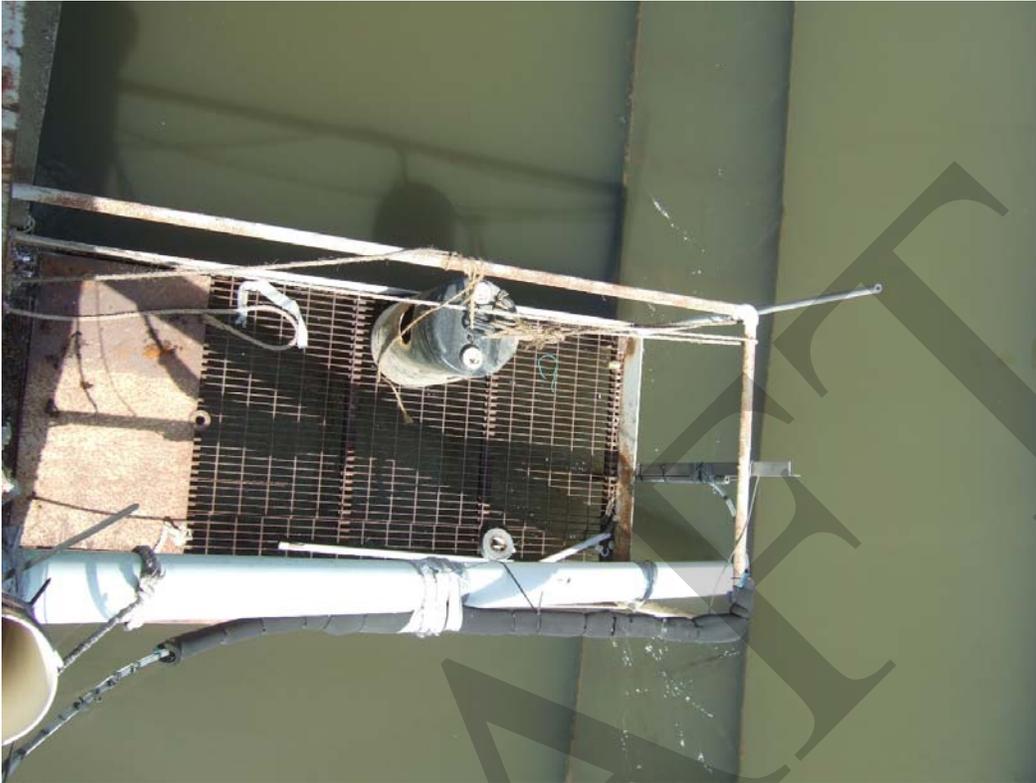
PHOTO 40: OVERFLOW STRUCTURE FOR CLEAR WATER POND

The only inflows to the impoundment include the waste water that flows in from the Bottom Ash Pond and storm runoff. The overflow structure was in good condition (**Photograph 40**). The concrete showed no signs of cracking or distress, and the water was free-flowing. Water was observed at the outlet discharging into the Ohio River. Some corrosion was observed along the metal walkway to the outlet structure. It appears to be about the same as was previously reported in past inspections.
