Assessment of Dam Safety

Coal Combustion Surface Impoundments (Task 3)

American Electric Power

Muskingum River
Power Plant

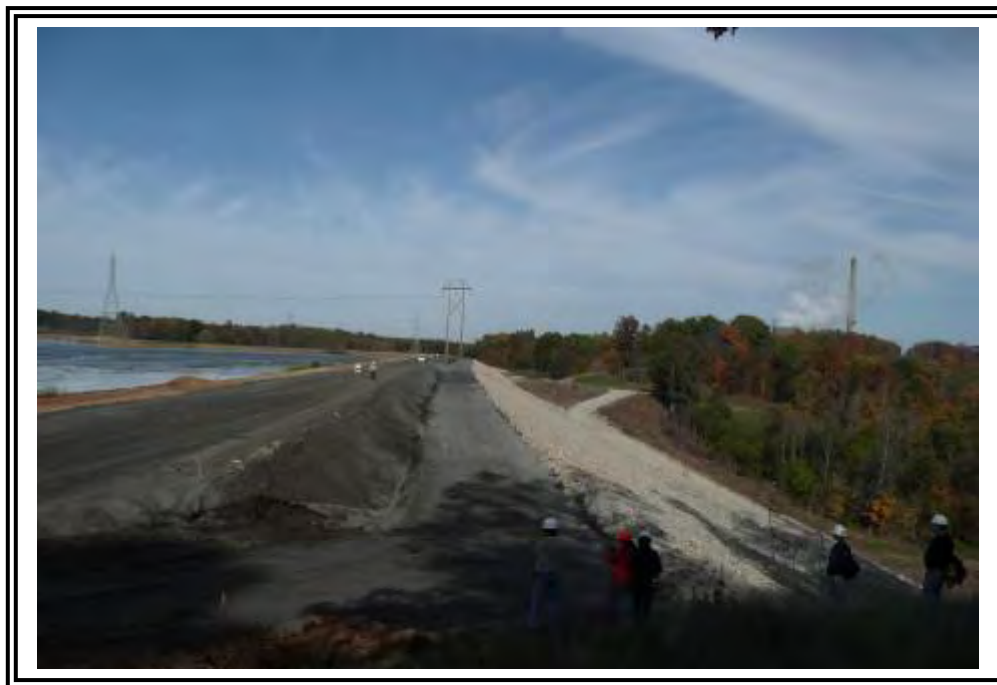
Crest and downstream fly ash construction bench of the Mill Stone Creek Dam, looking northwest.

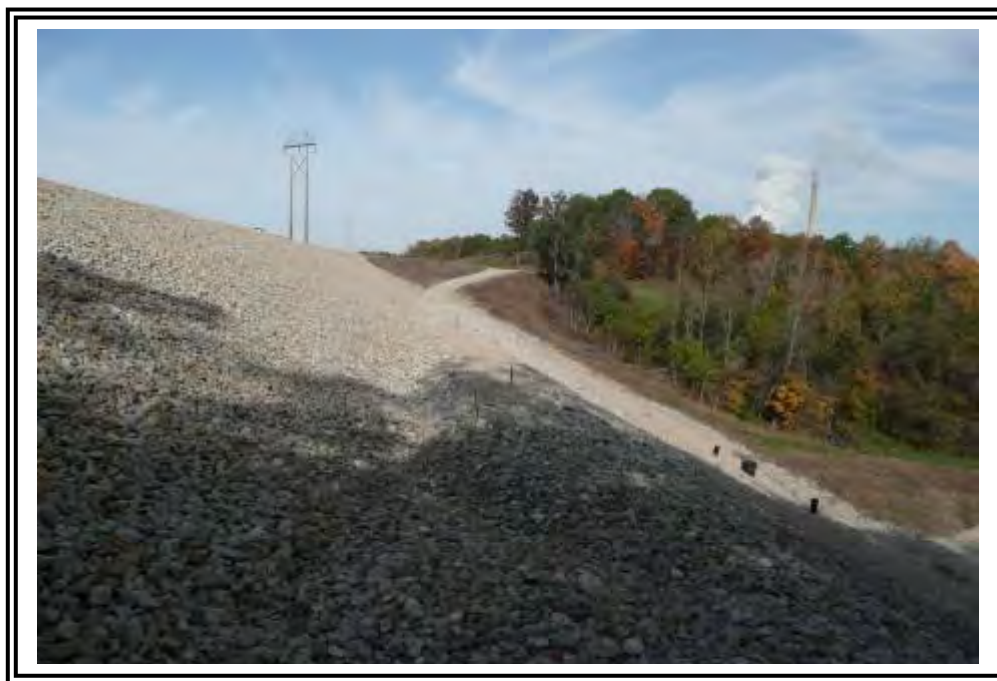
The downstream embankment slope of the Mill Stone Creek Dam is armored with rip rap (Photo 4). The rip rap is well maintained and in general free from vegetation, with only isolated, dying woody plants being visible. Rip rap is also used to line the drainage ditches along the southeast and northwest abutments at the natural hillside contact (Photo Nos. 3 and 8). Rock check dams were observed in these drainage ditches.

Downstream slope along mid-slope instrumentation bench at Mill Stone Creek Dam, looking northwest. Note rip-rap surface treatment.

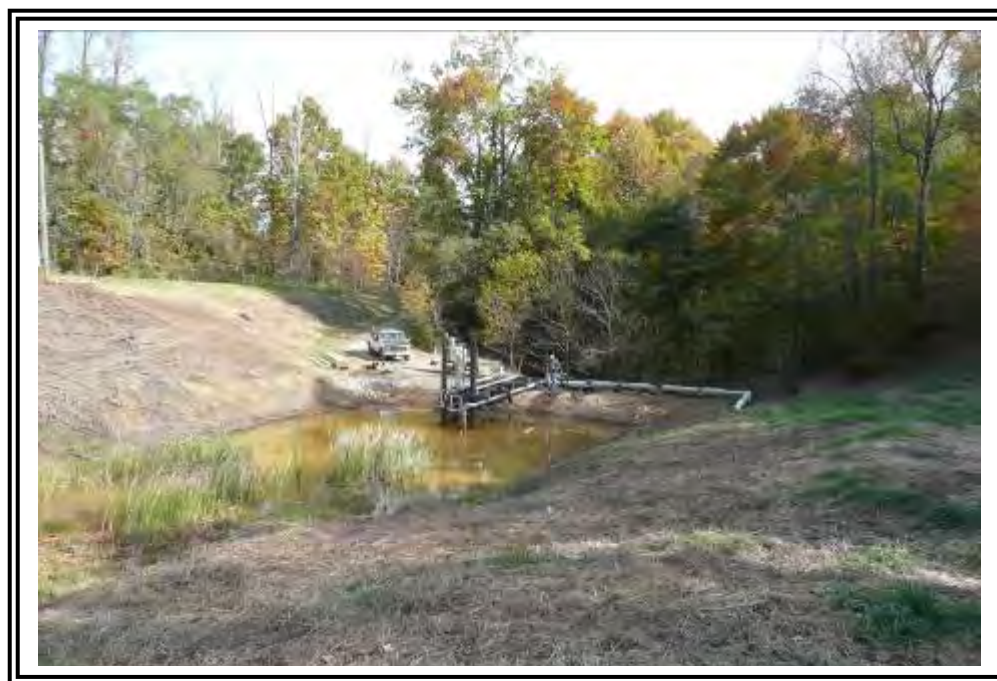
Seepage collection, treatment and recirculation basin at Mill Stone Creek Dam.

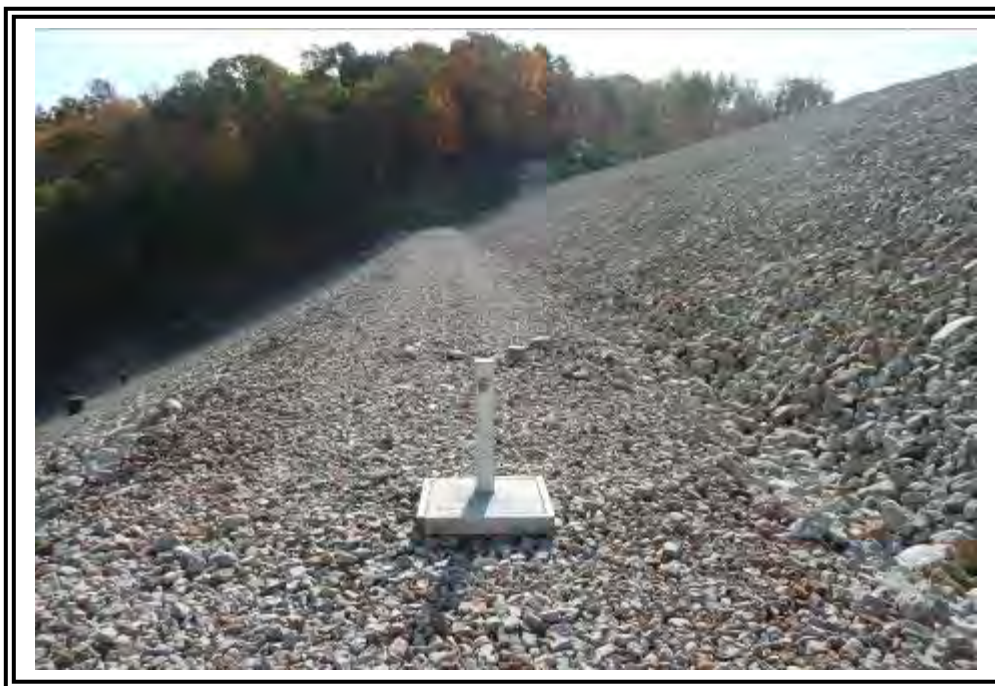
Instrumentation on bench of downstream slope of Mill Stone Creek Dam.

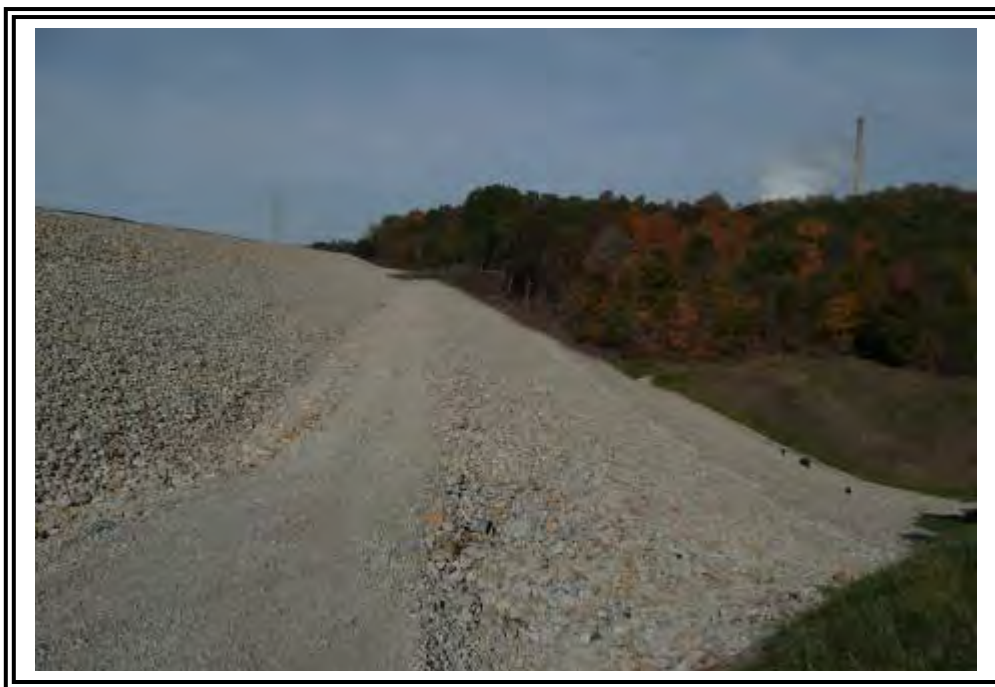
No-Name Creek Dam, looking northwest along the downstream slope at bench area.

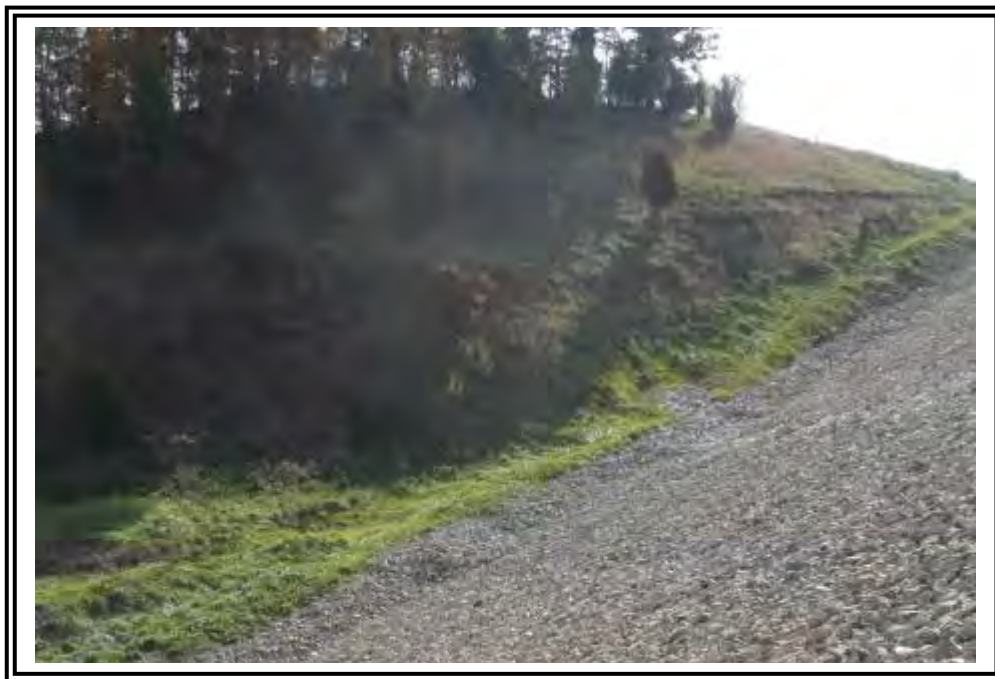
Slope at right (southeast) abutment contact where extension from groin was constructed to intercept hillside seepage, looking southeast.

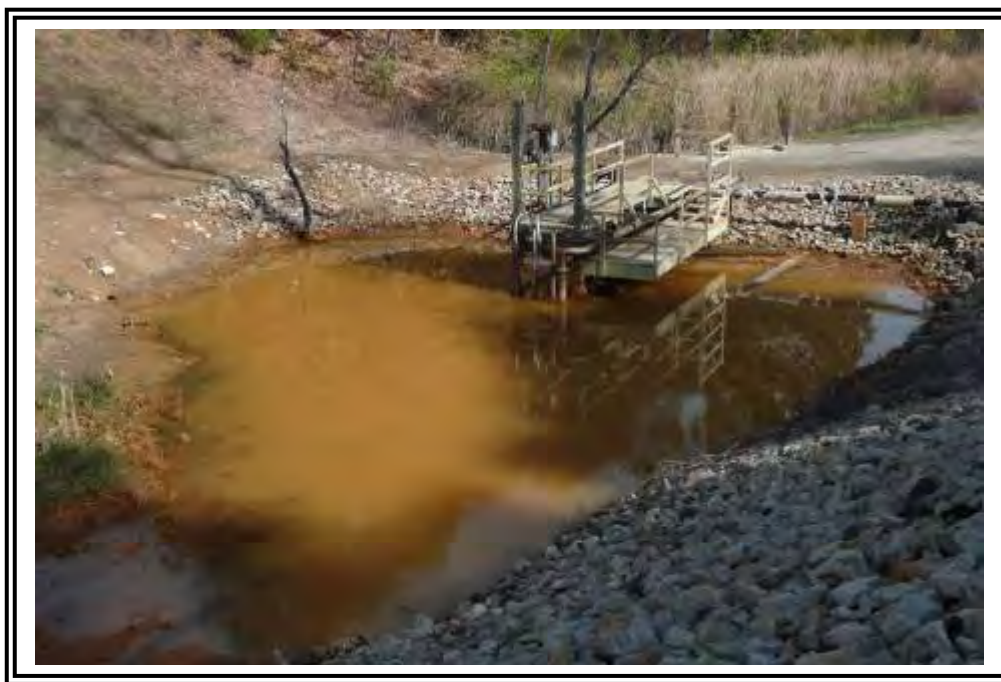
Seepage collection, treatment, and recirculation basin at No-Name Creek Dam.

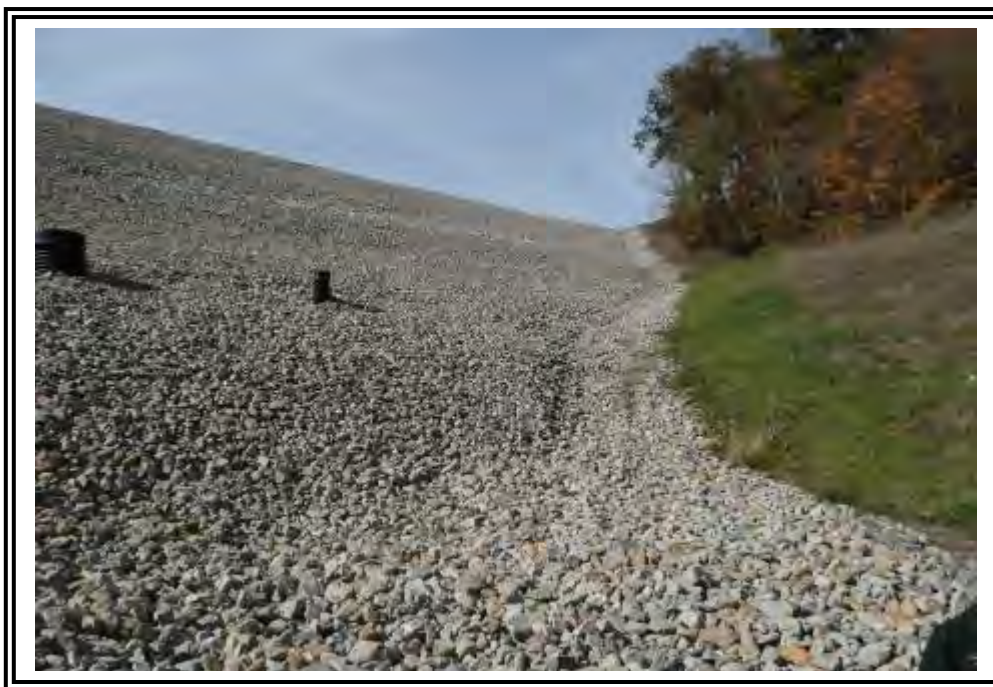
Downstream slope and left (northwest) abutment groin contact of the No-Name Creek Dam.
Note blanket drain system inspection, access and cleanout ports.

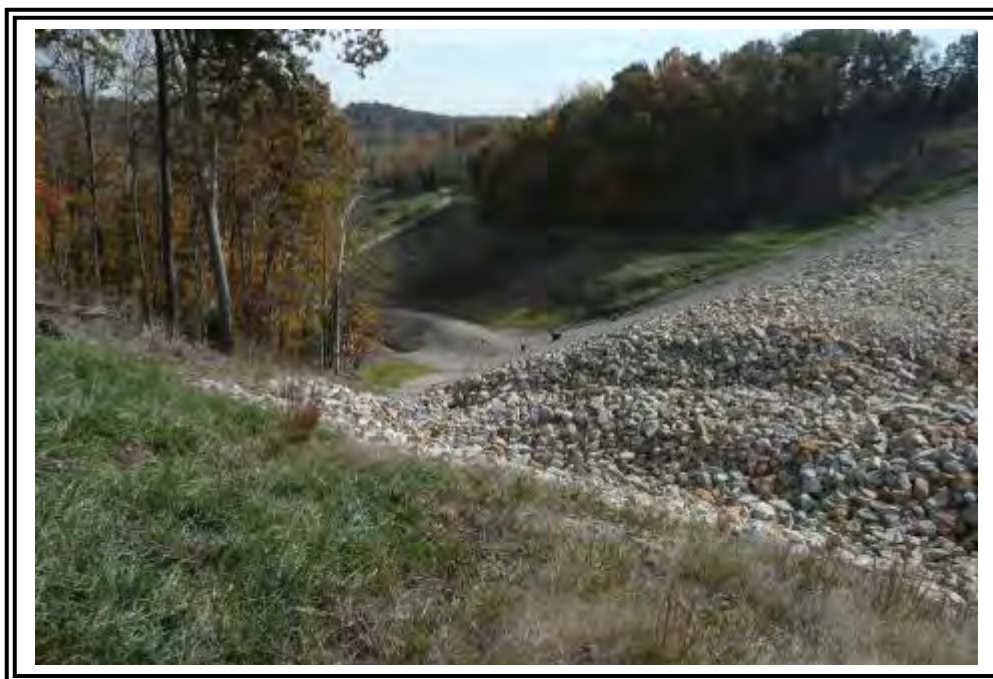
Downstream slope near crest of No-Name Creek Dam at left (northwest) abutment groin contact.

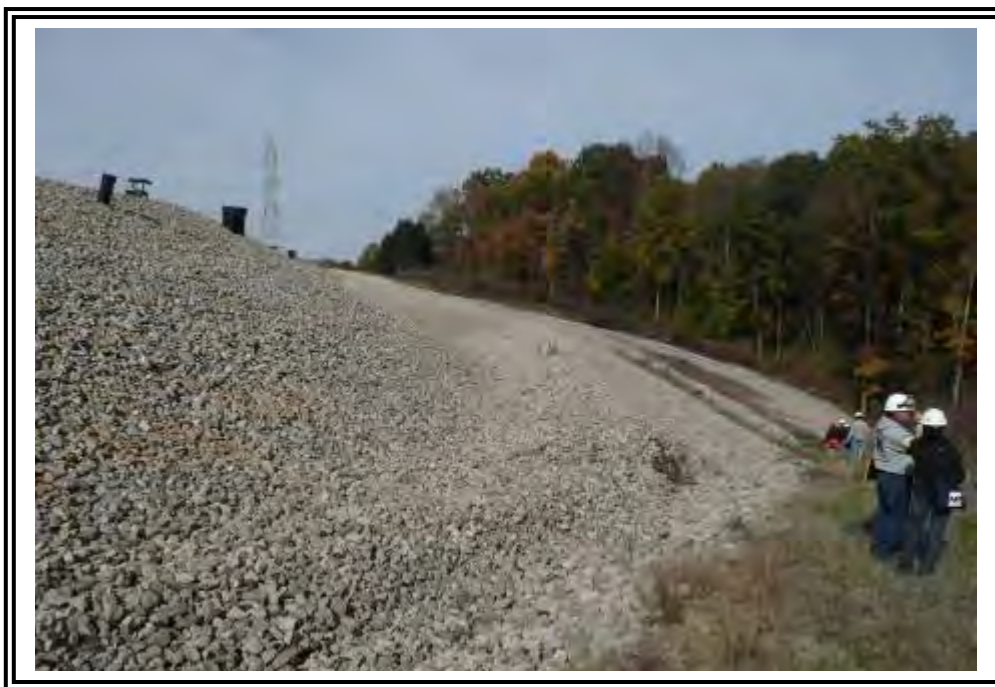
Downstream slope and abutment groin of the Wing Dam at right (southeast) abutment contact, looking northwest.
Note blanket drain system inspection, access, and cleanout ports in the slope.

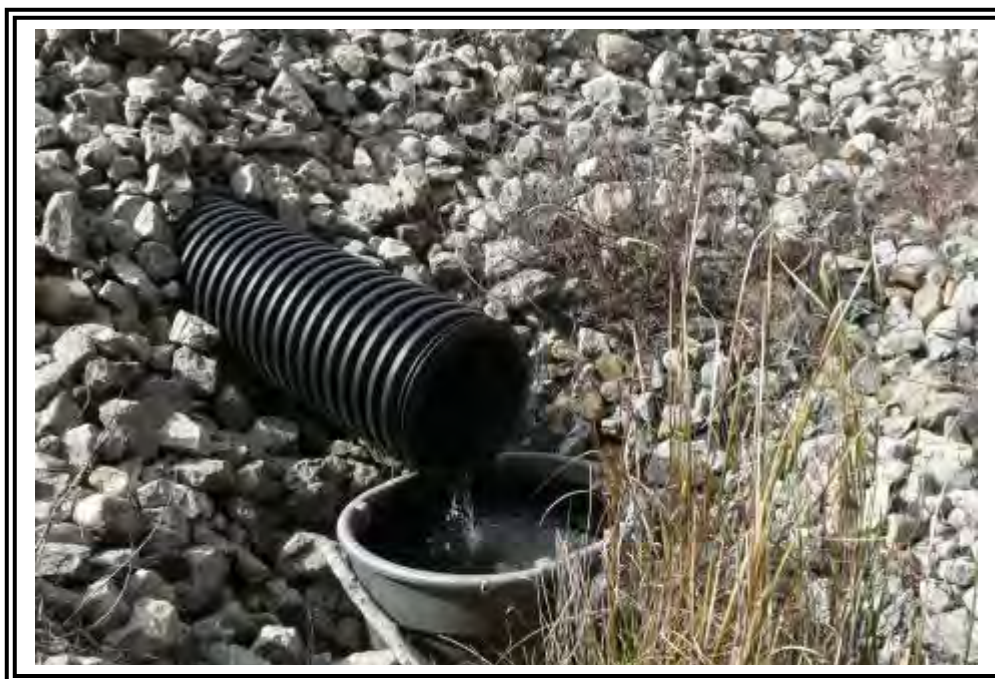
Active blanket drain outlet at Wing Dam. Note absence of iron precipitate.

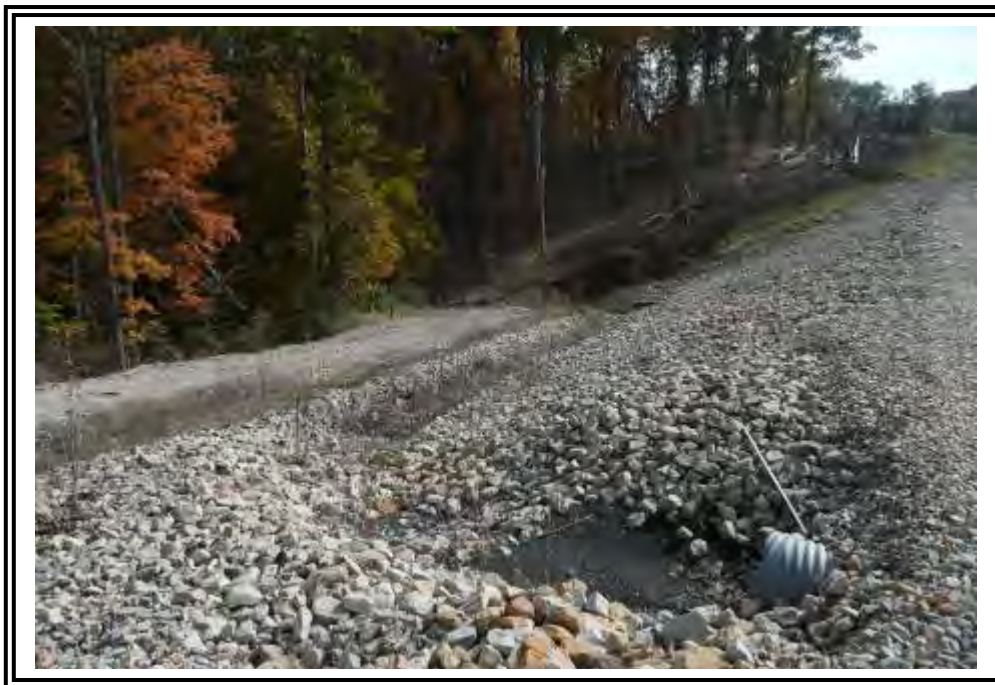
Mid-slope drainage groins and swale at toe of the Wing Dam downstream slope.

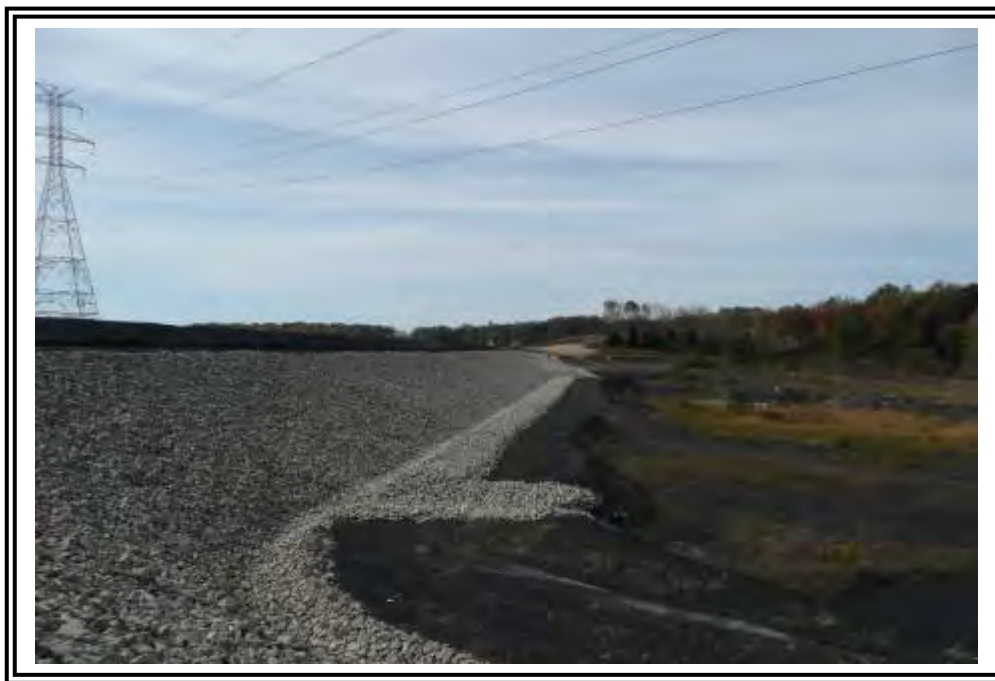
Downstream slope of the Wing Dam, looking west. Downstream slope toe forms upstream wall of the Middle Fly Ash Reservoir.

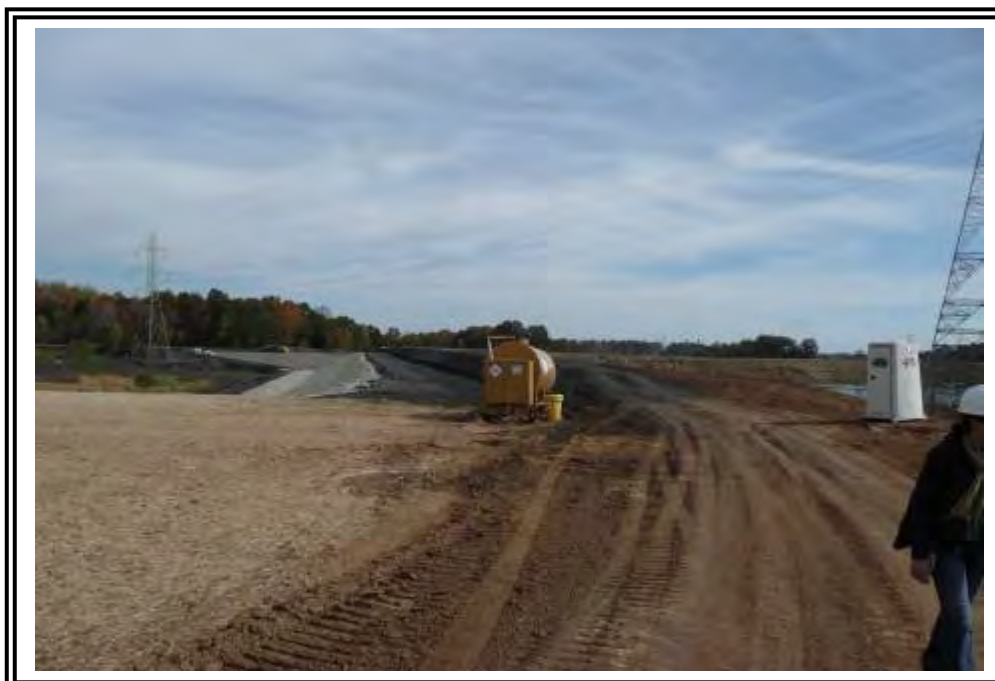
Wing Dam crest, looking east.

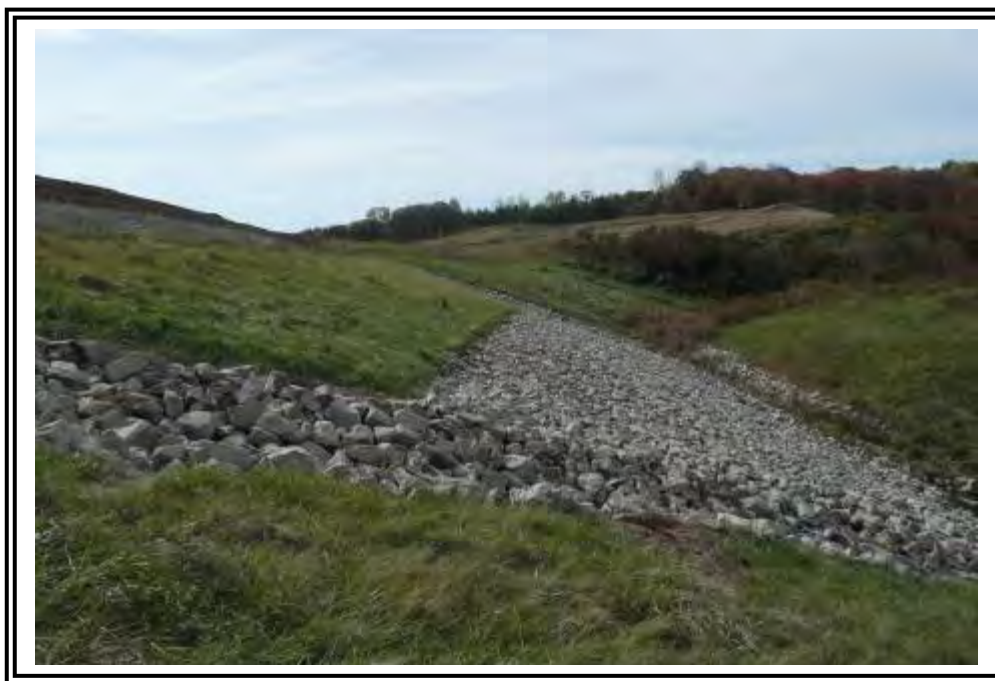
Downstream slope of the Spillway Dam showing upper grass covered slope and rip-rap protection on the lower portion of the slope, looking west.

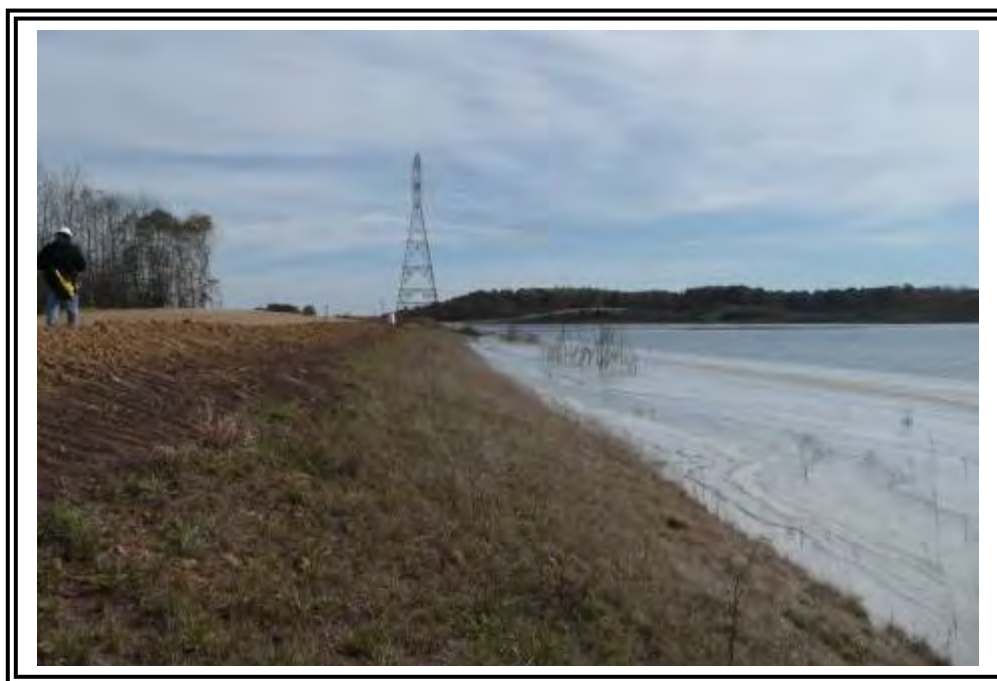
Upstream slope of the Spillway Dam, looking east towards transition to the Wing Dam.
Note grass cover and moderate slope.

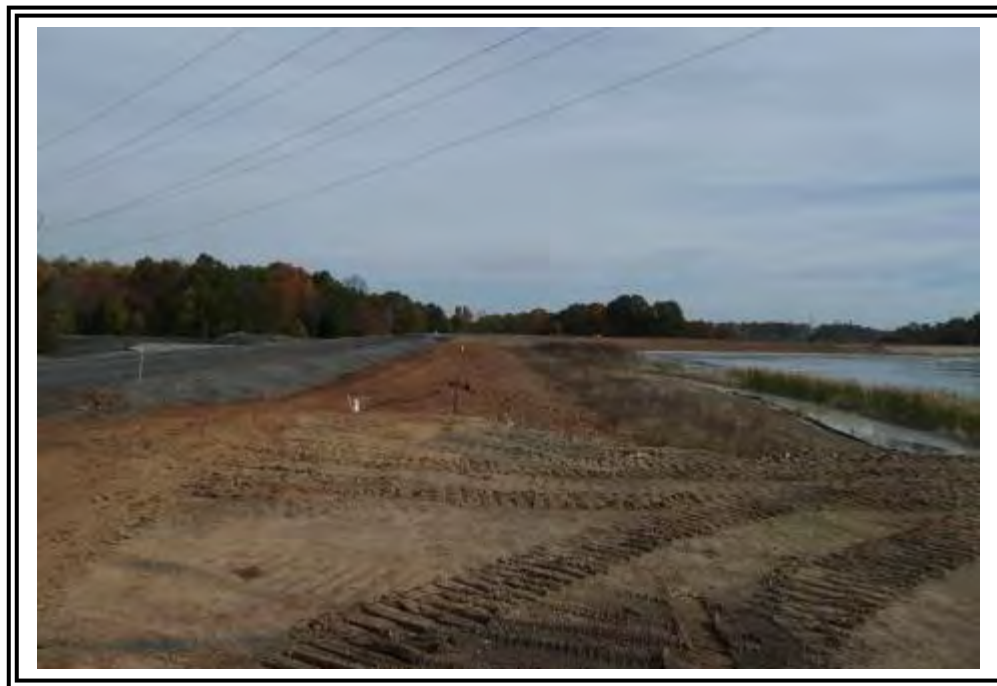
Crest and upstream slope of the Wing Dam, looking east.

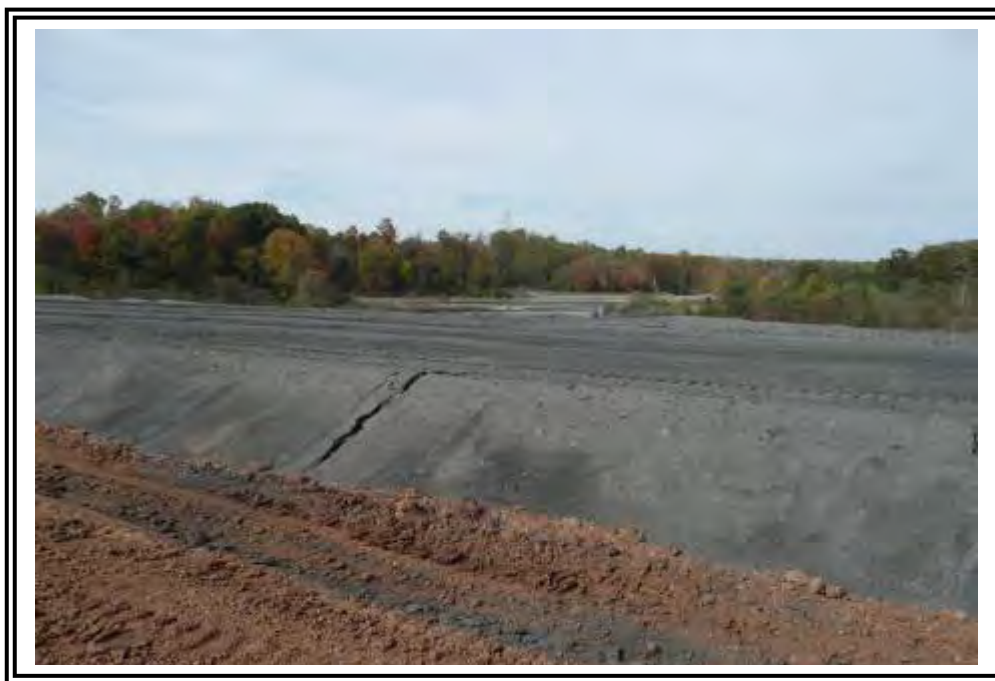
Erosion rill in exposed compacted ash being placed on the Wing Dam. Note Middle Fly Ash Reservoir in the distance.

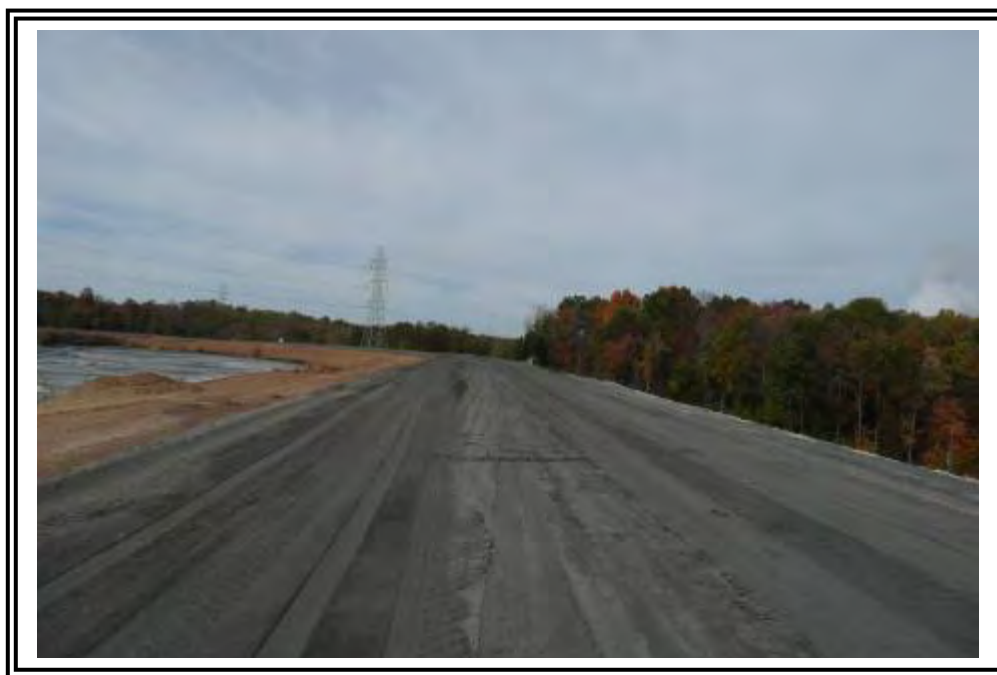
Crest of the No-Name Creek Dam, looking northwest.

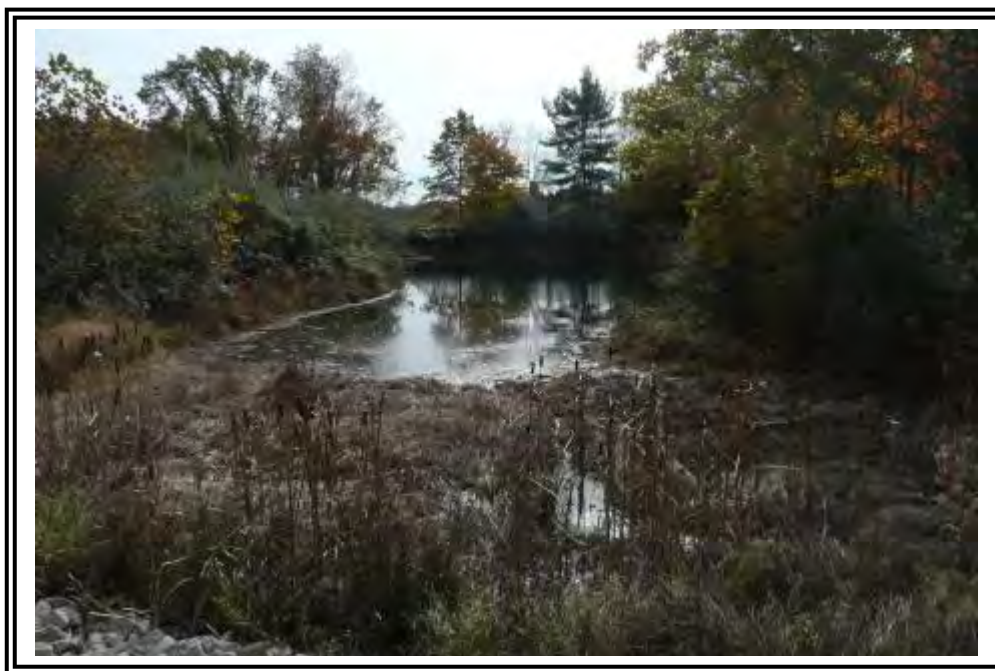
Small pond in drainage feature below toe of the Freeboard Dam near the western end.

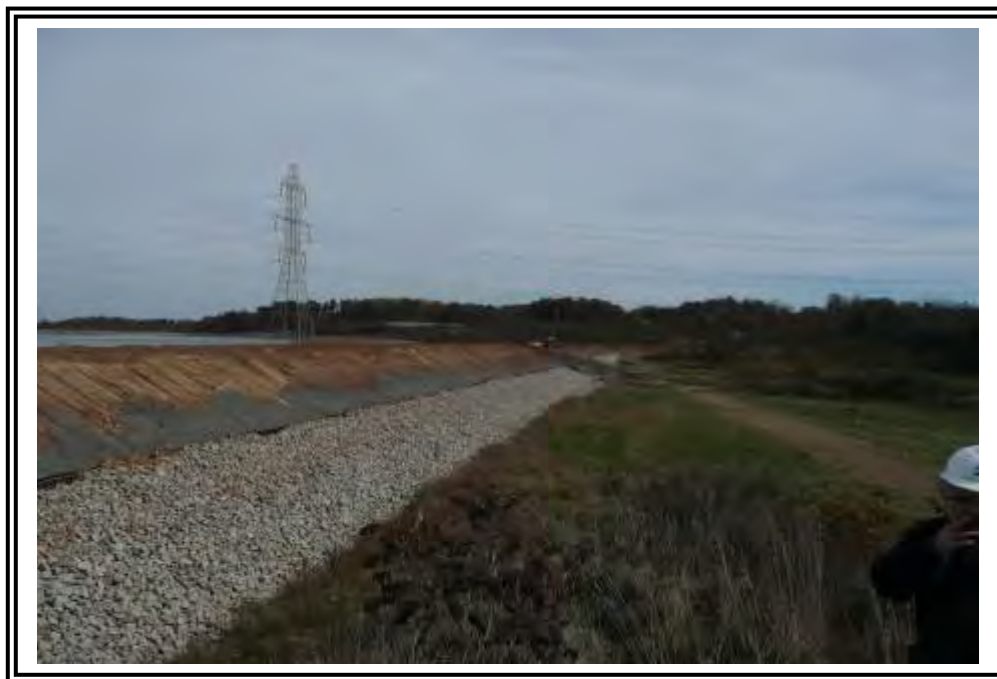
Downstream slope of the Freeboard Dam, looking east. Note zoned construction with ash and clay.

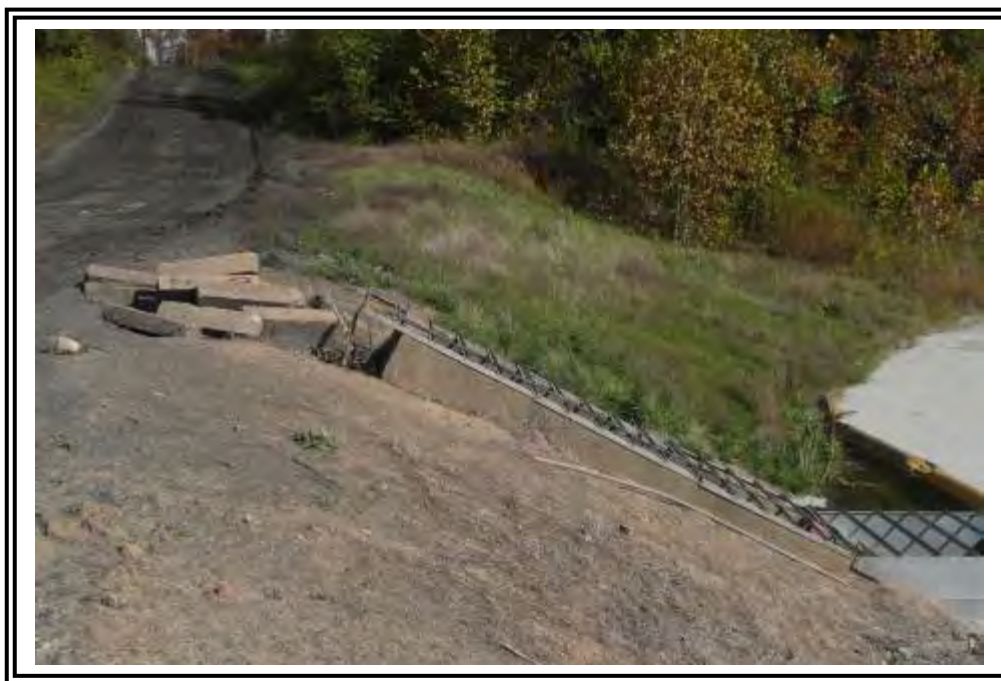
Upstream slope and inclined spillway of the Middle Fly Ash Dam, looking east. Note concrete stop logs at top of slope.

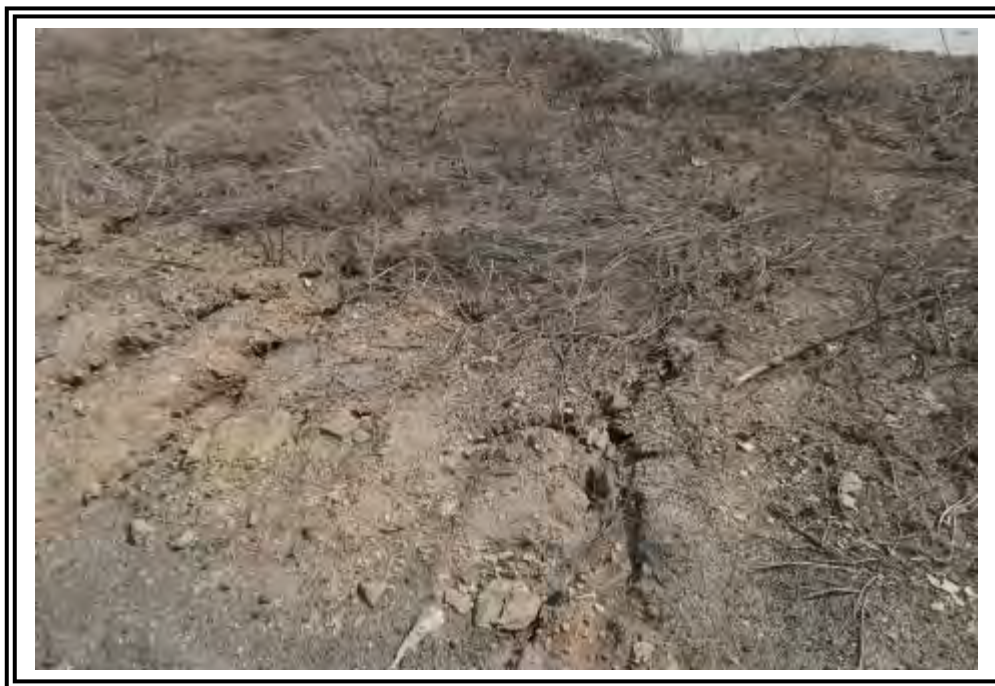
Erosion rills on upstream slope of the Middle Fly Ash Dam.

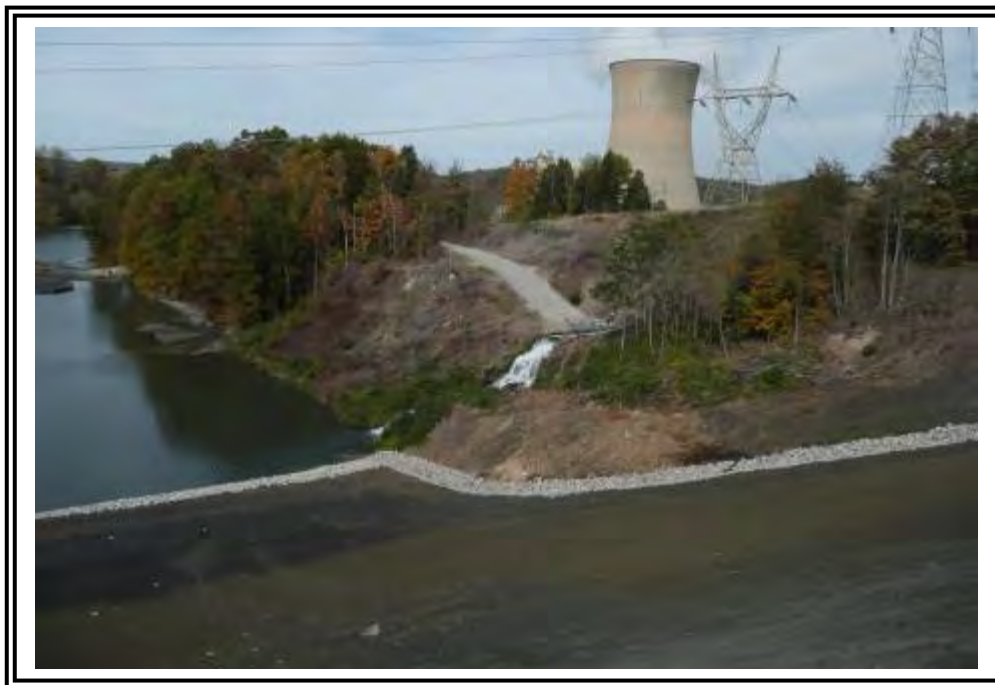
Looking downstream from the Middle Fly Ash Dam. Note effluent above right (east) abutment.

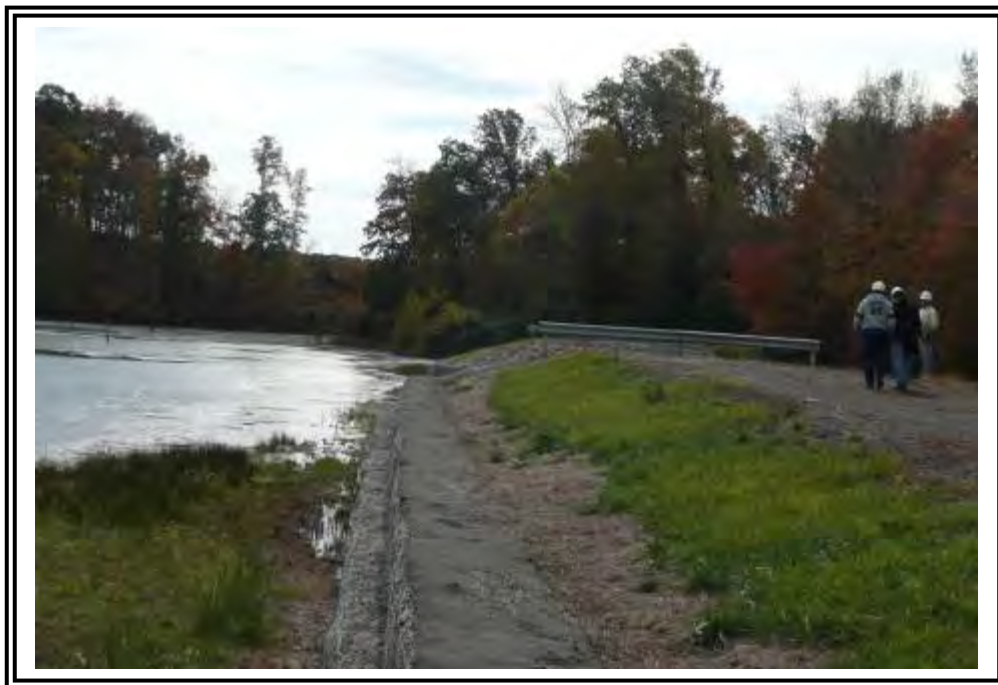
Looking southwest along upstream slope of the gabion emergency spillway.

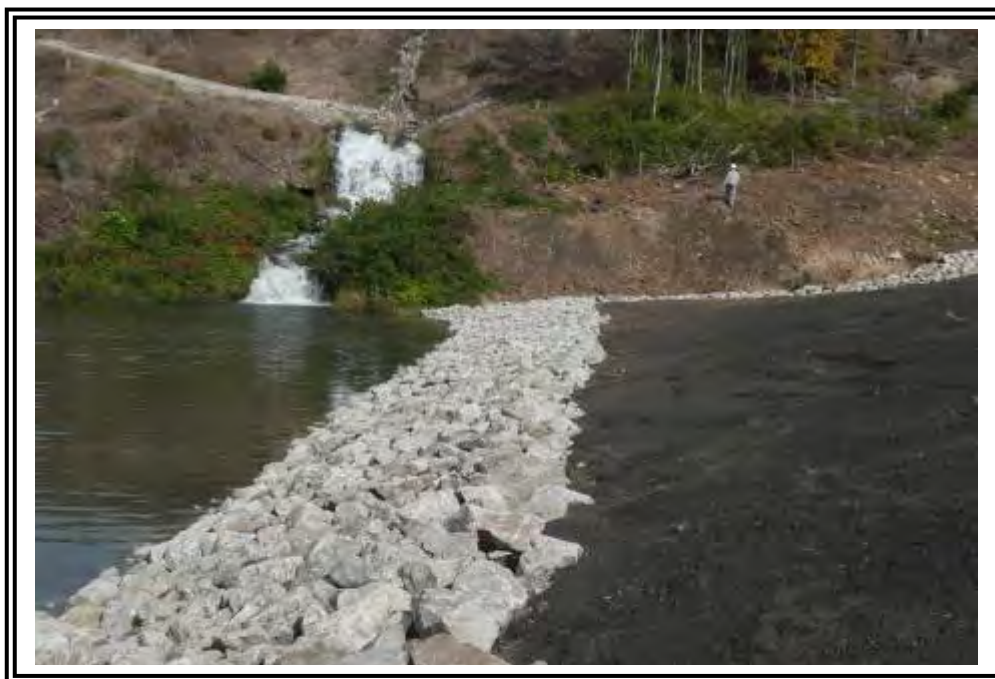
Looking east along rock toe drain and rip-rap slope protection of the Middle Fly Ash Dam.

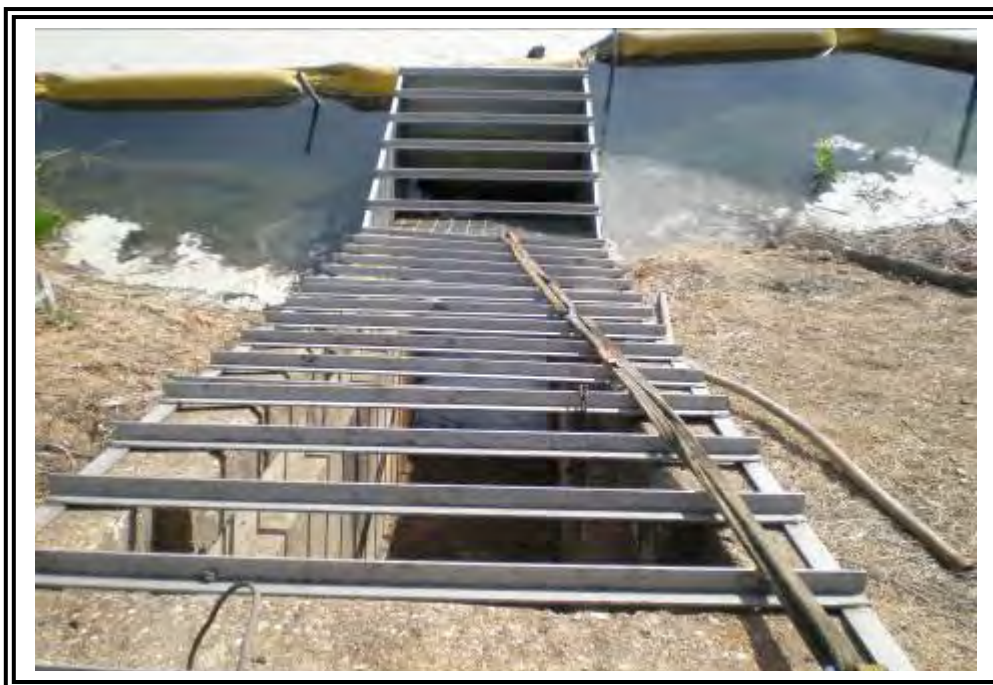
Looking down into the inclined spillway inlet of the Middle Fly Ash Dam.

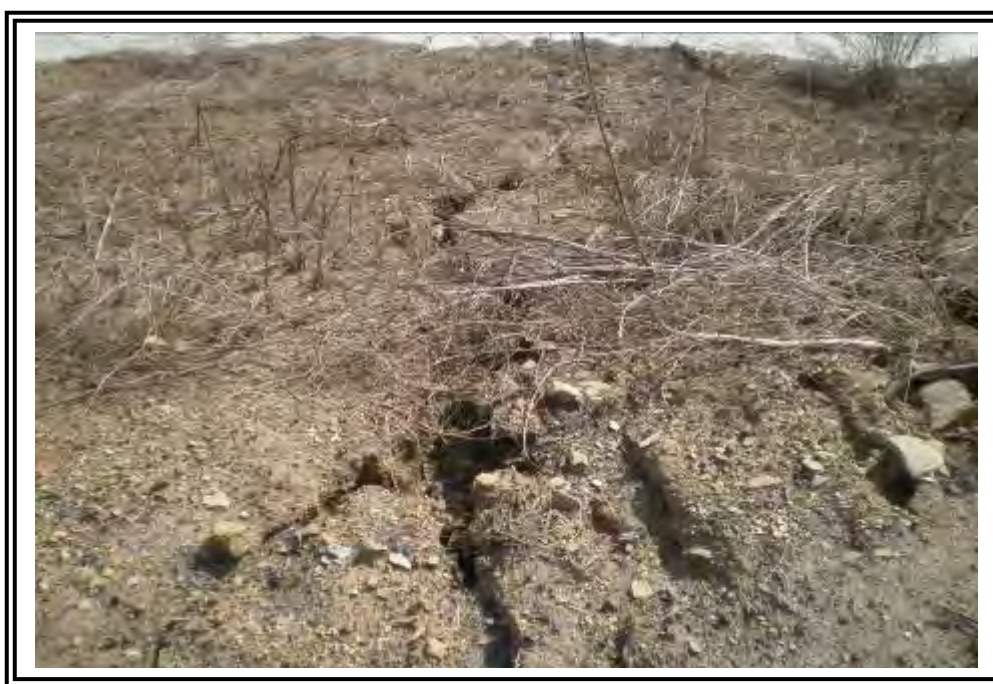
Erosion rills in upstream slope of the Middle Fly Ash Dam.

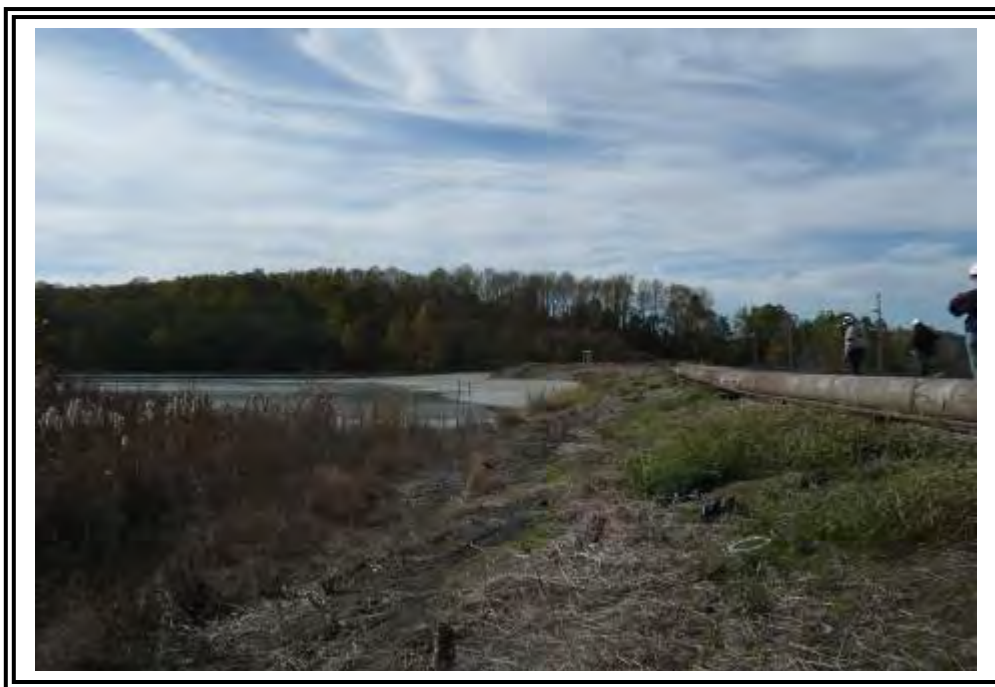
49

Lower Fly Ash Dam, upstream slope, looking northwest. Note dying weedy vegetation and old sluice lines at crest.

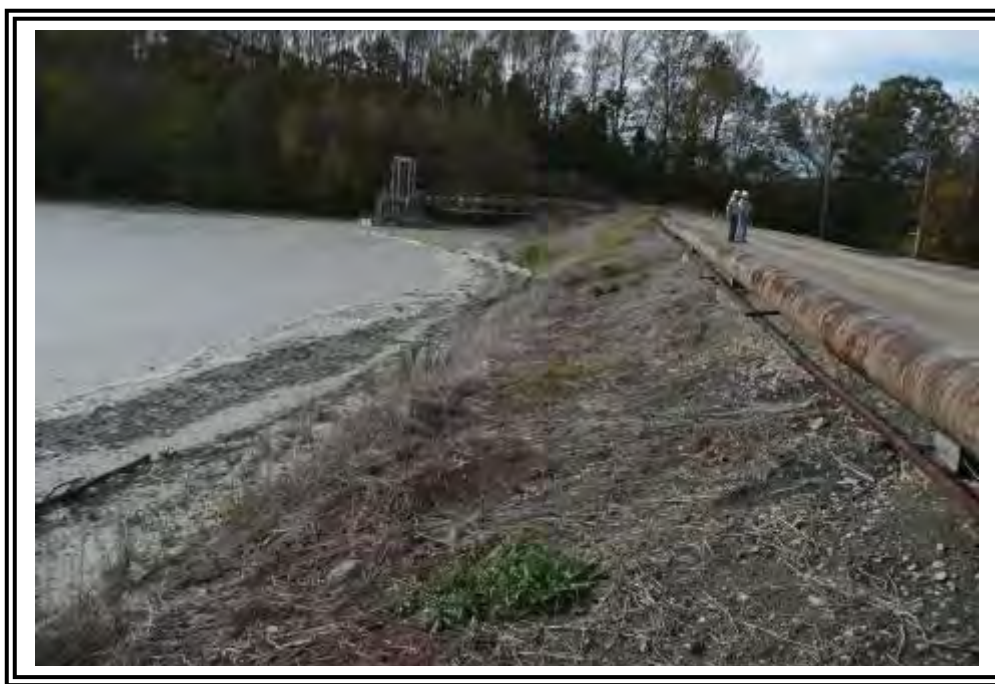
50

Lower Fly Ash Dam, upstream slope and crest looking northwest toward spillway riser structure.

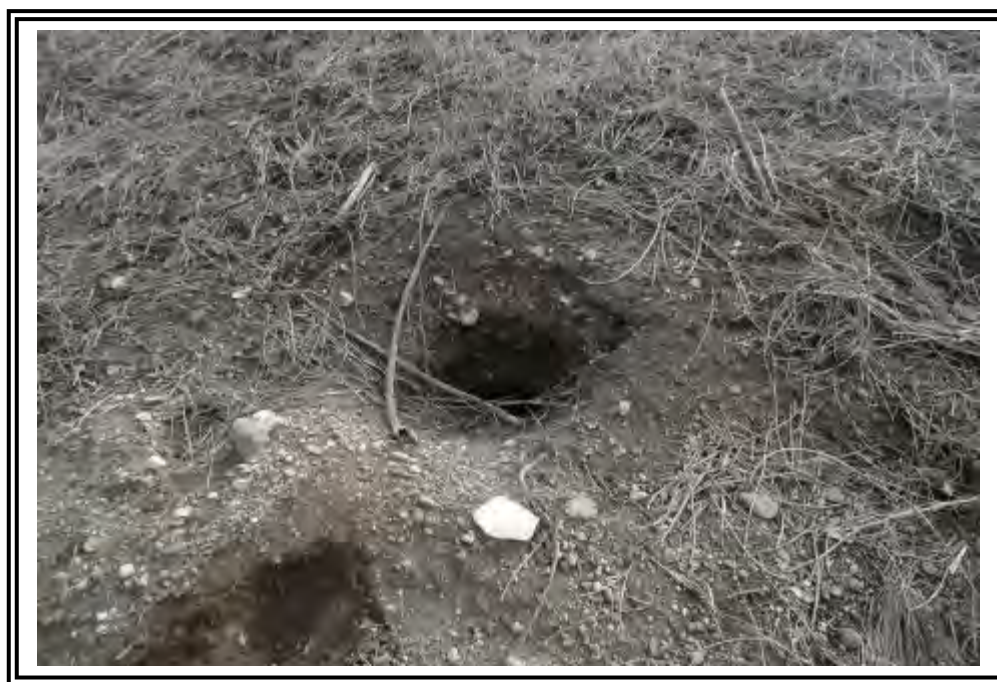
52

Lower Fly Ash Dam partially collapsed rodent burrow in downstream slope.
Note silty sand and gravel material in embankment surface.

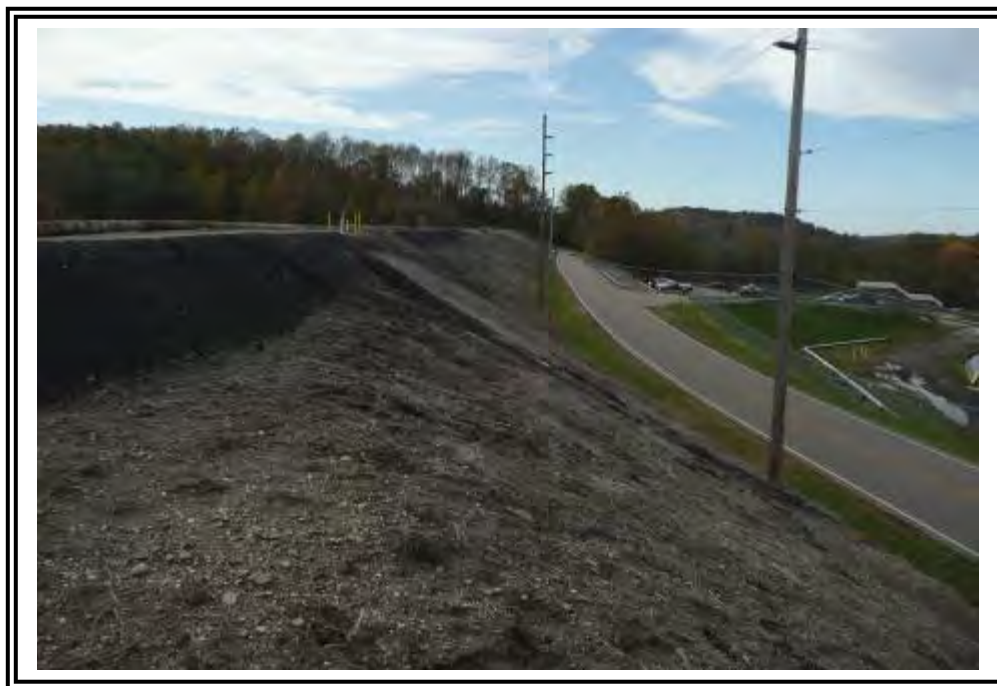
53

Lower Fly Ash Dam along downstream slope near crest, looking northwest. Note bottom ash material at crest elevation.
