Assessment of Dam Safety

Coal Combustion Surface Impoundments (Task 3)

American Electric Power

Muskingum River
Power Plant

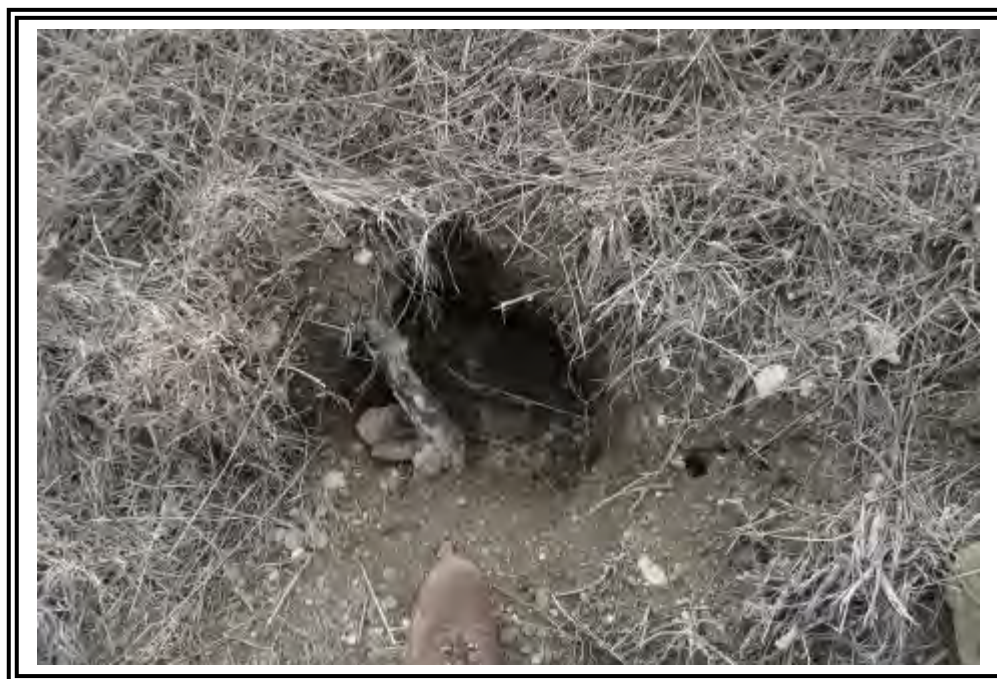
54

Rodent burrow on the Lower Fly Ash Dam, southeast facing downstream slope.

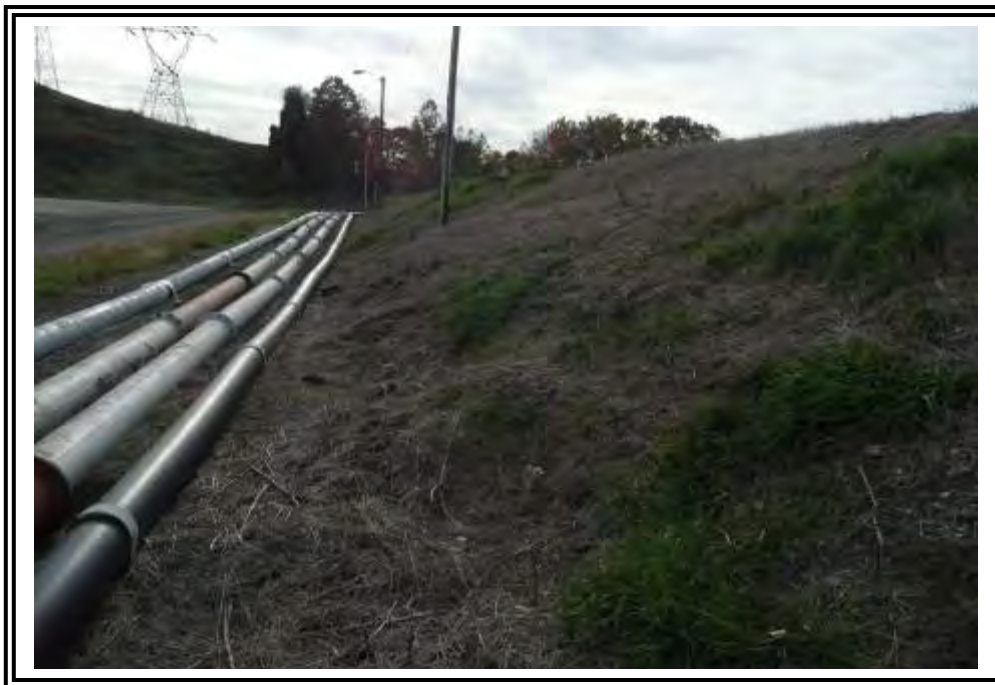
55

Lower Fly Ash Dam along southeast facing portion of the downstream slope adjacent to Unit 5 bottom ash sluice lines at the toe of the slope, looking southwest. Note slope undulations resulting from previous grading and dormant surficial sloughing.

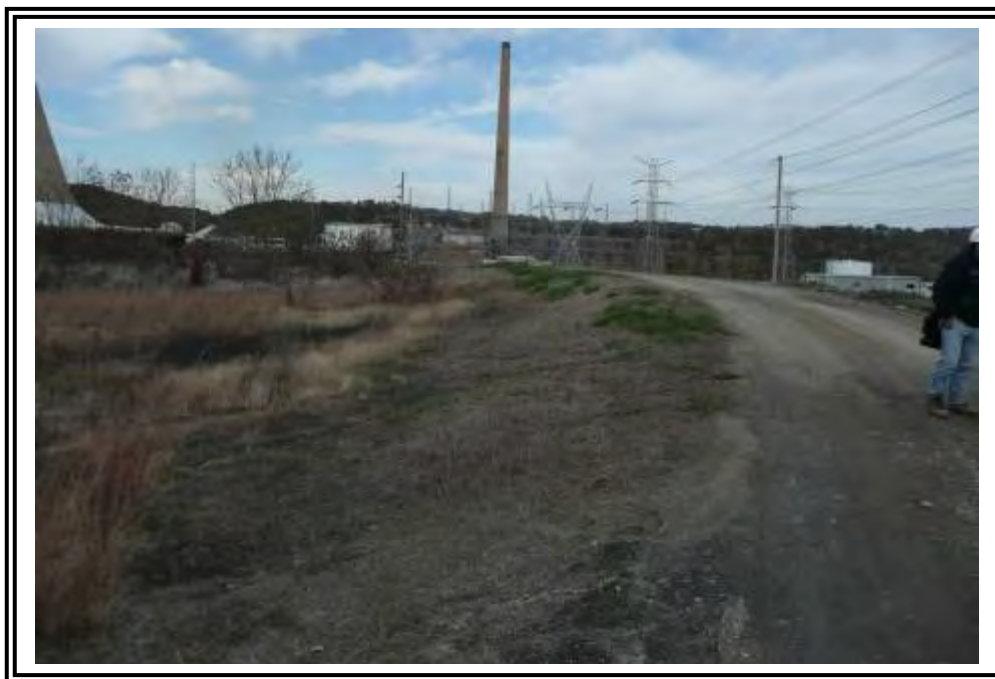
56

Lower Fly Ash Dam upstream slope and crest area along southeast facing portion of the dam.

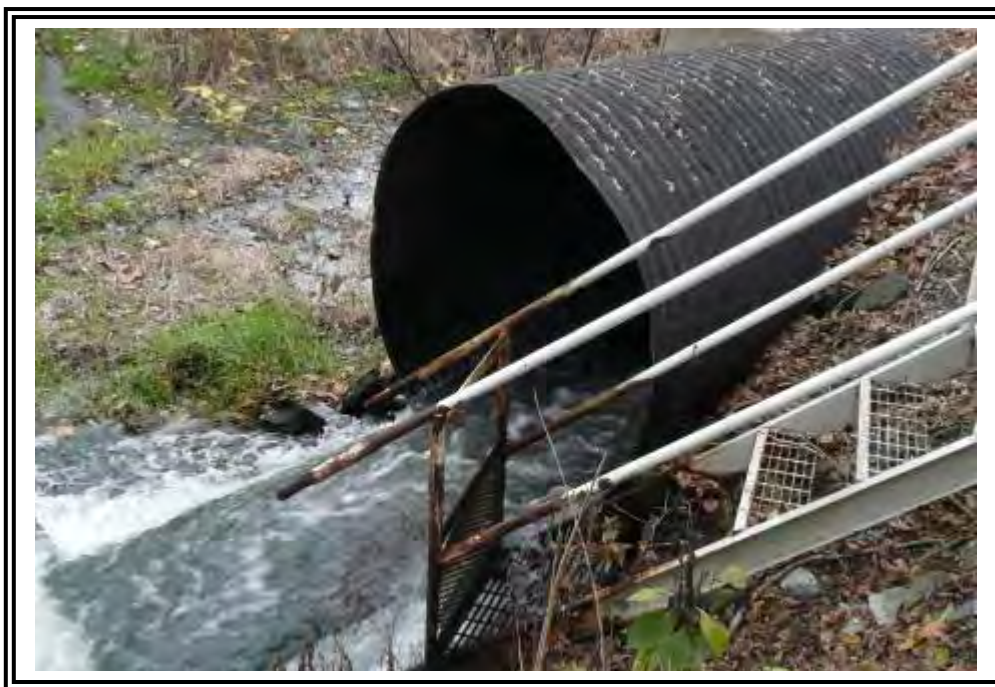
57

Lower Fly Ash Dam 72-inch diameter CMP spillway outlet.

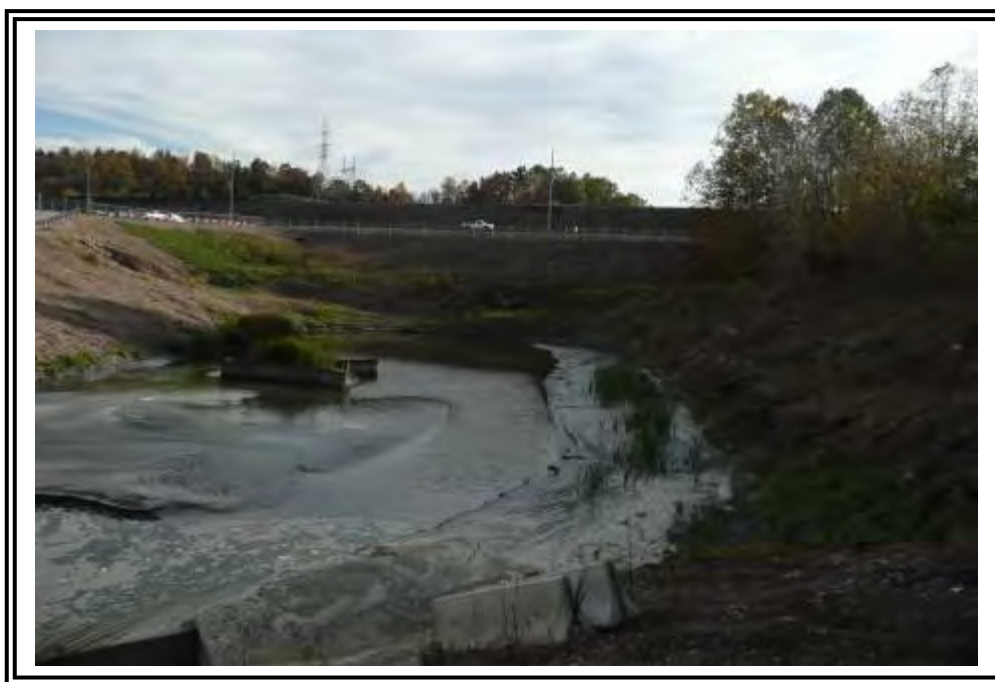
58

Partially incised wastewater, runoff, and seepage collection basin at toe of the Lower Fly Ash Dam.

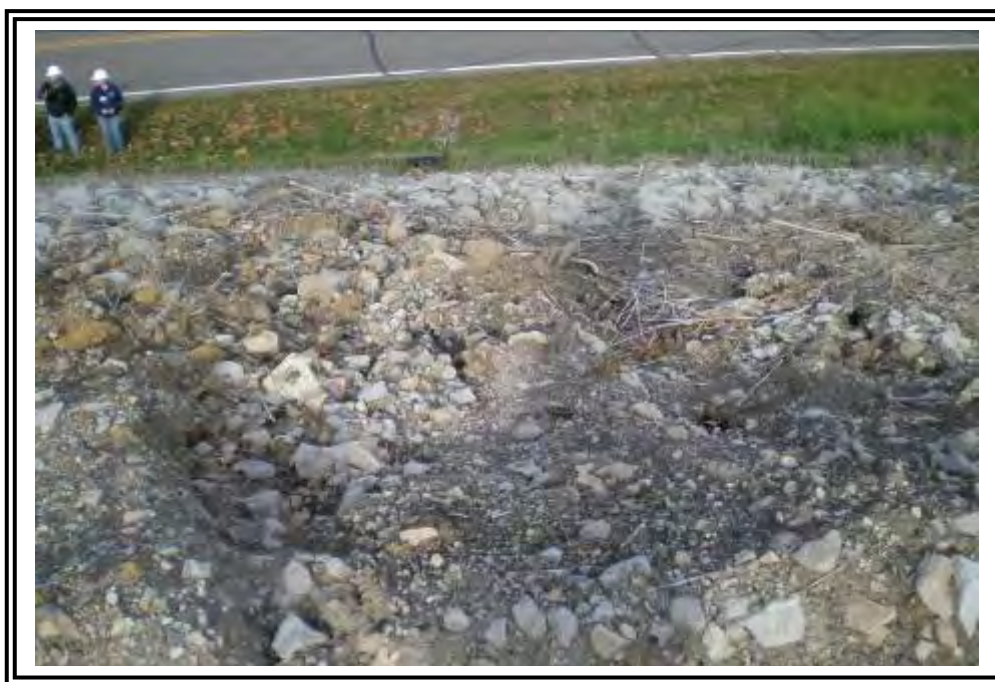
60

Erosion on the downstream slope of the Lower Fly Ash Dam near the crest elevation above the rip rap slope protection.

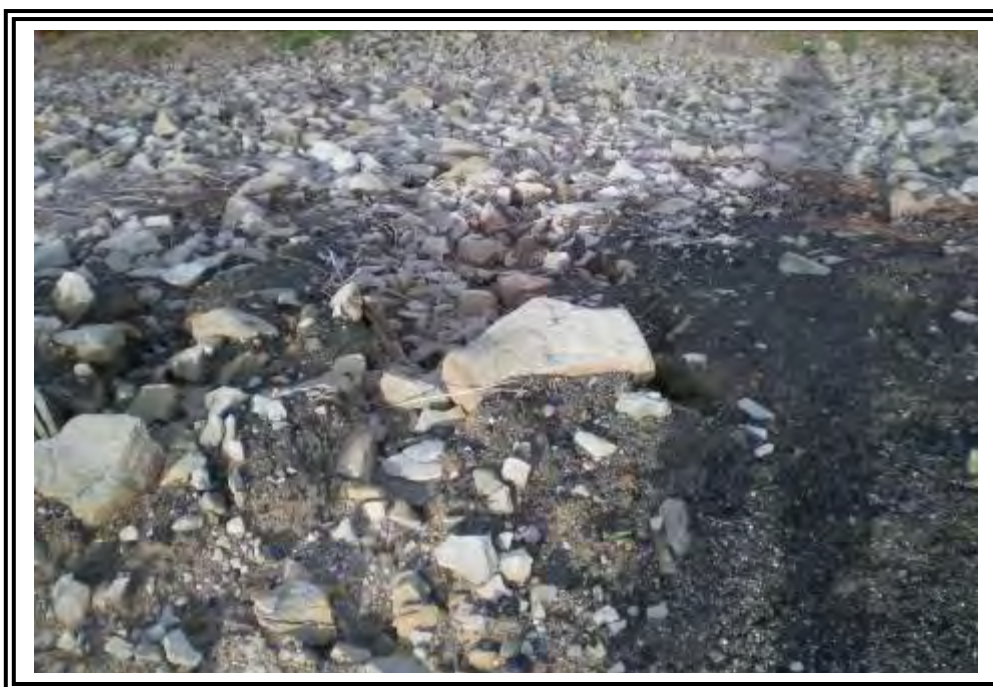
61

Migration of bottom ash material used to grade the crest onto the slope protection at the Lower Fly Ash Dam.

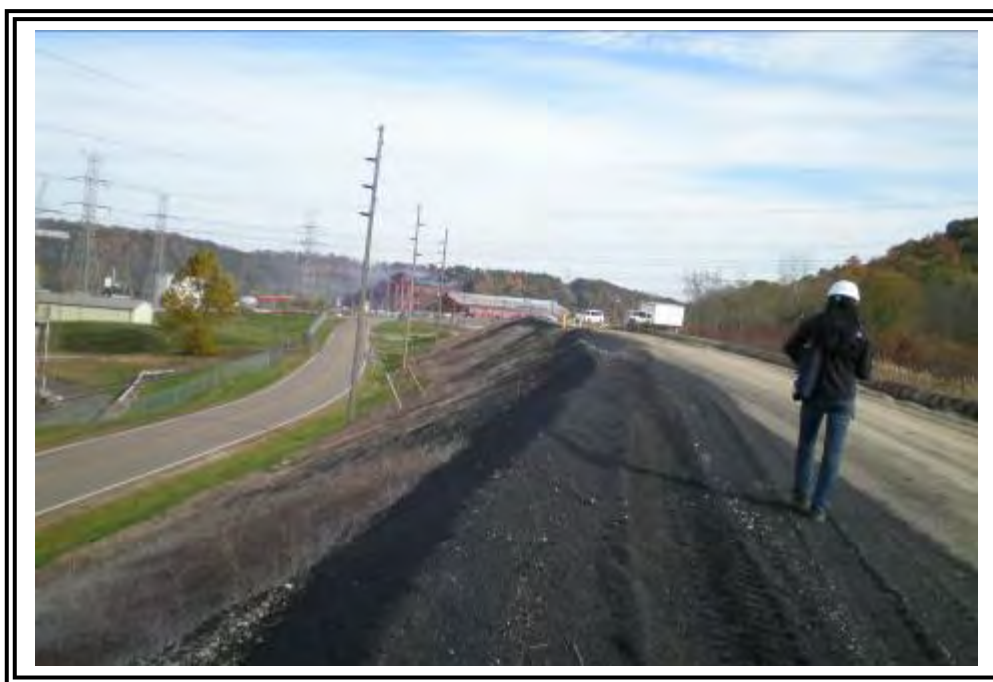
62

Lower Fly Ash Dam crest, looking southeast.

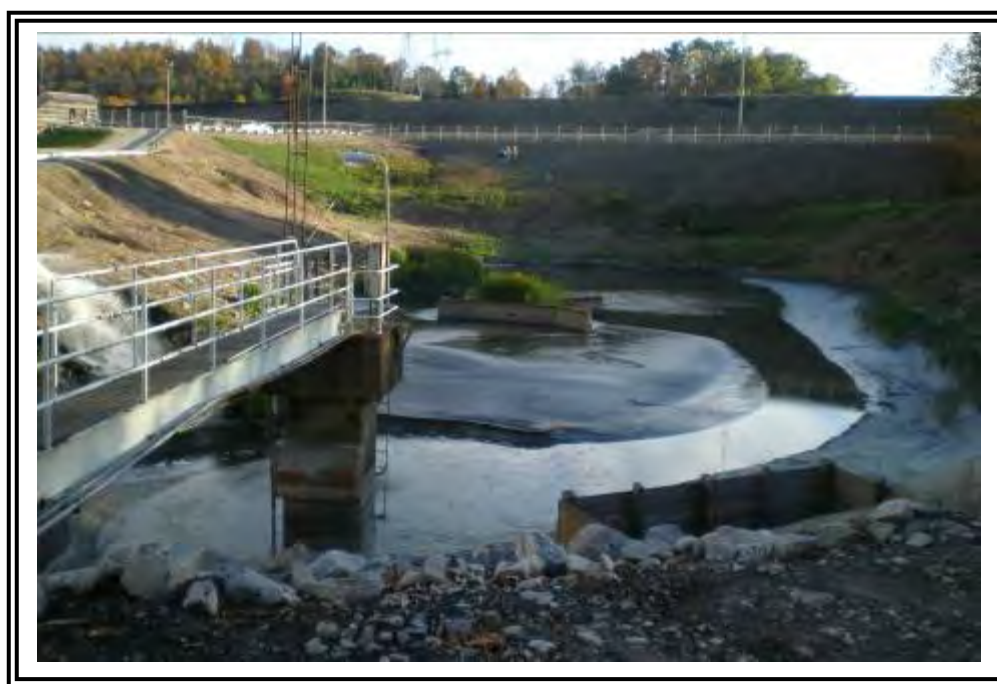
64

Looking south across the facility water and drainage catch basin at the toe of the Lower Fly Ash Dam.
Water entering basin is circulated into the Lower Fly Ash Reservoir.

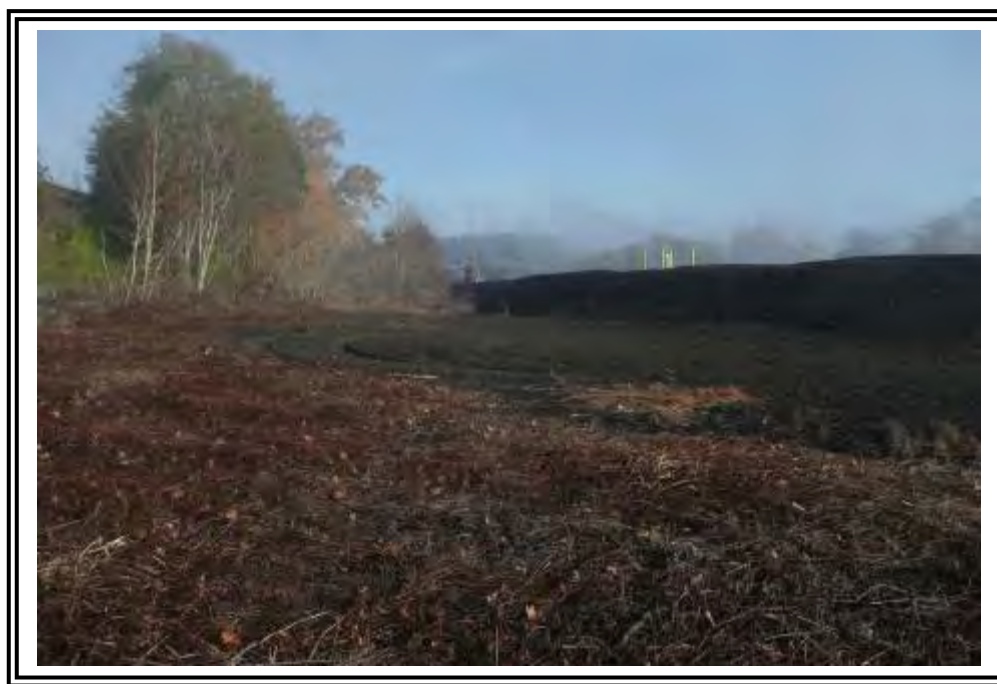
66

Units 1-4 Bottom Ash Pond west dike exterior slope, looking north.

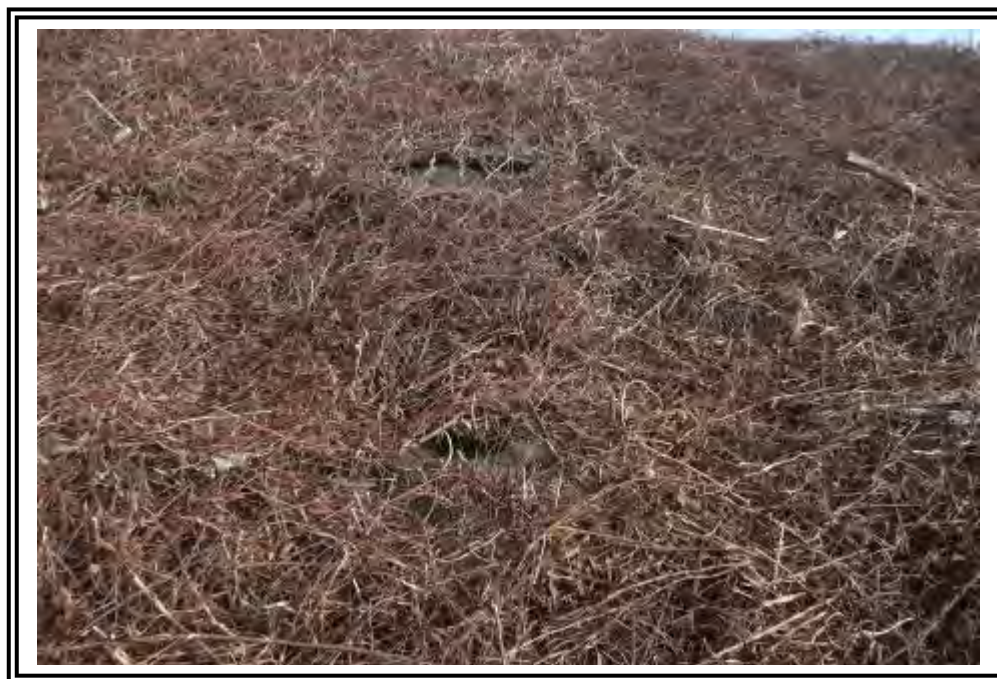
68

Rodent burrow on the Units 1-4 Bottom Ash Pond south dike exterior slope.

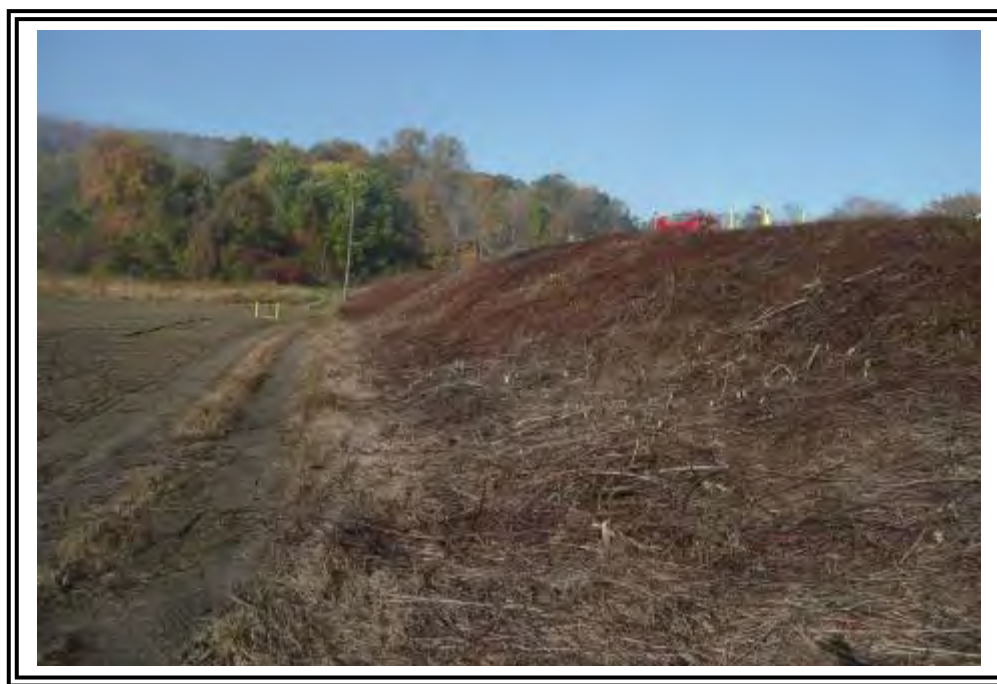
70

Units 1-4 Bottom Ash Pond south dike exterior slope, looking west from the southeast corner adjacent to the Muskingum River. Note recently cut heavy vegetation and woody brush.

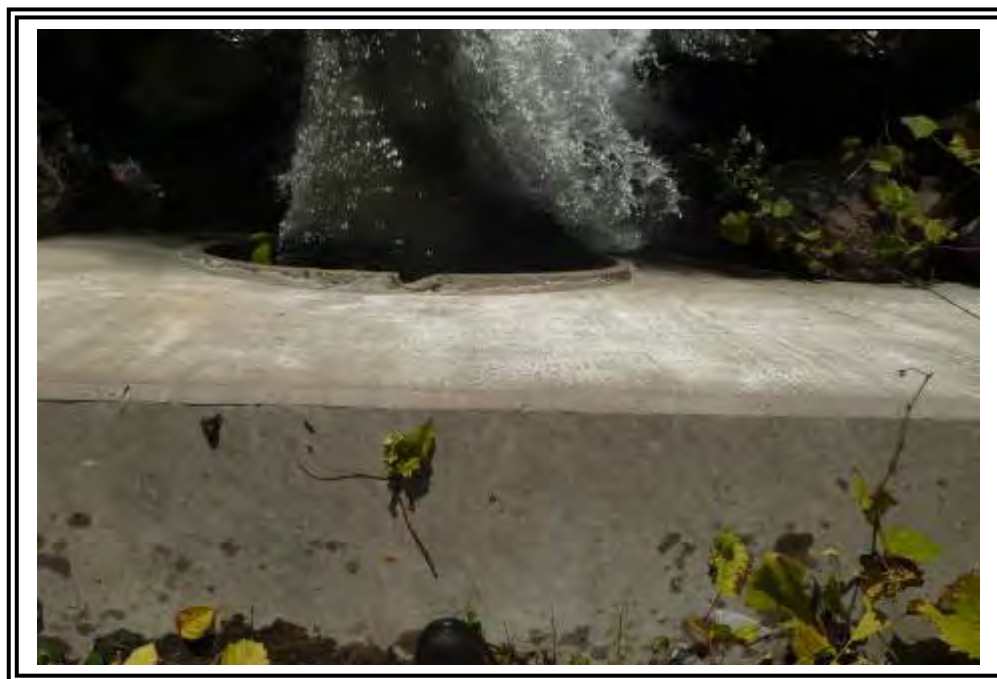
72

Units 1-4 Bottom Ash Pond outlet and headwall.

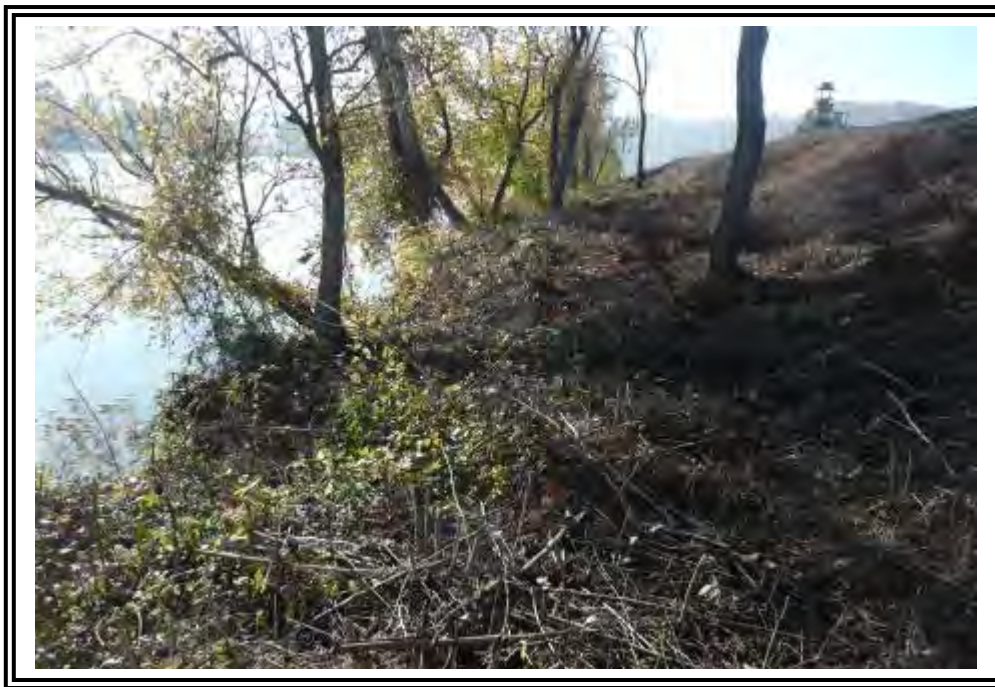
73

Units 1-4 Bottom Ash Pond east dike exterior slope, looking south. Note distance between river bank and dike toe.

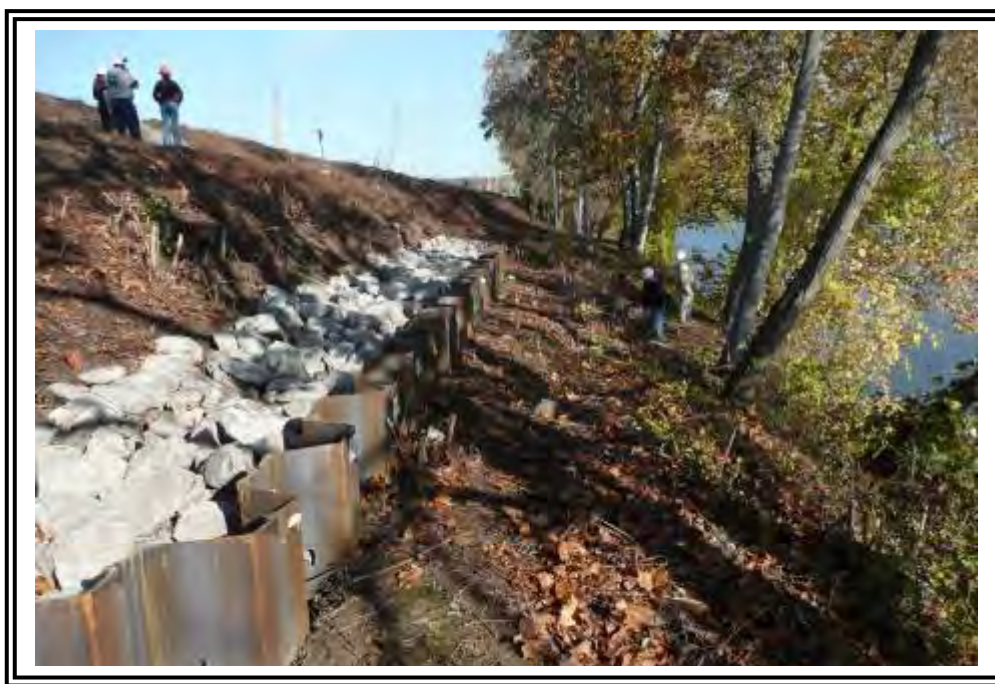
74

Units 1-4 Bottom Ash Pond east dike sheet pile stream bank stabilization at dike toe, looking north. Note leaning trees.

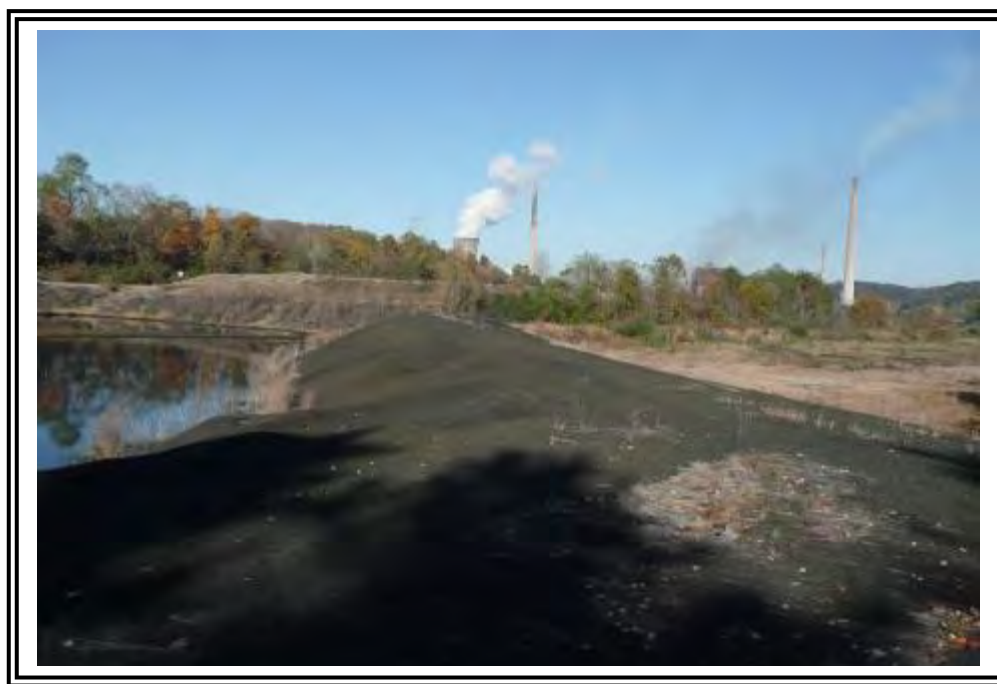
76

Units 1-4 Bottom Ash Pond interior dike crest and upstream slope at north end of the open pond area.
Note bottom ash construction and generally sparse to absent vegetation.

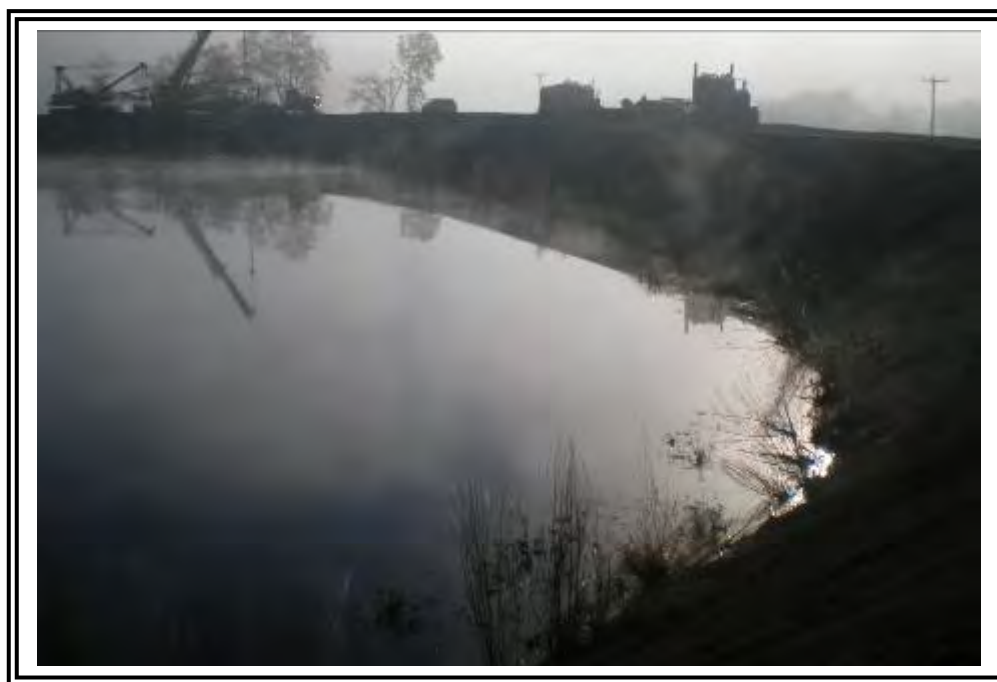
78

Units 1-4 Bottom Ash Pond south dike interior slope, looking east.

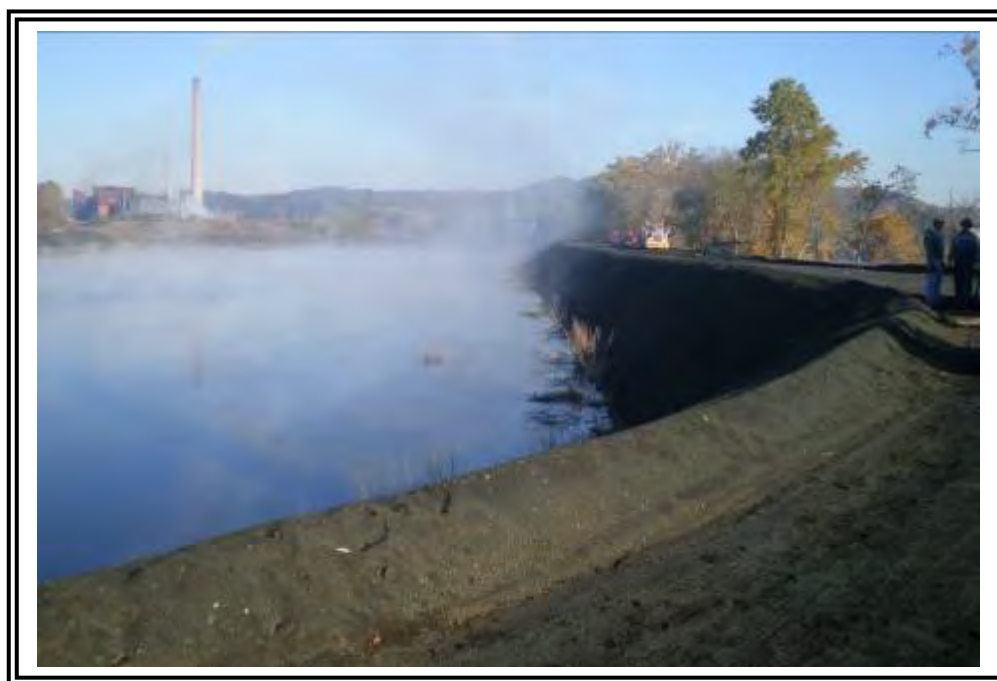
80

Units 1-4 Bottom Ash Pond east dike interior slope, looking east. Note relatively steep slope.

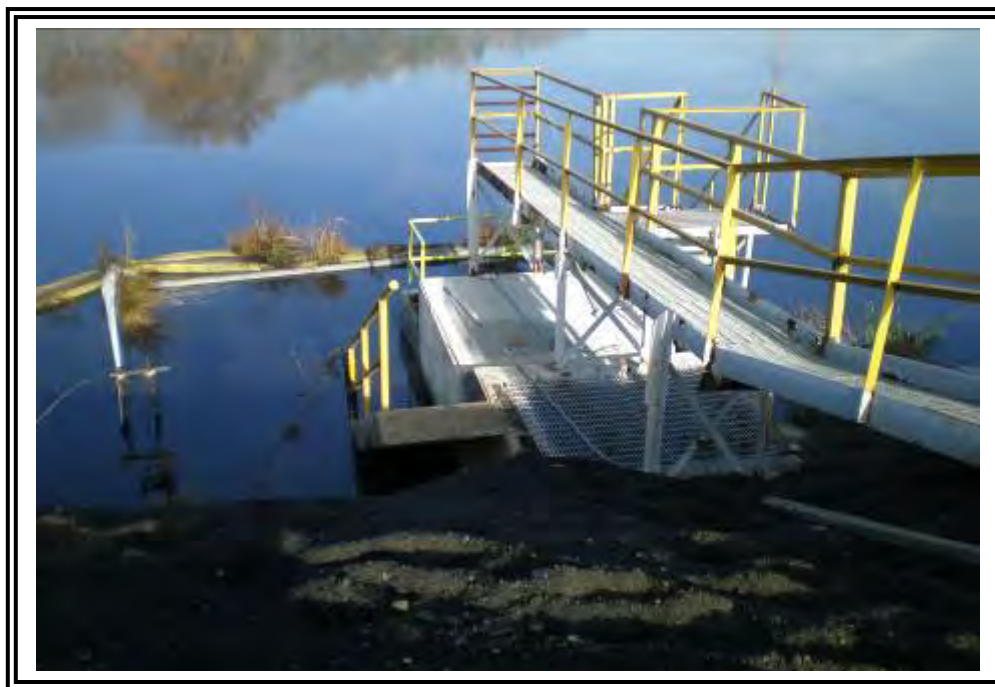
81

Outfall structure in the south dike of the Units 1-4 Bottom Ash Pond.

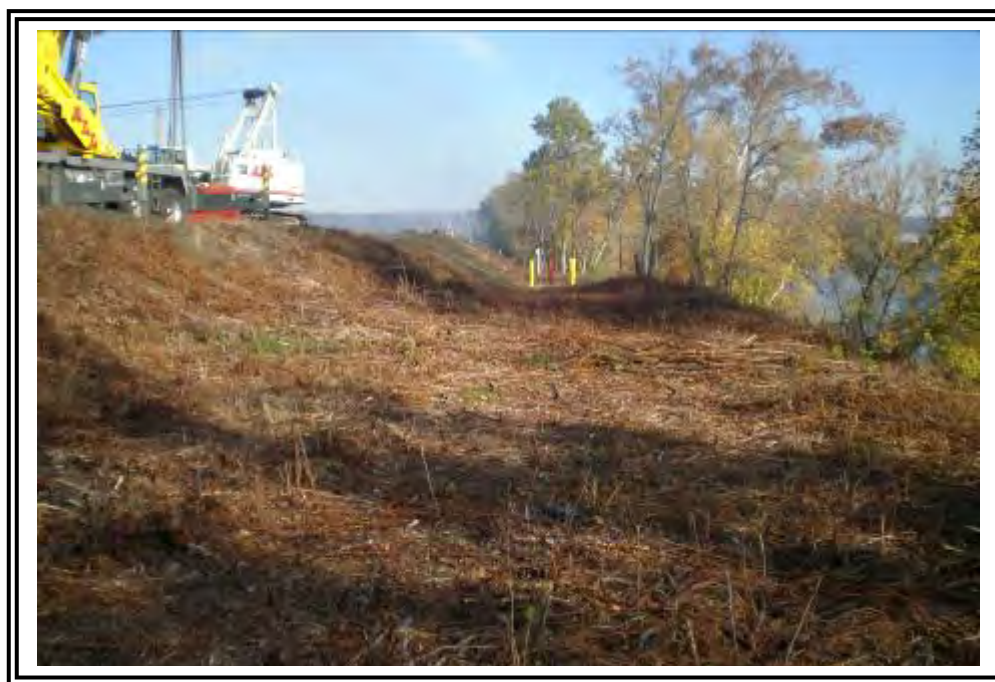
82

Units 1-4 Bottom Ash Pond east dike bench area and upper exterior slope. Bench is on the order of 15 to 20 feet wide in this area with evidence recently mowed dormant vegetation.

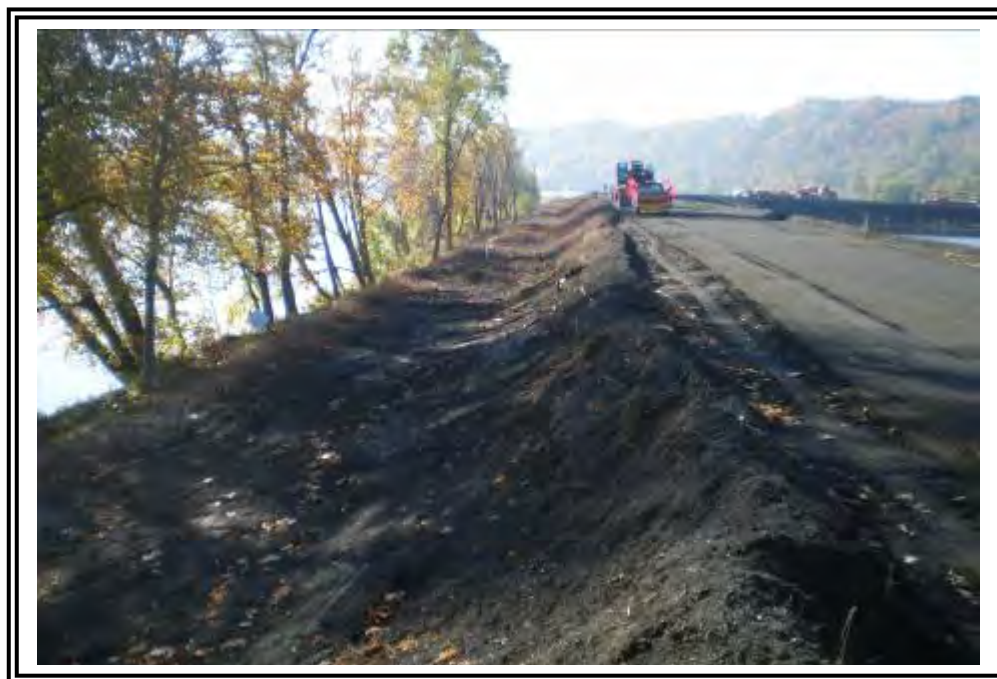
84

Crest area along the Units 1-4 Bottom Ash Pond east dike at the north end of the pond, looking south.

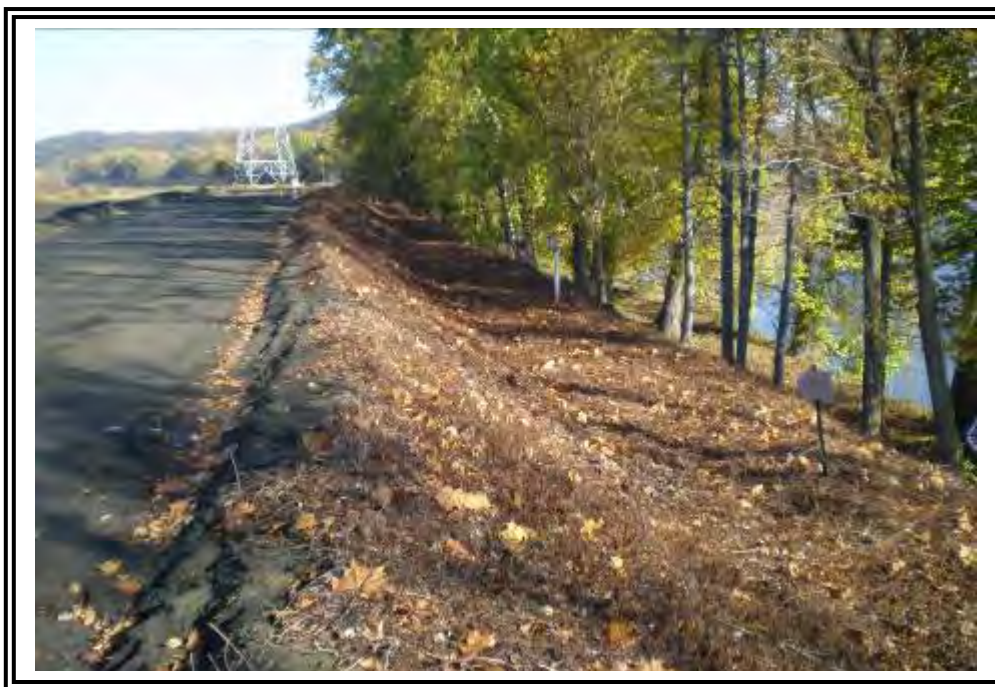
85

Crest area along Units 1-4 the Bottom Ash Pond east dike at the north end of the open pond, looking north.

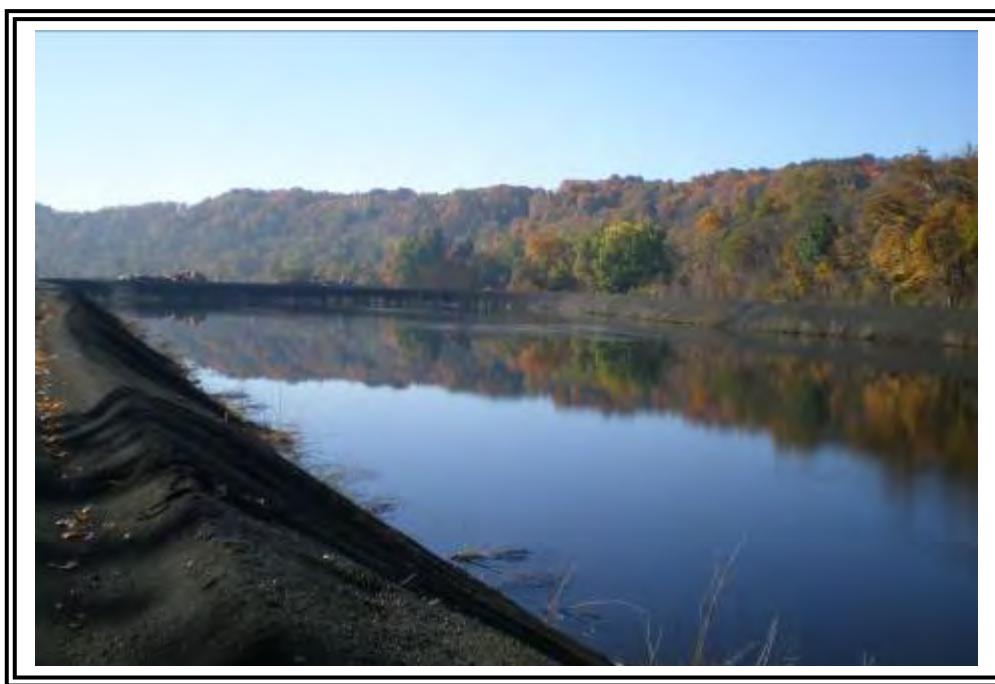
86

Units 1-4 Bottom Ash Pond east dike interior slope and open pond area, looking south.
Note relatively steep slopes and sparse to absent vegetation.

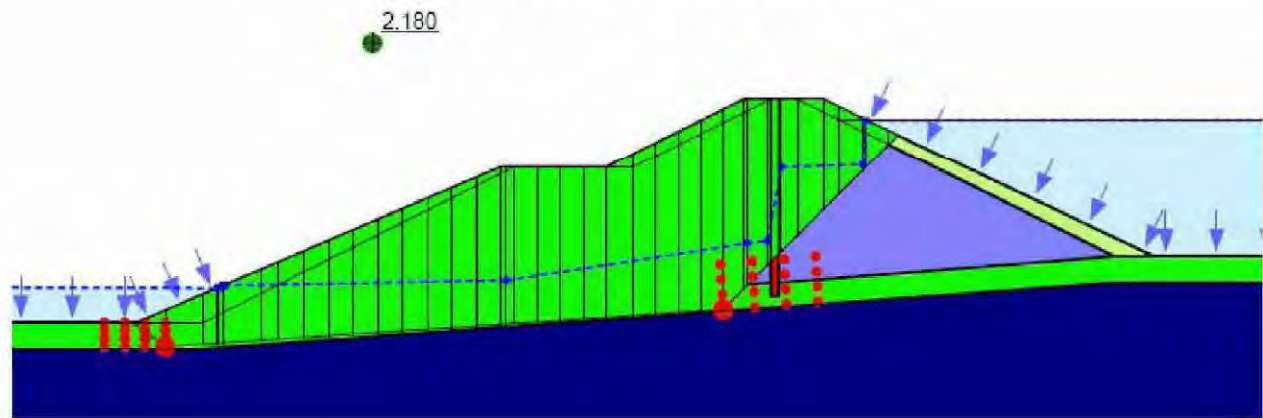
FIGURE 10A

Safety factor for a block failure mechanism passing through the foundation of the embankment was calculated to be 2.2. Safety factor for a large circular failure surface that passes through foundation soil was determined to be 2.1. Shallow failure surfaces at the upper and lower portions of the downstream slope resulted in a factor of safety of 2.0 for both portions. Pseudo static seismic analyses were also conducted to evaluate the performance of the dam under earthquake condition. All factors of safety under seismic condition were determined to be 1.7 or higher. Figures 10A and 10X show the outputs from preliminary these analyses.

Figure 10A. Block failure of the dam and the associated safety factor under steady-state condition
