# Assessment of Dam Safety Coal Combustion Surface Impoundments (Task 3) Final Report

American Electric Power  
Muskingum River  
Power Plant  
Waterford, Ohio

March 23, 2010

Have been assessed on October 20, 2009 and October 21, 2009

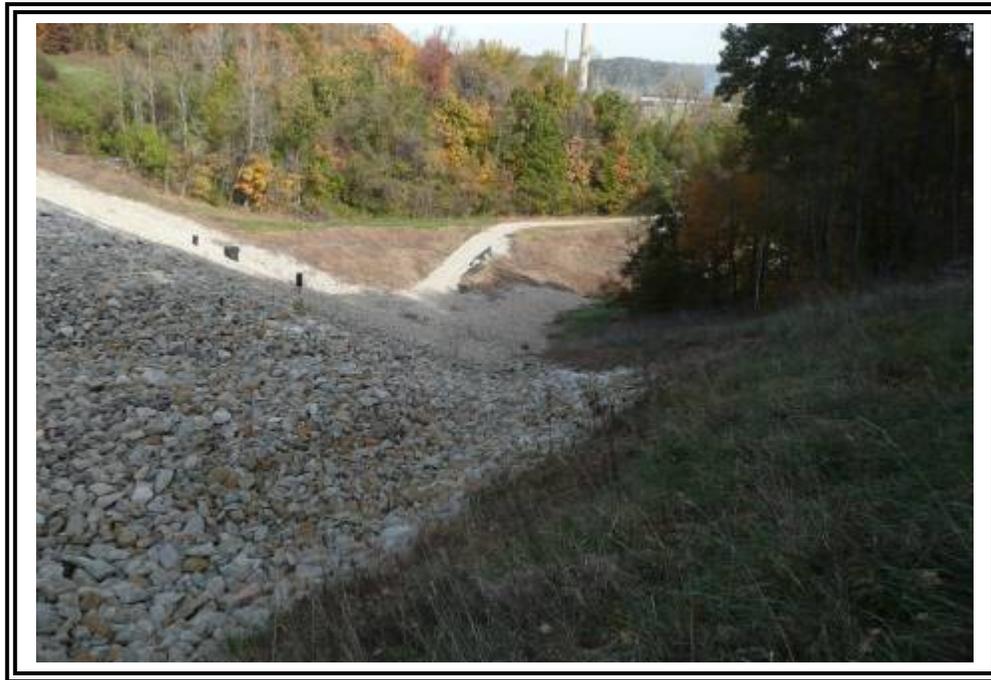
3

Looking downstream at Mill Stone Creek Dam right (southeast) abutment groin contact.

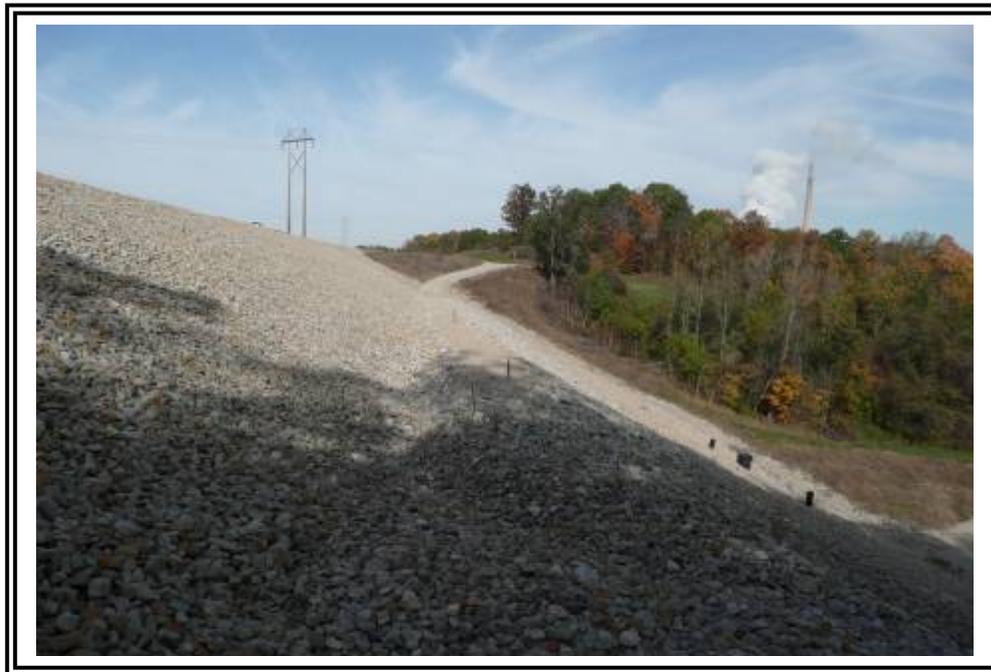
4

Downstream slope along mid-slope instrumentation bench at Mill Stone Creek Dam, looking northwest. Note rip-rap surface treatment.

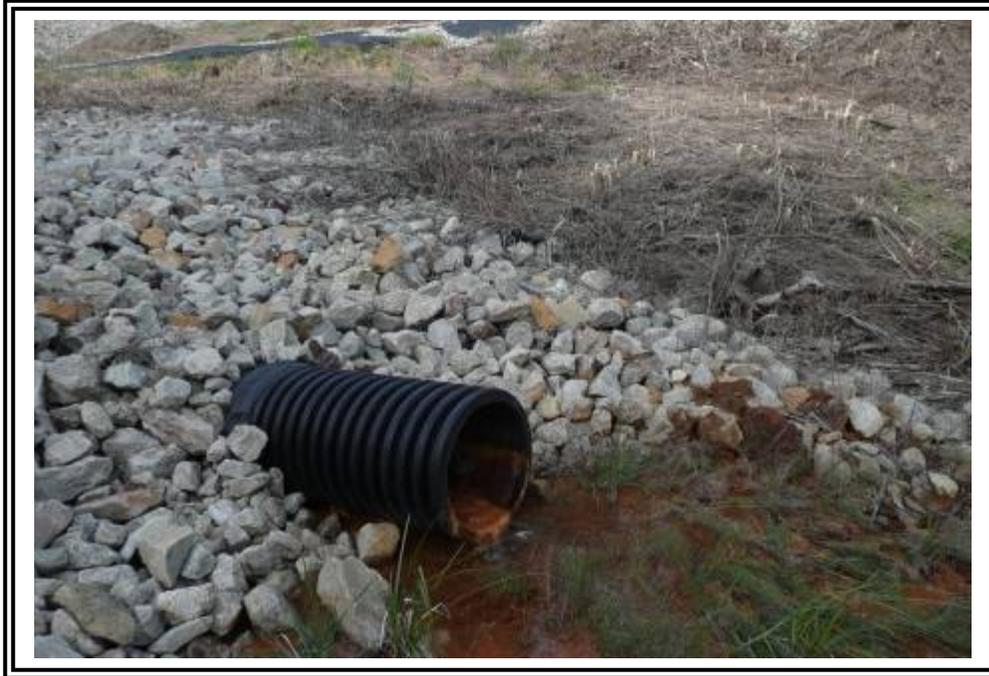
5

Active blanket drain outlet at Mill Stone Creek Dam. Note iron precipitate.

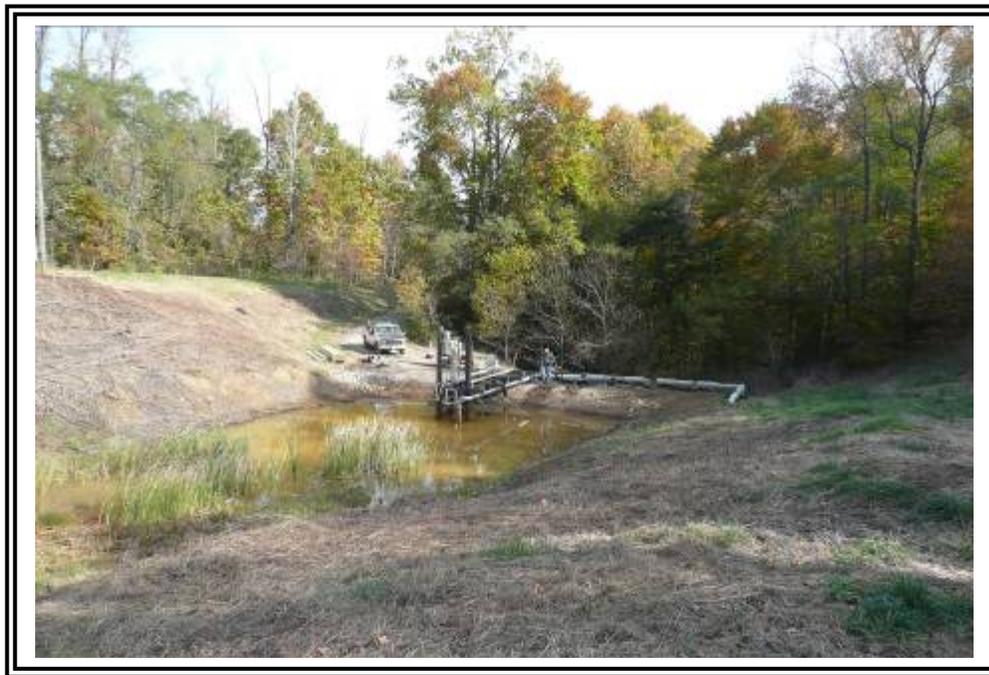
6

Seepage collection, treatment and recirculation basin at Mill Stone Creek Dam.

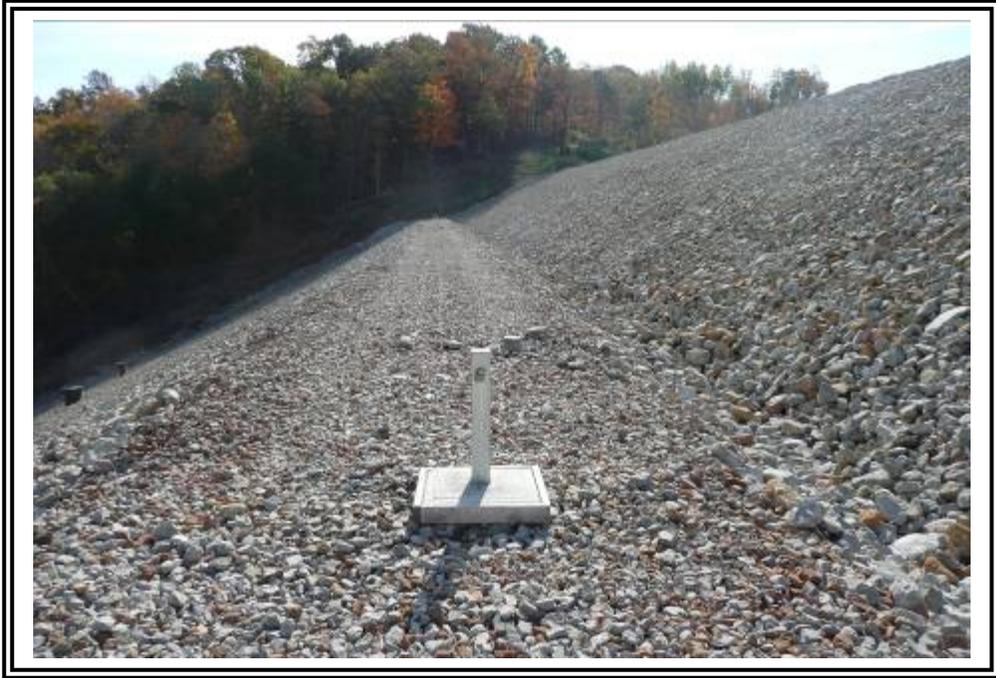
7

Instrumentation on bench of downstream slope of Mill Stone Creek Dam.

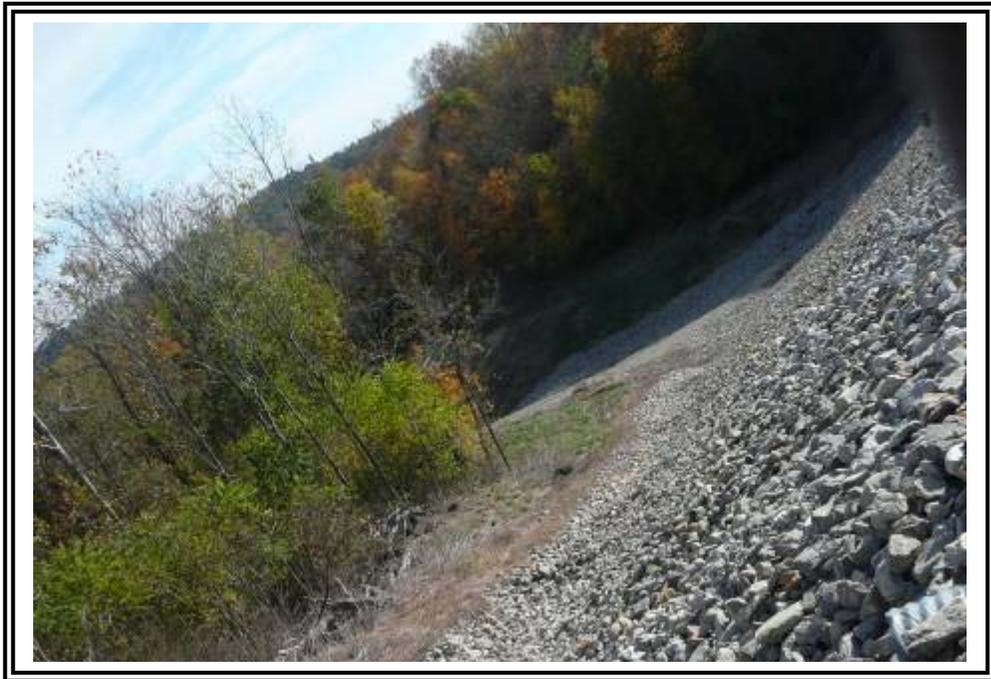
8

Downstream slope of Mill Stone Creek Dam left (northwest) abutment groin contact.

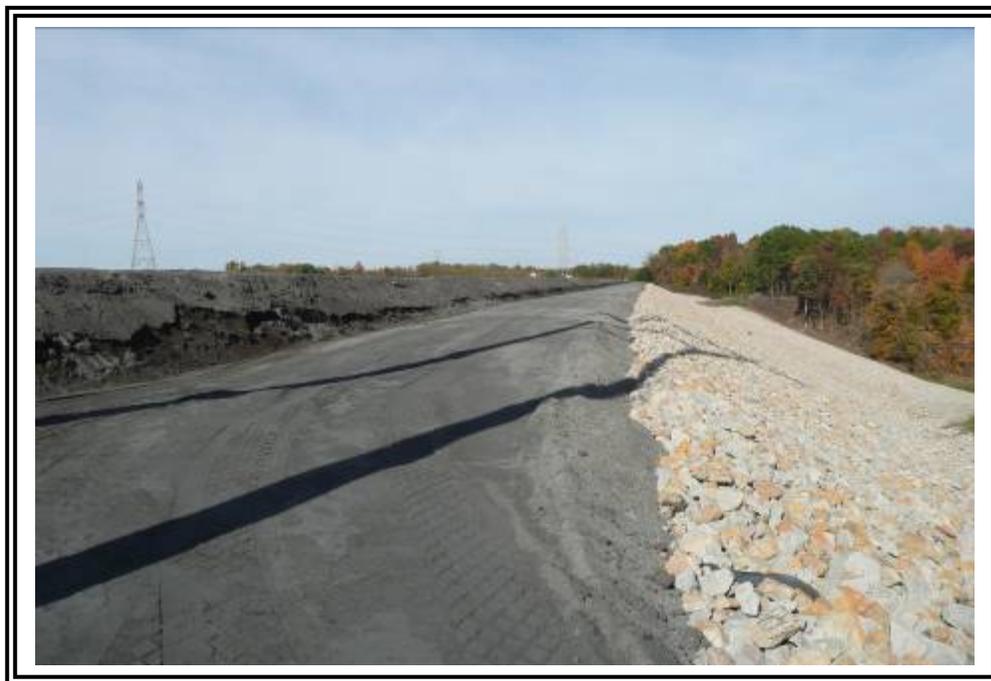
9

Fly ash bench near the crest of the No-Name Creek Dam.

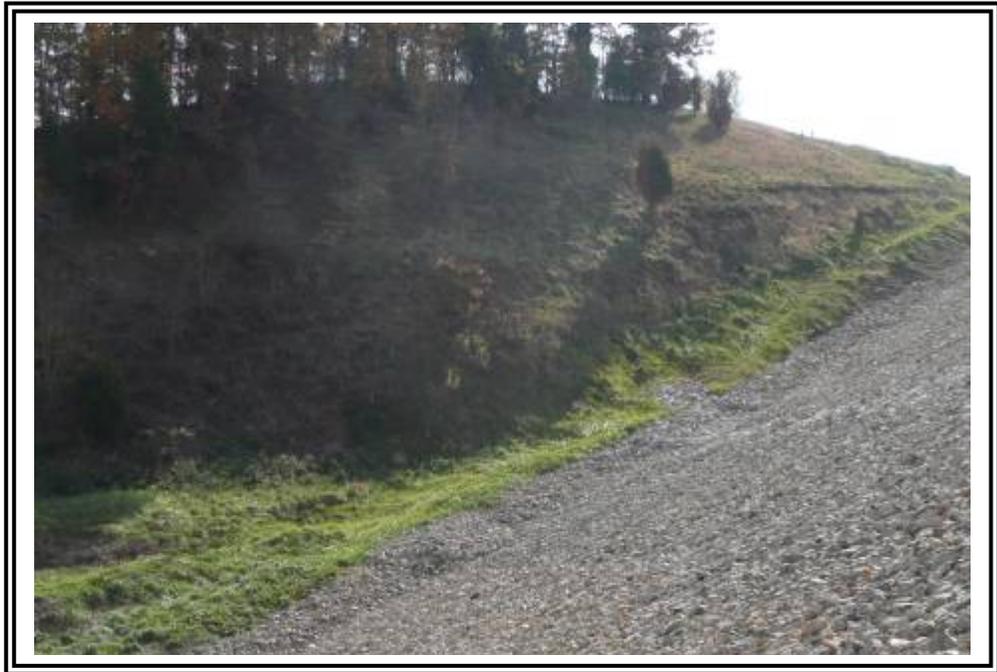
12

Slope at right (southeast) abutment contact where extension from groin was constructed to intercept hillside seepage, looking southeast.

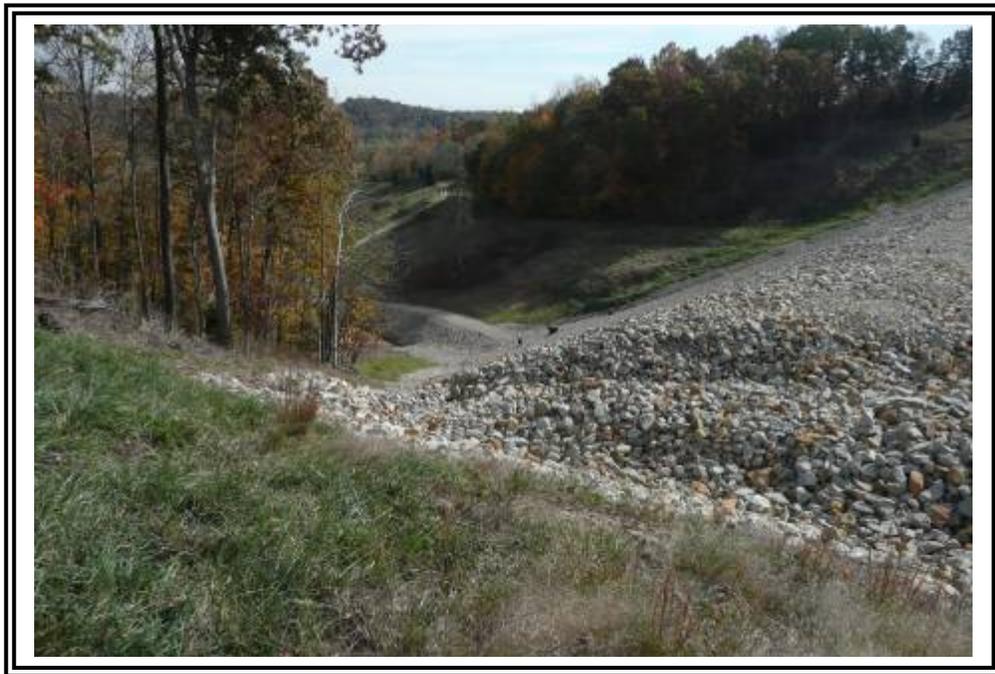
16

Downstream slope near crest of No-Name Creek Dam at left (northwest) abutment groin contact.

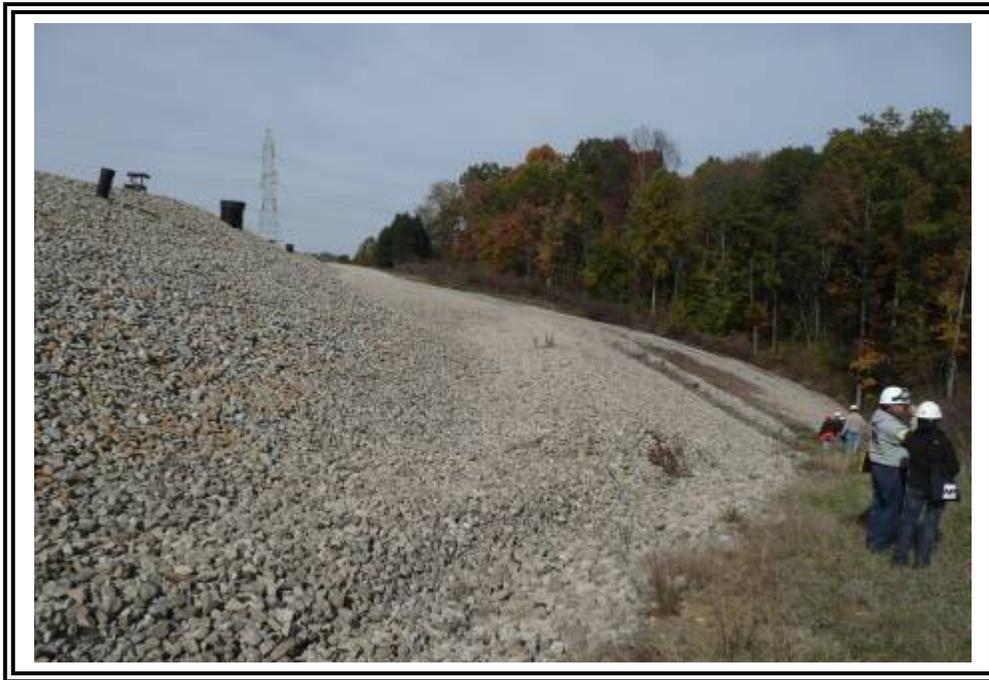
17

Downstream slope and abutment groin of the Wing Dam at right (southeast) abutment contact, looking northwest.  
 Note blanket drain system inspection, access, and cleanout ports in the slope.

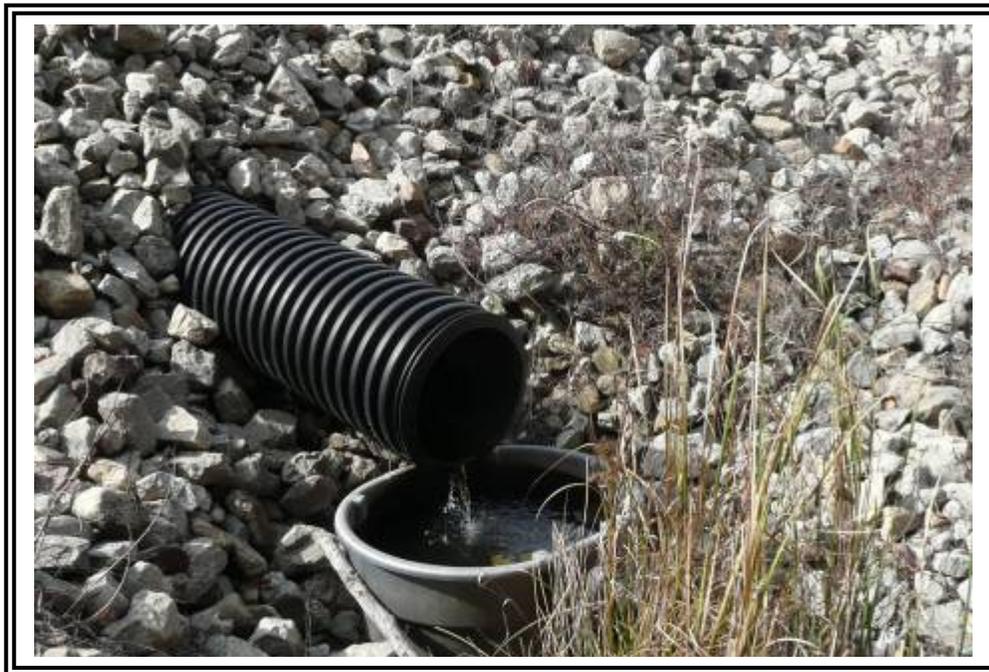
18

Active blanket drain outlet at Wing Dam. Note absence of iron precipitate.

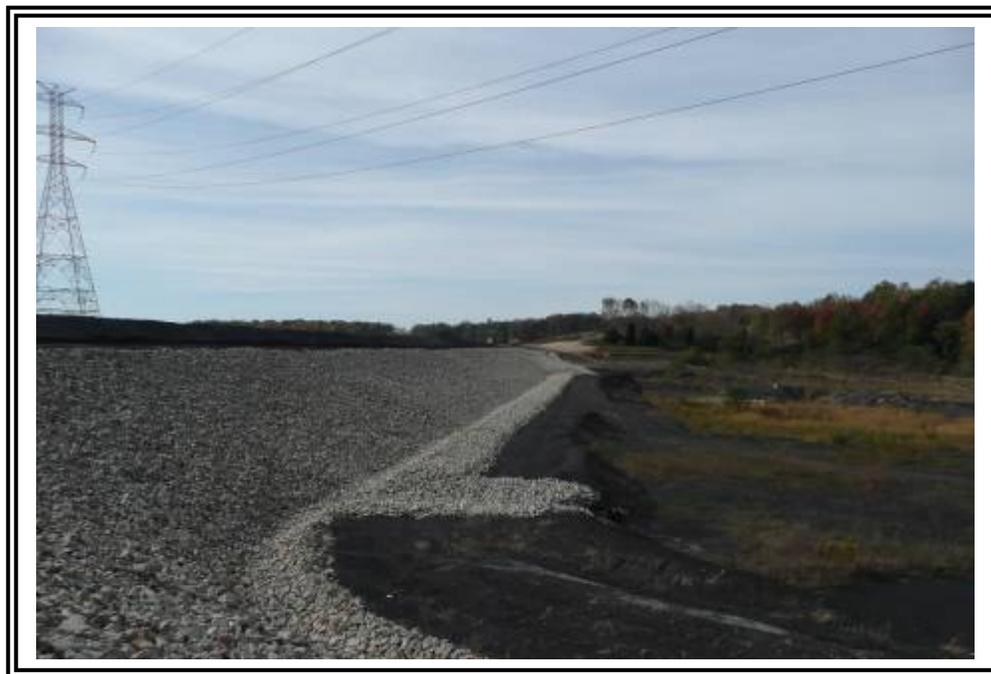
21

Downstream slope of the Wing Dam, looking west. Downstream slope toe forms upstream wall of the Middle Fly Ash Reservoir.

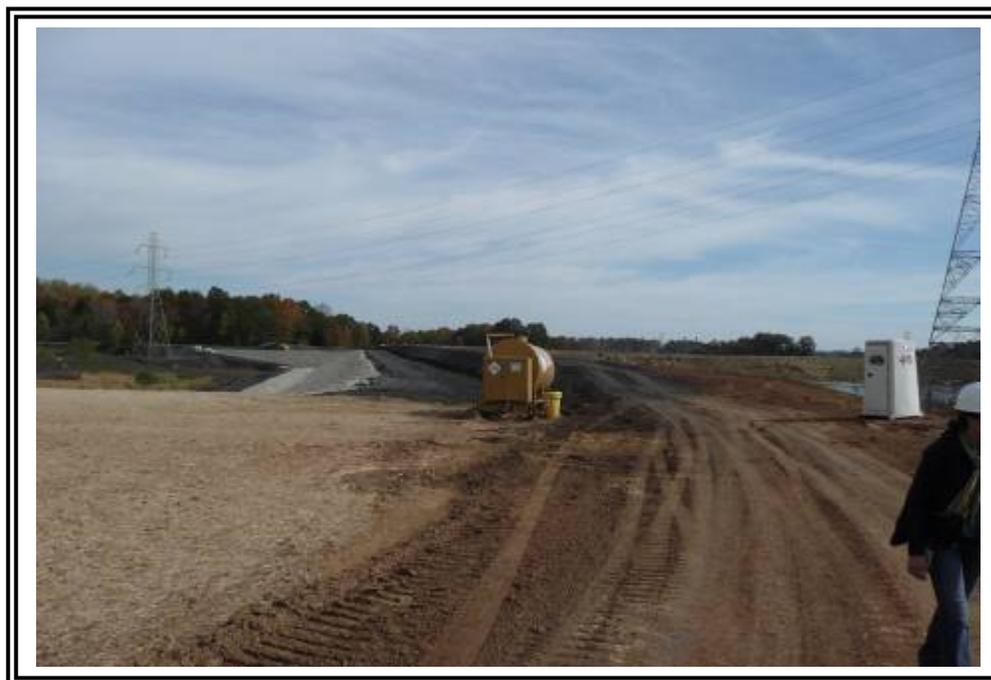
22

Wing Dam crest, looking east.

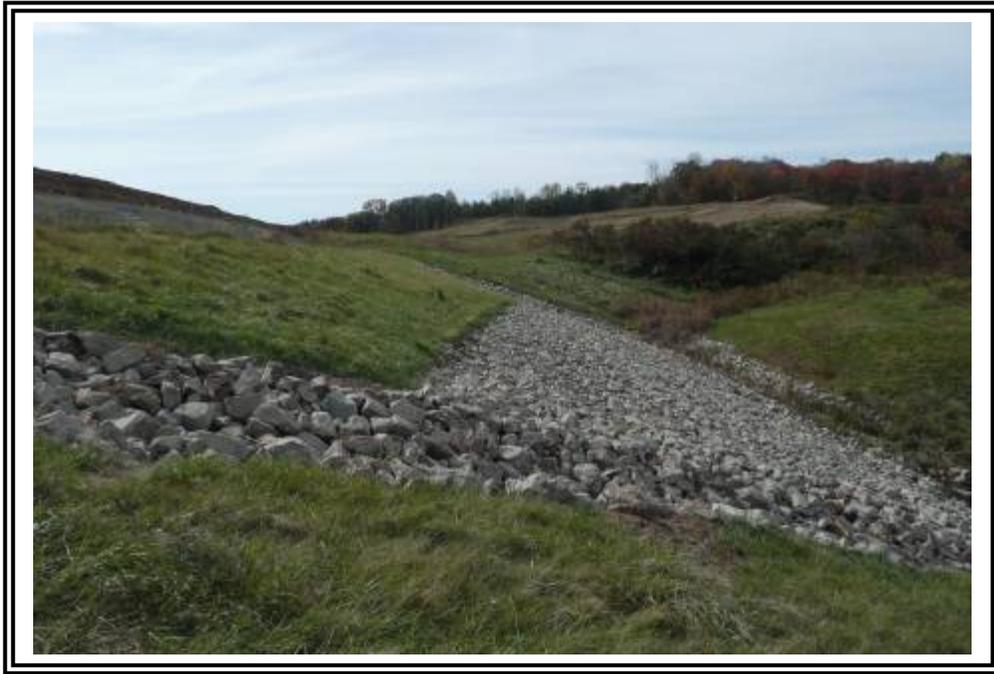
23

Downstream slope of the Spillway Dam showing upper grass covered slope and rip-rap protection on the lower portion of the slope, looking west.

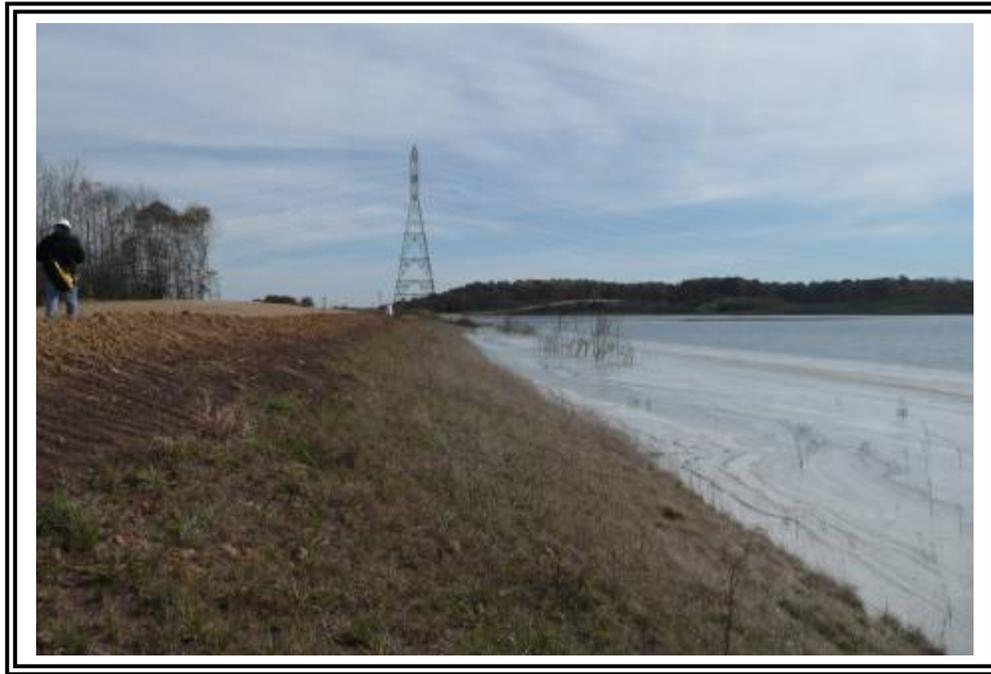
25

Upstream slope of the Spillway Dam, looking east towards transition to the Wing Dam.  
Note grass cover and moderate slope.

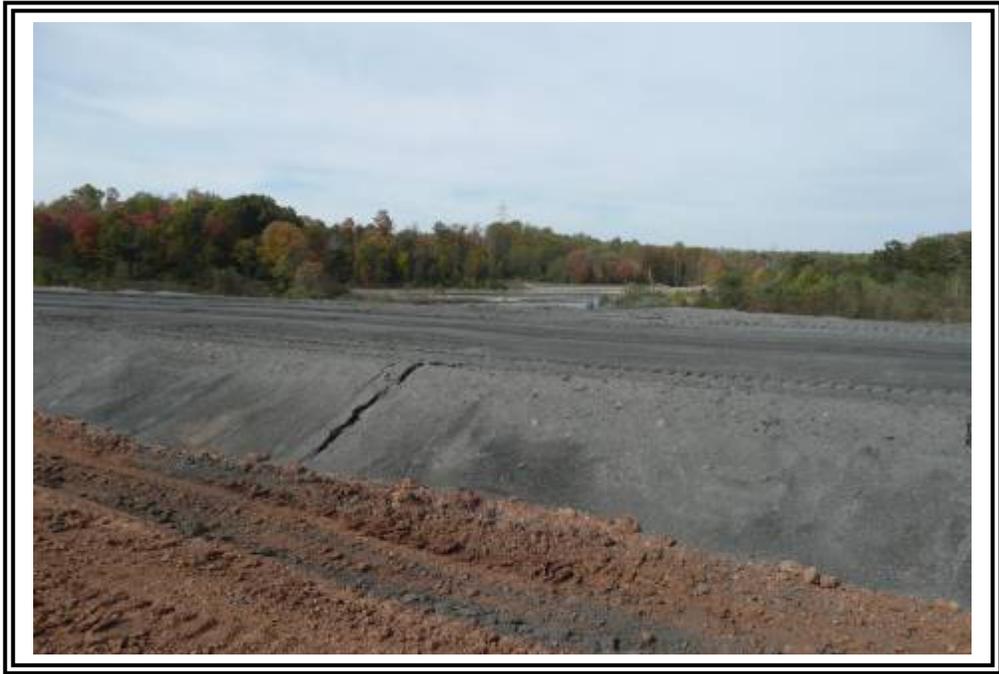
27

Erosion rill in exposed compacted ash being placed on the Wing Dam. Note Middle Fly Ash Reservoir in the distance.

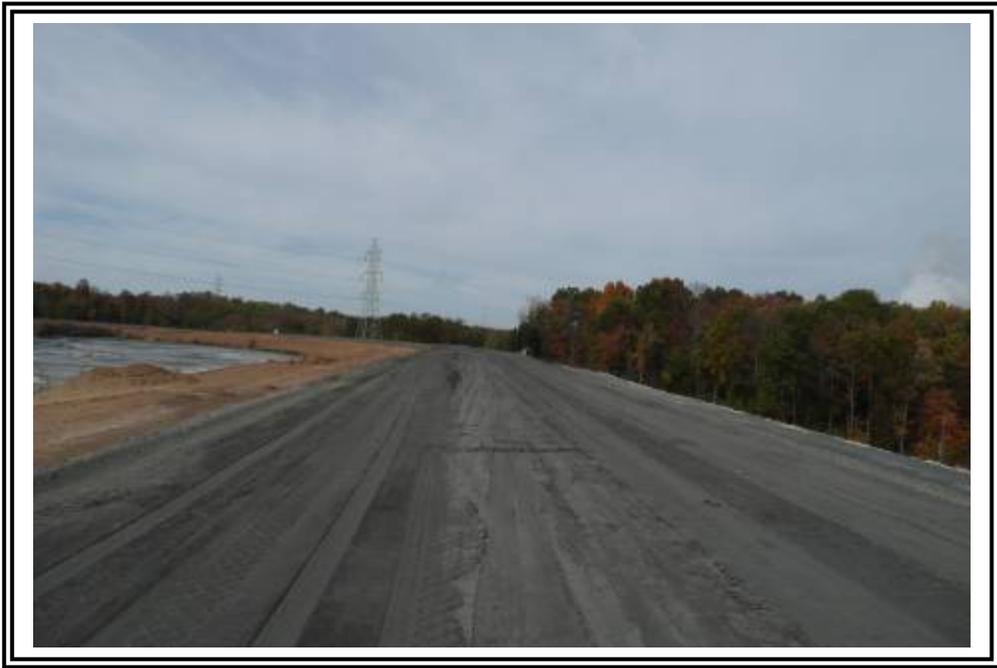
29

Crest of the No-Name Creek Dam, looking northwest.

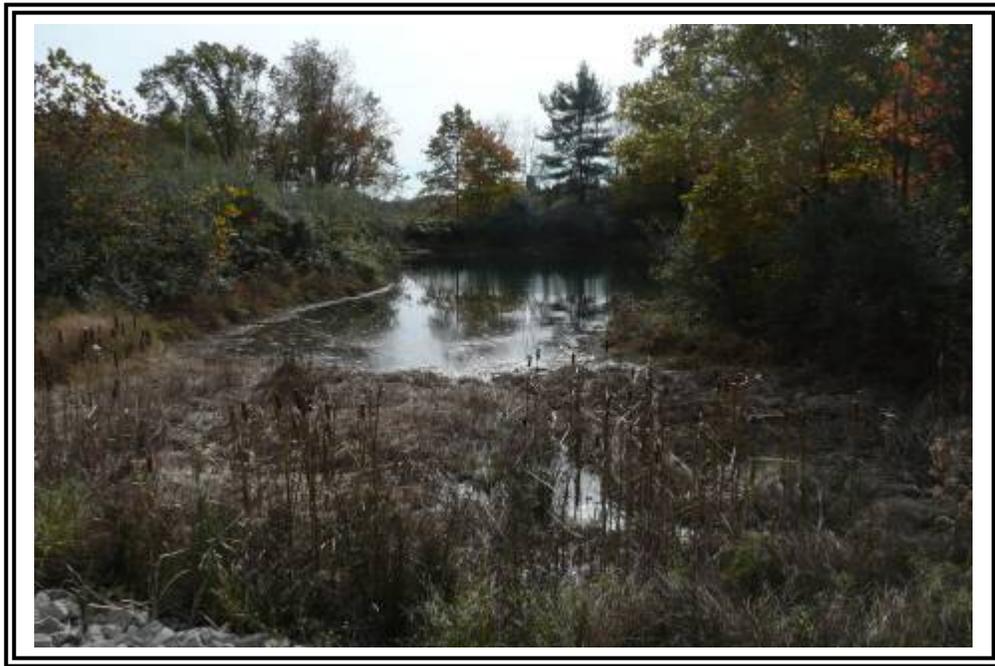
31

Small pond in drainage feature below toe of the Freeboard Dam near the western end.

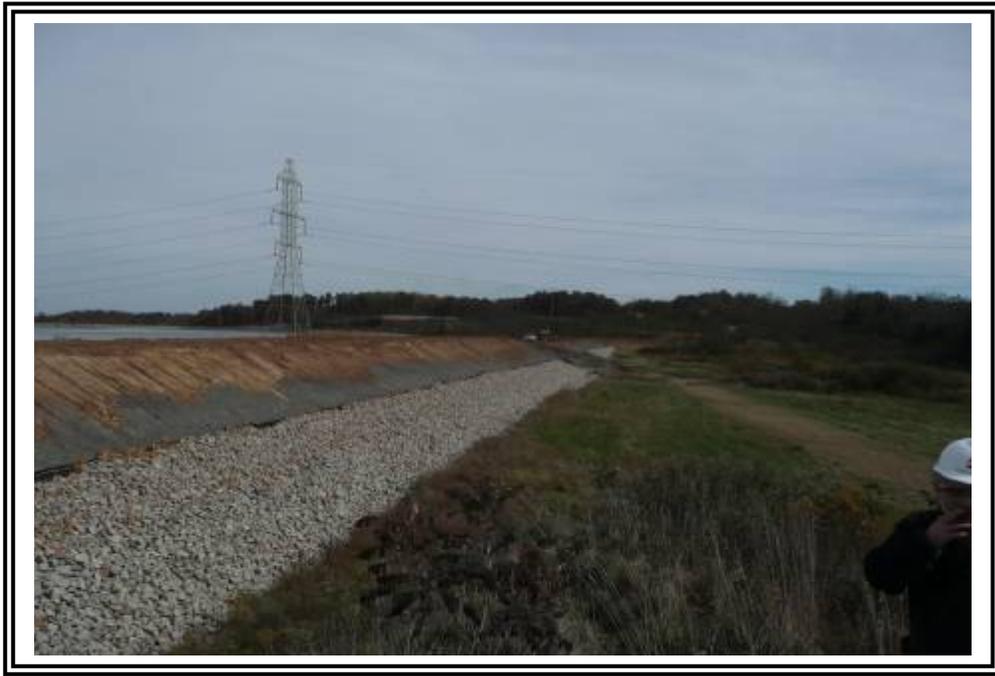
33

Downstream slope of the Freeboard Dam, looking east. Note zoned construction with ash and clay.

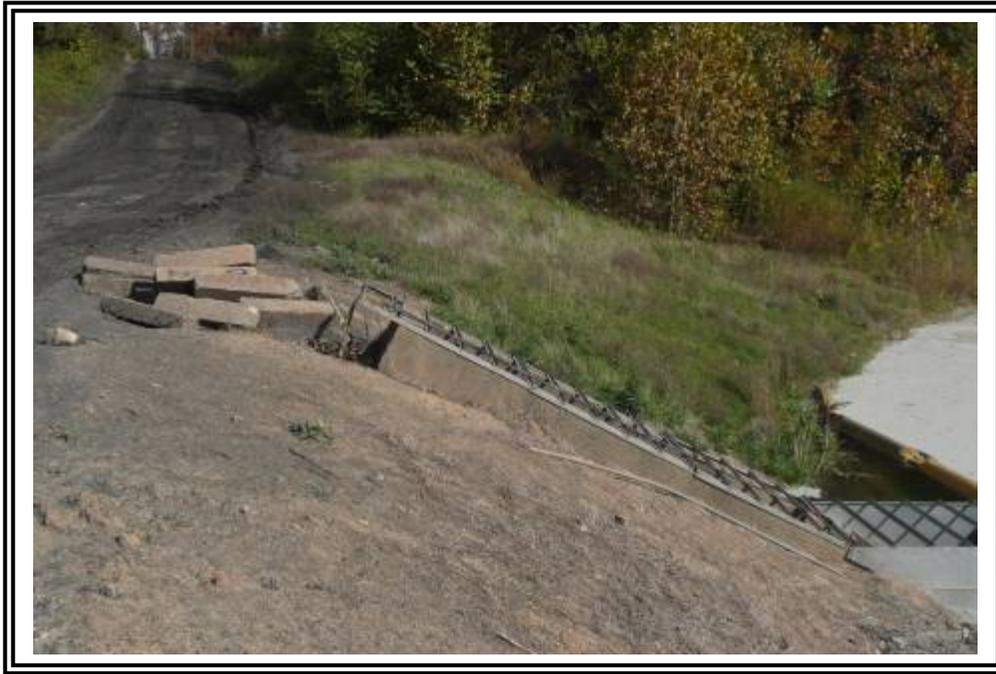
34

Upstream slope and inclined spillway of the Middle Fly Ash Dam, looking east. Note concrete stop logs at top of slope.

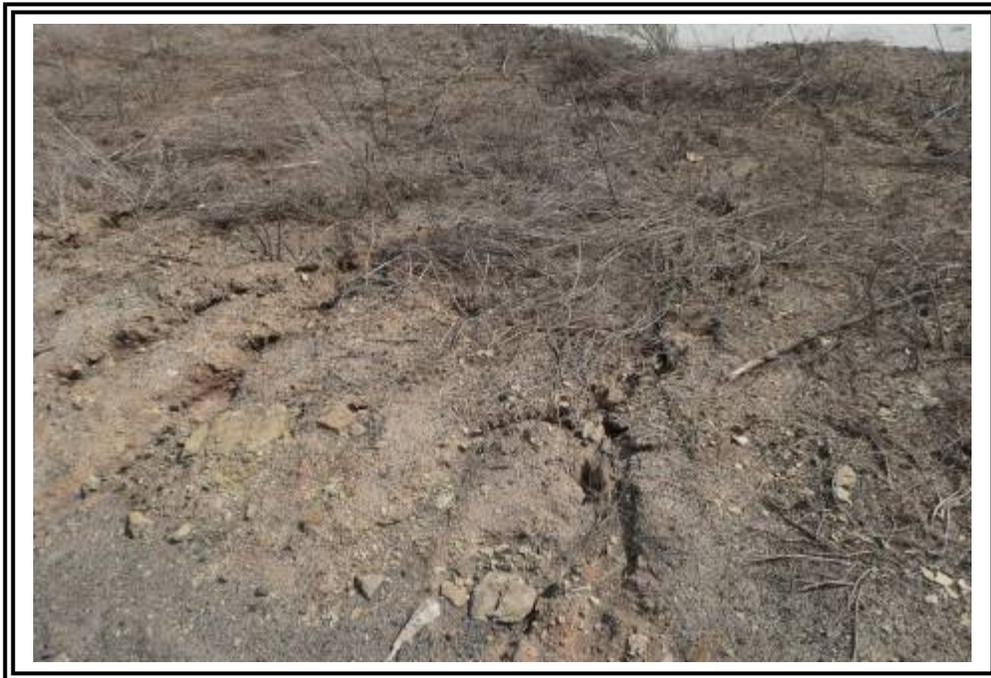
35

Erosion rills on upstream slope of the Middle Fly Ash Dam.

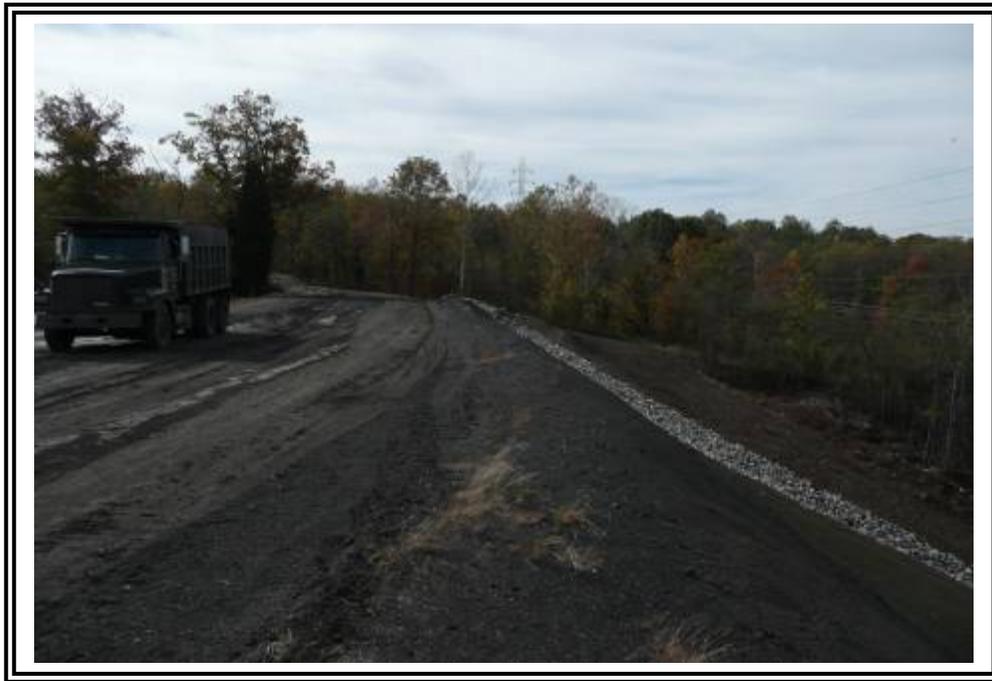
37

Crest of the Middle Fly Ash Dam, looking west.

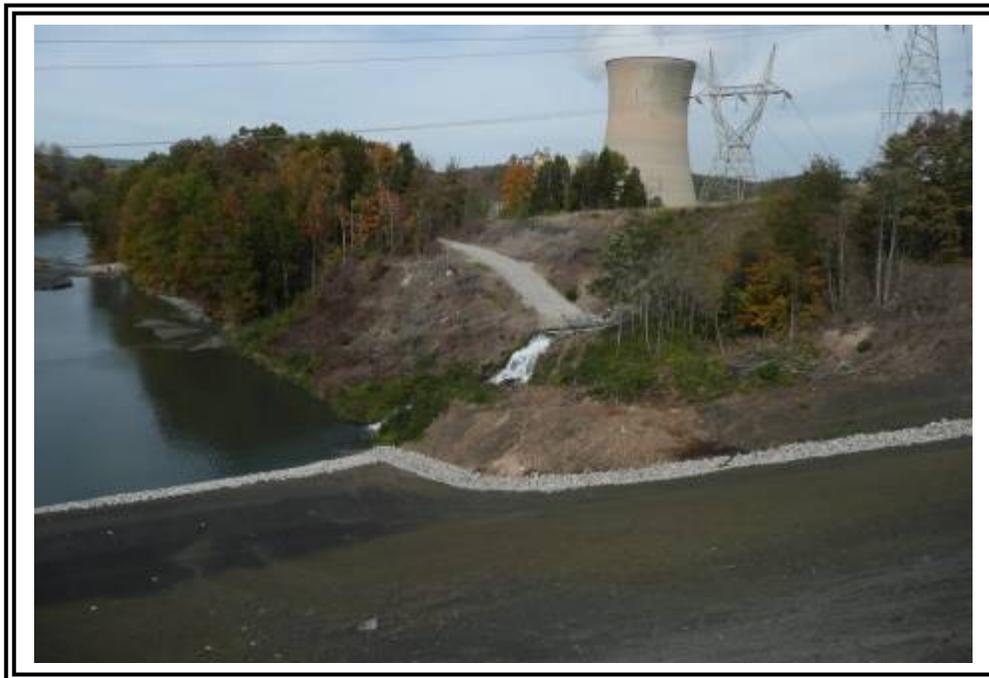
39

Looking downstream from the Middle Fly Ash Dam. Note effluent above right (east) abutment.

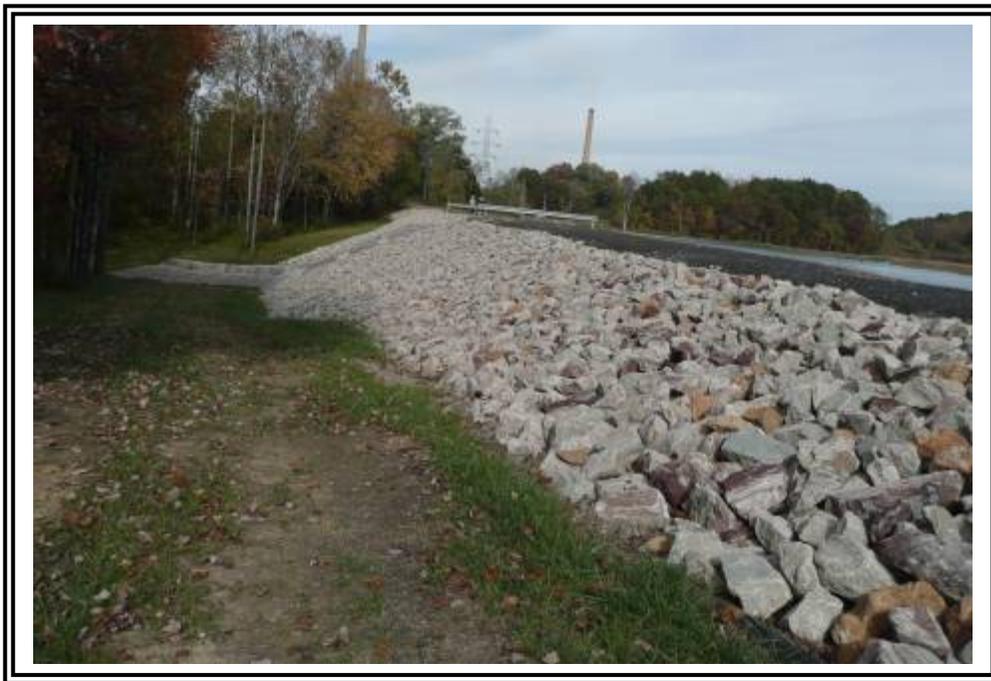
41

Downstream slope of emergency spillway embankment for the Middle Fly Ash Dam, looking northeast.

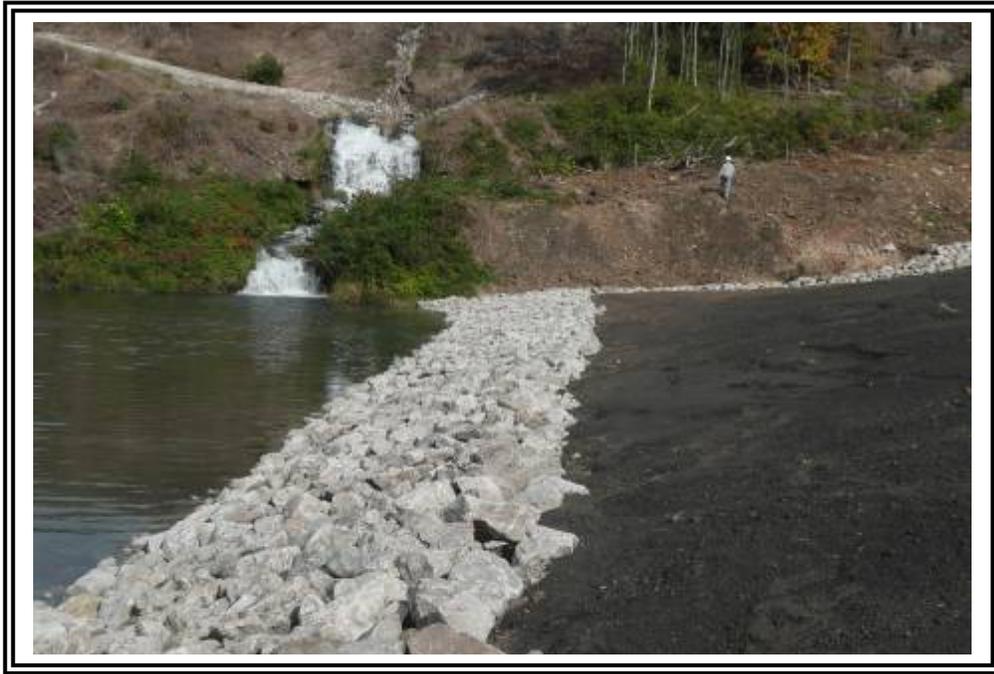
44

Looking east along rock toe drain and rip-rap slope protection of the Middle Fly Ash Dam.

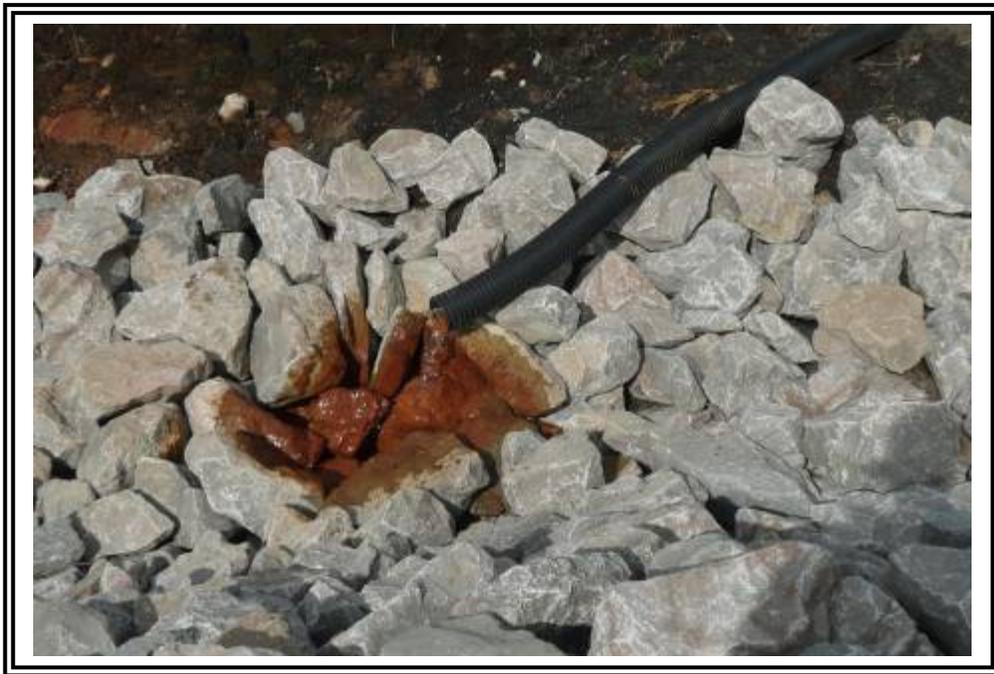
45

Seepage from hillside above the east abutment contact of the Middle Fly Ash Dam. Note iron precipitate.

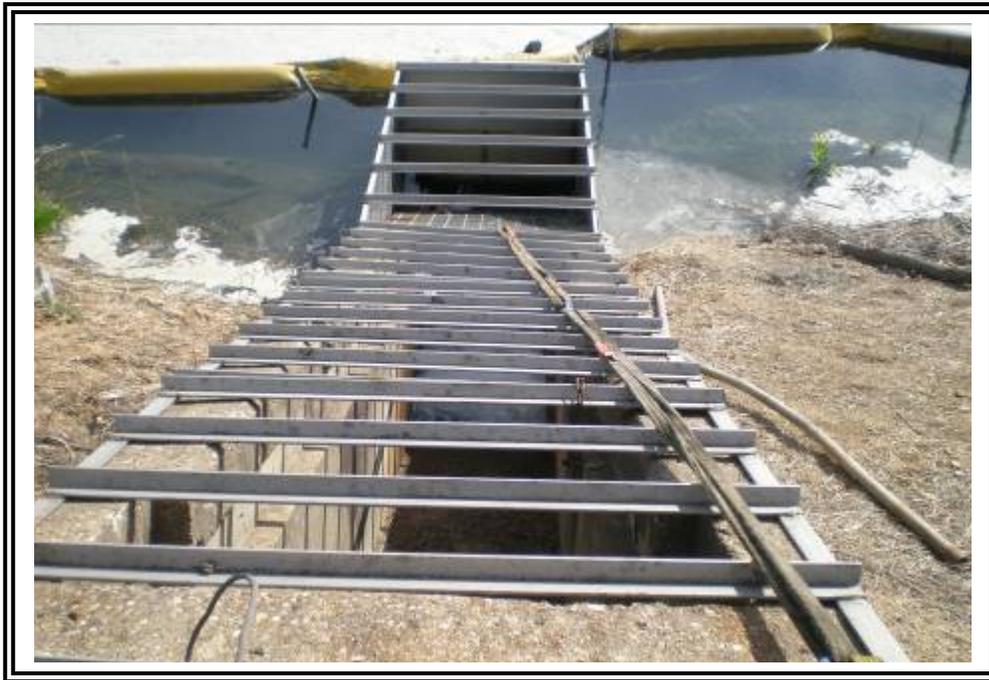
46

Looking down into the inclined spillway inlet of the Middle Fly Ash Dam.

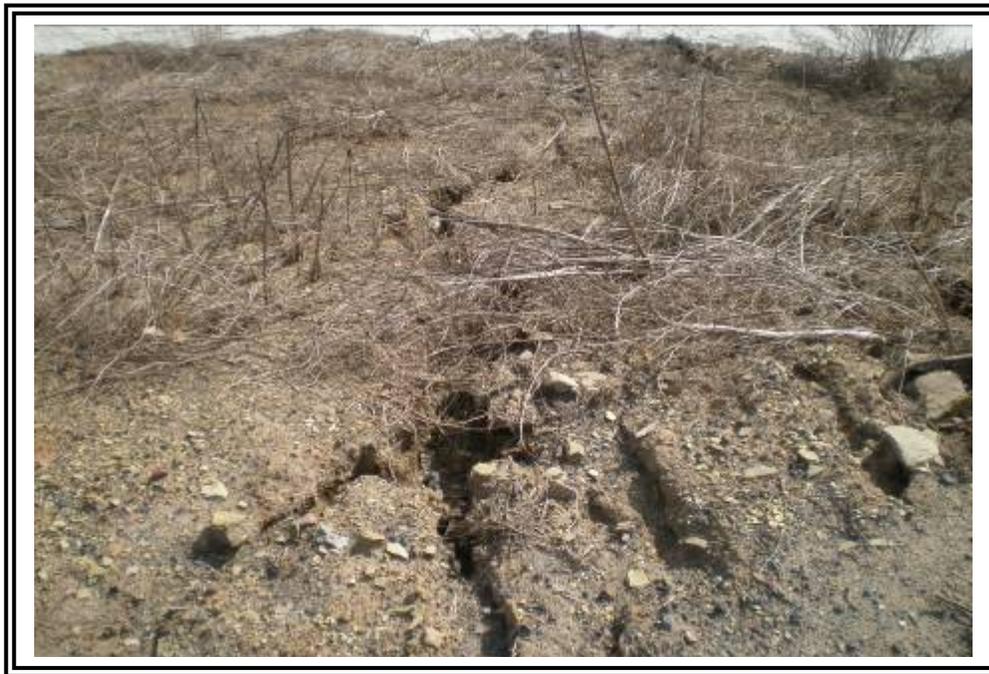
47

Erosion rills in upstream slope of the Middle Fly Ash Dam.

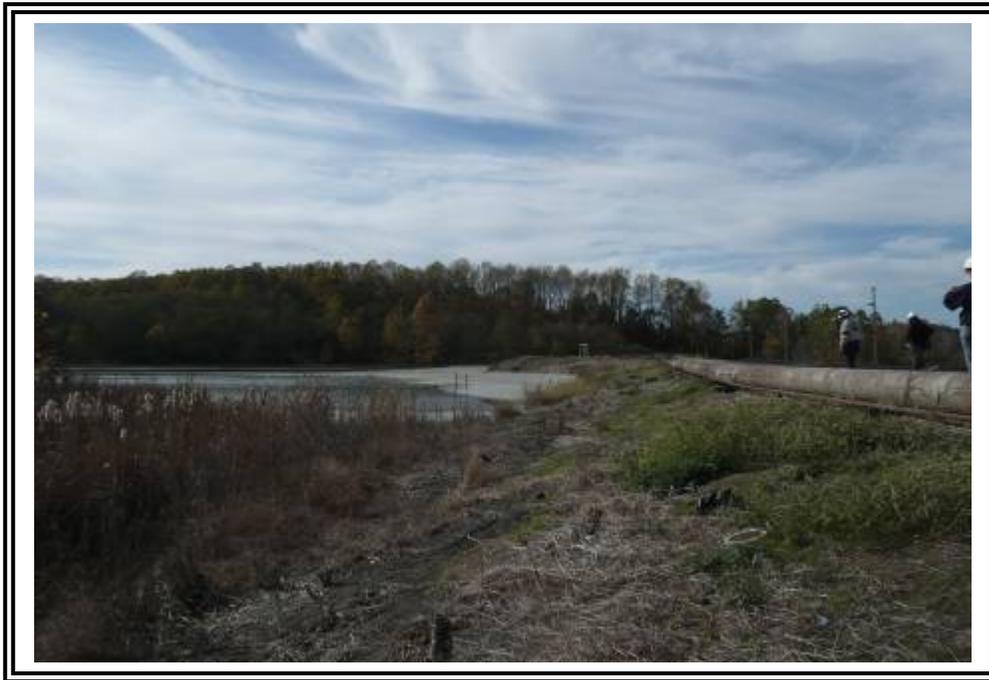
49

Lower Fly Ash Dam, upstream slope, looking northwest. Note dying weedy vegetation and old sluice lines at crest.

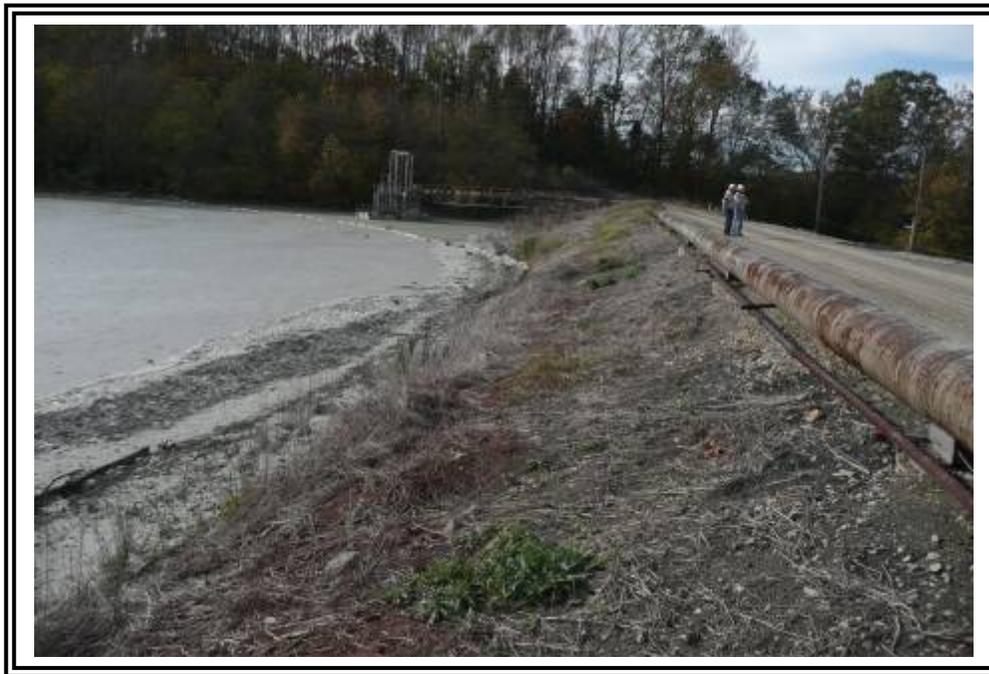
50

Lower Fly Ash Dam, upstream slope and crest looking northwest toward spillway riser structure.

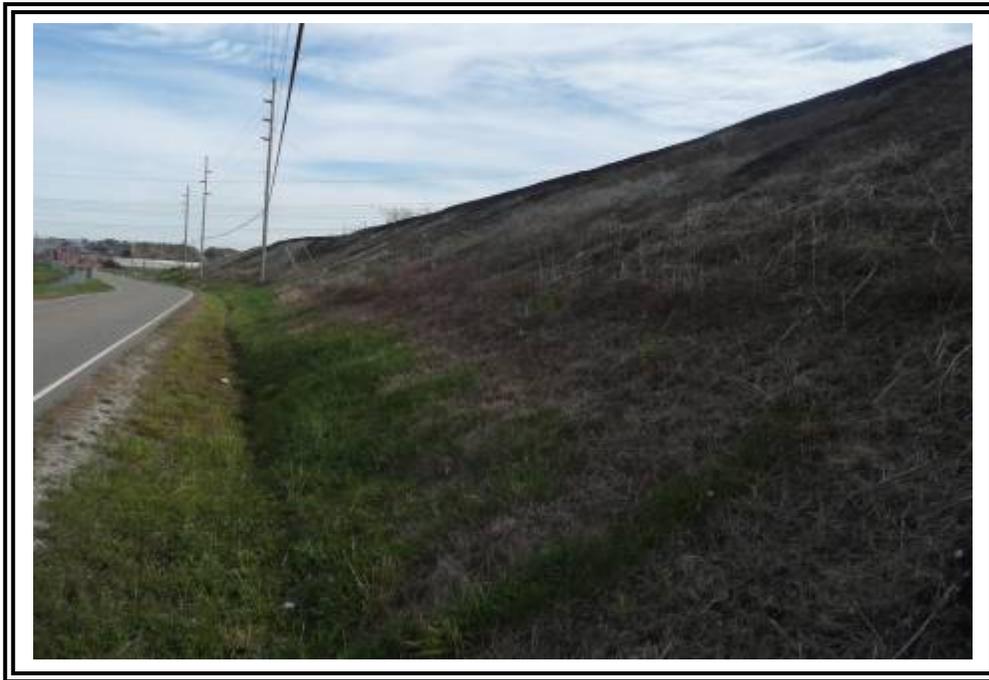
51

Lower Fly Ash Dam along downstream slope from the roadway bench elevation, looking southeast.

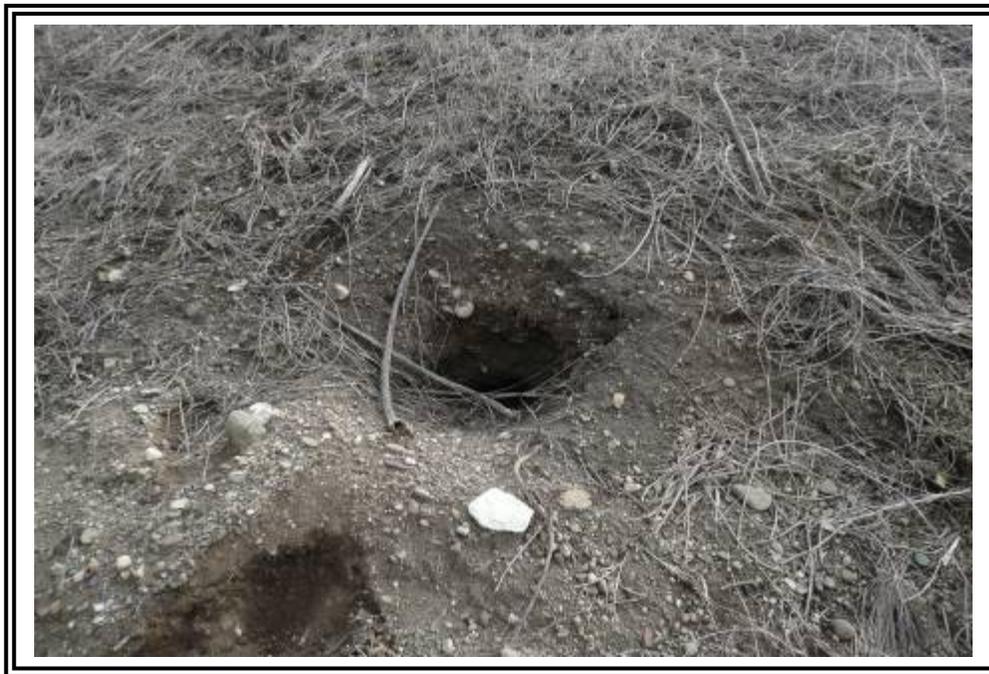
52

Lower Fly Ash Dam partially collapsed rodent burrow in downstream slope.  
Note silty sand and gravel material in embankment surface.

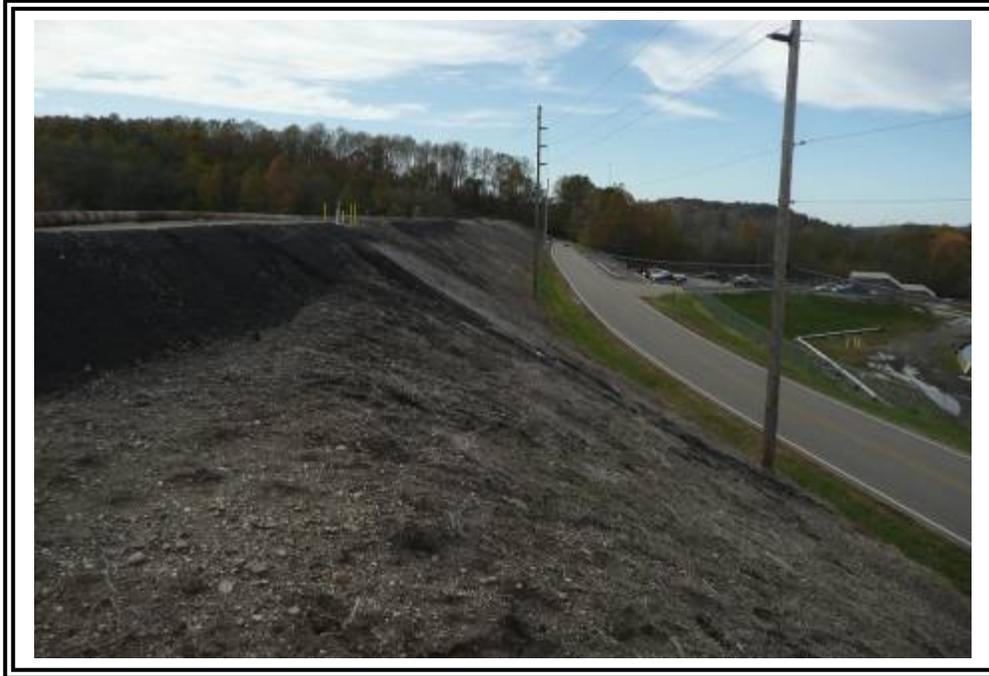
53

Lower Fly Ash Dam along downstream slope near crest, looking northwest. Note bottom ash material at crest elevation.
