# Assessment of Dam Safety Coal Combustion Surface Impoundments (Task 3) Final Report

American Electric Power  
Muskingum River  
Power Plant  
Waterford, Ohio

March 23, 2010

Have been assessed on October 20, 2009 and October 21, 2009

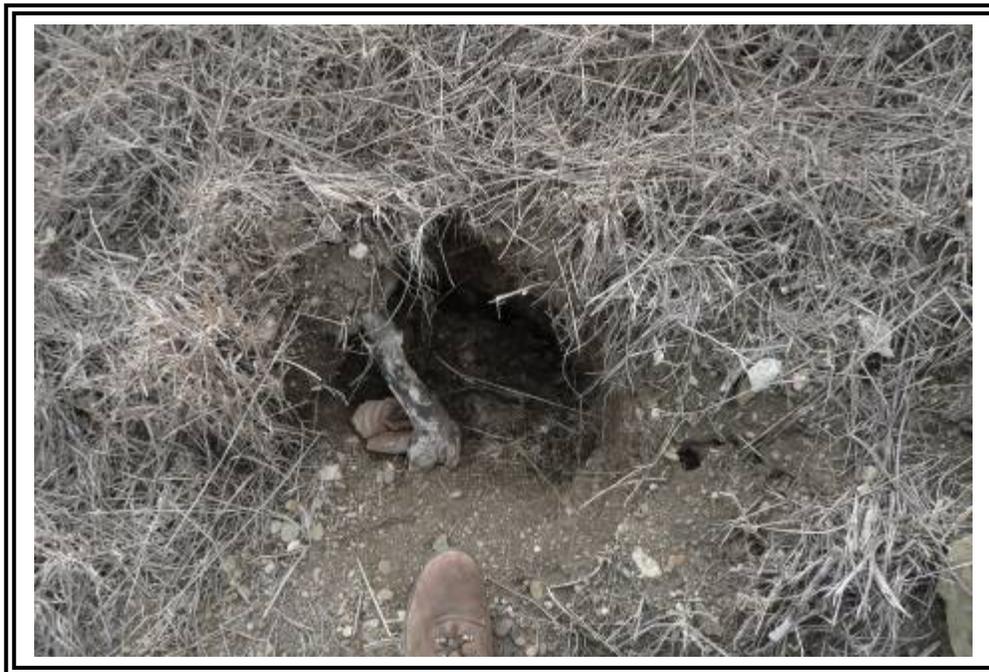
54

Rodent burrow on the Lower Fly Ash Dam, southeast facing downstream slope.

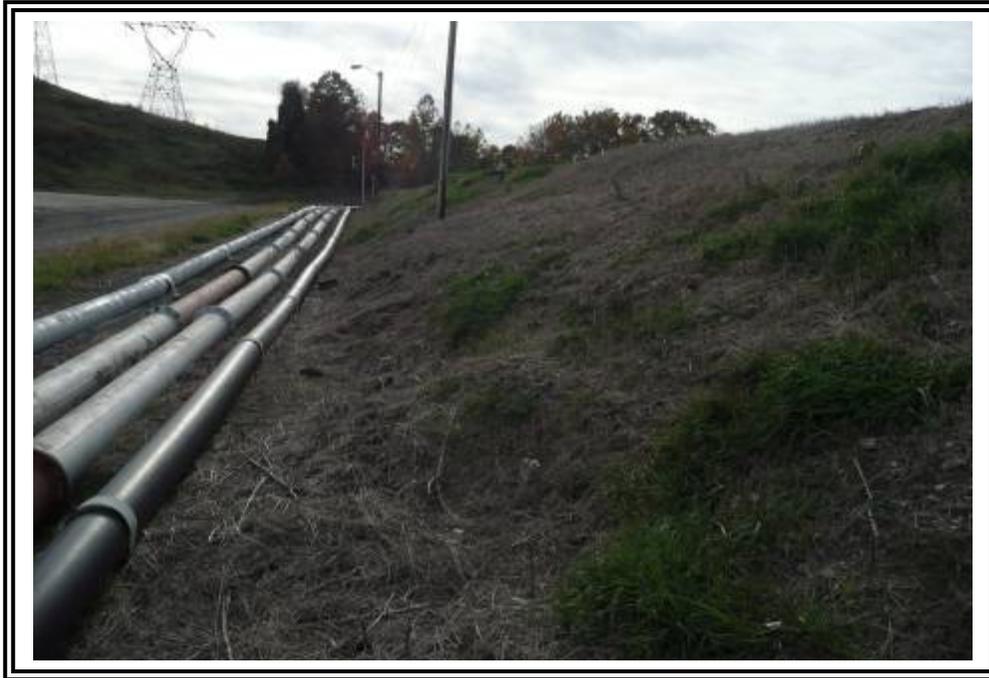
55

Lower Fly Ash Dam along southeast facing portion of the downstream slope adjacent to Unit 5 bottom ash sluice lines at the toe of the slope, looking southwest. Note slope undulations resulting from previous grading and dormant surficial sloughing.

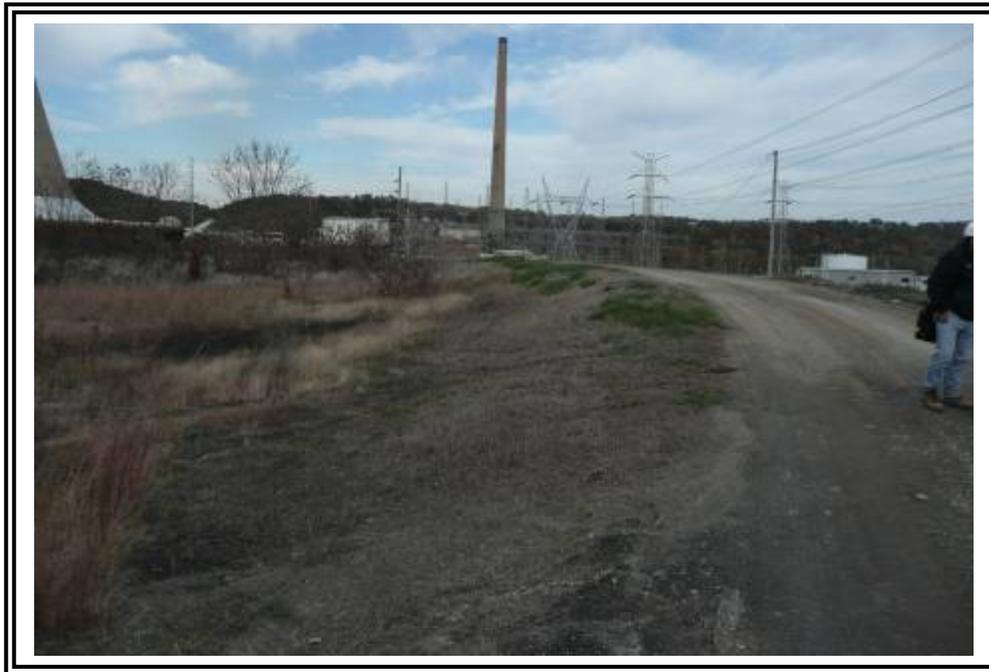
56

Lower Fly Ash Dam upstream slope and crest area along southeast facing portion of the dam.

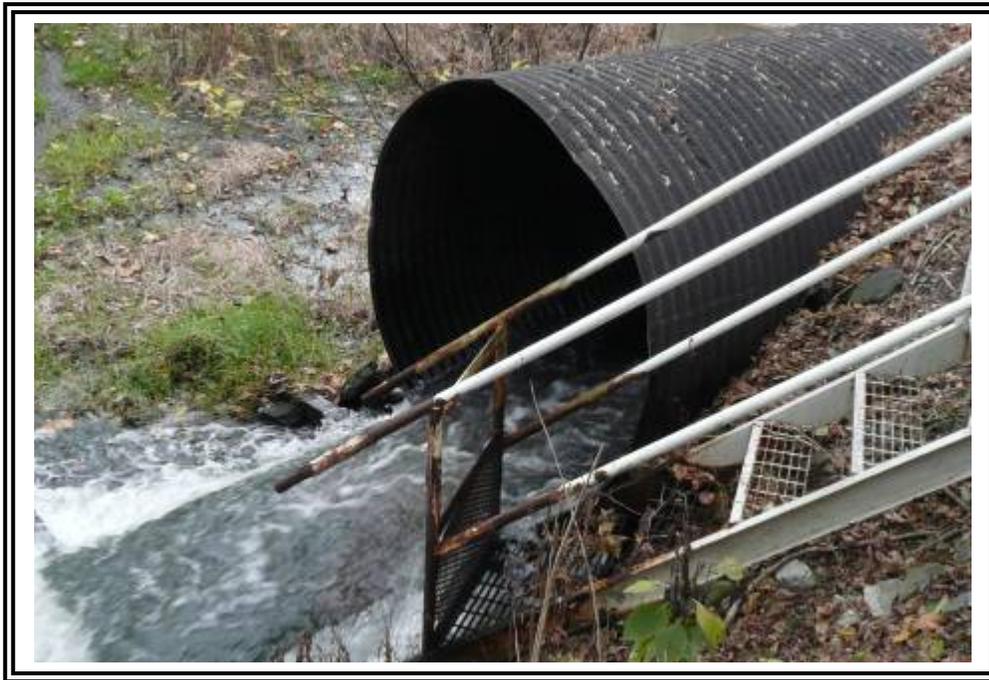
57

Lower Fly Ash Dam 72-inch diameter CMP spillway outlet.

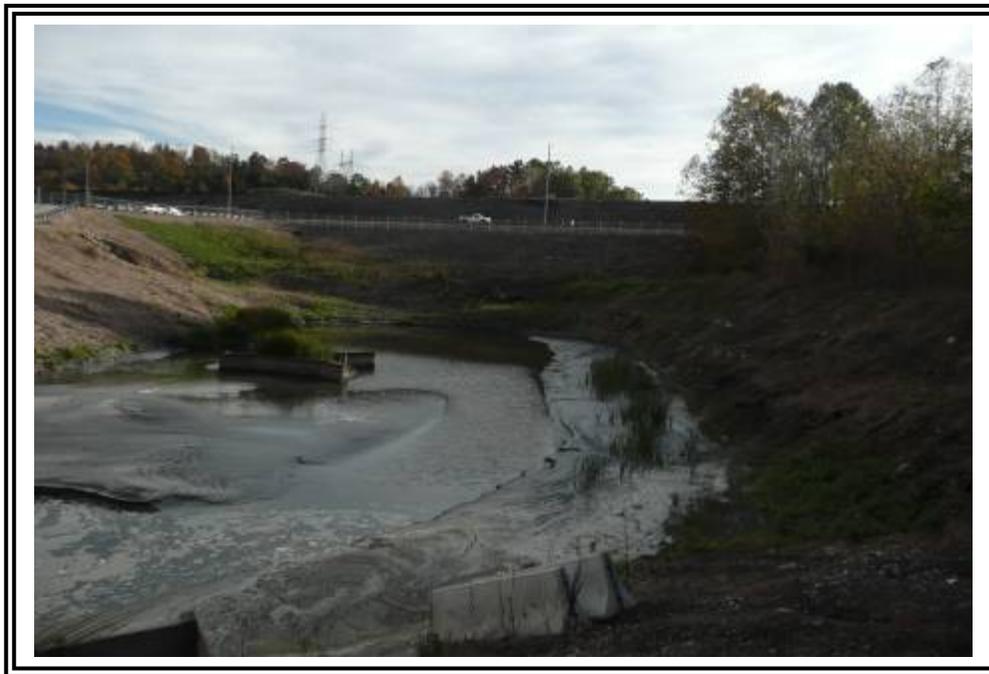
58

Partially incised wastewater, runoff, and seepage collection basin at toe of the Lower Fly Ash Dam.

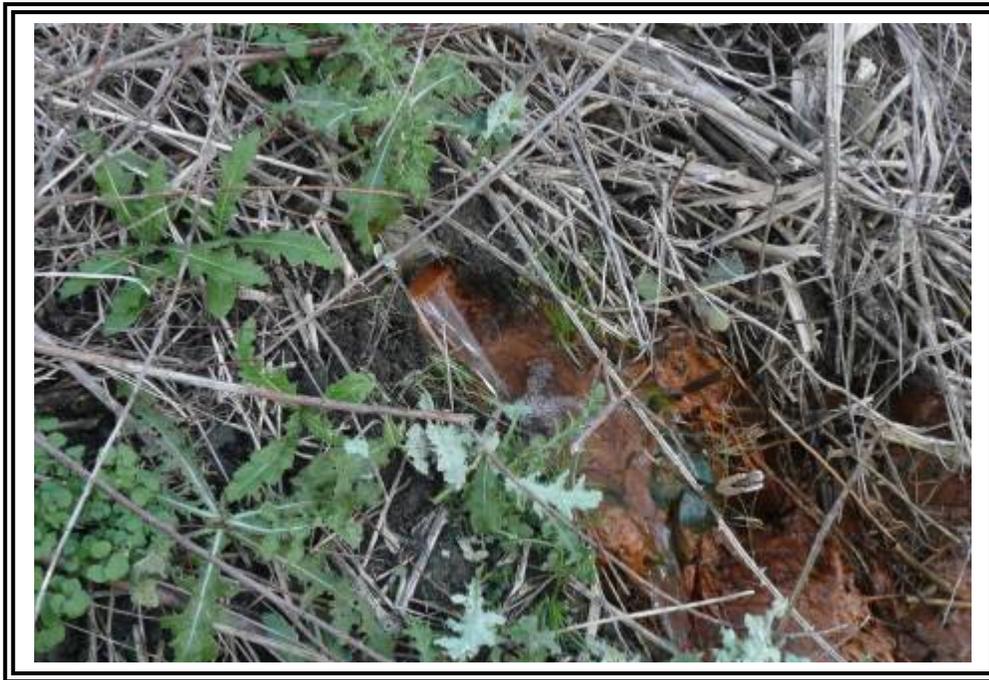
59

Lower Fly Ash Dam, active underdrain/toe drain outlet. Note iron precipitate.

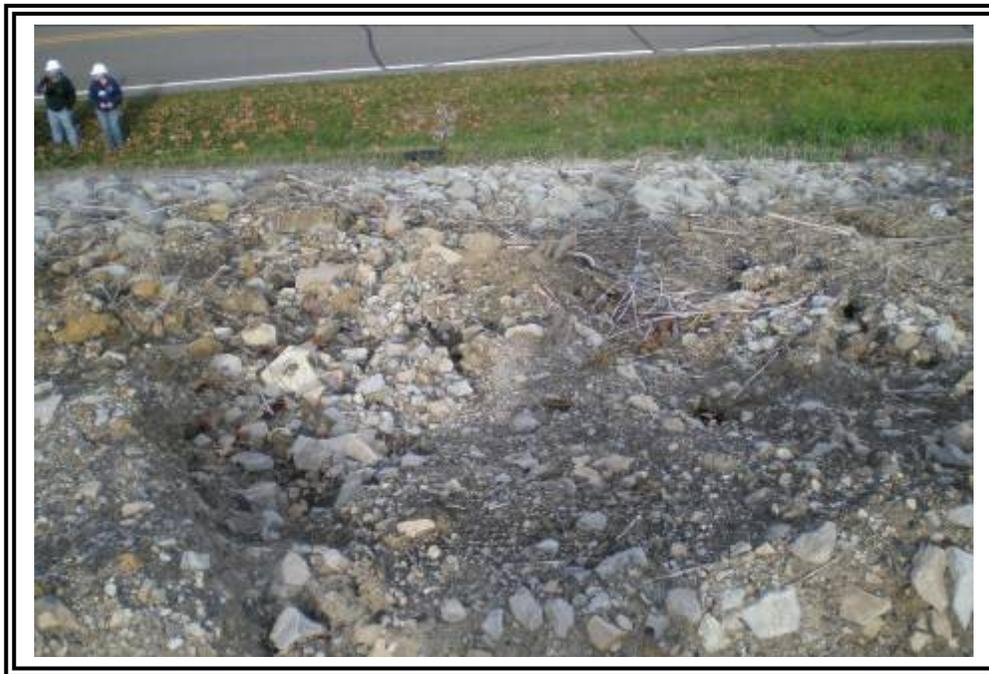
60

Erosion on the downstream slope of the Lower Fly Ash Dam near the crest elevation above the rip rap slope protection.

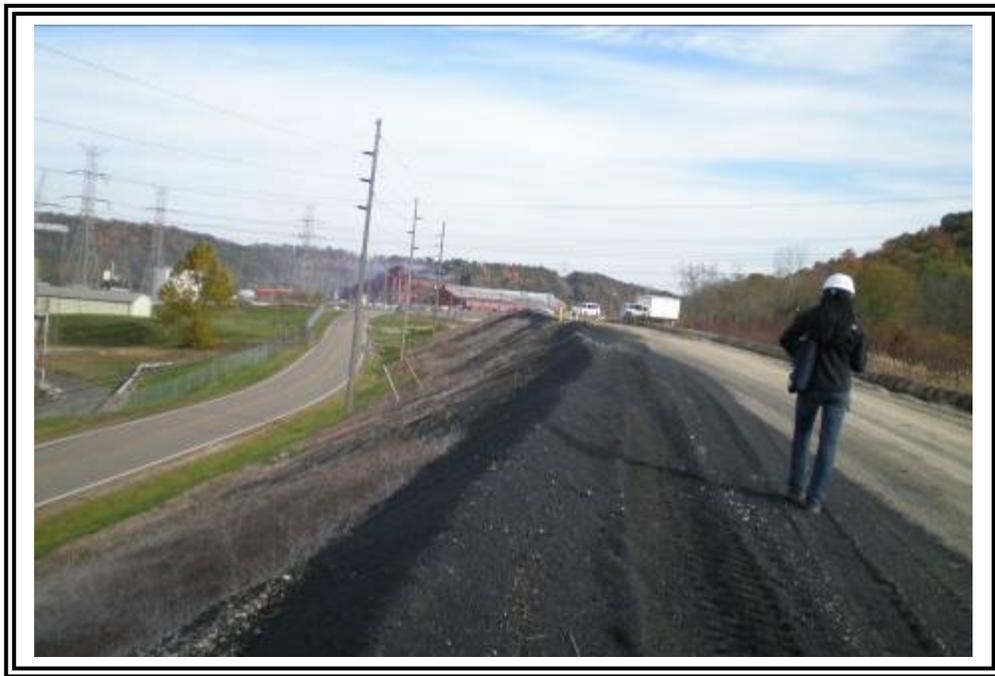
62

Lower Fly Ash Dam crest, looking southeast.

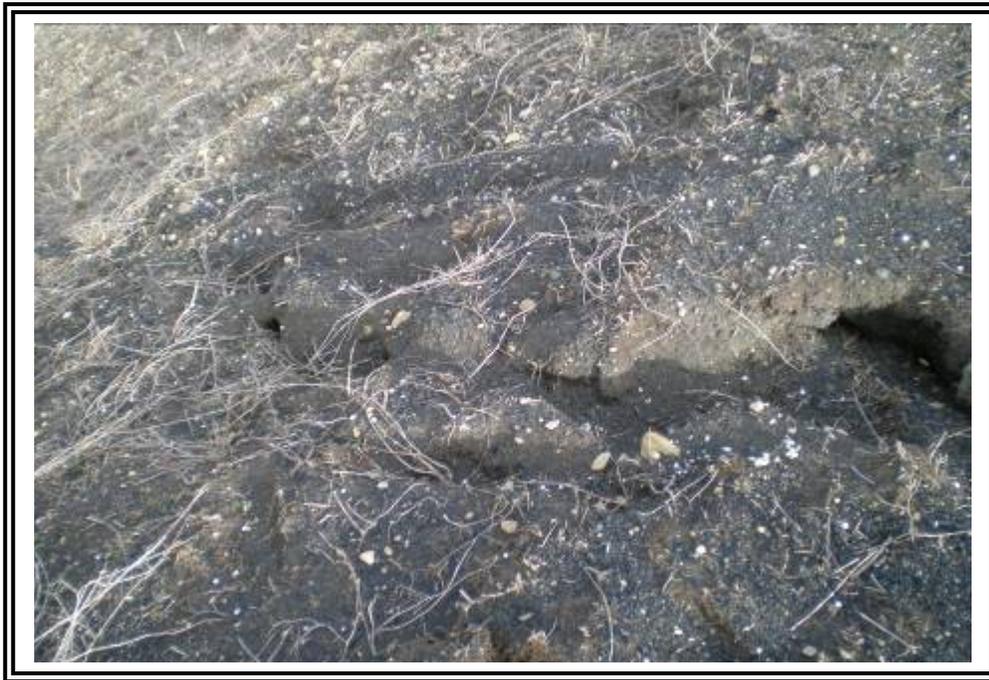
63

Erosion rills in bottom ash and soil surface on downstream slope of the Lower Fly Ash Dam.

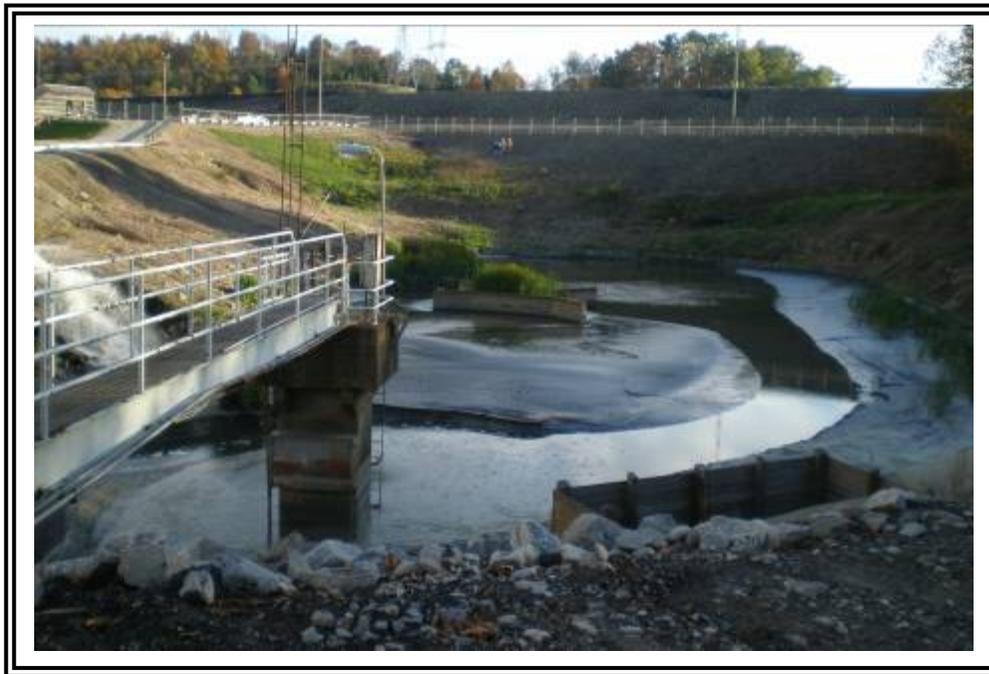
64

Looking south across the facility water and drainage catch basin at the toe of the Lower Fly Ash Dam.  
Water entering basin is circulated into the Lower Fly Ash Reservoir.

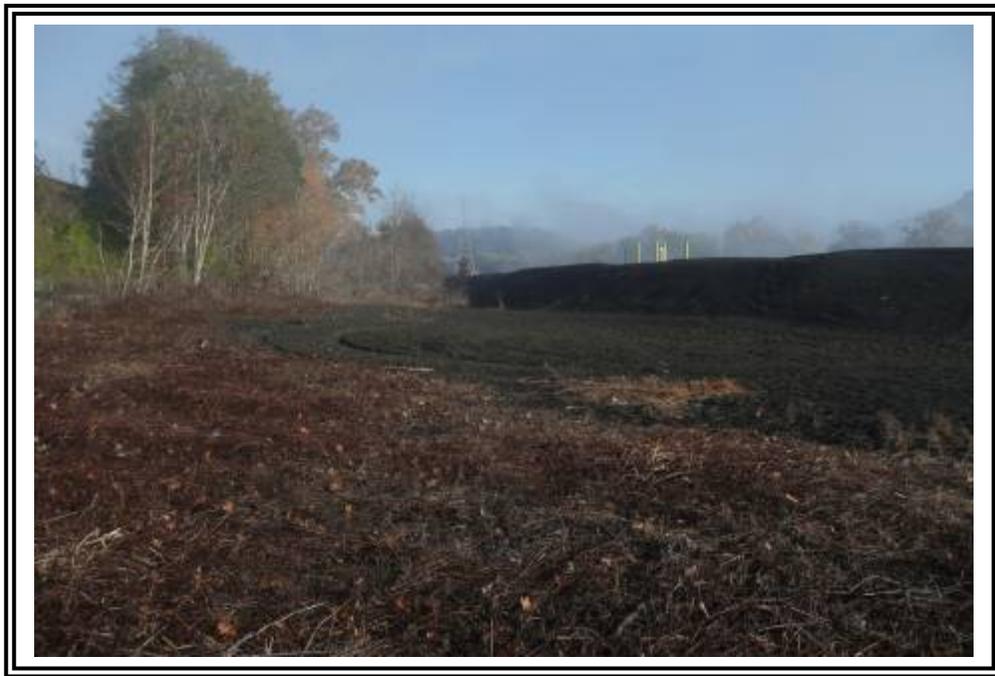
66

Units 1-4 Bottom Ash Pond west dike exterior slope, looking north.

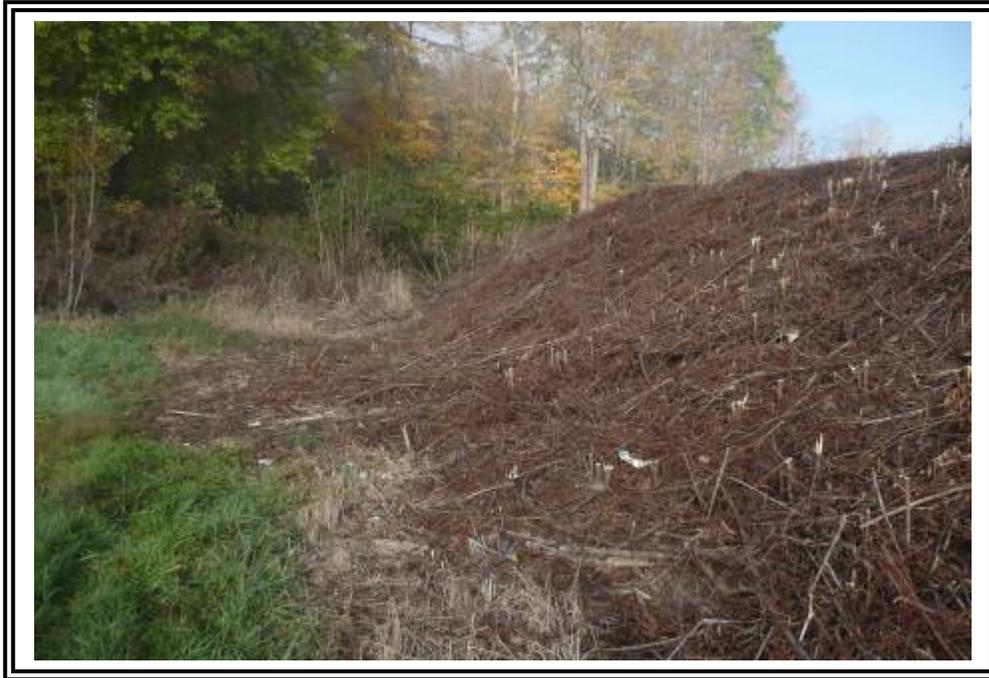
67

Units 1-4 Bottom Ash Pond south dike exterior slope, looking west.  
Note recently cut heavy vegetation and woody brush.

2. Establish a healthy grass cover on the embankment adjacent to the Muskingum River through routine mowing. Mowing frequency on grassed portions of the embankment must be increased to at least twice a year. If grass does not become established on portions of the embankment following an increased mowing schedule, seeding, spraying or other owner maintenance will be required to remove all brush and saplings.

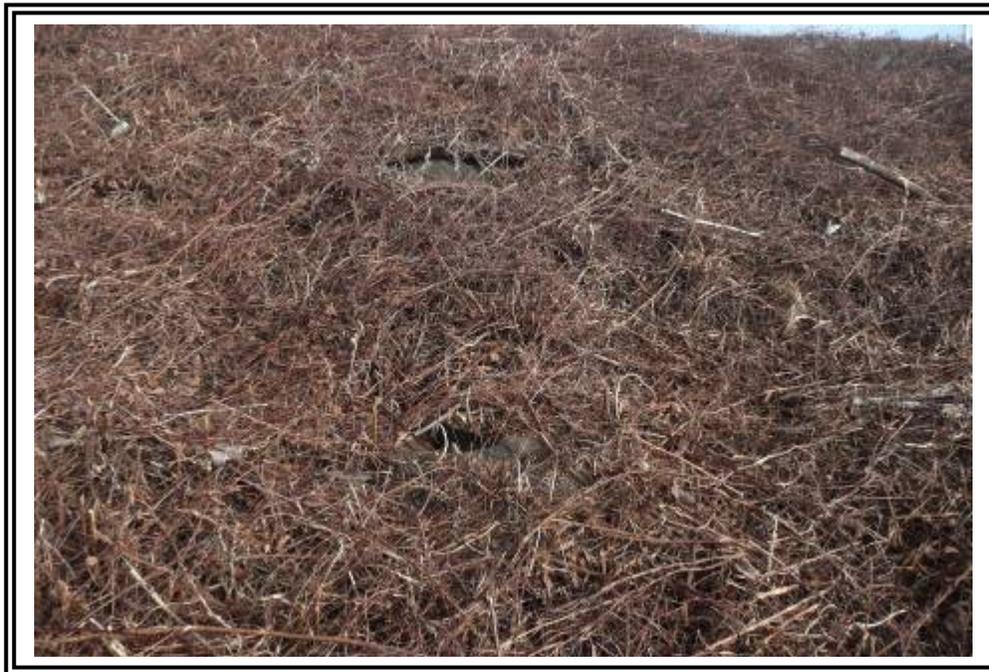
68

Rodent burrow on the Units 1-4 Bottom Ash Pond south dike exterior slope.

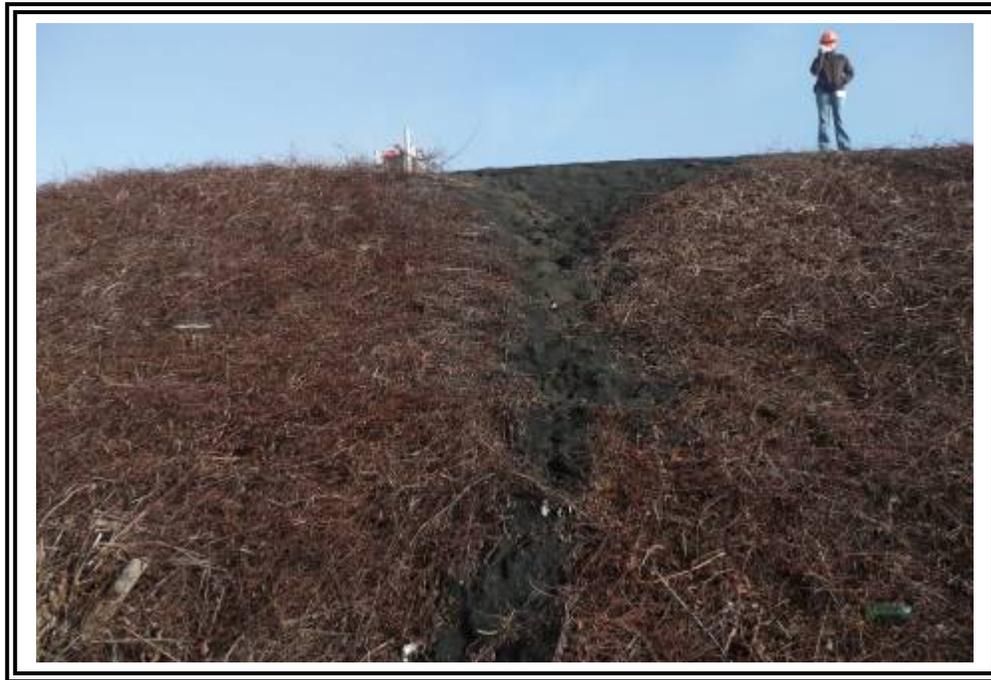
69

Erosion rill on the Units 1-4 Bottom Ash Pond south dike exterior slope.

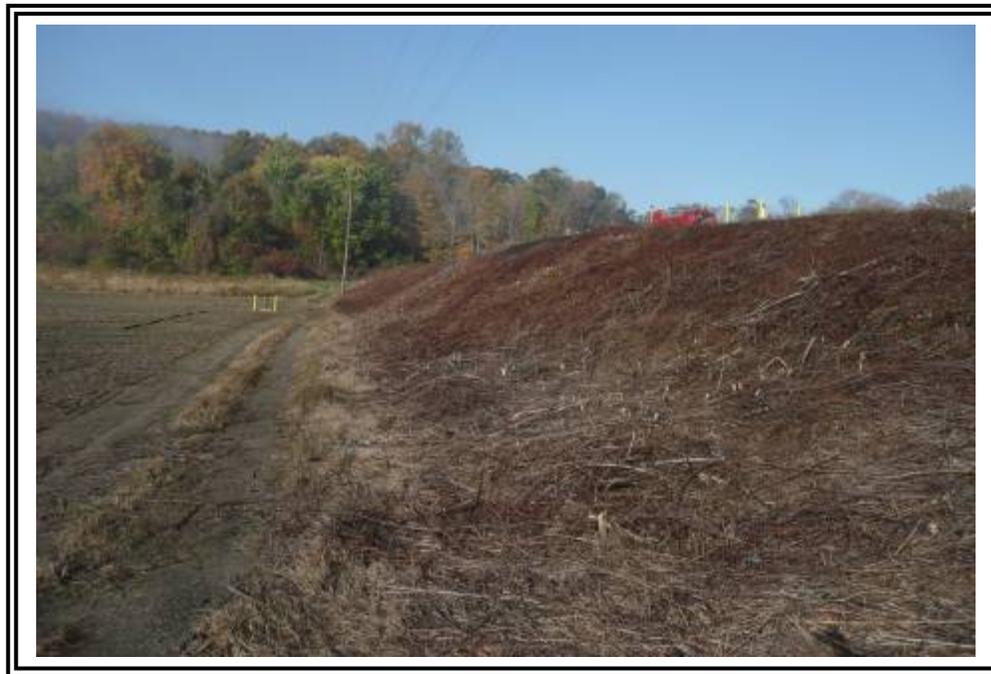
70

Units 1-4 Bottom Ash Pond south dike exterior slope, looking west from the southeast corner adjacent to the Muskingum River. Note recently cut heavy vegetation and woody brush.

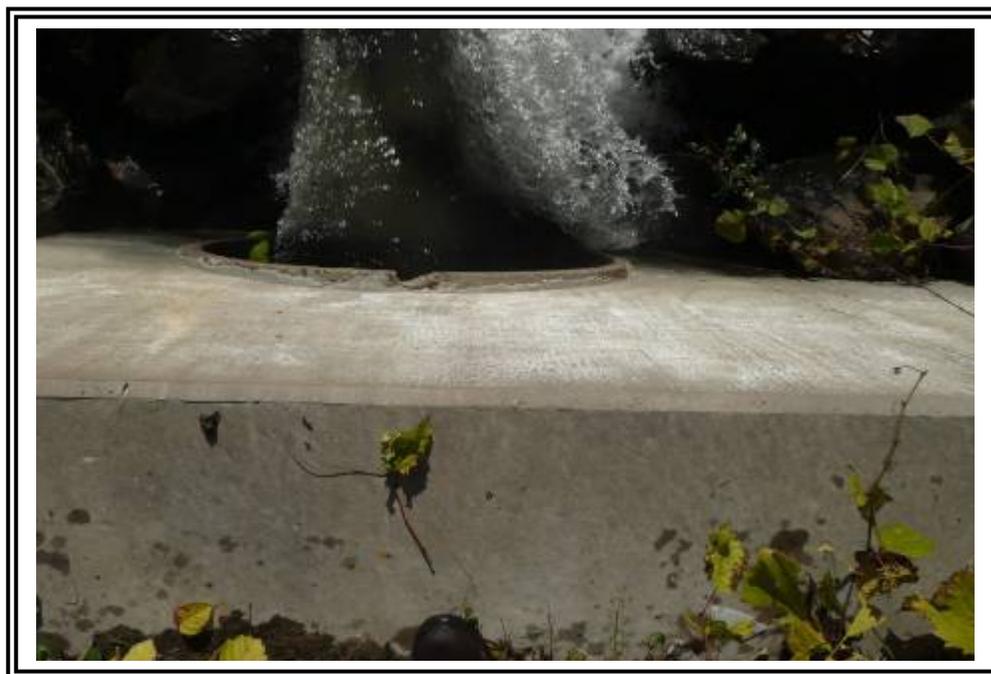
72

Units 1-4 Bottom Ash Pond outlet and headwall.

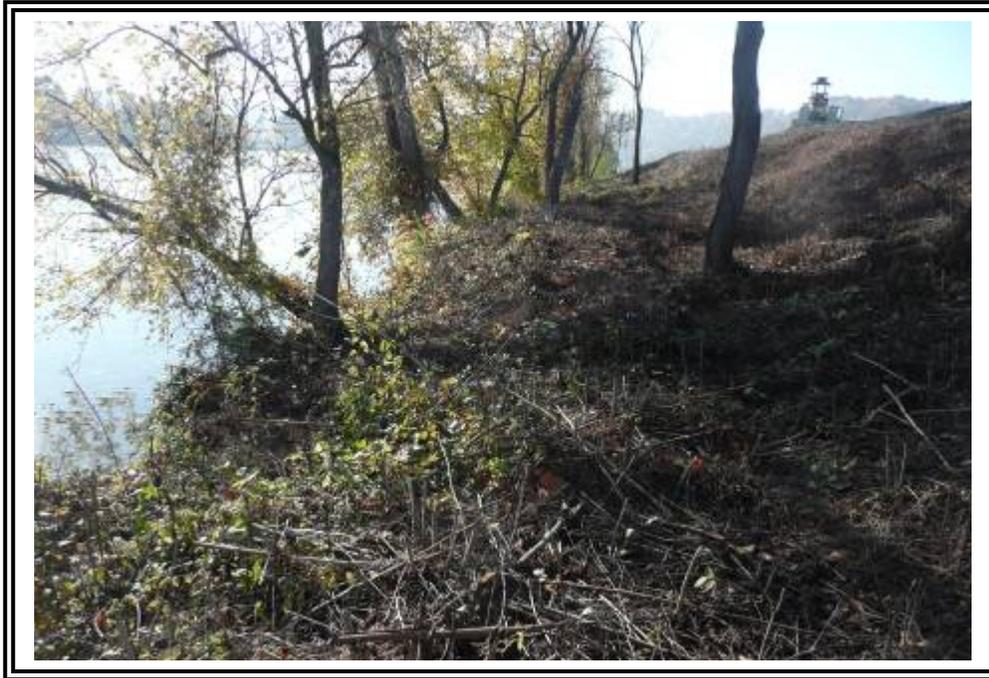
73

Units 1-4 Bottom Ash Pond east dike exterior slope, looking south. Note distance between river bank and dike toe.

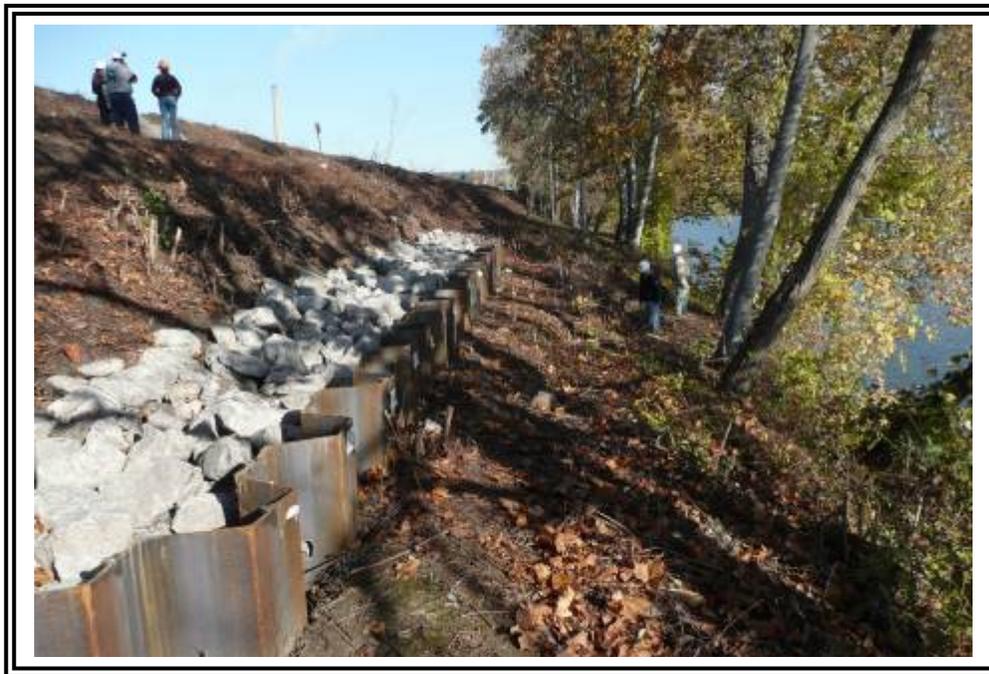
74

Units 1-4 Bottom Ash Pond east dike sheet pile stream bank stabilization at dike toe, looking north. Note leaning trees.

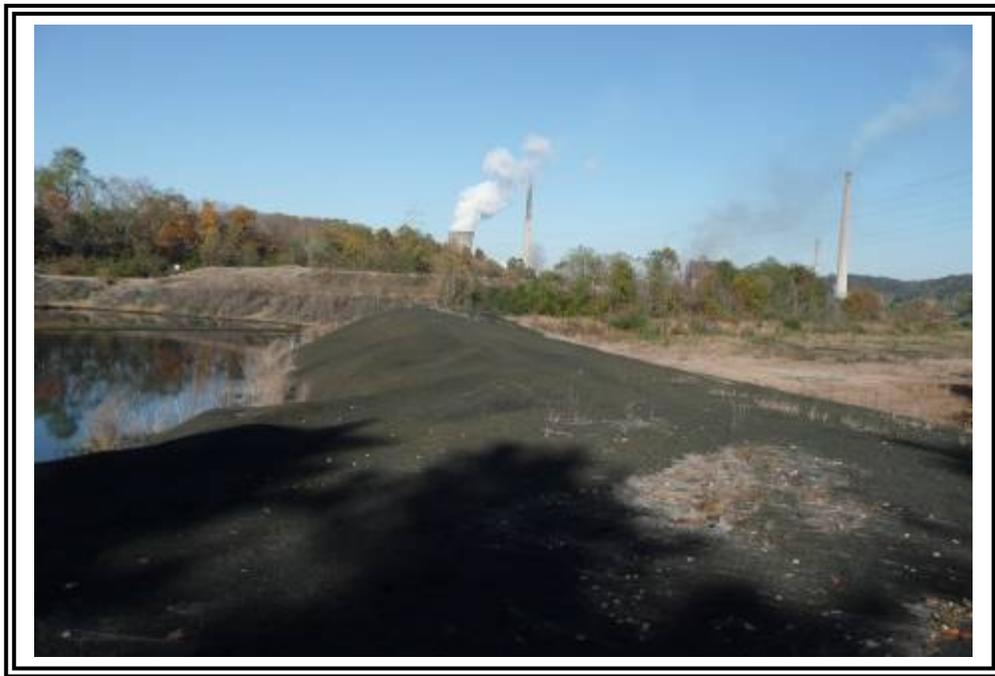
76

Units 1-4 Bottom Ash Pond interior dike crest and upstream slope at north end of the open pond area. Note bottom ash construction and generally sparse to absent vegetation.

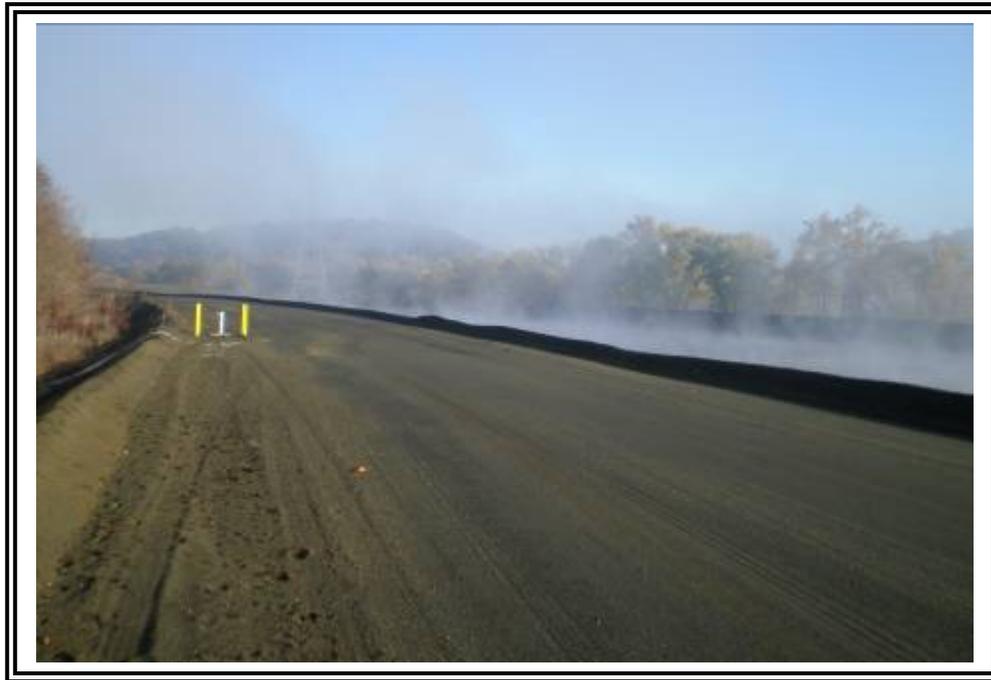
77

Units 1-4 Bottom Ash Pond west dike crest, looking north.

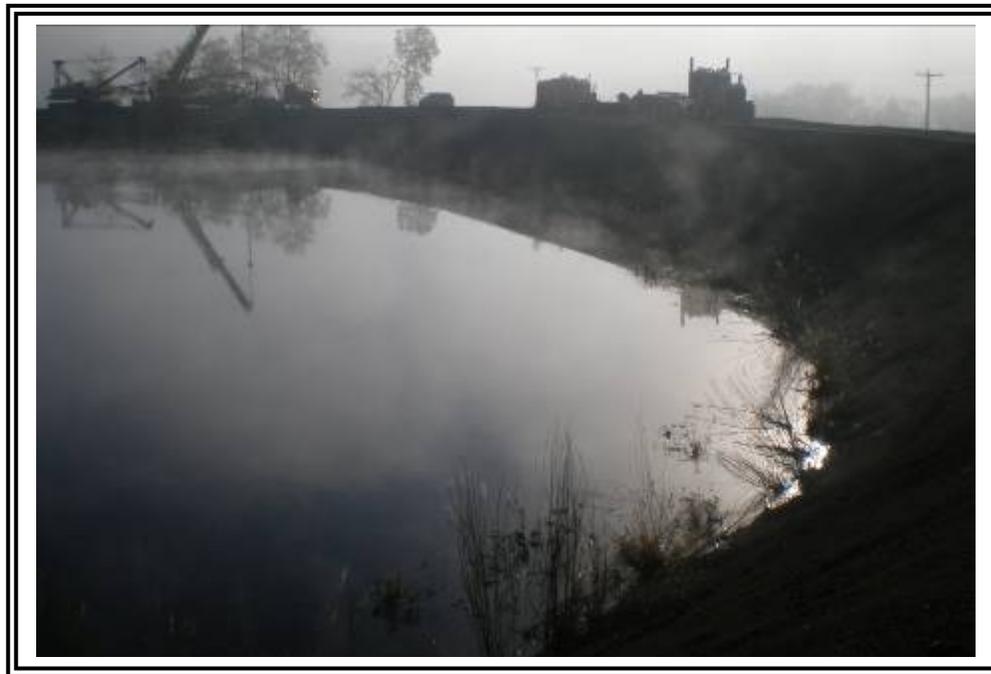
78

Units 1-4 Bottom Ash Pond south dike interior slope, looking east.

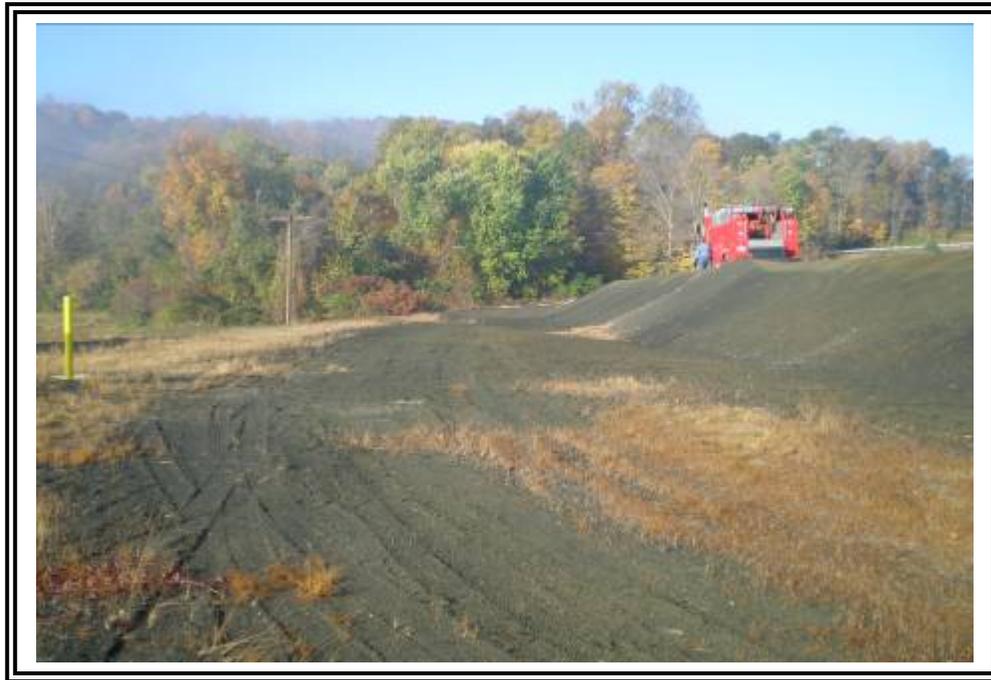
79

Units 1-4 Bottom Ash Pond south dike upper exterior slope and bench area, looking west.  
Note bench width in this area is on the order of 30 to 40 feet.

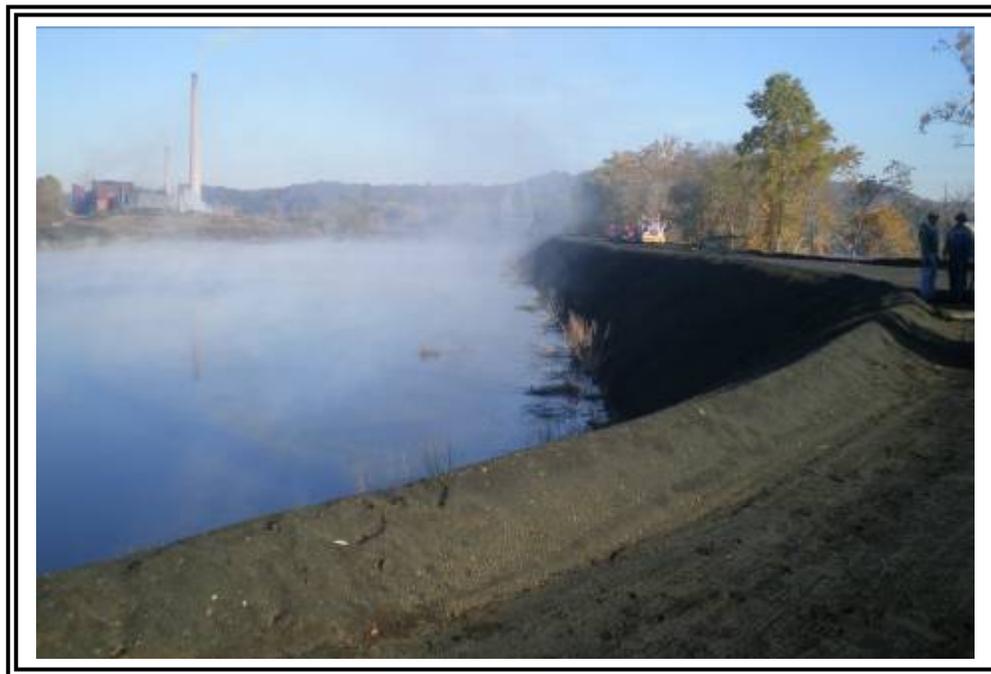
80

Units 1-4 Bottom Ash Pond east dike interior slope, looking east. Note relatively steep slope.

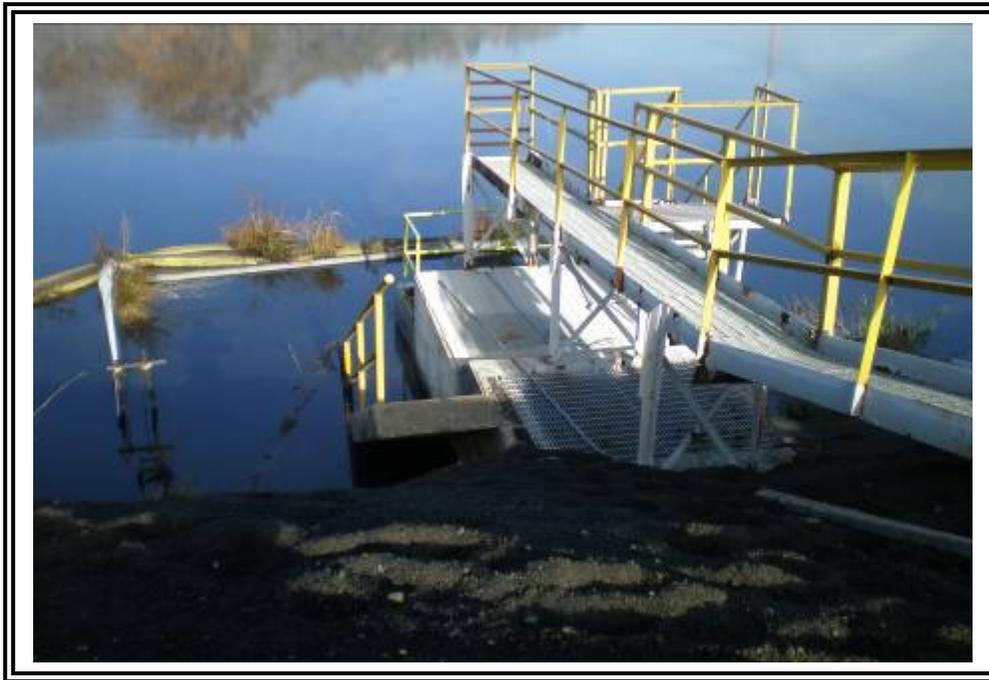
81

Outfall structure in the south dike of the Units 1-4 Bottom Ash Pond.

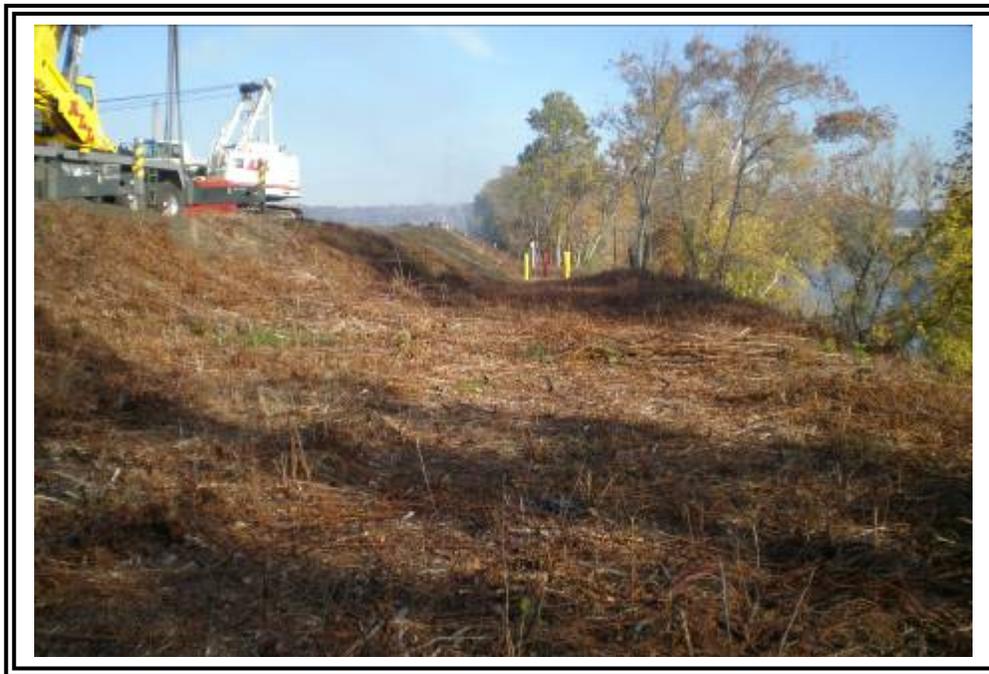
82

Units 1-4 Bottom Ash Pond east dike bench area and upper exterior slope. Bench is on the order of 15 to 20 feet wide in this area with evidence recently mowed dormant vegetation.

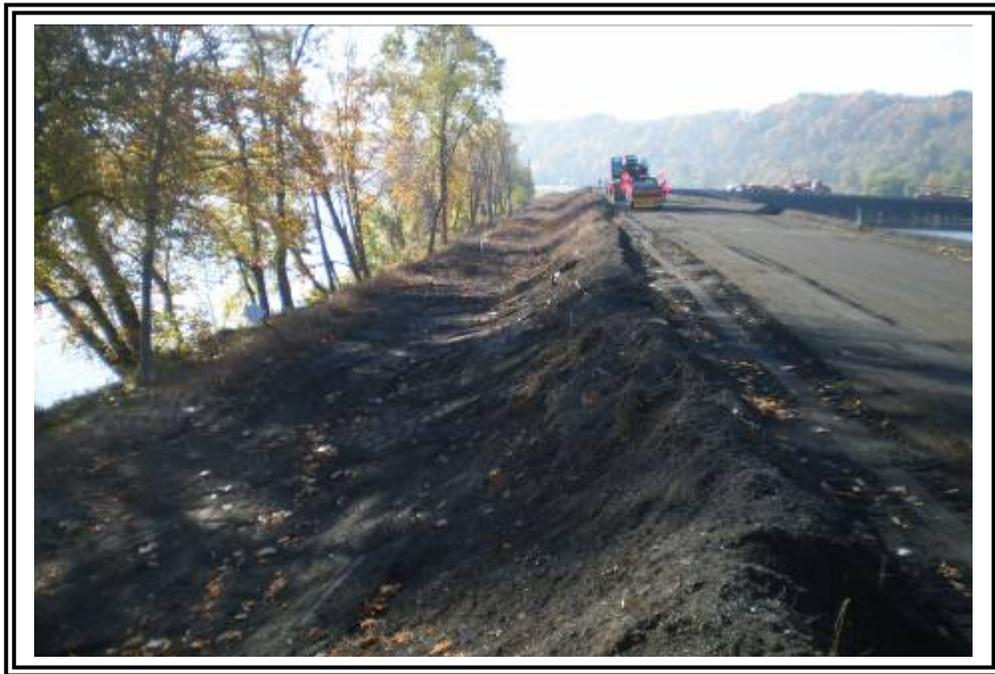
84

Crest area along the Units 1-4 Bottom Ash Pond east dike at the north end of the pond, looking south.

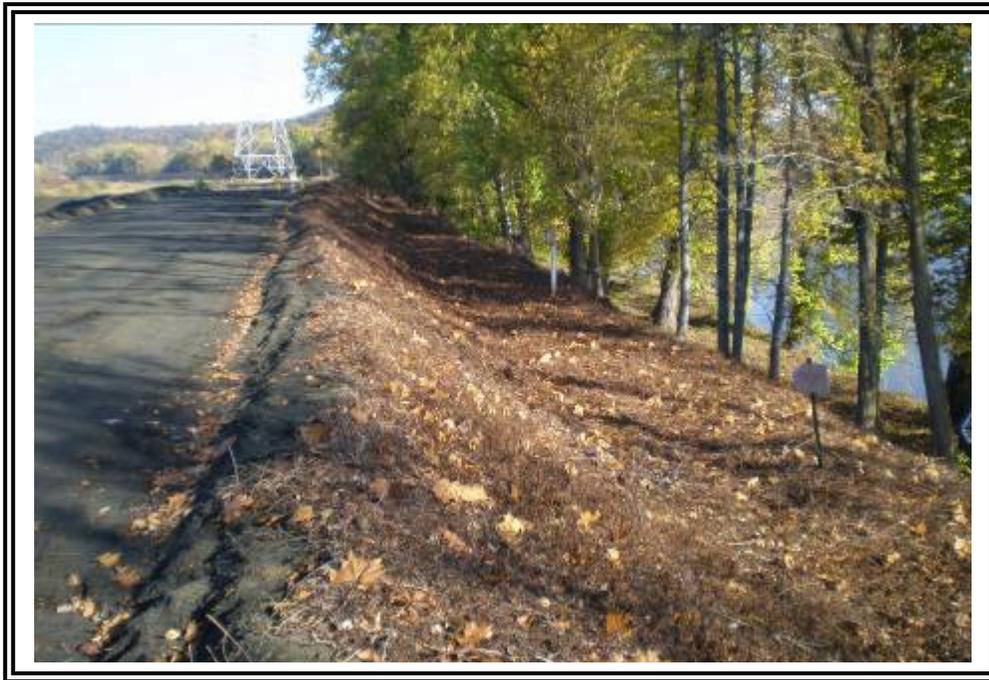
85

Crest area along Units 1-4 the Bottom Ash Pond east dike at the north end of the open pond, looking north.

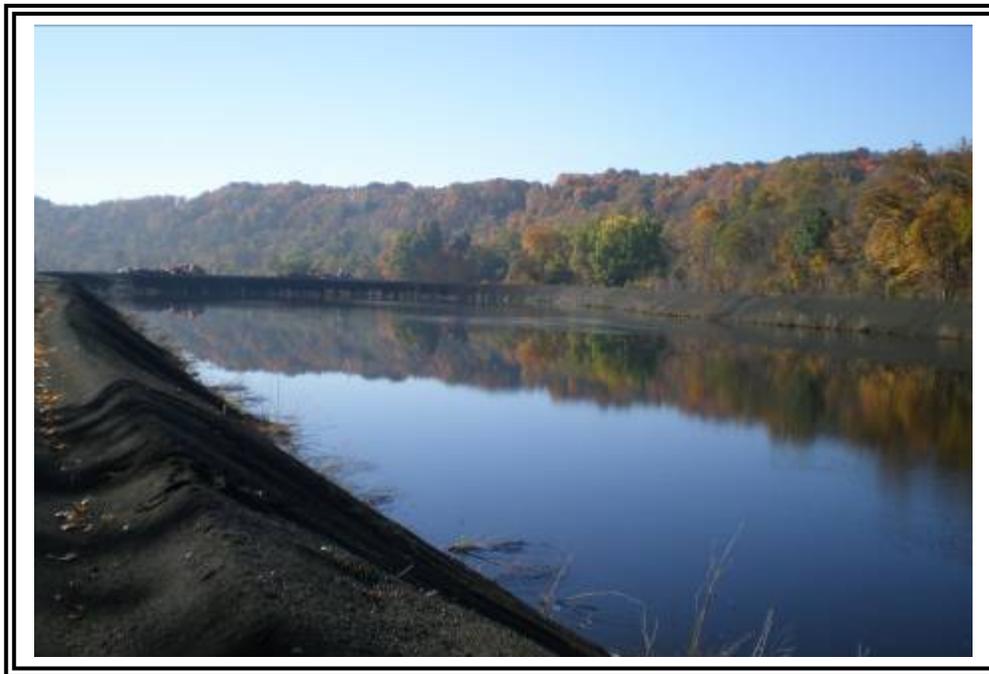
86

Units 1-4 Bottom Ash Pond east dike interior slope and open pond area, looking south.  
Note relatively steep slopes and sparse to absent vegetation.

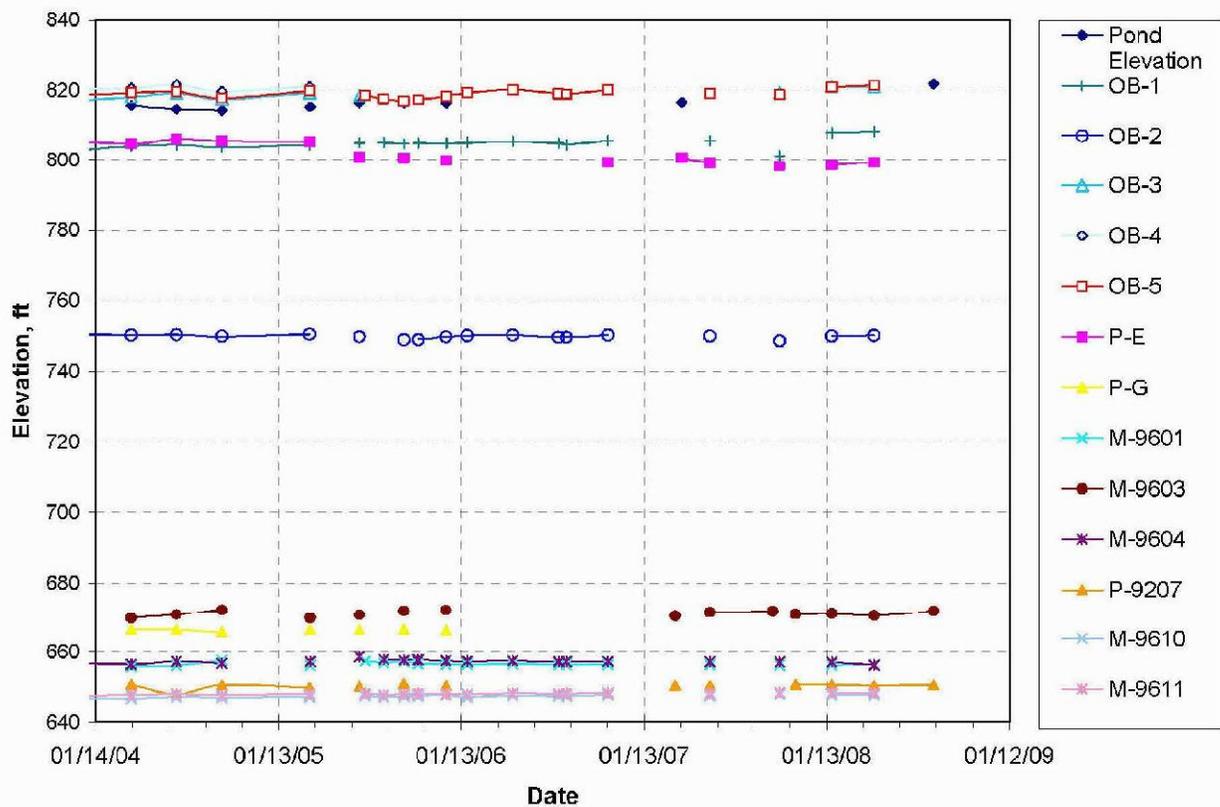
FIGURE 5A

Figures 5A and 5B show historical plots of the piezometer water levels for the piezometers around the Upper Fly Ash Reservoir from 2004 to 2008. In addition, the 2009 Inspection Report prepared by BBCM noted the following in regards to the piezometers:

**Figure 5A. Historical records of water levels at the Upper Reservoir since 2004**

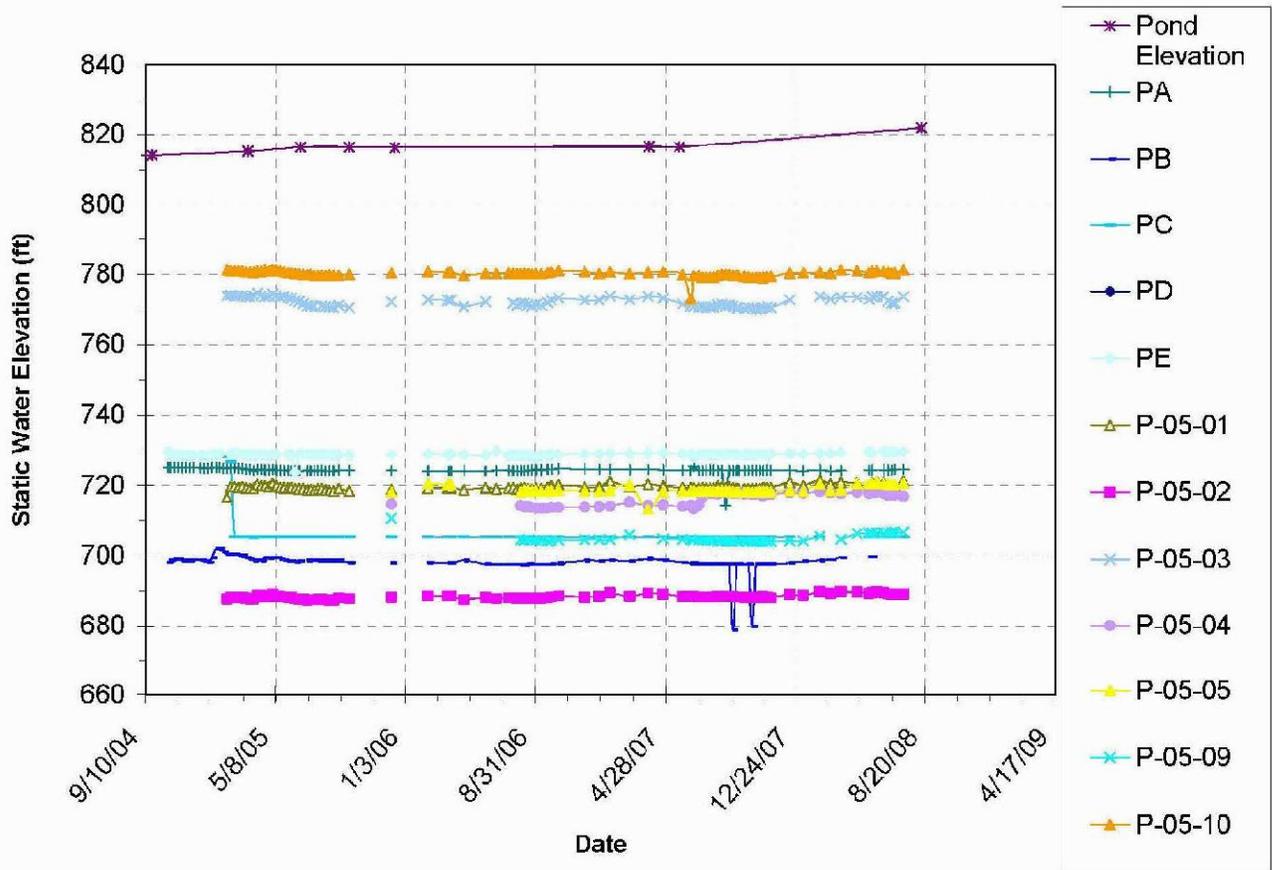
FIGURE 5B

Figure 5B. Water levels in piezometers at the Main dams since 2004

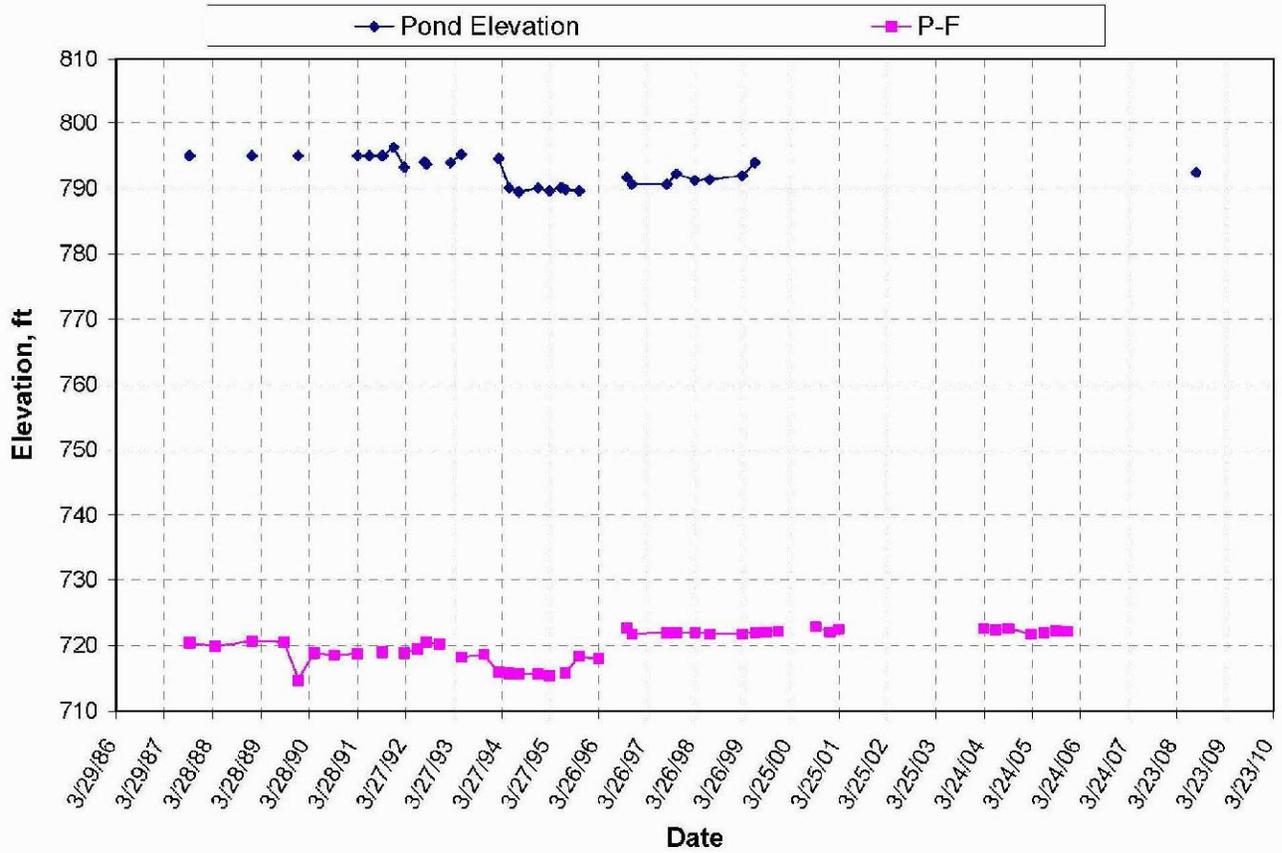
Figure 6. Historical records of water levels at the Middle Reservoir since 1987

There appears to be one piezometer located at the Middle Fly Ash Reservoir. The water level recorded in October 1996 showed that the Piezometer PF level had increased approximately 4 to 4½ feet from the previous year, since then the water level has been steady. The historical data is presented on Figure 6. No updates for this piezometer have been provided since 2006.
