# Assessment of Dam Safety Coal Combustion Surface Impoundments (Task 3) Final Report

American Electric Power  
Muskingum River  
Power Plant  
Waterford, Ohio

March 23, 2010

Have been assessed on October 20, 2009 and October 21, 2009

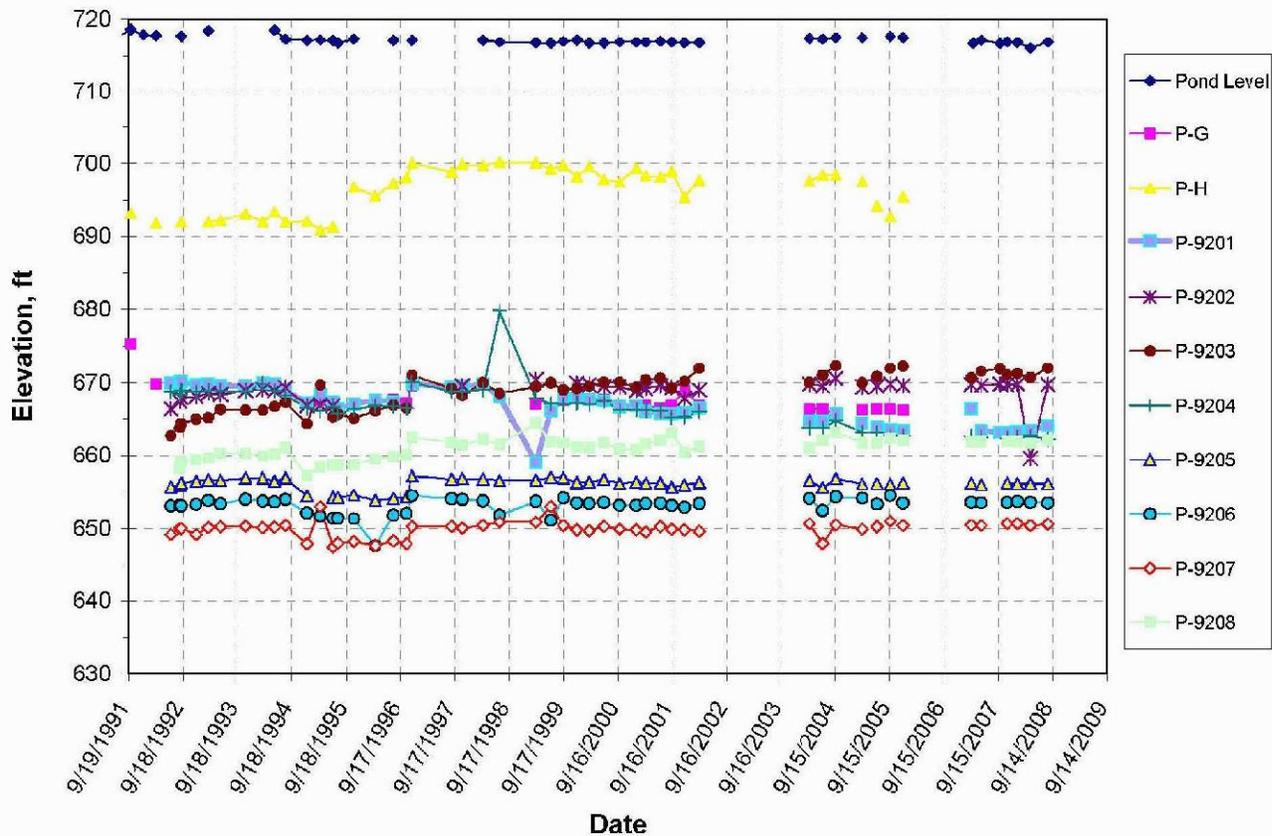
Figure 7. Historical records of water levels at the Lower Reservoir since 1991

Instrumentation installed at the Lower Fly Ash Reservoir appears to consist of 10 piezometers. Two original piezometers, PH and PG, are operating at the Lower Reservoir Dam. Piezometer PG is located downstream of the slurry wall and Piezometer PH is located upstream of the slurry wall. Piezometers P-9201 through P-9208 were installed after the construction of the slurry wall in the fall of 1992. The historical records of the piezometers are included in Figure 7.

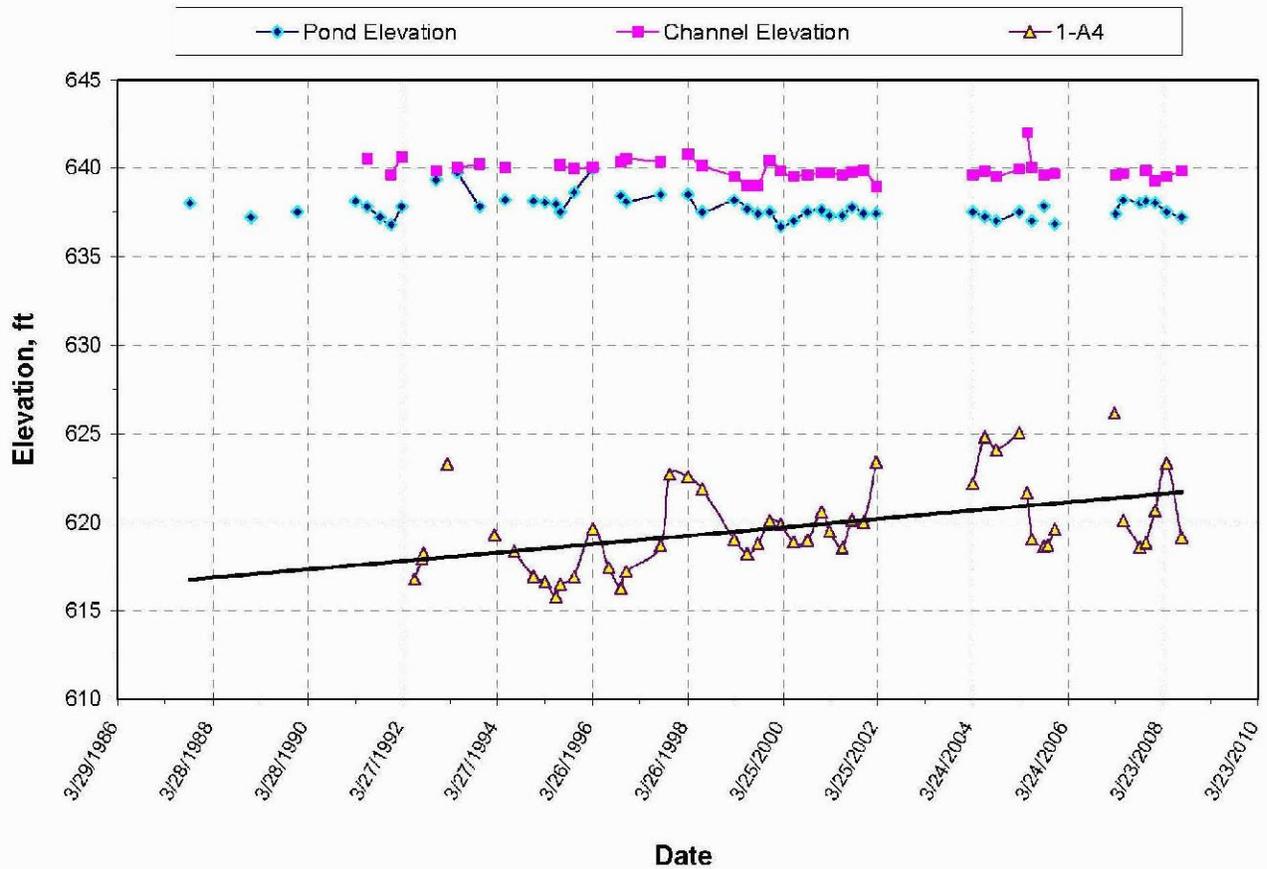
**Figure 8. Historical records of water levels at the Units 1-4 Bottom Ash pond and the connecting channel**

There appear to be a total of three piezometers installed at the Units 1-4 Bottom Ash Pond. One piezometer was installed above the old slide area on the riverbank dike opposite to the connecting channel and has been monitored since June 1992. The water levels in the piezometer have shown an increasing trend, as shown in Figure 8, even though the water level in the channel has remained fairly constant during the monitoring period. Two piezometers, 2W and 3E, were installed above the old slide area on the riverbank dike in 2005. Water level data from these piezometers have not been received from the plant to date.

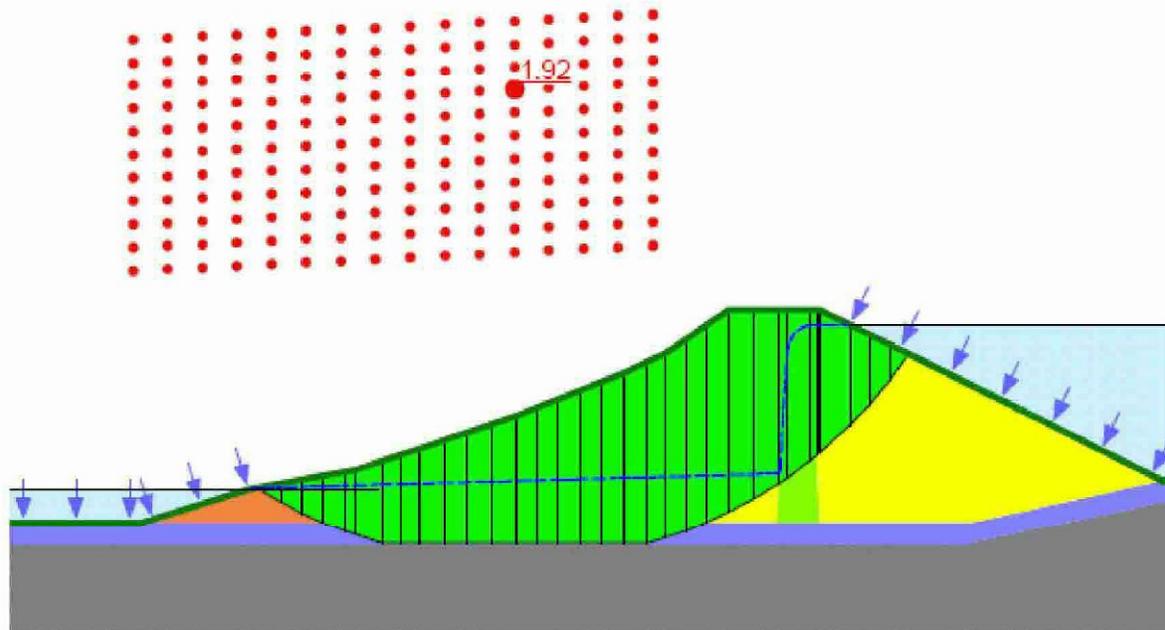
FIGURE 9A

The safety factor for a block failure mode similar to the one suggested by Casagrande was calculated to be 2.2. The safety factor for a large circular failure surface that passes through foundation soil was determined to be 1.9. A shallow failure surface that intersected the crest at about five feet offset from the edge resulted in a safety factor of 1.6. Pseudo static seismic analyses were also conducted to evaluate the performance of the dam under earthquake condition. All factors of safety under seismic condition were determined to be above 1.5. Figures 9A through 9C show the outputs from these analyses.

**Figure 9A. Stability analysis results for a failure surface that passes through the foundation soil**

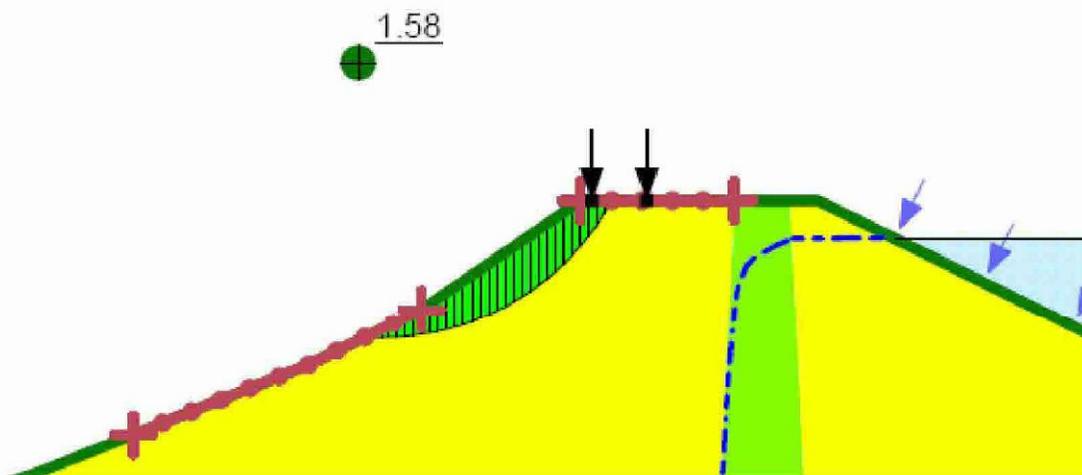
<p>III Winners Circle, PO Box 5269 · Albany, NY 12205-0269 Main: (518) 453-4500 · www.chacompanies.com</p>	<p>MIDDLE RESERVOIR DAM STABILITY ANALYSIS MUSKINGUM RIVER FACILITY WATERFORD, OHIO</p>	PROJECT NO. 20085.1010
		DATE: 12/2009
		FIGURE 9B

Figure 9B. Stability analysis with block failure surface

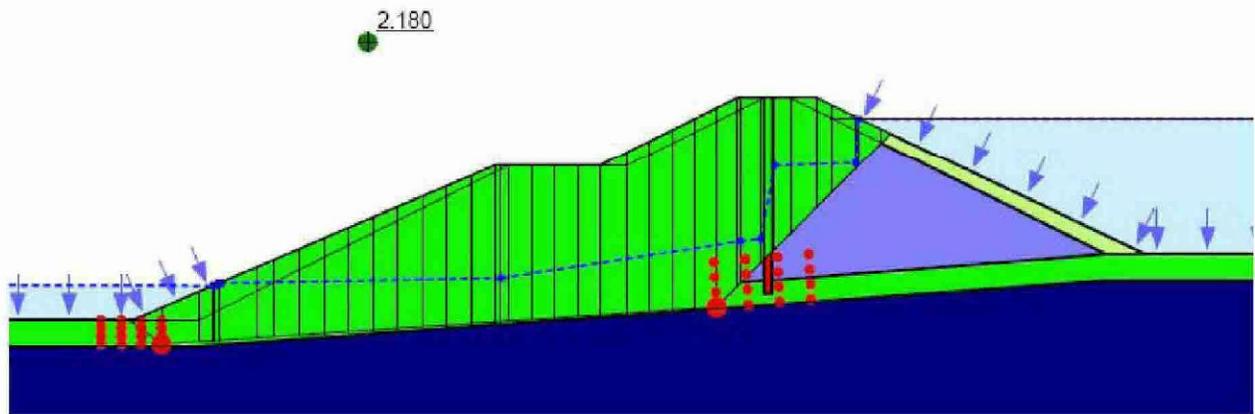
<p>III Winners Circle, PO Box 5269 · Albany, NY 12205-0269 Main: (518) 453-4500 · www.chacompanies.com</p>	<p>LOWER RESERVOIR DAM STABILITY ANALYSIS MUSKINGUM RIVER FACILITY WATERFORD, OHIO</p>	PROJECT NO. 20085.1010
		DATE: 12/2009
		FIGURE 10A

Safety factor for a block failure mechanism passing through the foundation of the embankment was calculated to be 2.2. Safety factor for a large circular failure surface that passes through foundation soil was determined to be 2.1. Shallow failure surfaces at the upper and lower portions of the downstream slope resulted in a factor of safety of 2.0 for both portions. Pseudo static seismic analyses were also conducted to evaluate the performance of the dam under earthquake condition. All factors of safety under seismic condition were determined to be 1.7 or higher. Figures 10A through 10D show the outputs from preliminary these analyses.

**Figure 10A. Block failure of the dam and the associated safety factor under steady-state condition**

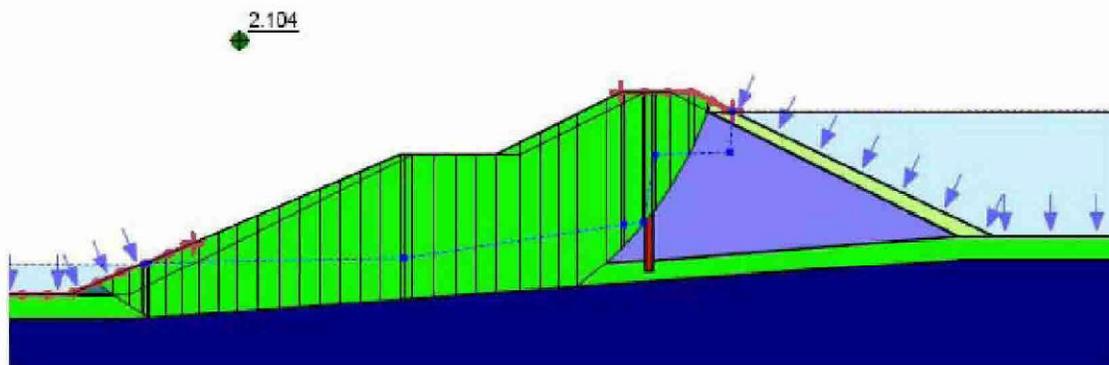
<p>III Winners Circle, PO Box 5269 · Albany, NY 12205-0269 Main: (518) 453-4500 · www.chacompanies.com</p>	<p>LOWER RESERVOIR DAM STABILITY ANALYSIS MUSKINGUM RIVER FACILITY WATERFORD, OHIO</p>	PROJECT NO. 20085.1010
		DATE: 12/2009
		FIGURE 10B

**Figure 10B. Stability analysis results under steady-state condition using a seep failure surface**

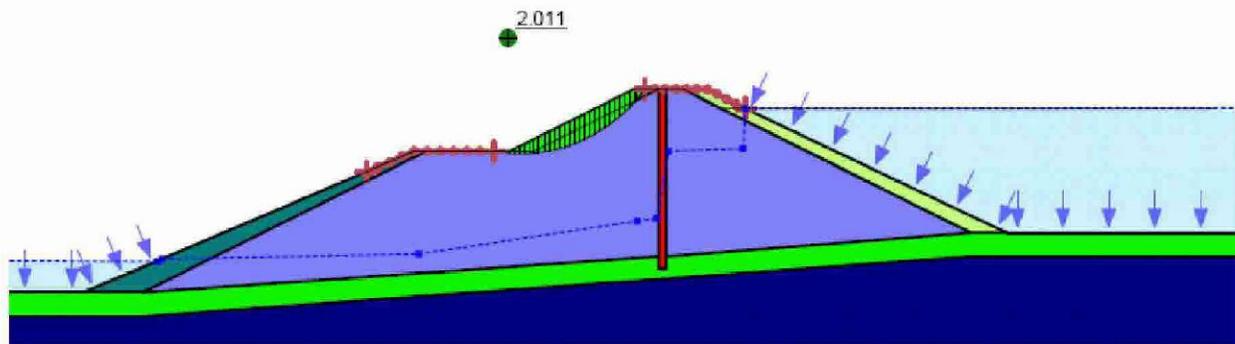
<p>III Winners Circle, PO Box 5269 · Albany, NY 12205-0269 Main: (518) 453-4500 · www.chacompanies.com</p>	<p>LOWER RESERVOIR DAM STABILITY ANALYSIS MUSKINGUM RIVER FACILITY WATERFORD, OHIO</p>	PROJECT NO. 20085.1010
		DATE: 12/2009
		FIGURE 10C

Figure 10C. Stability of the top portion of the slope under steady-state condition

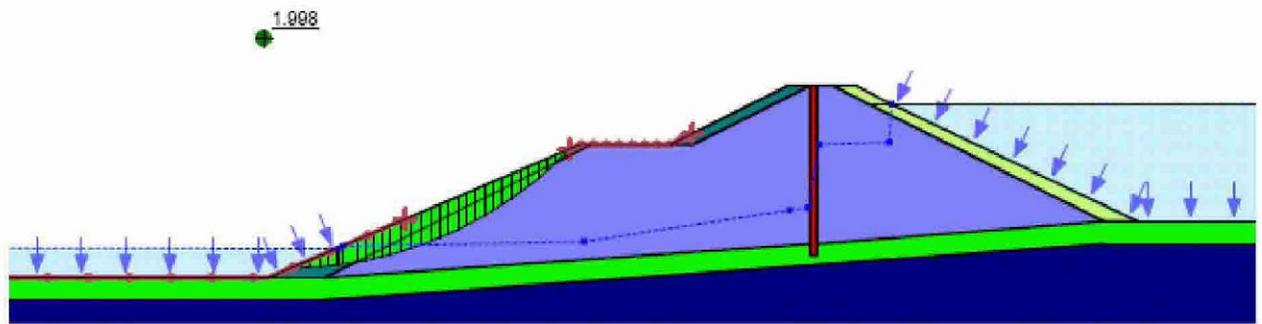
<p>III Winners Circle, PO Box 5269 · Albany, NY 12205-0269 Main: (518) 453-4500 · www.chacompanies.com</p>	<p>LOWER RESERVOIR DAM STABILITY ANALYSIS MUSKINGUM RIVER FACILITY WATERFORD, OHIO</p>	<p>PROJECT NO. 20085.1010</p> <p>DATE: 12/2009</p> <p>FIGURE 10D</p>
--	--	--

Figure 10D. Stability of the lower portion of the slope under steady-state condition
