# ASSESSMENT OF DAM SAFETY OF COAL COMBUSTION SURFACE IMPOUNDMENTS

**FirstEnergy Corp  
Albright Power Station  
Albright, West Virginia**

Prepared for  
*U.S. Environmental  
Protection Agency  
Washington, D.C.*

October 2012

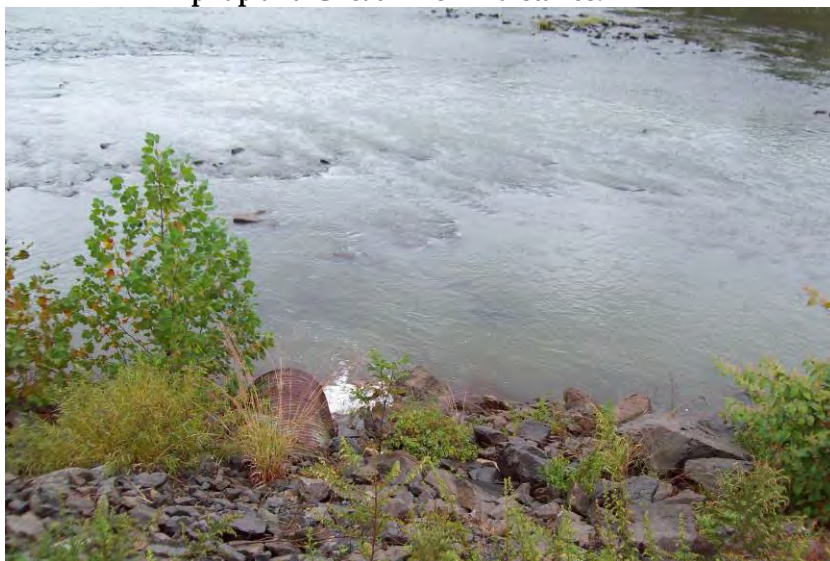
The outlet structure consists of a metal v-notched weir near the north embankment discharging to a 36-inch concrete pipe. The outlet structure also includes an opening with stoplogs at the end of a catwalk that also discharges to the 36-inch concrete pipe (Photograph 13). The stoplogs were removed during the site assessment. The weir and pipe were submerged at the time of visual assessment. The 36-inch concrete pipe discharges into a sump structure (Photograph 6) that directs liquids to the on-site wastewater treatment plant or discharges to the outfall at the Cheat River (Photograph 7).

Photo 7: 36-inch-diameter pipe discharging liquid from North Process Wastewater Lagoon sump into Cheat River.

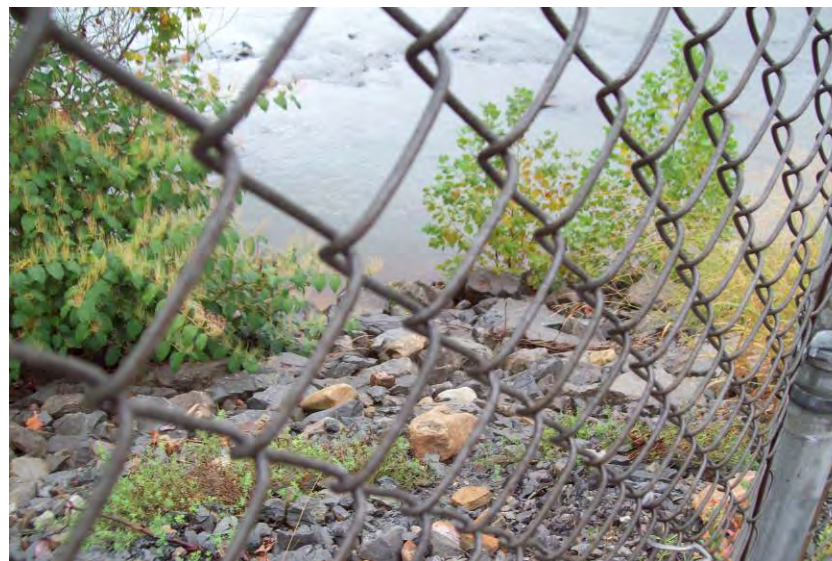
Photo 8: East embankment exterior slope near northeast corner. Note typical riprap and Cheat River in distance.

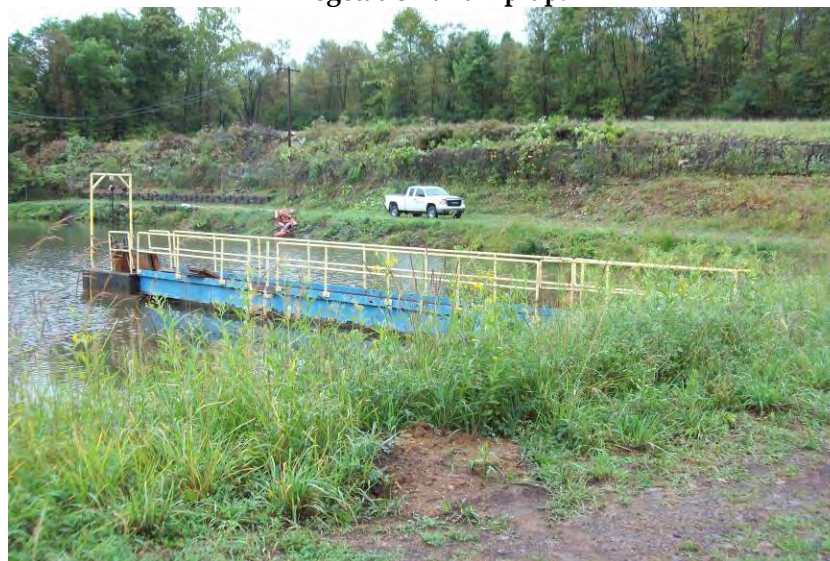
Photo 12: Catwalk and outlet structure at north embankment.

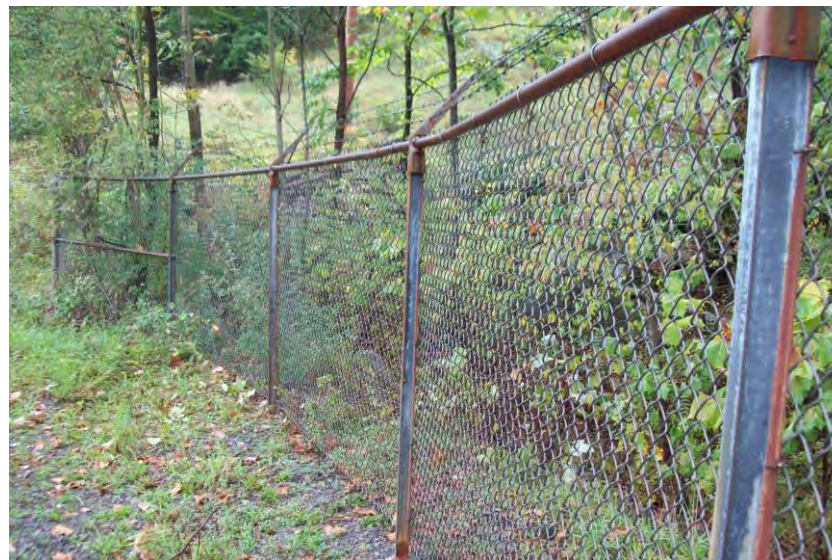
Photo 16: North embankment exterior slope at northwest corner, looking southwest. Note hillside at west embankment in background.

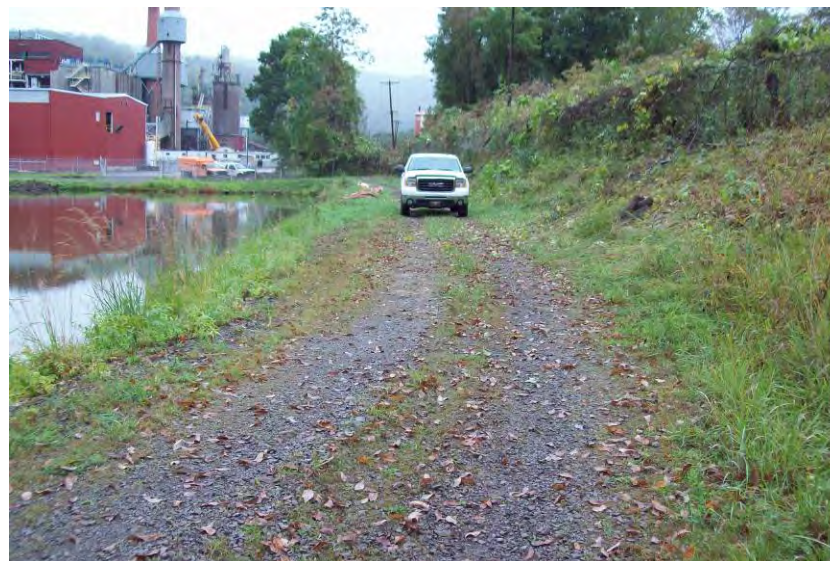
Photo 18: West embankment crest, looking southeast.

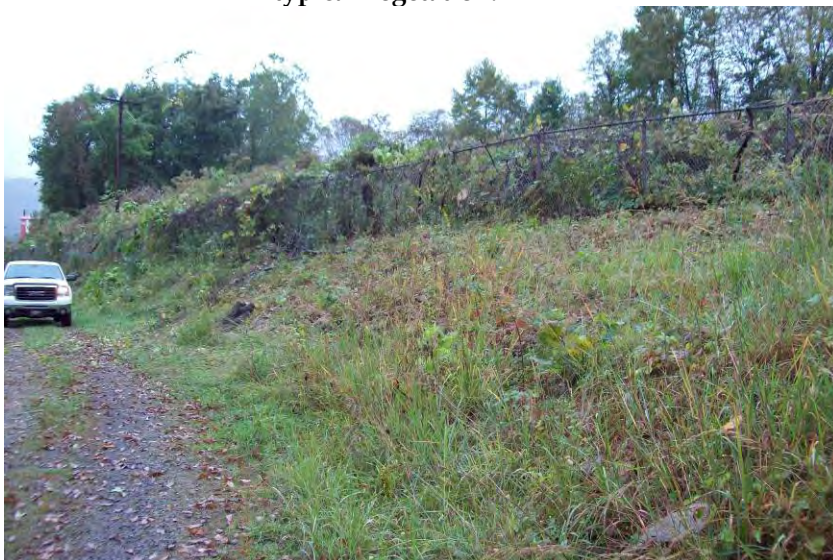
Photo 19: West embankment, looking southeast. Note hillside.

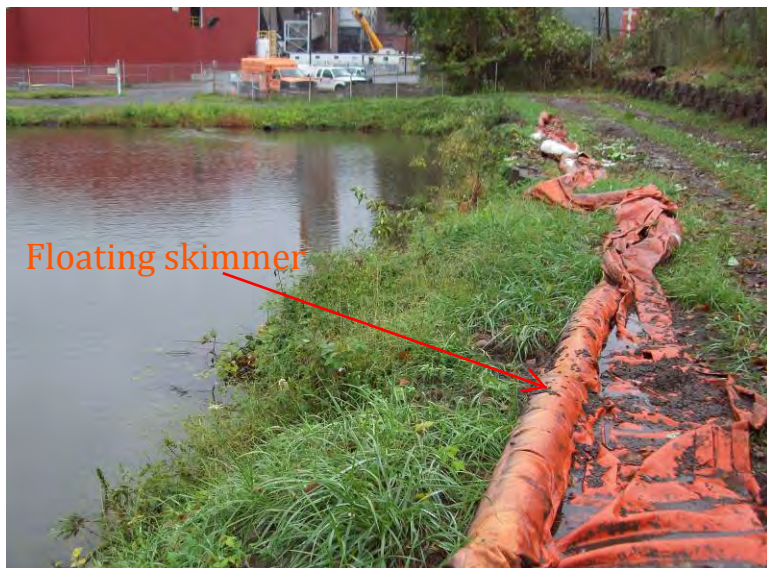
Photo 21: West embankment interior slope, looking southeast.

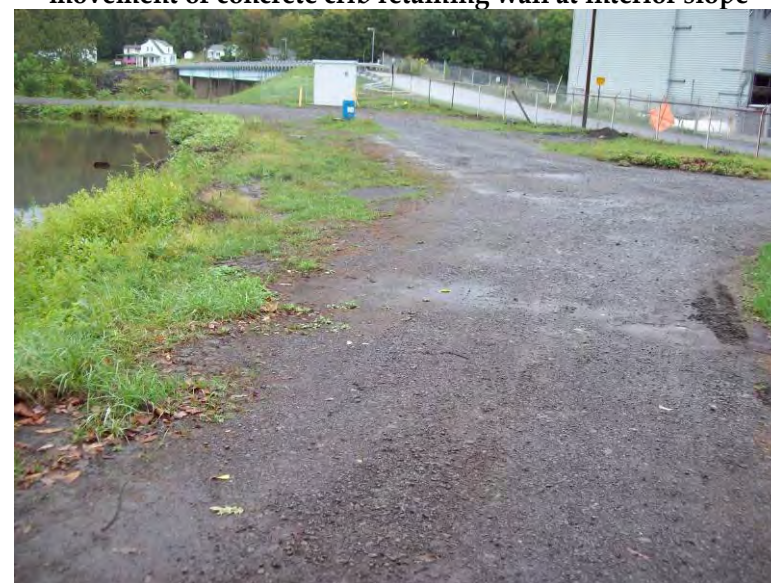
Photo 24: South embankment crest, looking northeast.

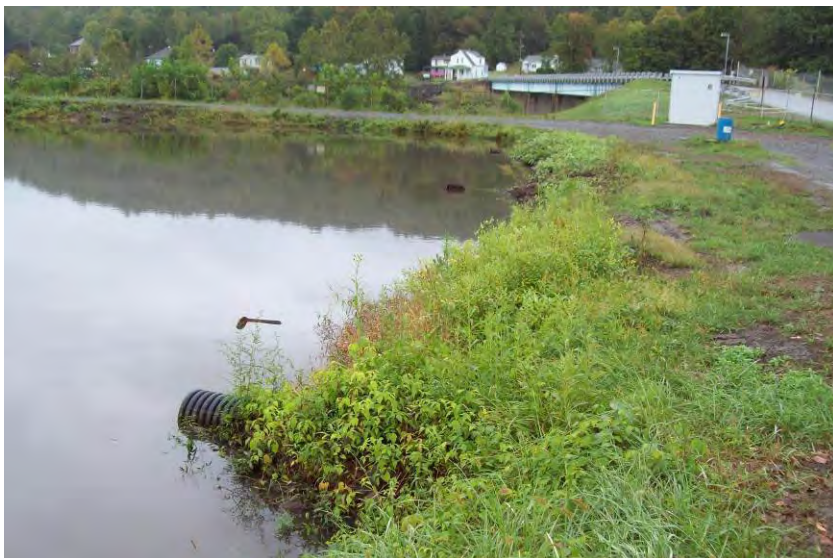
Due to the lagoon water level during the assessment, only the upper 0.5 to 1 ft of the interior slopes were visible (Photographs 2, 11, 17, and 25). Reportedly, the interior slopes are 3H:1V at all embankments except the west embankment which is at 2H:1V. A concrete crib retaining wall was located at the interior slope of the west embankment, near the southwest corner. The wall was approximately 75 feet long. A section of the wall, approximately 10 feet long, appeared to be displaced laterally towards the lagoon (Photographs 22 and 23). Due to the water level and lack of documentation, the wall height is unknown. Vegetation covered the portion of the interior slopes that were visible. Inlet pipes are located at the interior slope of the south embankment (Photograph 25).

Photo 25: South embankment interior slope, looking northeast. Note four inlet pipes (one 18-in-dia HDPE, and three 8-in-dia DI).

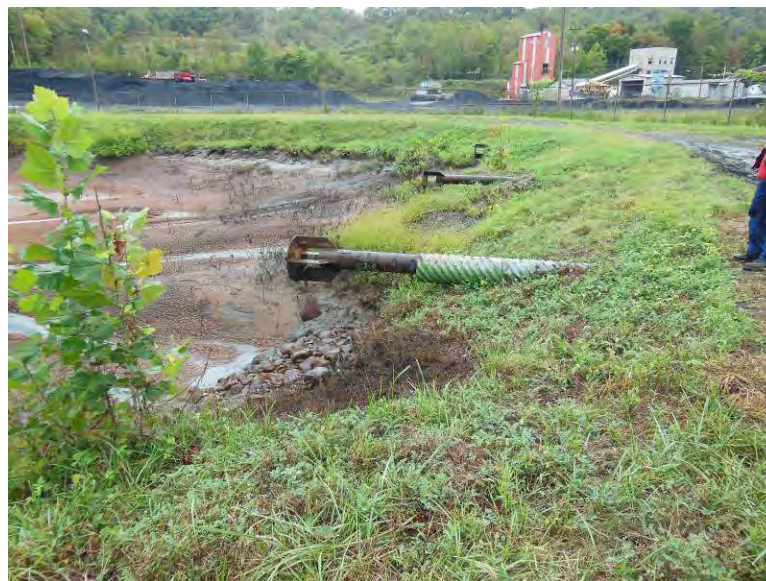
Interior slopes appeared to be in fair condition (Photographs 29, 33, 36, and 45). Areas of erosion were located just downstream at each of the three inlet pipes at the north embankment (Photograph 31) and at the inlet pipe at the west embankment (Photograph 34). Based on construction drawings, the interior slopes are 3H:1V at all embankments. Grassy vegetation covered the upper portion of the interior slopes.

Photo 29: North embankment interior slope, looking west. Note three 8-inch-diameter inlet pipes.

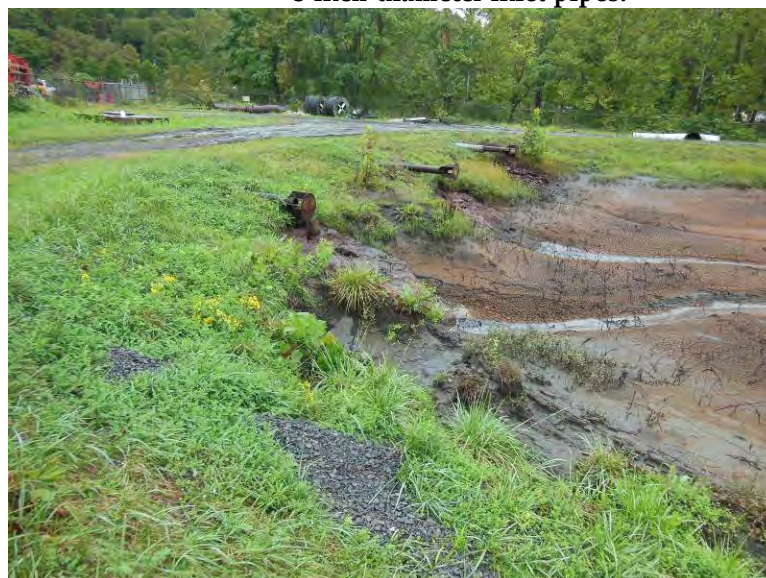
Photo 31: North embankment interior slope, looking east. Note areas of erosion at pipe discharge.

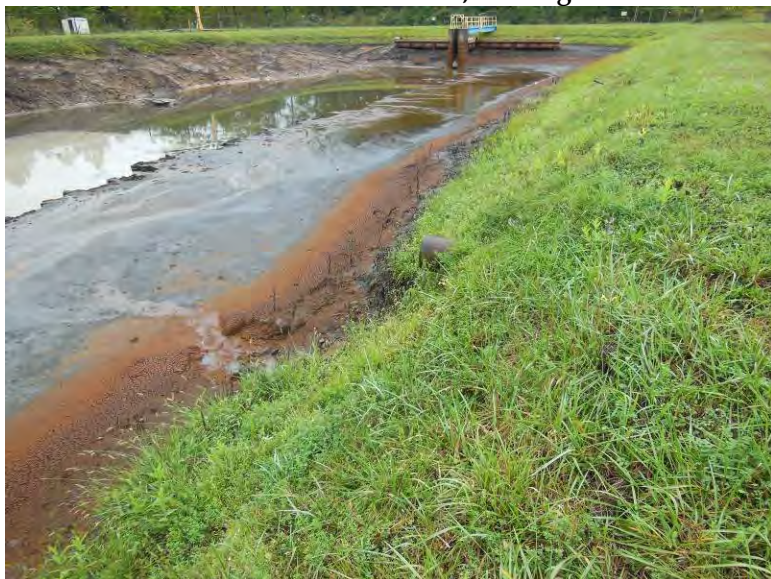
Three 8-inch-diameter inlet pipes are located at the interior slope of the north embankment (Photograph 30). One 18-inch-diameter inlet pipe is located at the interior slope of the west embankment (Photograph 34).

Photo 34: West embankment interior slope, looking south. Note 10-inch-diameter inlet pipe from coal pile runoff.

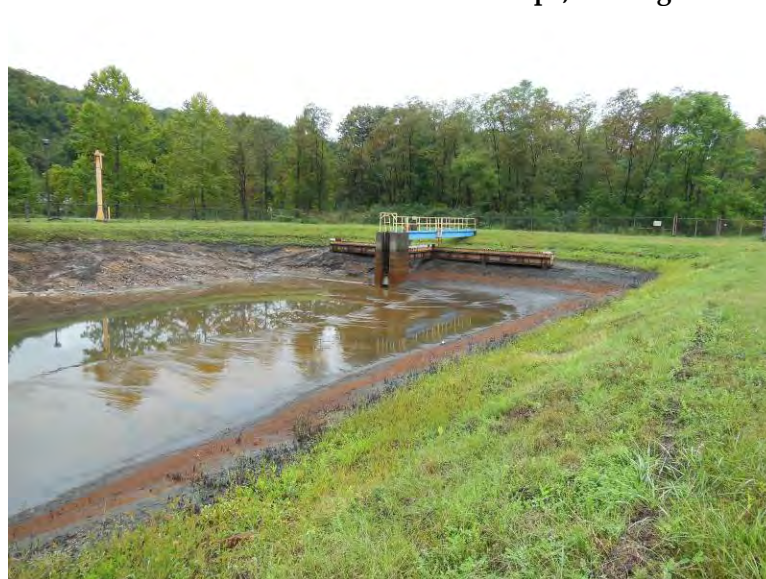
Photo 35: West embankment interior slope, looking southeast. Note outlet structure in distance.

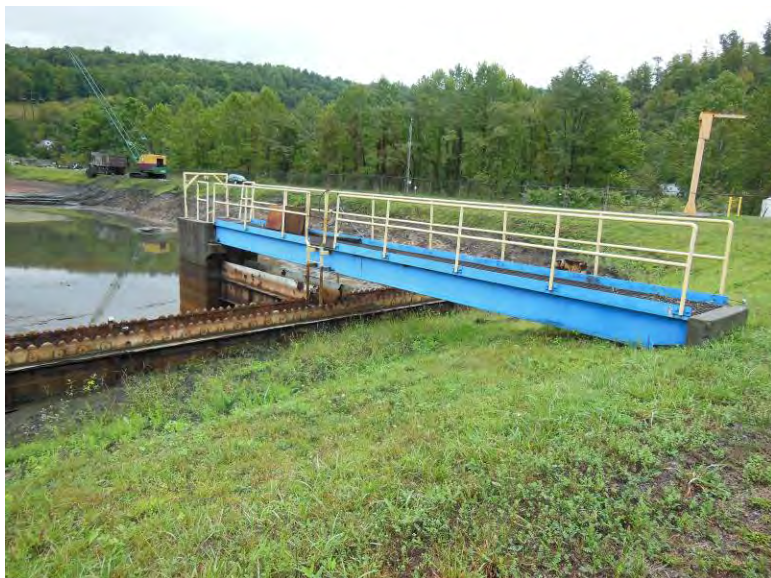
Photo 38: Outlet structure near south embankment.

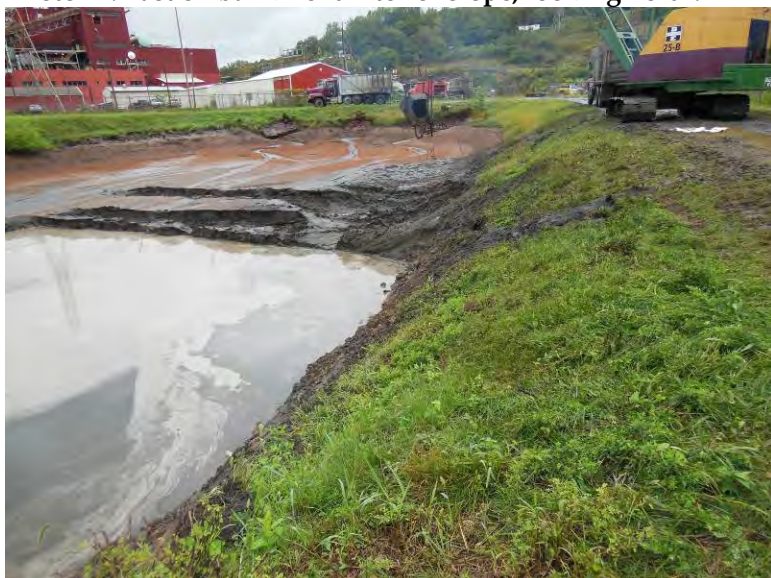
Photo 46: East embankment interior slope, looking north.  
Note dredging equipment on embankment crest.

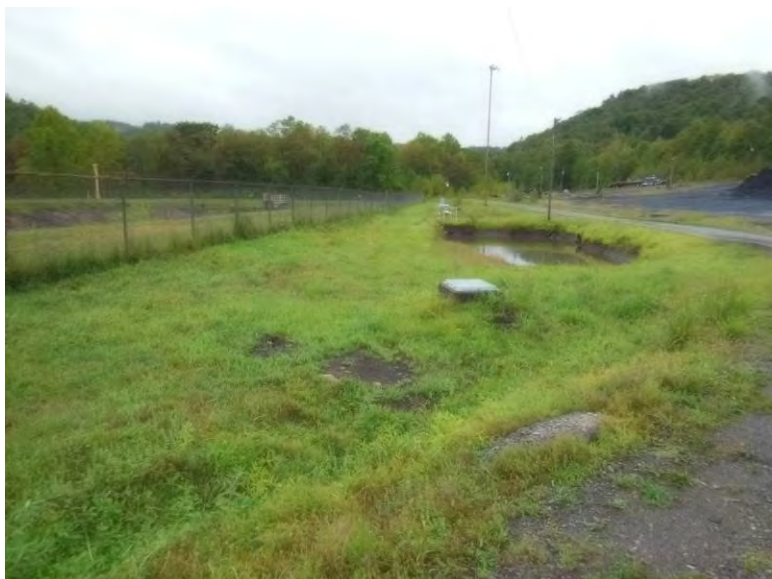
Photo 48: West embankment exterior slope, looking south.

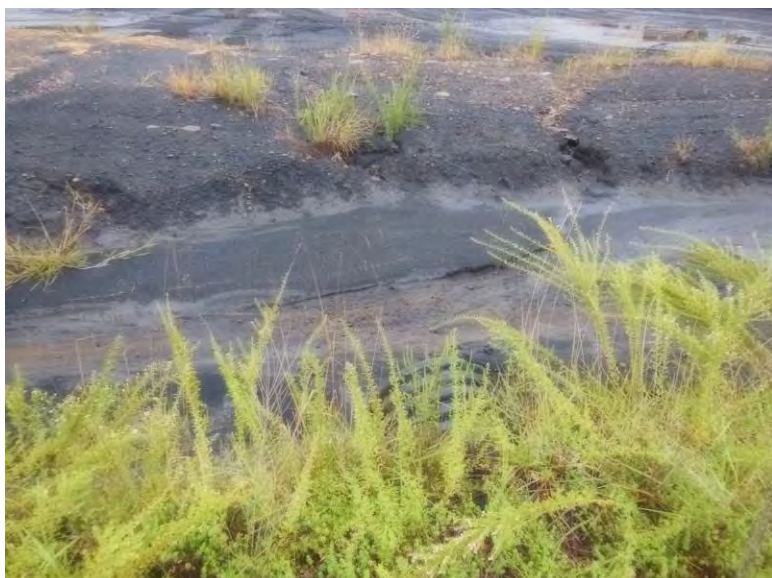
Photo 50: Coal pile runoff collection ditch just east of coal storage area, looking west.

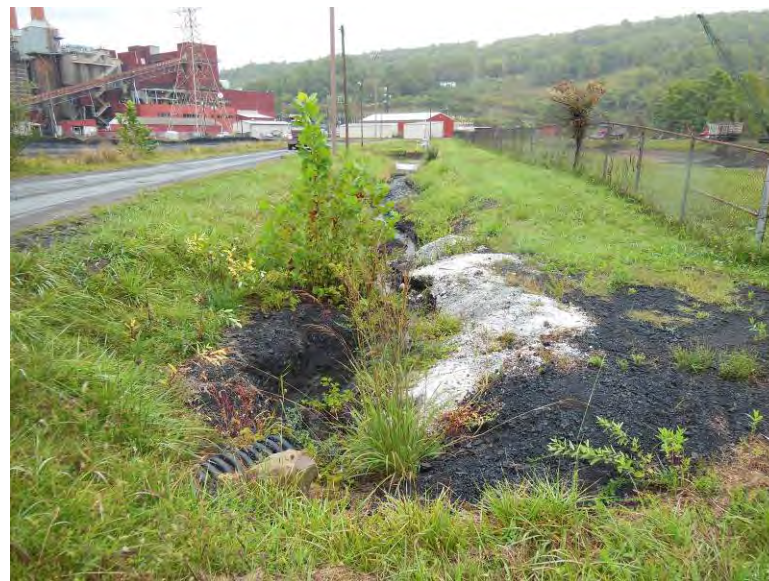
Photo 53: Coal pile runoff ditch to coal pile runoff pond, looking north.

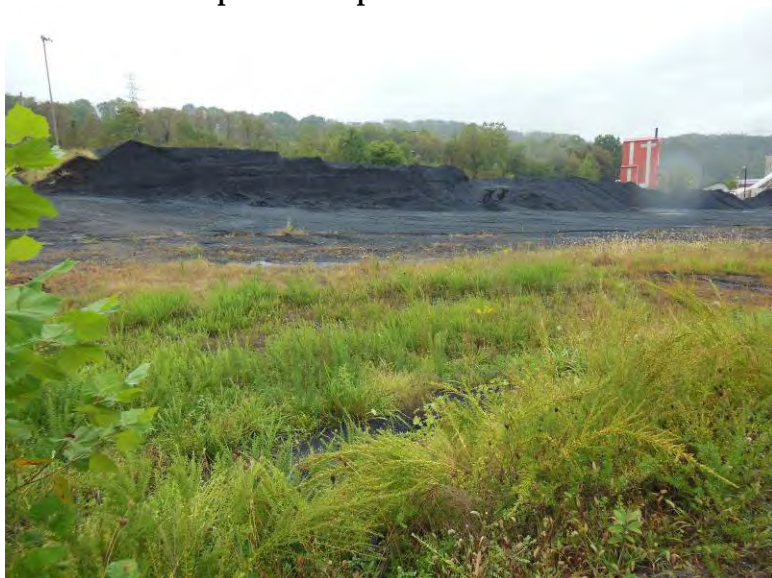
Photo 54: Coal pile storage area west of the south lagoon, looking west.

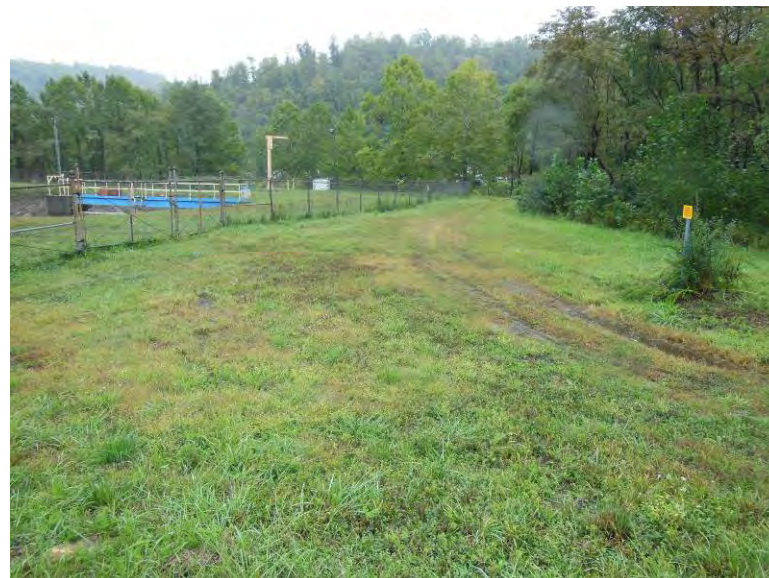
The lagoon includes exterior slopes on the west, east, and south embankments. The north embankment is incised (Photograph 47). Due to the terrain and vegetation on the exterior slopes of the east and south embankments of the South Lagoon, the slopes were only visible from the embankment crests. The west embankment exterior slope is a coal pile runoff drainage and storage ditch which was nearly full during the site assessment (Photographs 49, 51, and 52). Based on observations during the site assessment, the exterior slopes appear to be in satisfactory condition. The exterior slopes of the south and east embankments are between 1H:1V and 3H:1V based on topographic drawings. The exterior slopes of the south and east embankments are generally covered in dense vegetation (Photographs 55, 56, 59, and 62). The Cheat River is at the east embankment's exterior toe (Photographs 56 and 62).

Photo 55: South embankment exterior slope, looking east.

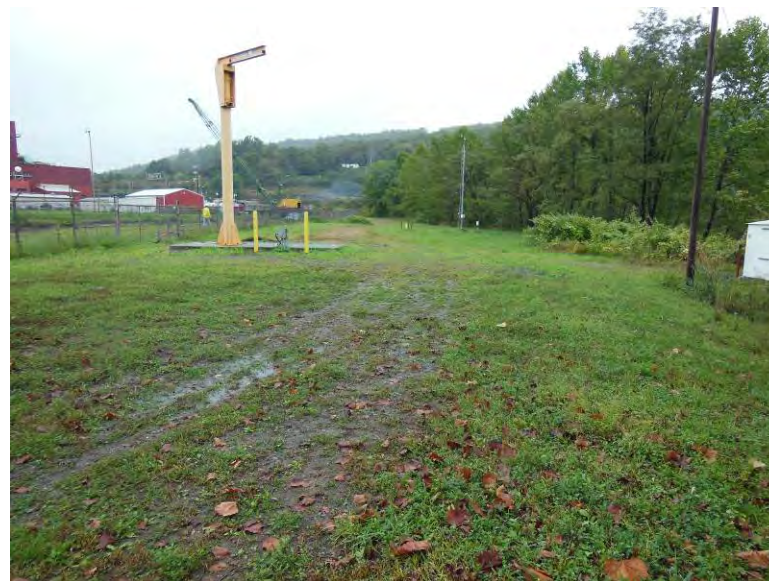
Photo 57: East embankment crest, looking north.

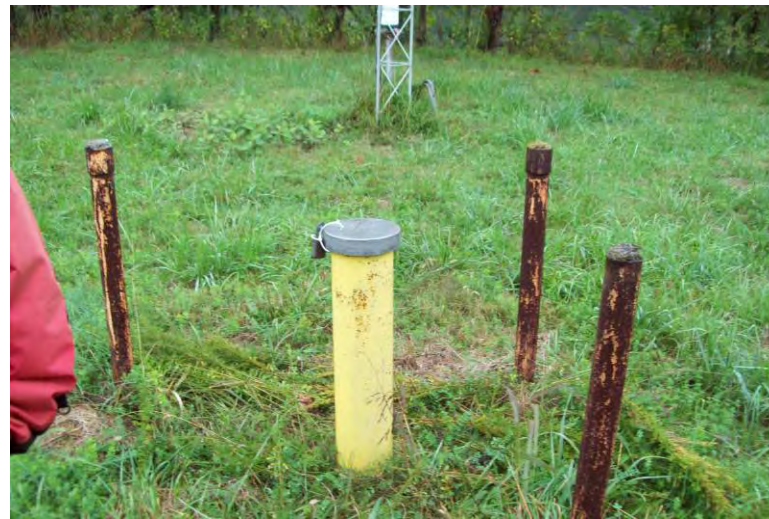
Photo 61: Monitoring well associated with coal pile storage at east embankment crest, looking east.
