Report of Geotechnical  
Assessment of Coal Combustion Surface  
Impoundments  
Minnesota Power  
Boswell Energy Center, Cohasset, MN

AMEC Project No. 3-2106-0174.0300

June 2010

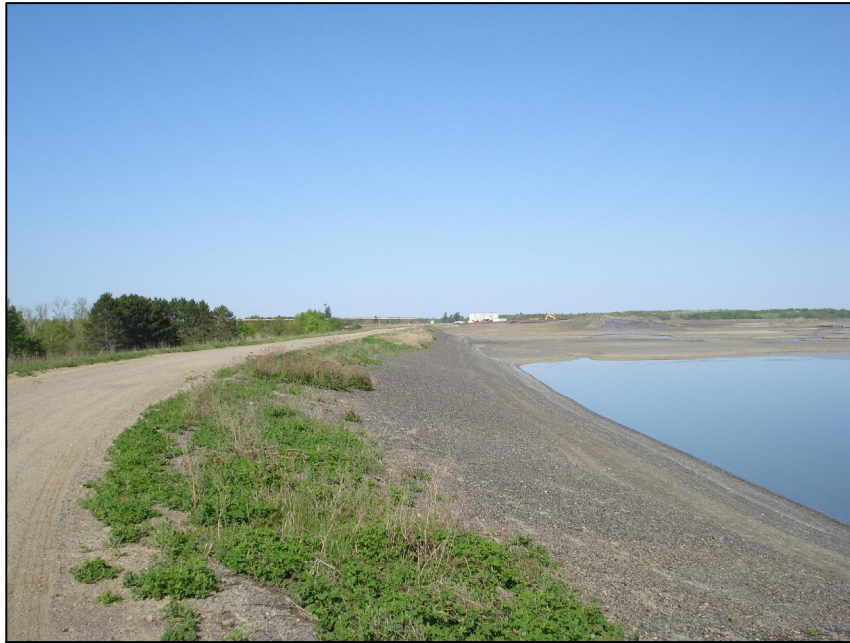
**1-1**

**FROM CREST OF SOUTHEAST DIKE LOOKING WEST TOWARDS BOTTOM ASH POND**

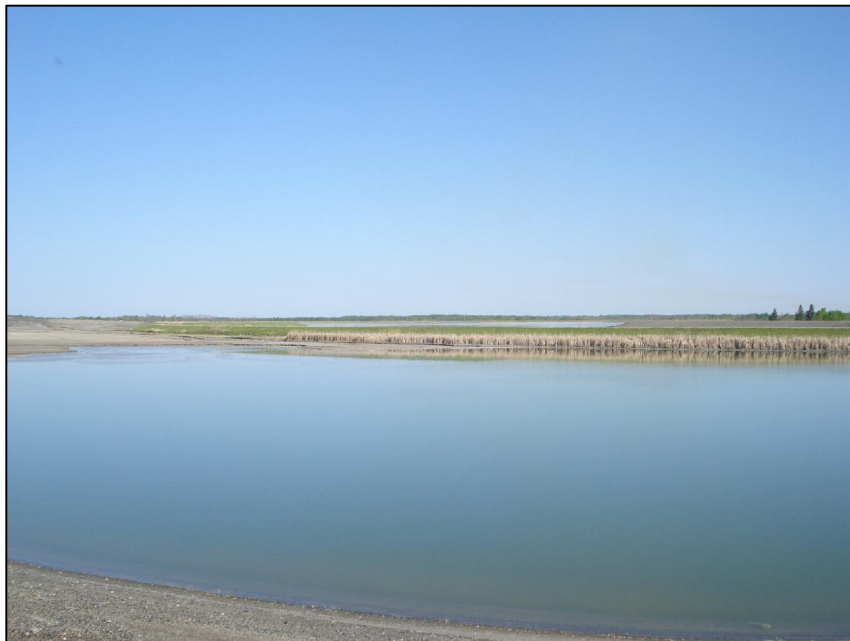
**1-2**

**FROM CREST OF SOUTHEAST DIKE LOOKING NORTH TOWARDS BOTTOM ASH POND**

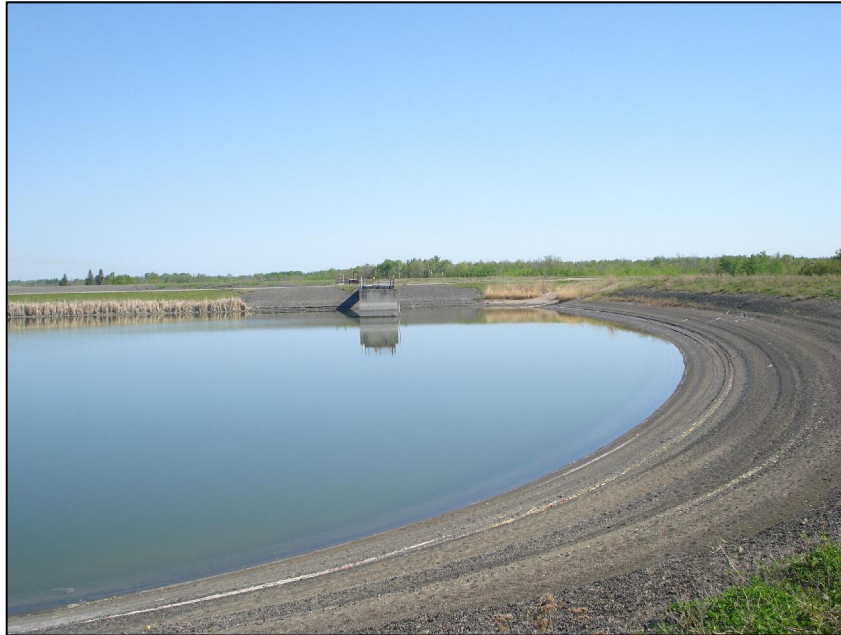
**1-3**

**FROM CREST OF SOUTHEAST DIKE LOOKING NORTHEAST TOWARDS BOTTOM ASH POND**

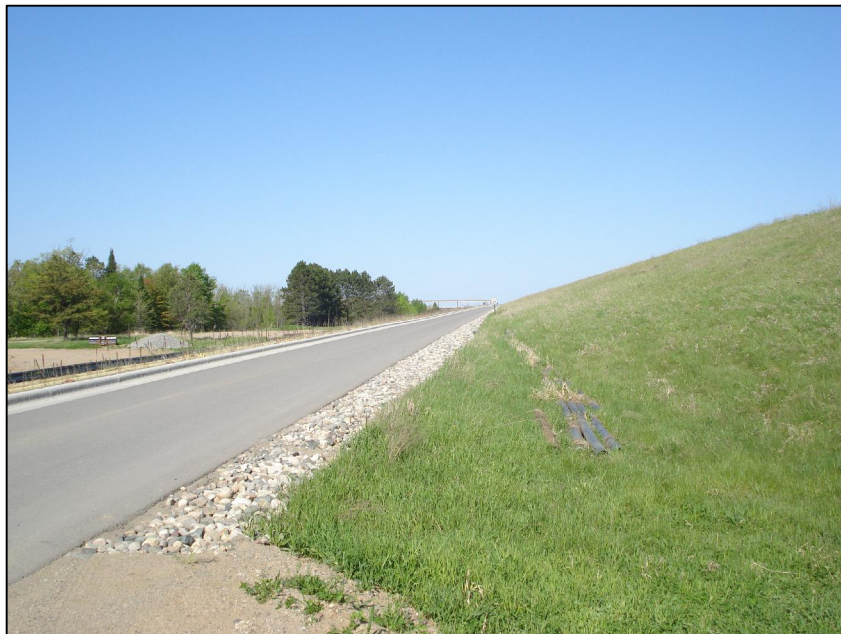
**1-4**

**FROM OLD ROUTE 6 ALONG SOUTHEAST DIKE LOOKING WEST**

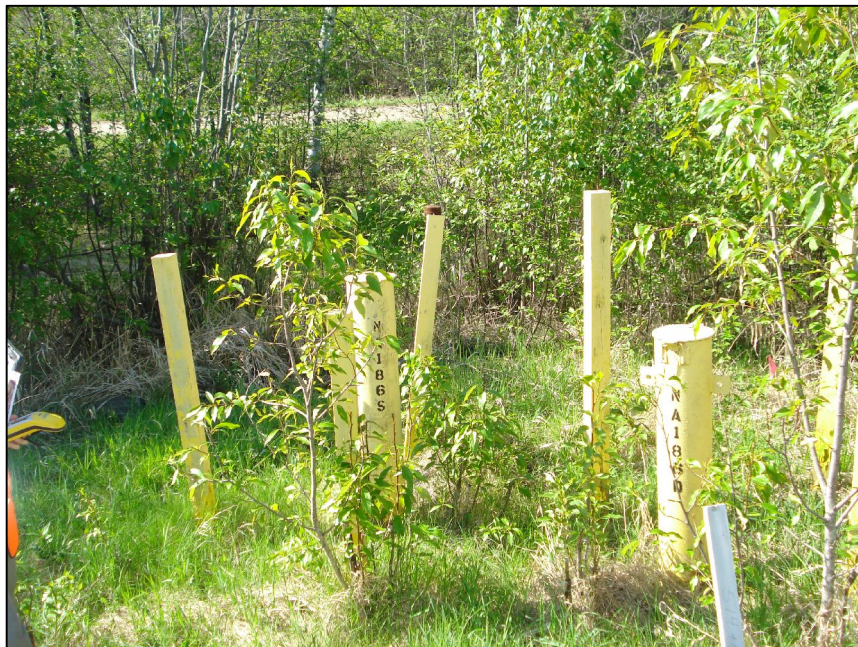
**1-6**  
**MONITORING WELLS NA186S AND NA186D**

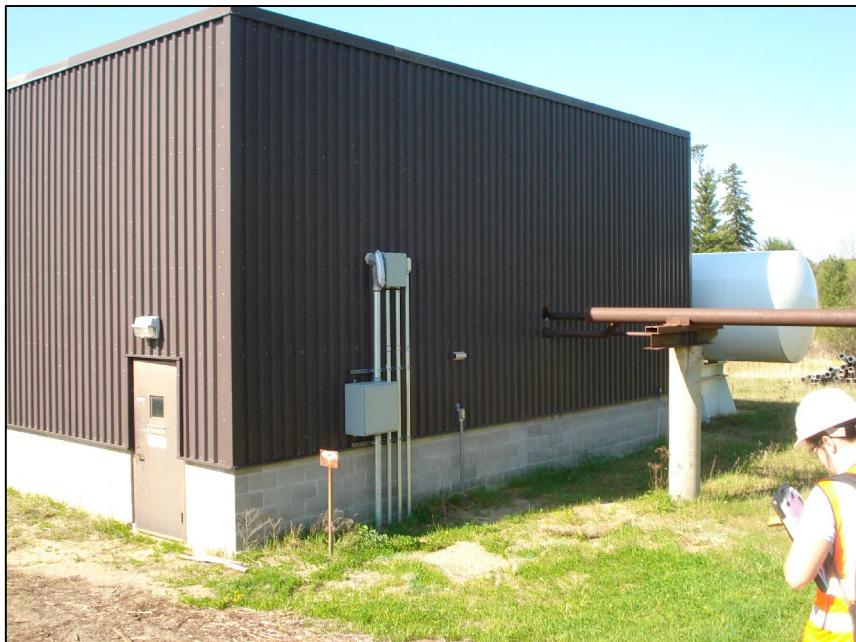
**1-8**

**INACTIVE INTAKE STRUCTURE**

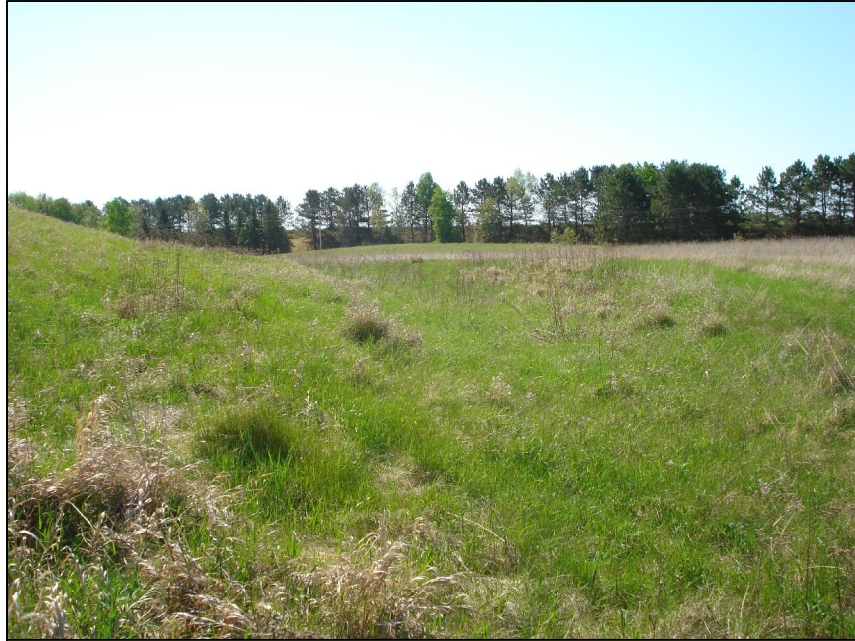
**1-9**

**WETLAND AREA ALONG SOUTHERN DOWNSTREAM TOE**

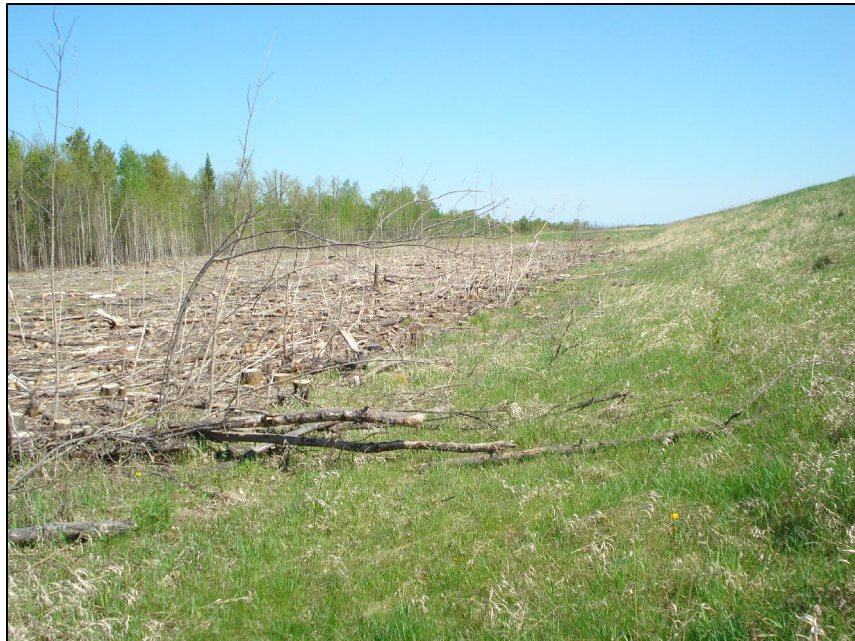
**1-10**

**CLEARED AREA ALONG WESTERN DOWNSTREAM TOE**

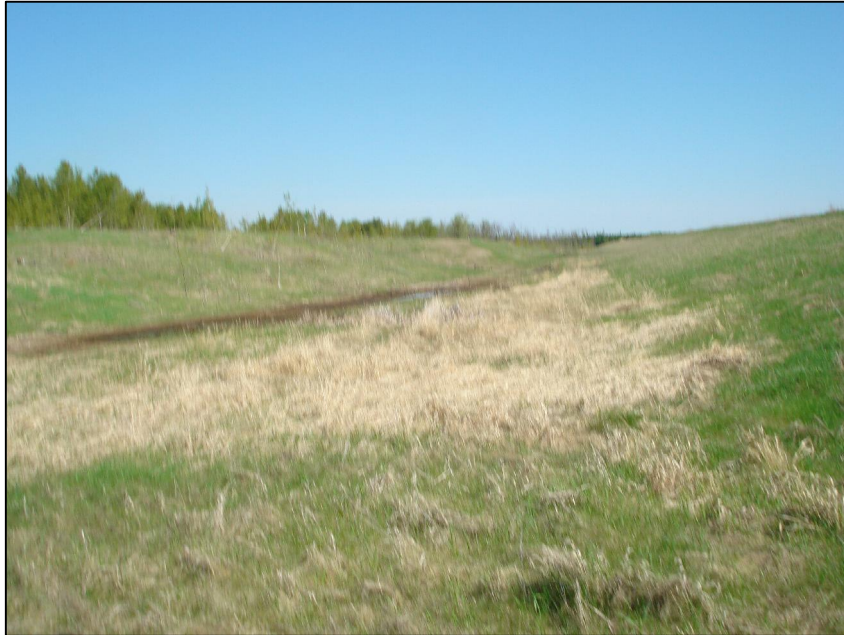
**1-11**

**LOW AREA ALONG WESTERN DOWNSTREAM TOE**

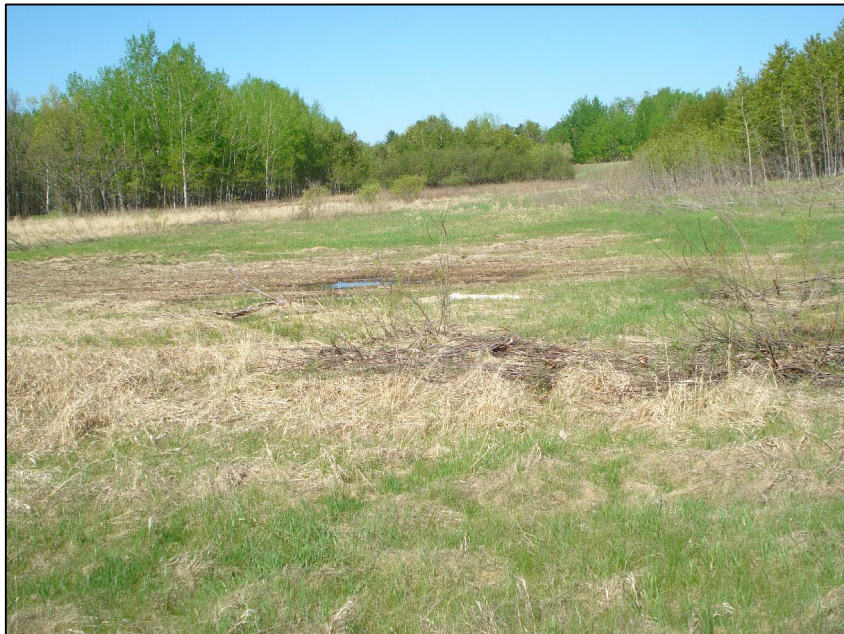
**1-12**

**WET AREA ALONG WESTERN DOWNSTREAM TOE**

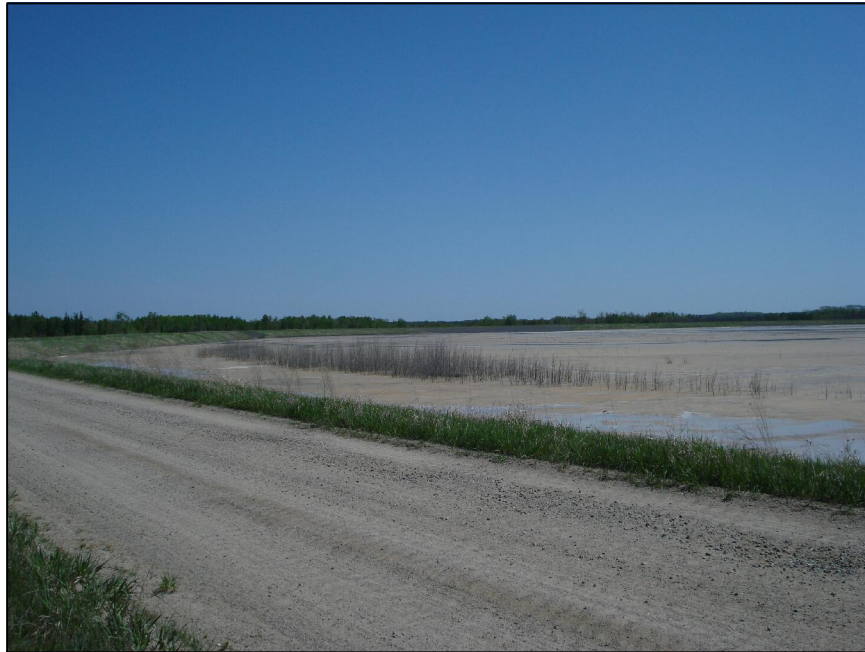
**1-13**

**VIEW FROM WESTERN DIKE LOOKING NORTHEAST TOWARDS POND 4**

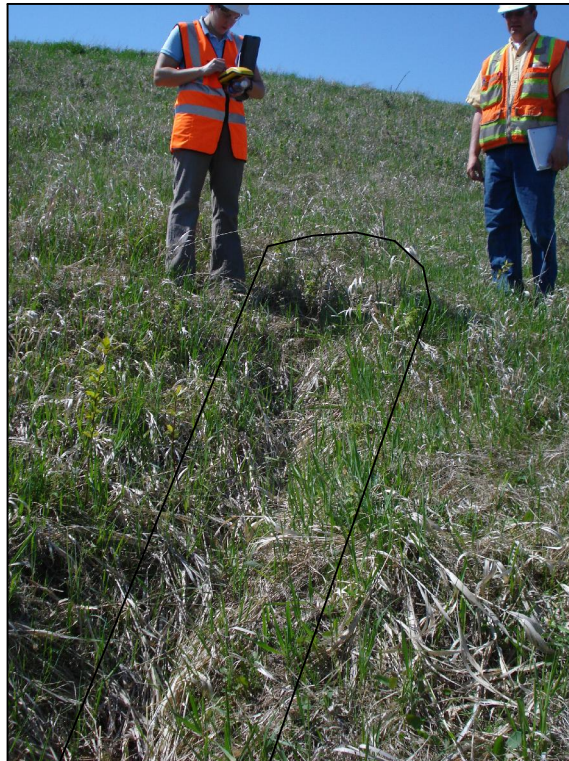
**1-15**

**SWALE ALONG SOUTHERN DOWNSTREAM SLOPE**

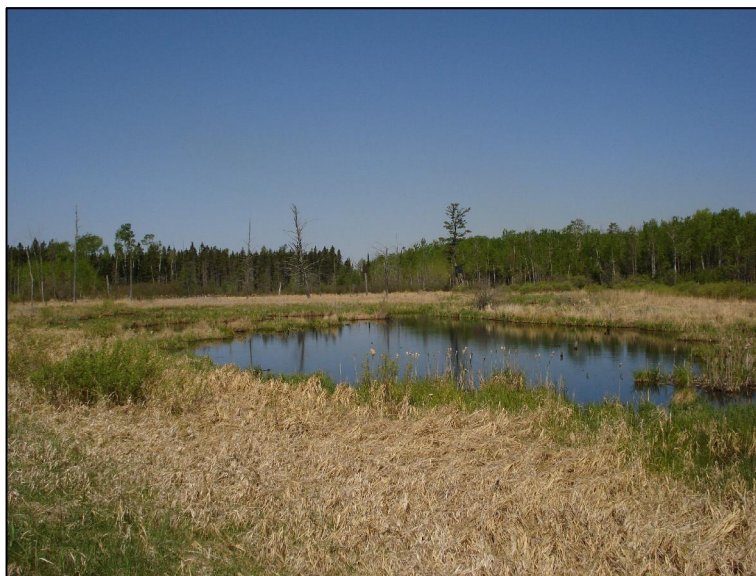
**1-16**

**WETLAND AREA ALONG NORTHWESTERN DOWNSTREAM TOE**

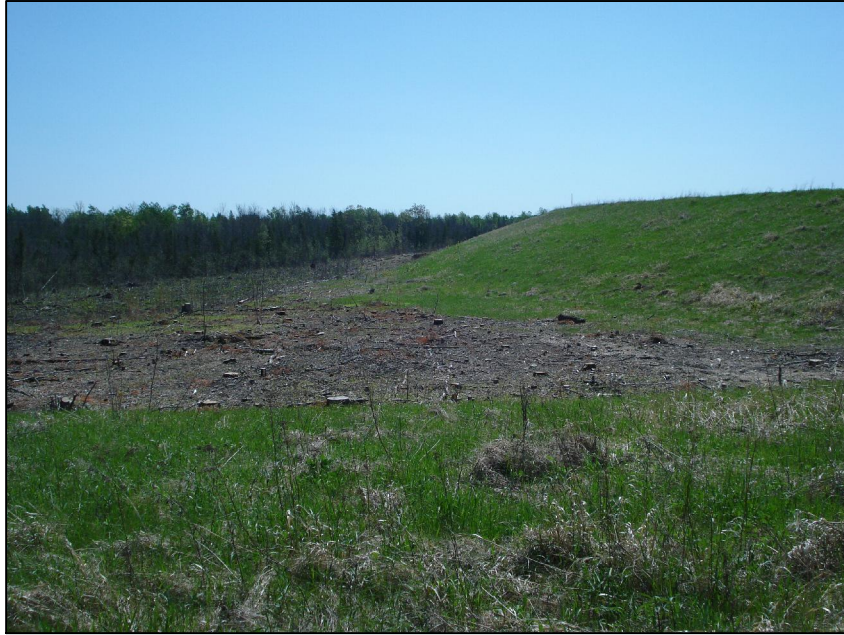
**1-17**

**CLEARED AREA ALONG NORTHEASTERN DOWNSTREAM TOE**

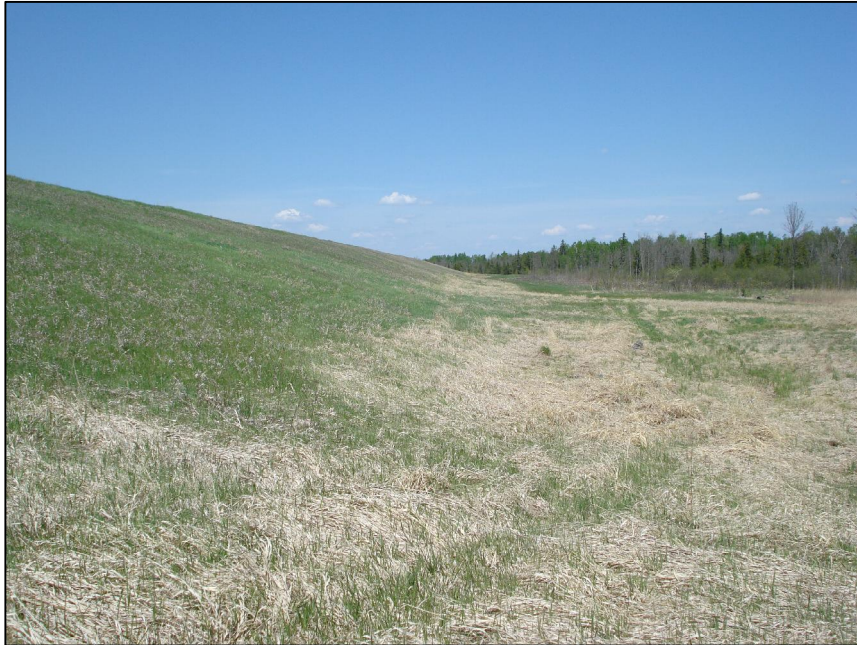
**1-19**

**GENERAL SITE PHOTO FROM EASTERN DOWNSTREAM TOE LOOKING NORTH**

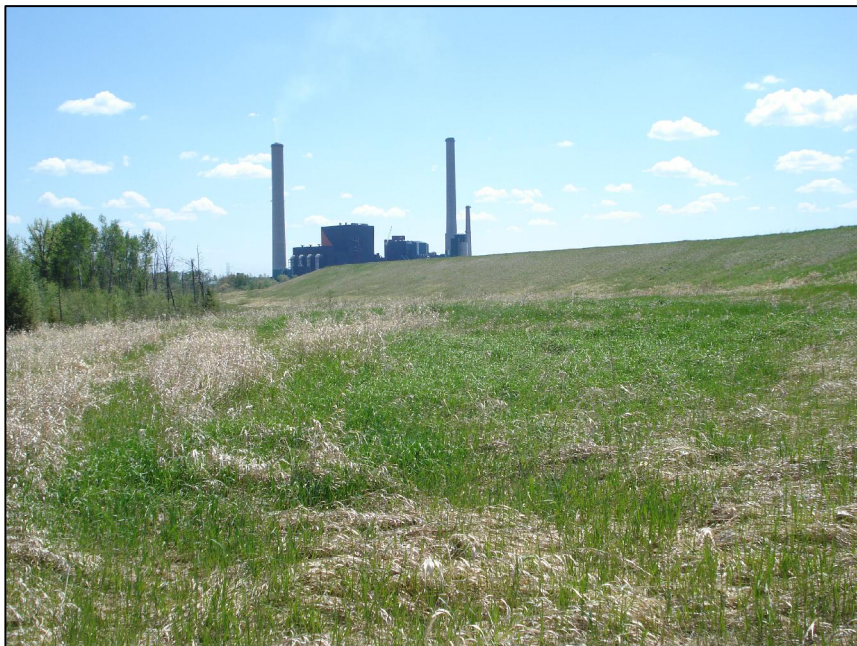
**1-20**

**FROM EASTERN DOWNSTREAM TOE LOOKING SOUTHEAST TOWARDS BOSWELL ENERGY CENTER**

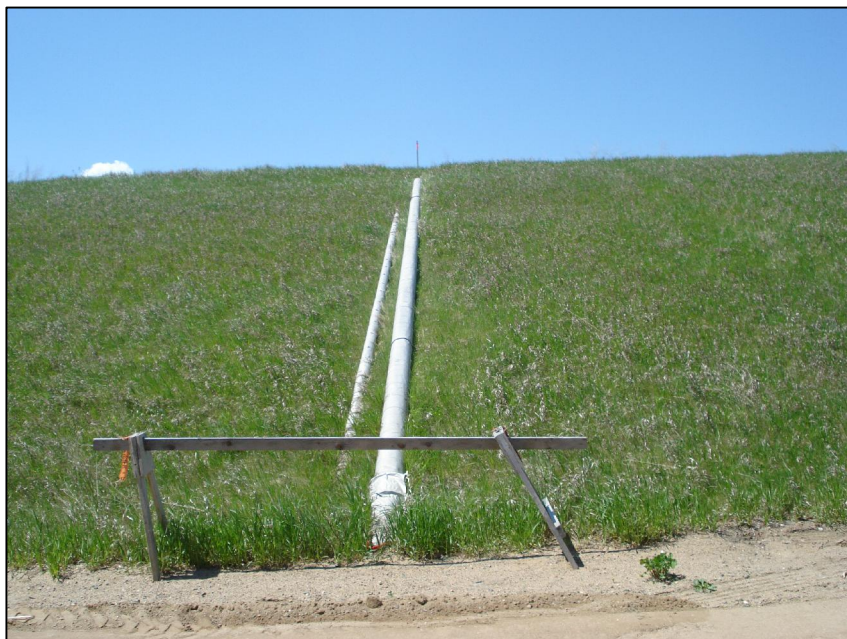
**1-21**

**DISCHARGE LINES FROM PUMP HOUSE ALONG SOUTHEASTERN TOE**

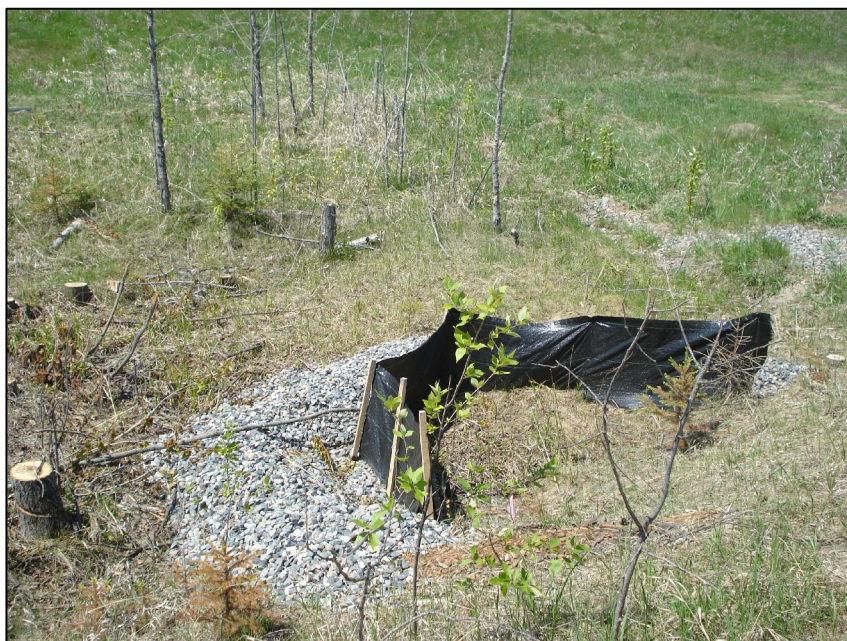
**1-22**

**EROSION CONTROL EFFORTS ALONG SOUTHEASTERN DOWNSTREAM TOE**

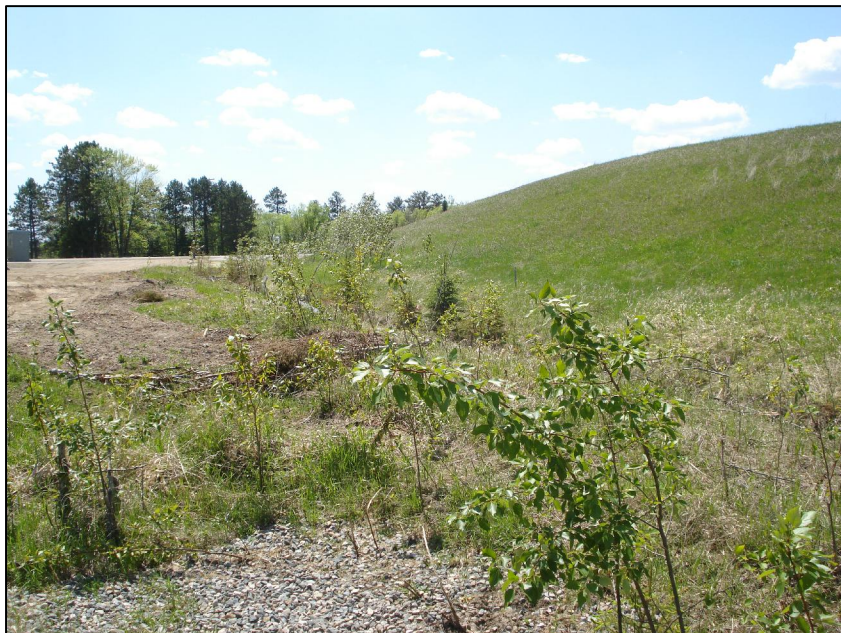
**1-23**

**GENERAL SITE PHOTO ALONG SOUTHEASTERN DOWNSTREAM TOE**

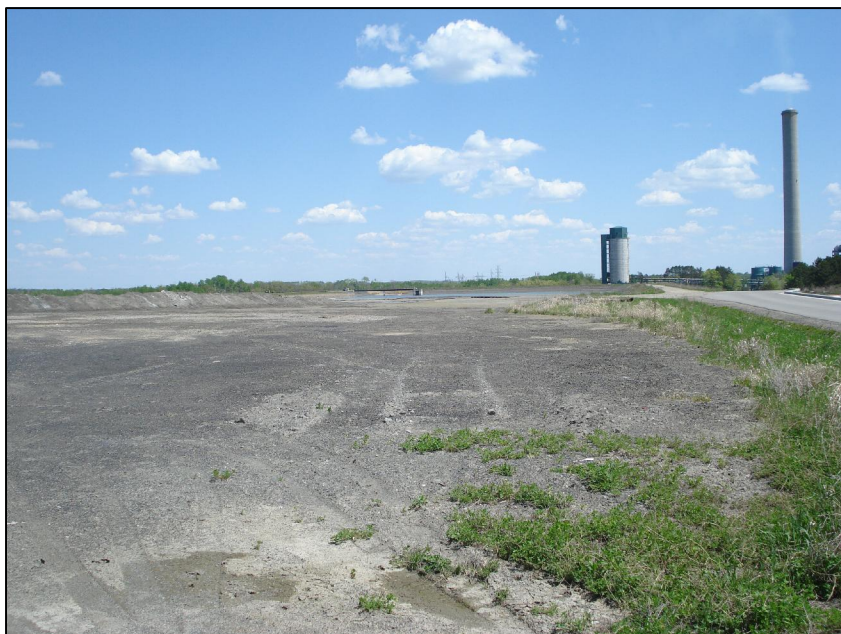
**1-24**

**VIEW FROM SOUTHERN DIKE ALONG BOTTOM ASH POND LOOKING EAST TOWARDS BOTTOM ASH POND**

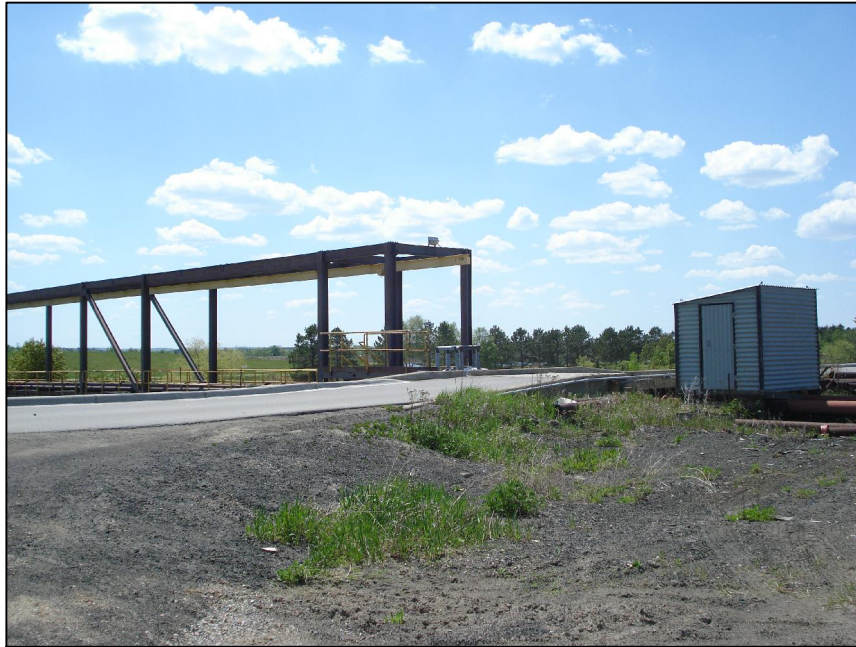
**1-25**

**INTAKE STRUCTURE FOR BOTTOM ASH POND DISCHARGE LINES**

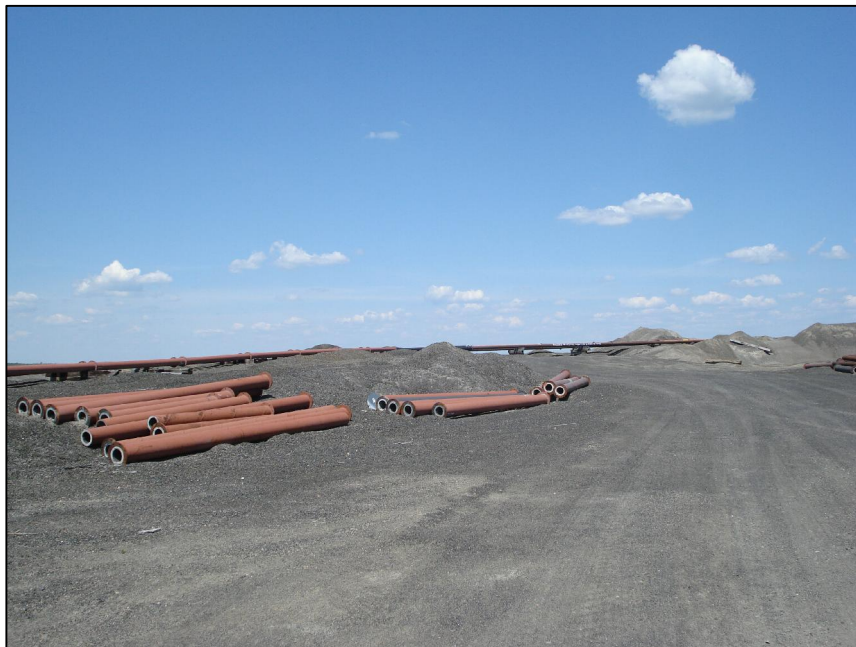
**1-26**

**VIEW FROM SOUTHERN DIKE ALONG BOTTOM ASH POND LOOKING NORTH**

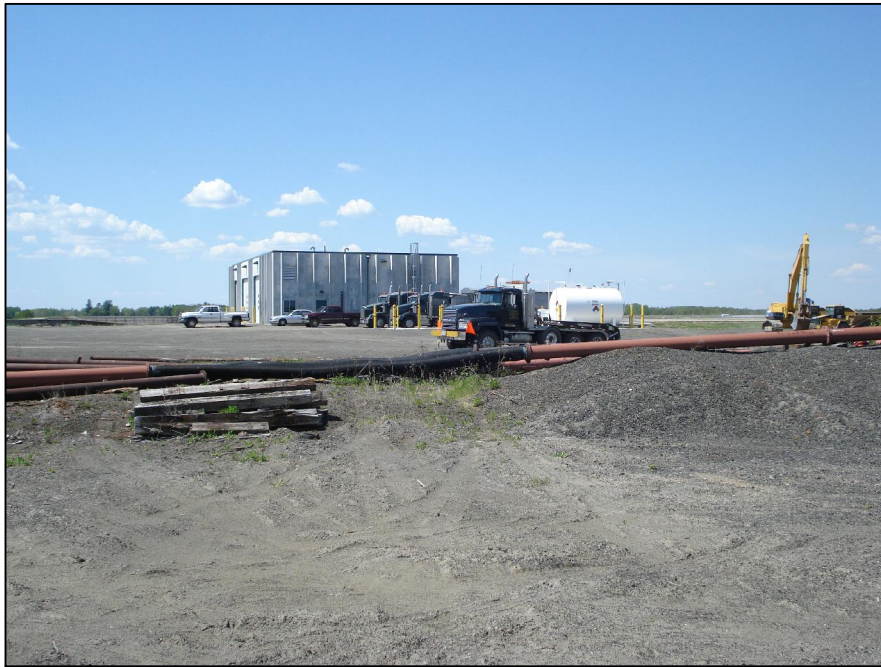
**1-27**

**MAINTENANCE STRUCTURE IN BOTTOM ASH POND, DISCHARGE LINES IN FOREGROUND**

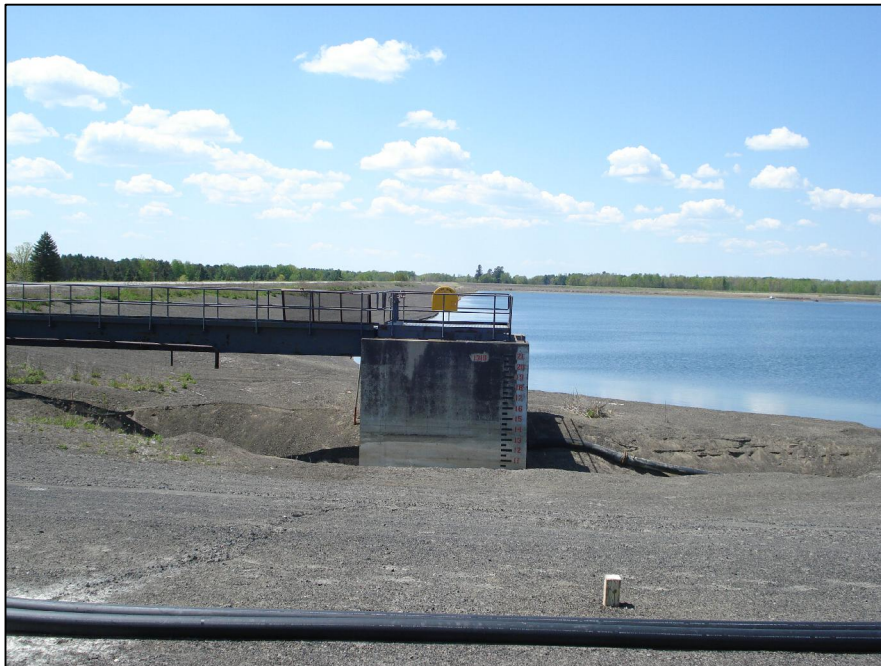
**1-28**

**OUTLET STRUCTURE FROM POND 3**

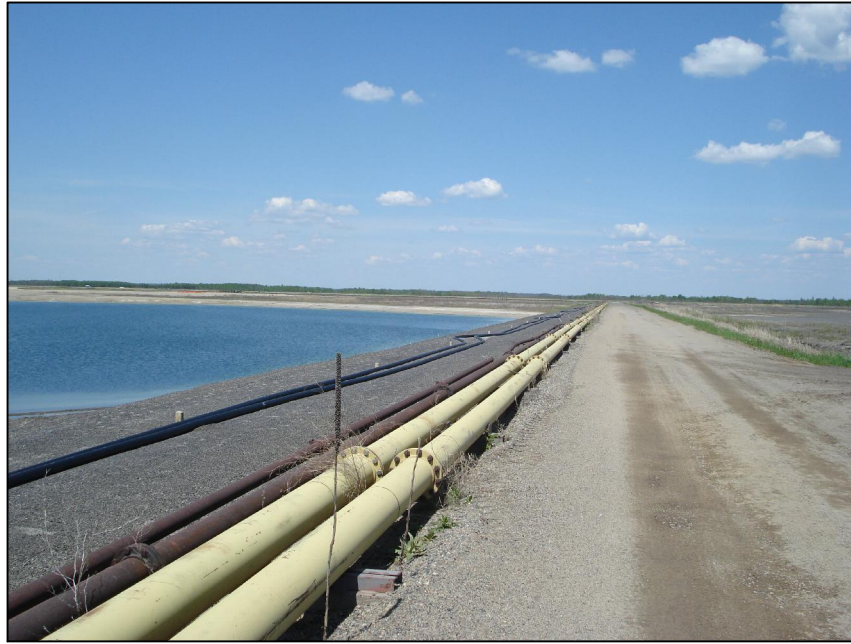
**1-29**

**VIEW FROM DIVIDING DIKE BETWEEN BOTTOM ASH POND AND POND 3 LOOKING NORTH**

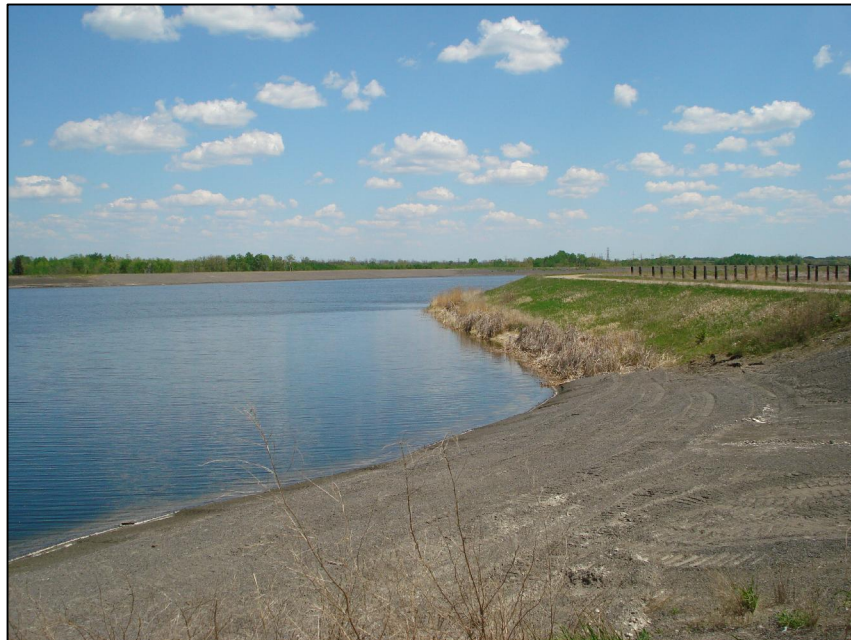
**1-30**

**VIEW FROM DIVIDING DIKE AT INTERSECTION OF BOTTOM ASH POND, POND 3 AND POND 4 LOOKING WEST**

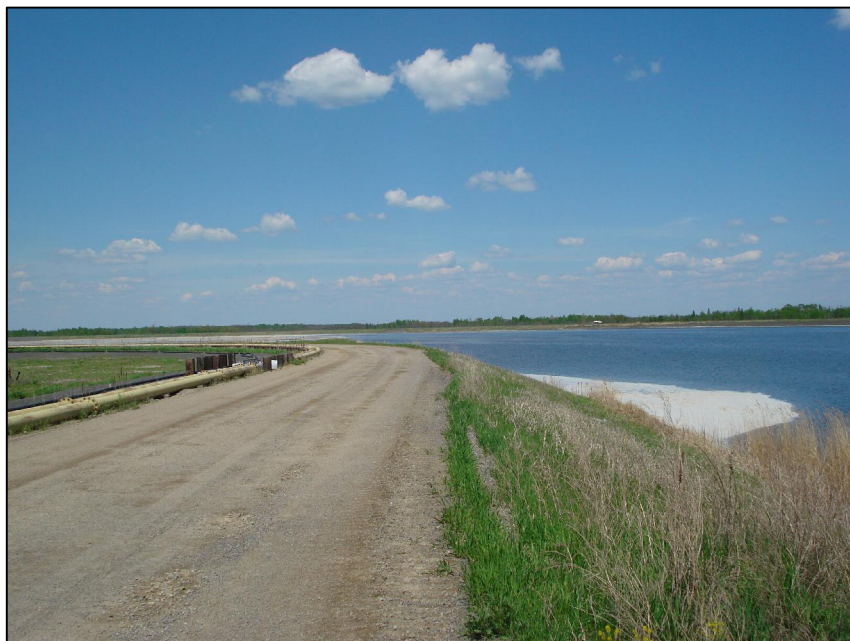
**1-31**

**VIEW FROM DIVIDING DIKE AT INTERSECTION OF BOTTOM ASH POND, POND 3 AND POND 4 LOOKING NORTH**

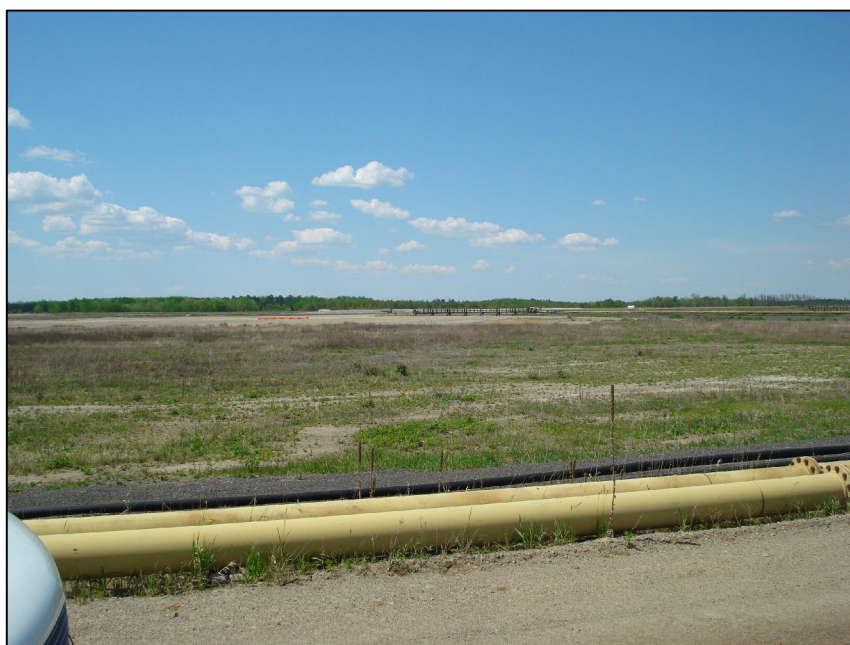
**1-32**

**VIEW FROM DIVIDING DIKE BETWEEN POND 3 AND POND 4 LOOKING SOUTH**

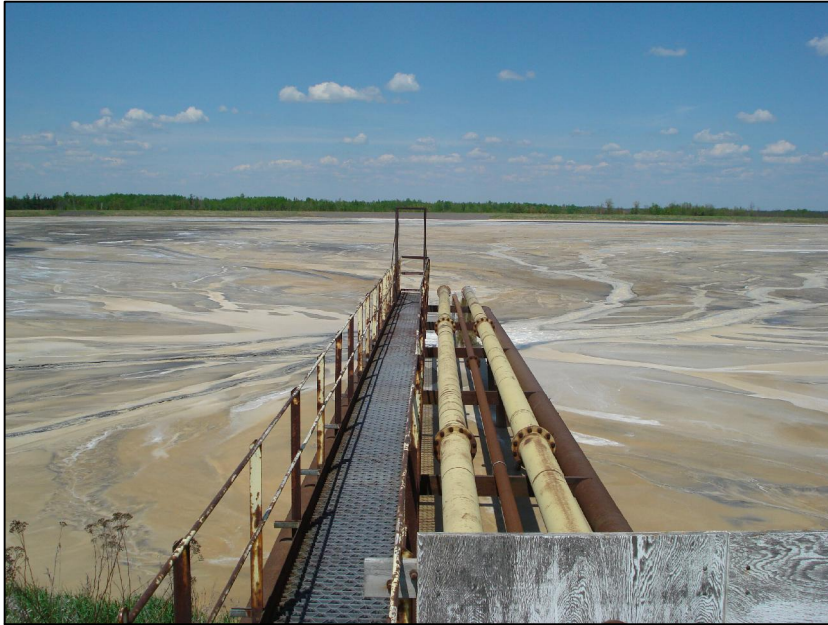
**1-33**

**DISCHARGE STRUCTURE FROM PLANT TO POND 4**

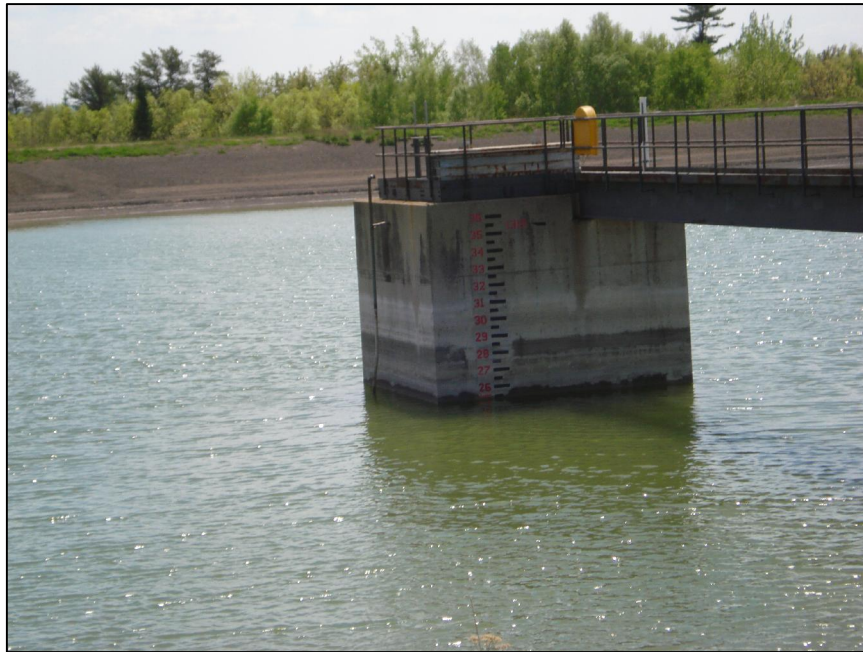
**1-39**

**OUTLET STRUCTURE FOR BOTTOM ASH POND**

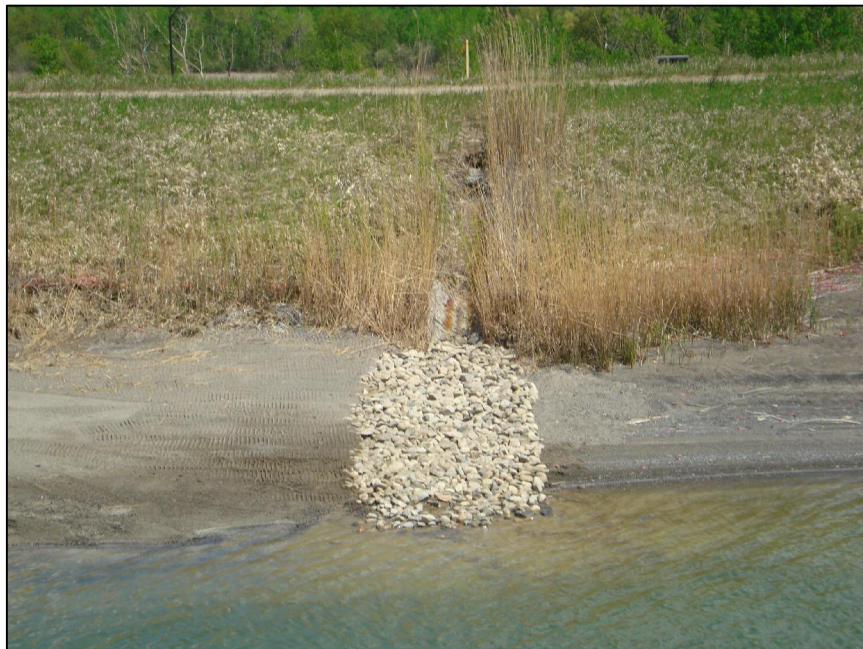
**1-40**

**OUTLET DRAIN FOR PUMP HOUSE ALONG SOUTHEASTERN DOWNSTREAM TOE**

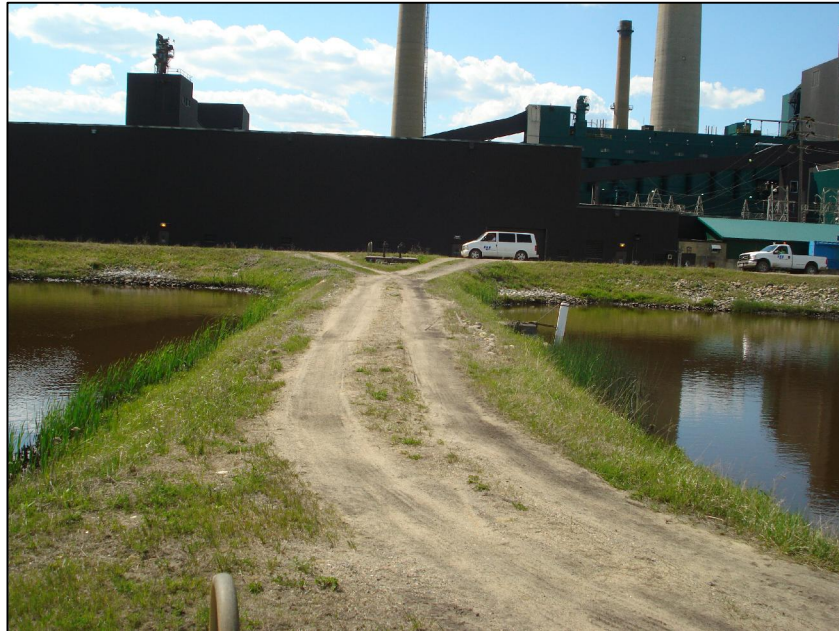
**2-1**

**GENERAL SITE PHOTO FROM CENTER OF POND LOOKING WEST**

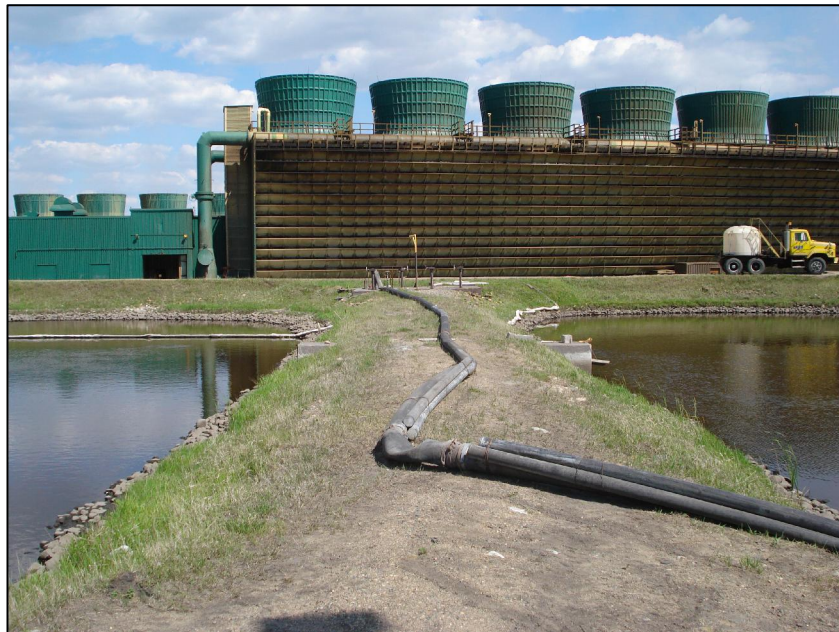
**2-2**

**GENERAL SITE PHOTO FROM CENTER OF POND LOOKING EAST**

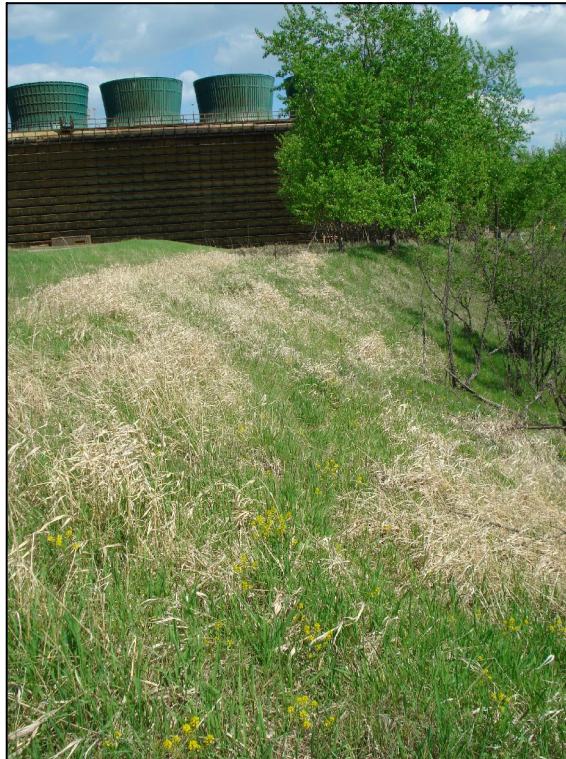
**2-3**

**VIEW ALONG OUTFALL (SD004) LOOKING EAST**

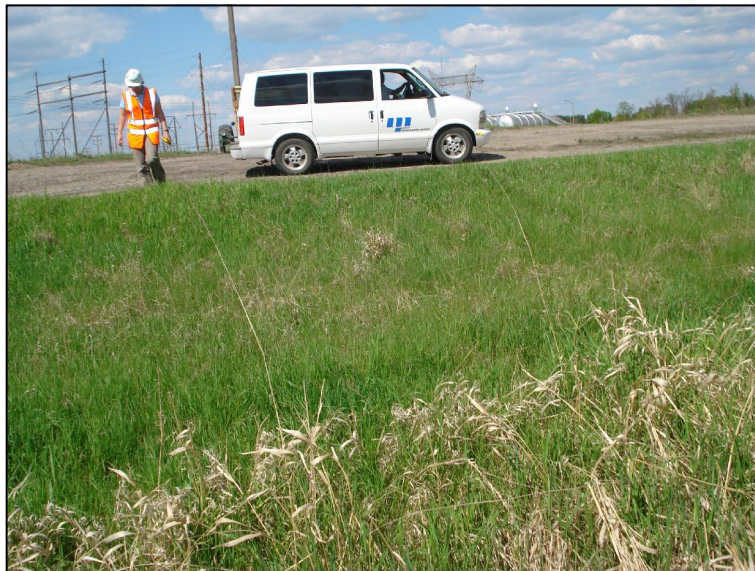
**2-4**

**GENERAL SITE PHOTO FROM CENTER OF POND LOOKING EAST**

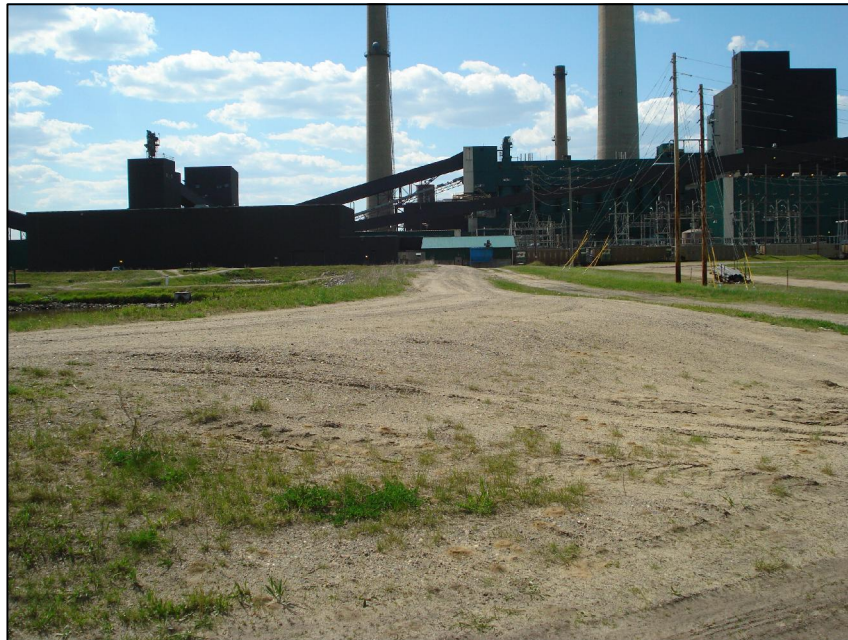
**2-5**

**FROM NORTHEASTERN EDGE OF WWTP LOOKING WEST TOWARDS PLANT**

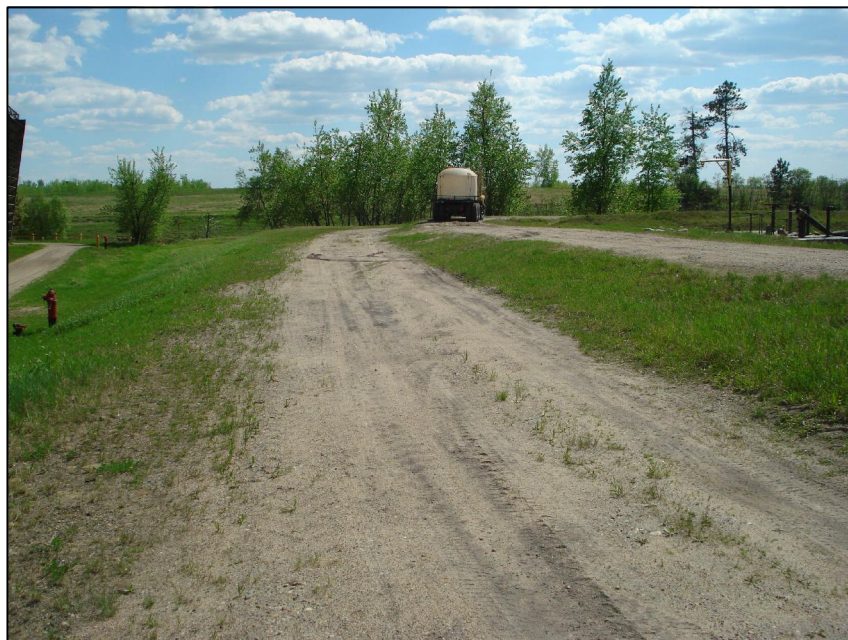
**2-6**

**FROM NORTHEASTERN EDGE OF WWTP LOOKING EAST**

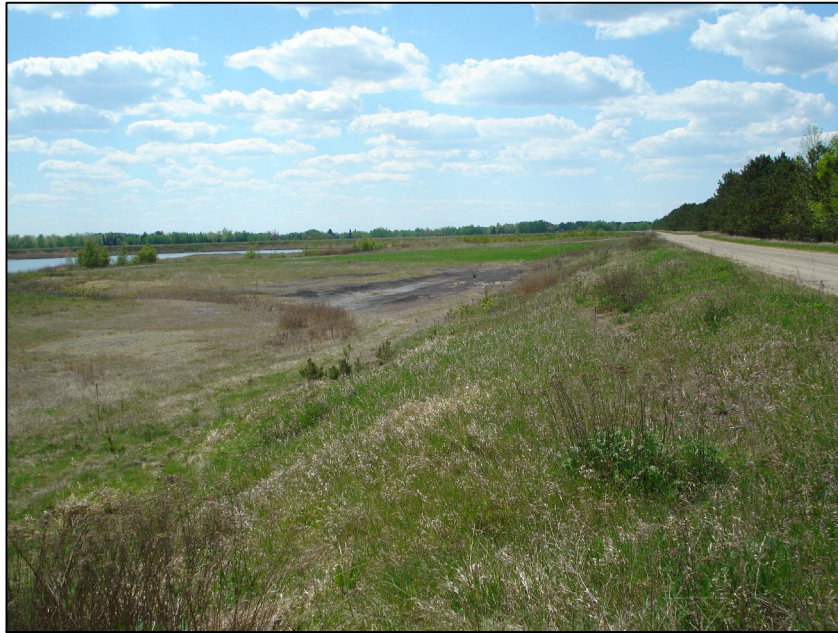
**3-1**

**GENERAL SITE PHOTO FROM NORTHERN DIKE LOOKING WEST**

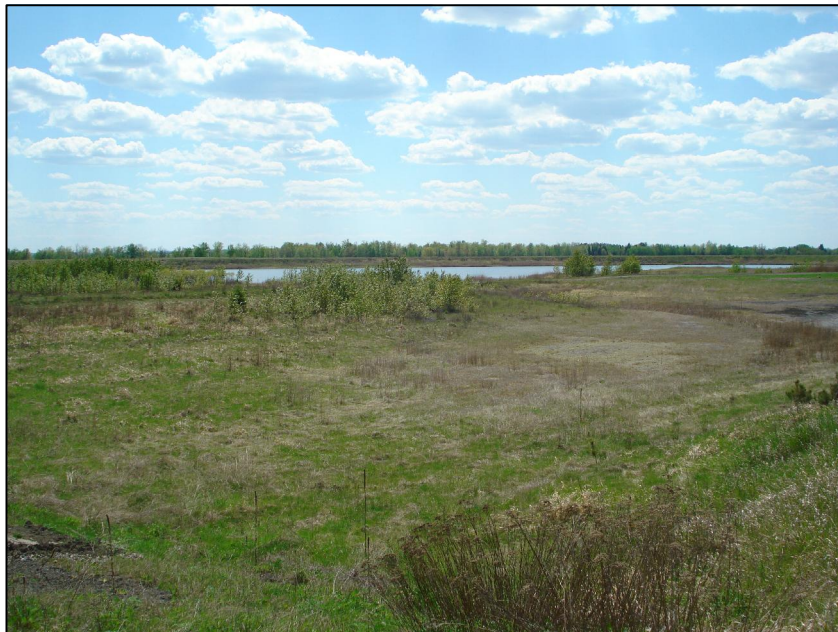
**3-2**

**GENERAL SITE PHOTO FROM NORTHERN DIKE LOOKING NORTHWEST**

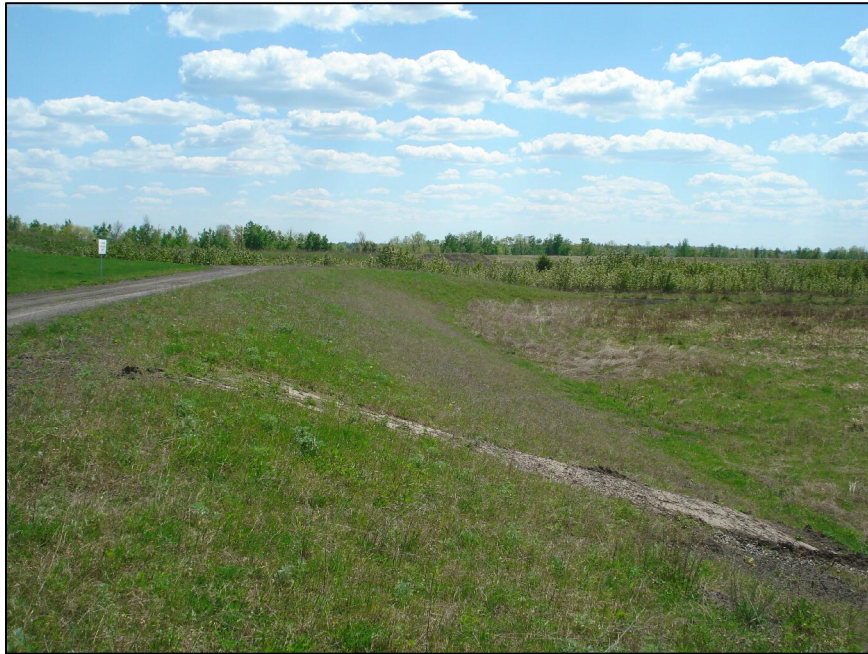
**3-3**

**GENERAL SITE PHOTO FROM NORTHERN DIKE LOOKING NORTH**

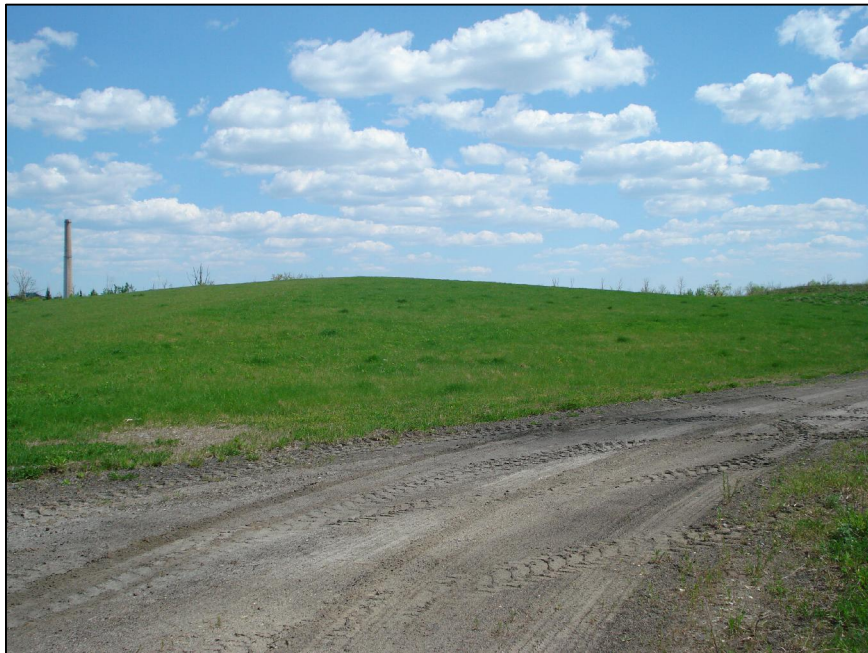
**3-4**

**GENERAL SITE PHOTO FROM NORTHERN DIKE LOOKING EAST TOWARDS THE CLOSED HIBBING PUBLIC UTILITIES ASH CELL**
