Report of Geotechnical  
Assessment of Coal Combustion Surface  
Impoundments  
Minnesota Power  
Boswell Energy Center, Cohasset, MN

AMEC Project No. 3-2106-0174.0300

June 2010

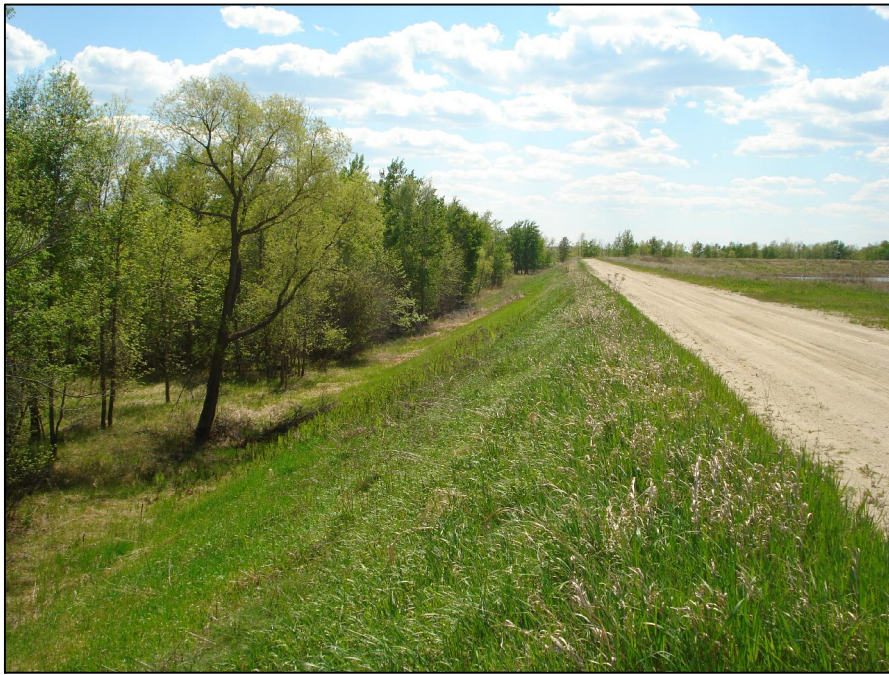
**3-5**

**GENERAL DOWNSTREAM SLOPE ALONG EASTERN DIKE**

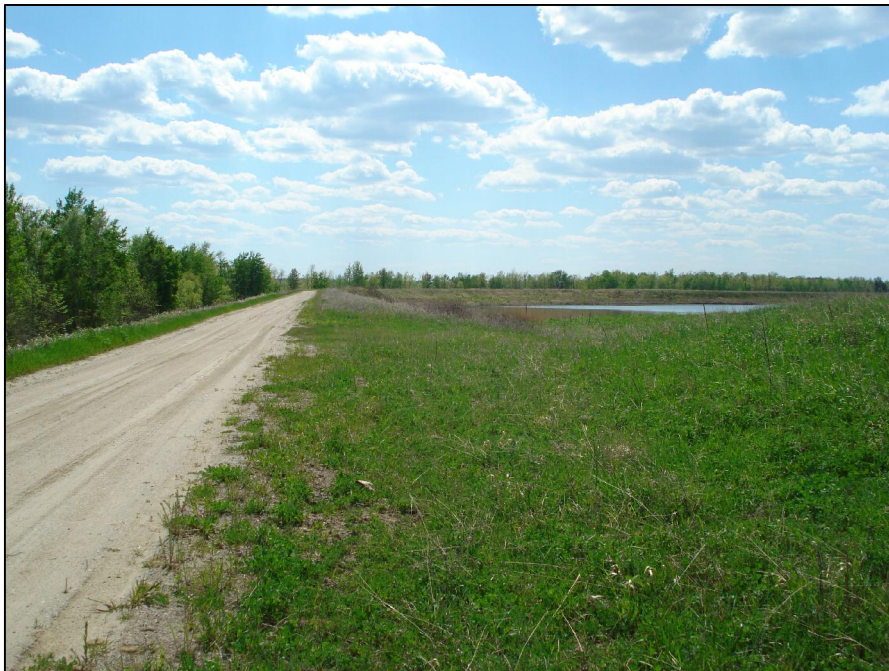
**3-6**

**VIEW FROM EASTERN DIKE LOOKING SOUTHWEST TOWARDS INDUSTRIAL SOLID WASTE AREA AND INACTIVE BOTTOM ASH POND**

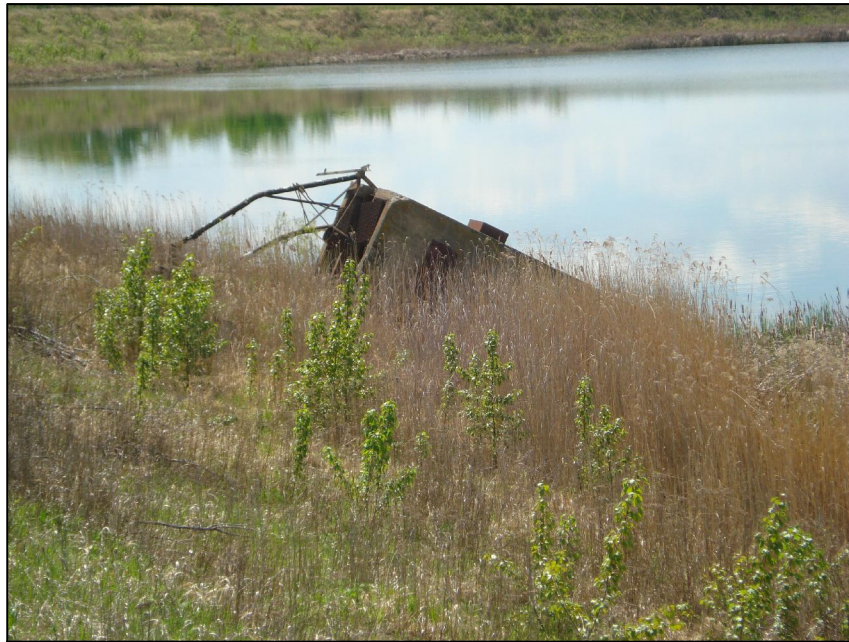
**3-7**

**OLD DISCHARGE STRUCTURE ALONG SOUTHEASTERN DOWNSTREAM TOE**

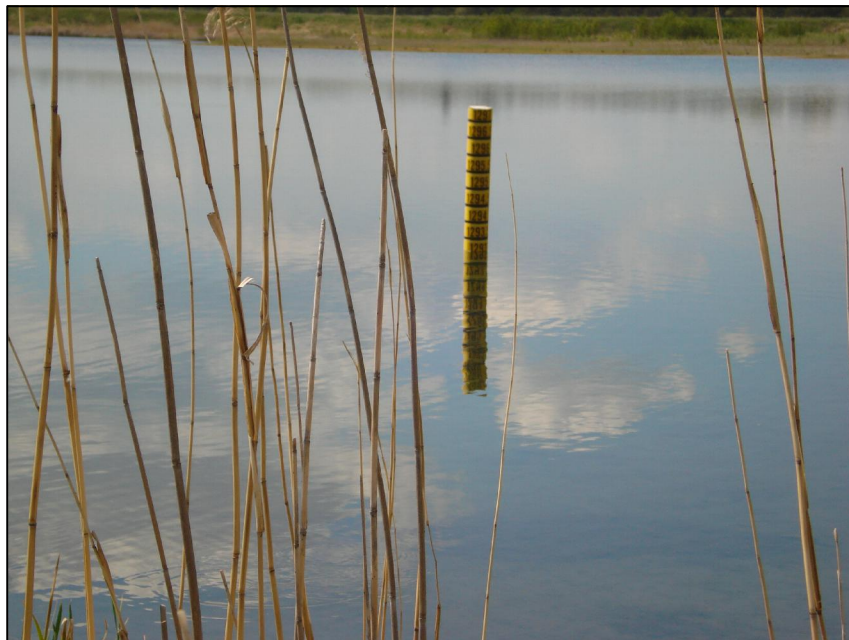
**3-8**

**GAUGE IN INACTIVE BOTTOM ASH POND ALONG SOUTHEASTERN UPSTREAM TOE AT APPROX 1282 FEET**

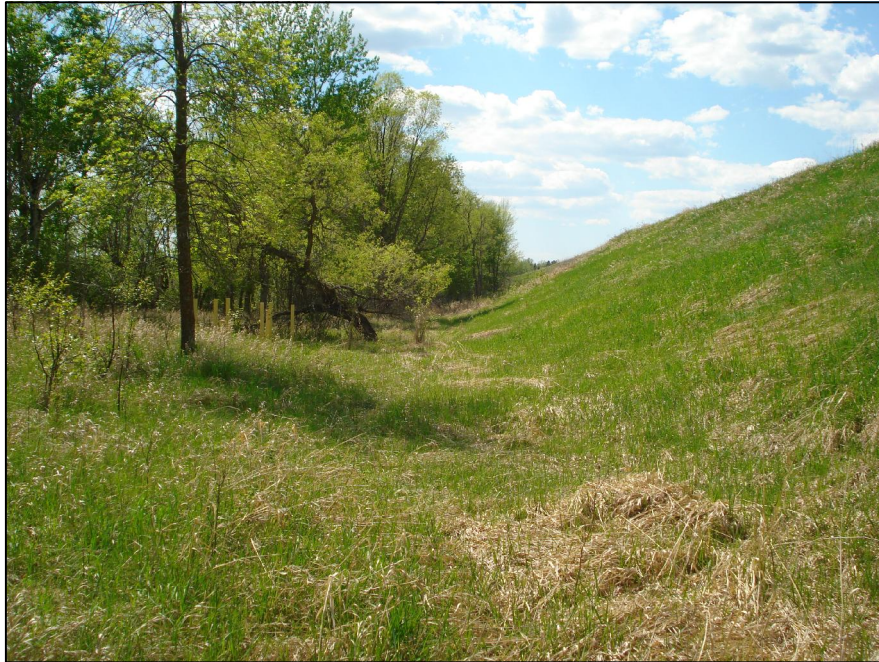
**3-9**

**GENERAL SITE PHOTO ALONG SOUTHERN DOWNSTREAM TOE LOOKING WEST (NEAR MONITORING WELLS NDM24S/24D)**

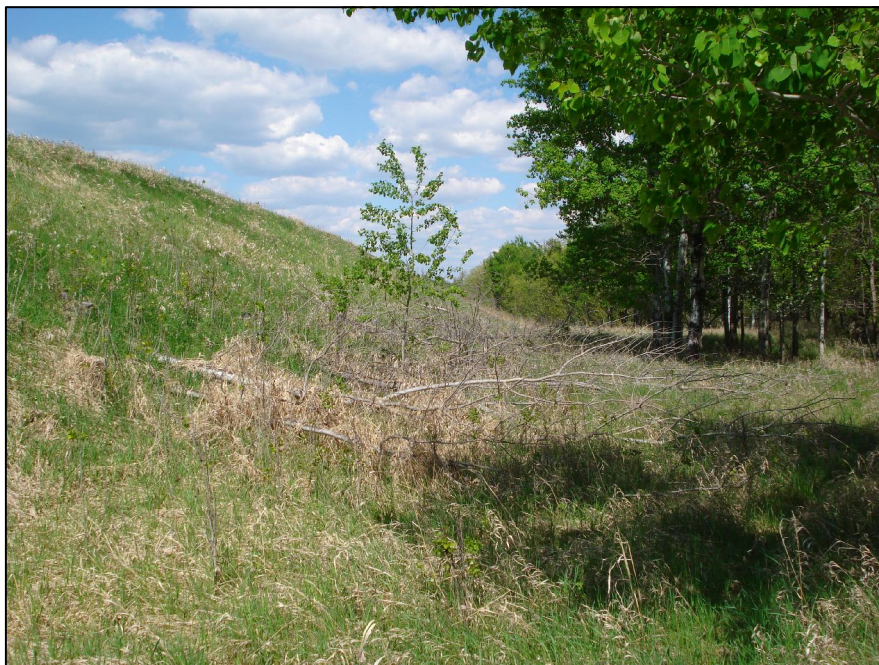
**3-10**

**GENERAL SITE PHOTO ALONG SOUTHERN DOWNSTREAM TOE LOOKING EAST**

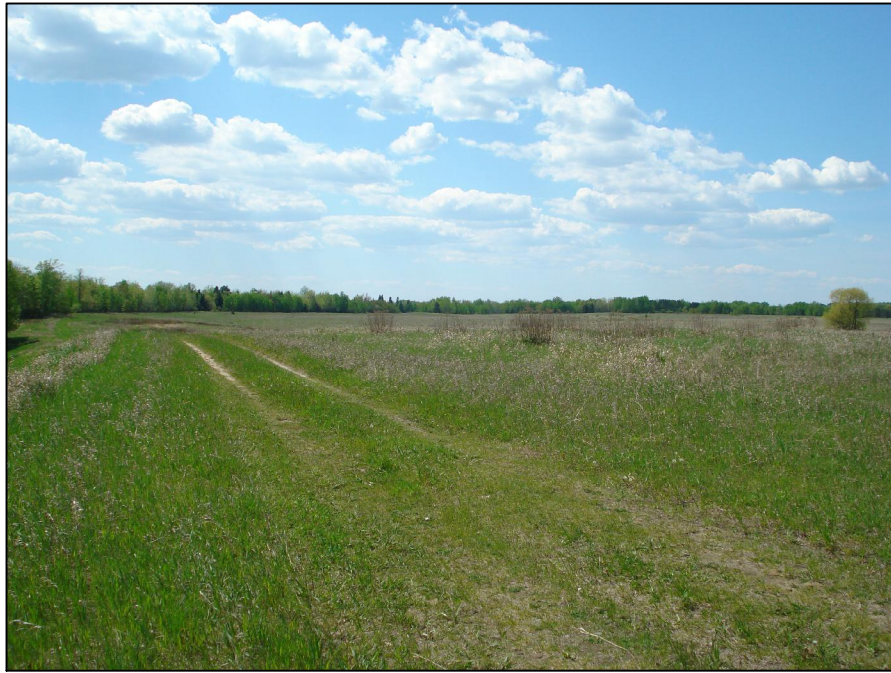
**3-11**

**VIEW FROM SOUTHERN DIKE LOOKING WEST TOWARDS INACTIVE FLY ASH POND**

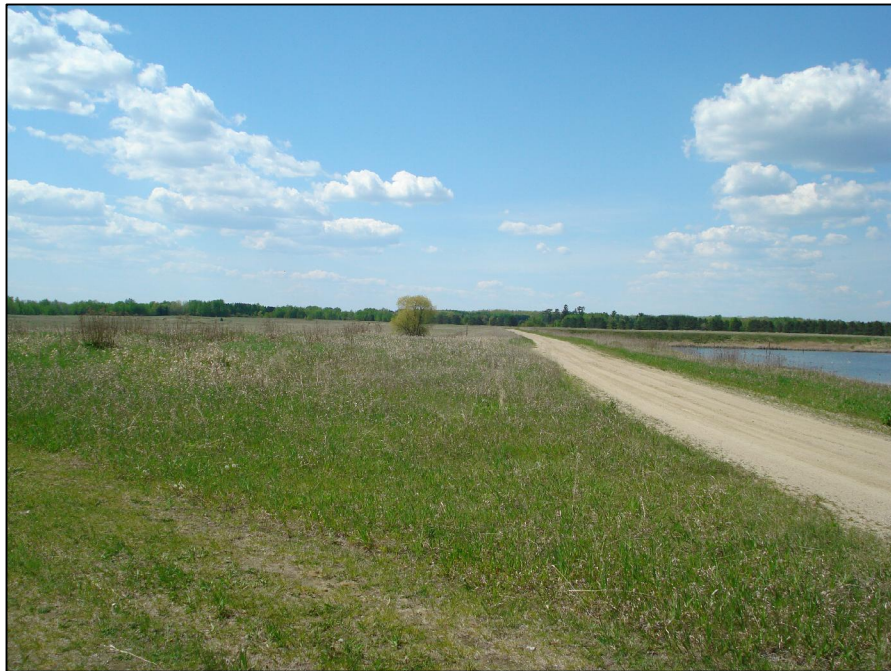
**3-12**

**VIEW FROM SOUTHERN DIKE LOOKING NORTH TOWARDS INACTIVE FLY ASH POND AND DIVIDING DIKE**

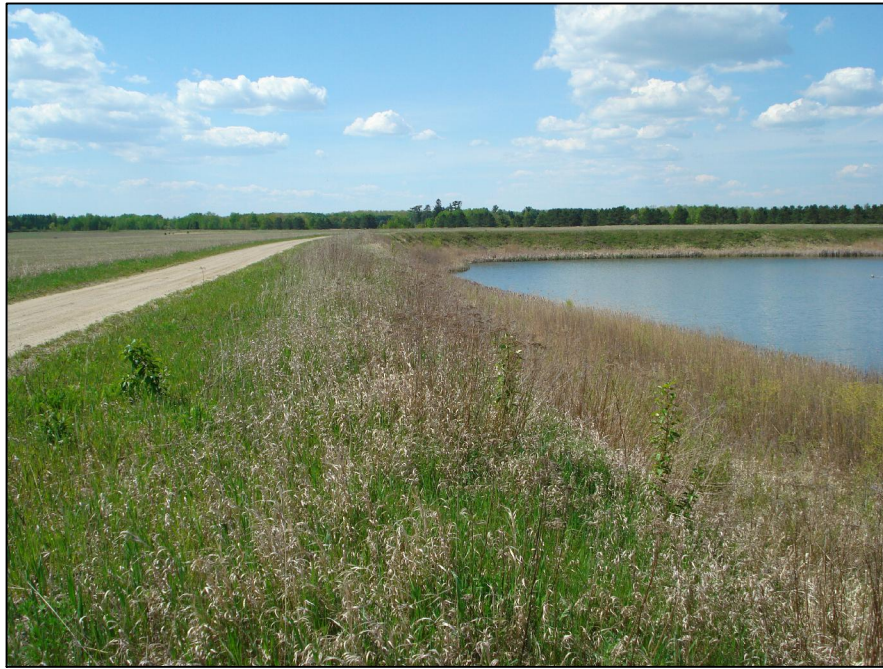
**3-13**

**TYPICAL DOWNSTREAM SLOPE FROM WESTERN (DIVIDING) DIKE LOOKING NORTH**
