**DRAFT REPORT
ROUND 7 DAM ASSESSMENT - WISCONSIN POWER & LIGHT
COLUMBIA GENERATING STATION
PRIMARY ASH, SECONDARY ASH, POLISHING & LANDFILL
STORMWATER PONDS
PARDEEVILLE, WISCONSIN**

January 17, 2011

Re: Round 7 Dam Assessment - Draft Report
EPA Contract No. EP10W001313
Wisconsin Power & Light – Columbia Generating Station
Primary Ash, Secondary Ash, Polishing & Landfill Storm Water Ponds
Pardeeville, Wisconsin

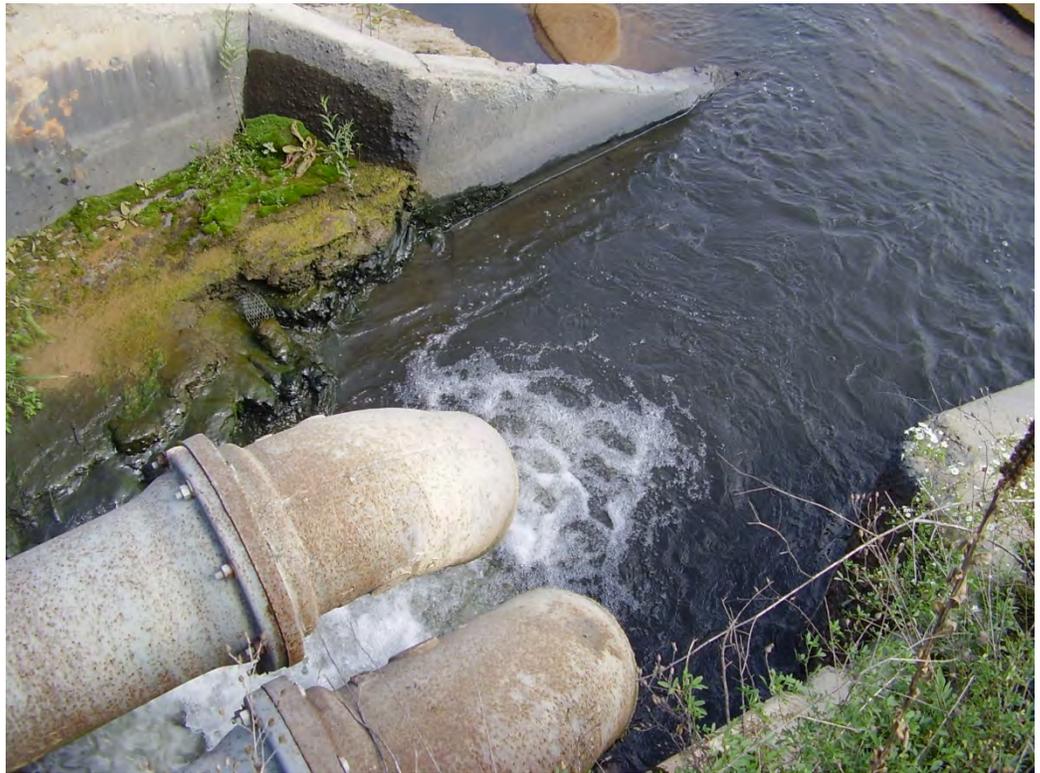
Photo No. 3	Date: 9/28/10
Direction Photo Taken: Northeast

Description:
PAP Discharge Pipelines:
(2) 12" Diameter

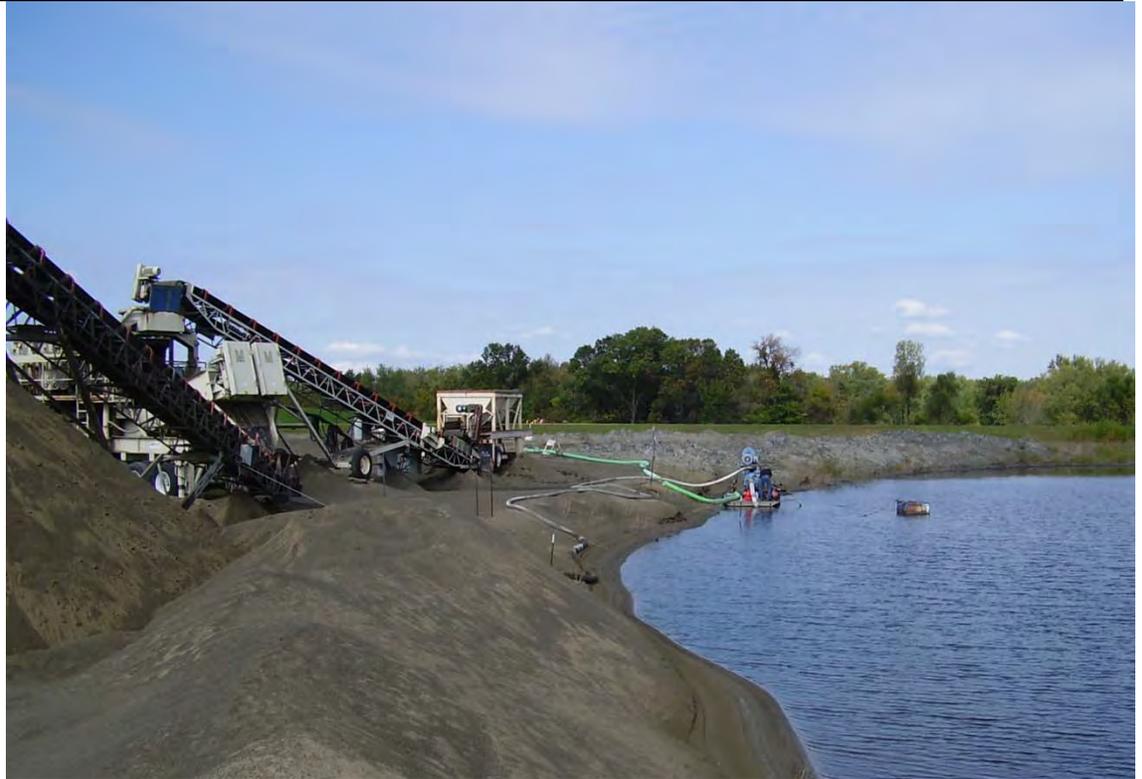
Description:
Upstream slope of PAP

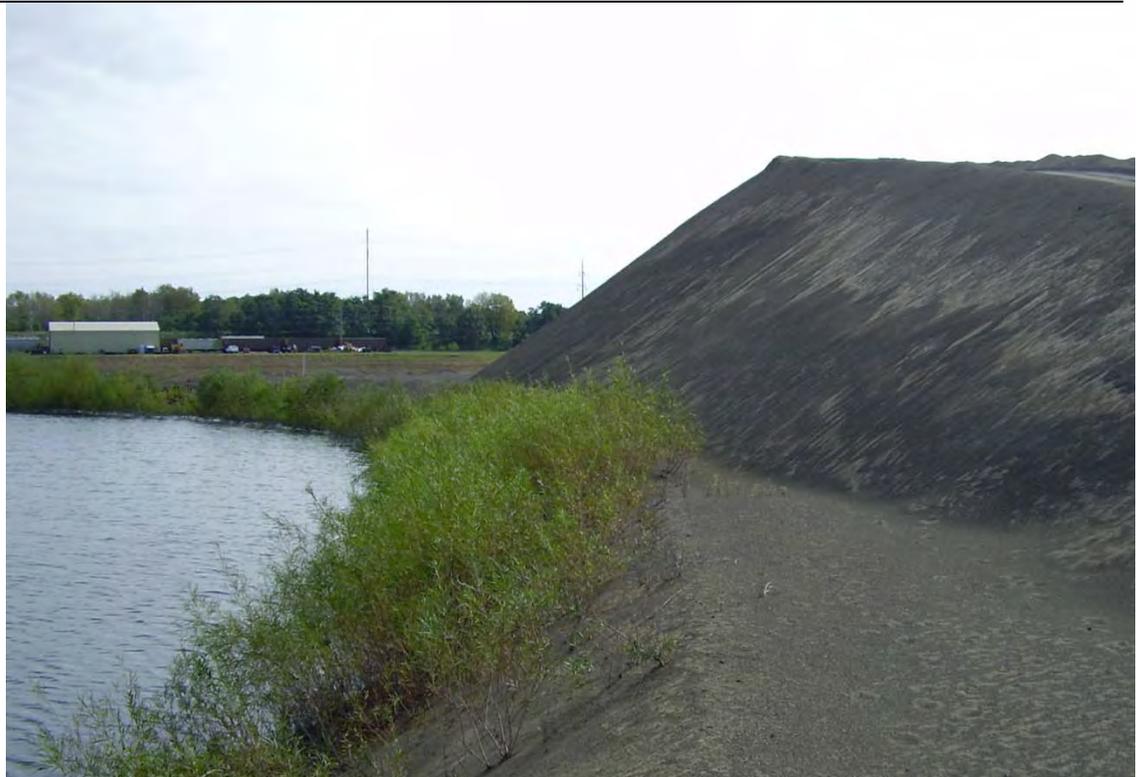
Photo No.
12

Description:
Upstream slope of PAP.

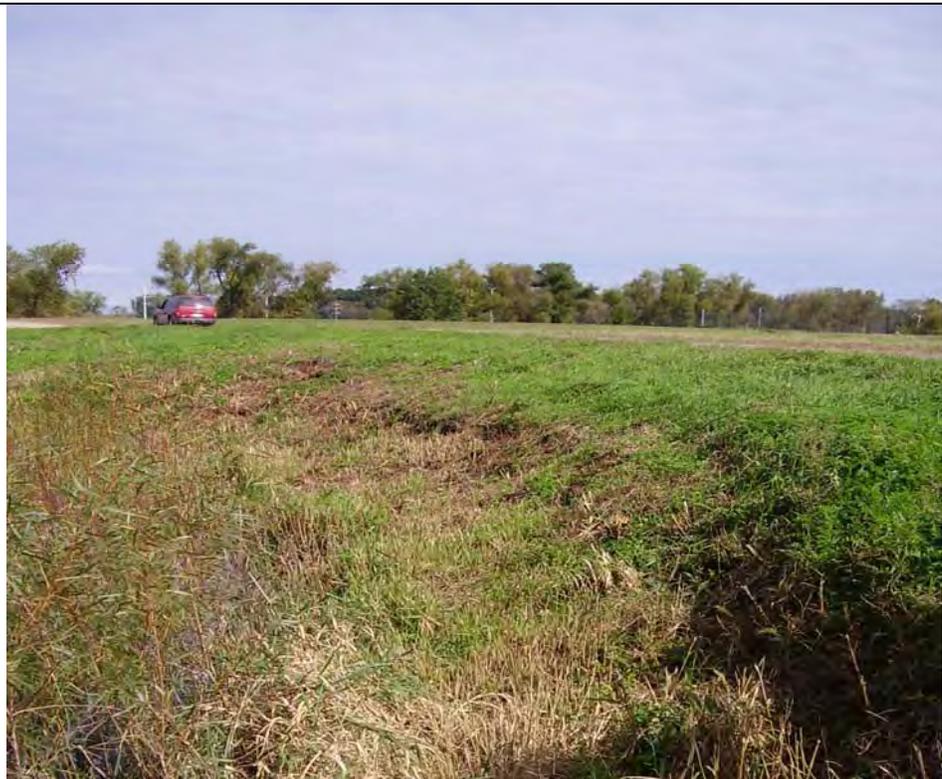
Photo No.
16

The PAP water surface elevation at the time of inspection was at an elevation of 796 feet MSL. Therefore, the lower portion of the upstream slope was underwater or covered by ash deltas and not visible. No rip rap was present on the upstream slope and there was wave action erosion of the upstream slope at the pond water elevation throughout much of the impoundment. An example of the observed erosion is shown in Photo 16. The upstream slope was generally vegetated with grass that appeared to be regularly mowed.

Upstream slope of PAP and
downstream slope of SAP.

1. Evaluate the extent of wave action erosion on the upstream slopes of the PAP;
2. Perform a hydrologic/hydraulic analysis of the PAP, SAP and PP to determine the adequacy of the current operating conditions and design to accommodate the appropriate precipitation event;
3. Evaluate the slope and seepage stability of the PAP, SAP and LSP based on current operating conditions and methodologies. The effects of high water events from the Wisconsin River should be considered in the analysis for the PAP and SAP; and,
4. Develop an EAP for the impoundments.

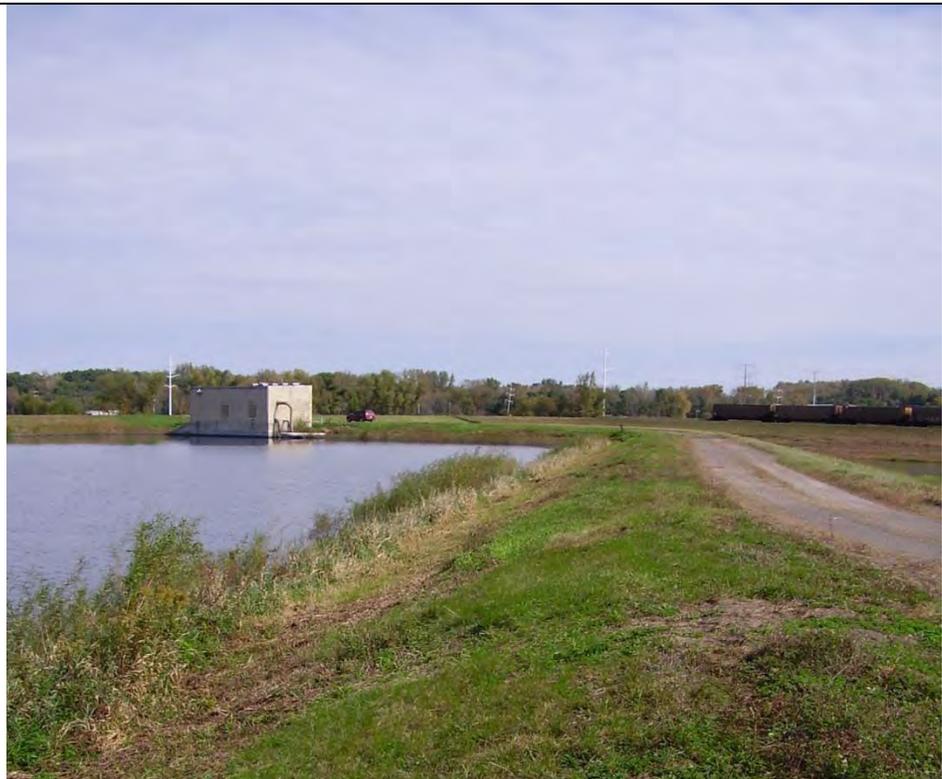
Photo No.
20

Description:
Crest of embankment
separating PAP and SAP.

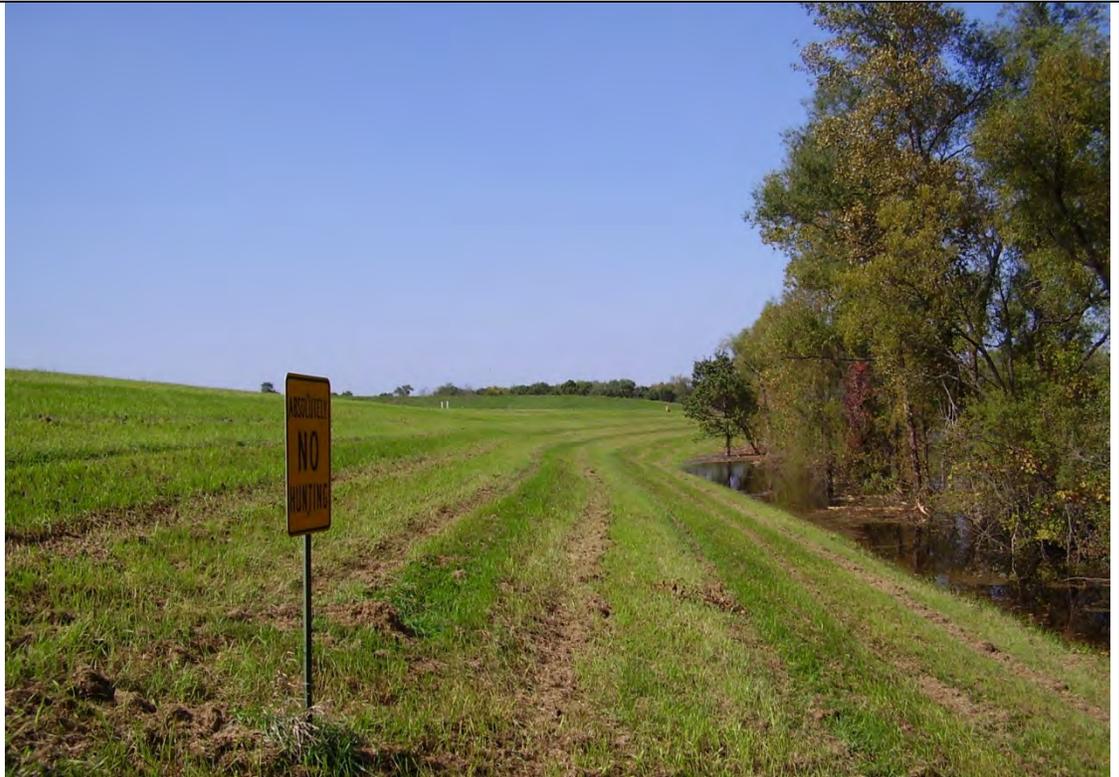
Photo No.
24

Description:
Downstream slope of PAP

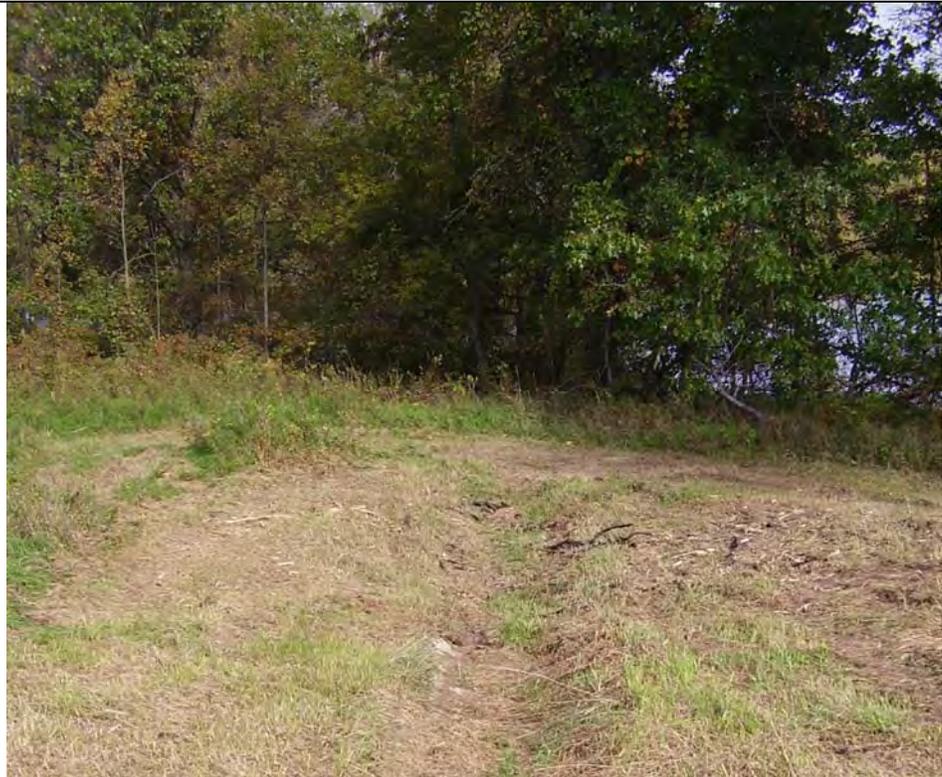
Photo No.
28

Description:
Downstream slope of PAP
and concrete lined ditch

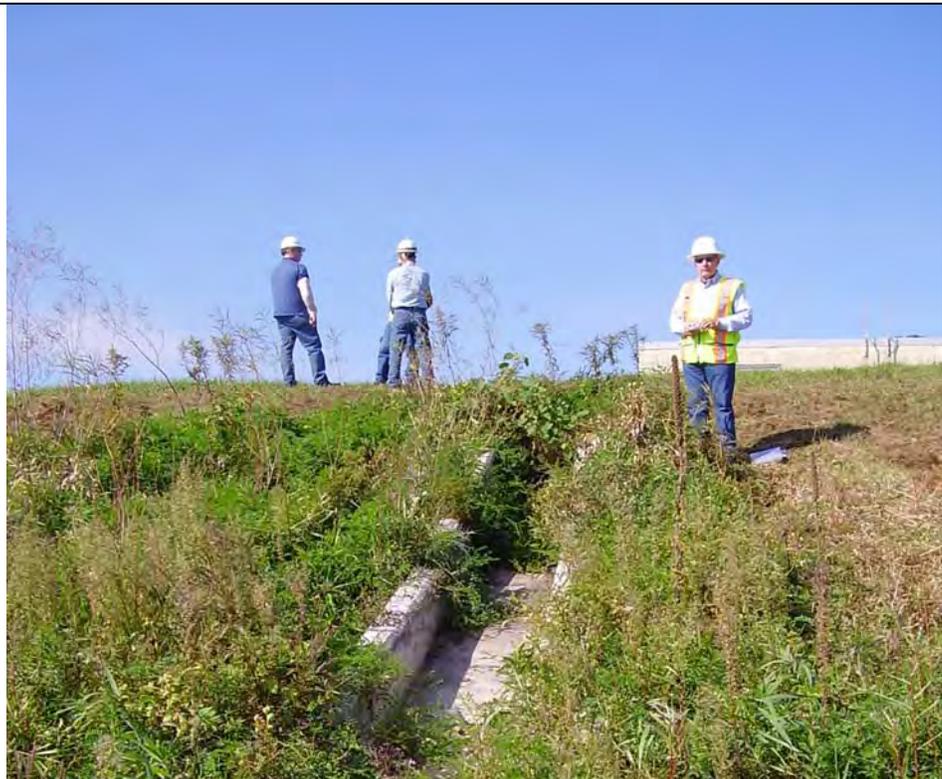
Photo No.
30

Description:
Upstream slope of SAP,
downstream slope of PAP,
and 8" discharge pipeline
and concrete spillway.

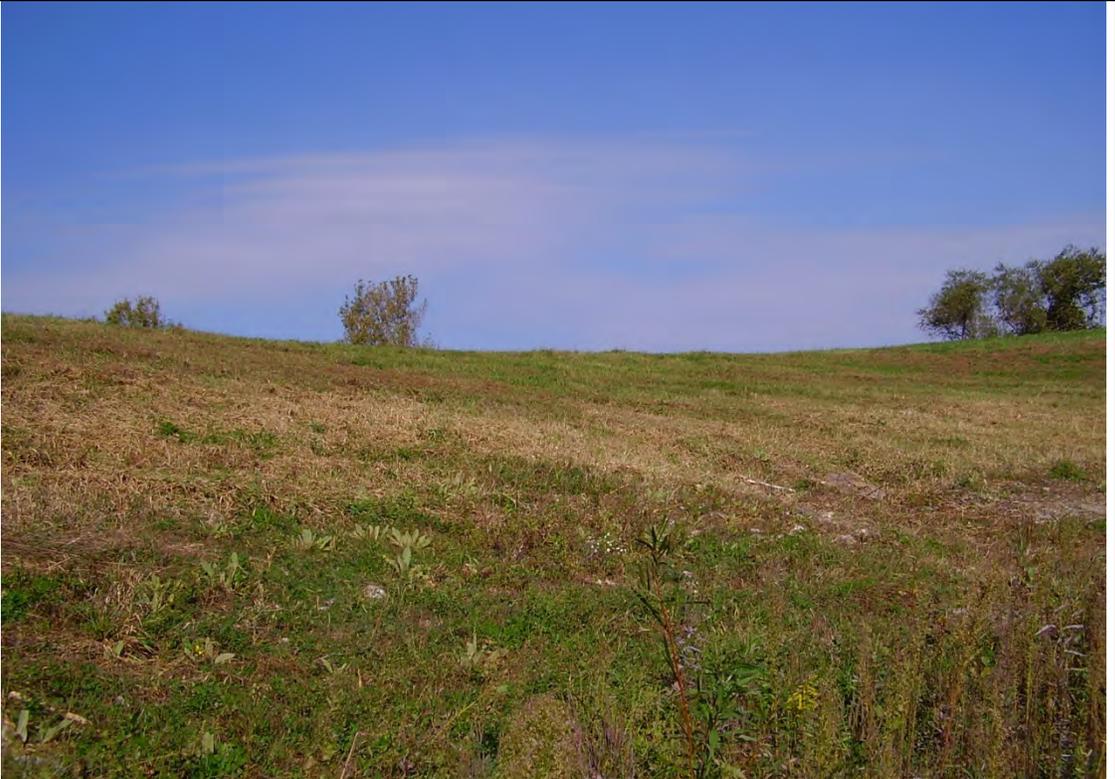
Photo No. 31	Date: 9/28/10
Direction Photo Taken: North

The SAP water elevation at the time of inspection was approximately at an elevation of 790 feet MSL¹⁵. Therefore, the lower portion of the upstream slope was underwater or covered by ash deltas and not visible. No rip rap was present on the upstream slope and there was minor wave action erosion of the upstream slope at the historic pond water elevation (approximately 796 feet MSL) throughout much of the impoundment. An example of the observed erosion is shown in Photo 31. The upstream slope was generally vegetated with grass that appeared to be regularly mowed.

Description:
Upstream slope of SAP and downstream slope of PAP.

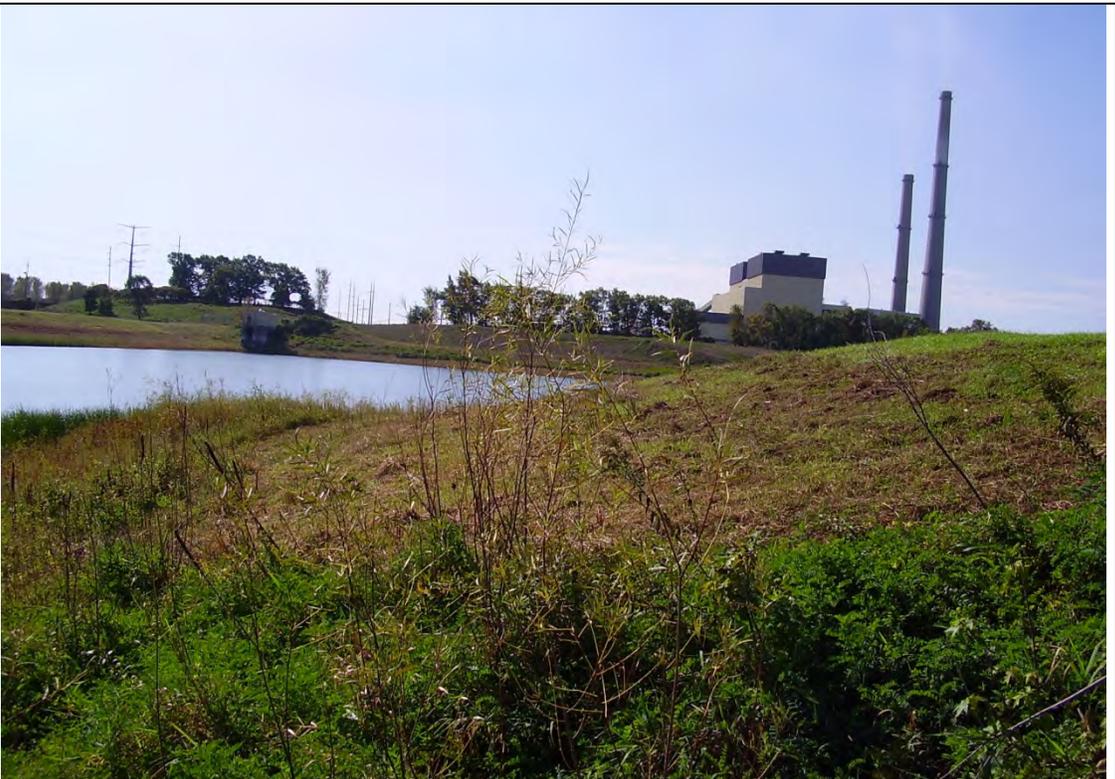
Photo No. 32	Date: 9/28/10
Direction Photo Taken: South

Description:
Upstream slope of SAP and downstream slope of PAP.

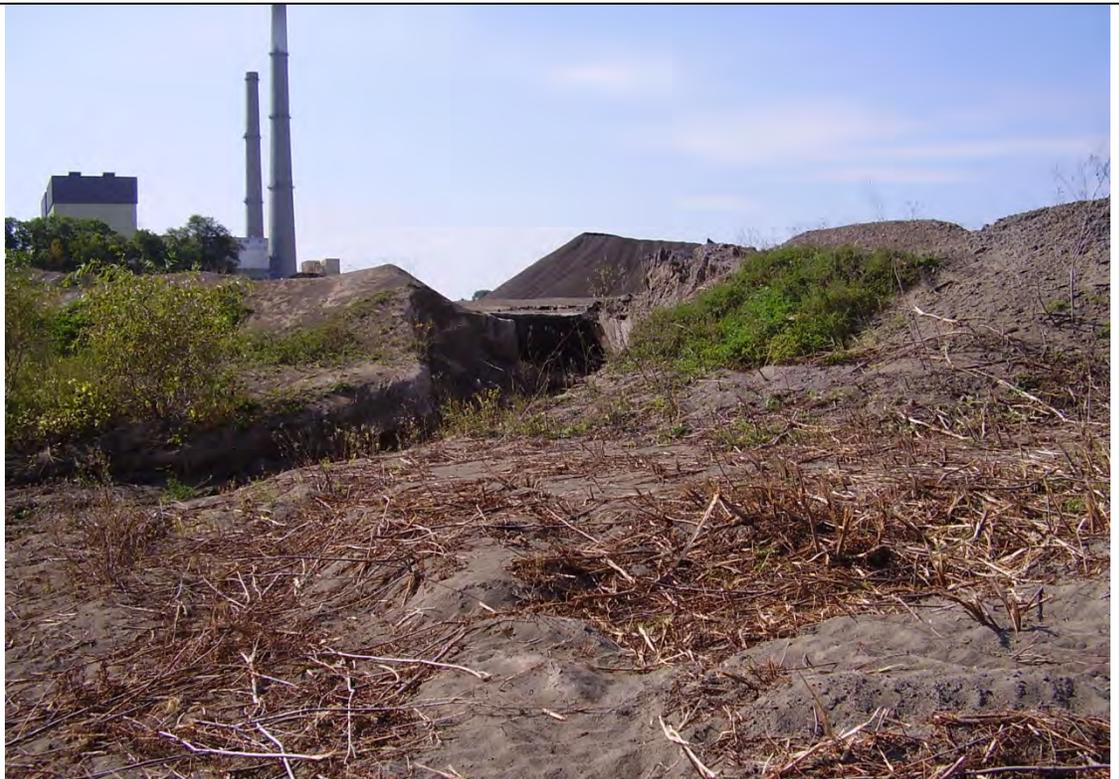
Photo No.
34

The impoundment is incised along the western and southern embankments. An embankment separates the PAP from the SAP such that the eastern embankment downstream slope of the PAP is the same as the western embankment upstream slope of the SAP. The backwaters of the Wisconsin River are generally near the downstream slope of the northern embankment of the PAP. During high water events, such as occurred during our Site visit, the backwaters of the Wisconsin River cover the downstream toe and part of the northern embankment as shown in Photos 24 through 26. The downstream slope of the northern embankment of the impoundment was generally in good condition. The northern embankment was vegetated with grass that appeared to be regularly mowed and trees had recently been removed from the northern embankment as shown in Photo 27. There was minor wave action erosion over much of the eastern embankment downstream slope as shown in Photos 31 and 32. A large ditch that appeared to be formed by stormwater erosion was noted on the downstream slope near the southeast corner of the PAP. The eroded ditch was approximately 10 feet wide, 6 feet to 8 feet deep, and 50 feet long and is shown in Photos 34 and 35.

Description:
Upstream slope of SAP,
downstream slope of PAP,
and large erosional feature.

1. Repair erosion ditches present in the PAP, SAP and LSP.

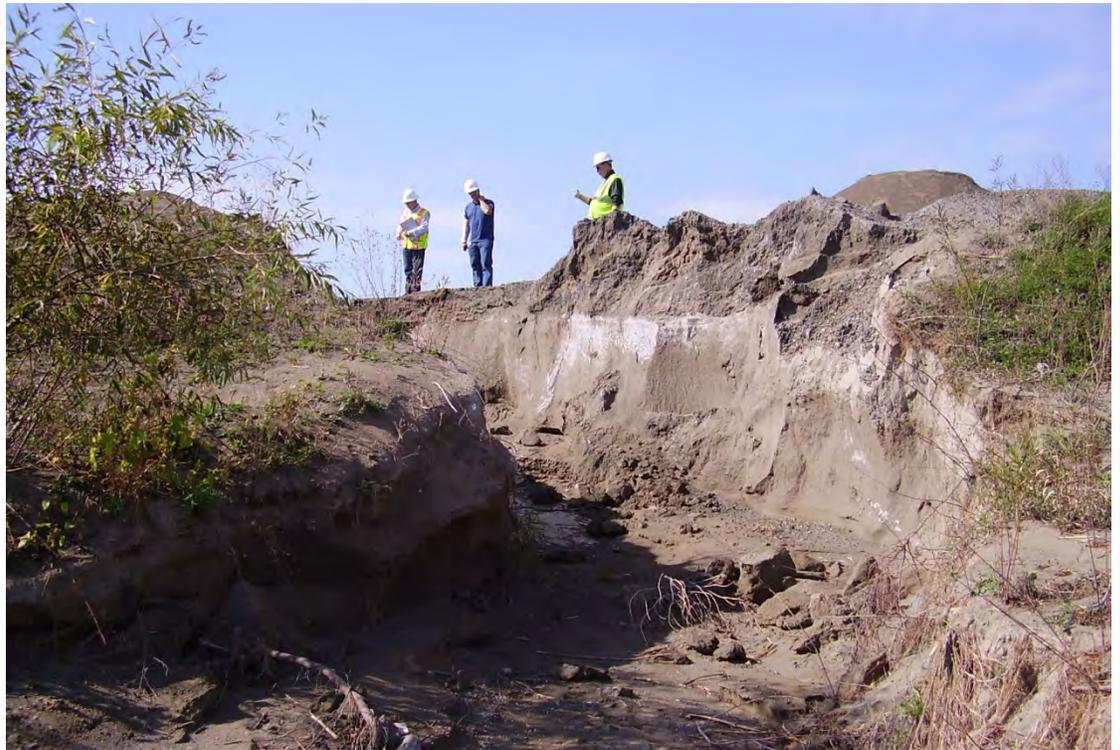
Description:
Erosional feature in SAP.

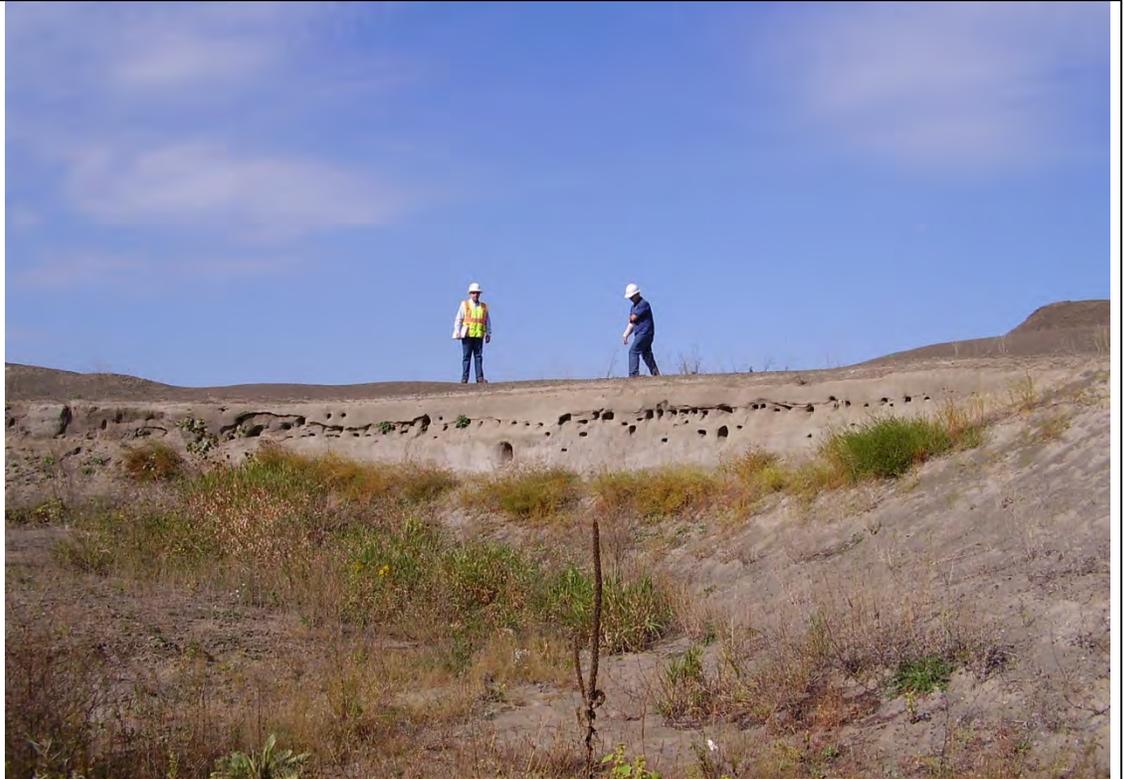
Description:
Downstream slope of PAP
and animals/bird burrows.

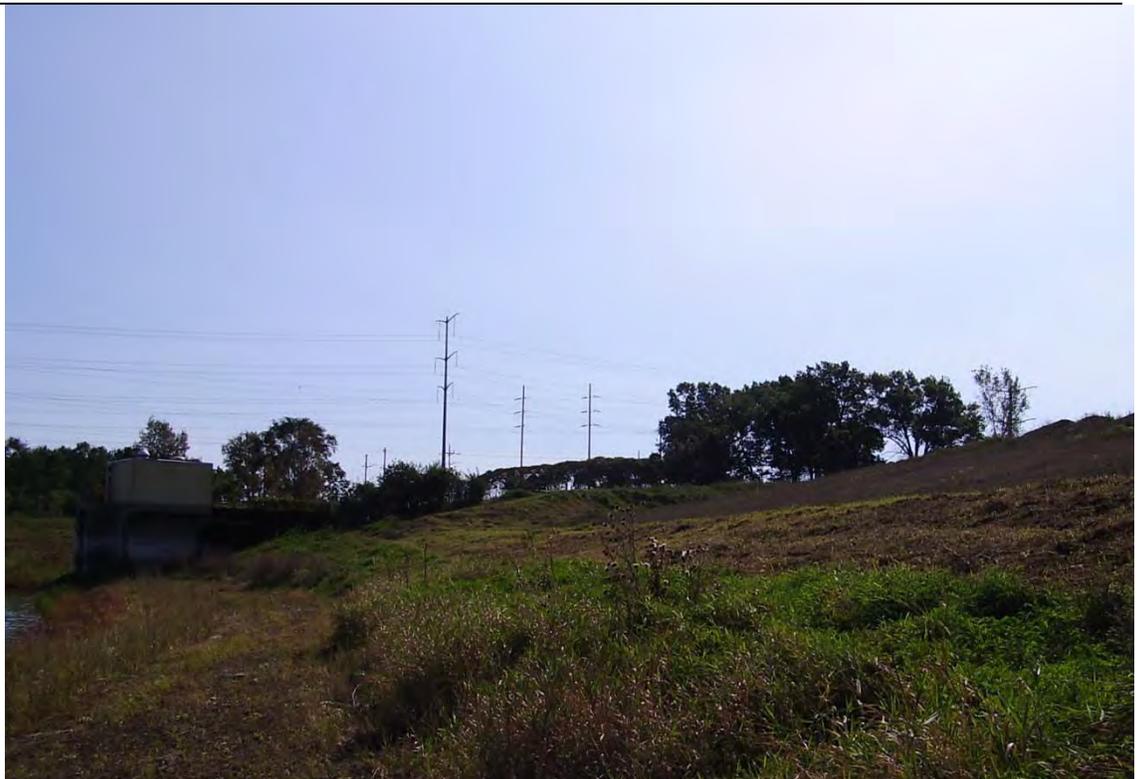
Photo No.
38

Description:
Upstream slope of SAP and
SAP pump house.

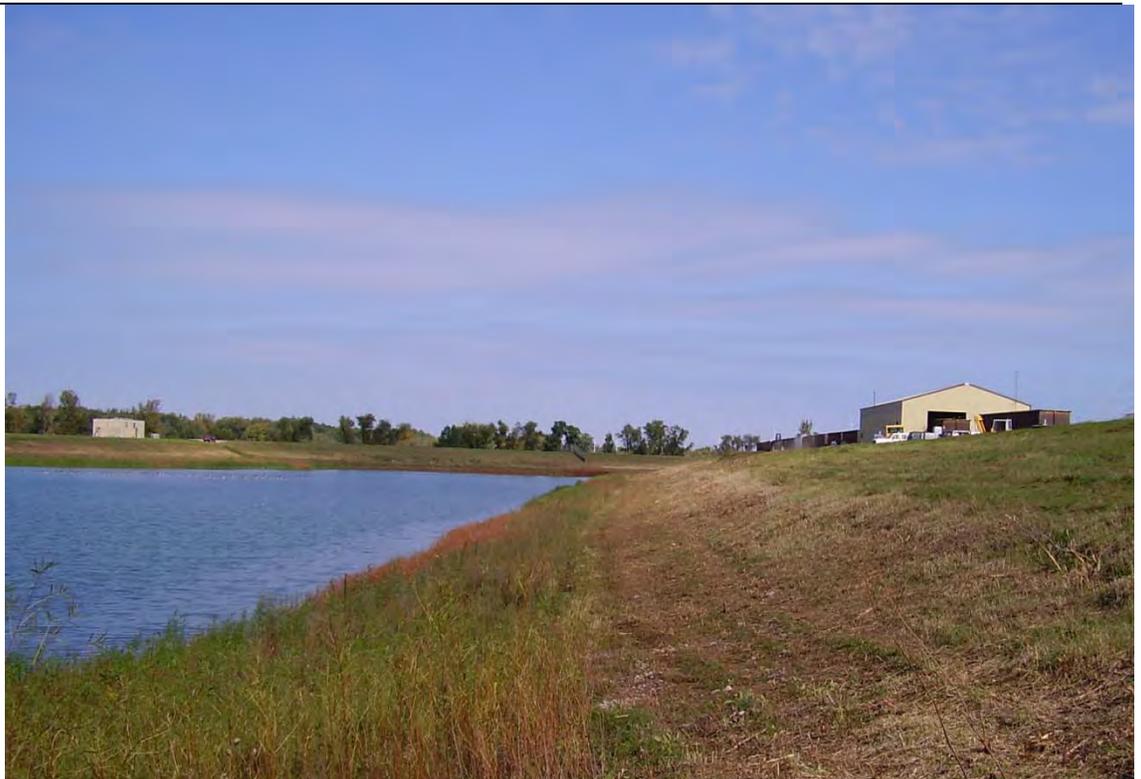
Photo No.
40

Description:
Upstream slope of SAP.

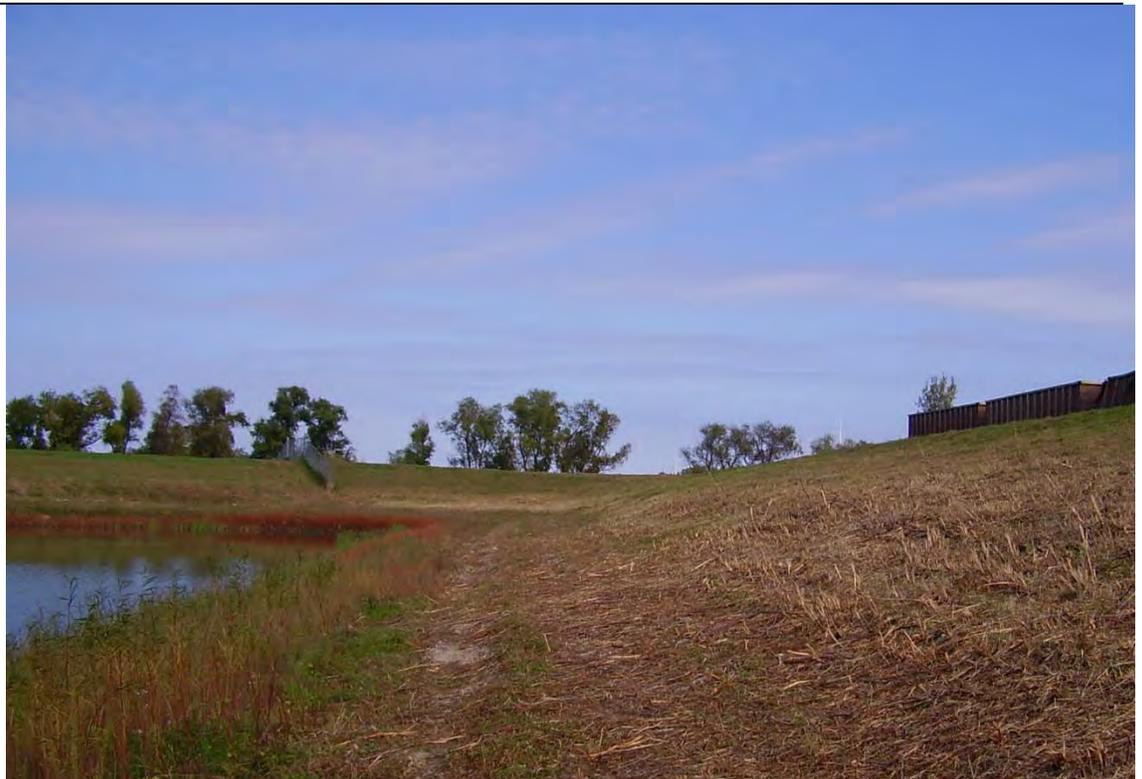
Photo No.
42

Description:
Upstream slope of SAP.

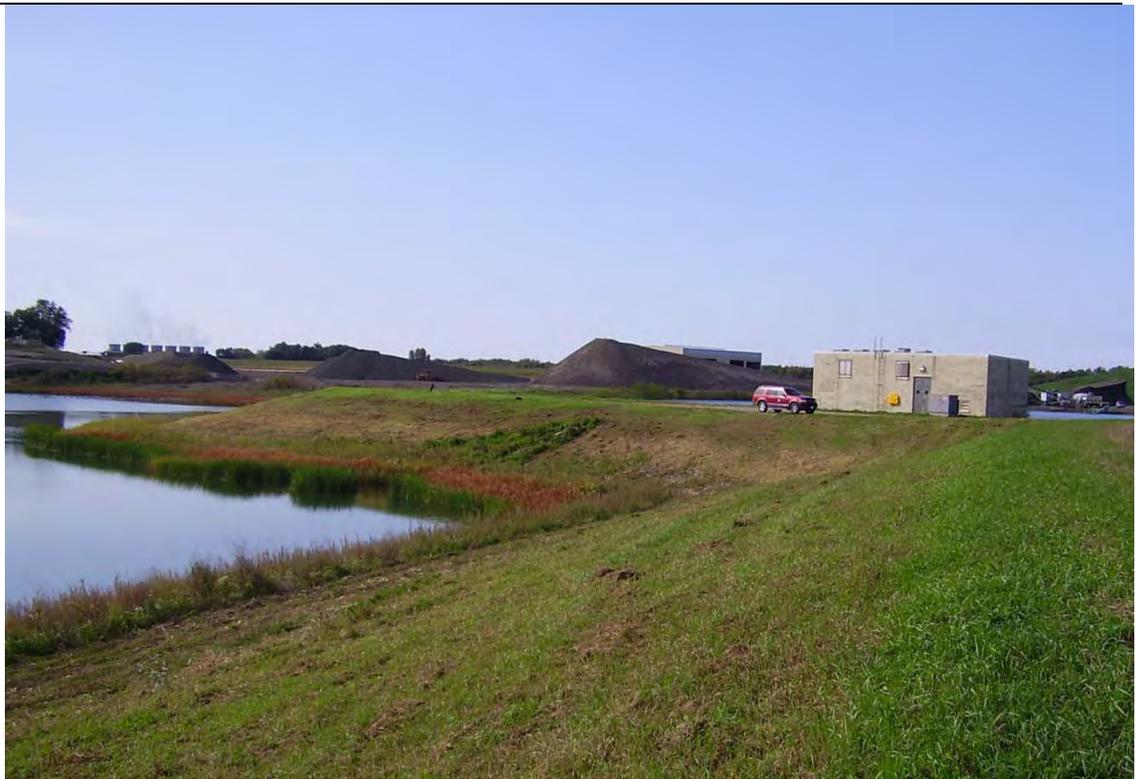
Description:
Upstream slope of SAP and
PAP pump house.

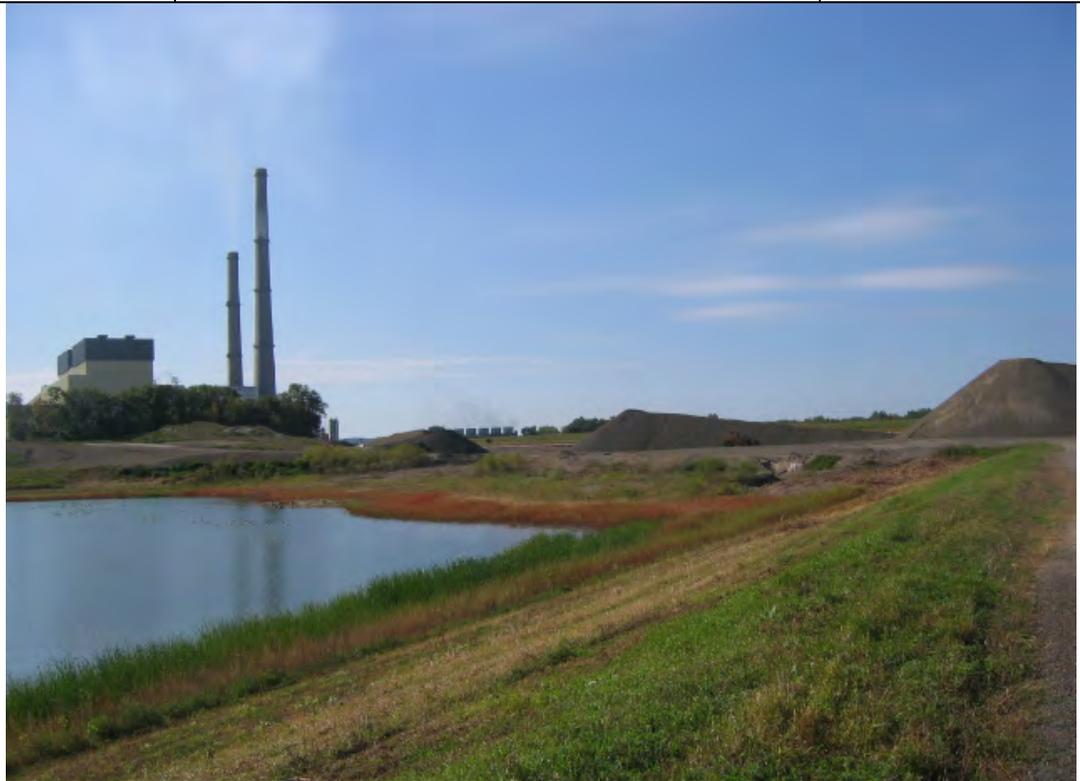
Description:
Upstream slope of SAP and
downstream slope of PAP
and crest.

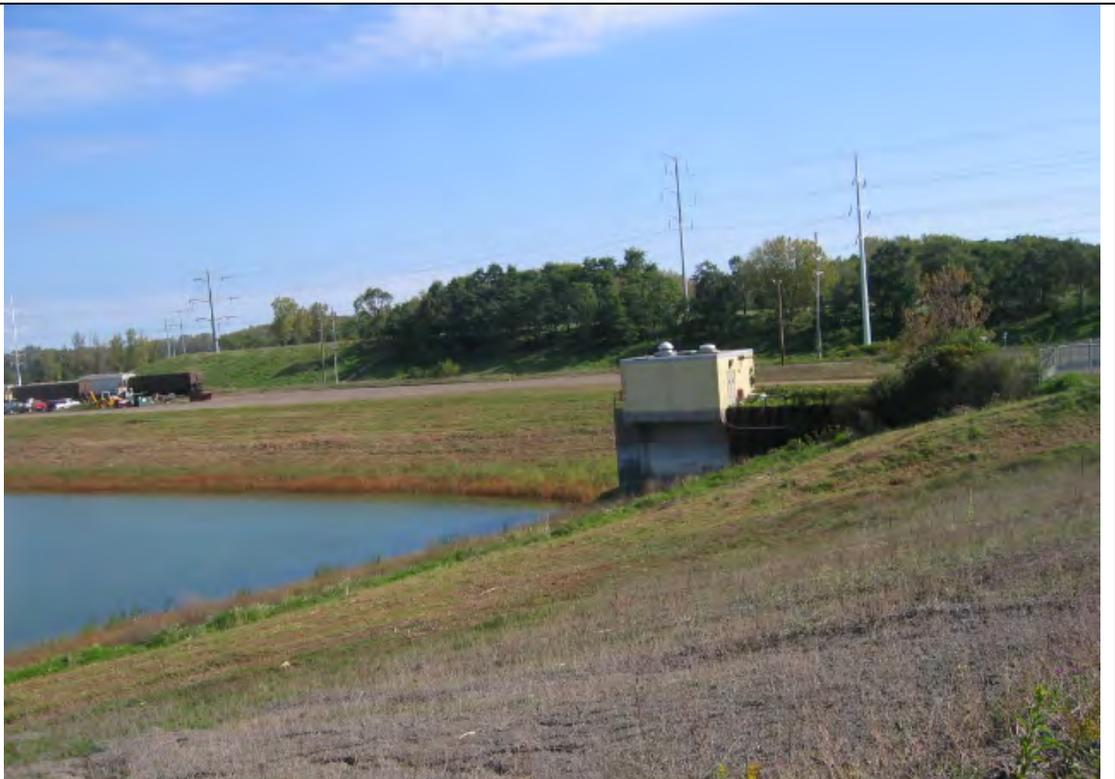
Photo No.
46

Description:
Crest of SAP and SAP pump
house.

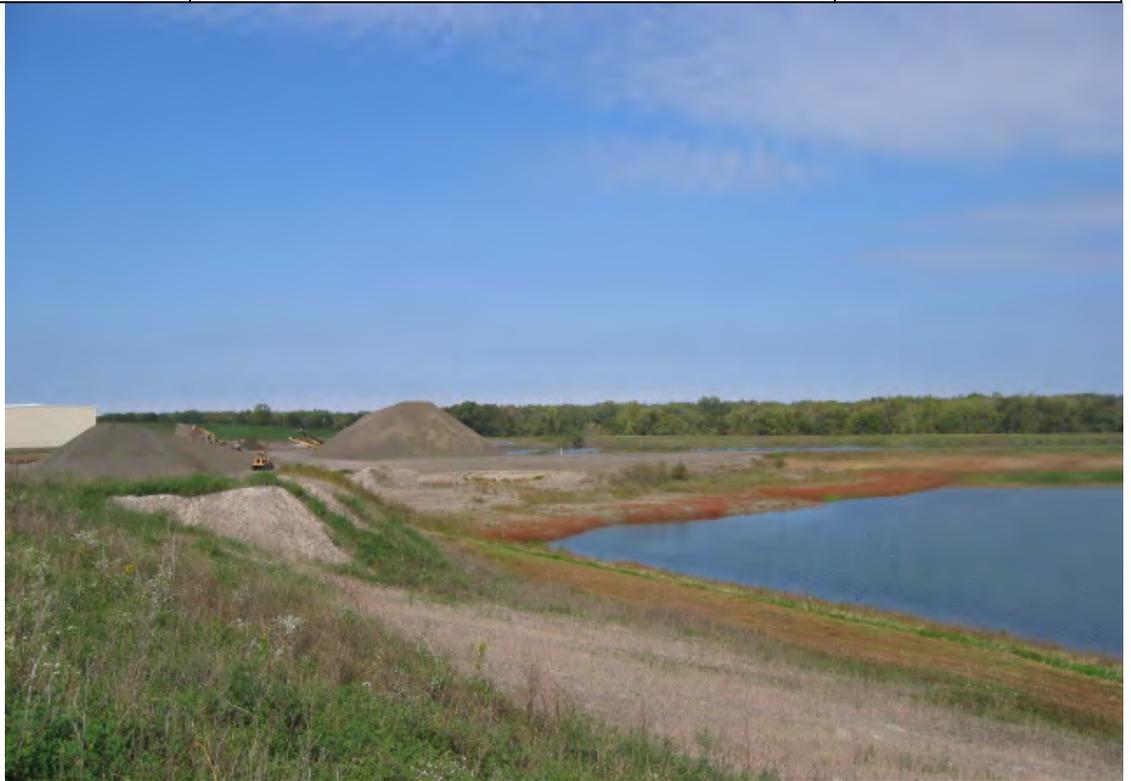
Description:
Crest of SAP.

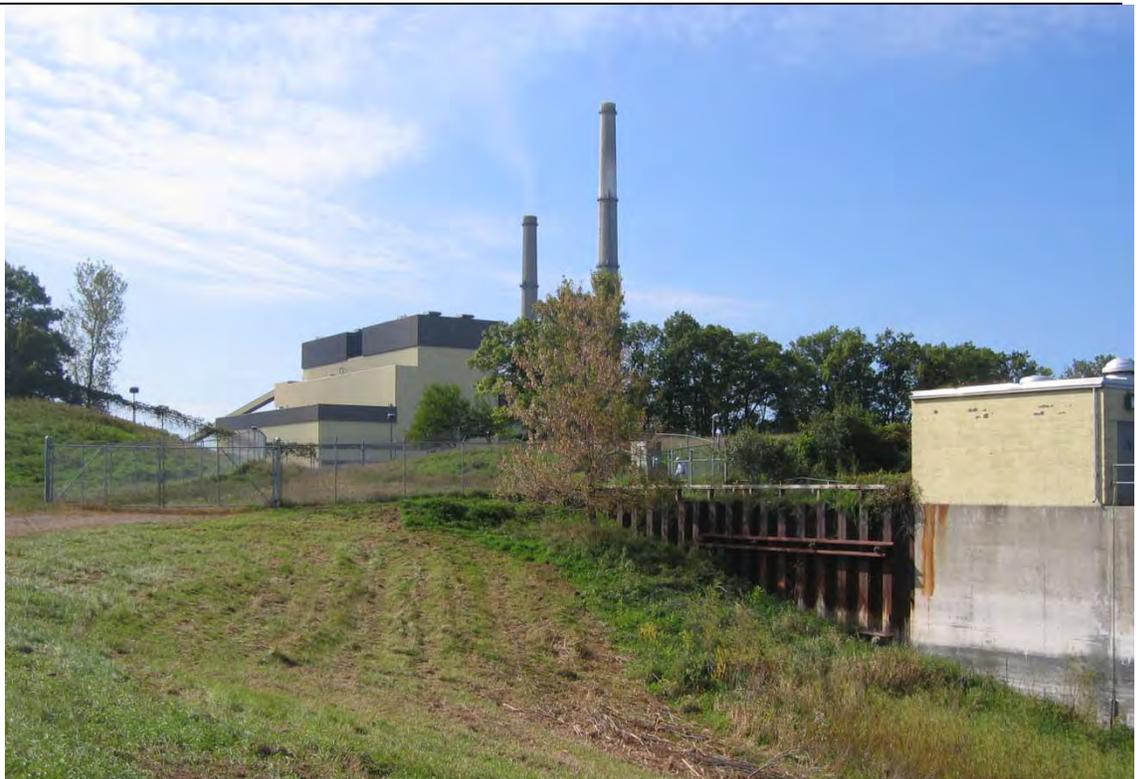
Photo No.
48

Description:
Crest of SAP and SAP pump
house.

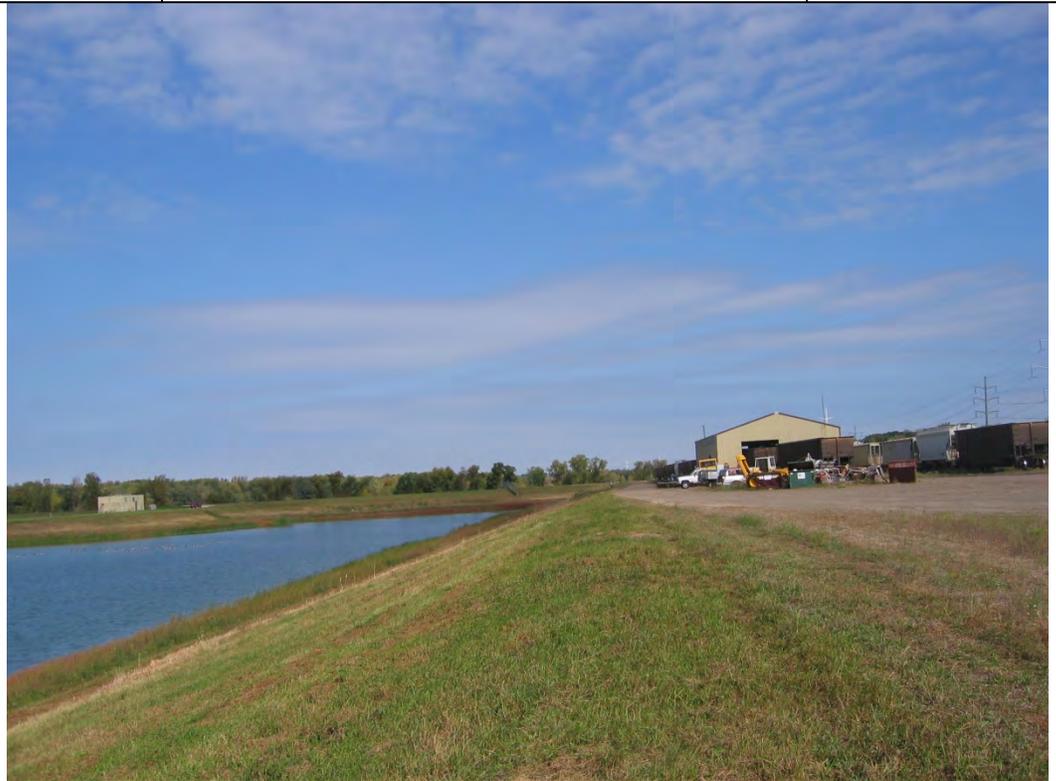
Description:
Crest of SAP

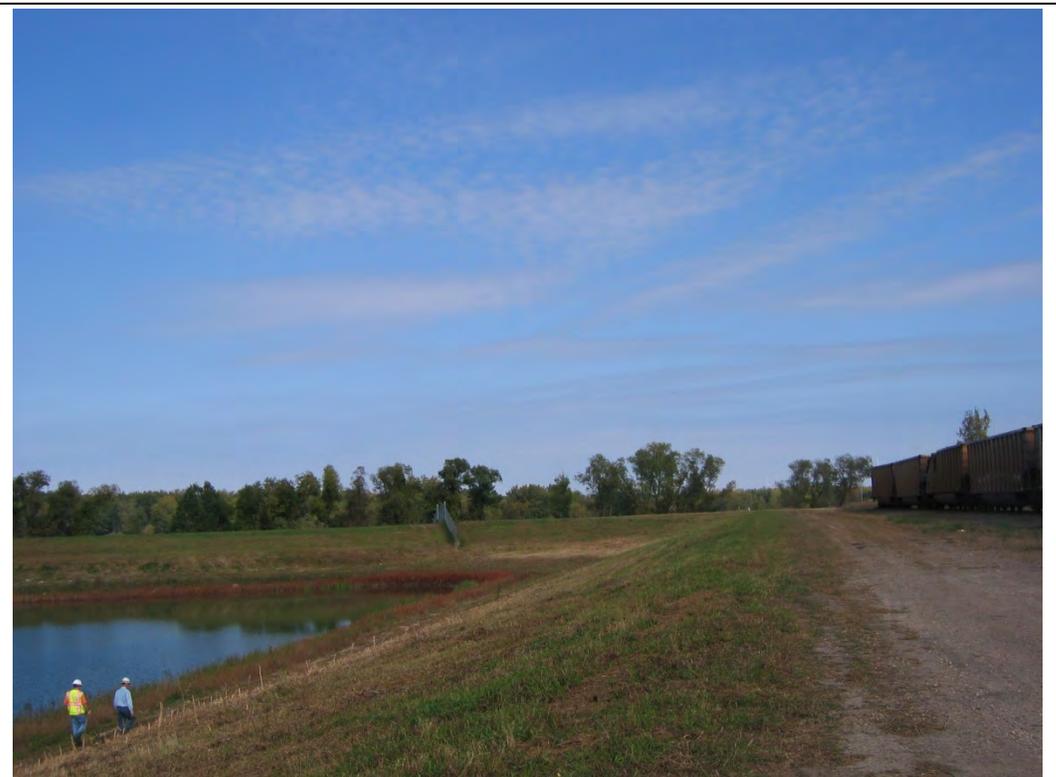
Photo No.
50

Description:
Crest of SAP.

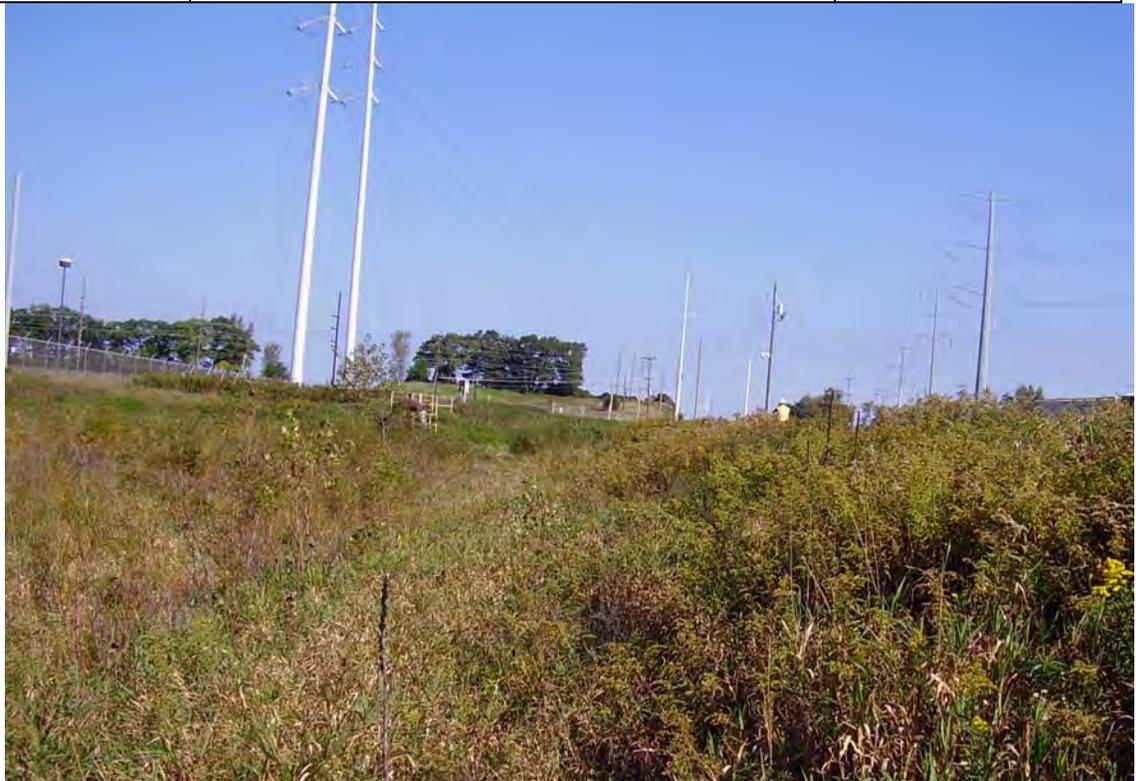
Description:
Upstream slope of Polishing
Pond Impoundment (PP).

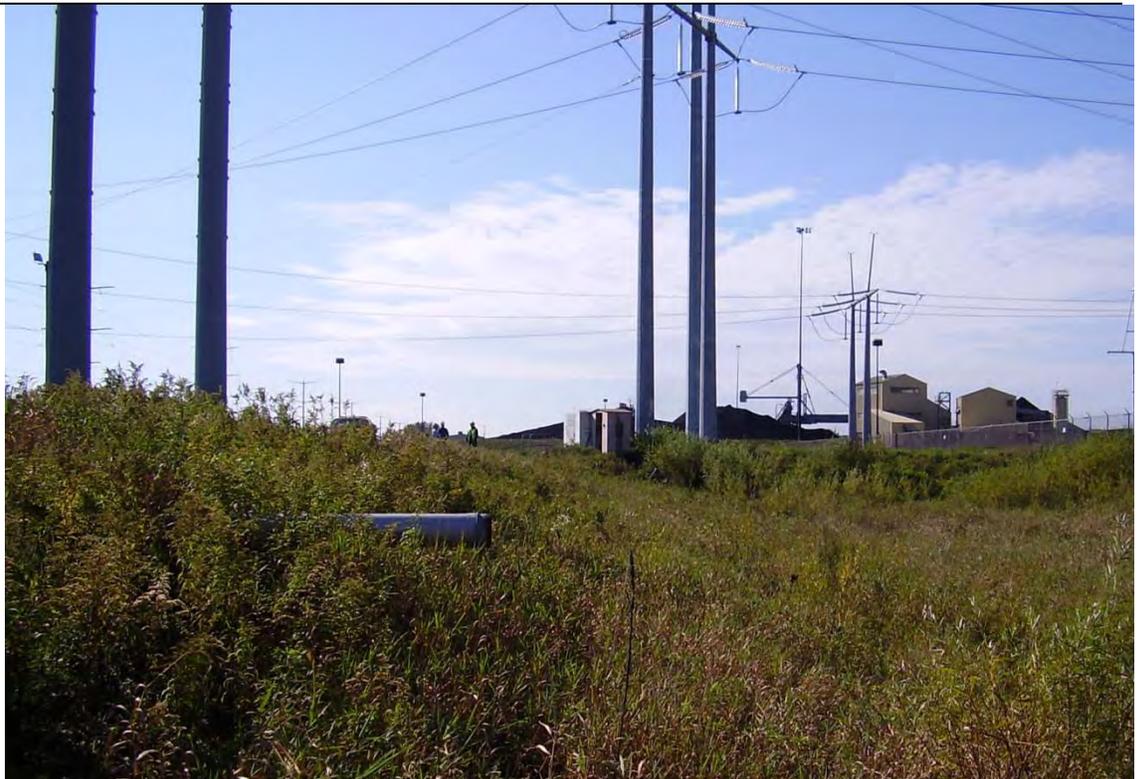
Photo No.
52

Description:
Upstream slope of PP and
(1) 8" inlet pipe.
