**DRAFT REPORT
ROUND 7 DAM ASSESSMENT - WISCONSIN POWER & LIGHT
COLUMBIA GENERATING STATION
PRIMARY ASH, SECONDARY ASH, POLISHING & LANDFILL
STORMWATER PONDS
PARDEEVILLE, WISCONSIN**

January 17, 2011

Re: Round 7 Dam Assessment - Draft Report
EPA Contract No. EP10W001313
Wisconsin Power & Light – Columbia Generating Station
Primary Ash, Secondary Ash, Polishing & Landfill Storm Water Ponds
Pardeeville, Wisconsin

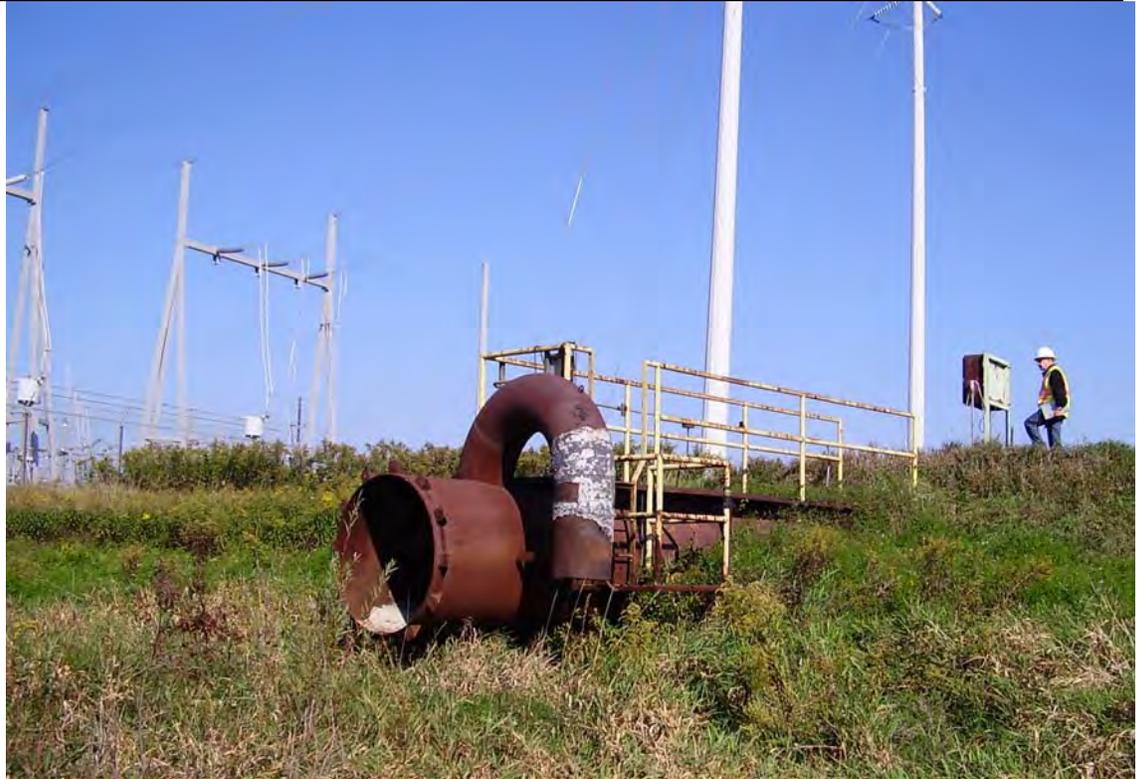
Description:
Upstream slope of PP and
(1) 4' inlet pipe.

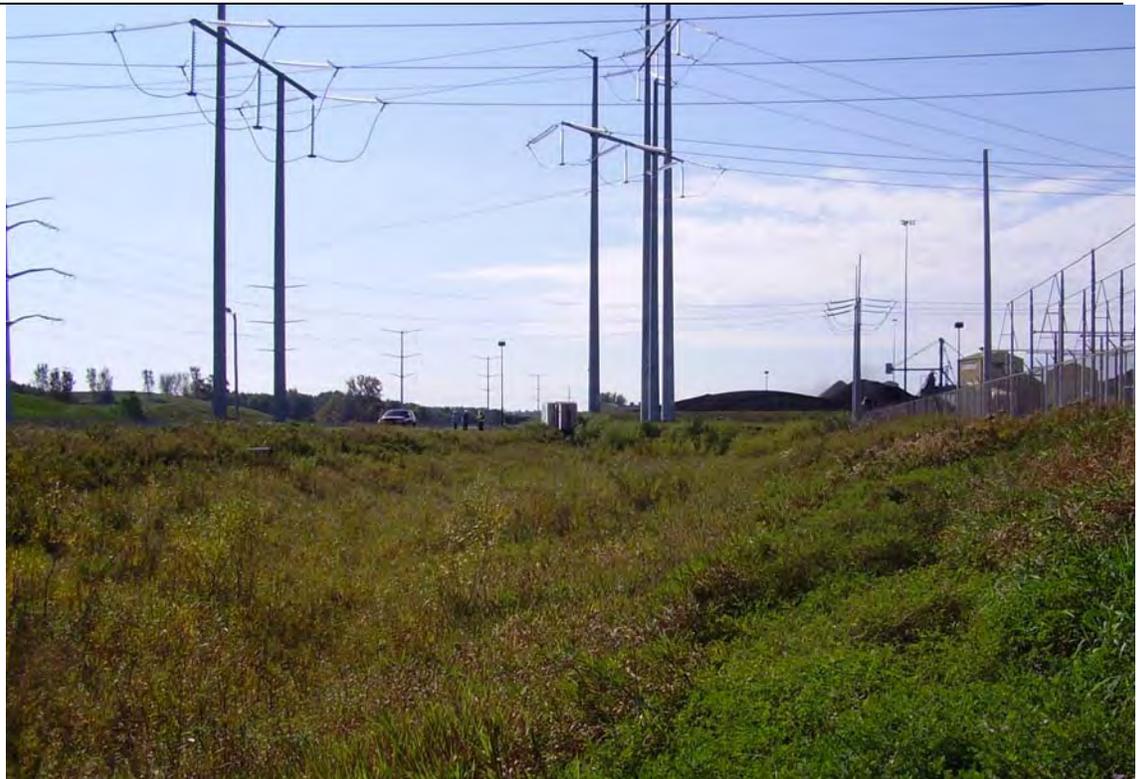
Photo No.
54

Description:
Upstream slope of PP.

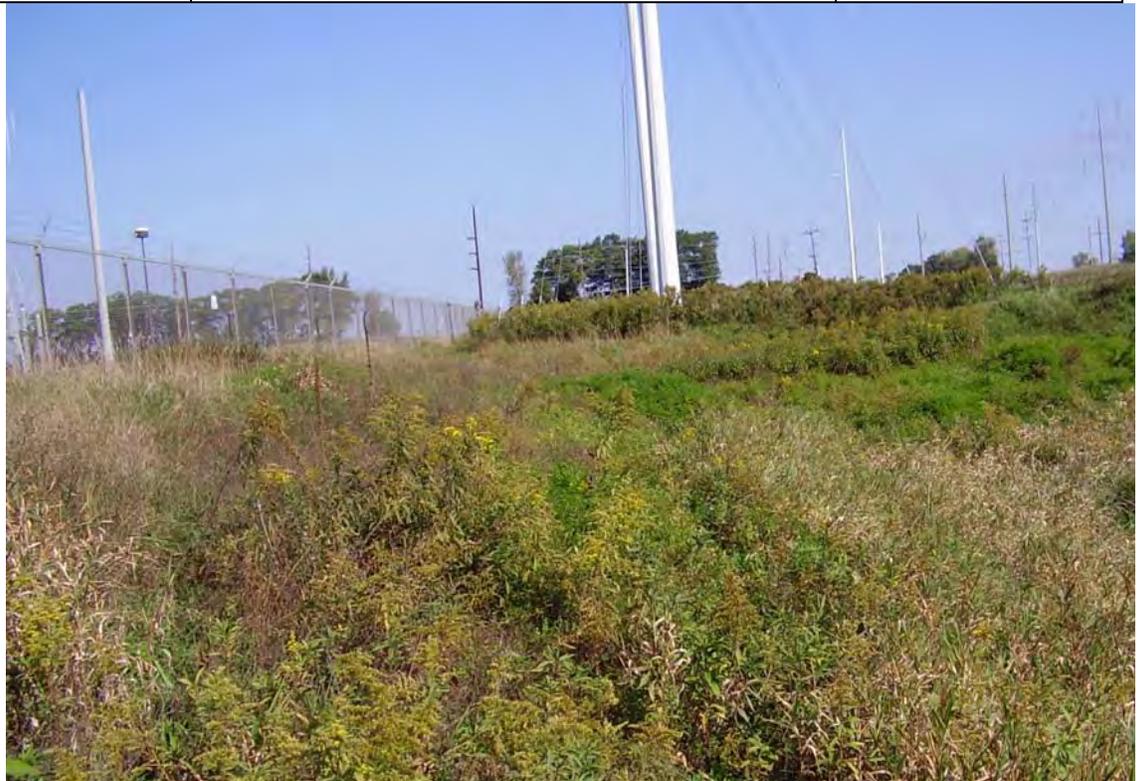
Description:
Upstream slope of PP.

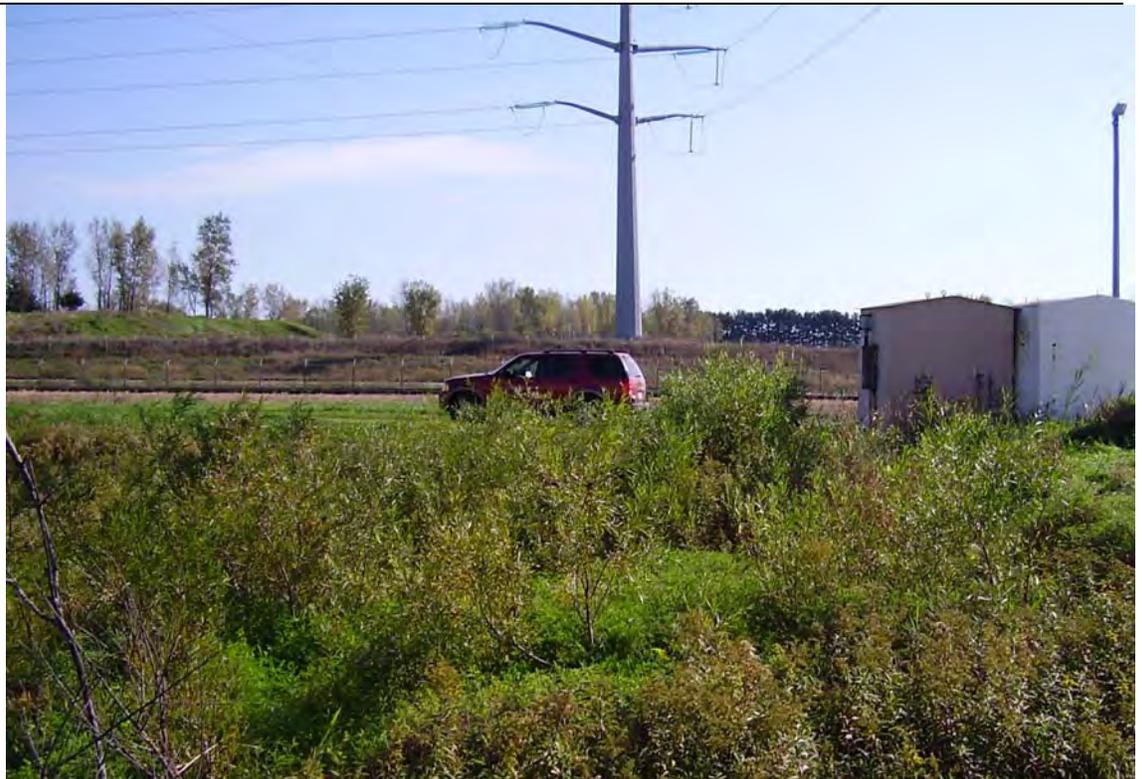
Photo No.
56

Description:
Crest of PP.

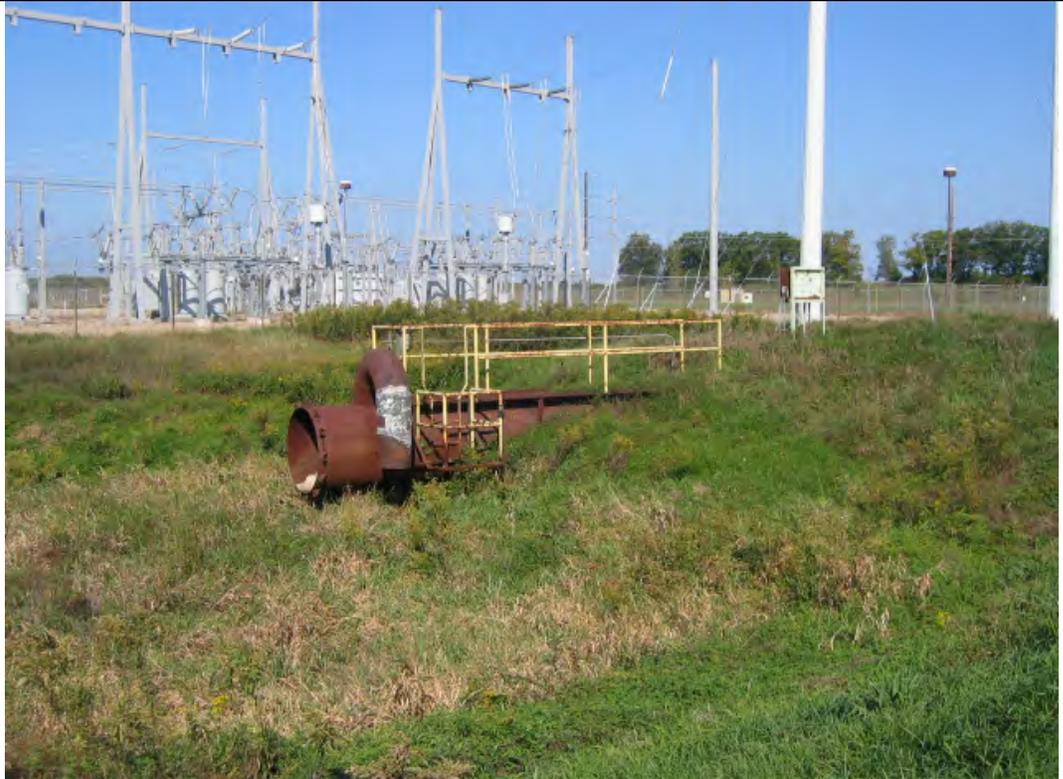
Description:
Crest of PP.

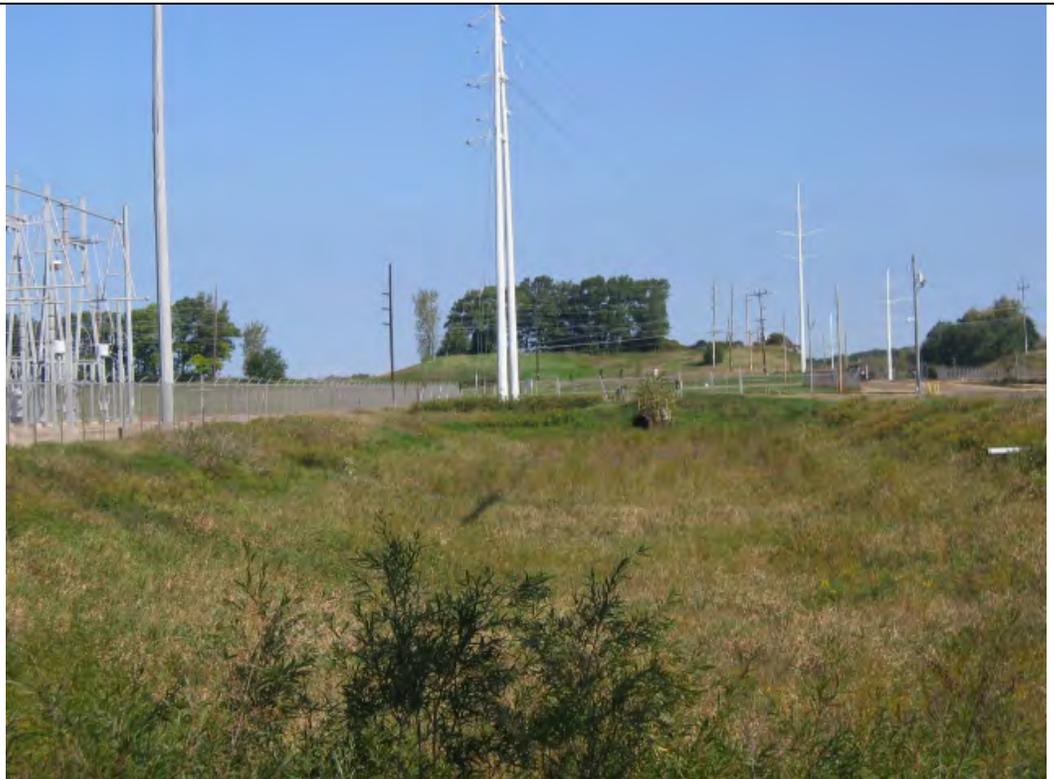
Photo No.
60

Description:
Upstream slope and crest of
PP.

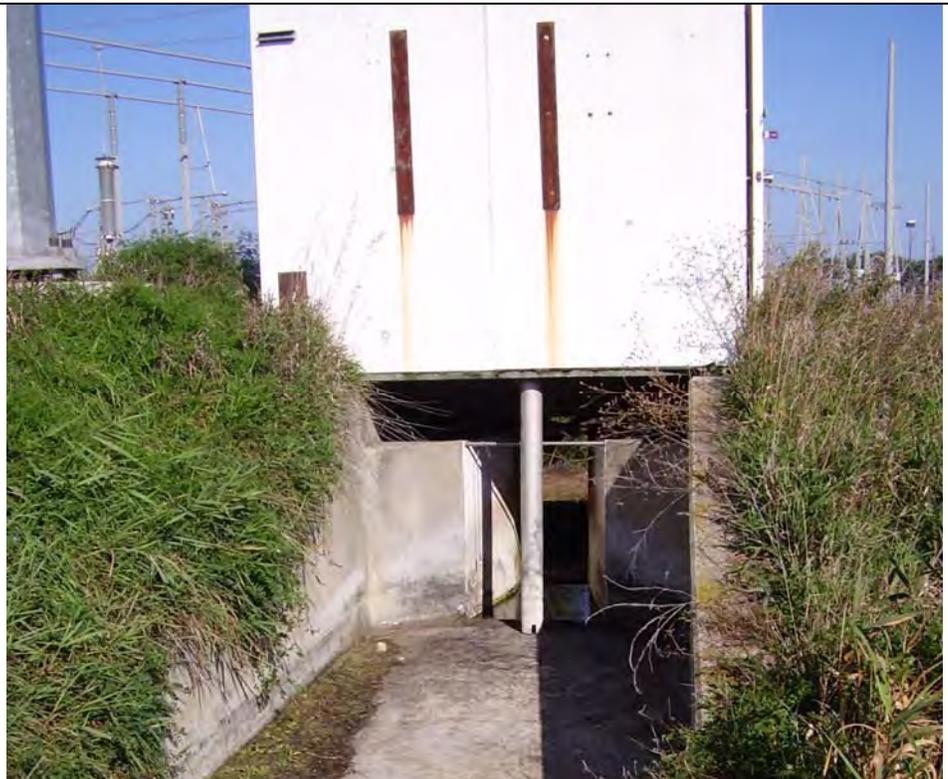
Description:
PP primary Spillway.

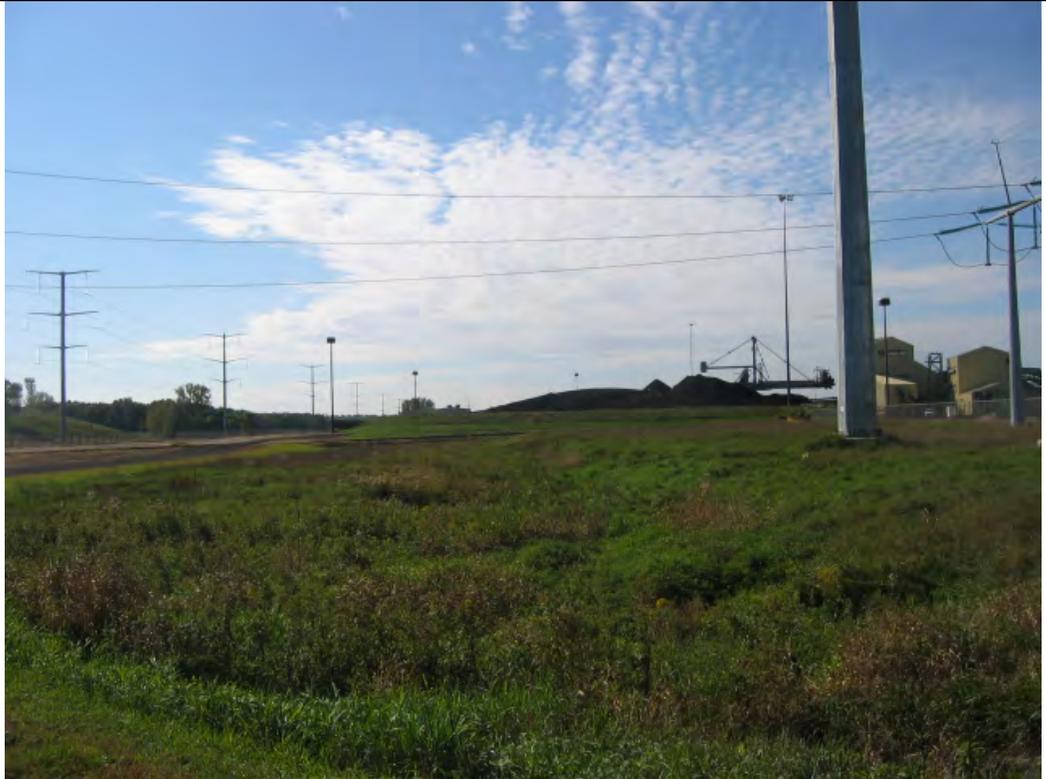
Description:
Drainage ditch south of PP.

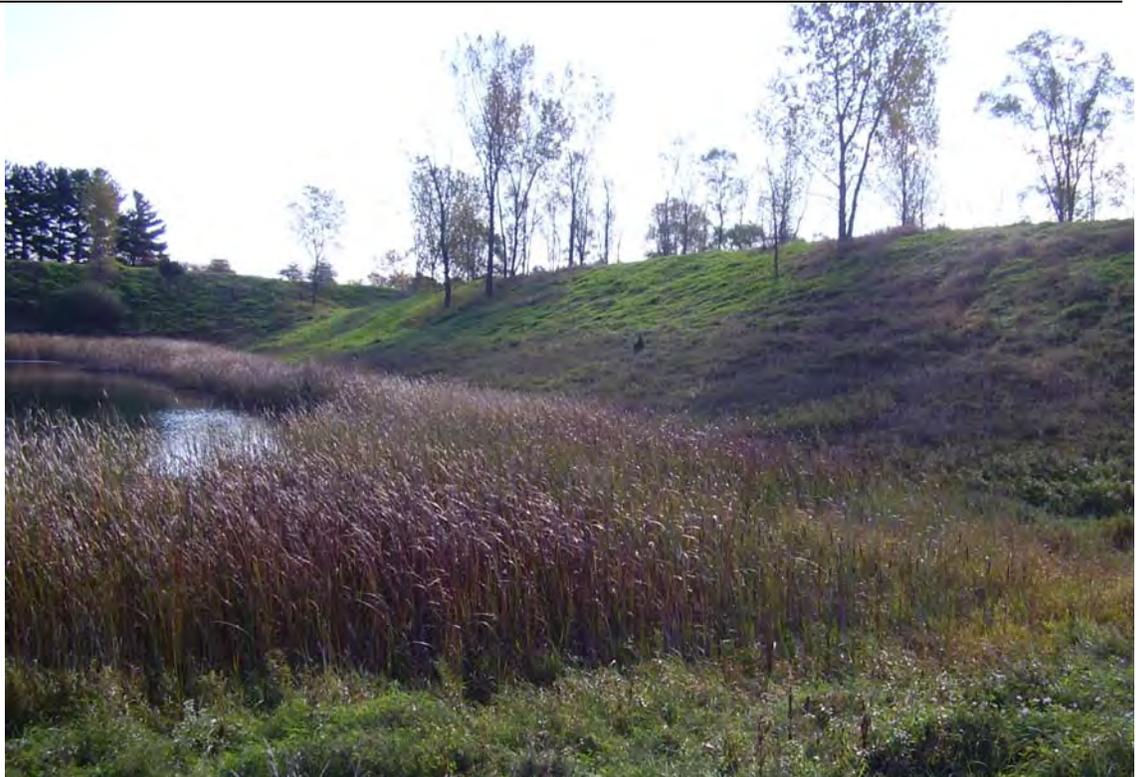
Photo No.
64

Description:
Upstream slope of the
Landfill Stormwater Pond
Impoundment (LSP).

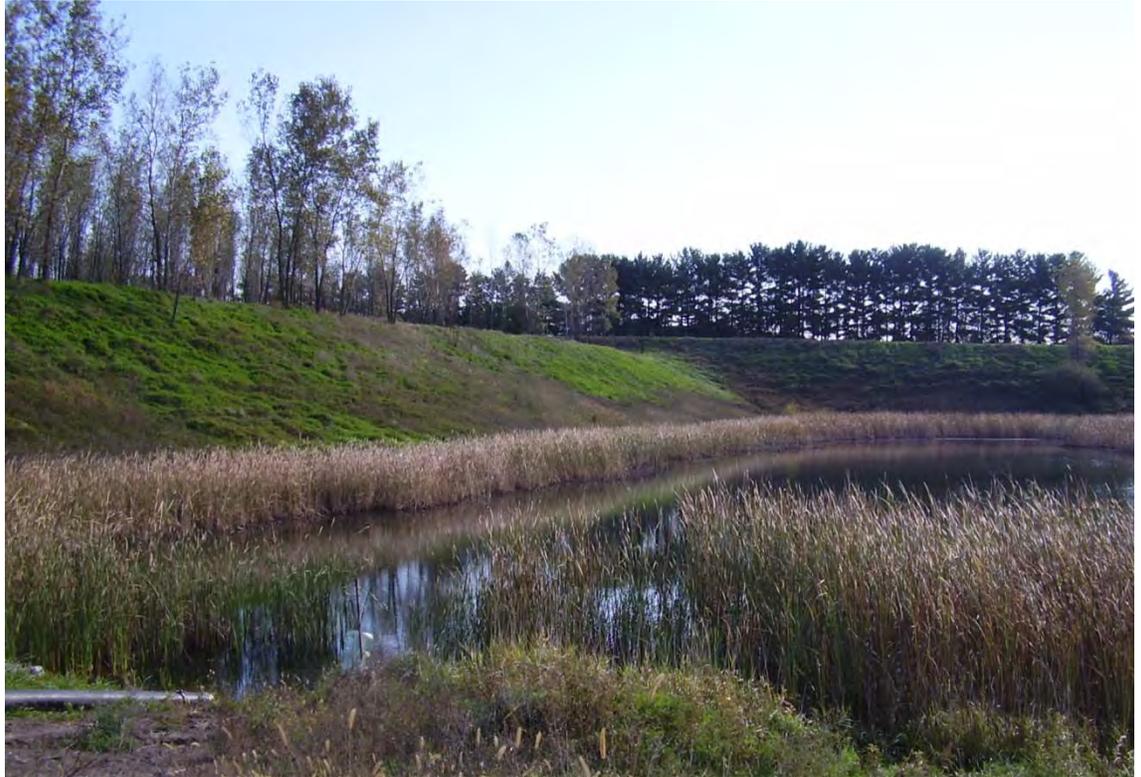
Description:
Upstream slope of LSP.

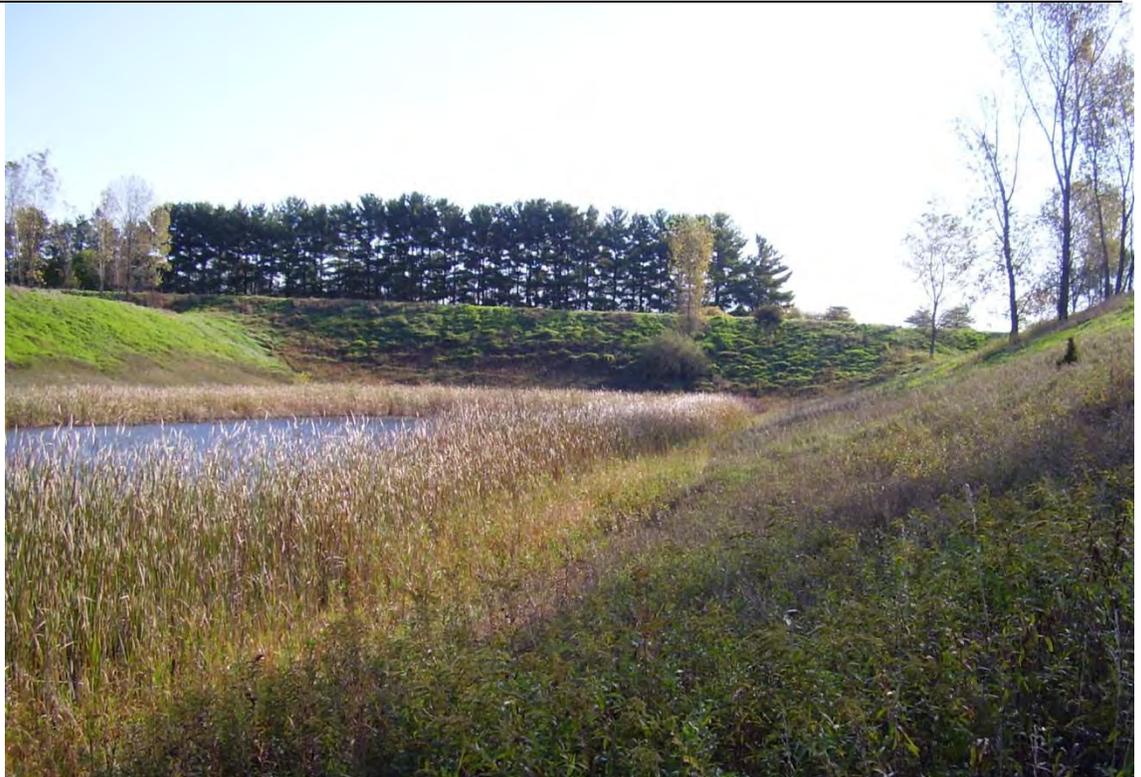
Photo No.
66

Description:
Upstream slope of LSP.

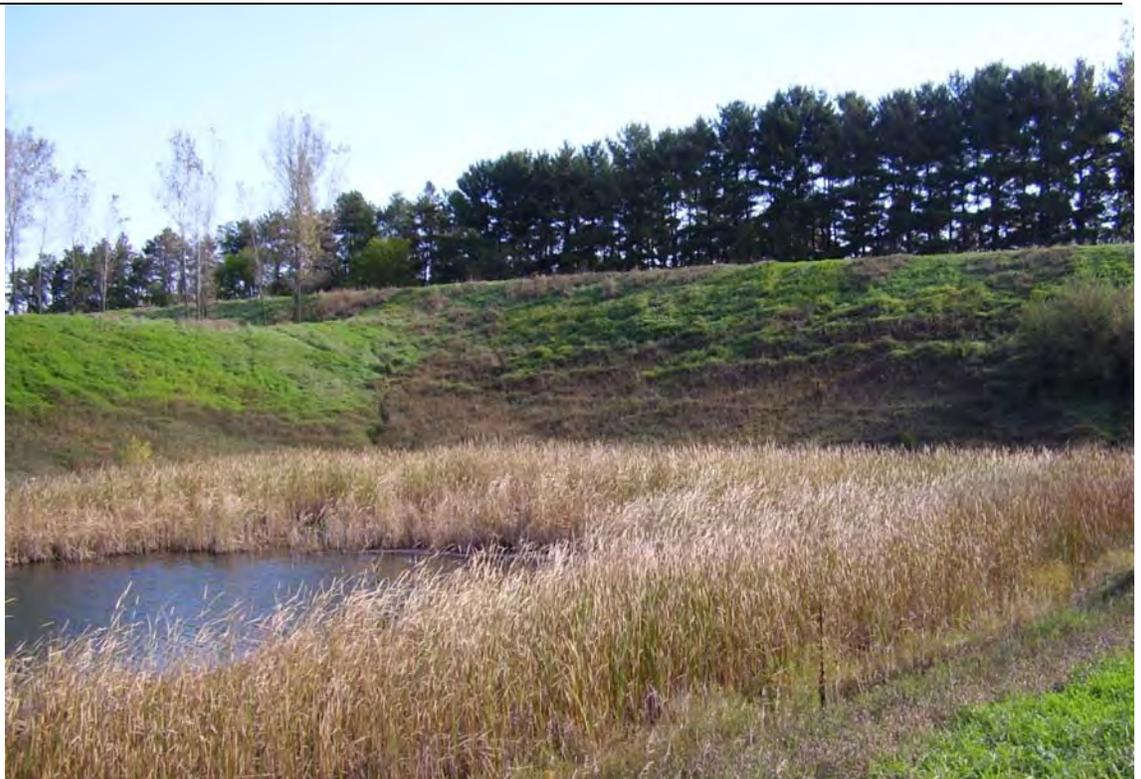
Photo No.
68

Description:
Upstream slope of LSP.

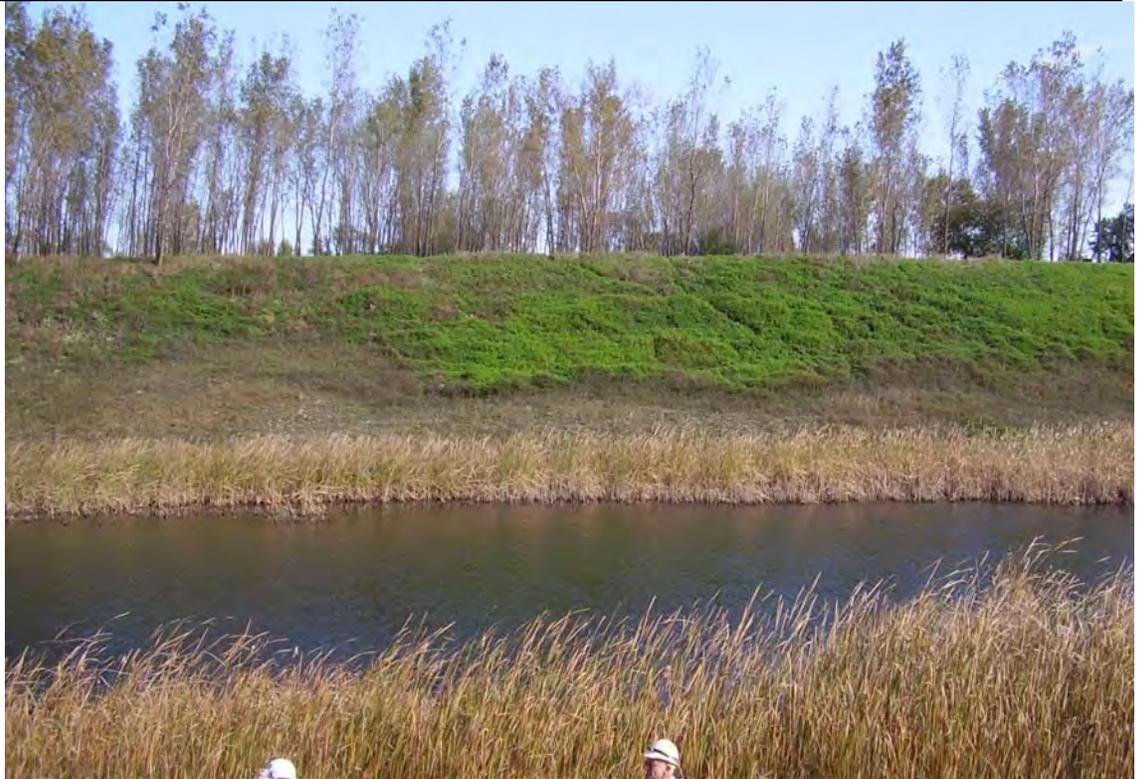
Description:
Upstream slope of LSP.

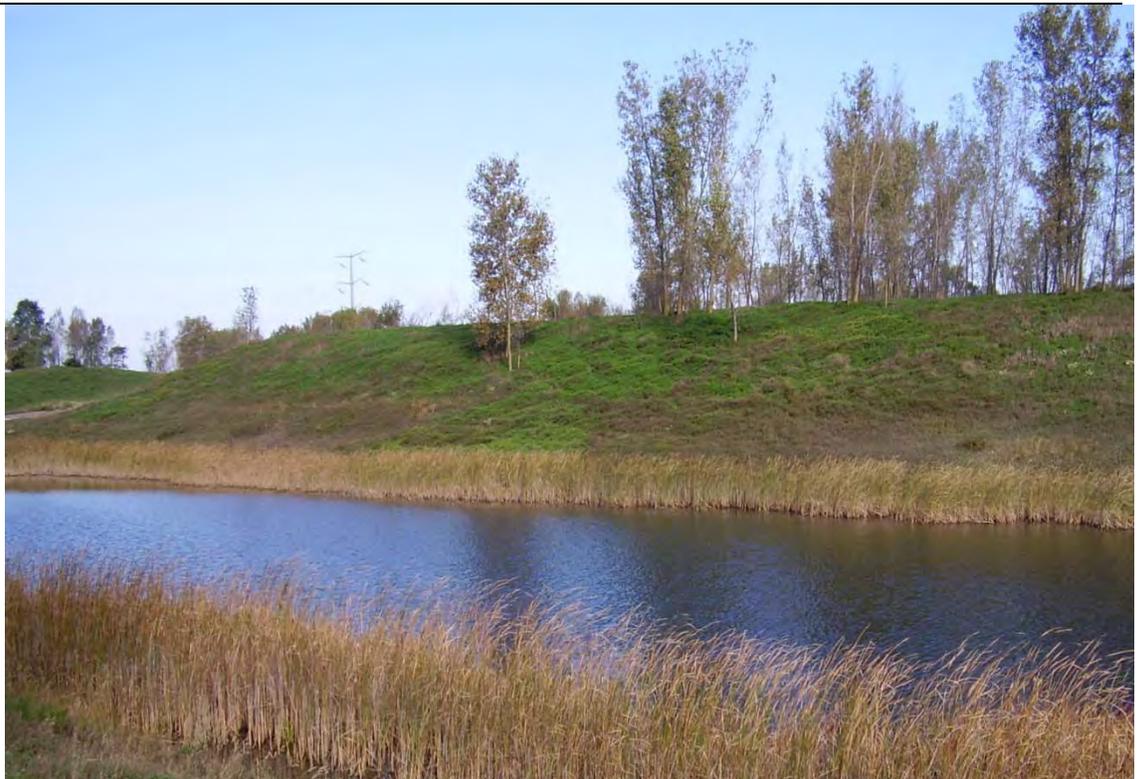
Photo No.
70

Description:
Upstream slope of LSP.

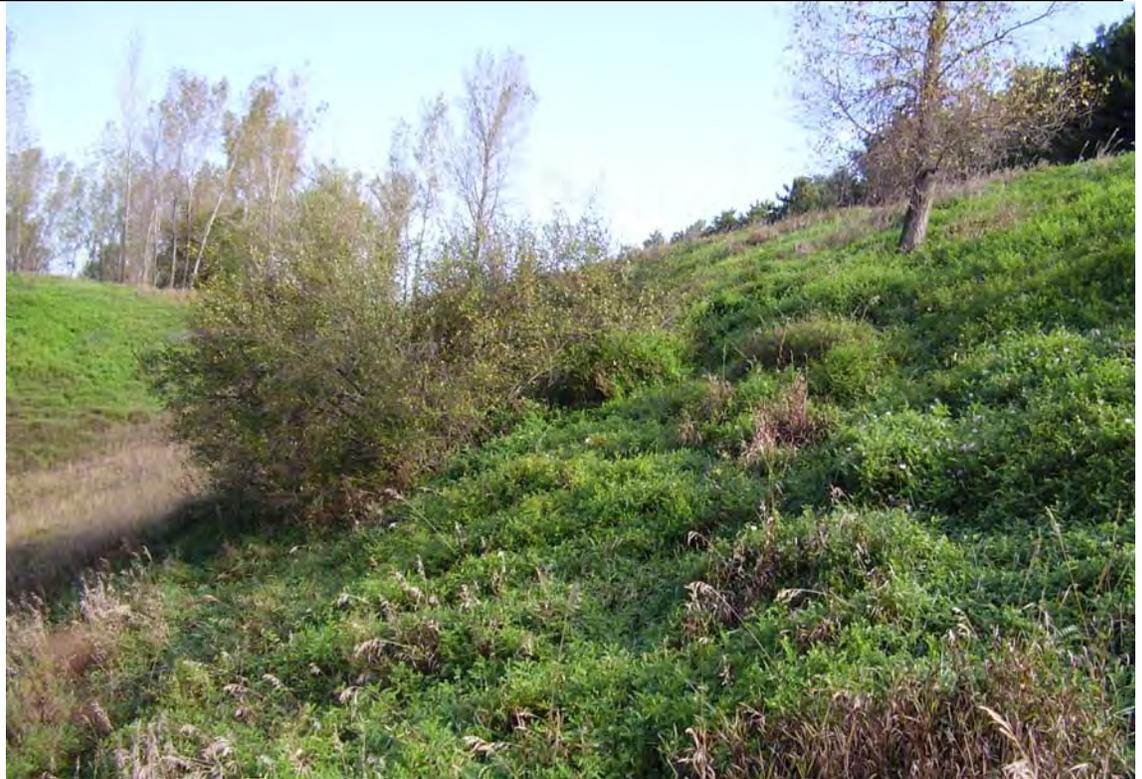
Description:
Upstream slope of LSP.

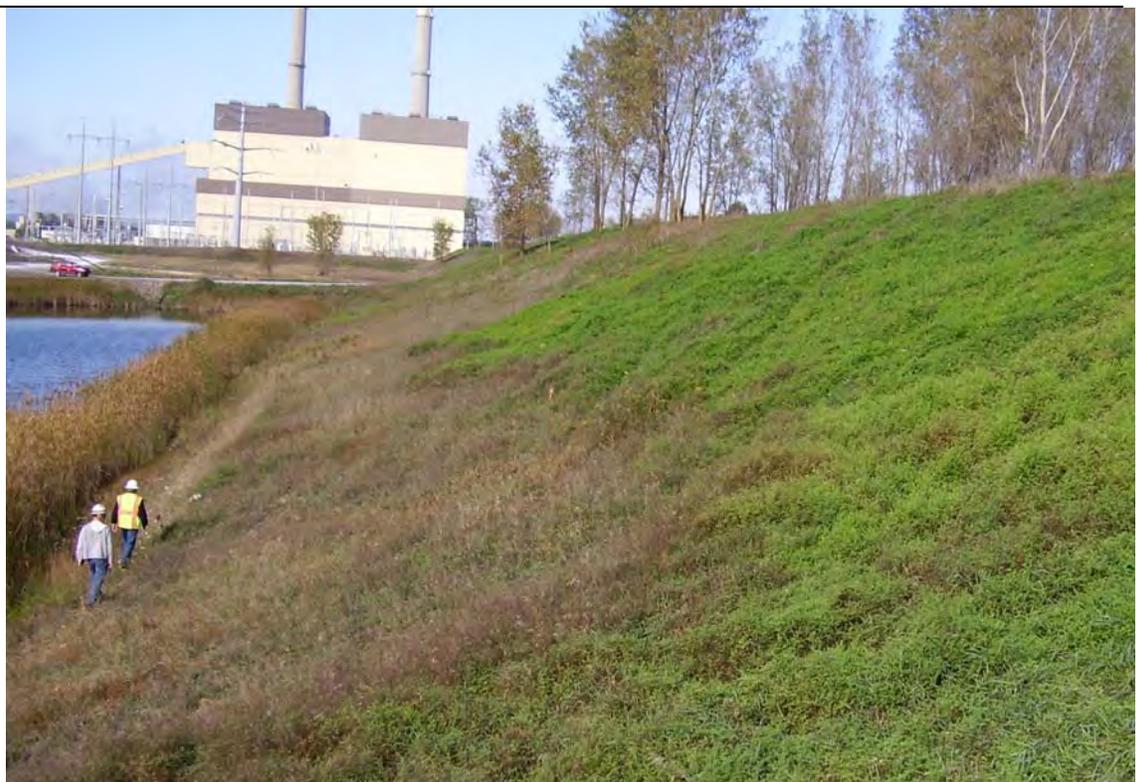
Photo No.
72

Description:
Upstream slope of LSP.

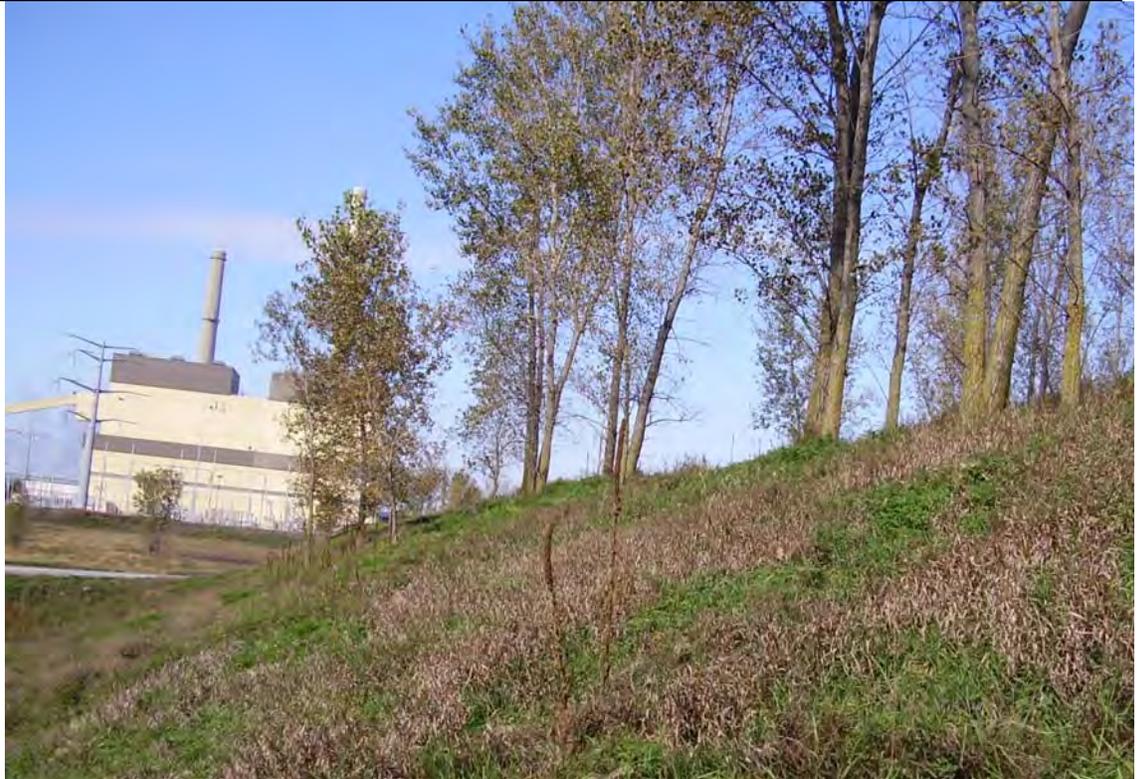
Description:
Upstream slope of LSP.

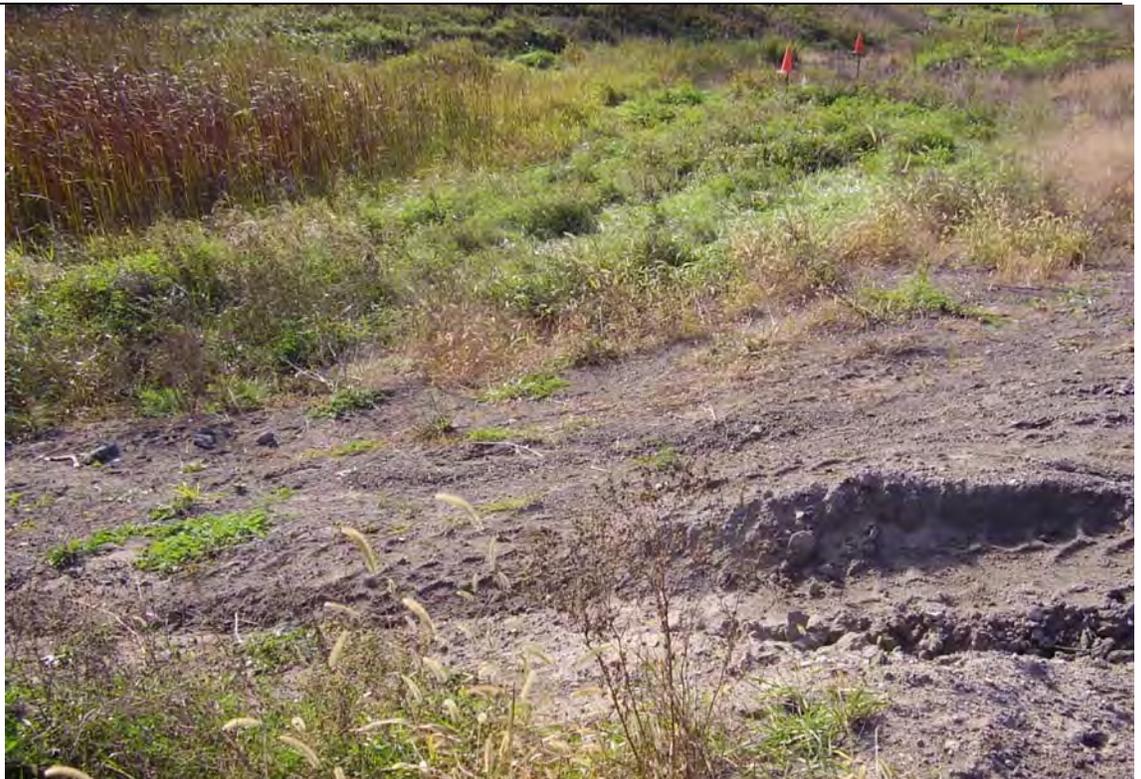
Photo No.
74

Description:
Upstream slope of LSP.

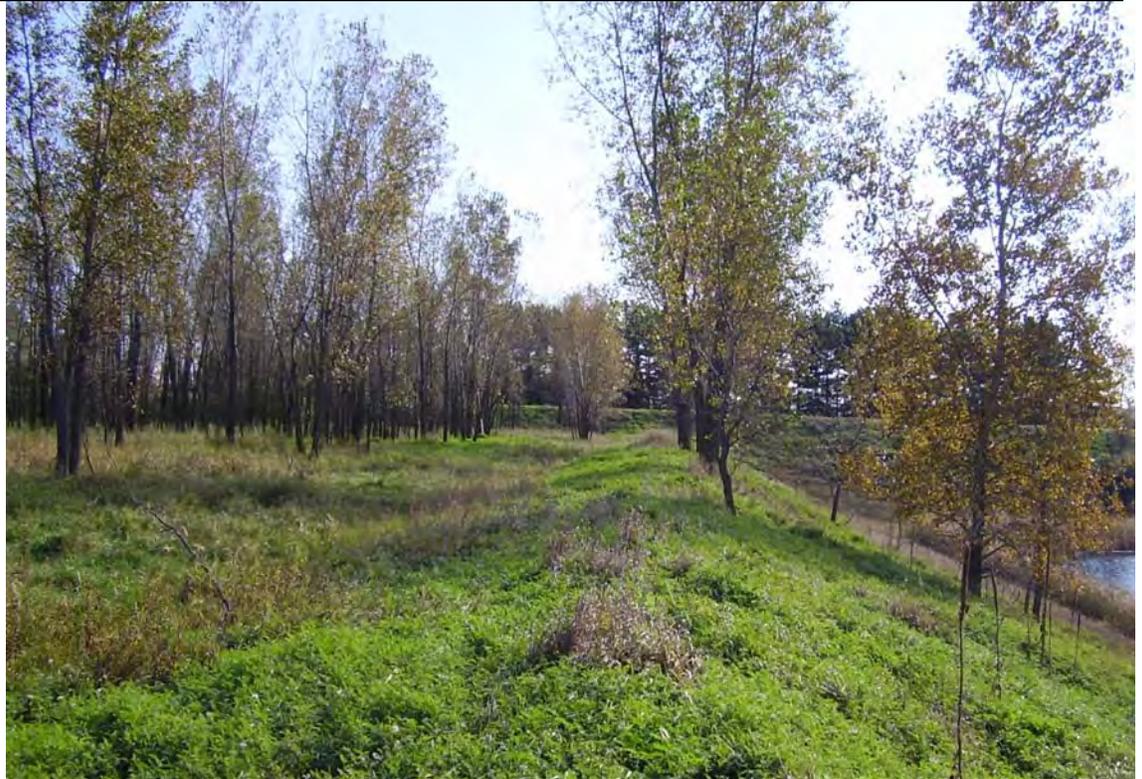
Description:
Crest of LSP.

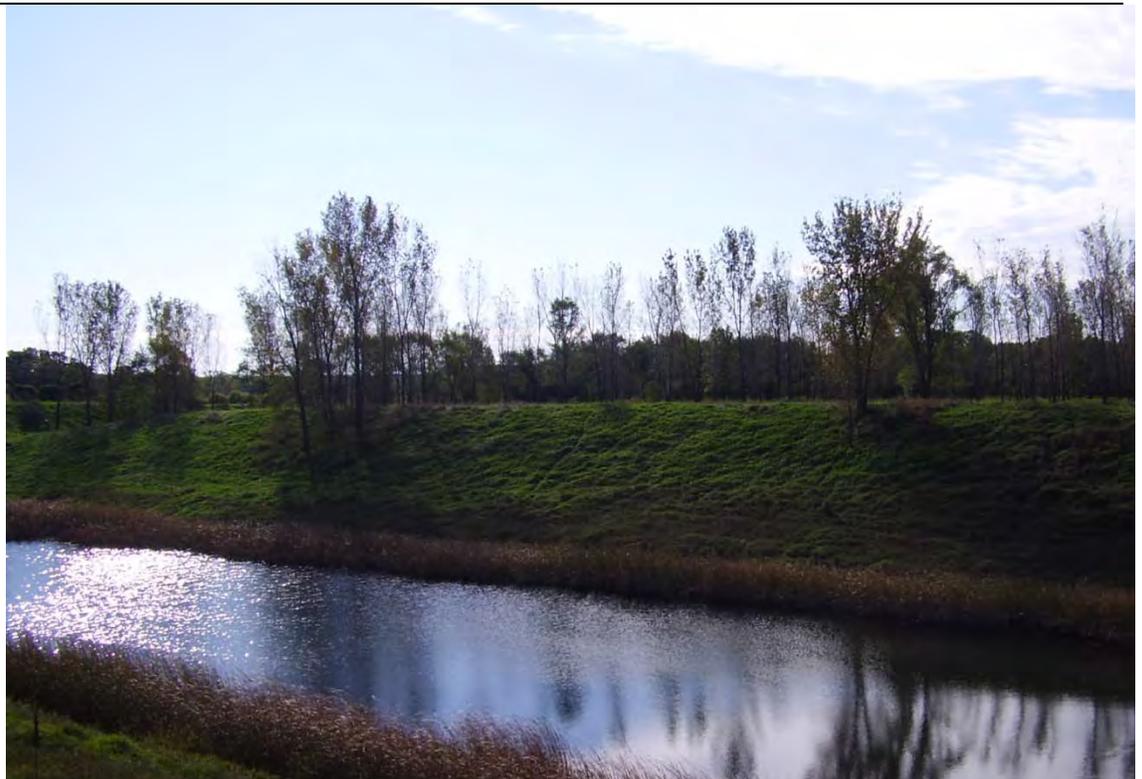
Photo No.
76

Description:
Crest of LSP.

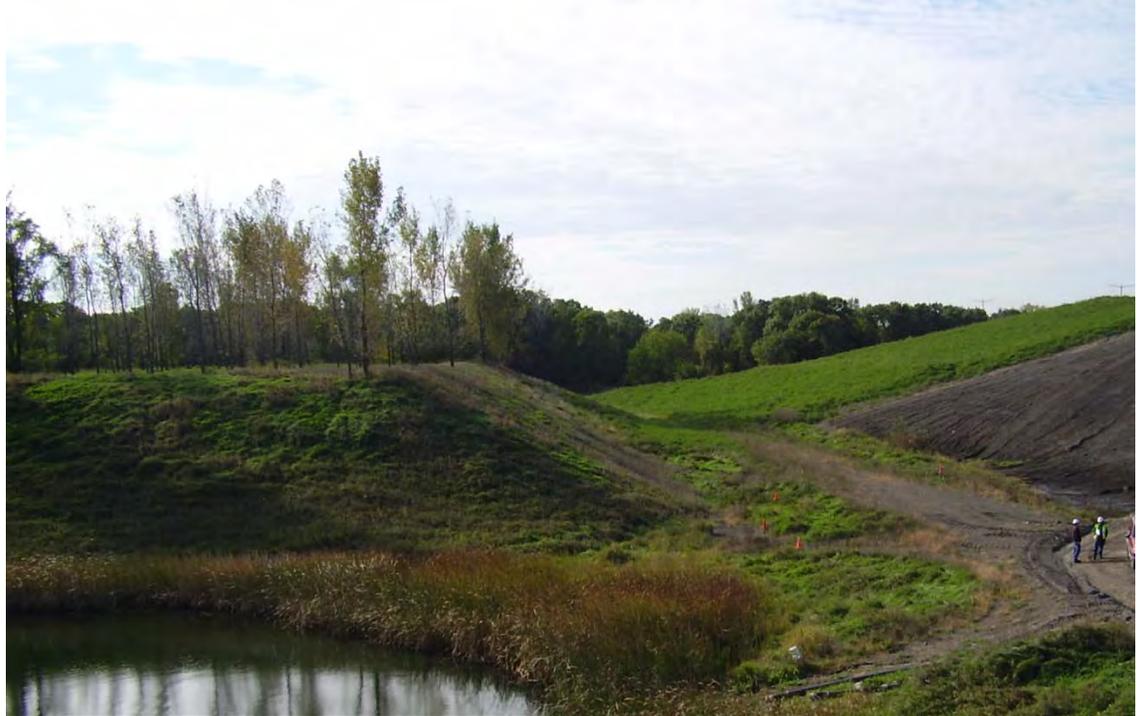
Description:
Upstream slope and crest of
LSP.

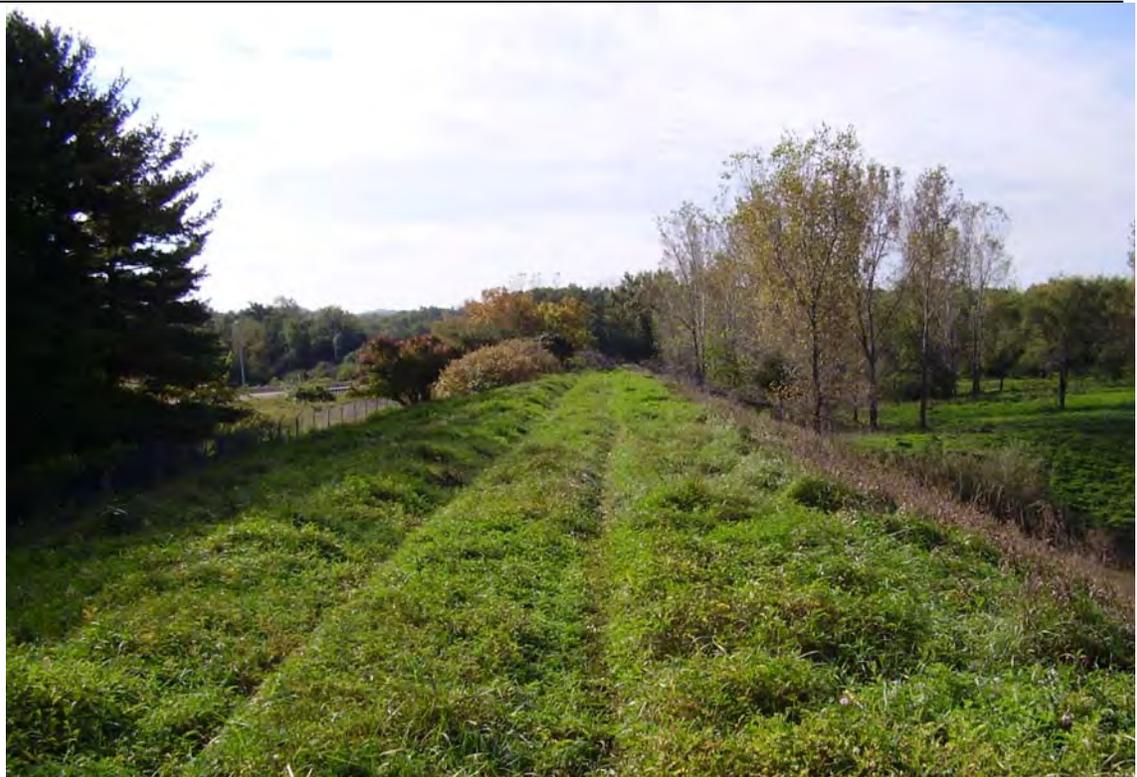
Photo No.
78

Description:
Crest of LSP.

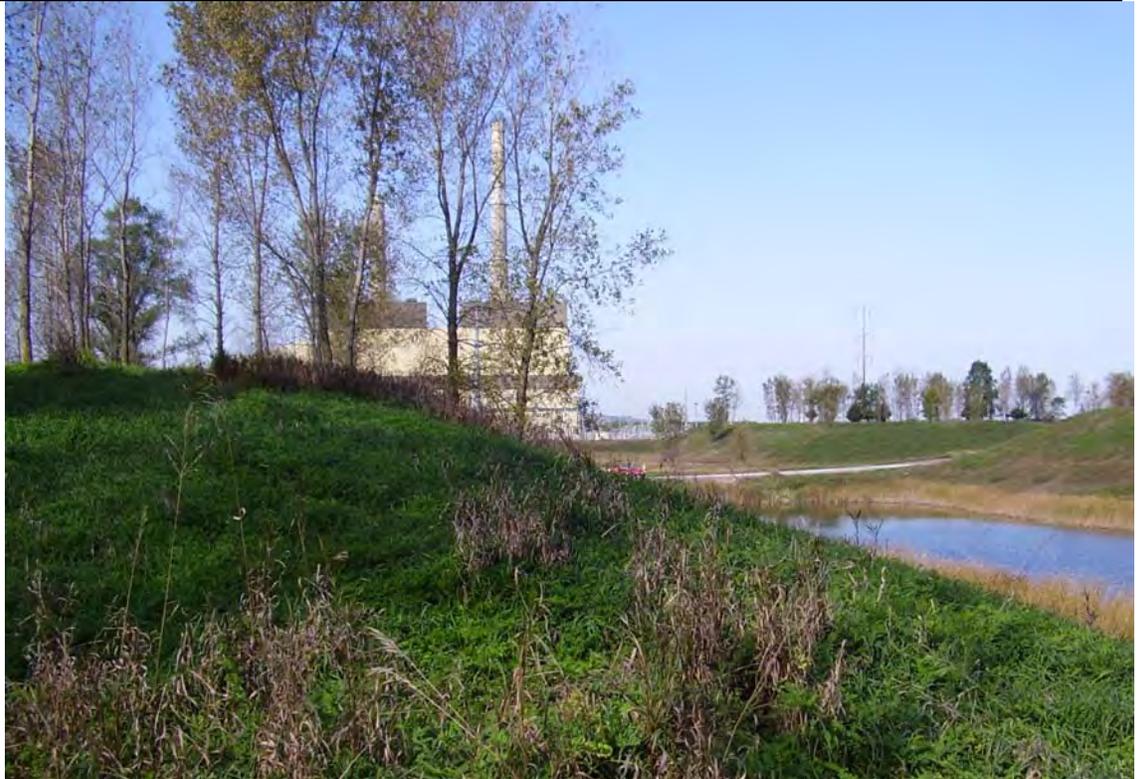
Description:
Crest of LSP.

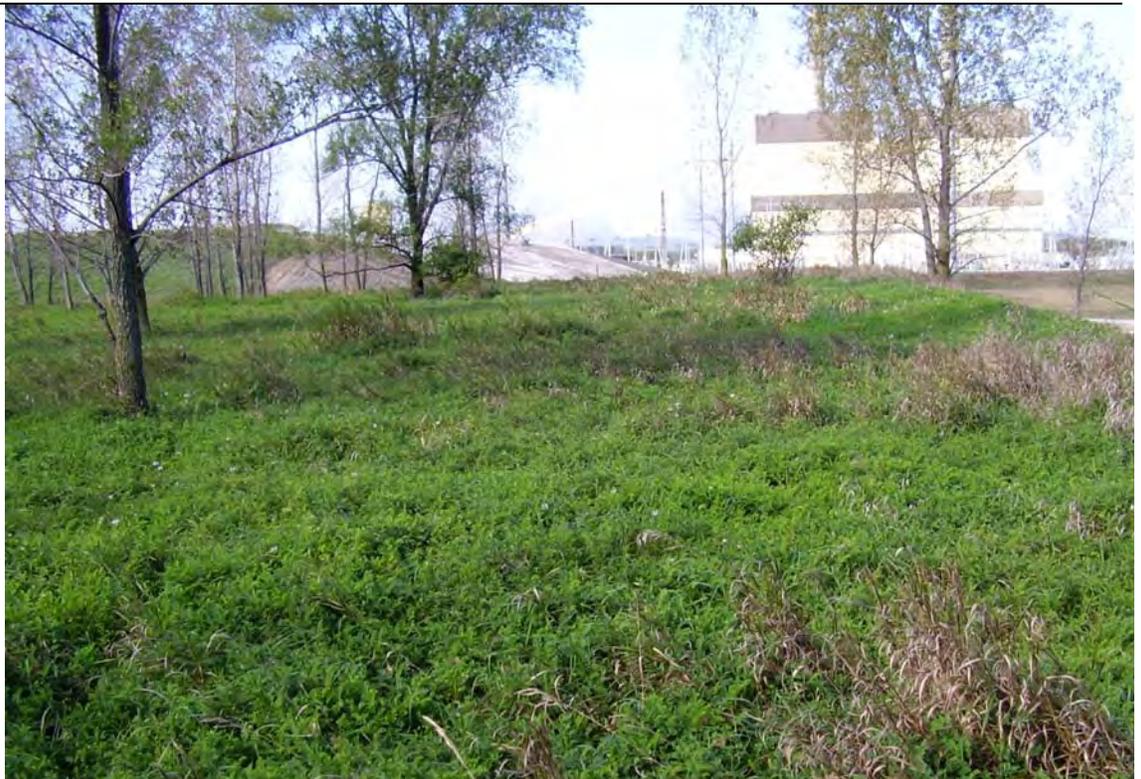
Photo No.
80

Description:
Crest of LSP.

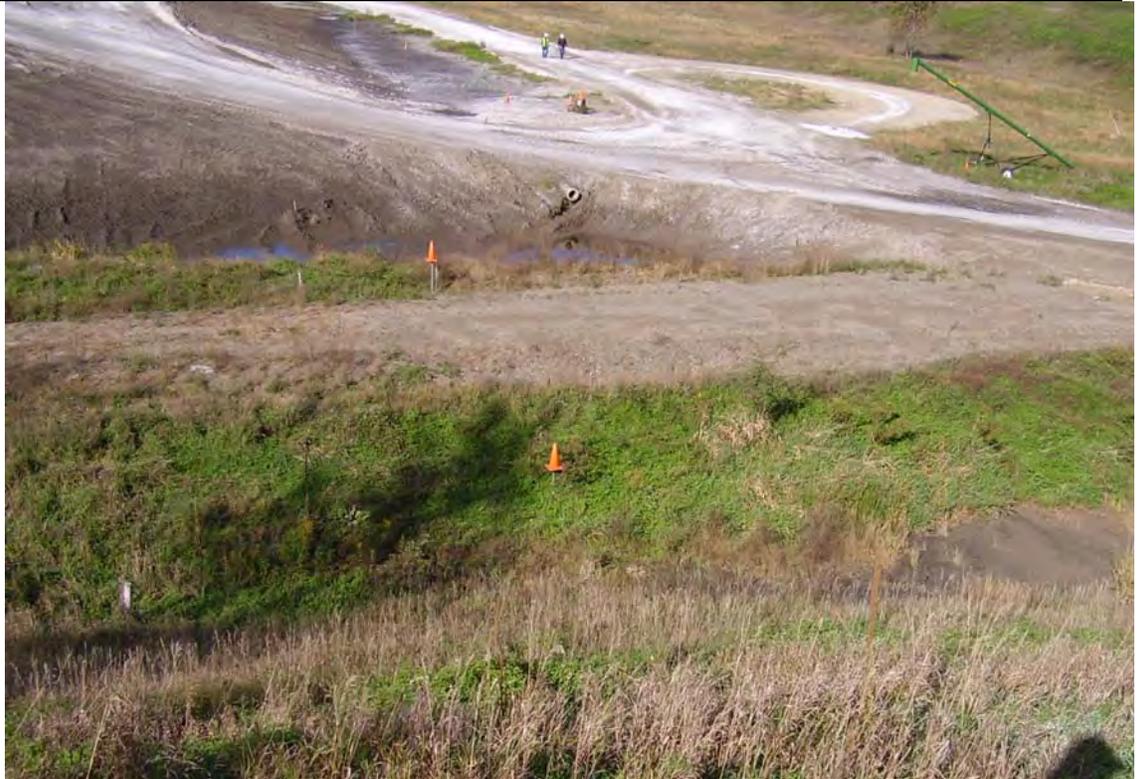
Description:
Crest of LSP.

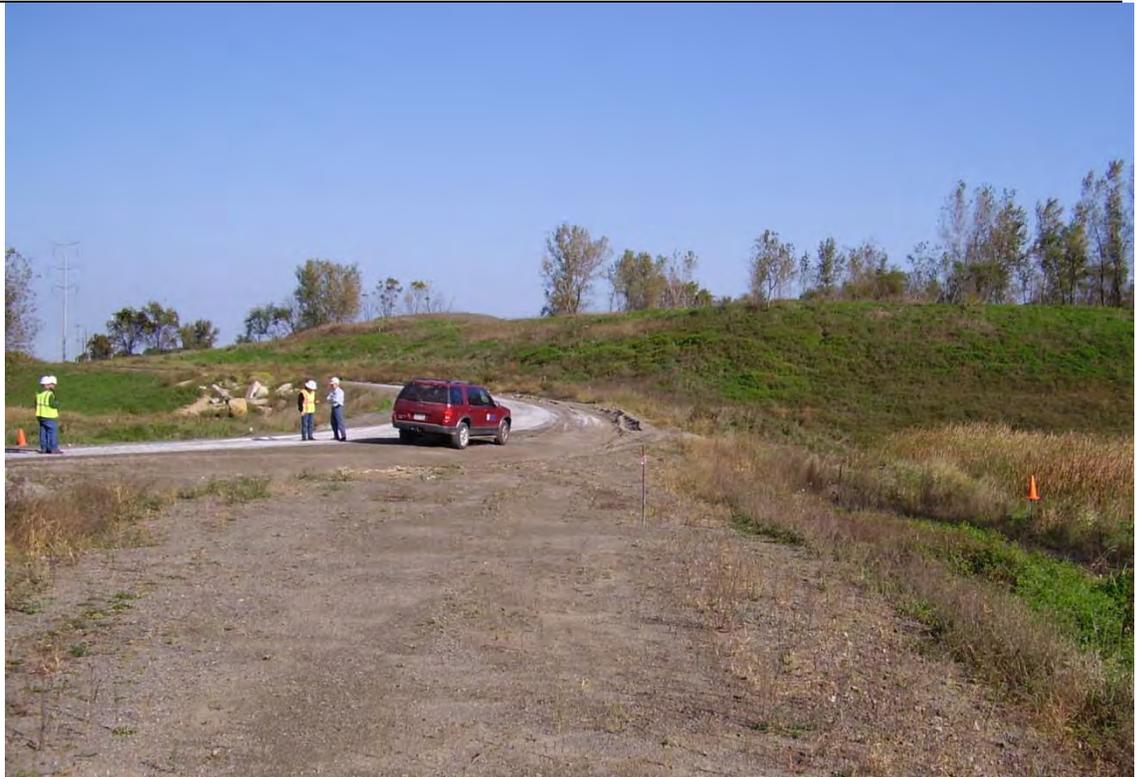
Photo No.
82

Description:
Crest of LSP.
