**DRAFT REPORT
ROUND 7 DAM ASSESSMENT - WISCONSIN POWER & LIGHT
COLUMBIA GENERATING STATION
PRIMARY ASH, SECONDARY ASH, POLISHING & LANDFILL
STORMWATER PONDS
PARDEEVILLE, WISCONSIN**

January 17, 2011

Re: Round 7 Dam Assessment - Draft Report
EPA Contract No. EP10W001313
Wisconsin Power & Light – Columbia Generating Station
Primary Ash, Secondary Ash, Polishing & Landfill Storm Water Ponds
Pardeeville, Wisconsin

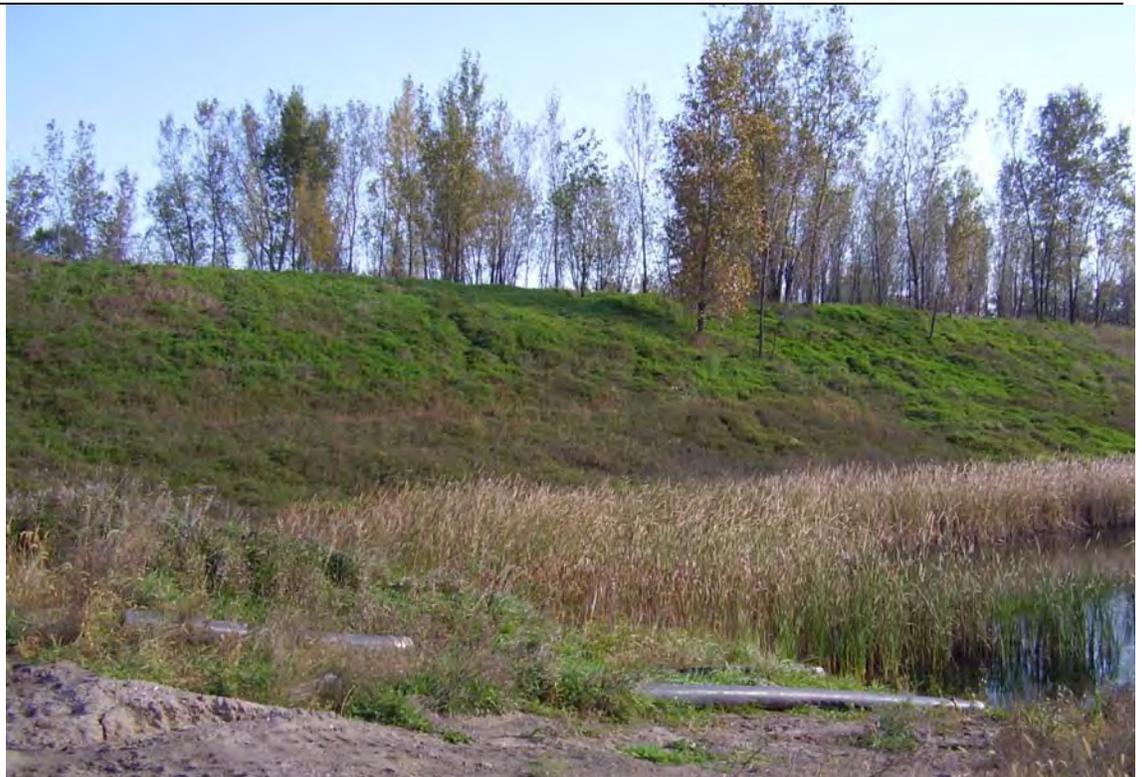
Photo No.
84

Description:
Upstream slope and crest of
PP.

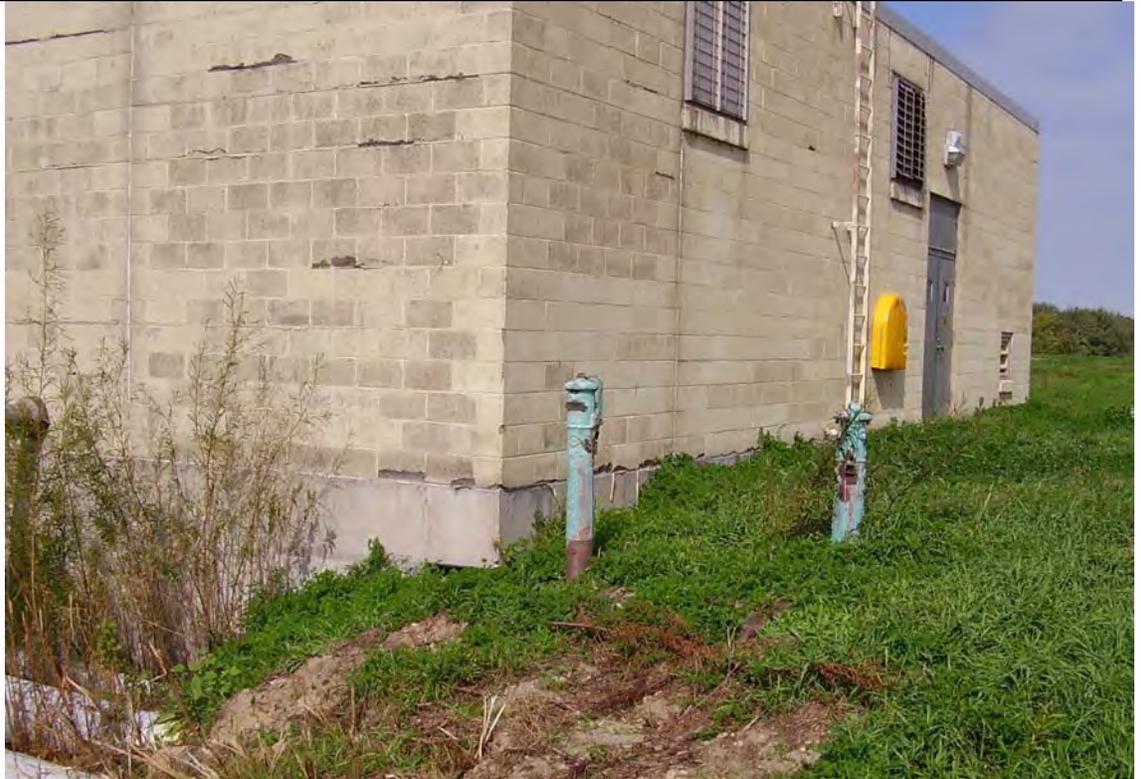
Direction Photo
Taken:
Northwest

Description:
PAP pump house.

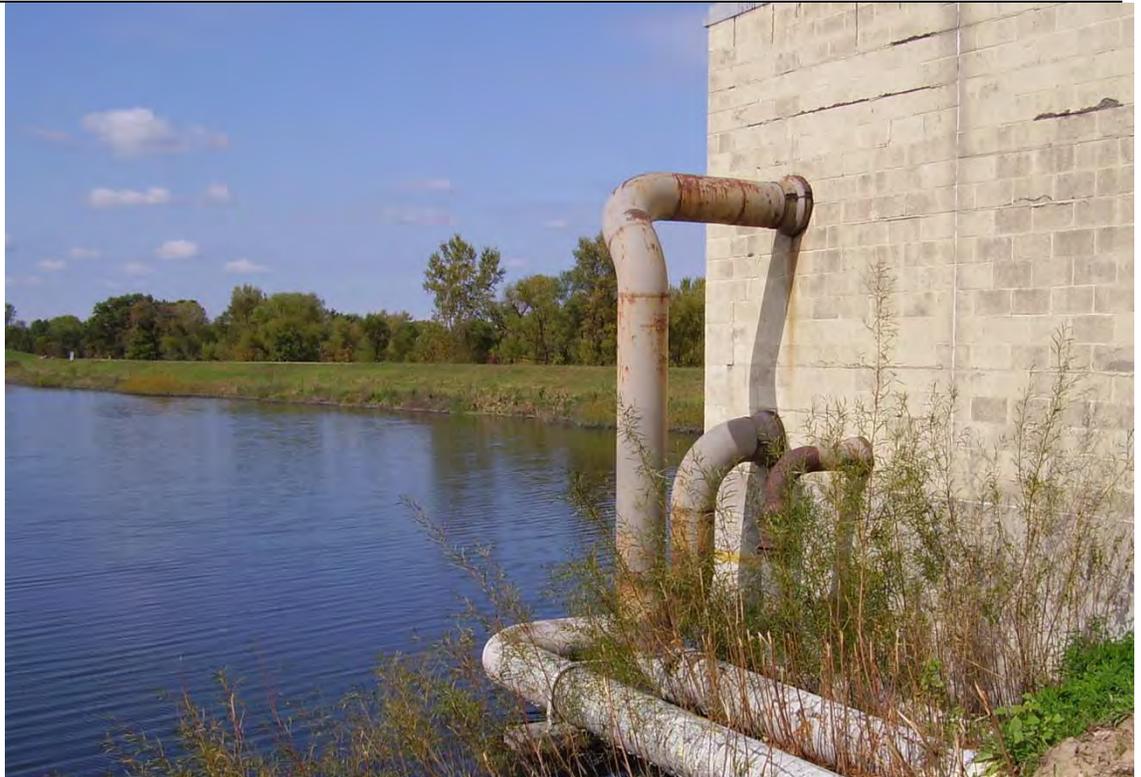
Photo No.
86

Direction Photo
Taken:
Northwest

Description:
PAP pump house.

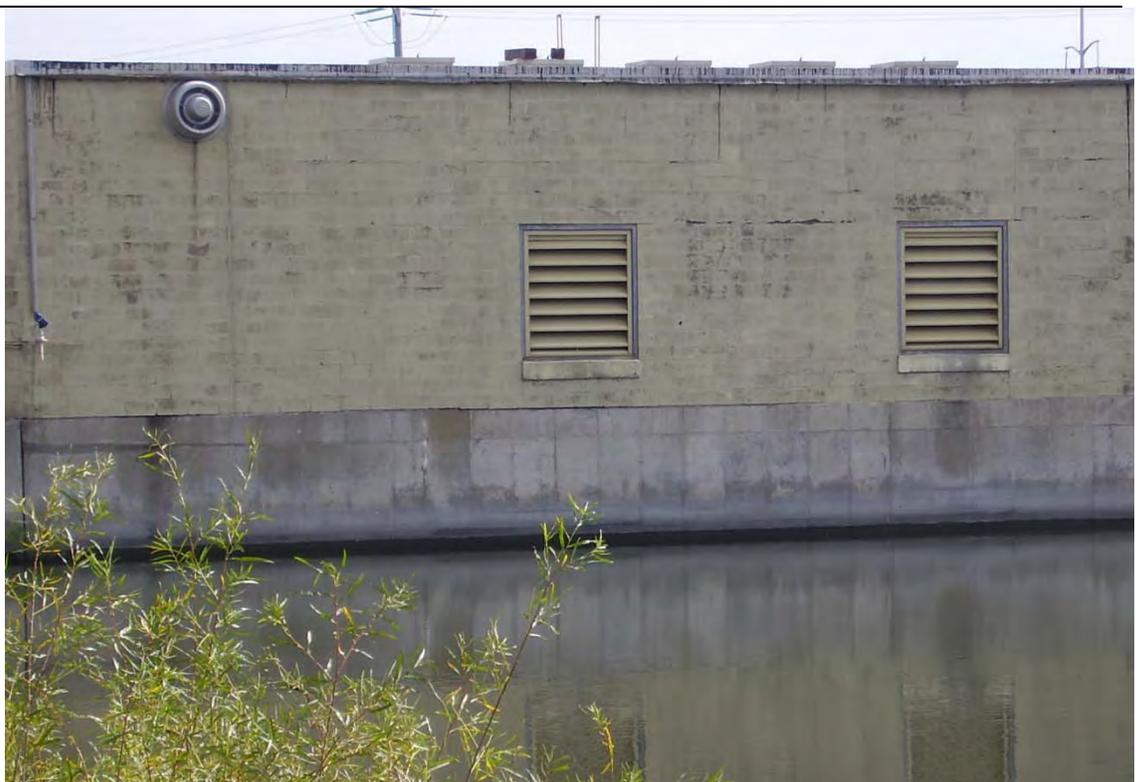
Direction Photo
Taken:
East

Description:
PAP pump house.

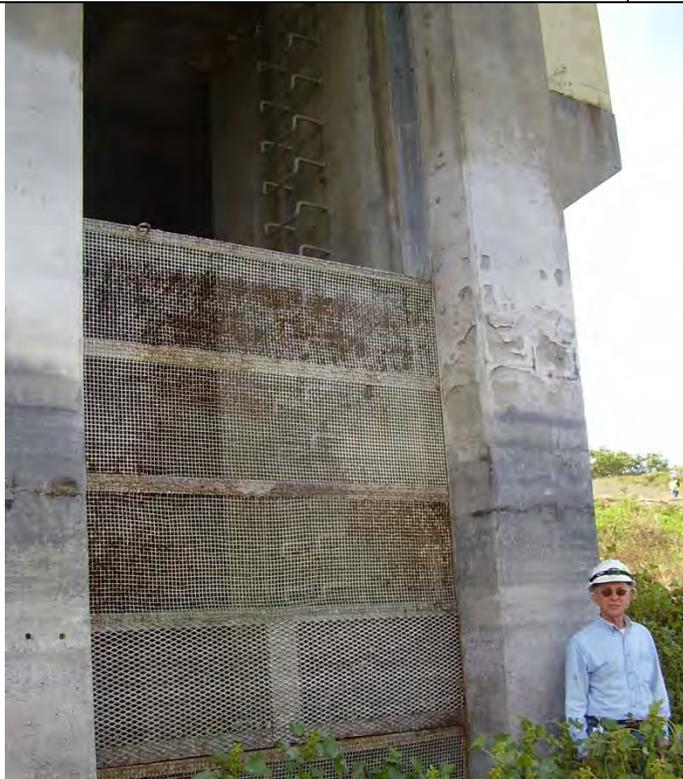
Direction Photo
Taken:
Southwest

Description:
SAP pump house intake.

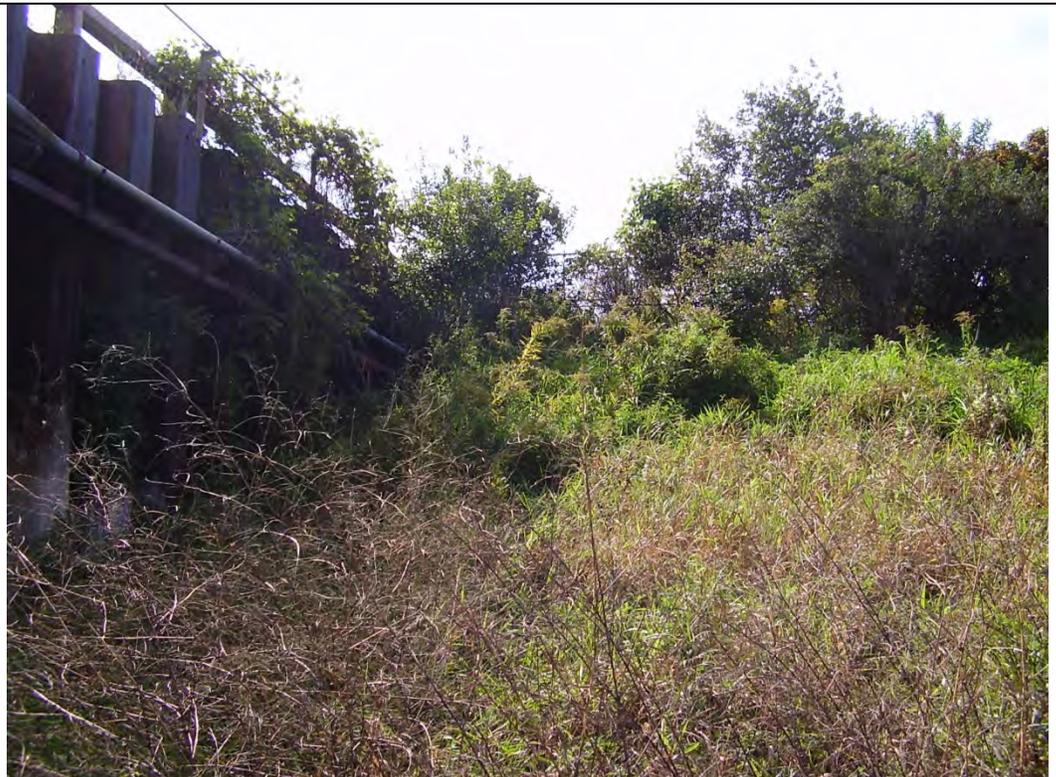
Photo No.
90

Direction Photo
Taken:
South

Description:
SAP pump house.

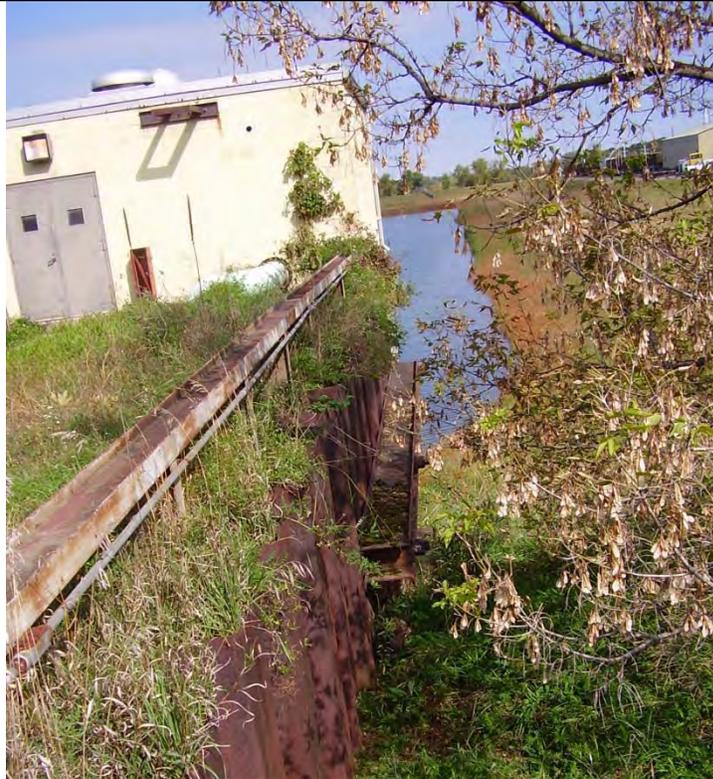
Direction Photo
Taken:
North

Description:
SAP pump house.

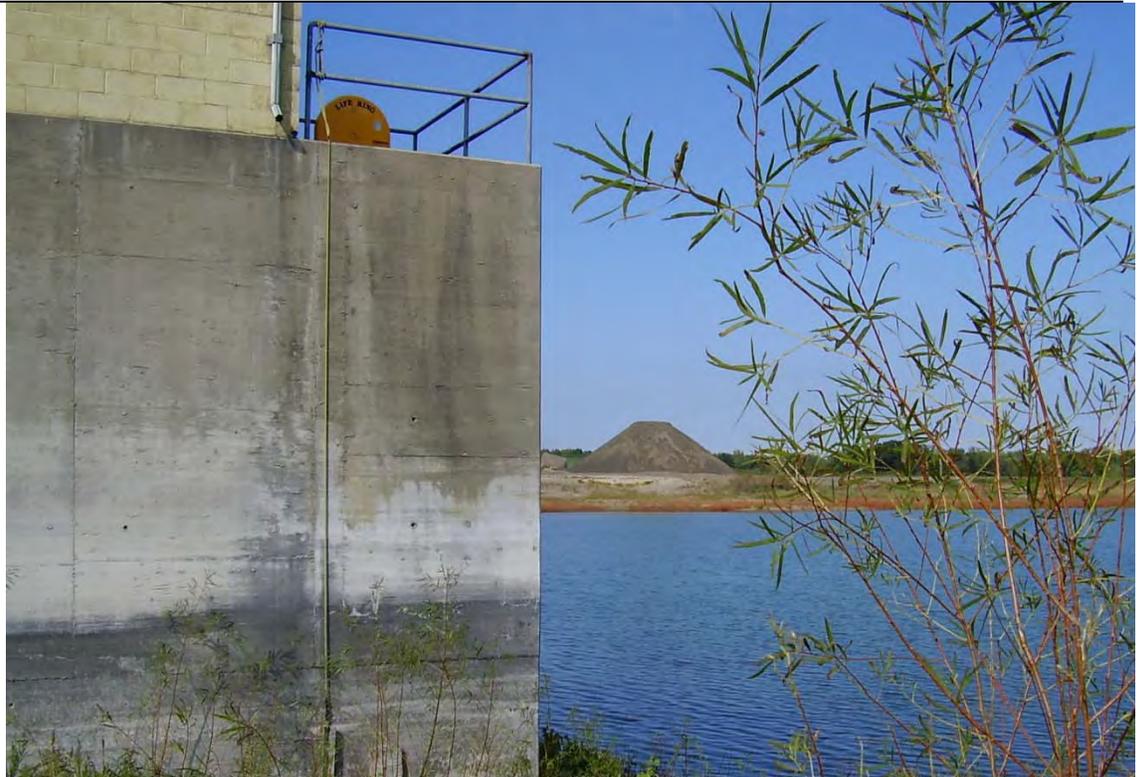
Photo No.
92

Direction Photo
Taken:
Northwest

Description:
SAP pump house.

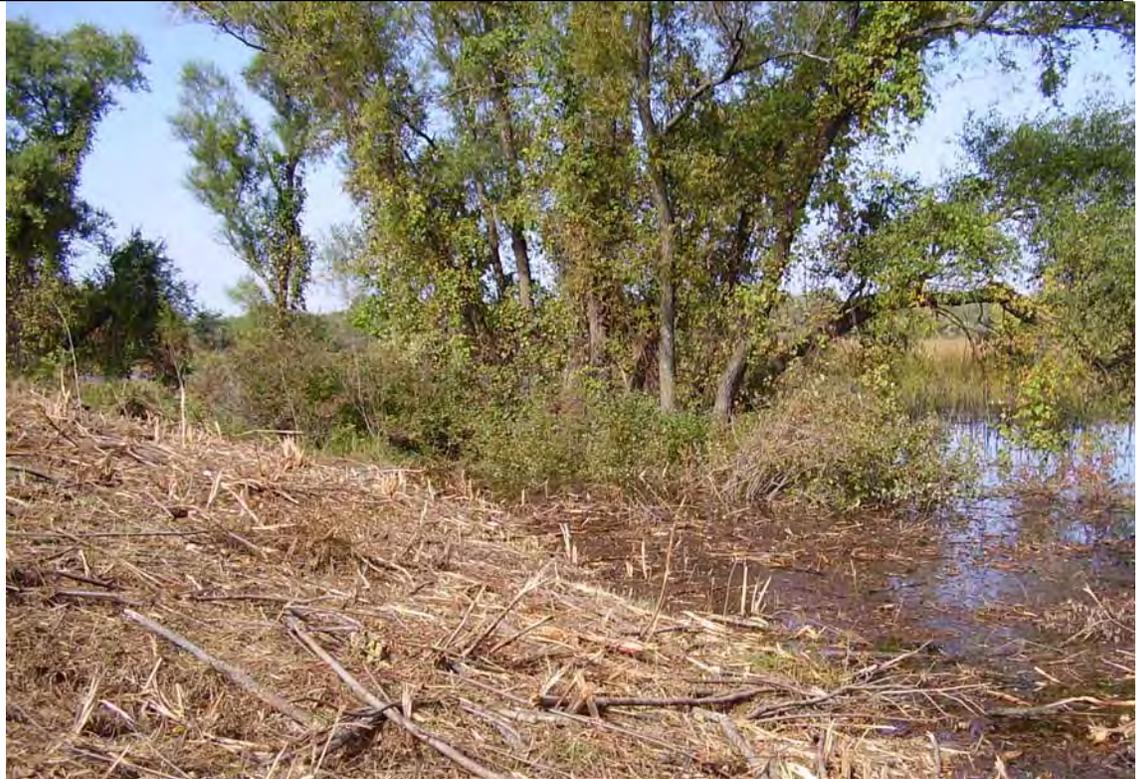
Direction Photo
Taken:
Northwest

Description:
SAP downstream slope.
