**Coal Combustion Waste Impoundment
Round 7 - Dam Assessment Report**

Lansing Energy (Site # 11)

Alliant Energy
Lansing, Iowa

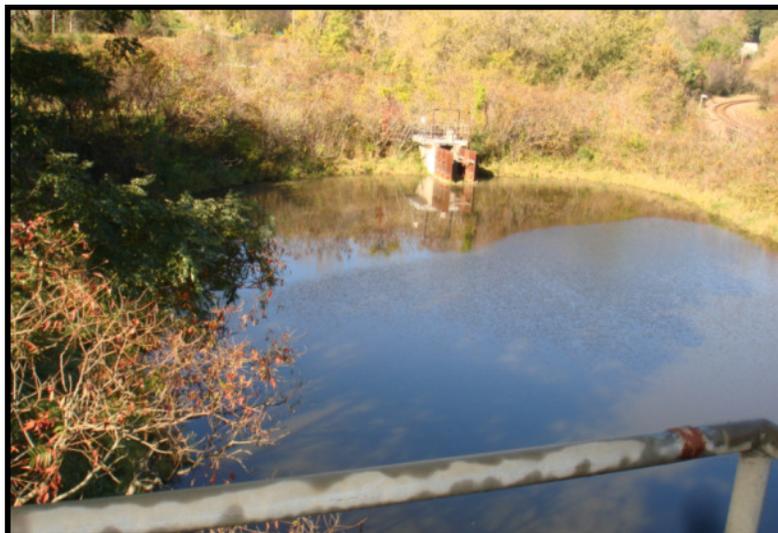
Photograph 3.6. Pond 2 Outfall structure.

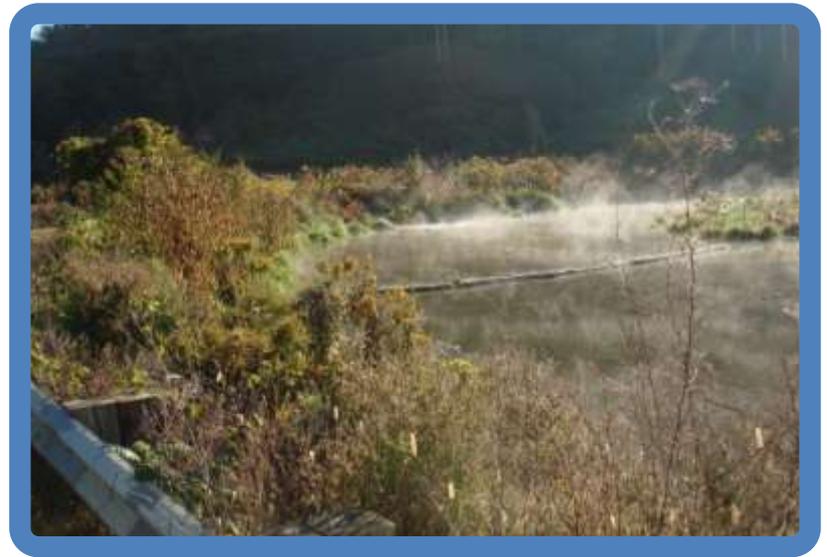
Picture 1.2
Pond 1 Northeast corner inside dike Looking east

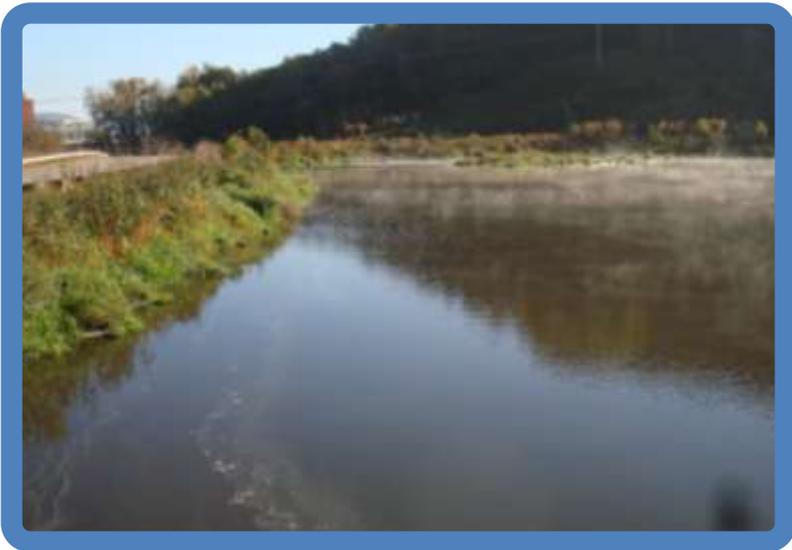
Picture 1.3
Pond 1 north inside dike Looking east

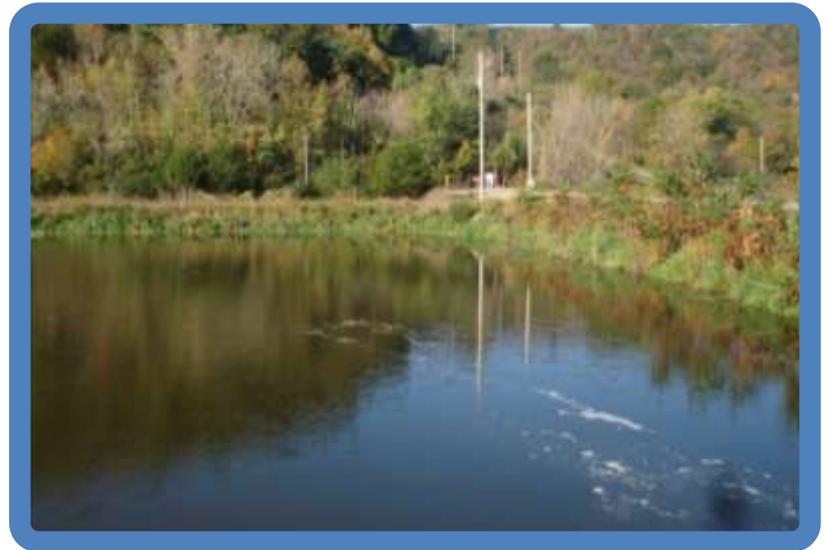
Photograph 1.4. Pond 1 northwest corner inside dike, looking west.

Picture 1.4
Pond 1 Northwest corner inside dike Looking west

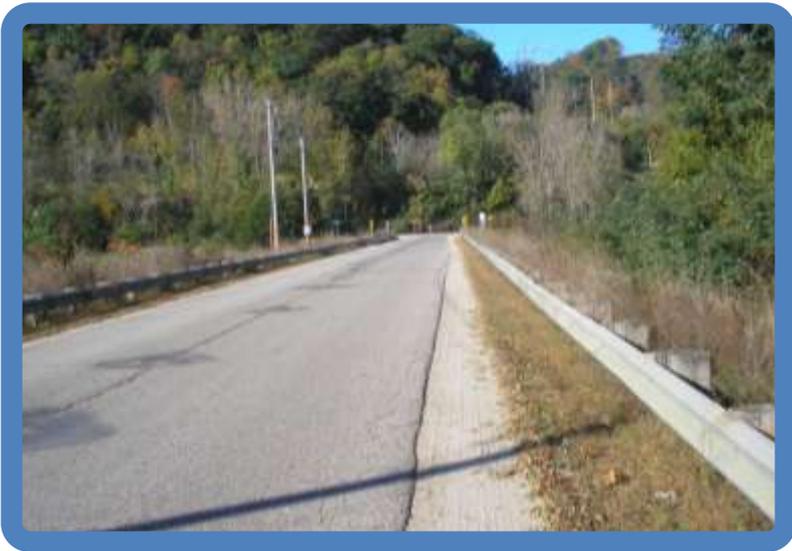
Picture 1.7

Power Plant Road Pond 1 north dike crest Looking east

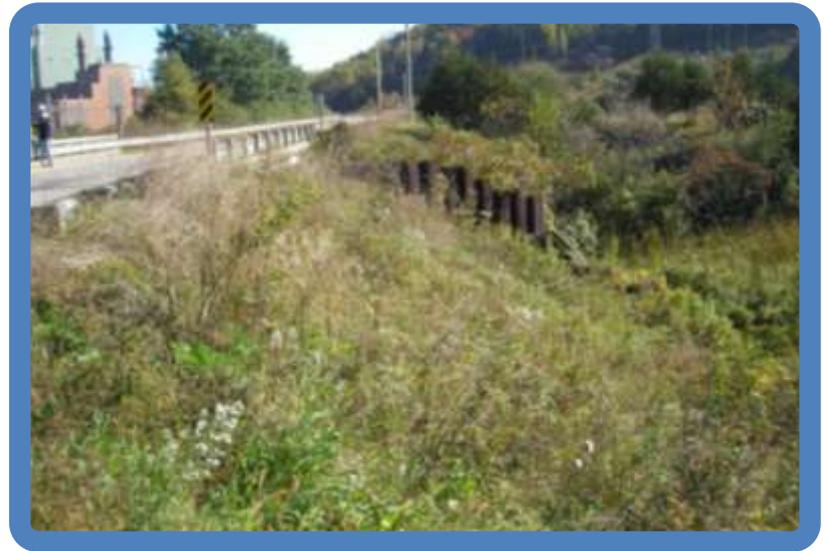
Picture 1.8

Pond 1 North outside dike Looking east

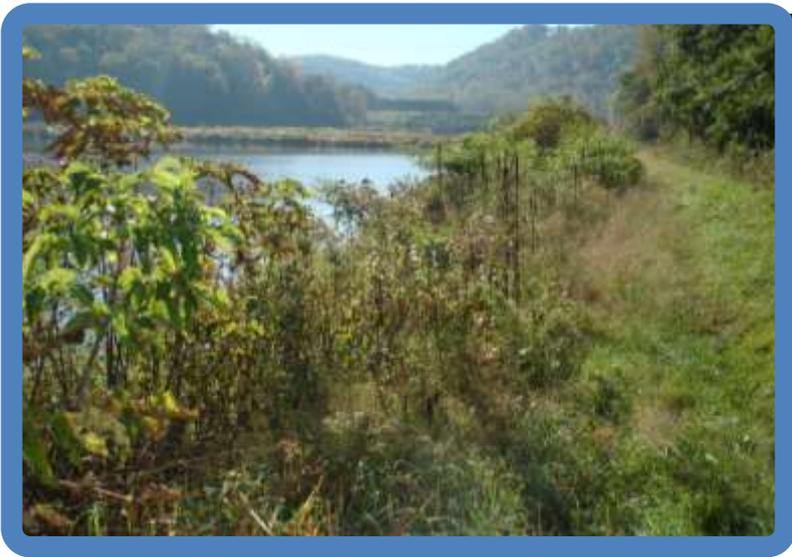
Picture 1.9

Pond 1 West crest and inside dike Looking south

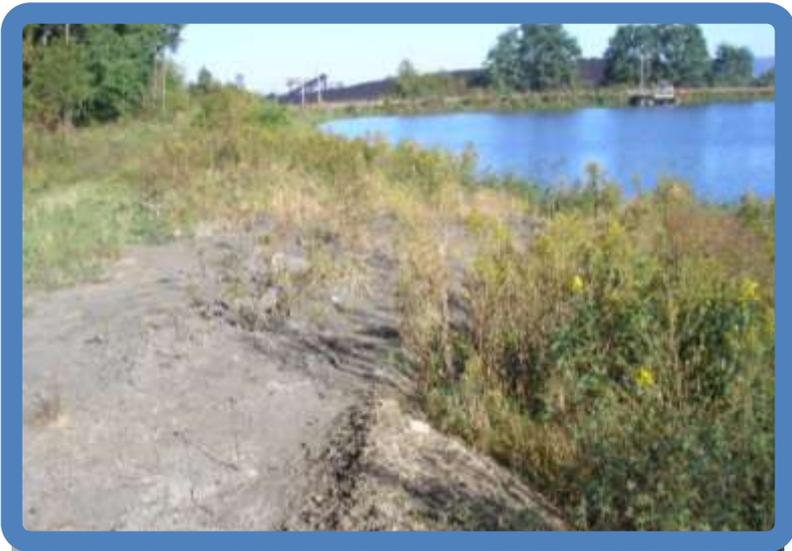
Picture 1.11

Pond 1 West Crest dike Looking north

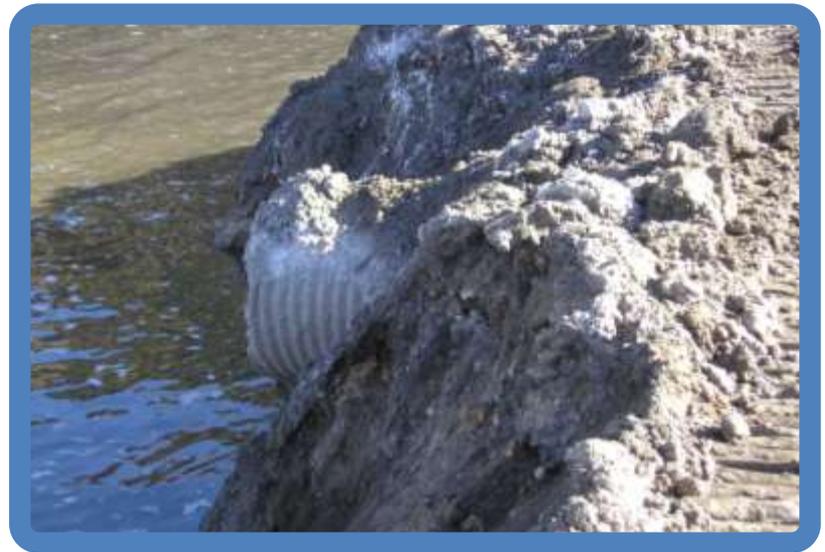
Picture 1.19
Pond 1 Small eroded areas adjacent to channelized portion

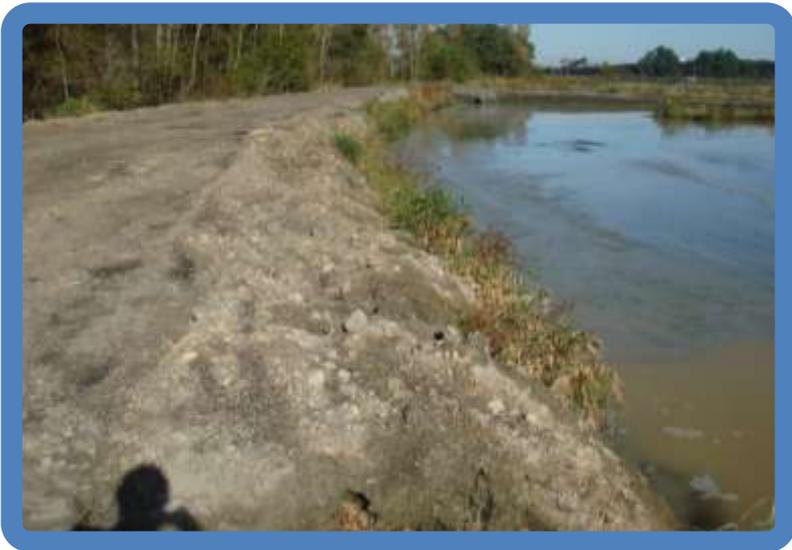
Picture 1.22

Pond 1 Small eroded area adjacent to channelized portion

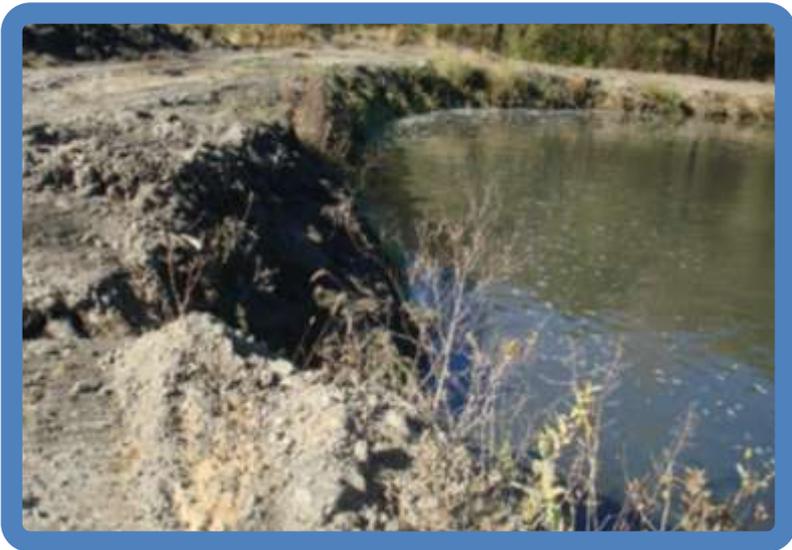
Picture 1.26 Pond 1 Ash spoil on south crest of dike
Landfill in background. Note landfill runoff culvert

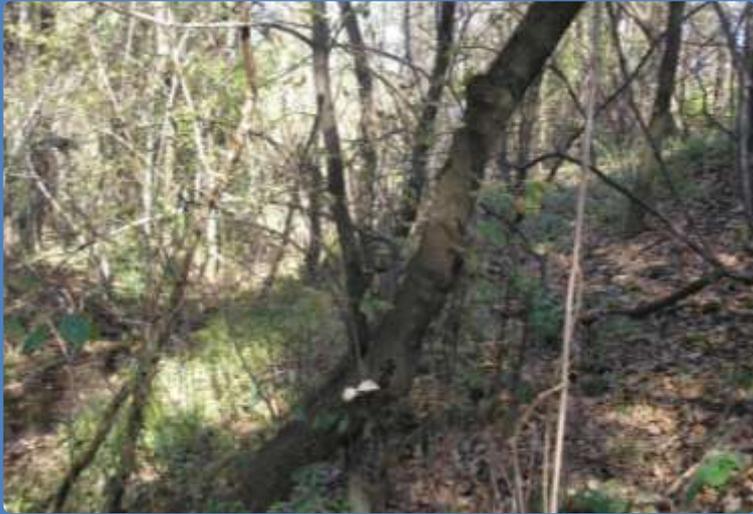
Picture 1.36

No significant erosion areas were observed. Generally on the west outside slope there was heavy tree growth and fairly thick undergrowth. Photograph 1.36 shows an area on the west outside slope of Pond 1. Rip rap was spread across the entire slope. No other obvious signs of slumps, slides, bulges, tension cracks, seepage, or animal holes were observed. This area does not appear to have any seepage problems. The north side of the access road was generally grassed with some sections of tree growth.

Pond 1 West outside dike Looking east

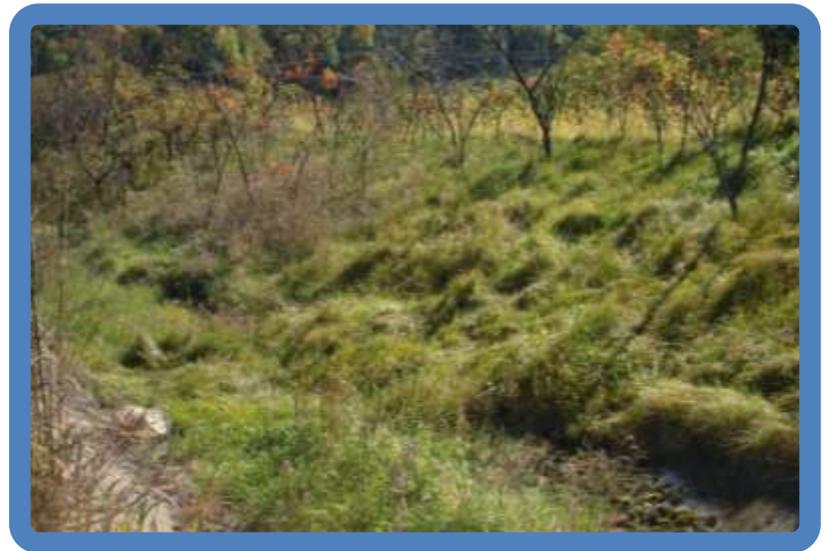
The crest around the west north and east sides of Ash Pond 2 join into the access road. The crest around all sides of Ash Pond 2 is accessible with automobiles. Photograph 2.8 shows the grassed maintenance access road along the outside slope of the north dike of Ash Pond 2.

Picture 2.8
Pond 2 Maintenance road along mid-slope of the embankment of the north dike .

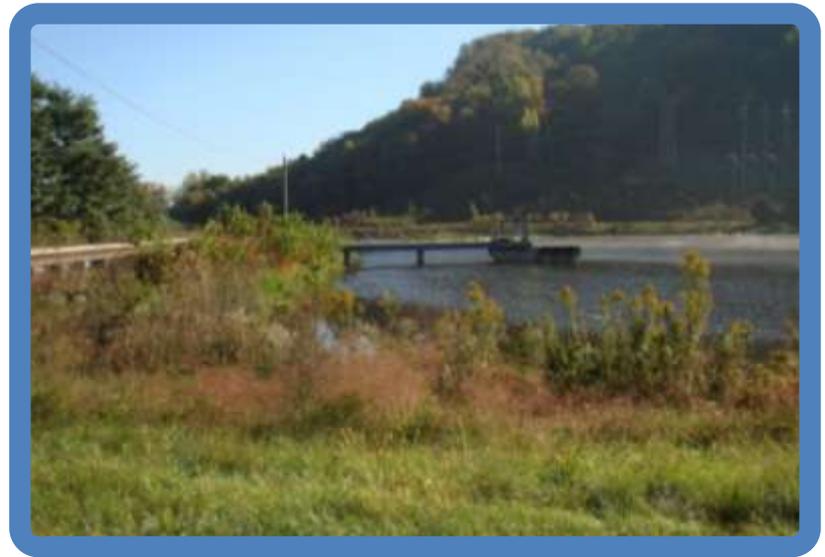
There overflow structure for Ash Pond 1 is located on the north side of the pond, see Photograph 3.1. The outfall structure is a grated concrete square weir inlet box. The concrete inlet box surrounding the inlet was observed to be in good condition. Water was flowing into the box during the visit. The outfall RCP culvert is a 24" RCP culvert.

Picture 3.1
Outfall Pond 1 Intake Structure Looking west

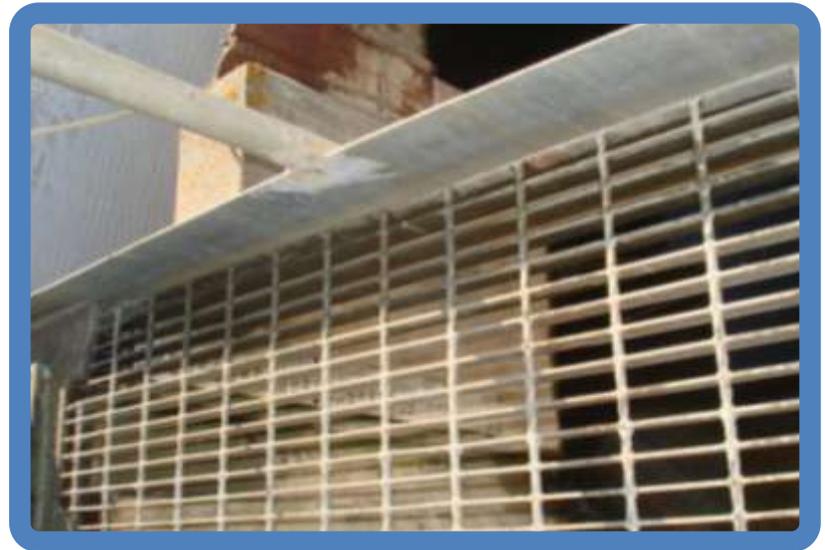
Picture 3.3
Outfall Pond 1 Intake detail filter fabric

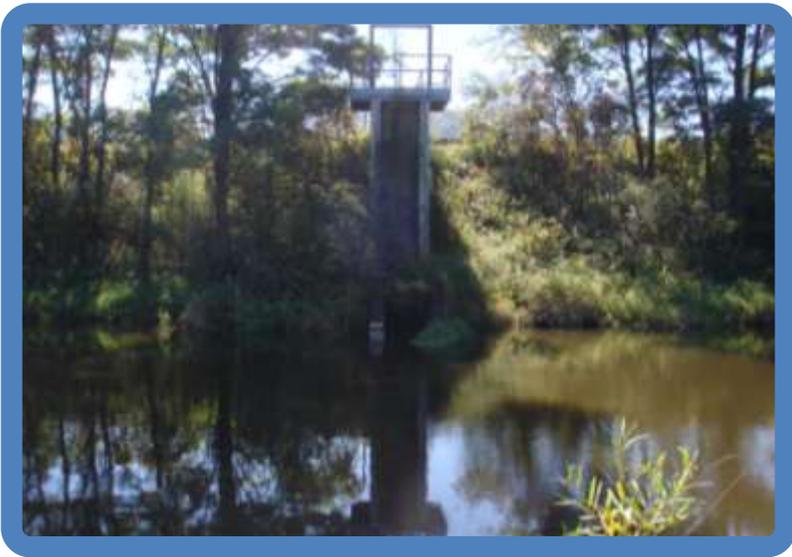
Picture 3.4
Outfall Pond 1 Intake staff gauge

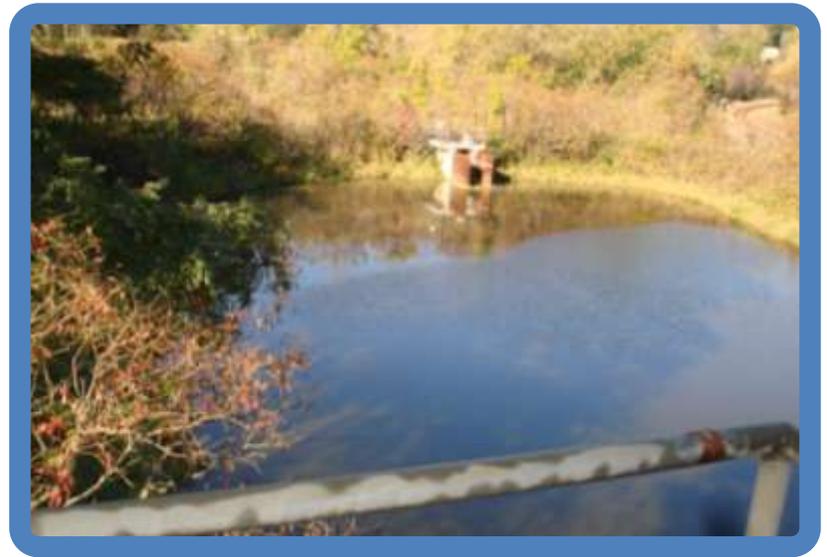
Picture 3.5

Outfall Pond 2 Inflow drop Structure Looking south

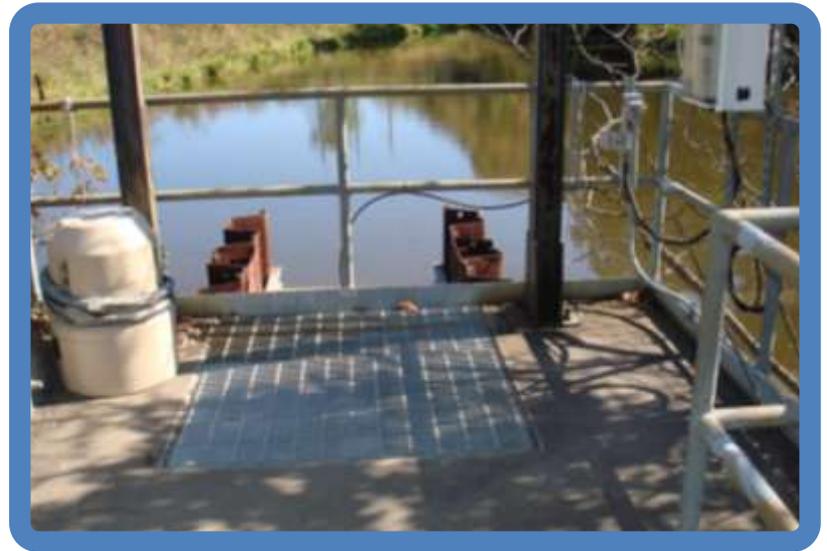
Picture 3.7

Outfall Pond 2 Upstream end of Outflow Structure

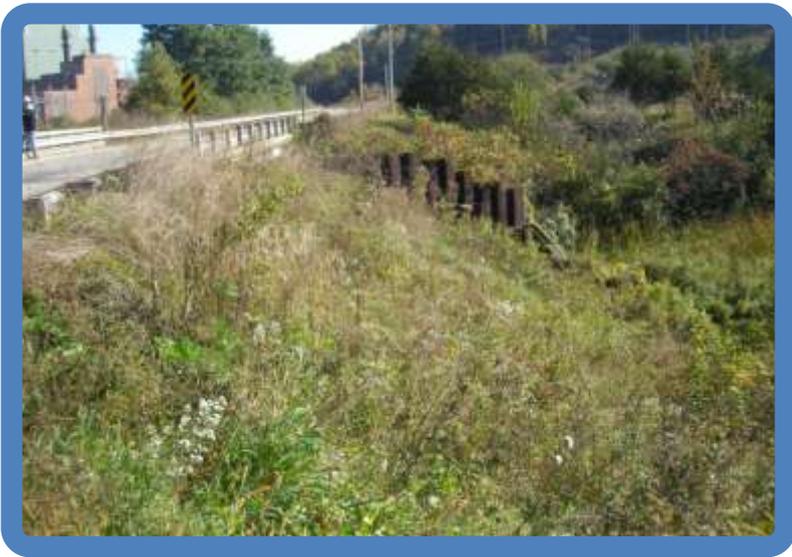
Picture 3.8

Outfall Pond 2 Upstream end of Outflow Structure (on deck)

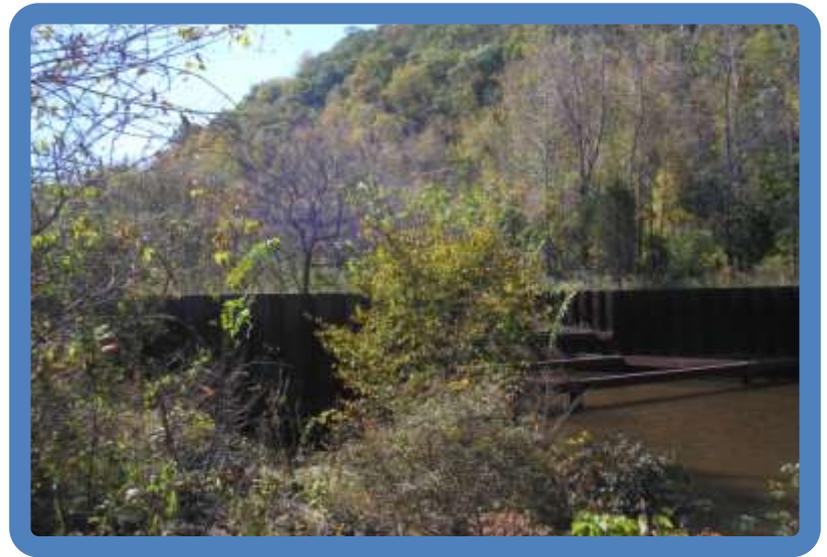
Picture 3.9

Outfall Downstream end of access road box culvert

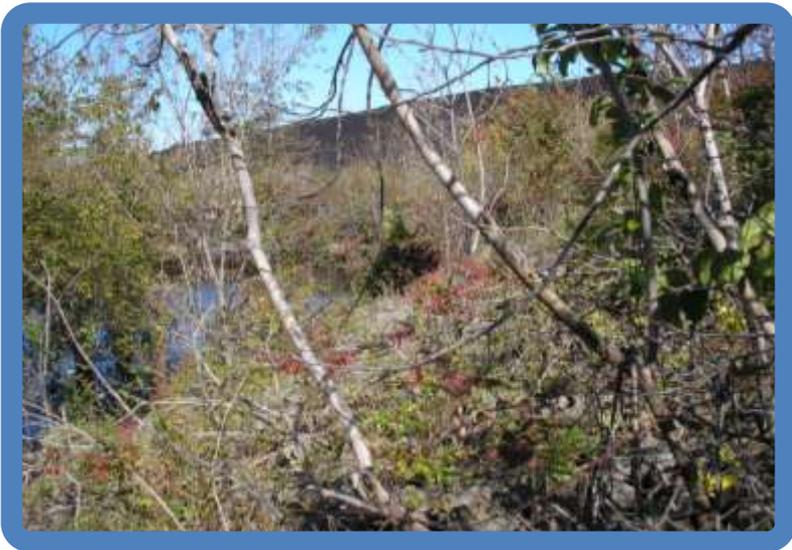
Picture 3.10

Outfall Access Road box culvert Looking south

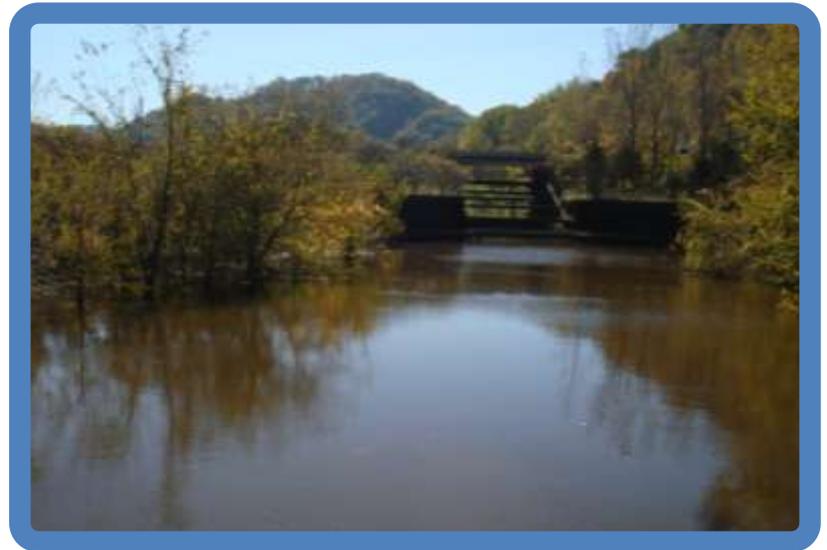
Picture 3.11

Outfall Pond 2 discharge area into channel Looking north
