Coal Combustion Waste Impoundment

Round 7 - Dam Assessment Report

Lansing Generating Station

**Interstate Power and Light Company (IPL)
Lansing, Iowa**

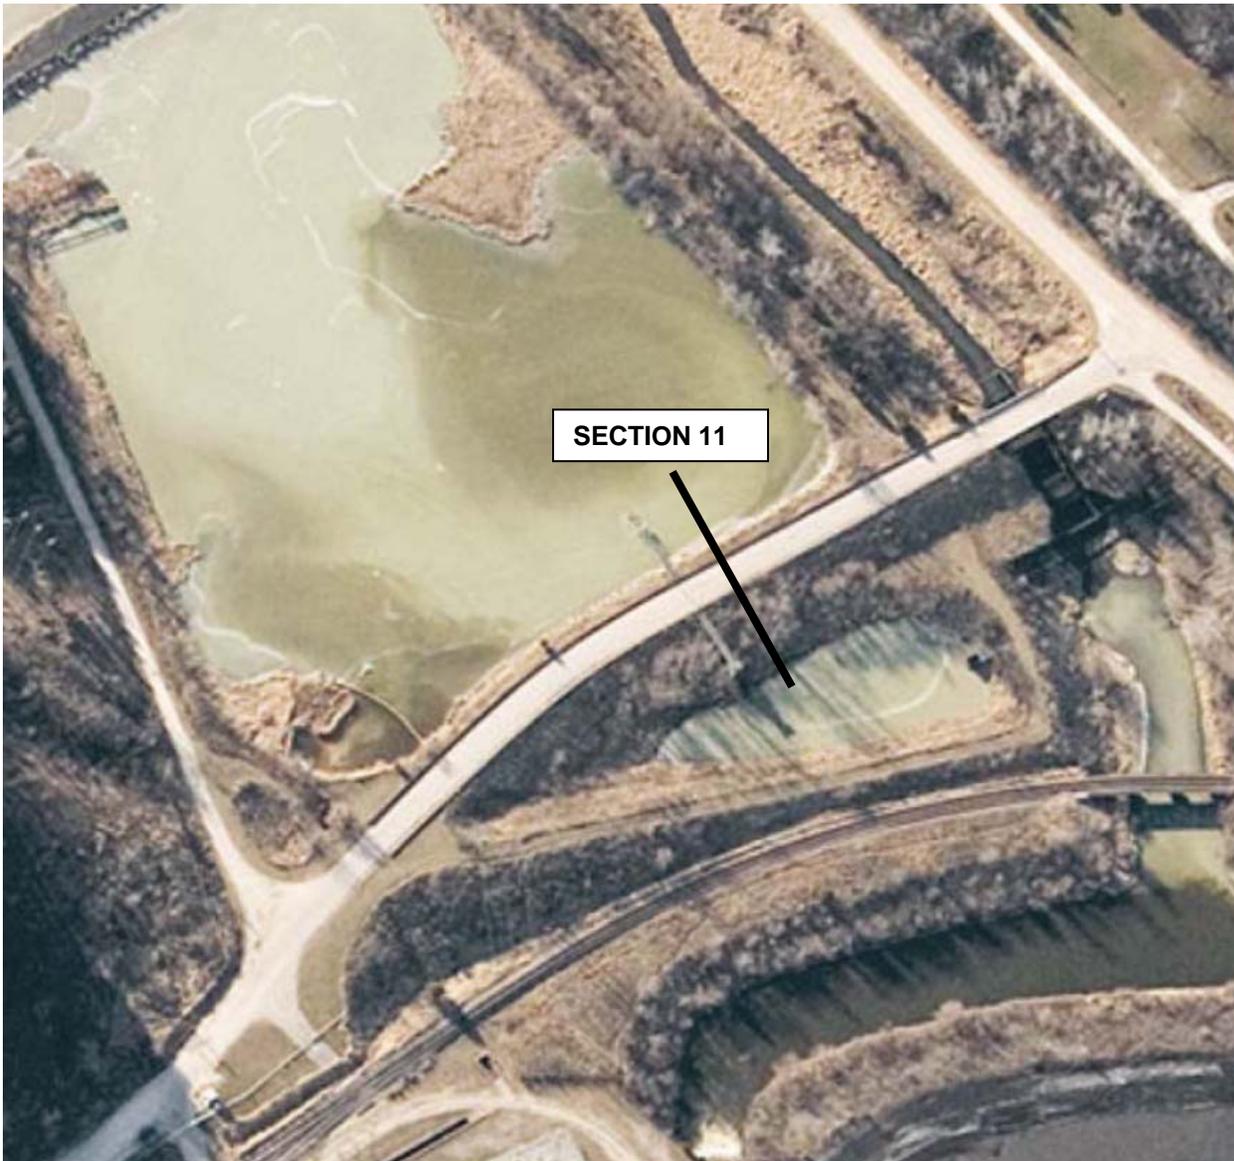
FIGURE 1

- Dike cross-section locations and the cross-section dimensions were obtained from References 1 and 2.
- The location of the dike section analyzed (Section 11) is shown on Figure 1. The pond dike is highest at Section 11. Therefore, this section was analyzed to address the most critical stability condition.

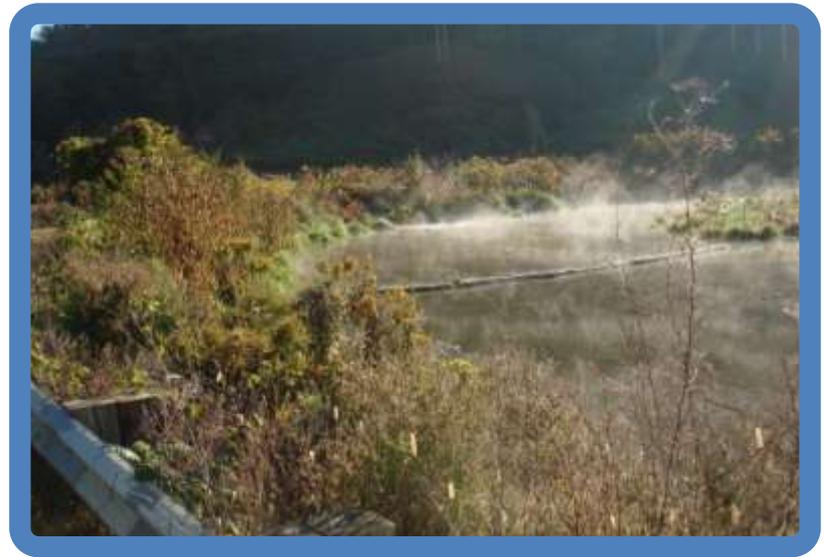
Picture 1.2
Pond 1 Northeast corner inside dike Looking east

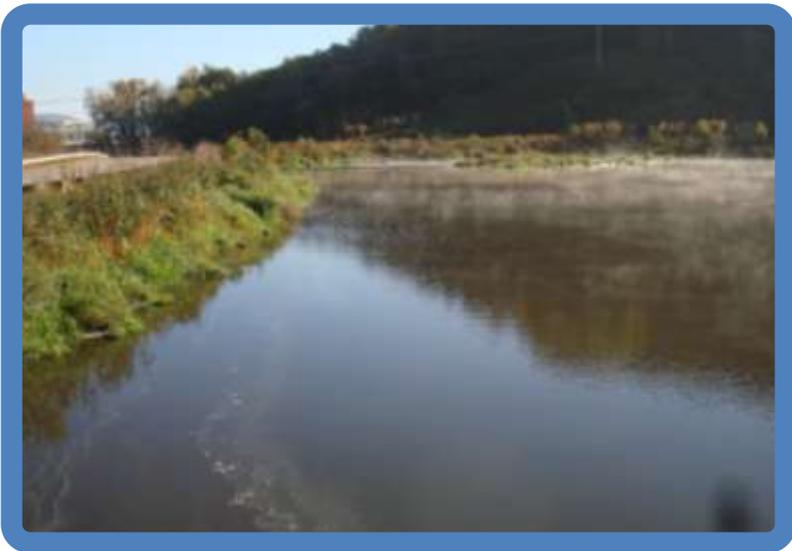
Picture 1.3
Pond 1 north inside dike Looking east

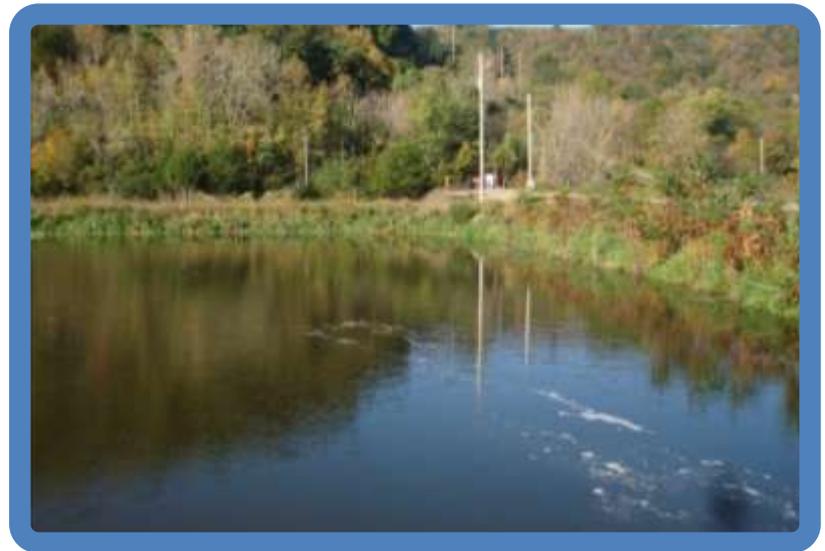
Picture 1.4
Pond 1 Northwest corner inside dike Looking west

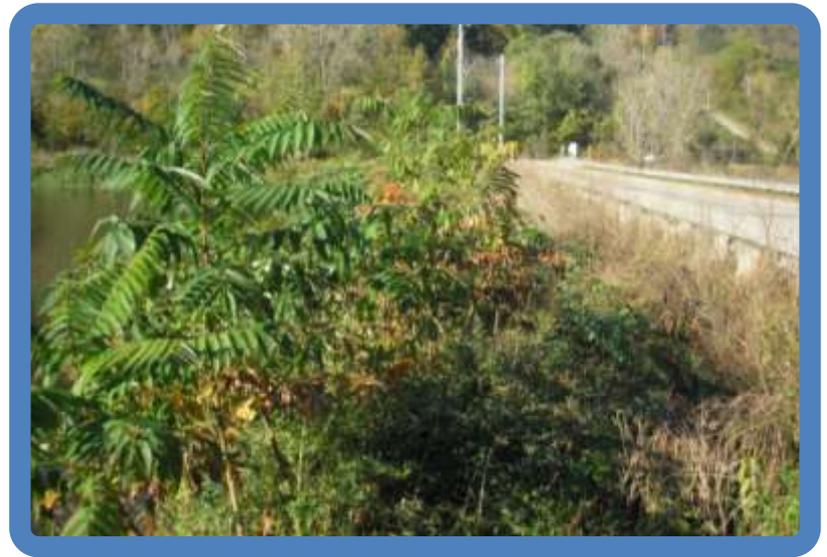
Picture 1.6

Pond 1 North inside dike Looking west

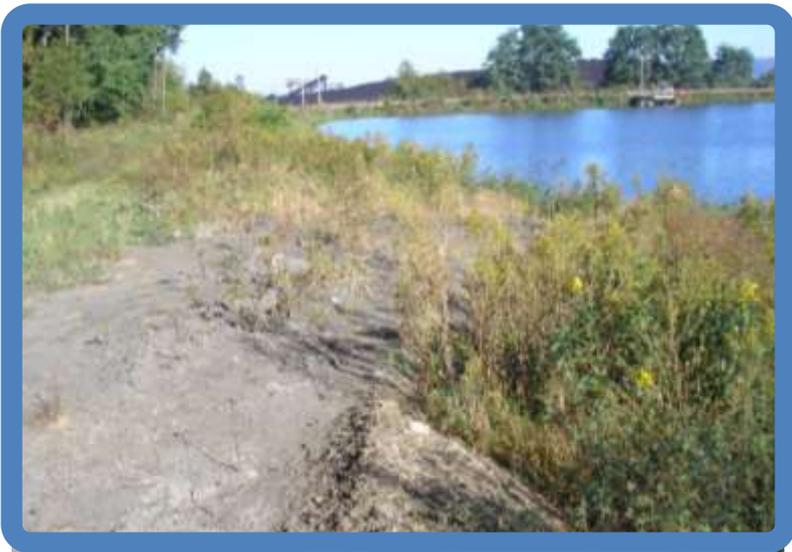
Picture 1.11
Pond 1 West Crest dike Looking north

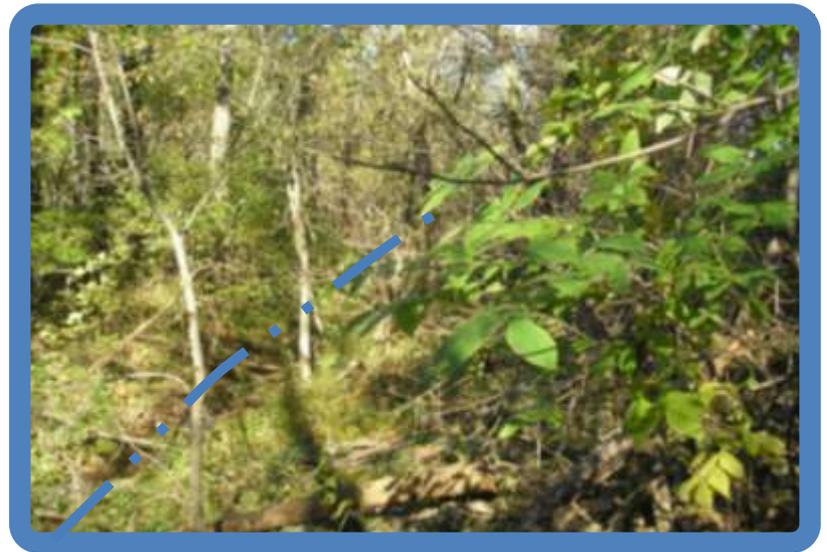
Picture 1.12
Pond 1 West outside berm Looking north (Note creek bed)

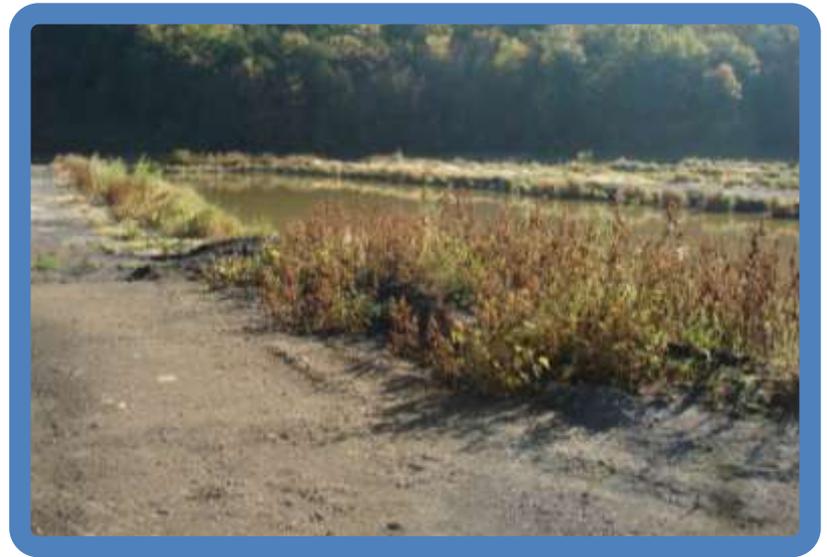
Picture 1.13
Pond 1 East side inside dike Looking east

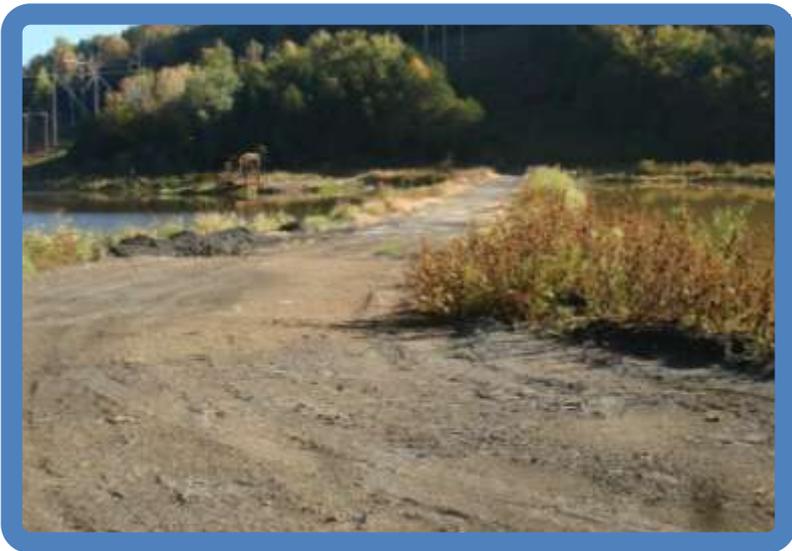
Picture 1.14
Pond 1 Begin channelized area Looking east

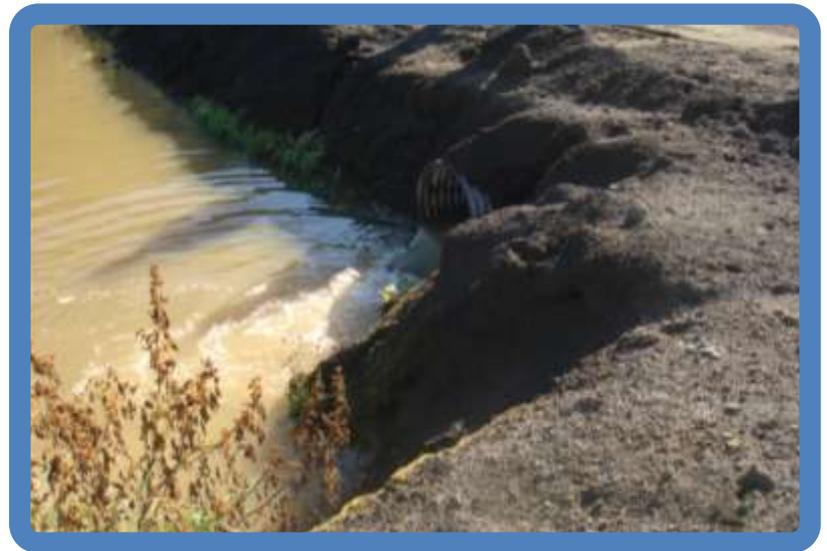
Picture 1.15
Pond 1 First channelized interior berm Looking east

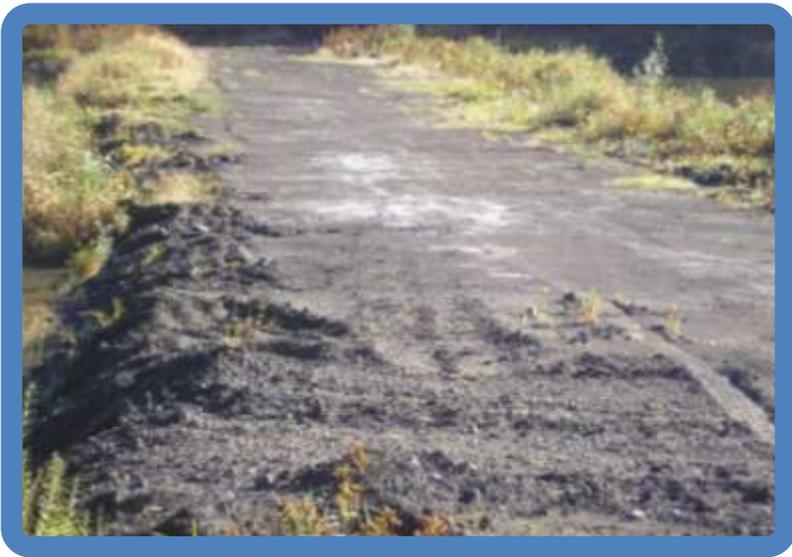
Picture 1.16
Pond 1 Culvert connection in channelized area

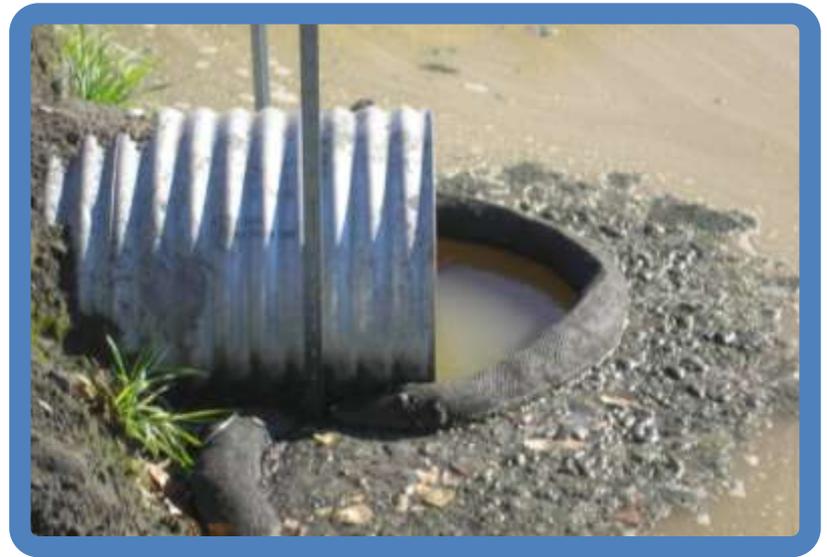
Picture 1.17
Pond 1 Third interior dike Looking east

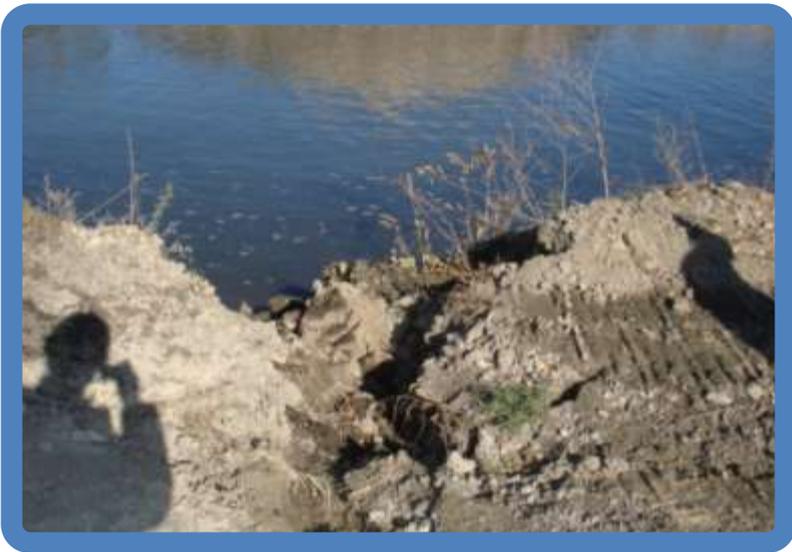
Picture 1.18
Pond 1 Upstream end of culvert fabric filtered inflow

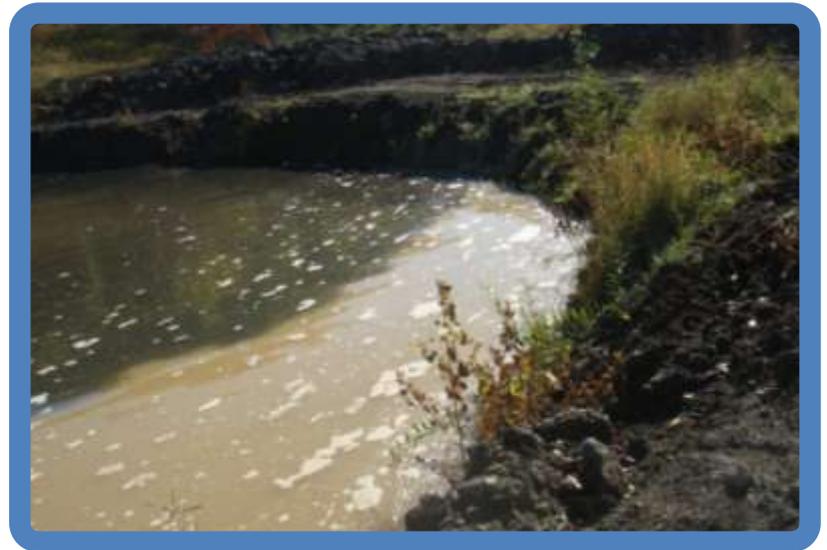
Picture 1.23

Pond 1 West inside dike Looking north

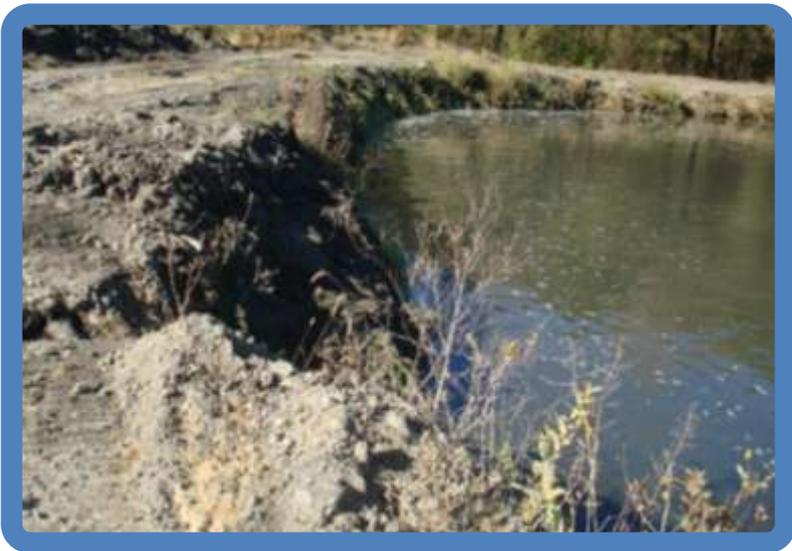
Picture 1.26 Pond 1 Ash spoil on south crest of dike
Landfill in background. Note landfill runoff culvert

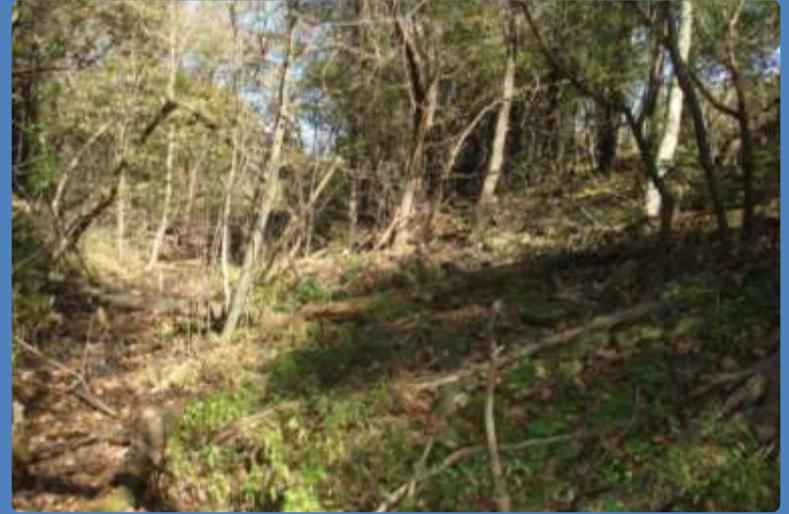
Picture 1.33

Pond 1 West outside dike Looking east and upward

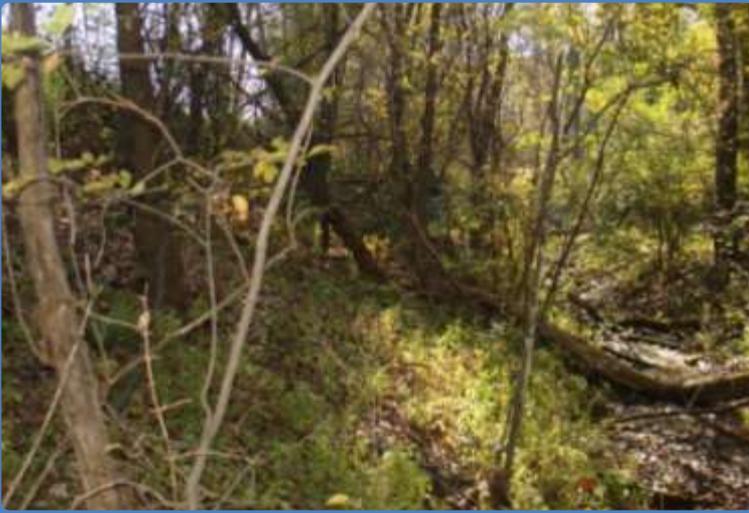
Picture 1.34

Pond 1 West outside dike Looking north at toe

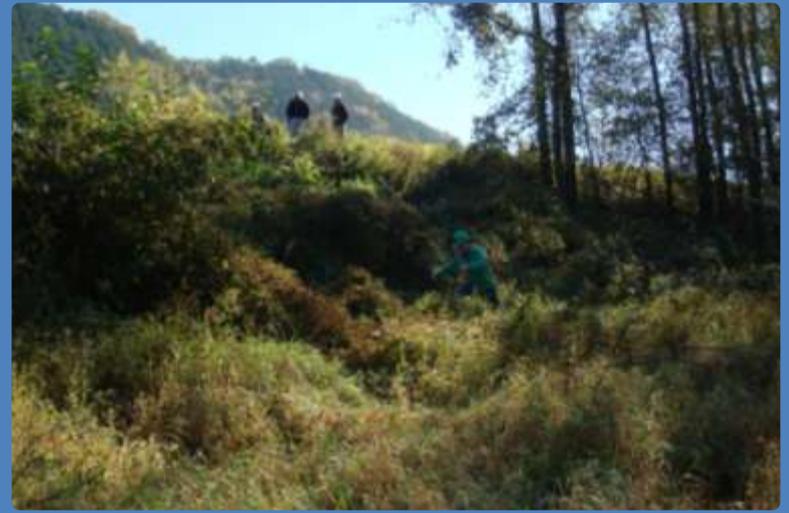
Picture 1.35

Pond 1 West outside dike Looking south at unnamed creek

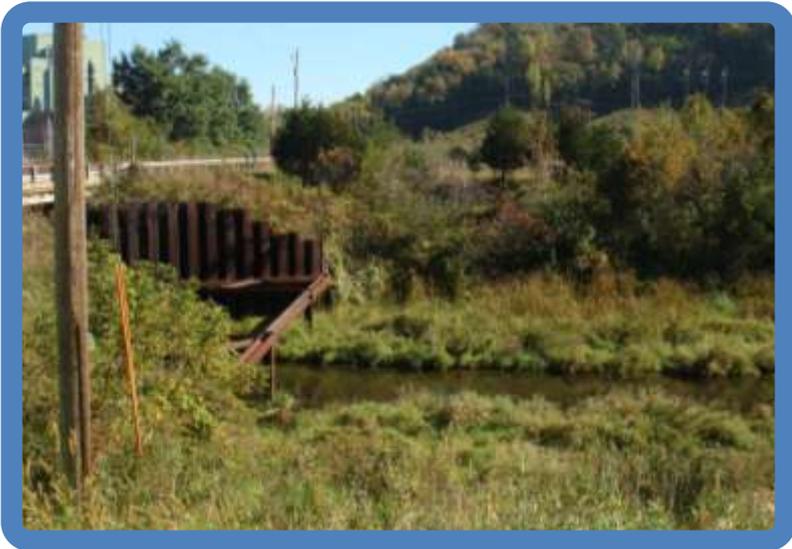
Picture 1.41

Outfall path Downstream side of Access Road Looking north

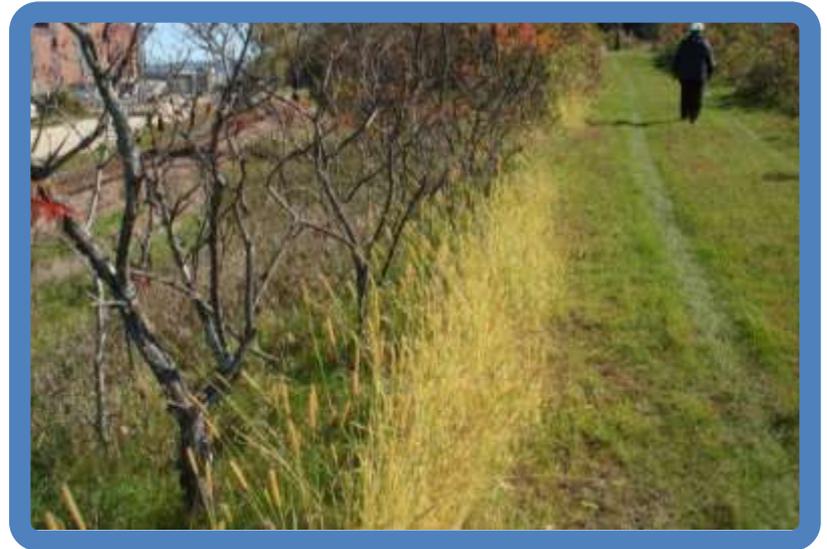
Picture 1.42

Pond 1 North outside dike Looking east

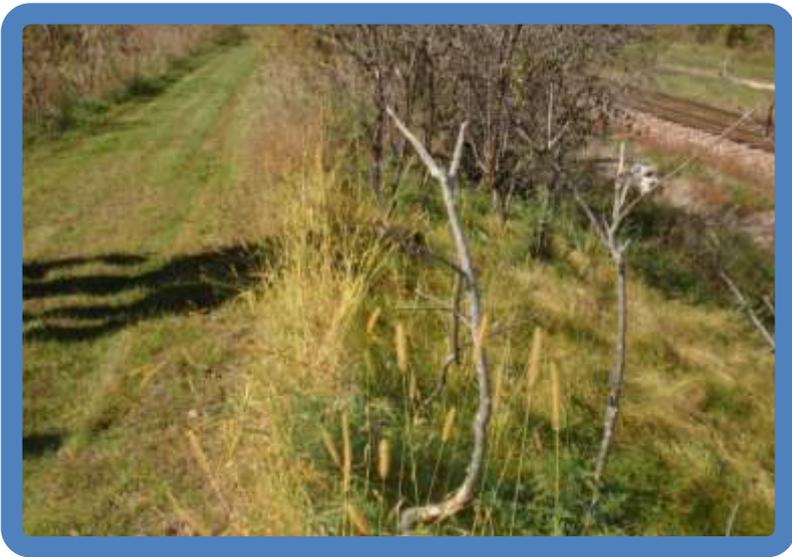
Picture 2.1

Pond 2 Crest and North outside dike Looking east

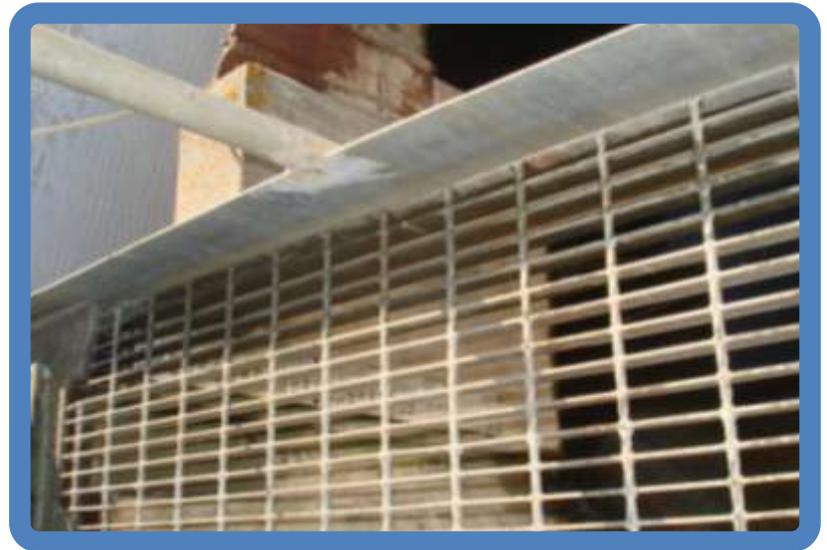
Picture 3.3
Outfall Pond 1 Intake detail filter fabric

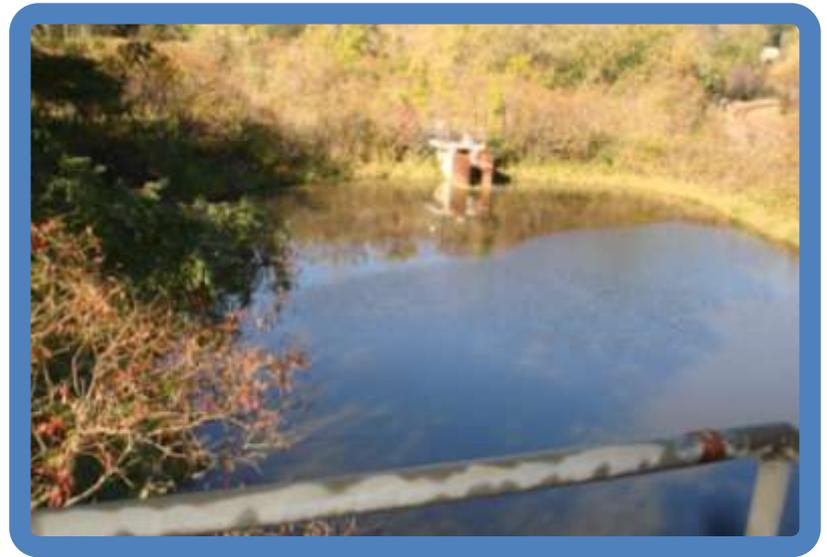
Picture 3.6

Outfall Pond 2 Upstream end of Outflow structure

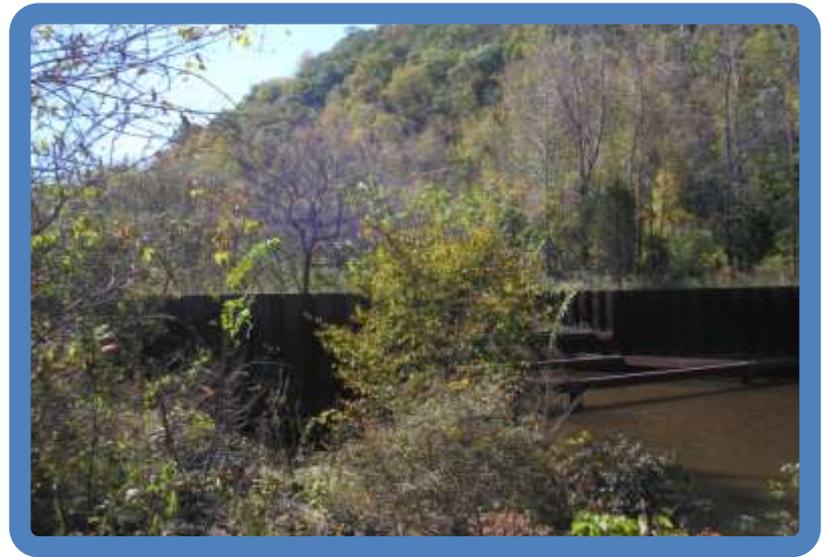
Picture 3.10
Outfall Access Road box culvert Looking south

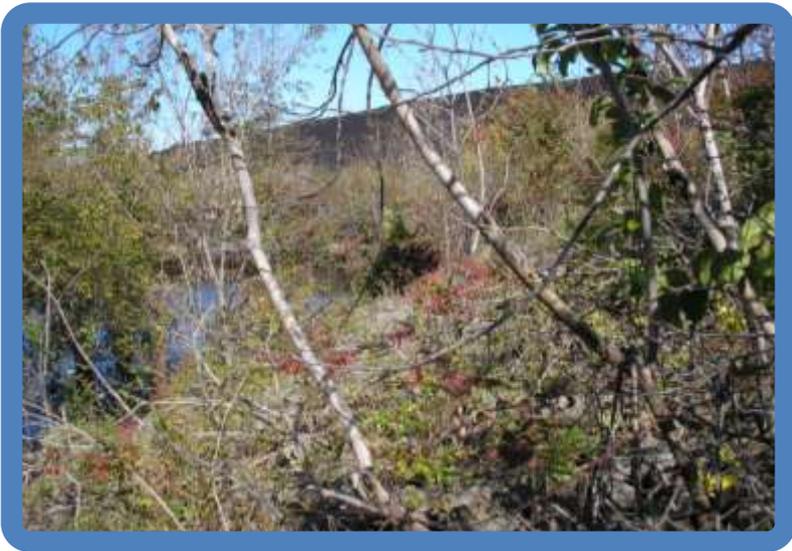
Picture 3.11
Outfall Pond 2 discharge area into channel Looking north

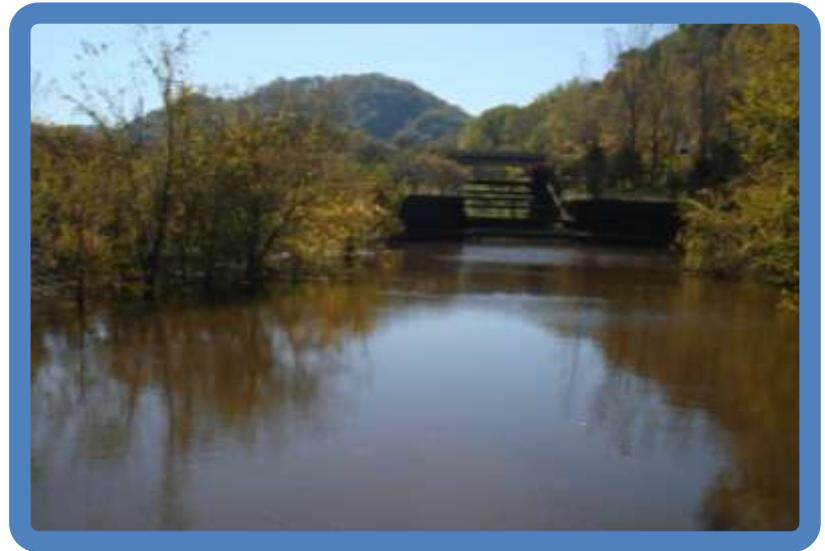
Picture 3.12
Outfall Access Road box culvert Looking south
