**DRAFT REPORT  
ROUND 10 DAM ASSESSMENT - MAY 31, 2011  
ALLIANT ENERGY – EDGEWATER GENERATING STATION  
SLAG POND, NORTH POND A, SOUTH POND A, POND B, POND F  
SHEBOYGAN, WISCONSIN**

RE: Assessment of Dam Safety of Coal Combustion Surface Impoundments at the Edgewater  
Generating Station

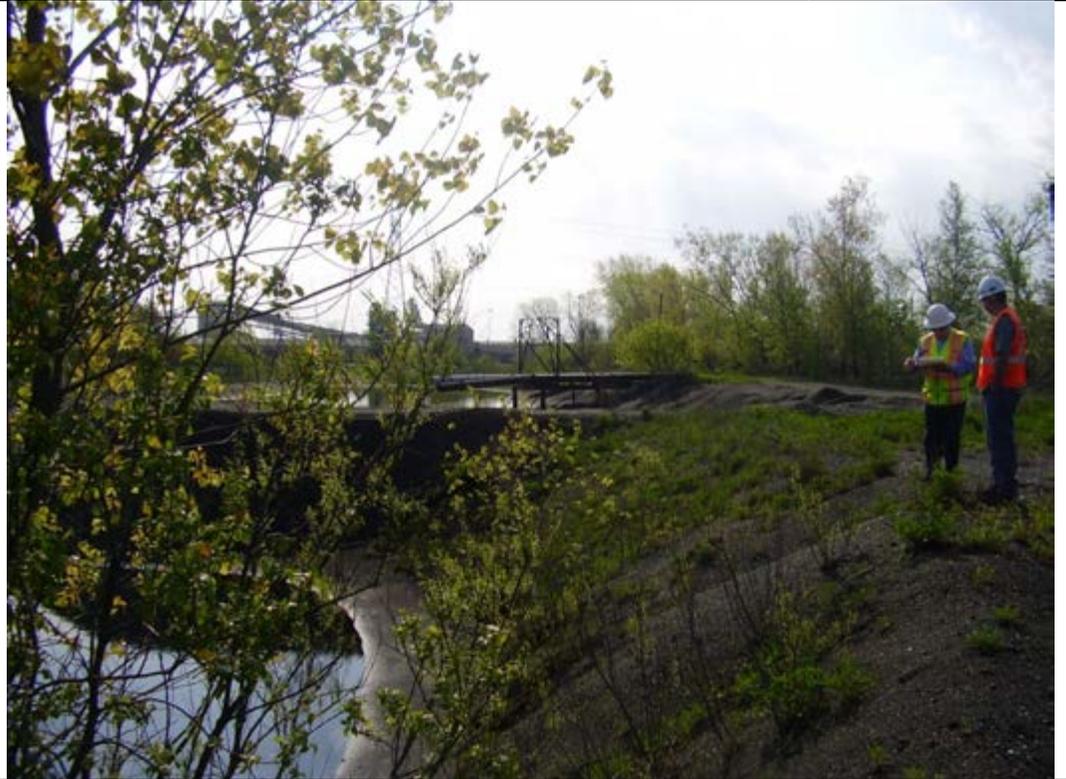
Upstream slope of the Slag Pond with the discharge pipe trestle in the background.

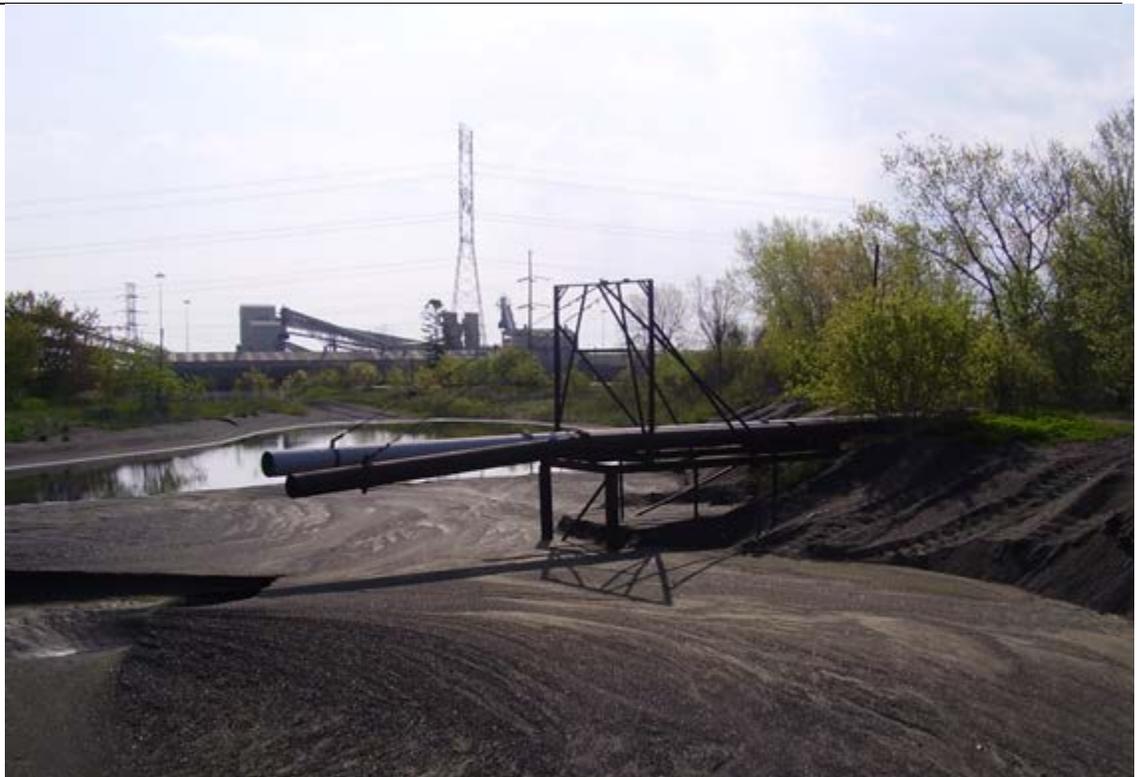
**Photo No.**  
2

Upstream slope of the Slag Pond with the discharge pipe trestle.

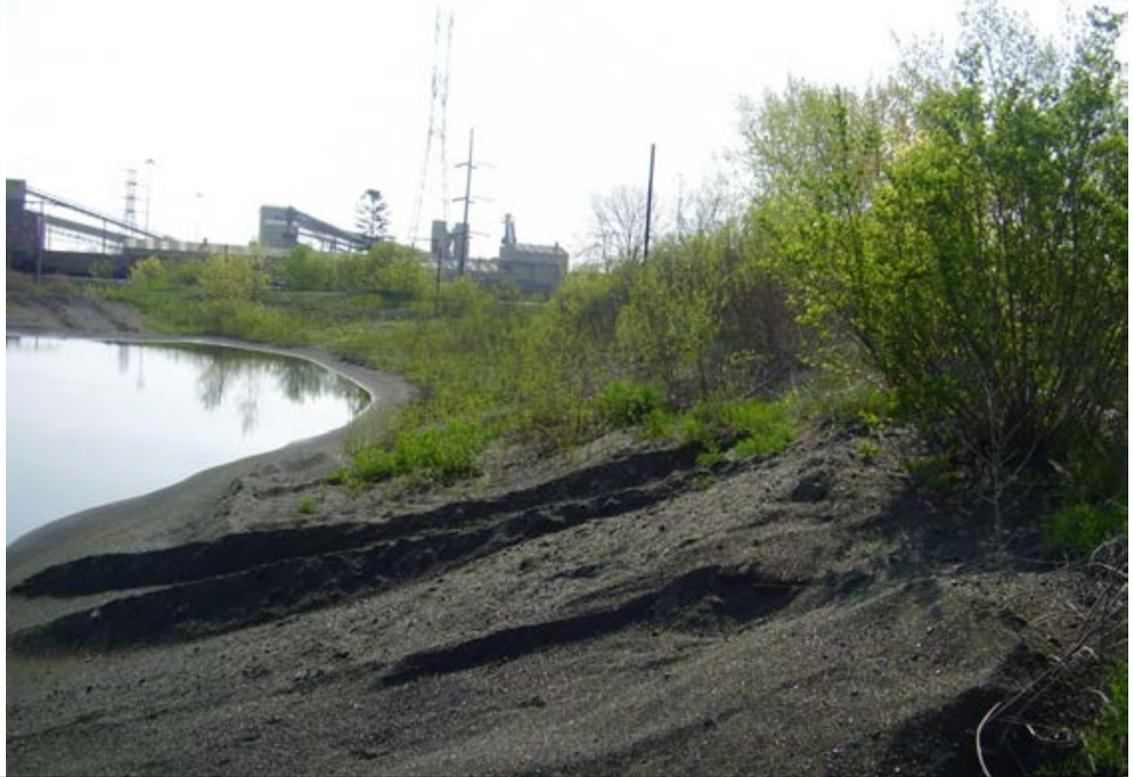
**Description:**  
Upstream slope of the Slag Pond.

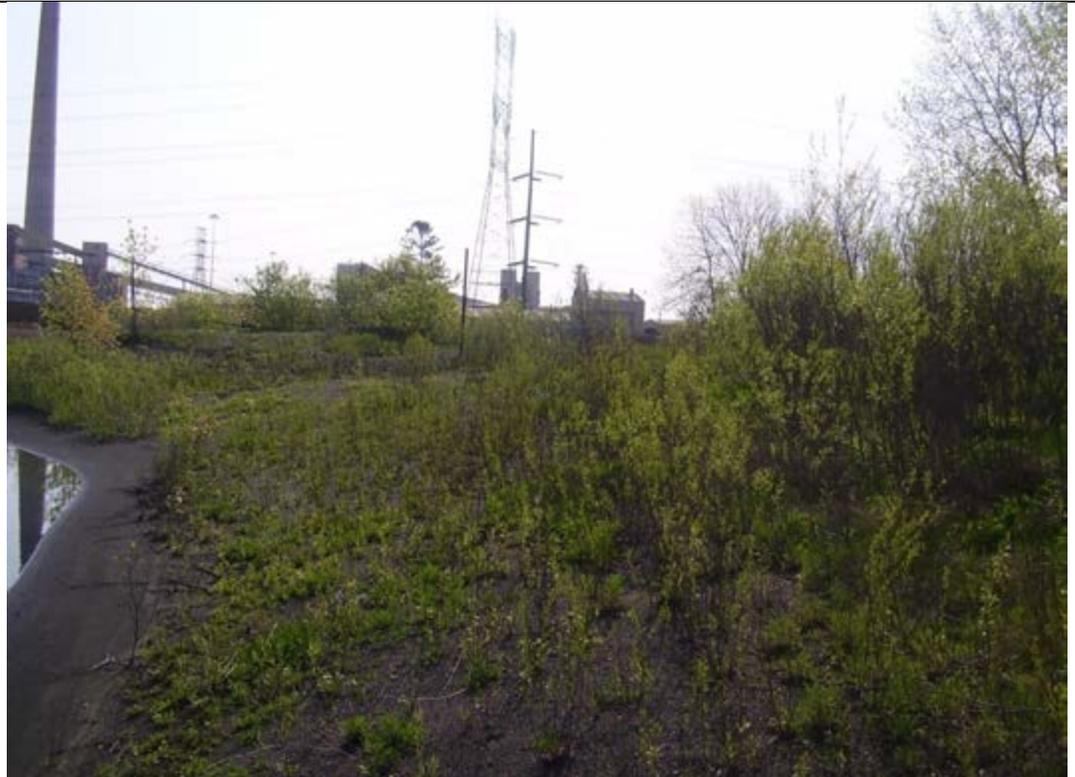
**Photo No.**  
**4**

**Description:**  
Upstream slope of the Slag Pond.

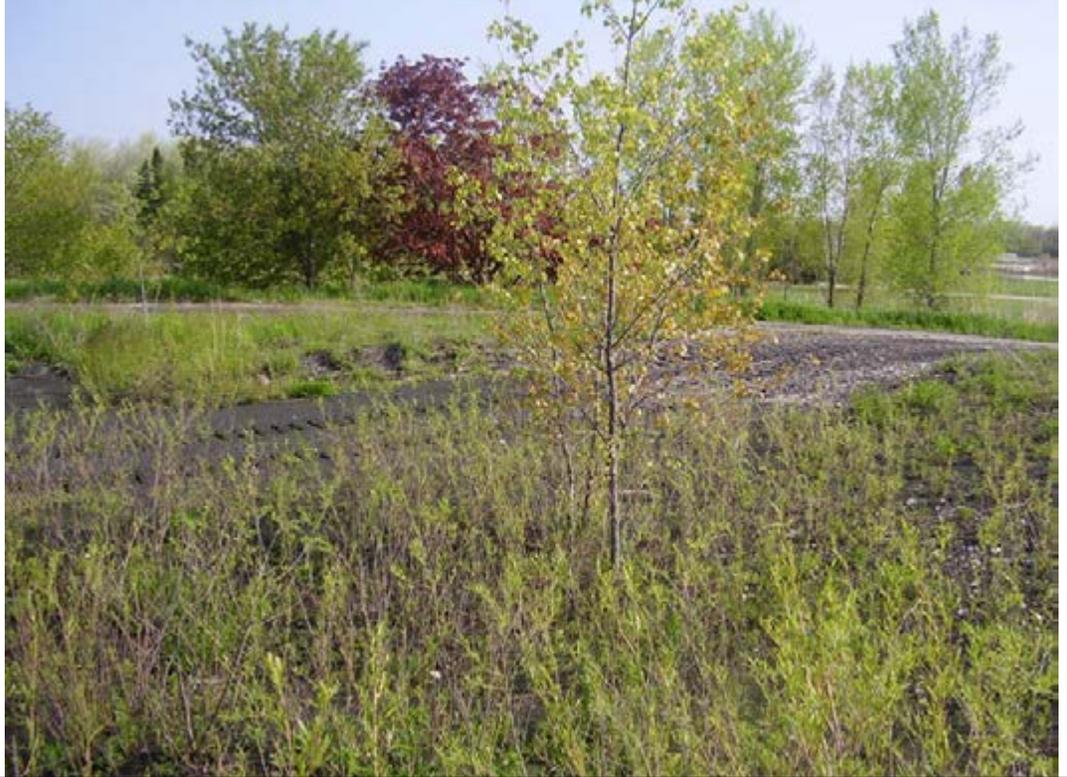
**Description:**  
Upstream slope of the Slag Pond.

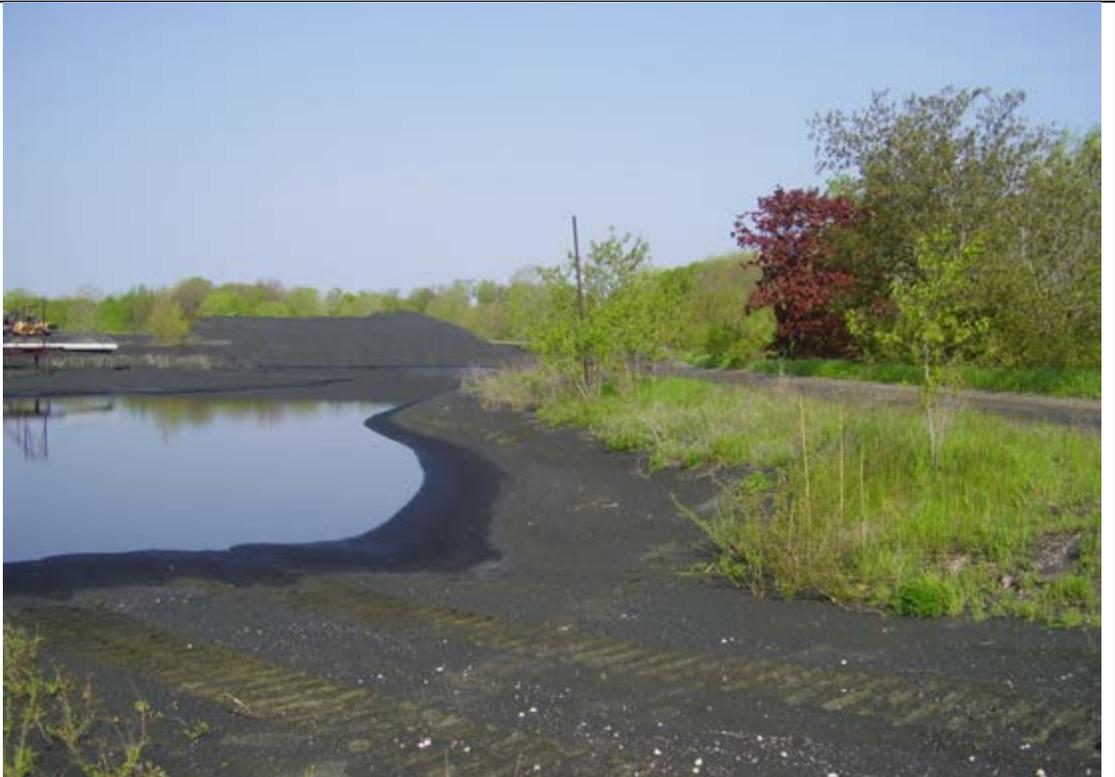
**Photo No.**  
**6**

**Description:**  
Upstream slope of the Slag Pond.

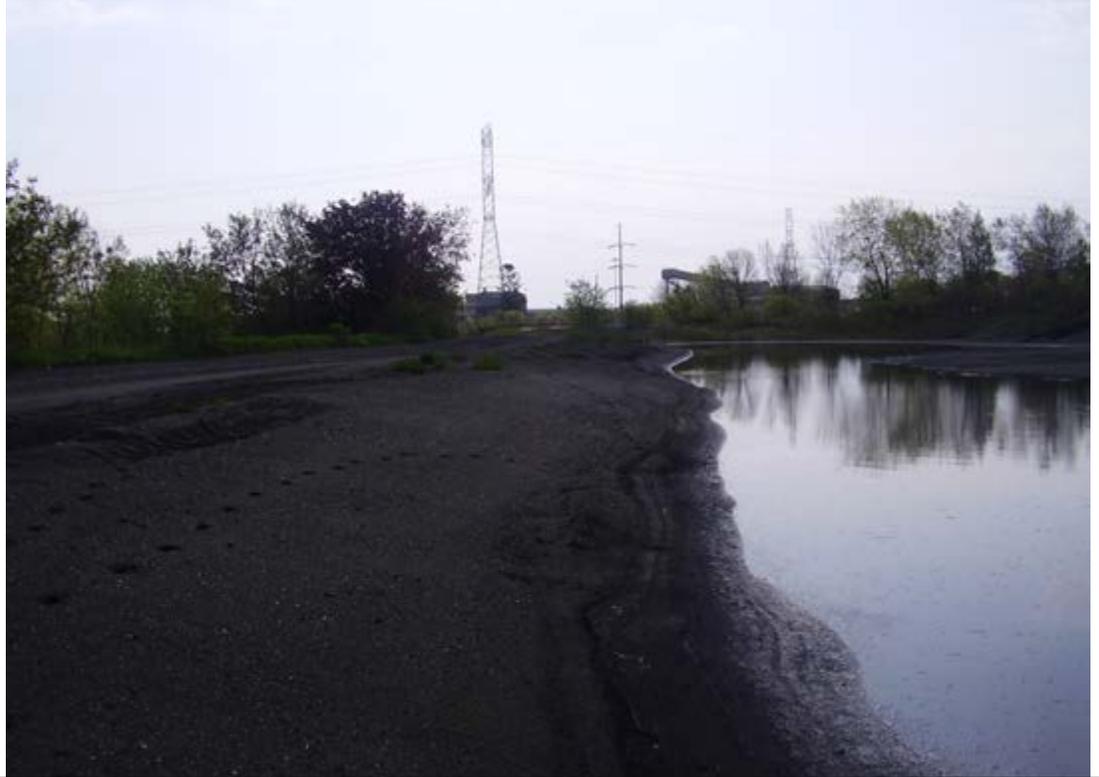
**Description:**  
Upstream slope of the Slag Pond.

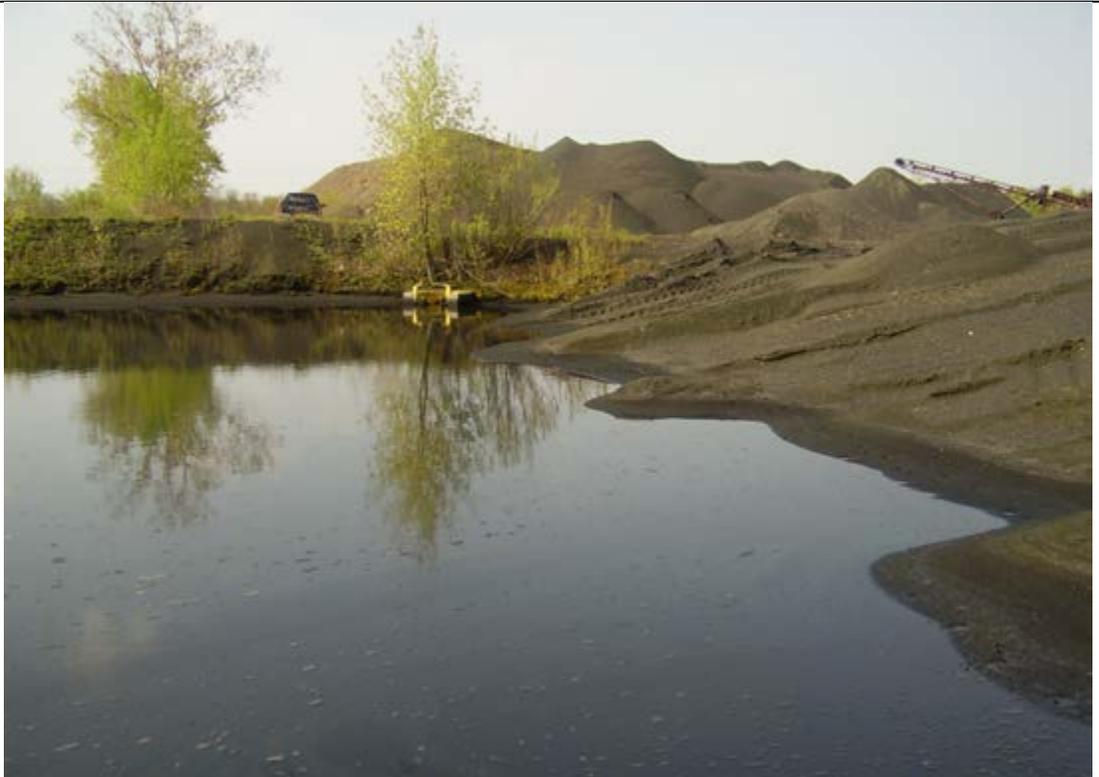
**Photo No.**  
8

**Description:**  
Upstream slope of the Slag Pond.

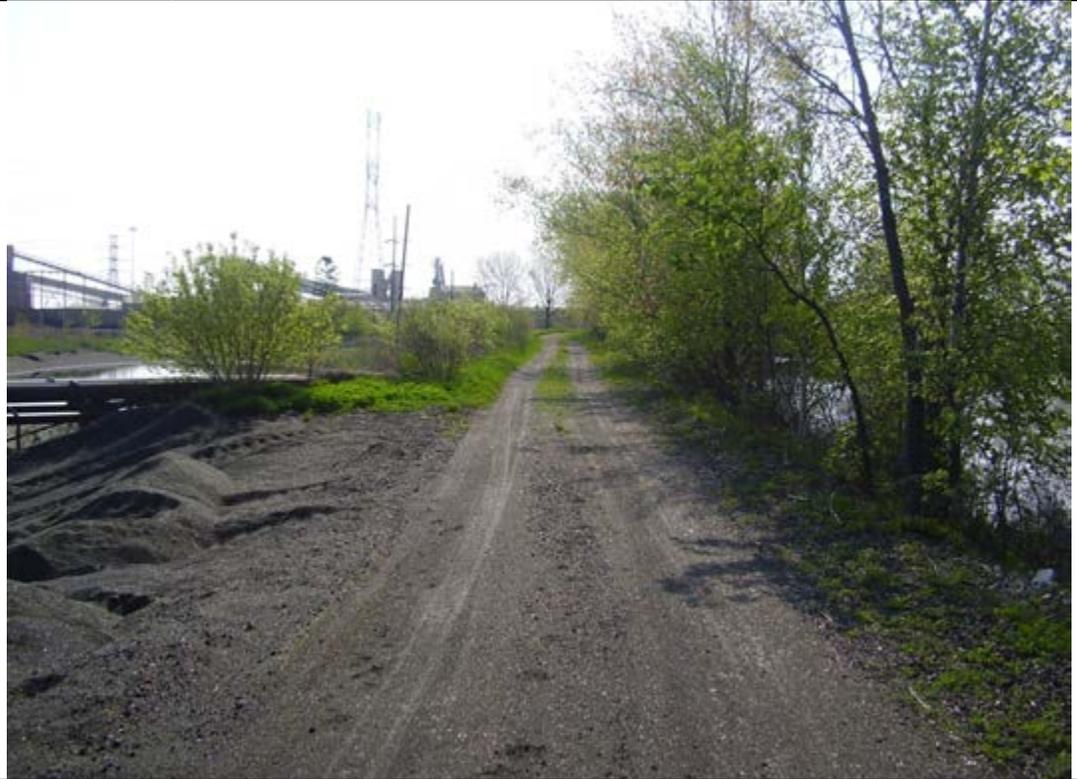
**Description:**  
Crest of the Slag Pond.

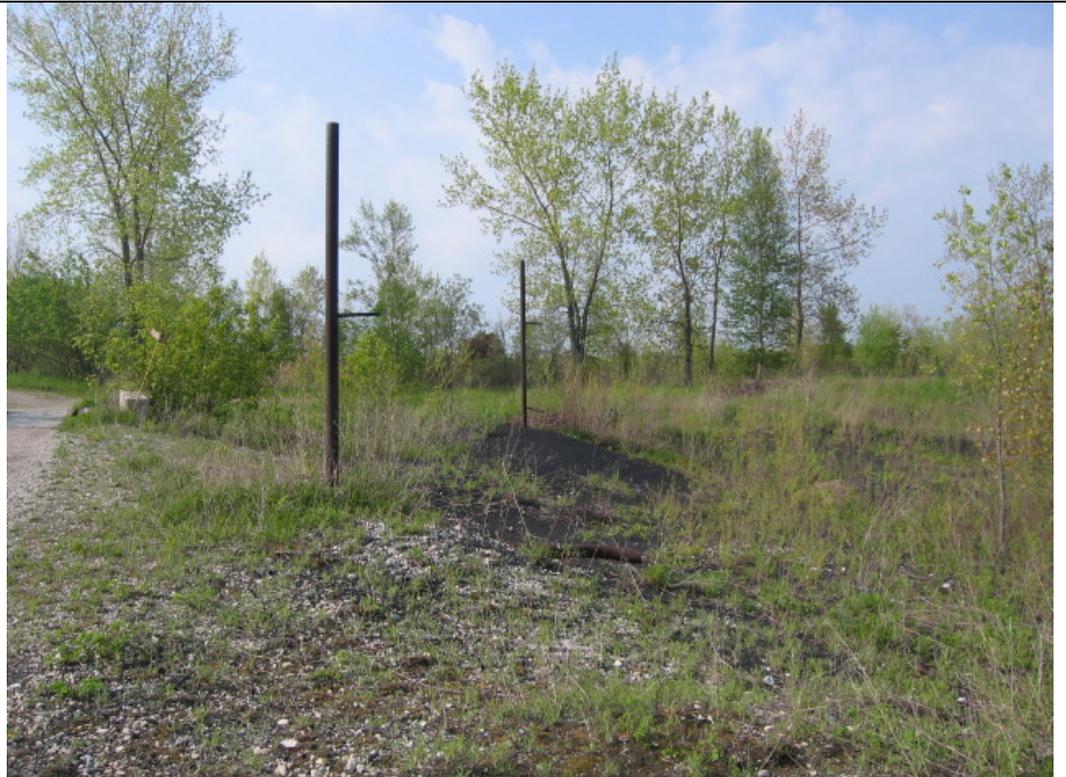
**Photo No.**  
**10**

**Description:**  
Crest of the Slag Pond.

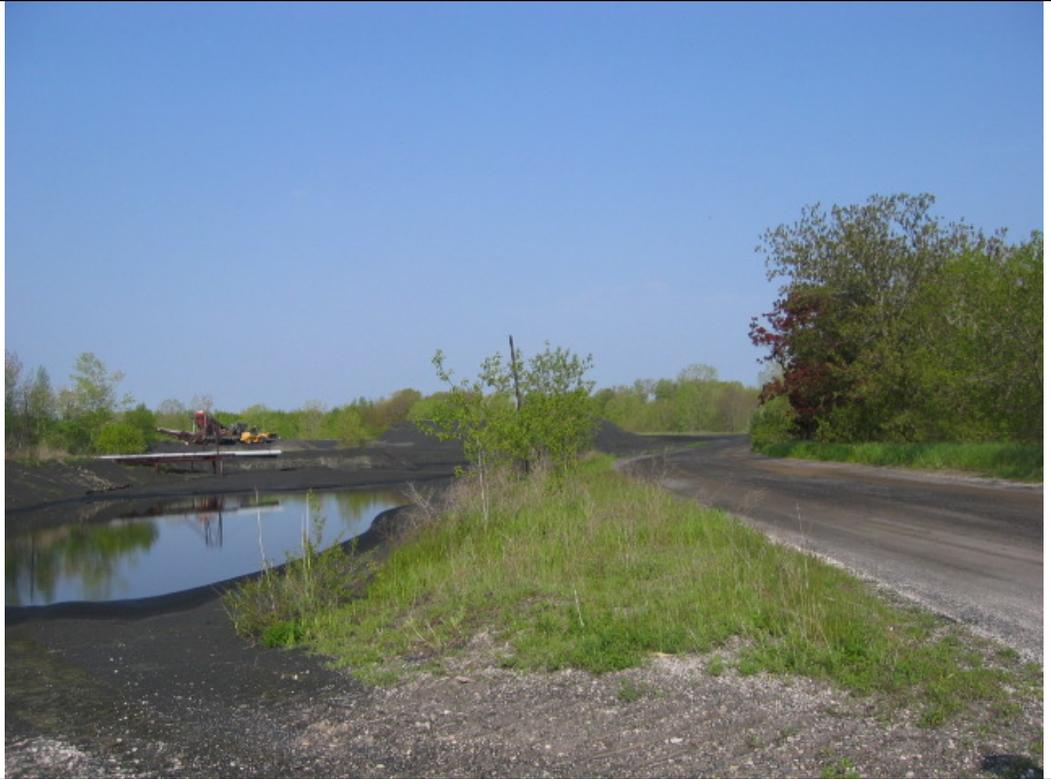
Description:  
Crest and upstream slope of  
the Slag Pond.

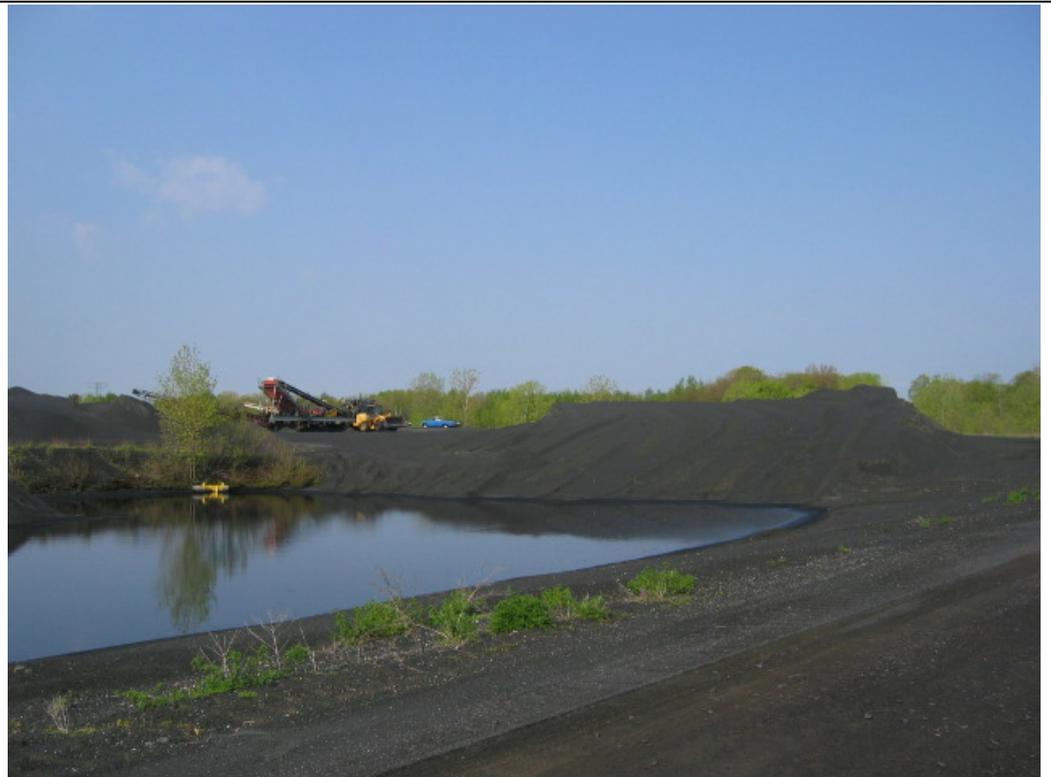
Photo No.  
**12**

Description:  
Crest and upstream slope of  
the Slag Pond.

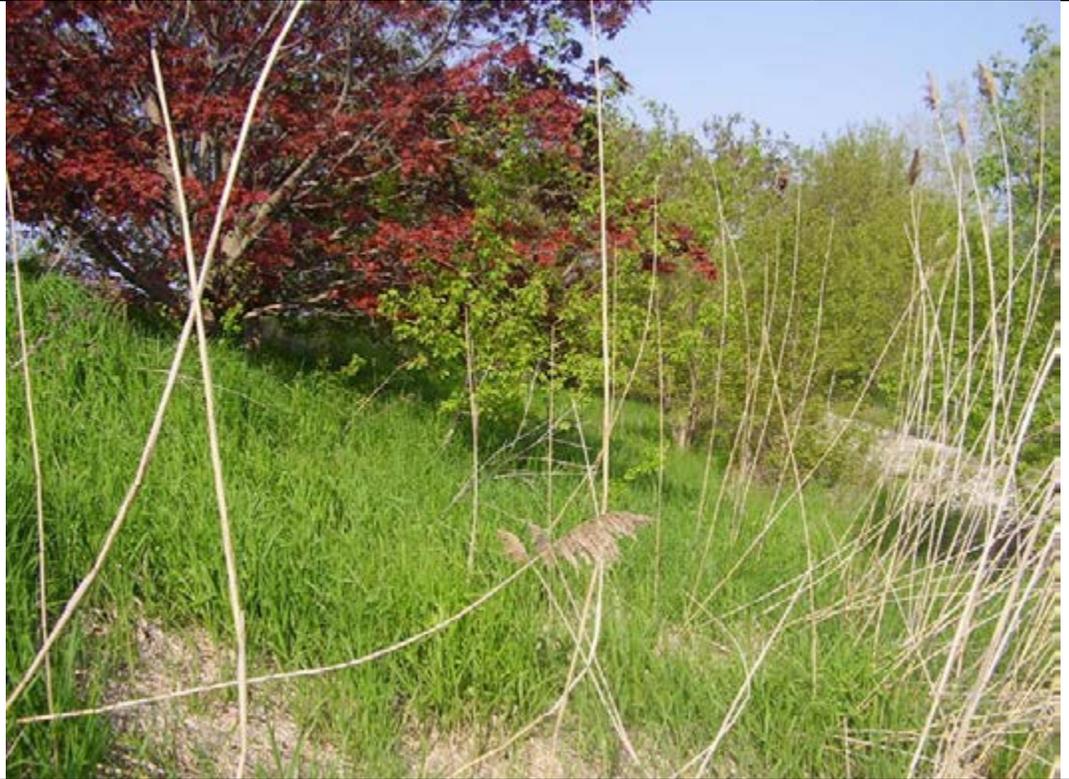
Description:  
Downstream slope of the  
northern embankment of the  
Slag Pond.

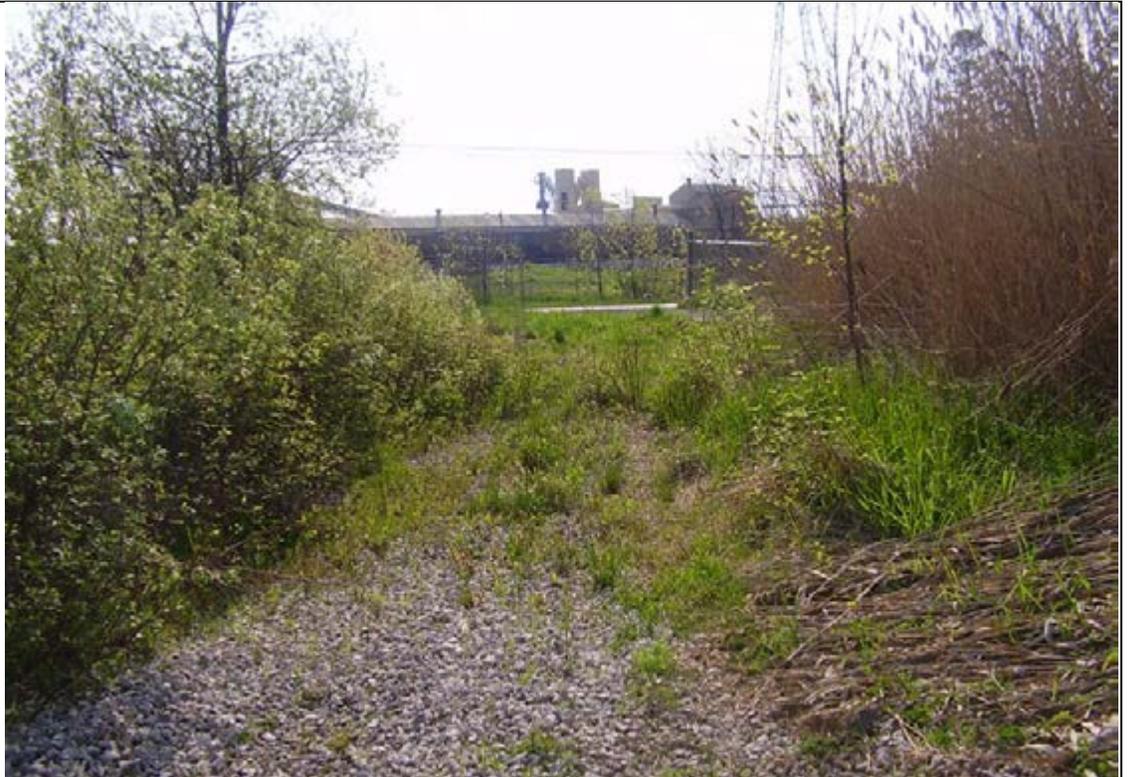
Photo No.  
14

Description:  
Downstream slope and toe of  
the Slag Pond.

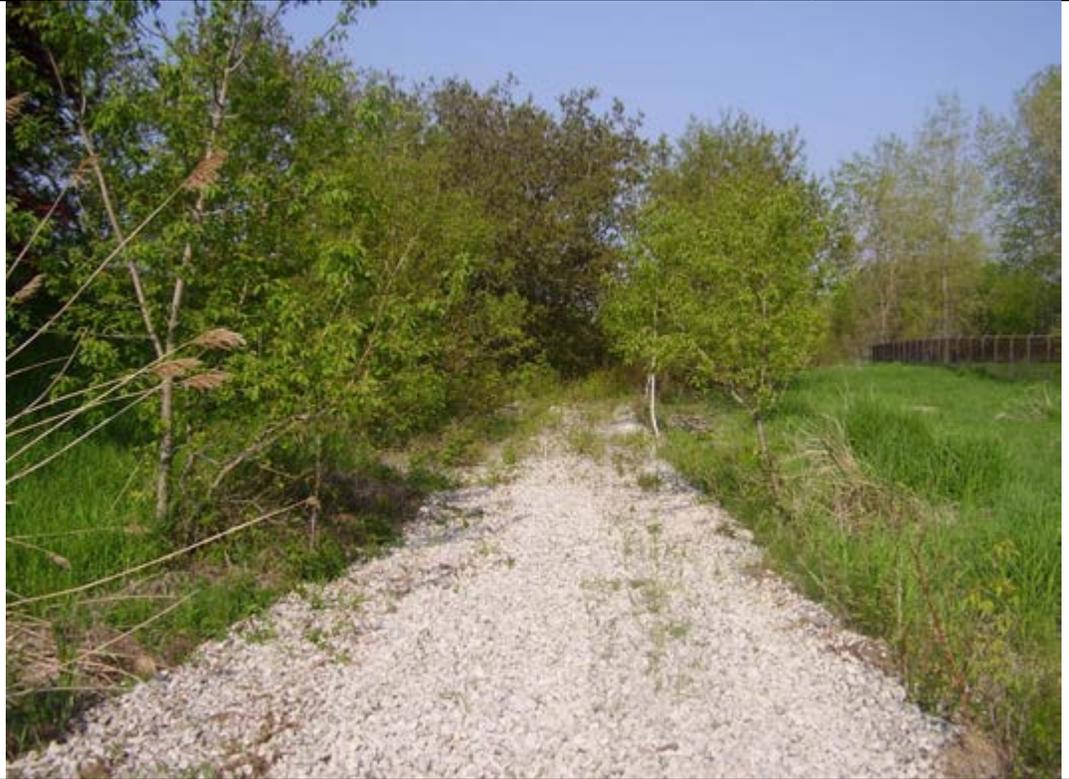
**Description:**  
Downstream slope and toe of the Slag Pond.

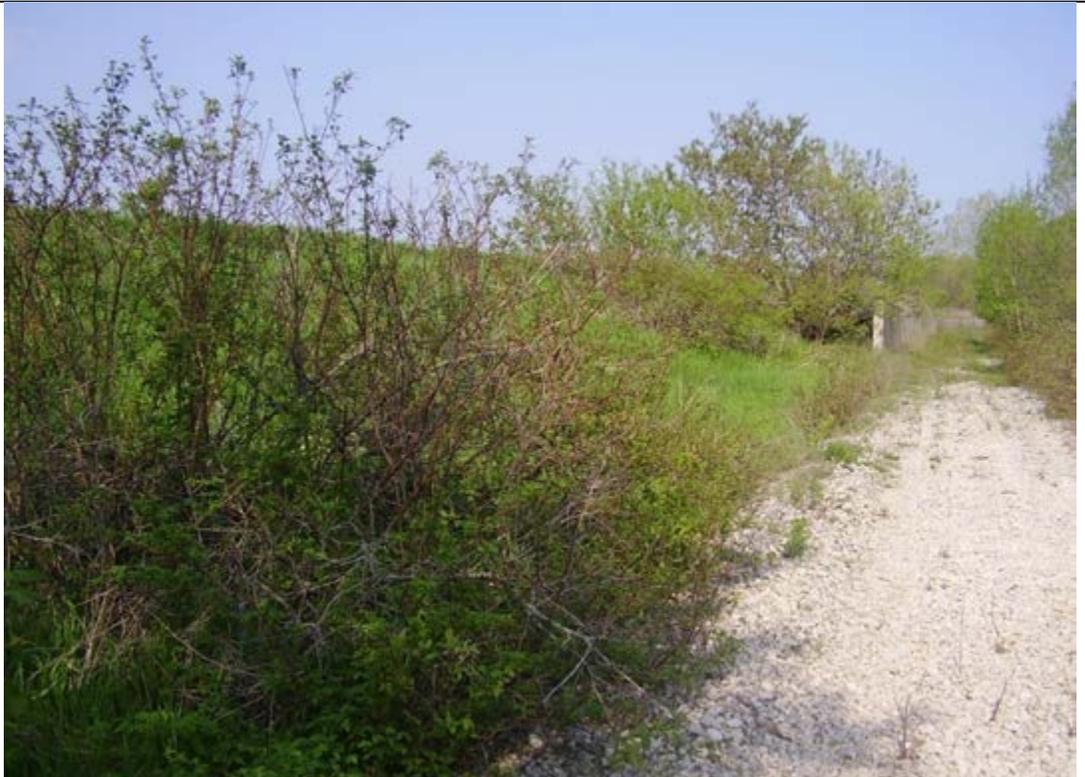
**Photo No.**  
**16**

**Description:**  
Downstream slope and toe of the Slag Pond.

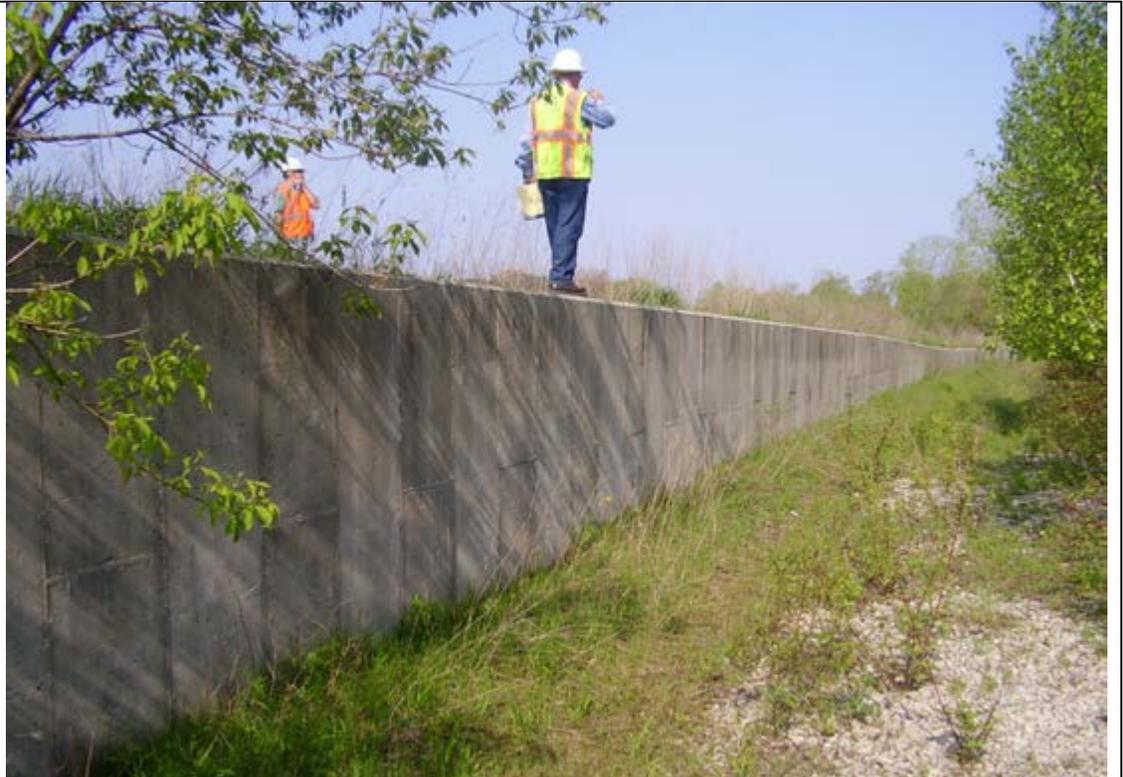
Cast-in-place concrete retaining wall on western portion of the downstream slope of Slag Pond.

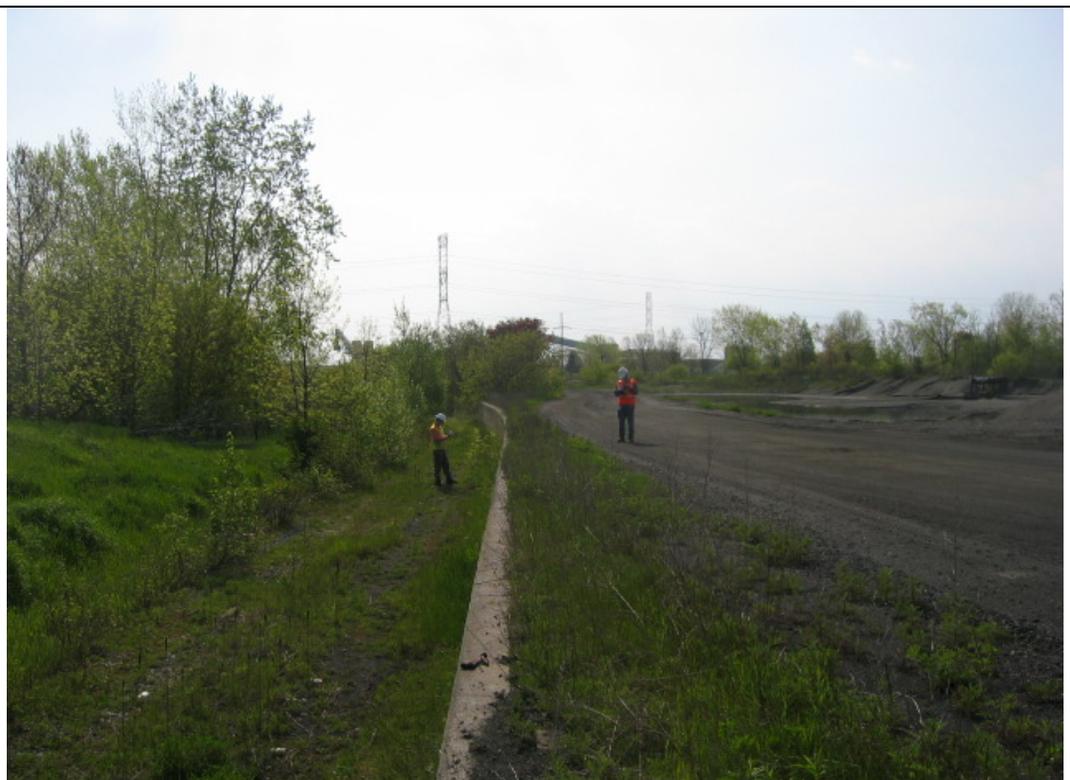
**Description:**  
Top of the concrete retaining wall.

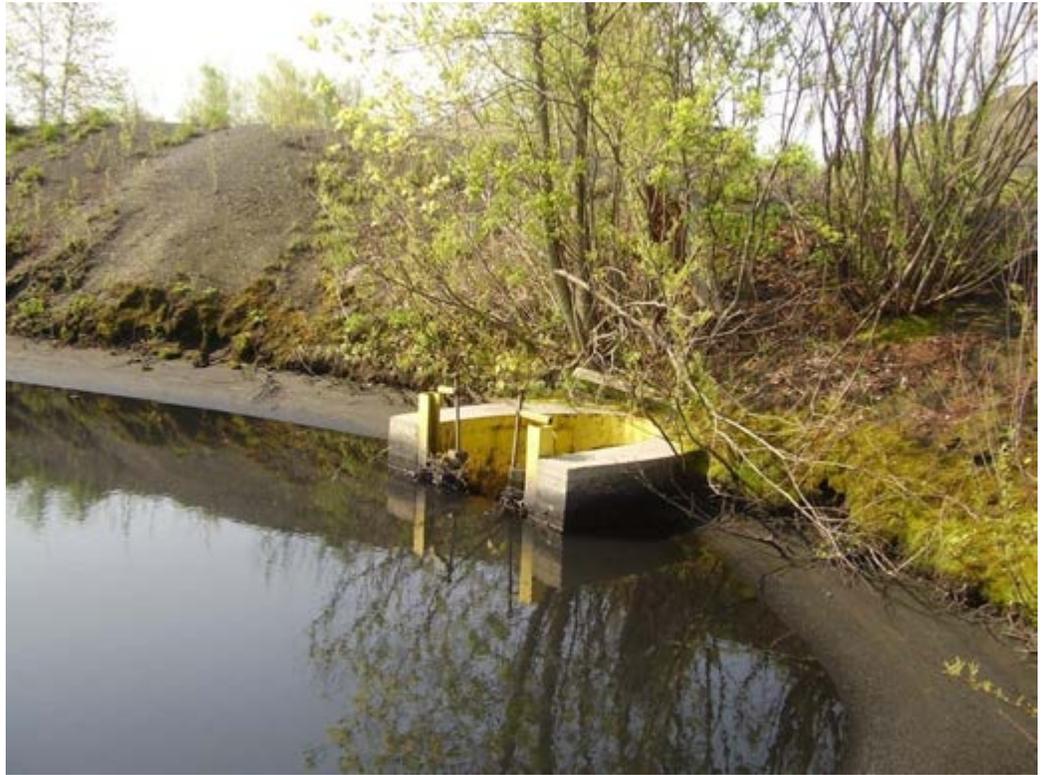
Decant structure in the  
southwest corner of the Slag  
Pond.

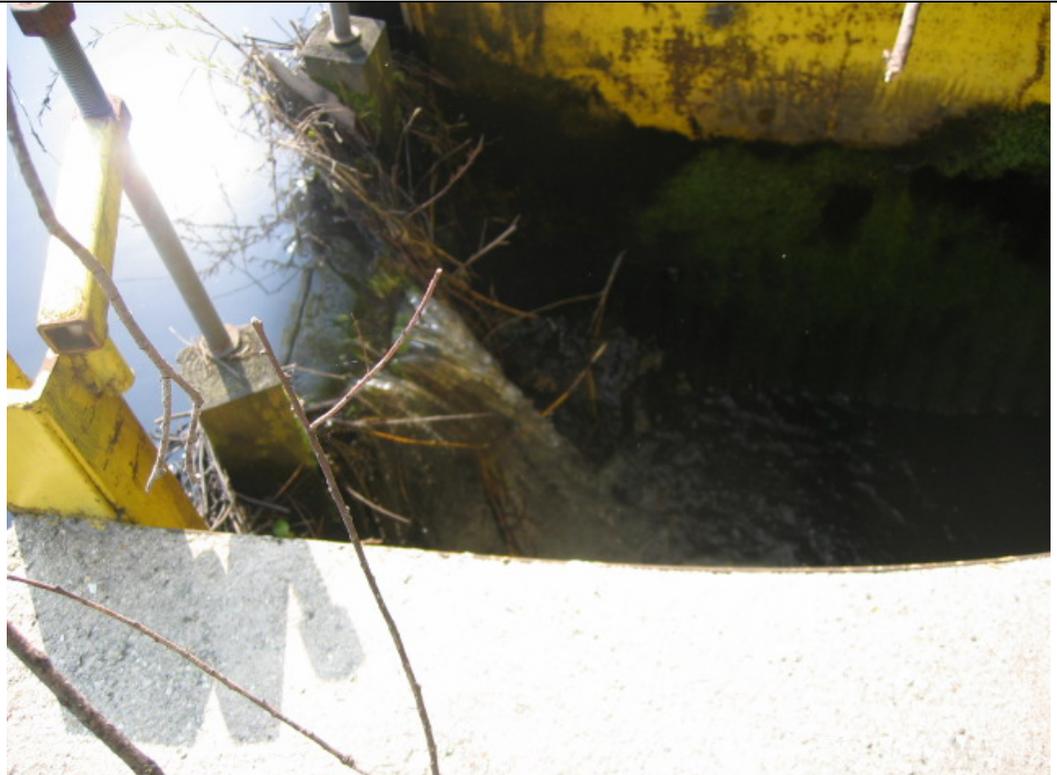
Photo No.  
**22**

Decant structure in the  
southwest corner of the Slag  
Pond.

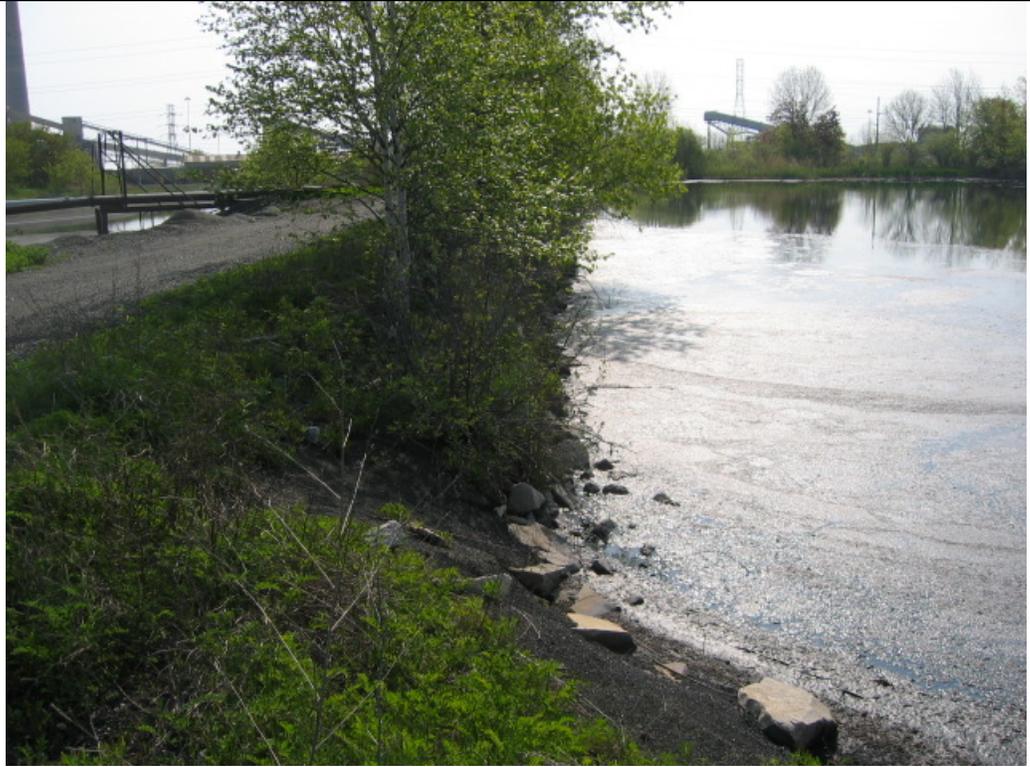
**Description:**  
Upstream slope of the North Pond A.

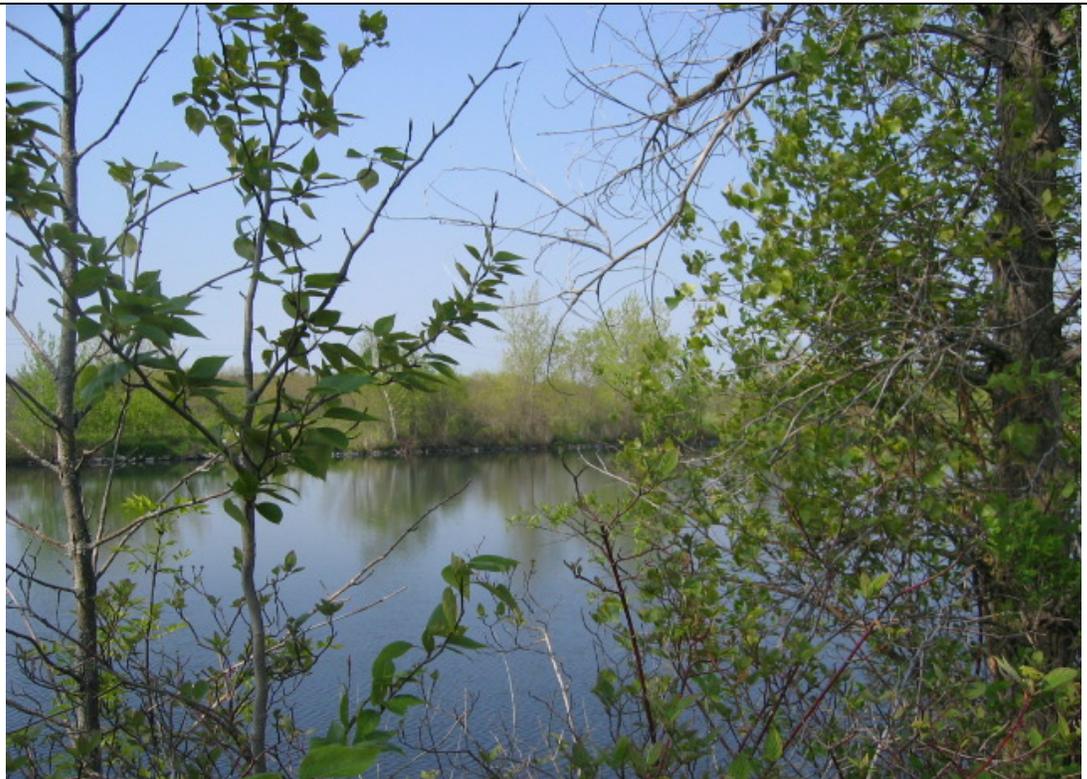
**Photo No.**  
**24**

**Description:**  
Upstream slope of the North Pond A.

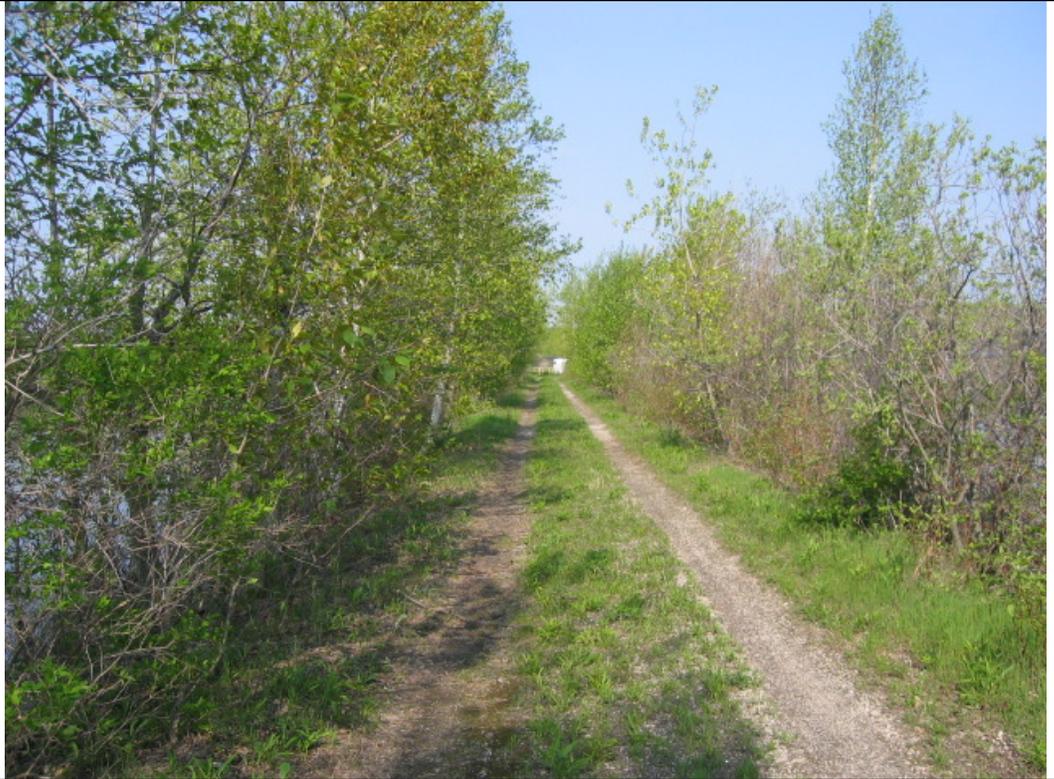
**Description:**  
Crest and Upstream slope of North Pond A and South Pond A.

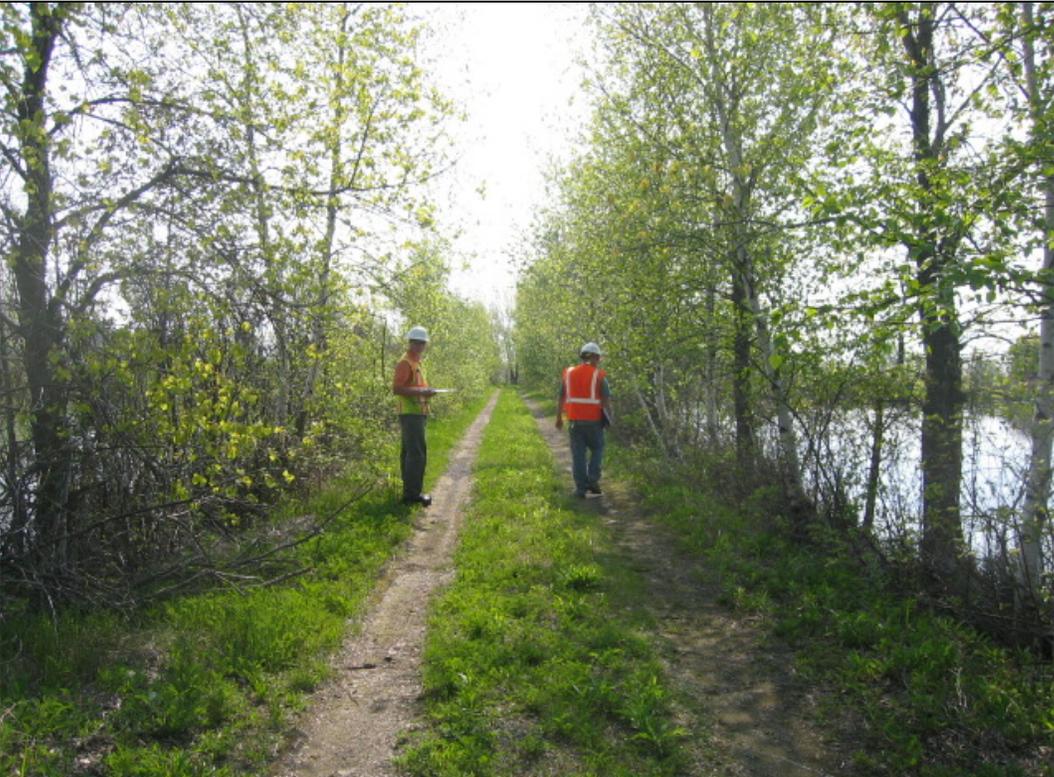
**Photo No.**  
**26**

**Description:**  
Crest and Upstream slope of North Pond A and South Pond A.

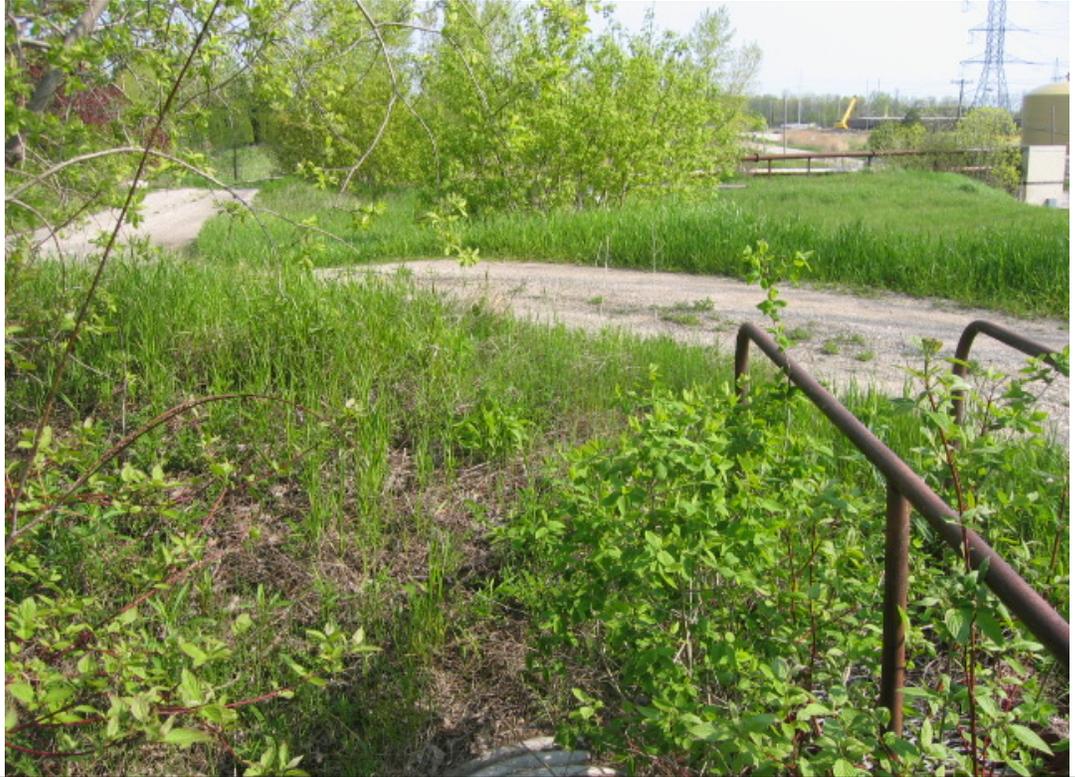
Description:  
Crest and Upstream slope of  
North Pond A.

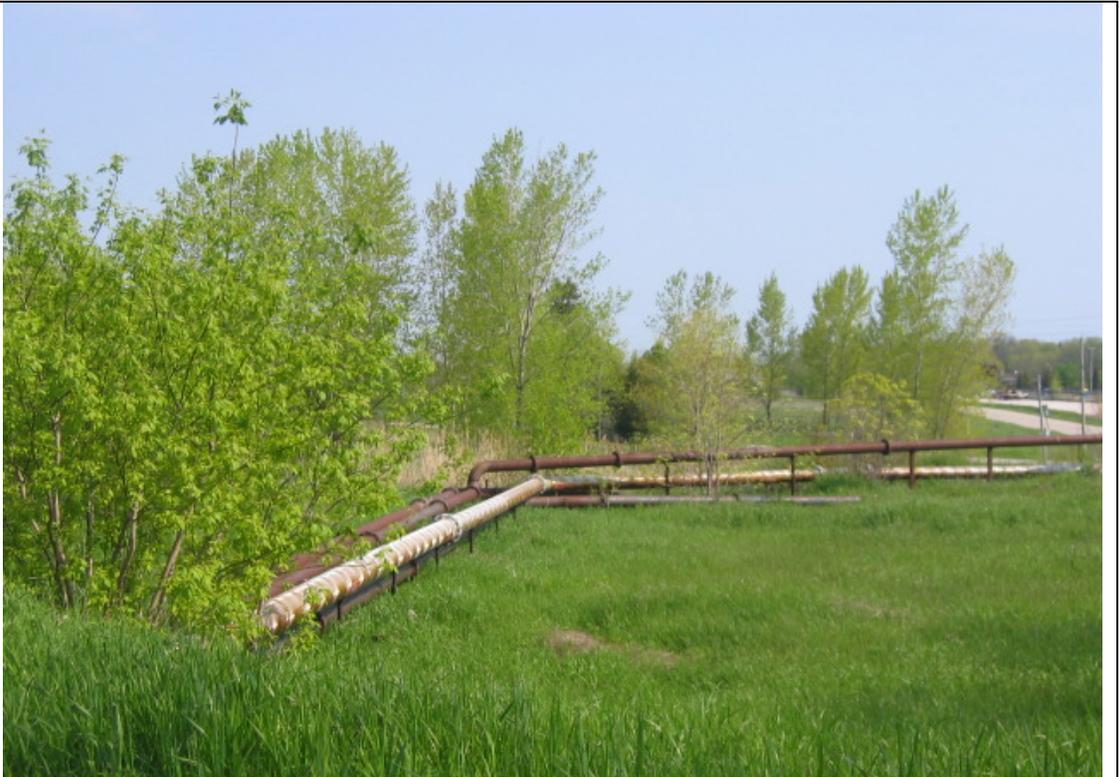
Photo No.  
**28**

Description:  
Sluice pipes for transporting  
water and Coal Combustion  
Waste from the plant.

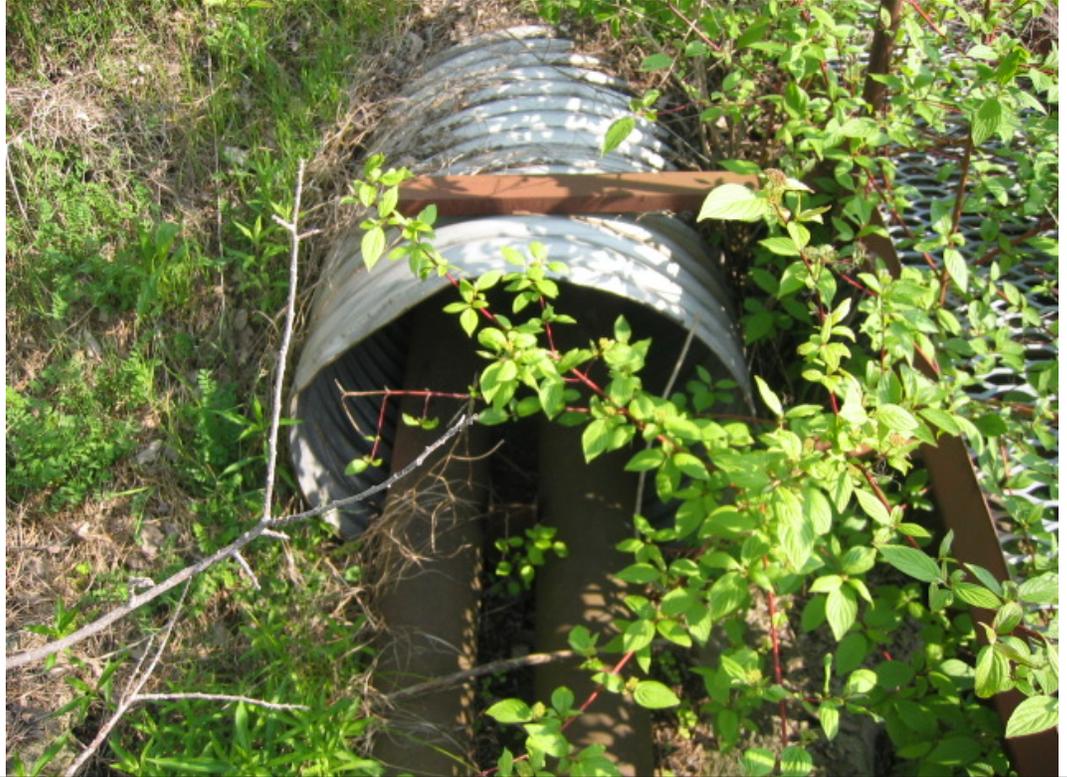
**Description:**  
Sluice pipes where they  
penetrate the embankment to  
the North Pond A.
